Amarillo LE- ADA Evaluation

LE-Amarillo TX, ADA Evaluation
203 SW 8th Ave
Amarillo, TX 79101
Accessibility Evaluation
Inspection Date: 01/17/2023
Inspectors: Jessica Burke

Report Date: 01/12/2024

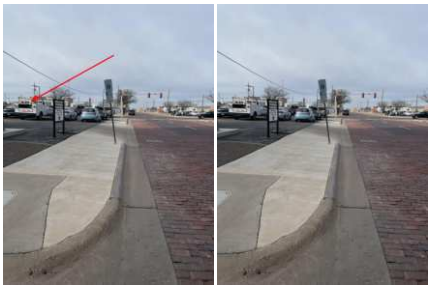
Finding Number	Area Description	Finding	As Built	Recommendation	Citation	Photos	Figure
1	Exterior of Property (Public) : Parking lot (Reserved Lot)	There are no accessible parking stalls. Each lot where parking is provided for the public as clients, guests or employees, shall provide accessible parking and shall be located on the shortest accessible route of travel from adjacent parking to an accessible entrance. There are a total of (XX) parking stalls in the parking lot that could be reasonably associated with this facility. There should be a minimum of (XX) accessible stalls with a minimum of (XX) being designed as van accessible.	No accessible parking spaces provided in reserved lot of building. 4 visitor spaces provided but none are ADA compliant. * Need more pictures	N/A - Refer to Finding	2012 TAS Section: 208.2 2010 ADAS Section: 208.2

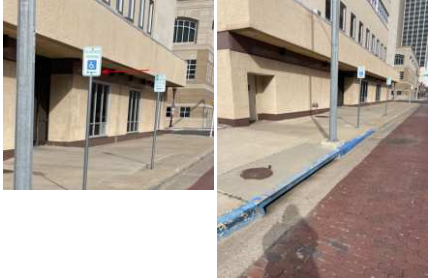
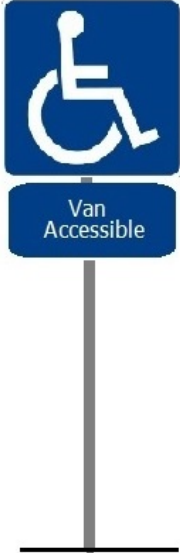
Finding Number	Area Description	Finding	As Built	Recommendation	Citation	Photos	Figure
4	Exterior of Property (Public) : Parking Off Street (2 Spaces) 2 Labeled - Accessible Stall (Labeled #1)	The van stall is missing a sign identifying it as a van accessible stall. Parking space identification signs shall include the International Symbol of Accessibility. Signs identifying van parking spaces shall contain the designation "van accessible."	Sign does not designate van accessible parking.		https://www.access-board.gov/ada/#ada-502_6 2012 TAS Section: 502.6 2010 ADAS Section: 502.6

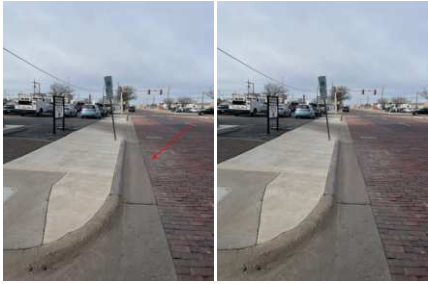
8	Exterior of Property (Public) : Parking Off Street (2 Spaces) 2 Labeled - Accessible Stall (Labeled #2)	The parking space is in not nearly compliant. The parking space the minimum width. The floor or ground surface is not firm stable or slip resistant. The parking space contains changes in level and/or gaps that exceed the maximum allowable requirements. The parking space does not have the proper identifications signs or the signs are not installed at the correct height. The parking space is missing an adjacent access aisle.	Accessible spot located on street. No designated markings for space dimensions or access aisle	https://www.access-board.gov/ada/#ada-502_1	2012 TAS Section: 502.1, 502.1 Exception 2010 ADAS Section: 502.1, 502.1 Exception

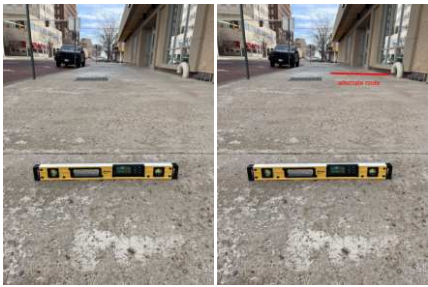
12	Exterior of Property (Public) : Path of Travel to Building - Path of Travel (Main Route)	The accessible path of travel has cross slopes greater than 2%. Surface cross slopes shall not exceed one unit vertical in 48 units horizontal (2-percent slope). When the slope in the direction of travel of any walk exceeds 1 unit vertical in 20 units horizontal (5-percent slope), it must be constructed as a ramp.	4.8% cross slope on sidewalk leading to exterior door. Pathway is large enough for alternative accessible route.	https://www.access-board.gov/ada/#ada-403_3	2012 TAS Section: 403.3 2010 ADAS Section: 403.3

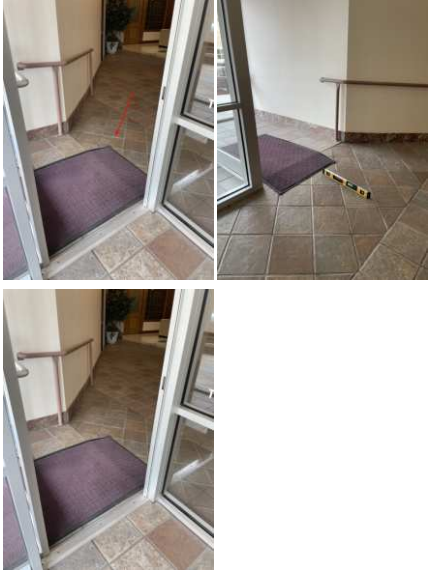
Finding Number	Area Description	Finding	As Built	Recommendation	Citation	Photos	Figure
15	First Floor Main Building LOBBY (Public): Exterior Entrance/Exit into Lobby	The clear floor space required at the element is not flat (2% or 1:48 maximum slope) in all directions. Changes in level are not permitted at required clear floor or ground space except that slopes not steeper than 1:48 shall be permitted.	9.8% slope on ramp directly connected to door opening space	https://www.access-board.gov/ada/#ada-305_2	2012 TAS Section: 305.2 2010 ADAS Section: 305.2

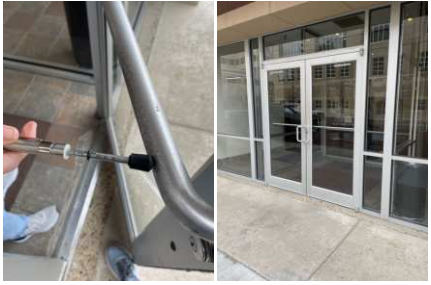
16	First Floor Main Building LOBBY (Public): Exterior Entrance/Exit into Lobby - Entrance Doors	The force required to operate the door hardware exceeds 5 pounds. The force required to activate operable parts is 5 pounds maximum.	15 pounds of force required to open door. Interior vestibule door.	https://www.access-board.gov/ada/#ada-309_4	2012 TAS Section: 309.4 2010 ADAS Section: 309.4

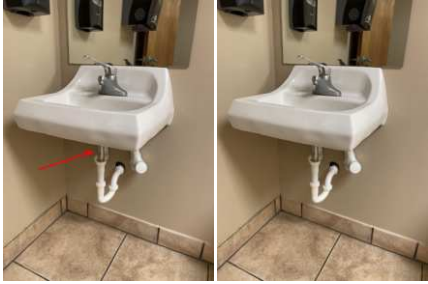
24	First Floor Main Building LOBBY (Public): Lobby Area - Restroom (Men's)	The water and drain pipes under the lavatory are not adequately insulated. Water supply and drain pipes under lavatories and sinks shall be insulated or otherwise configured to protect against contact. There shall be no sharp or abrasive surfaces under lavatories and sinks.	N/A	https://www.access-board.gov/ada/#ada-606_5	2012 TAS Section: 606.5 2010 ADAS Section: 606.5

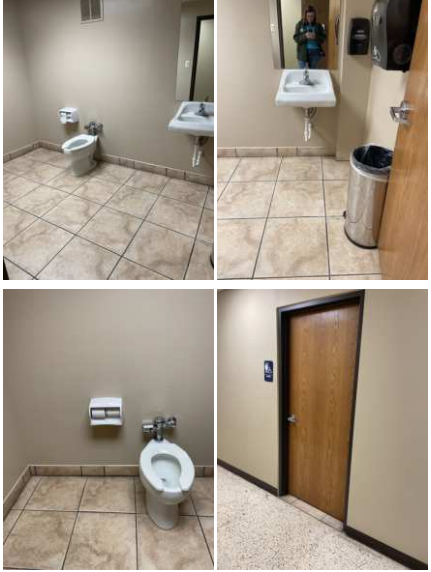
Finding Number	Area Description	Finding	As Built	Recommendation	Citation	Photos	Figure
25	First Floor Main Building LOBBY (Public): Lobby Area - Restroom (Women's)	The restroom is not nearly compliant. The restroom does not have the required minimum clear floor space or maneuvering clearances for the toilet. The restroom does not have the required minimum clear floor space or maneuvering clearances for the lavatory. The entry door does not contain the required minimum maneuvering spaces on the pull/push sides. The entry door encroach into the required clear floor space for fixtures. Grab bars are missing and/or incorrectly installed. Accessories, such as toilet seat covers, paper towel holders, garbage cans, hand dryers, and mirrors are either too high or without clear floor space or both. The restroom contain floor level changes greater than a 1/2 inch of the floor drains and is slope (XX) - (XX), the shower is too small and missing numerous accessible elements.	This restroom is not compliant	This restroom requires a number of componets to gain compliance. https://www.access-board.gov/ada/#ada-213_2 Review restrooms componets to make accessible. https://www.access-board.gov/ada/#ada-603	2012 TAS Section: 213.2 2010 ADAS Section: 213.2

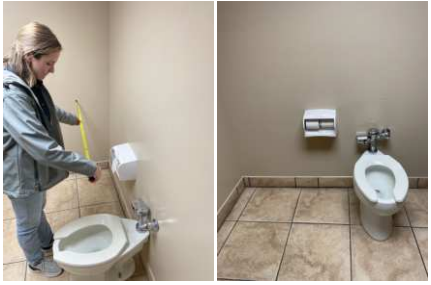
26	First Floor Main Building LOBBY (Public): Lobby Area - Restroom (Women's)	The toilet is not located within the range allowed from the side wall or partition. The centerline of the toilet must be 16 to 18 inches from the side wall.	Toilet more than 18" from side wall	https://www.access-board.gov/ada/#ada-604_2	2012 TAS Section: 604.2 2010 ADAS Section: 604.2

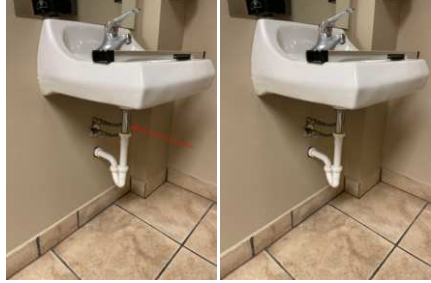
Finding Number	Area Description	Finding	As Built	Recommendation	Citation	Photos	Figure
30	First Floor Main Building LOBBY (Public): Lobby Area - Restroom (Women's)	The water and drain pipes under the lavatory are not adequately insulated. Water supply and drain pipes under lavatories and sinks shall be insulated or otherwise configured to protect against contact. There shall be no sharp or abrasive surfaces under lavatories and sinks.	N/A	https://www.access-board.gov/ada/#ada-606_5	2012 TAS Section: 606.5 2010 ADAS Section: 606.5

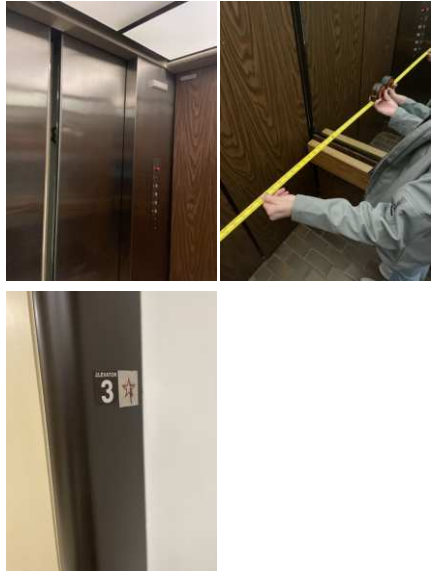
31	First Floor Main Building LOBBY (Public): Lobby Area - Elevator	The elevator audible signal is missing. A visible and audible signal shall be provided at each hoistway entrance to indicate which car is answering a call. Where in-car signals are provided, they shall be visible from the floor area adjacent to the hall call buttons.	The elevator does not audible signal passing floors.	https://www.access-board.gov/ada/#ada-407_2_2_1	2012 TAS Section: 407.2.2.1 Exception 2 2010 ADAS Section: 407.2.2.1 Exception 2

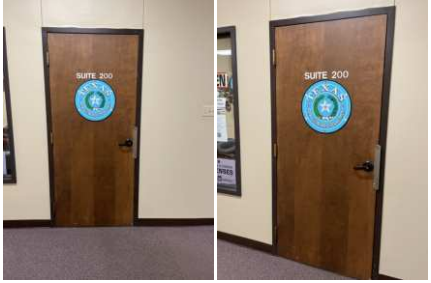
Finding Number	Area Description	Finding	As Built	Recommendation	Citation	Photos	Figure
35	Second Floor TPWD LE Office (Public): LE Office Interior - Entrance Doors into LE Office	The room identification sign is noncompliant. Wall signs identifying permanent rooms and spaces of a building shall be in a horizontal format and the characters raised 1/32 inch minimum and shall be sans serif uppercase characters a minimum of 5/8 inch and a maximum of 2 inches high. Characters and their background shall have a non-glare finish. Characters shall contrast with their background with either light characters on a dark background or dark characters on a light background. Signs with raised characters or Braille shall be located 48 inches minimum above the finish floor or ground surface, measured from the baseline of the lowest tactile character and 60 inches maximum above the finish floor or ground surface, measured from the baseline of the highest tactile character.	Signs that identify a room, space or area are required to have raised characters and Braille. This requirement includes both public access areas as well as all employee areas.	Wall sign designation https://www.access-board.gov/ada/#ada-216_2 Wall signs general https://www.access-board.gov/ada/#ada-703_1	2012 TAS Section: 216.2, 703.1 2010 ADAS Section: 216.2, 703.1

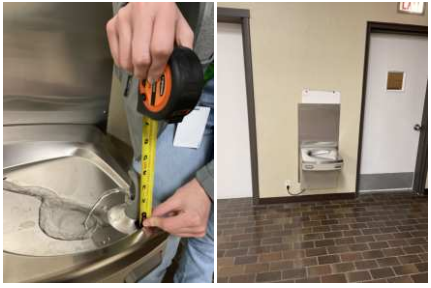
37	Second Floor TPWD LE Office (Public): Interior Hallways of Building - Water Fountain	The water flow does not meet minimum height requirements. The spout shall provide a flow of water 4 inches high minimum. The angle of the water stream from spouts within 3 inches of the front of the drinking fountain shall be 30 degrees maximum, and from spouts between 3 inches and 5 inches from the front of the unit, the angle of the water stream shall be 15 degrees maximum.	N/A	https://www.access-board.gov/ada/#ada-602_6	2012 TAS Section: 602.6 2010 ADAS Section: 602.6
