# College Station LE- ADA Evaluation

**LE-College Station TX, ADA Evaluation**  
**12815 Farm to Market Rd 2154 Suite 160**  
**College Station, TX 77845**  
**Accessibility Evaluation**  
**Inspection Date: 12/28/2022**  
**Inspectors: Christopher Meza**

Report Date: 01/12/2024

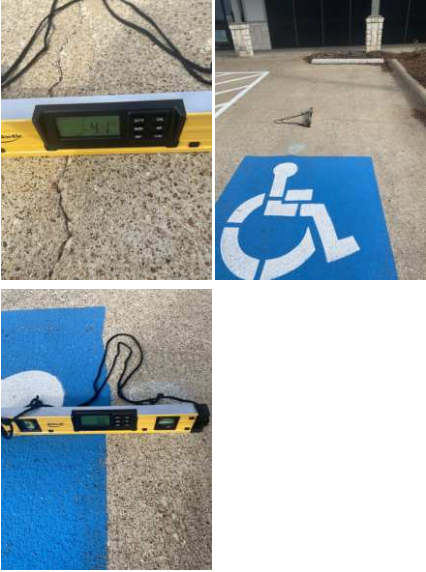
Finding Number	Area Description	Finding	As Built	Recommendation	Citation	Photos	Figure
3	Exterior of Property (Public) : Parking Lot (1 Space) 1 Van - Van Accessible Stall (R)	The running slope (long dimension) of the accessible parking stall exceeds 2%. The running slope in an accessible parking stall and the access aisle must not exceed 2%.	Slopes measures at 4.1%, location in additional photos.	<a href="https://www.access-board.gov/ada/#ada-502_4">https://www.access-board.gov/ada/#ada-502_4</a>	2012 TAS Section: 502.4  2010 ADAS Section: 502.4

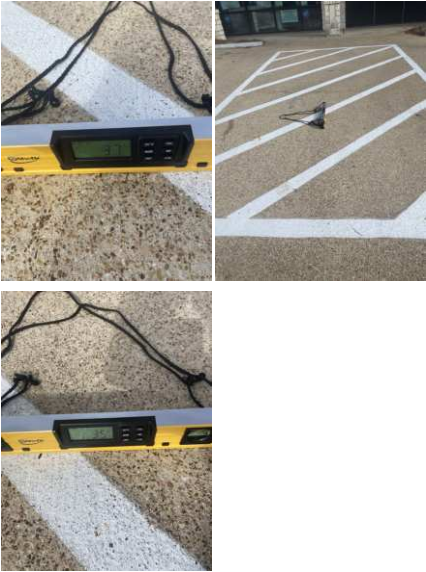
4	Exterior of Property (Public) : Parking Lot (1 Space) 1 Van - Accessible Aisle (Van)	The running slope of the access aisle (long dimension) exceeds 2%. The running slope in an accessible parking stall and the access aisle must not exceed 2%.	Slope measures at 3.7%, see additional photos for location	<a href="https://www.access-board.gov/ada/#ada-502_4">https://www.access-board.gov/ada/#ada-502_4</a>	2012 TAS Section: 502.4  2010 ADAS Section: 502.4

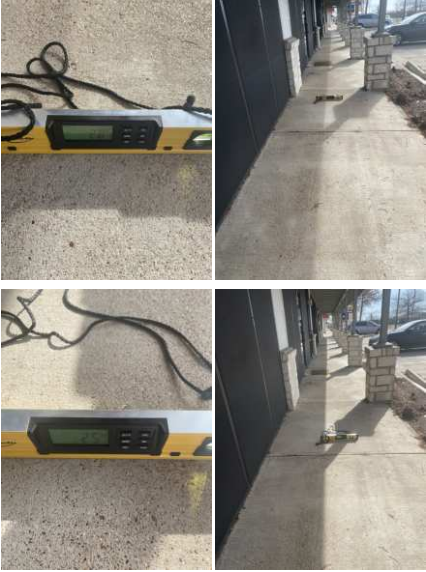
Finding Number	Area Description	Finding	As Built	Recommendation	Citation	Photos	Figure
5	Exterior of Property (Public) : Path of Travel to Building - Path of Travel (Main Route)	The accessible path of travel between the building entrance and the accessible parking has cross slopes greater than 2%. Surface cross slopes shall not exceed 1 unit vertical in 48 units horizontal (2-percent slope).	Cross slope measures at 2.8%, see additional photos for location.	<a href="https://www.access-board.gov/ada/#ada-403_3">https://www.access-board.gov/ada/#ada-403_3</a>	2012 TAS Section: 403.3  2010 ADAS Section: 403.3

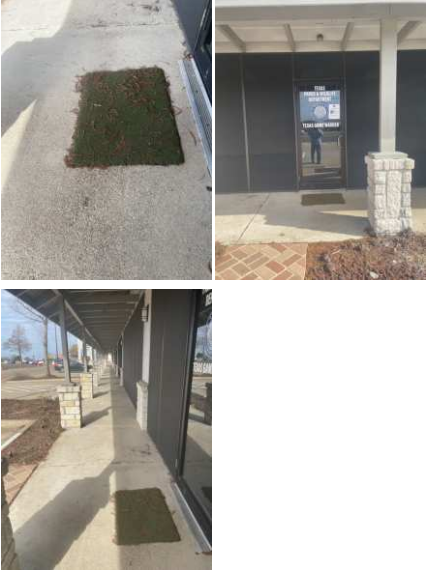
Finding Number	Area Description	Finding	As Built	Recommendation	Citation	Photos	Figure
6	First Floor Main Building LOBBY (Public): Entrance into Lobby - Entrance Doors	The floor mat at the door is not secured in place. If carpet or carpet tile is used on a ground or floor surface, then it shall be securely attached; have a firm cushion, pad or backing or no cushion or pad; and have a level loop, textured loop, level-cut pile or level-cut/uncut pile texture. The maximum pile height shall be 1/2 inch. Exposed edges of carpet shall be fastened to floor surfaces and have trim along the entire length of the exposed edge. Recessed doormats shall be adequately anchored to prevent interference with wheelchair traffic.	Door mat is not of compliant size or durability and does not meet compliance	<a href="https://www.access-board.gov/ada/#ada-302_2">https://www.access-board.gov/ada/#ada-302_2</a>	2012 TAS Section: 302.2  2010 ADAS Section: 302.2

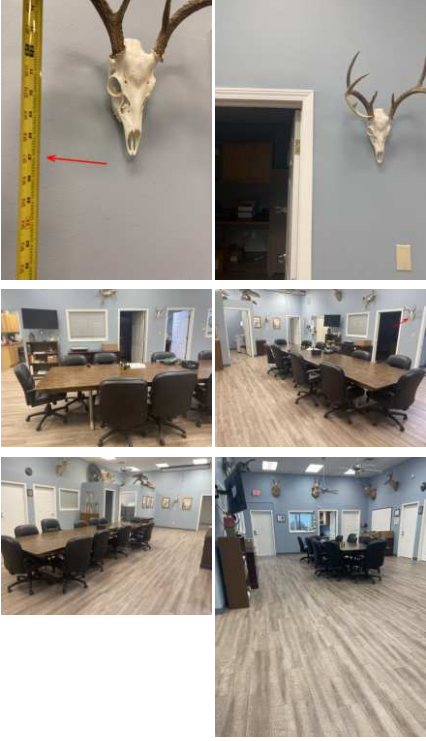
Finding Number	Area Description	Finding	As Built	Recommendation	Citation	Photos	Figure
8	First Floor Main Building (STAFF): Conference Room	The element projects more than 4 inches into the circulation path. Wall-mounted objects that have leading edges between 27 inches and 80 inches from the floor must not project more than 4 inches into the circulation path. Protruding objects that extend to the floor or within 27 inches of the floor are cane detectable and are therefore not hazardous. Where it is necessary or desirable to have objects protrude from the wall, a manner of cane detection must be provided.	Protruding object measures at 67" Located on side wall, see additional photos for location.	<a href="https://www.access-board.gov/ada/#ada-307_2">https://www.access-board.gov/ada/#ada-307_2</a>	2012 TAS Section: 307.2  2010 ADAS Section: 307.2

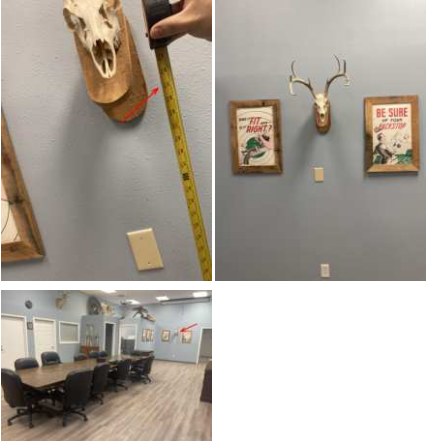
9	First Floor Main Building (STAFF): Conference Room	The element projects more than 4 inches into the circulation path. Wall-mounted objects that have leading edges between 27 inches and 80 inches from the floor must not project more than 4 inches into the circulation path. Protruding objects that extend to the floor or within 27 inches of the floor are cane detectable and are therefore not hazardous. Where it is necessary or desirable to have objects protrude from the wall, a manner of cane detection must be provided.	Protruding object measures 67" Located on back wall, see additional photos for location.	<a href="https://www.access-board.gov/ada/#ada-307_2">https://www.access-board.gov/ada/#ada-307_2</a>	2012 TAS Section: 307.2  2010 ADAS Section: 307.2

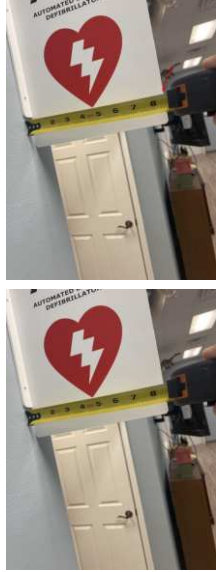
Finding Number	Area Description	Finding	As Built	Recommendation	Citation	Photos	Figure
14	First Floor Main Building (STAFF): Conference Room	The element projects more than 4 inches into the circulation path. Wall-mounted objects that have leading edges between 27 inches and 80 inches from the floor must not project more than 4 inches into the circulation path. Protruding objects that extend to the floor or within 27 inches of the floor are cane detectable and are therefore not hazardous. Where it is necessary or desirable to have objects protrude from the wall, a manner of cane detection must be provided.	AED sign protrudes over 8" into walkway.	<a href="https://www.access-board.gov/ada/#ada-307_2">https://www.access-board.gov/ada/#ada-307_2</a>	2012 TAS Section: 307.2  2010 ADAS Section: 307.2

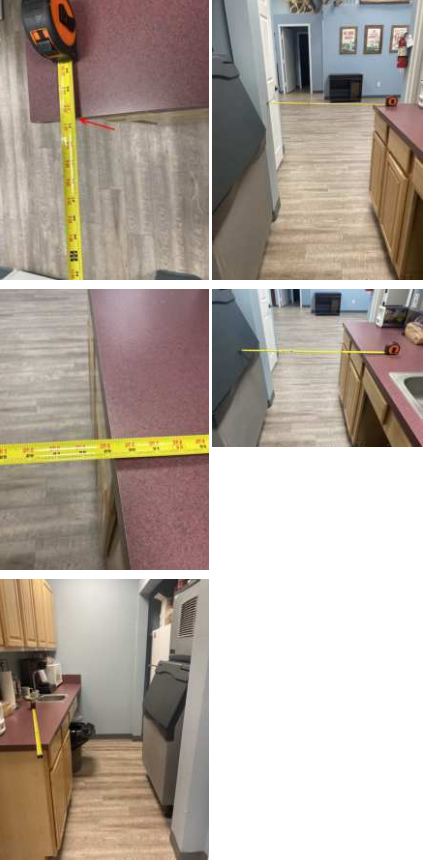
Finding Number	Area Description	Finding	As Built	Recommendation	Citation	Photos	Figure
15	First Floor Main Building (STAFF): Kitchenette	The route of travel does not provide a minimum width of 36 inches. The clear width shall be permitted to be reduced to 32 inches minimum for a length of 24 inches maximum provided that reduced width segments are separated by segments that are 48 inches long minimum and 36 inches wide minimum.	Width measures no more than 32" and extends longer than 24".	<a href="https://www.access-board.gov/ada/#ada-403_5_1">https://www.access-board.gov/ada/#ada-403_5_1</a>	2012 TAS Section: 403.5.1  2010 ADAS Section: 403.5.1

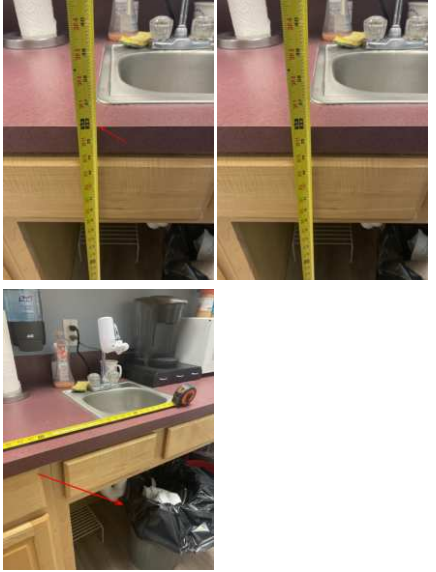
Finding Number	Area Description	Finding	As Built	Recommendation	Citation	Photos	Figure
16	First Floor Main Building (STAFF): Kitchenette	The kitchen counter top is too high. The kitchen work surface shall be 34 inches maximum above the finish floor or ground.	Counter top measures at 36". No accessible route to access sink. Knee and toe space provided is impeded by barriers. Sinks are not accessible via frontal or parallel approach due to rim height. Sinks do not require knee and toe space since there is no stove top oven in vicinity,	<a href="https://www.access-board.gov/ada/#ada-804_3_2">https://www.access-board.gov/ada/#ada-804_3_2</a>	2012 TAS Section: 804.3.2  2010 ADAS Section: 804.3.2

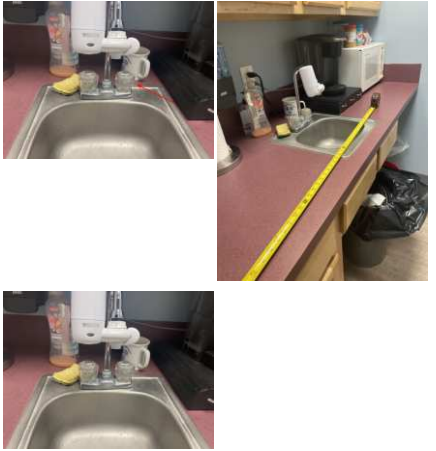
17	First Floor Main Building (STAFF): Kitchenette	The sink controls requires tight grasping, tight pinching or twisting of the wrist to operate. Controls and operating mechanisms shall be operable with one hand and shall not require tight grasping, pinching or twisting of the wrist. The force required to activate controls shall be no greater than 5 pounds of force.	N/A	<a href="https://www.access-board.gov/ada/#ada-309_4">https://www.access-board.gov/ada/#ada-309_4</a>	2012 TAS Section: 309.4  2010 ADAS Section: 309.4

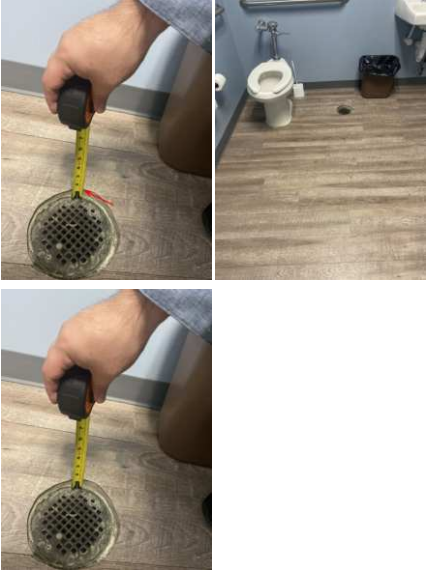
Finding Number	Area Description	Finding	As Built	Recommendation	Citation	Photos	Figure
18	First Floor Main Building (STAFF): Restrooms/Water Fountains - Restroom (Men's)	The floor drain is set too low in the floor which causes a steep slope and/or vertical changes of elevation greater than 1/4 inch. Changes in level up to 1/4 inch may be vertical and without edge treatment. Changes in level between 1/4 inch and 1/2 inch maximum shall be beveled with a slope no greater than 1 unit vertical in 2 units horizontal (50-percent slope).	Drain threshold measures at 1"	<a href="https://www.access-board.gov/ada/#ada-303_3">https://www.access-board.gov/ada/#ada-303_3</a>	2012 TAS Section: 303.3  2010 ADAS Section: 303.3

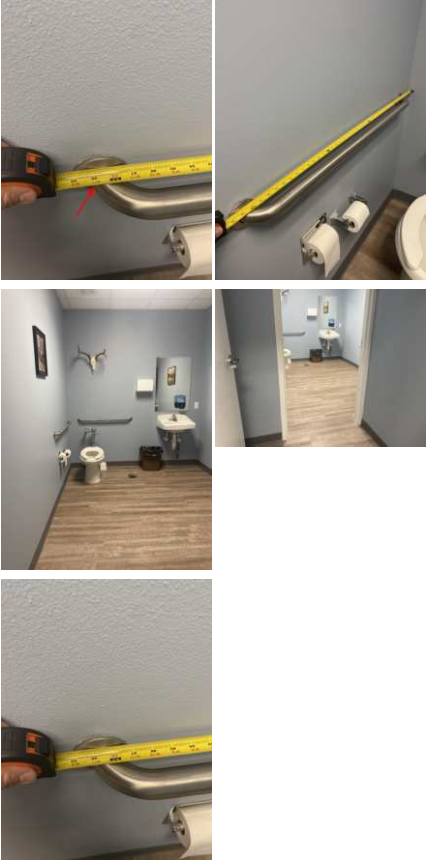
Finding Number	Area Description	Finding	As Built	Recommendation	Citation	Photos	Figure
19	First Floor Main Building (STAFF): Restrooms/Water Fountains - Restroom (Men's)	The side grab bar does not extend far enough from the rear wall. The side grab bar must extend at least 54 inches minimum beyond the rear wall and start a maximum of 12 inches from the rear wall. A 42 inch grab bar installed the maximum distance from the rear wall (12 inches) will leave the leading end 54 inches from the rear wall. Grab bars shall be installed in a horizontal position, 33 inches minimum and 36 inches maximum above the finish floor measured to the top of the gripping surface.	Side grab bar measures at 49"	<a href="https://www.access-board.gov/ada/#ada-604_5_1">https://www.access-board.gov/ada/#ada-604_5_1</a>	2012 TAS Section: 604.5.1  2010 ADAS Section: 604.5.1

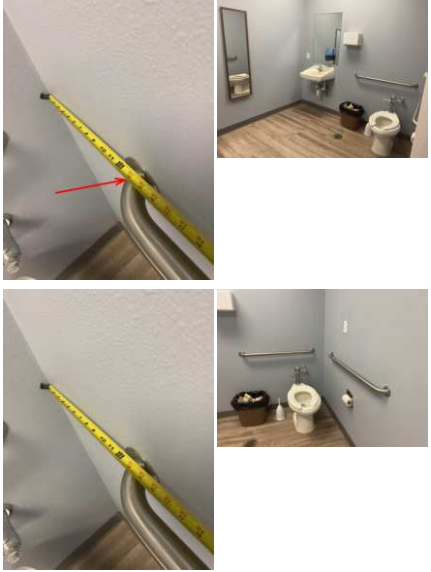
Finding Number	Area Description	Finding	As Built	Recommendation	Citation	Photos	Figure
22	First Floor Main Building (STAFF): Restrooms/Water Fountains - Restroom (Women's)	The side grab bar is located greater than 12 inches from the rear wall. The side grab bar must extend at least 54 inches minimum beyond the rear wall and start a maximum of 12 inches from the rear wall. A 42 inch grab bar installed the maximum distance from the rear wall (12 inches) will leave the leading end 54 inches from the rear wall. Grab bars shall be installed in a horizontal position, 33 inches minimum and 36 inches maximum above the finish floor measured to the top of the gripping surface.	Side grab bar gap is 13"	<a href="https://www.access-board.gov/ada/#ada-604_5_1">https://www.access-board.gov/ada/#ada-604_5_1</a>	2012 TAS Section: 604.5.1  2010 ADAS Section: 604.5.1

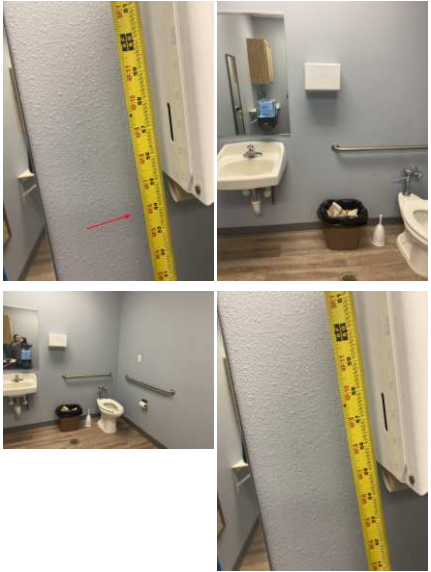
23	First Floor Main Building (STAFF): Restrooms/Water Fountains - Restroom (Women's)	The paper towel dispenser's operation mechanism is too high off the floor. Dispensers must have all operable parts a maximum of 48 inches above the floor.	Paper towel access height measures at 54"	<a href="https://www.access-board.gov/ada/#ada-308_2_1">https://www.access-board.gov/ada/#ada-308_2_1</a>	2012 TAS Section: 308.2.1  2010 ADAS Section: 308.2.1

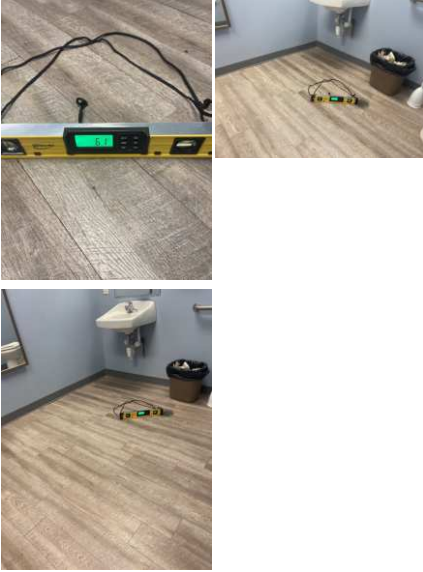
Finding Number	Area Description	Finding	As Built	Recommendation	Citation	Photos	Figure
24	First Floor Main Building (STAFF): Restrooms/Water Fountains - Restroom (Women's)	The floor drain is set too low in the floor which causes a slope over 2 percent. Changes in level are not permitted in clear floor or ground spaces or surfaces of a turning spaces and shall not slope greater than 1:48.	Slope measurement is 6.1% near drain.	<a href="https://www.access-board.gov/ada/#ada-304_2">https://www.access-board.gov/ada/#ada-304_2</a>	2012 TAS Section: 303.3, 304.2, 304.2 Exception  2010 ADAS Section: 303.3, 304.2, 304.2 Exception

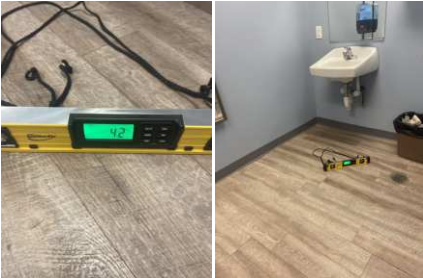
25	First Floor Main Building (STAFF): Restrooms/Water Fountains - Restroom (Women's)	The accessible route of travel contains cross slopes greater than 2%. Surface cross slopes shall not exceed 1 unit vertical in 48 units horizontal (2-percent slope). When the slope in the direction of travel of any walk exceeds 1 unit vertical in 20 units horizontal (5-percent slope), it must be constructed as ramp.	Slope in restroom useable space measures at 4.2%	<a href="https://www.access-board.gov/ada/#ada-403_3">https://www.access-board.gov/ada/#ada-403_3</a>	2012 TAS Section: 206.2.4, 403.3  2010 ADAS Section: 206.2.4, 403.3
