# Corpus Christi LE- ADA Evaluation

## LE- Corpus Christi TX, ADA Evaluation

Accessibility Evaluation

Inspection Date: 02/15/2023

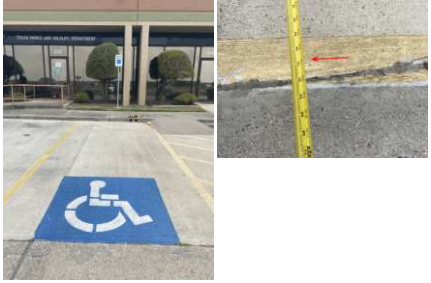
Finding Number	Area Description	Finding	As Built	Recommendation	Citation	Photos	Figure
1	Exterior of Property (Public): Parking Lot (2 Spaces) 1 Van 1 Car - Car Accessible Stall	The accessible parking stall is not wide enough. Each parking space must be at least 8 feet wide and shall be marked to define the width. Alternatively, the stall can be 11 feet wide minimum with a 5 foot wide minimum access aisle. The measurements of parking spaces and access aisles shall be made from the centerline of the markings. Where the parking space is not adjacent to another parking space or access aisle, the measurement shall be permitted to include the full width of the line defining the parking space.	Accessible car stall less than 8' wide.	<a href="https://www.access-board.gov/ada/#ada-502_2">https://www.access-board.gov/ada/#ada-502_2</a>	2012 TAS Section: 502.2  2010 ADAS Section: 502.2

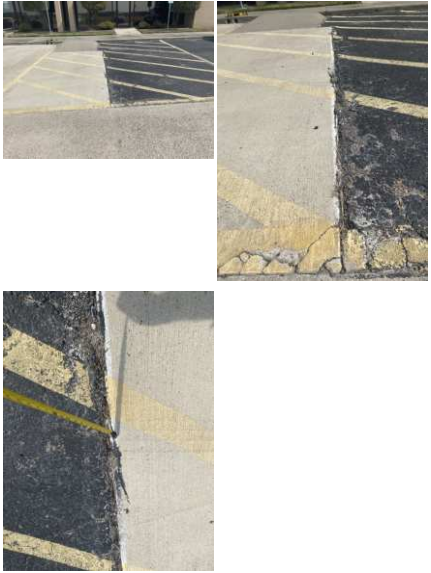
2	Exterior of Property (Public): Parking Lot (2 Spaces) 1 Van 1 Car - Access Aisle (Shared)	The access aisle contains loose gravel and/or surface materials that do not provide for a stable, firm slip resistant surface. Parking spaces and access aisles serving them shall comply with floor or ground surface requirements. The ground surface shall be stable, firm, and slip resistant. Access aisles shall be at the same level as the parking spaces they serve. Changes in level, slopes exceeding 1:48, and detectable warnings shall not be permitted.	Access aisle showing advanced signs of deterioration, causing large gaps and creases preventing access.	<a href="https://www.access-board.gov/ada/#ada-502_2">https://www.access-board.gov/ada/#ada-502_2</a> <a href="https://www.access-board.gov/ada/#ada-302_3">https://www.access-board.gov/ada/#ada-302_3</a>	2012 TAS Section: 502.4  2010 ADAS Section: 502.4

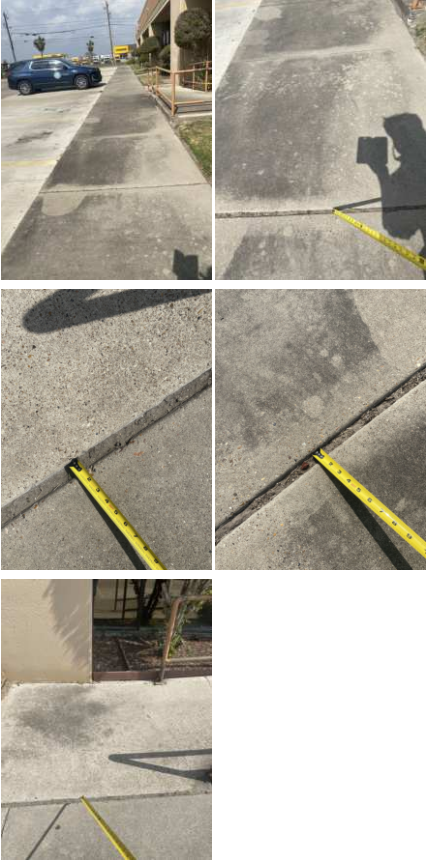
Finding Number	Area Description	Finding	As Built	Recommendation	Citation	Photos	Figure
5	Exterior of Property (Public): Path of Travel to Building - Path of Travel (Main Route)	The route contains openings greater than 1/2 inch. Openings in floor or ground surfaces shall not allow passage of a sphere more than 1/2 inch diameter. Elongated openings shall be placed so that the long dimension is perpendicular to the dominant direction of travel.	There are several locations on exterior pathway which exceed 1/2". See additional photos for location of gap non compliance on accessible pathway to building.	<a href="https://www.access-board.gov/ada/#ada-302_3">https://www.access-board.gov/ada/#ada-302_3</a>	2012 TAS Section: 302.3  2010 ADAS Section: 302.3

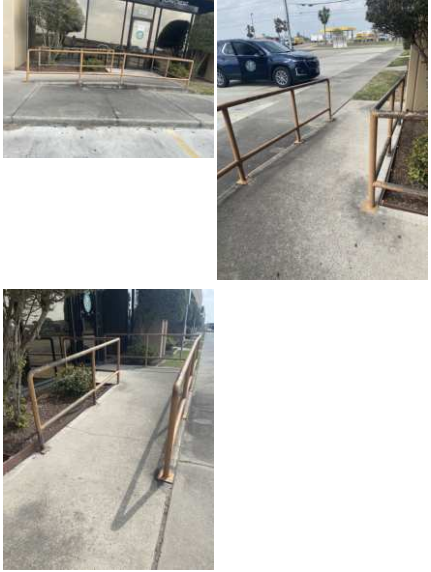
Finding Number	Area Description	Finding	As Built	Recommendation	Citation	Photos	Figure
6	Exterior of Property (Public): Path of Travel to Building - Entrance Ramp (Non Curb Ramp)	The handrails do not meet minimum height requirements. Handrails are measured to the top of the gripping surface and must be between 34 inches and 38 inches above the ramp surface. Handrails must extend horizontally 12 inches beyond the top and bottom of the ramp.	Entrance ramp handrail height measured at 32.5"	<a href="https://www.access-board.gov/ada/#ada-505_4">https://www.access-board.gov/ada/#ada-505_4</a>	2012 TAS Section: 505.4  2010 ADAS Section: 505.4

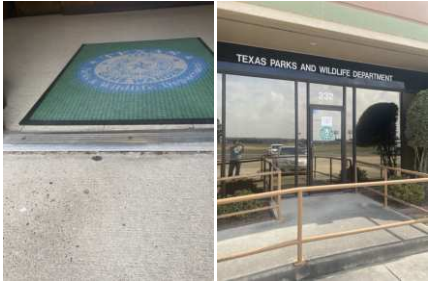
10	First Floor Main Building LOBBY (Public): Entrance into Lobby - Entrance Doors	The threshold has a vertical change greater than 1/4 inch. The threshold at a doorway shall be no higher than 1/2 inch. Changes in level between 1/4 inch and 1/2 inch must be beveled at 1:2 or less. The maximum vertical rise shall be 1/4 inch.	Lip on door, crease causes non compliant	<a href="https://www.access-board.gov/ada/#ada-404_2_5">https://www.access-board.gov/ada/#ada-404_2_5</a>	2012 TAS Section: 404.2.5  2010 ADAS Section: 404.2.5

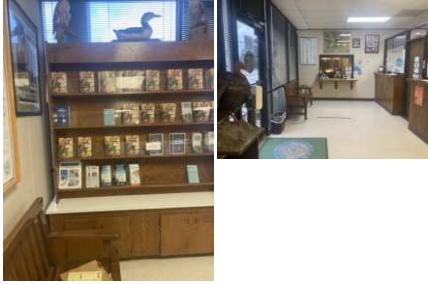
11	First Floor Main Building LOBBY (Public): Lobby Area	The element is not positioned correctly for either a side or front approach. Where a clear floor or ground space allows a parallel or front approach and the side reach is unobstructed, the high side reach shall be 48 inches maximum above the finish floor or ground and the low side reach shall be 15 inches minimum above the finish floor or ground.	In lobby area, upper tier pamphlets out of reach range.	<a href="https://www.access-board.gov/ada/#ada-308_2_1">https://www.access-board.gov/ada/#ada-308_2_1</a> <a href="https://www.access-board.gov/ada/#ada-308_3_1">https://www.access-board.gov/ada/#ada-308_3_1</a>	2012 TAS Section: 308.2.1, 308.3.1  2010 ADAS Section: 308.2.1, 308.3.1

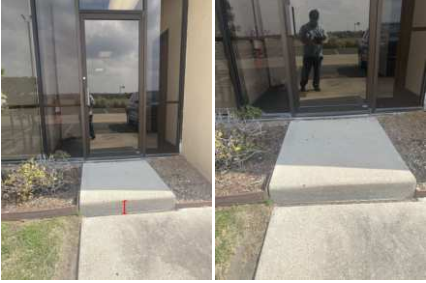
Finding Number	Area Description	Finding	As Built	Recommendation	Citation	Photos	Figure
12	First Floor Main Building LOBBY (Public): Exterior Route to Public Restrooms	The walkway contains abrupt vertical edges and/or variations over a 1/2 inch. 1/4 inch is the maximum vertical rise. Changes in level between 1/4 inch and 1/2 inch must be beveled at 1:2 or less. Changes in level greater than 1/2 inch must be by way of a ramp.	There is no accessible route to public restrooms. Building shares restrooms, access through LE office to restrooms not possible. General public restroom users cannot access restrooms independently. LE staff have to unlock restroom area for users.	<a href="https://www.access-board.gov/ada/#ada-303_2">https://www.access-board.gov/ada/#ada-303_2</a>	2012 TAS Section: 303.3, 303.2  2010 ADAS Section: 303.3, 303.2

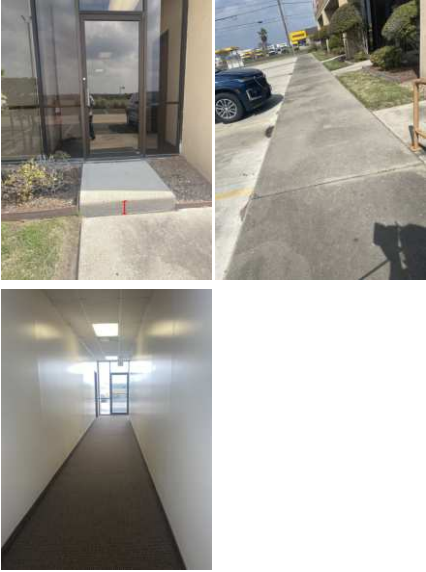
13	First Floor Main Building LOBBY (Public): Exterior Route to Public Restrooms	The building entrance is not located on an accessible route. When a building, or portion of a building, is required to be accessible, an accessible route of travel shall be provided to all portions of the building, to accessible building entrances and between the building and the public way. At least one accessible route within the boundary of the site must be provided from public transportation stops, accessible parking and accessible passenger loading zones and public streets or sidewalks to the accessible building entrance they serve. The accessible route shall, to the maximum extent feasible, coincide with the route for the general public. At least one accessible route shall connect accessible buildings, facilities, elements and spaces that are on the same site. At least one accessible route shall connect accessible building or facility entrances with all accessible spaces and elements.	The exterior path to restrooms is not compliant due to large step up leading to restroom area and large gaps in exterior pathway from parking to restroom.	<a href="https://www.access-board.gov/ada/#ada-206_2_1">https://www.access-board.gov/ada/#ada-206_2_1</a>	2012 TAS Section: 206.2.1  2010 ADAS Section: 206.2.1

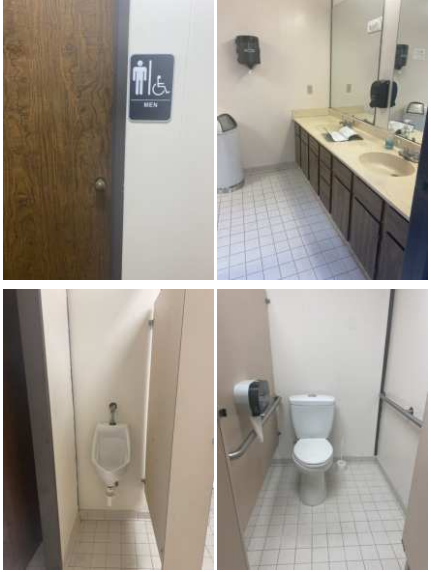
Finding Number	Area Description	Finding	As Built	Recommendation	Citation	Photos	Figure
14	First Floor Main Building LOBBY (Public): Exterior Route to Public Restrooms - Restroom (Men's)	The restrooms is not nearly compliant. Restrooms have multiple non compliance findings.	This restroom is for public use and would need multiple readjustments to gain compliance.	<a href="https://www.access-board.gov/ada/#ada-213_2">https://www.access-board.gov/ada/#ada-213_2</a> Review restrooms componets to make accessible. <a href="https://www.access-board.gov/ada/#ada-603">https://www.access-board.gov/ada/#ada-603</a>	2012 TAS Section: 213.2  2010 ADAS Section: 213.2

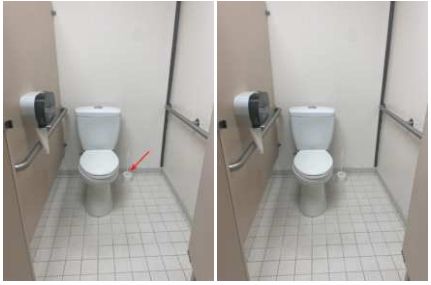
15	First Floor Main Building LOBBY (Public): Exterior Route to Public Restrooms - Restroom (Men's)	The clear floor space around the toilet is obstructed by the toilet bowl brush. No fixtures are allowed in the clear floor space required for the toilet. The required clearance around the water closet shall be permitted to overlap the water closet, associated grab bars, dispensers, sanitary napkin disposal units, coat hooks, shelves, accessible routes, clear floor space and clearances required at other fixtures, and the turning space. No other fixtures or obstructions shall be located within the required water closet clearance.	N/A	<a href="https://www.access-board.gov/ada/#ada-604_3_2">https://www.access-board.gov/ada/#ada-604_3_2</a>	2012 TAS Section: 604.3.2  2010 ADAS Section: 604.3.2

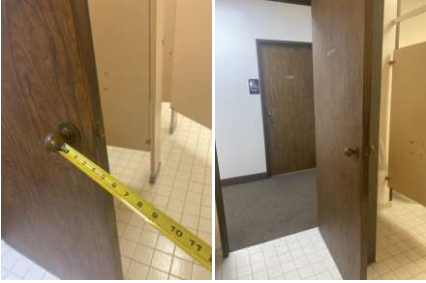
Finding Number	Area Description	Finding	As Built	Recommendation	Citation	Photos	Figure
28	First Floor Main Building LOBBY (Public): Exterior Route to Public Restrooms - Restroom (Men's)	The door/gate operating hardware is not accessible. Hand-activated door/gate opening hardware, handles, pulls, latches, locks, and other operating devices on accessible doors shall have a shape that is easy to grasp with one hand and does not require tight grasping, pinching or twisting of the wrist to operate. Hardware shall be 34 inches minimum and 48 inches maximum above the finish floor or ground.	N/A		<a href="https://www.access-board.gov/ada/#ada-404_2_7">https://www.access-board.gov/ada/#ada-404_2_7</a>  2012 TAS Section: 404.2.7  2010 ADAS Section: 404.2.7

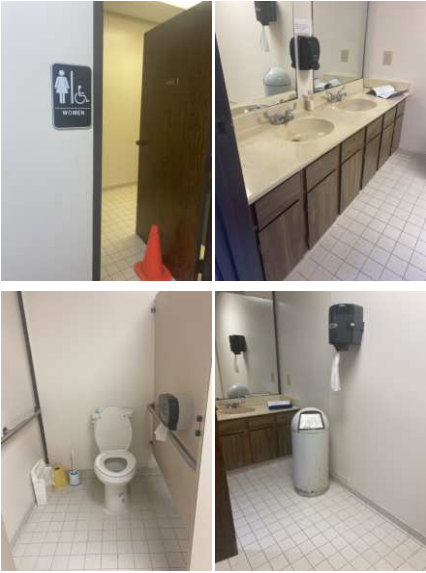
29	First Floor Main Building LOBBY (Public): Exterior Route to Public Restrooms - Restroom (Women's)	The restrooms is not nearly compliant. Restrooms have multiple non compliance findings.	This restroom requires a number of componets to gain compliance.	<a href="https://www.access-board.gov/ada/#ada-213_2">https://www.access-board.gov/ada/#ada-213_2</a> Review restrooms componets to make accessible. <a href="https://www.access-board.gov/ada/#ada-603">https://www.access-board.gov/ada/#ada-603</a>	2012 TAS Section: 213.2  2010 ADAS Section: 213.2

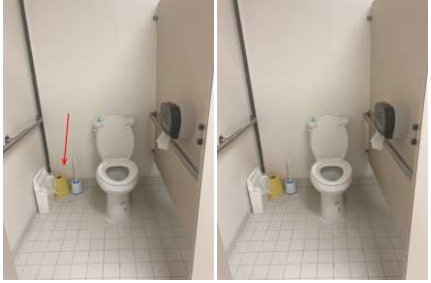
Finding Number	Area Description	Finding	As Built	Recommendation	Citation	Photos	Figure
30	First Floor Main Building LOBBY (Public): Exterior Route to Public Restrooms - Restroom (Women's)	The clear floor space around the toilet is obstructed by the toilet bowl brush and other barriers. No fixtures are allowed in the clear floor space required for the toilet. The required clearance around the water closet shall be permitted to overlap the water closet, associated grab bars, dispensers, sanitary napkin disposal units, coat hooks, shelves, accessible routes, clear floor space and clearances required at other fixtures, and the turning space. No other fixtures or obstructions shall be located within the required water closet clearance.	N/A	<a href="https://www.access-board.gov/ada/#ada-604_3_2">https://www.access-board.gov/ada/#ada-604_3_2</a>	2012 TAS Section: 604.3.2  2010 ADAS Section: 604.3.2

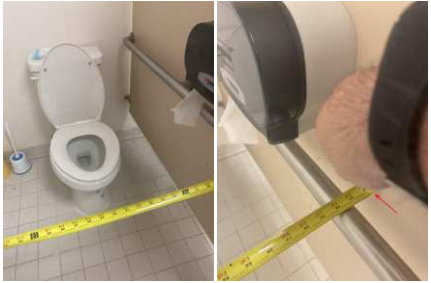
31	First Floor Main Building LOBBY (Public): Exterior Route to Public Restrooms - Restroom (Women's)	The toilet compartment is not wide enough. Wheelchair accessible compartments shall be 60 inches wide minimum measured perpendicular to the side wall, and 56 inches deep minimum for wall hung water closets and 59 inches deep minimum for floor mounted water closets measured perpendicular to the rear wall.	width is 46"	<a href="https://www.access-board.gov/ada/#ada-604_8_1_1">https://www.access-board.gov/ada/#ada-604_8_1_1</a>	2012 TAS Section: 604.8.1.1  2010 ADAS Section: 604.8.1.1

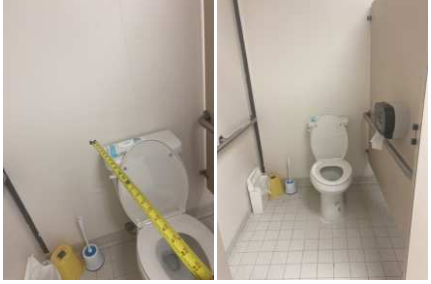
32	First Floor Main Building LOBBY (Public): Exterior Route to Public Restrooms - Restroom (Women's)	The rear grab bar is missing. Grab bars shall be installed in a horizontal position, 33 inches minimum and 36 inches maximum above the finish floor measured to the top of the gripping surface and the space between the grab bar and the top of the tank (any obstruction) shall be 1-1/2 inches minimum.	N/A	<a href="https://www.access-board.gov/ada/#ada-609_4">https://www.access-board.gov/ada/#ada-609_4</a> <a href="https://www.access-board.gov/ada/#ada-604_5_2">https://www.access-board.gov/ada/#ada-604_5_2</a>	2012 TAS Section: 609.4  2010 ADAS Section: 609.4

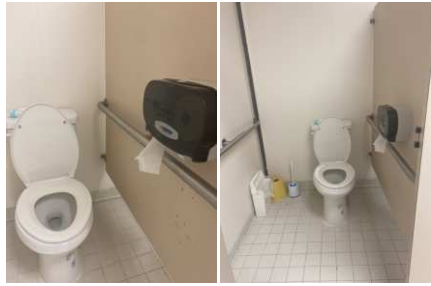
Finding Number	Area Description	Finding	As Built	Recommendation	Citation	Photos	Figure
36	First Floor Main Building LOBBY (Public): Exterior Route to Public Restrooms - Restroom (Women's)	The toilet paper is not installed within the compliant range. Toilet paper dispensers shall be 7 inches minimum and 9 inches maximum in front of the water closet measured to the centerline of the dispenser. The outlet of the dispenser shall be 15 inches minimum and 48 inches maximum above the finish floor and shall not be located behind grab bars. Dispensers shall not be of a type that controls delivery or that does not allow continuous paper flow. There shall be a clearance of 1 1/2 inches minimum below the grab bar.	TP dispenser not mounted in correct location.		<a href="https://www.access-board.gov/ada/#ada-604_7">https://www.access-board.gov/ada/#ada-604_7</a>  2012 TAS Section: 604.7  2010 ADAS Section: 604.7

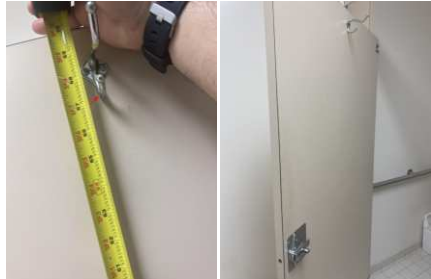
37	First Floor Main Building LOBBY (Public): Exterior Route to Public Restrooms - Restroom (Women's)	The coat hook is installed greater than 48 inches above the finished floor. Where a forward reach is unobstructed, the high forward reach shall be 48 inches maximum above the finished floor.	Coat hook reach over 67"		<a href="https://www.access-board.gov/ada/#ada-308_2_1">https://www.access-board.gov/ada/#ada-308_2_1</a>  2012 TAS Section: 308.2.1  2010 ADAS Section: 308.2.1

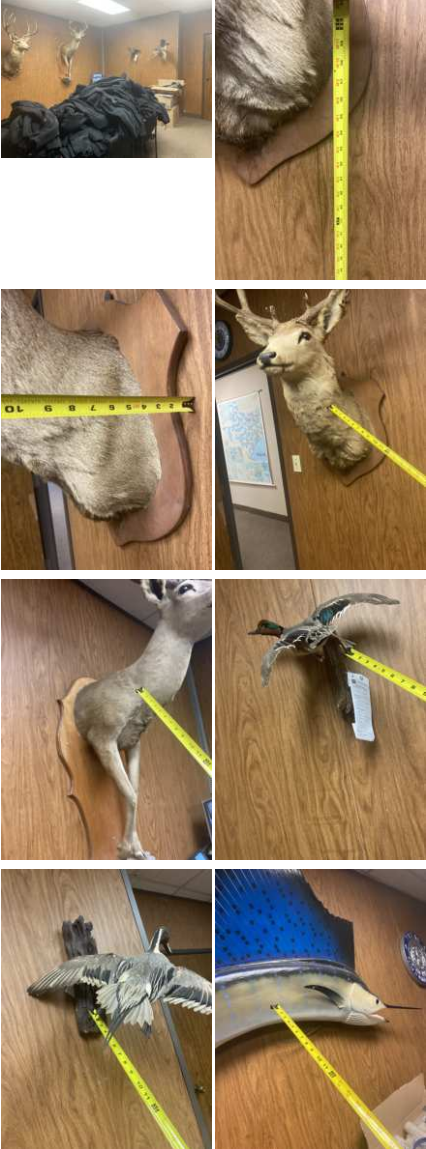
Finding Number	Area Description	Finding	As Built	Recommendation	Citation	Photos	Figure
43	First Floor Main Building (STAFF): Conference Room	The element projects more than 4 inches into the circulation path. Wall-mounted objects that have leading edges between 27 inches and 80 inches from the floor must not project more than 4 inches into the circulation path. Protruding objects that extend to the floor or within 27 inches of the floor are cane detectable and are therefore not hazardous. Where it is necessary or desirable to have objects protrude from the wall, a manner of cane detection must be provided.	Multiple mounts (5 total) within non compliant range. See additional pictures for location details.	<a href="https://www.access-board.gov/ada/#ada-307_2">https://www.access-board.gov/ada/#ada-307_2</a>	2012 TAS Section: 307.2  2010 ADAS Section: 307.2

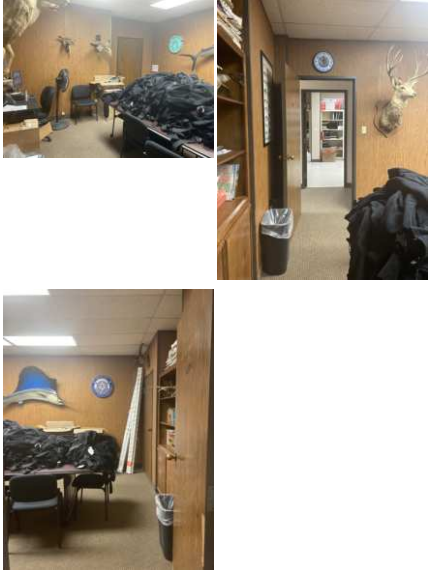
Finding Number	Area Description	Finding	As Built	Recommendation	Citation	Photos	Figure
44	First Floor Main Building (STAFF): Conference Room	The walking surface is obstructed. A 36 inch wide minimum clear walking surface is required.	Room clutter preventing access.	<a href="https://www.access-board.gov/ada/#ada-403_5_1">https://www.access-board.gov/ada/#ada-403_5_1</a>	2012 TAS Section: 403.5.1  2010 ADAS Section: 403.5.1

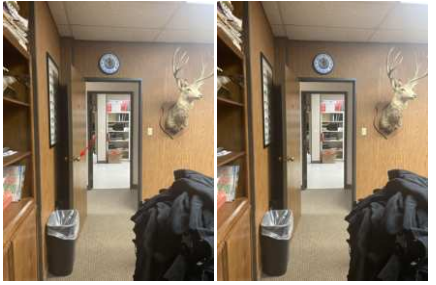
45	First Floor Main Building (STAFF): Conference Room	The door/gate operating hardware is not accessible. Hand-activated door/gate opening hardware, handles, pulls, latches, locks, and other operating devices on accessible doors shall have a shape that is easy to grasp with one hand and does not require tight grasping, pinching or twisting of the wrist to operate. Hardware shall be 34 inches minimum and 48 inches maximum above the finish floor or ground.	Door knobs on conference room entrance.	<a href="https://www.access-board.gov/ada/#ada-404_2_7">https://www.access-board.gov/ada/#ada-404_2_7</a>	2012 TAS Section: 404.2.7  2010 ADAS Section: 404.2.7

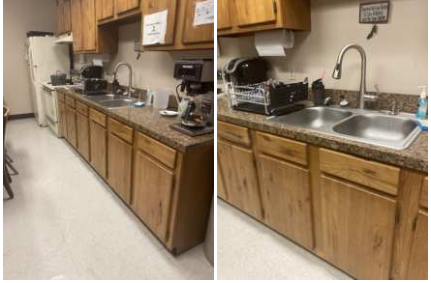
Finding Number	Area Description	Finding	As Built	Recommendation	Citation	Photos	Figure
49	First Floor Main Building (STAFF): Kitchenette	Knee and toe clearance has not been provided at the sink. The knee clearance shall be 11 inches deep minimum at 9 inches above the finish floor or ground, and 8 inches deep minimum at 27 inches above the finish floor or ground. The toe clearance is the space under the sink between the finish floor or ground and 9 inches above the finish floor 30 inches wide minimum. The toe clearance shall extend a minimum of 17 inches and a maximum of 25 inches underneath the sink.	Knee and toe must be provided since kitchenette contain stove top range. In kitchens, kitchenettes, and breakrooms without a cooktop or conventional range, a parallel approach is permitted at kitchen sinks.	<a href="https://www.access-board.gov/ada/#ada-606_2">https://www.access-board.gov/ada/#ada-606_2</a>	2012 TAS Section: 606.2  2010 ADAS Section: 606.2

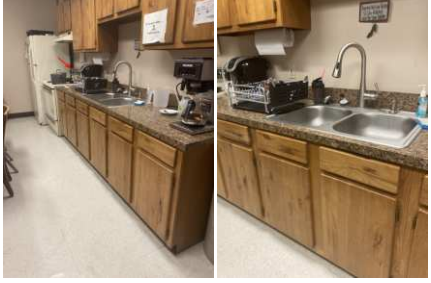
50	First Floor Main Building (STAFF): Kitchenette	The controls are located such that operation require reaching across burners. Where knee and toe space is provided, the underside of the range or cooktop shall be insulated or otherwise configured to prevent burns, abrasions, or electrical shock. The location of controls shall not require reaching across burners	Stove type is not compliant	<a href="https://www.access-board.gov/ada/#ada-804_6_4">https://www.access-board.gov/ada/#ada-804_6_4</a>	2012 TAS Section: 804.6.4  2010 ADAS Section: 804.6.4
