# El Paso LE- ADA Evaluation

**LE- El Paso TX, ADA Evaluation**  
**401 E Franklin Ave Suite 520**  
**Downtown El Paso, TX 79901**  
**Accessibility Evaluation**  
**Inspection Date: 06/16/2023**  
**Inspectors: Christopher Meza**

Report Date: 01/14/2024

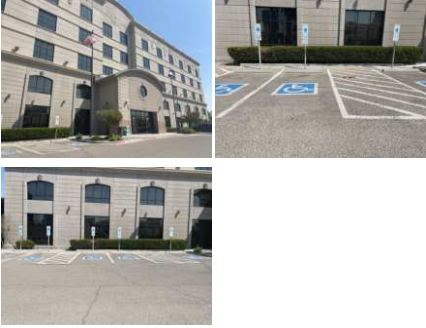
Finding Number	Area Description	Finding	As Built	Recommendation	Citation	Photos	Figure
1	Exterior of Property (Public): Parking Lot (9 Spaces) 8 Car 1 Van	The required number of van accessible stalls is not provided. There are (8) accessible parking stalls including (1) designated for a van.	N/A		<a href="https://www.access-board.gov/ada/#ada-208_2_4">https://www.access-board.gov/ada/#ada-208_2_4</a>  2012 TAS Section: 208.2, 208.2.4  2010 ADAS Section: 208.2, 208.2.4

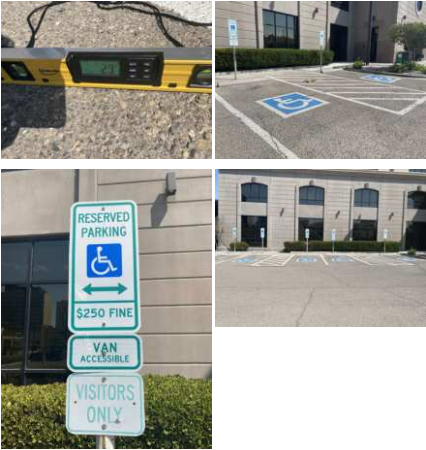
2	Exterior of Property (Public): Parking Lot (9 Spaces) 8 Car 1 Van - Van Accessible Stall (L Side)	The cross slope (narrow dimension) of the parking stall exceeds 2%. The running and cross slope in an accessible parking stall and the access aisle must not exceed 2%.	Van stall is accessible, minor sloping issues in spot and access aisle. There was nothing recorded over 3%. There are 6 total accessible parking spaces to left side of entrance. 1 labeled van.		<a href="https://www.access-board.gov/ada/#ada-502_4">https://www.access-board.gov/ada/#ada-502_4</a>  2012 TAS Section: 502.4  2010 ADAS Section: 502.4

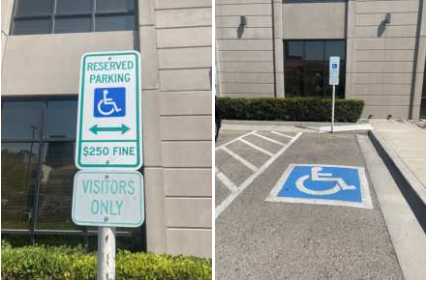
Finding Number	Area Description	Finding	As Built	Recommendation	Citation	Photos	Figure
4	Exterior of Property (Public): Parking Lot (9 Spaces) 8 Car 1 Van - Car Accessible Stall (R) Side	The van stall is missing a sign identifying it as a van accessible stall. Parking space identification signs shall include the International Symbol of Accessibility. Signs identifying van parking spaces shall contain the designation "van accessible."	There is no van identification sign for this spot. There are 9 total accessible parking stalls on location with only 1 labeled as van. Additional van spot is required due to size of parking lot.	<a href="https://www.access-board.gov/ada/#ada-502_6">https://www.access-board.gov/ada/#ada-502_6</a> There are 3 car accessible spot to right of entrance. Spot pictured in this finding has dimensions and marking for van. Recommend adding van sign to spot pictured in this finding.	2012 TAS Section: 502.6  2010 ADAS Section: 502.6

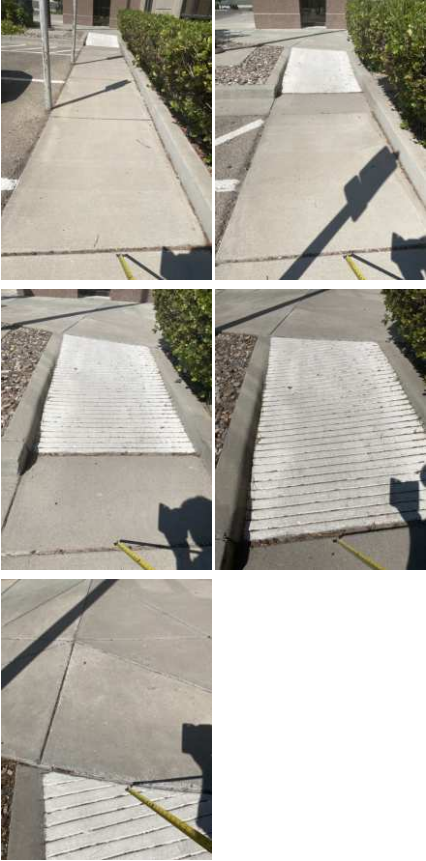
Finding Number	Area Description	Finding	As Built	Recommendation	Citation	Photos	Figure
5	Exterior of Property (Public): Path of Travel to Building - Path of Travel (R Side)	The route contains openings greater than 1/2 inch. Openings in floor or ground surfaces shall not allow passage of a sphere more than 1/2 inch diameter. Elongated openings shall be placed so that the long dimension is perpendicular to the dominant direction of travel.	There are several locations where exterior pathway gap exceeds 1/2" tolerance. See additional photos for location of gap noncompliance on accessible pathway to building.	<a href="https://www.access-board.gov/ada/#ada-302_3">https://www.access-board.gov/ada/#ada-302_3</a>	2012 TAS Section: 302.3  2010 ADAS Section: 302.3

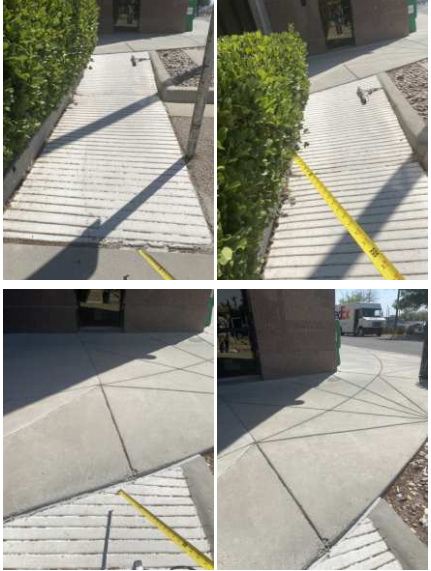
Finding Number	Area Description	Finding	As Built	Recommendation	Citation	Photos	Figure
6	Exterior of Property (Public): Path of Travel to Building - Path of Travel (L Side)	The route contains openings greater than 1/2 inch. Openings in floor or ground surfaces shall not allow passage of a sphere more than 1/2 inch diameter. Elongated openings shall be placed so that the long dimension is perpendicular to the dominant direction of travel.	There are several locations where exterior pathway gap exceeds 1/2" tolerance. See additional photos for location of gap noncompliance on accessible pathway to building. Bushes impeding walkway to less than 36"	<a href="https://www.access-board.gov/ada/#ada-302_3">https://www.access-board.gov/ada/#ada-302_3</a>	2012 TAS Section: 302.3  2010 ADAS Section: 302.3

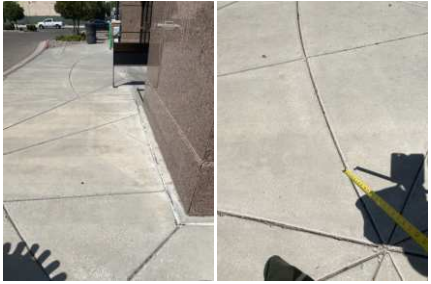
7	Exterior of Property (Public): Path of Travel to Building - Path of Travel (Main Route)	The route contains openings greater than 1/2 inch. Openings in floor or ground surfaces shall not allow passage of a sphere more than 1/2 inch diameter. Elongated openings shall be placed so that the long dimension is perpendicular to the dominant direction of travel.	There are several locations where exterior pathway gap exceeds 1/2" tolerance. See additional photos for location of gap noncompliance on accessible pathway to building.	<a href="https://www.access-board.gov/ada/#ada-302_3">https://www.access-board.gov/ada/#ada-302_3</a>	2012 TAS Section: 302.3  2010 ADAS Section: 302.3

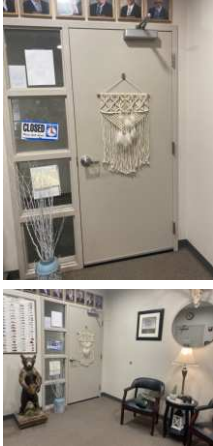
Finding Number	Area Description	Finding	As Built	Recommendation	Citation	Photos	Figure
9	Fifth Floor TPWD LE Office (Public): LE Office Interior - Entrance Doors into LE Office	The door exceeds the maximum allowable opening force. Interior doors shall have a maximum opening force of 5 pounds. These forces do not apply to the force required to retract latch bolts or disengage other devices that hold the door or gate in a closed position.	Door pressure measured over 5lbs of force.	<a href="https://www.access-board.gov/ada/#ada-404_2_9">https://www.access-board.gov/ada/#ada-404_2_9</a>	2012 TAS Section: 404.2.9  2010 ADAS Section: 404.2.9

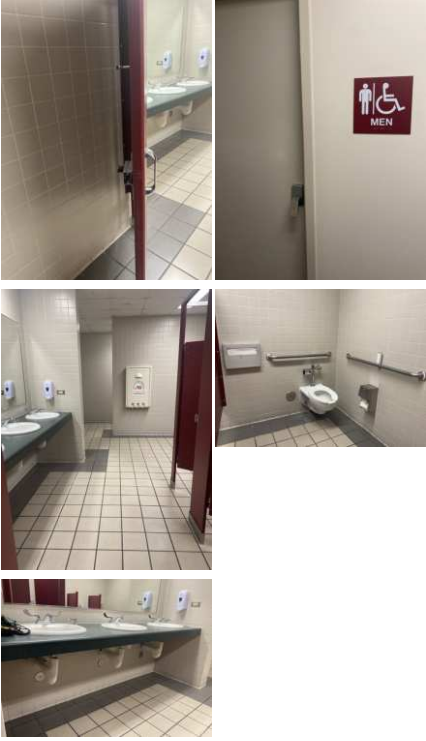
Finding Number	Area Description	Finding	As Built	Recommendation	Citation	Photos	Figure
10	Fifth Floor TPWD LE Office (Public): Interior Hallways of Building - Restroom (Men's)	The water closet compartment is missing a loop handle on the one side of the door. Water closet compartments must be equipped with a door that has a loop or U-shaped handle on both sides of the door near the latch. The latch must be flip-over style, sliding or other hardware not requiring the user to grasp or twist.	Missing handle loop on 1 side. All other restroom elements are fully compliant.	<a href="https://www.access-board.gov/ada/#ada-604_8_1_2">https://www.access-board.gov/ada/#ada-604_8_1_2</a>	2012 TAS Section: 604.8.1.2  2010 ADAS Section: 604.8.1.2

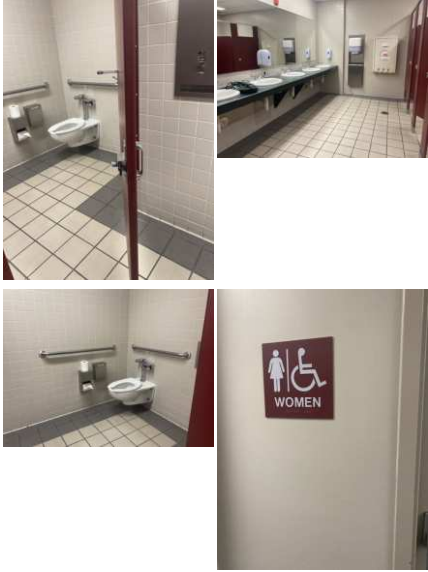
Finding Number	Area Description	Finding	As Built	Recommendation	Citation	Photos	Figure
11	Fifth Floor TPWD LE Office (Public): Interior Hallways of Building - Restroom (Women's)	The water closet compartment is missing a loop handle on the one side of the door. Water closet compartments must be equipped with a door that has a loop or U-shaped handle on both sides of the door near the latch. The latch must be flip-over style, sliding or other hardware not requiring the user to grasp or twist.	Missing loop handle on one side. All other restroom elements are fully compliant.	<a href="https://www.access-board.gov/ada/#ada-604_8_1_2">https://www.access-board.gov/ada/#ada-604_8_1_2</a>	2012 TAS Section: 604.8.1.2  2010 ADAS Section: 604.8.1.2
