# Fort Worth LE- ADA Evaluation

**LE- Fort Worth TX, ADA Evaluation**  
**5400 Airport Fwy Suite E**  
**Haltom City, TX 76117**  
**Accessibility Evaluation**  
**Inspection Date: 03/22/2023**  
**Inspectors: Christopher Meza**

Report Date: 01/14/2024

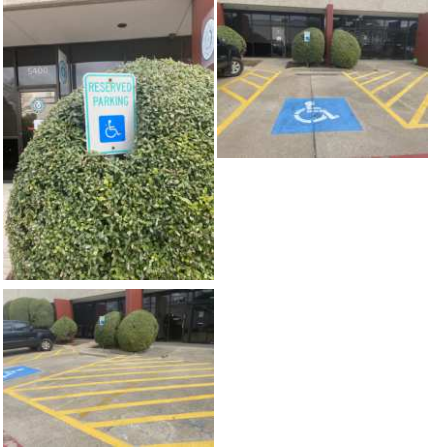
Finding Number	Area Description	Finding	As Built	Recommendation	Citation	Photos	Figure
1	Exterior of Property (Public): Parking Lot (1 Space) 1 Car - Car Accessible Stall	The van stall is missing a sign identifying it as a van accessible stall. Parking space identification signs shall include the International Symbol of Accessibility. Signs identifying van parking spaces shall contain the designation "van accessible."	Incorrect sign, this accessible parking space needs van designation. Space has correct dimensions and enough access aisle space to right of stall. Left access aisle not wide enough.	Van designation sign needs to be added. <a href="https://www.access-board.gov/ada/#ada-502_6">https://www.access-board.gov/ada/#ada-502_6</a>	2012 TAS Section: 502.6 2010 ADAS Section: 502.6

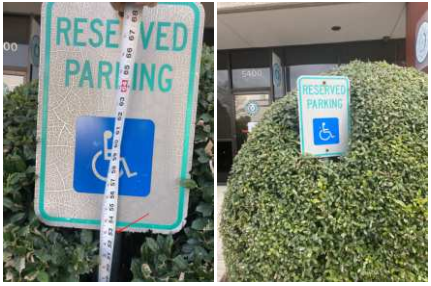
2	Exterior of Property (Public): Parking Lot (1 Space) 1 Car - Car Accessible Stall	The parking sign is mounted too low. Parking space identification signs shall include the International Symbol of Accessibility. Signs identifying van parking spaces shall contain the designation "van accessible." Signs shall be 60 inches minimum above the finish floor or ground surface measured to the bottom of the sign.	The accessible parking sign height is 53"	<a href="https://www.access-board.gov/ada/#ada-502_6">https://www.access-board.gov/ada/#ada-502_6</a>	2012 TAS Section: 502.6 2010 ADAS Section: 502.6

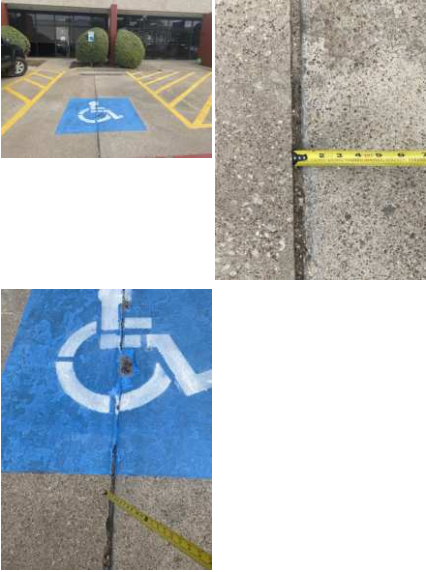
Finding Number	Area Description	Finding	As Built	Recommendation	Citation	Photos	Figure
3	Exterior of Property (Public): Parking Lot (1 Space) 1 Car - Car Accessible Stall	The accessible parking space and/or access aisle contains loose gravel and/or surface materials that do not provide for a stable, firm slip resistant surface. Parking spaces and access aisles serving them shall comply with floor or ground surface requirements. The ground surface shall be stable, firm, and slip resistant. Access aisles shall be at the same level as the parking spaces they serve. Changes in level, slopes exceeding 1:48, and detectable warnings shall not be permitted.	Accessible parking stall has large gap running through center of space.	<a href="https://www.access-board.gov/ada/#ada-502_4">https://www.access-board.gov/ada/#ada-502_4</a> <a href="https://www.access-board.gov/ada/#ada-302_3">https://www.access-board.gov/ada/#ada-302_3</a>	2012 TAS Section: 502.4  2010 ADAS Section: 502.4

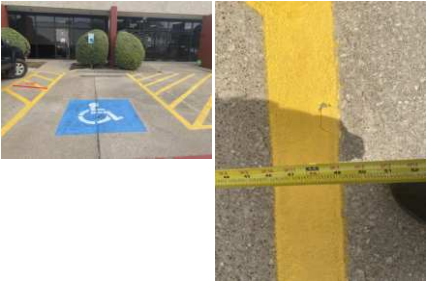
4	Exterior of Property (Public): Parking Lot (1 Space) 1 Car - Access Aisle (Car (L) Side)	The access aisle is not a minimum 5 feet wide. An accessible parking stall's access aisle must be a minimum of 5 feet wide measured from centerline to centerline. Where the access aisle is not adjacent to another parking space or access aisle, measurements shall be permitted to include the full width of the line defining the access aisle.	Access aisle width requirements depend on van stall size. van stall 11' access aisle 5' or van stall 8' access aisle 8' Access Aisle on (L) side is 4'	This access aisle is not necessary for compliance since (R) side satisfies compliance. Access aisles shall be permitted to be placed on either side of the parking space except for angled van parking spaces which shall have access aisles located on the passenger side of the parking spaces. <a href="https://www.access-board.gov/ada/#ada-502_3_1">https://www.access-board.gov/ada/#ada-502_3_1</a>	2012 TAS Section: 502.3.1  2010 ADAS Section: 502.3.1

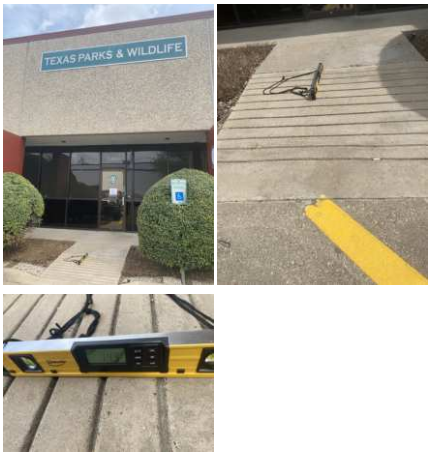
Finding Number	Area Description	Finding	As Built	Recommendation	Citation	Photos	Figure
5	Exterior of Property (Public): Path of Travel to Building - Entrance Ramps (Non Curb Ramp (L) Side)	The ramps exceeds the maximum running slope (direction of travel) allowable of 8.33%. Ramps should have the least possible slope but in no case more than 8.3% (1:12).	The textured entrance ramp on (L) side of accessible parking stall running slope of 14.9%	<a href="https://www.access-board.gov/ada/#ada-405_2">https://www.access-board.gov/ada/#ada-405_2</a>	2012 TAS Section: 405.2  2010 ADAS Section: 405.2

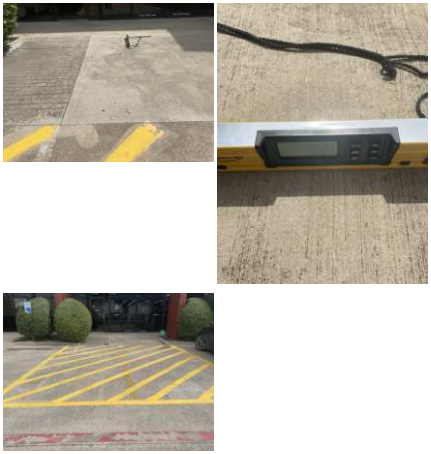
6	Exterior of Property (Public): Path of Travel to Building - Entrance Ramps (Non Curb Ramp (R) Side)	The ramps exceeds the maximum running slope (direction of travel) allowable of 8.33%. Ramps should have the least possible slope but in no case more than 8.3% (1:12).	The non textured entrance ramp on (R) side of accessible parking stall running slope is 9.2%	<a href="https://www.access-board.gov/ada/#ada-405_2">https://www.access-board.gov/ada/#ada-405_2</a>	2012 TAS Section: 405.2  2010 ADAS Section: 405.2

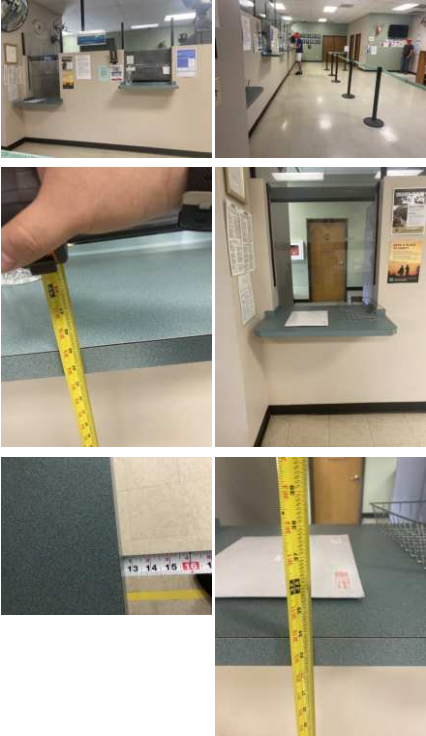
Finding Number	Area Description	Finding	As Built	Recommendation	Citation	Photos	Figure
7	First Floor Main Building LOBBY (Public): Lobby Area - Service Counter	The sales or service counter does not allow for a forward or parallel approach. Accessible counters must provide a compliant forward or parallel approach.	There is no accessible service desk at this location. Accessible counters must provide a compliant forward or parallel approach. There is not forward or parallel approach for service desk. Compliant knee and/or toe space is not provided for forward approach. There is not enough clear floor space compliance for parallel approach. .	Service desks approach requirements <a href="https://www.access-board.gov/ada/#ada-904_4">https://www.access-board.gov/ada/#ada-904_4</a>	2012 TAS Section: 904.4  2010 ADAS Section: 904.4

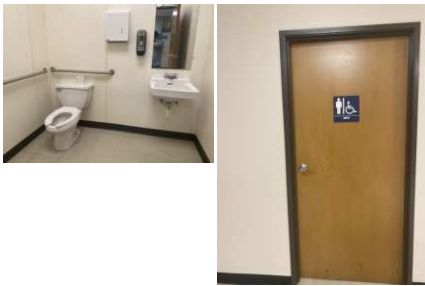
Finding Number	Area Description	Finding	As Built	Recommendation	Citation	Photos	Figure
9	First Floor Main Building LOBBY (Public): Lobby Area - Restroom (Men's)	The restroom is not nearly compliant. The restroom does not have the required minimum clear floor space or maneuvering clearances for the toilet. The restroom does not have the required minimum clear floor space or maneuvering clearances for the lavatory. The entry door does not contain the required minimum maneuvering spaces on the pull/push sides. The entry door encroach into the required clear floor space for fixtures. Grab bars are missing and/or incorrectly installed. Accessories, such as toilet seat covers, paper towel holders, garbage cans, hand dryers, and mirrors are either too high or without clear floor space or both. The restroom contain floor level changes greater than a 1/2 inch of the floor drains and is slope (XX) - (XX), the shower is too small and missing numerous accessible elements.	This restroom is for public use and would need multiple readjustments to gain compliance.	<a href="https://www.access-board.gov/ada/#ada-213_2">https://www.access-board.gov/ada/#ada-213_2</a> Review restrooms componets to make accessible. <a href="https://www.access-board.gov/ada/#ada-603">https://www.access-board.gov/ada/#ada-603</a>	2012 TAS Section: 213.2  2010 ADAS Section: 213.2

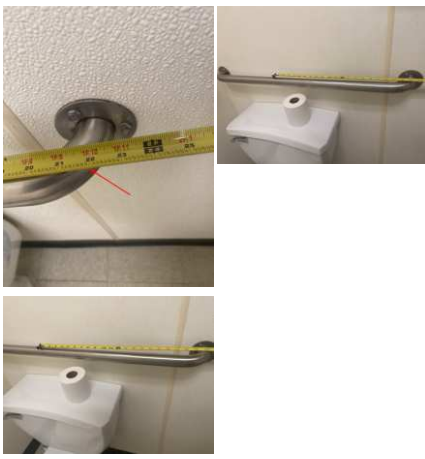
10	First Floor Main Building LOBBY (Public): Lobby Area - Restroom (Men's)	The rear grab bar does not extend adequately past the toilet on the wide side. The rear grab bar must be a minimum of 36 inches long and extend from the centerline of the toilet 12 inches minimum on wall side and 24 inches minimum on the wide side. Grab bars shall be installed in a horizontal position, 33 inches minimum and 36 inches maximum above the finish floor measured to the top of the gripping surface and the space between the grab bar and the top of the tank shall be 1-1/2 inches minimum.	Rear grab bar is under 22" Rear grab bar is mounted in wrong location, needs to extend 24' min to right of toilet from midline	<a href="https://www.access-board.gov/ada/#ada-604_5_2">https://www.access-board.gov/ada/#ada-604_5_2</a>	2012 TAS Section: 604.5.2  2010 ADAS Section: 604.5.2

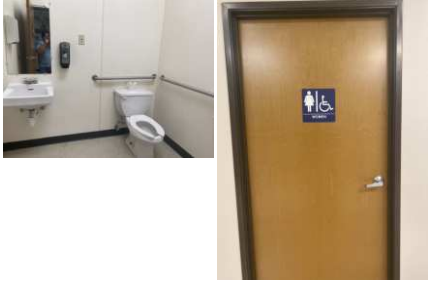
Finding Number	Area Description	Finding	As Built	Recommendation	Citation	Photos	Figure
20	First Floor Main Building LOBBY (Public): Lobby Area - Restroom (Women's)	The restroom is not nearly compliant. The restroom does not have the required minimum clear floor space or maneuvering clearances for the toilet. The restroom does not have the required minimum clear floor space or maneuvering clearances for the lavatory. The entry door does not contain the required minimum maneuvering spaces on the pull/push sides. The entry door encroach into the required clear floor space for fixtures. Grab bars are missing and/or incorrectly installed. Accessories, such as toilet seat covers, paper towel holders, garbage cans, hand dryers, and mirrors are either too high or without clear floor space or both. The restroom contain floor level changes greater than a 1/2 inch of the floor drains and is slope (XX) - (XX), the shower is too small and missing numerous accessible elements.	This restroom is for public use and would need multiple readjustments to gain compliance.	https://www.access-board.gov/ada/#ada-213_2 Review restrooms componets to make accessible. https://www.access-board.gov/ada/#ada-603	2012 TAS Section: 213.2  2010 ADAS Section: 213.2

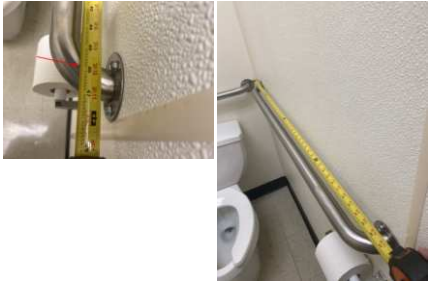
22	First Floor Main Building LOBBY (Public): Lobby Area - Restroom (Women's)	The side grab bar does not extend far enough from the rear wall. The side grab bar must extend at least 54 inches minimum beyond the rear wall and start a maximum of 12 inches from the rear wall. A 42 inch grab bar installed the maximum distance from the rear wall (12 inches) will leave the leading end 54 inches from the rear wall. Grab bars shall be installed in a horizontal position, 33 inches minimum and 36 inches maximum above the finish floor measured to the top of the gripping surface.	Side grab bar installed in wrong location. Side grab bar range is 46". Side grab bar needs to reach 54' total length from rear wall	https://www.access-board.gov/ada/#ada-604_5_1	2012 TAS Section: 604.5.1  2010 ADAS Section: 604.5.1

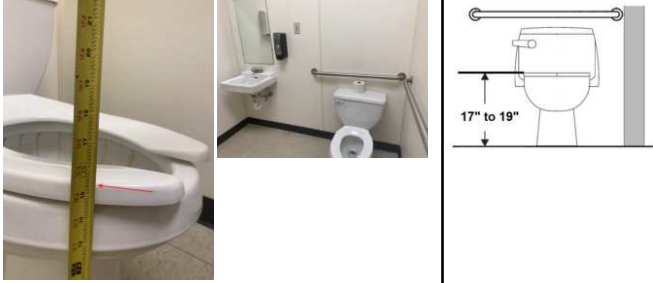
Finding Number	Area Description	Finding	As Built	Recommendation	Citation	Photos	Figure
23	First Floor Main Building LOBBY (Public): Lobby Area - Restroom (Women's)	The toilet seat is not located within the range allowed off the floor. The height of accessible water closets shall be a minimum of 17 inches and a maximum of 19 inches measured to the top of the toilet seat. The seat itself shall be a maximum of 2 inch high.	Toilet seat height is under 16" and too low for compliance.		<a href="https://www.access-board.gov/ada/#ada-604_4">https://www.access-board.gov/ada/#ada-604_4</a>	2012 TAS Section: 604.4  2010 ADAS Section: 604.4

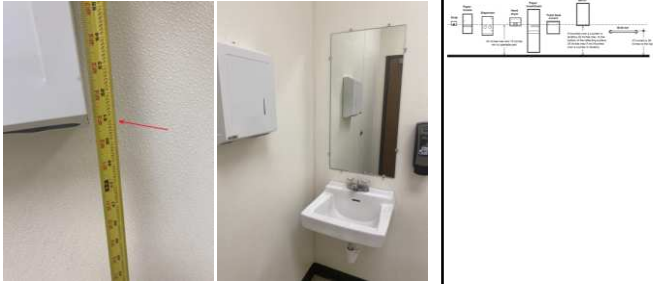
24	First Floor Main Building LOBBY (Public): Lobby Area - Restroom (Women's)	The paper towel dispenser's operation mechanism is too high off the floor. Dispensers must have all operable parts a maximum of 48 inches above the floor.	Paper towel dispenser is 51"		<a href="https://www.access-board.gov/ada/#ada-308_2_1">https://www.access-board.gov/ada/#ada-308_2_1</a>	2012 TAS Section: 308.2.1  2010 ADAS Section: 308.2.1

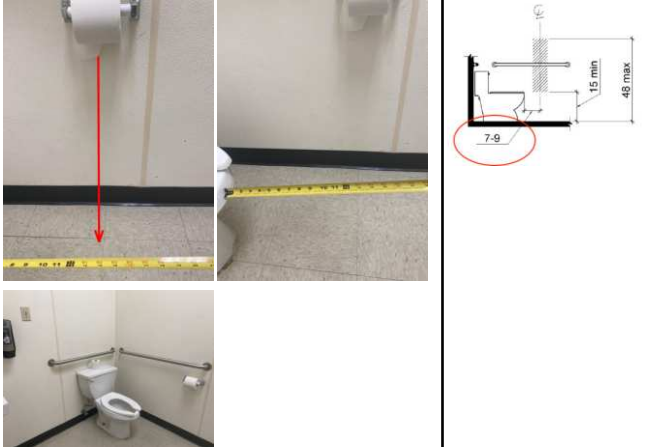
25	First Floor Main Building LOBBY (Public): Lobby Area - Restroom (Women's)	The toilet paper is not installed within the compliant range in front of the toilet. Toilet paper dispensers shall be 7 inches minimum and 9 inches maximum in front of the water closet measured to the centerline of the dispenser. The outlet of the dispenser shall be 15 inches minimum and 48 inches maximum above the finish floor and shall not be located behind grab bars. Dispensers shall not be of a type that controls delivery or that does not allow continuous paper flow. There shall be a clearance of 1 1/2 inches minimum below the grab bar.	TP dispenser is over 13" from front of toilet.		<a href="https://www.access-board.gov/ada/#ada-604_7">https://www.access-board.gov/ada/#ada-604_7</a>	2012 TAS Section: 604.7  2010 ADAS Section: 604.7

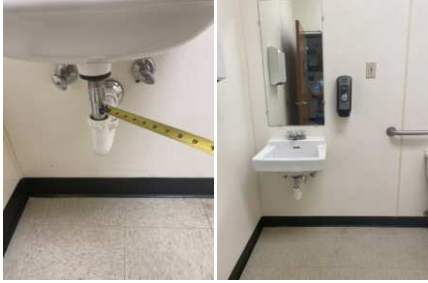
Finding Number	Area Description	Finding	As Built	Recommendation	Citation	Photos	Figure
26	First Floor Main Building LOBBY (Public): Lobby Area - Restroom (Women's)	The water and drain pipes under the lavatory are not adequately insulated. Water supply and drain pipes under lavatories and sinks shall be insulated or otherwise configured to protect against contact. There shall be no sharp or abrasive surfaces under lavatories and sinks.	Sinks are partially insulated.	<a href="https://www.access-board.gov/ada/#ada-606_5">https://www.access-board.gov/ada/#ada-606_5</a>	2012 TAS Section: 606.5  2010 ADAS Section: 606.5

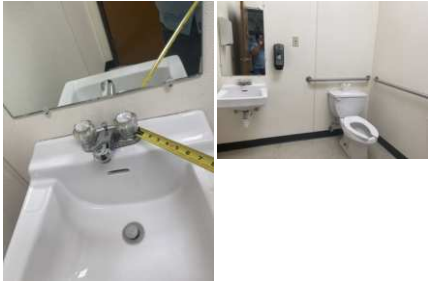
27	First Floor Main Building LOBBY (Public): Lobby Area - Restroom (Women's)	The faucet controls require twisting of the wrist. Faucet controls and operating mechanisms shall be operable with one hand and shall not require tight grasping, pinching or twisting of the wrist. The force required to activate controls shall be no greater than 5 lb. Lever-operated, push-type and electronically controlled mechanisms are examples of acceptable designs. Self-closing valves are allowed if the faucet remains open for at least 10 seconds.	N/A	<a href="https://www.access-board.gov/ada/#ada-606_4">https://www.access-board.gov/ada/#ada-606_4</a> <a href="https://www.access-board.gov/ada/#ada-309_4">https://www.access-board.gov/ada/#ada-309_4</a>	2012 TAS Section: 606.4  2010 ADAS Section: 606.4

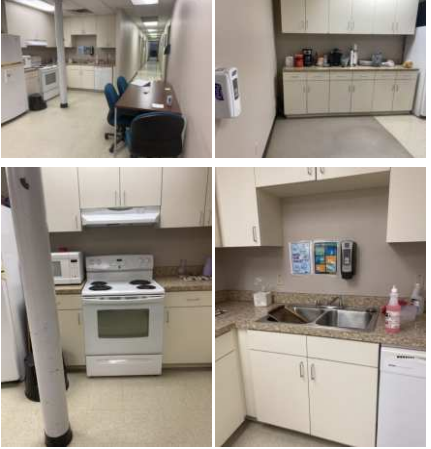
Finding Number	Area Description	Finding	As Built	Recommendation	Citation	Photos	Figure
30	First Floor Main Building (STAFF): Kitchenette	Knee and toe space has not been provided at the sink. Kitchen sinks must be provided with a clear floor space positioned for a forward approach including knee and toe clearance.	Knee and toe must be provided since kitchenette contain stove top range. In kitchens, kitchenettes, and breakrooms without a cooktop or conventional range, a parallel approach is permitted at kitchen sinks	<a href="https://www.access-board.gov/ada/#ada-606_2">https://www.access-board.gov/ada/#ada-606_2</a>	2012 TAS Section: 606.2, 804.4  2010 ADAS Section: 606.2, 804.4

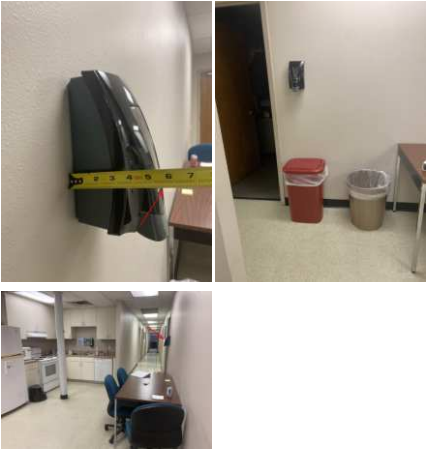
31	First Floor Main Building (STAFF): Kitchenette	The element projects more than 4 inches into the circulation path. Wall-mounted objects that have leading edges between 27 inches and 80 inches from the floor must not project more than 4 inches into the circulation path. Protruding objects that extend to the floor or within 27 inches of the floor are cane detectable and are therefore not hazardous. Where it is necessary or desirable to have objects protrude from the wall, a manner of cane detection must be provided.	Hand sanitizer is protruding object, measures at under 6" but temporarily blocked by trash can placement. Consider moving to better location.	<a href="https://www.access-board.gov/ada/#ada-307_2">https://www.access-board.gov/ada/#ada-307_2</a>	2012 TAS Section: 307.2  2010 ADAS Section: 307.2

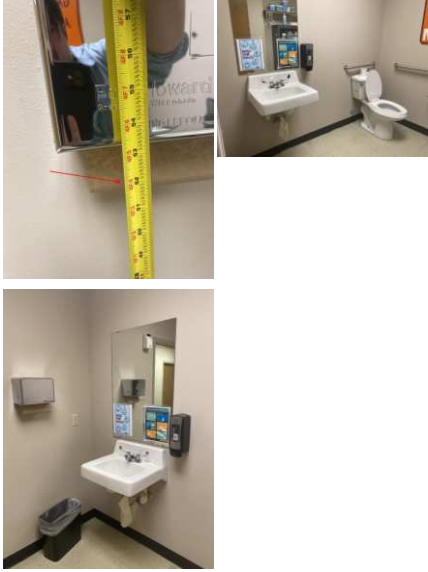
33	First Floor Main Building (STAFF): Restrooms/Water Fountains - Restroom (Men's)	The paper towel dispenser's operation mechanism is too high off the floor. Dispensers must have all operable parts a maximum of 48 inches above the floor.	Paper Towel dispenser height is over 52"	<a href="https://www.access-board.gov/ada/#ada-308_2_1">https://www.access-board.gov/ada/#ada-308_2_1</a>	2012 TAS Section: 308.2.1  2010 ADAS Section: 308.2.1

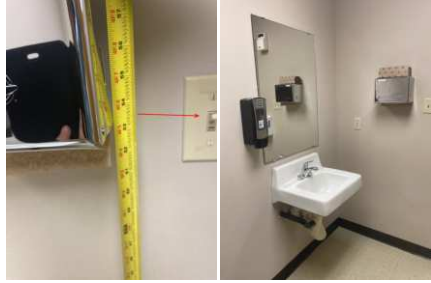
Finding Number	Area Description	Finding	As Built	Recommendation	Citation	Photos	Figure
38	First Floor Main Building (STAFF): Restrooms/Water Fountains - Restroom (Women's)	The receptacle/switch is not positioned correctly for either a side or front approach. Where a clear floor or ground space allows a parallel or front approach to a switch or receptacle and the side reach is unobstructed, the high side reach shall be 48 inches maximum above the finish floor or ground and the low side reach shall be 15 inches minimum above the finish floor or ground.	Light switch access point under 54"	<a href="https://www.access-board.gov/ada/#ada-308_2_1">https://www.access-board.gov/ada/#ada-308_2_1</a>	2012 TAS Section: 308.2.1, 308.3.1  2010 ADAS Section: 308.2.1

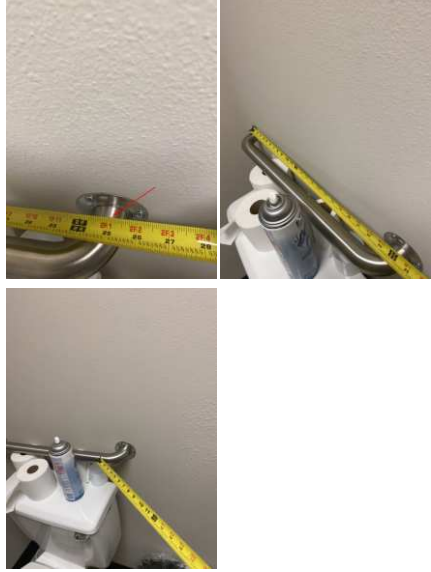
39	First Floor Main Building (STAFF): Restrooms/Water Fountains - Restroom (Women's)	The rear grab bar is not a minimum 36 inches in length. Grab bars shall be installed in a horizontal position, 33 inches minimum and 36 inches maximum above the finish floor measured to the top of the gripping surface and the space between the grab bar and the top of the tank (any obstruction) shall be 1-1/2 inches minimum.	Rear grab bar length is 25" and clutter underneath bar needs to be removed.	<a href="https://www.access-board.gov/ada/#ada-604_5_2">https://www.access-board.gov/ada/#ada-604_5_2</a>	2012 TAS Section: 604.5.2  2010 ADAS Section: 604.5.2
