**LE- Hamilton TX, TGWTC ADA Evaluation**

**4363 FM1047**

**Accessibility Evaluation**

**Inspection Date: 04/27/2023**

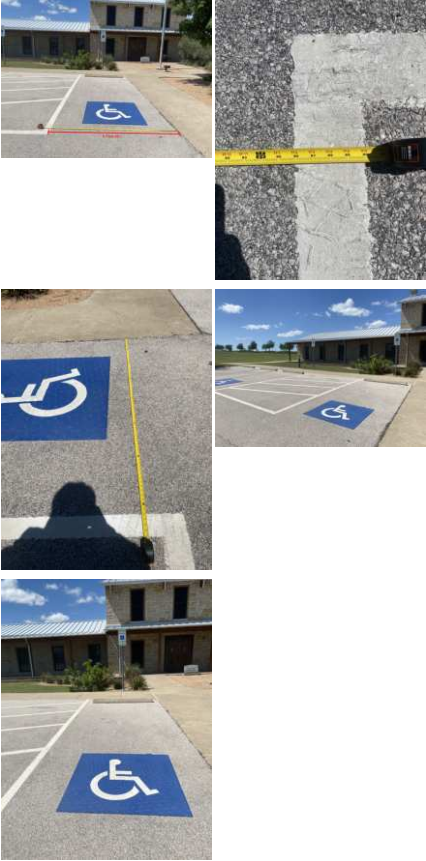
Finding Number	Area Description	Finding	As Built	Recommendation	Citation	Photos	Figure
1	Exterior of Property (Public Tour) : Parking Lot- 2 Van Spots (Administration Building) - Van Accessible Stall (R) Side	The accessible parking stall is not wide enough. Each parking space must be at least 8 feet wide and shall be marked to define the width. Alternatively, the stall can be 11 feet wide minimum with a 5 foot wide minimum access aisle. The measurements of parking spaces and access aisles shall be made from the centerline of the markings. Where the parking space is not adjacent to another parking space or access aisle, the measurement shall be permitted to include the full width of the line defining the parking space.	This accessible parking space (R) side, is less than 8' width and is not compliant. Only required to have 1 accessible (van designated space) in parking lot this size. (L) side van stall and access aisle is compliant.	<a href="https://www.access-board.gov/ada/#ada-502_2">https://www.access-board.gov/ada/#ada-502_2</a>	2012 TAS Section: 502.2  2010 ADAS Section: 502.2

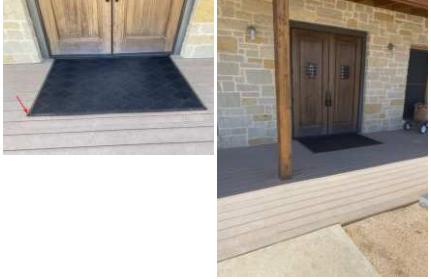
3	Exterior of Property (Public Tour) : Parking Lot- 2 Van Spots (Administration Building) - Path of Travel to Administration Building from Parking Lot	The floor mat at the door is not secured in place. If carpet or carpet tile is used on a ground or floor surface, then it shall be securely attached; have a firm cushion, pad or backing or no cushion or pad; and have a level loop, textured loop, level-cut pile or level-cut/uncut pile texture. The maximum pile height shall be 1/2 inch. Exposed edges of carpet shall be fastened to floor surfaces and have trim along the entire length of the exposed edge. Recessed doormats shall be adequately anchored to prevent interference with wheelchair traffic.	Door mat is beginning to fold and deteriorate. Floor mat is no longer compliant and needs to be replaced.	<a href="https://www.access-board.gov/ada/#ada-302_2">https://www.access-board.gov/ada/#ada-302_2</a>	2012 TAS Section: 302.2  2010 ADAS Section: 302.2

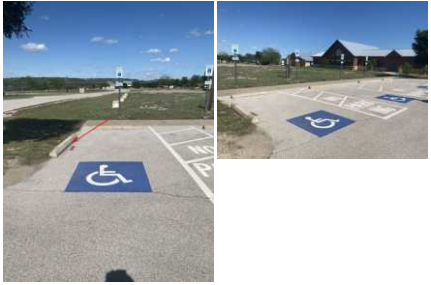
4	Exterior of Property (Public Tour) : Parking Lot- 2 Van 2 Car spots (Cafeteria) - Car Accessible Stall (L) Side	The stripe is missing at the left side of the left parking stall which identifies its border. Vehicle spaces shall be marked to define the width, and shall have an adjacent access aisle.	Accessible stall border is a curb- recommend painting the ground next to the curb. The width of the space can be taken all the way up to the curb. Low priority when compliant width of stall is provided. Car accessible stall on (L) side parking lot is missing border to (L) of stall.	<a href="https://www.access-board.gov/ada/#ada-502_2">https://www.access-board.gov/ada/#ada-502_2</a>	2012 TAS Section: 502.2  2010 ADAS Section: 502.2

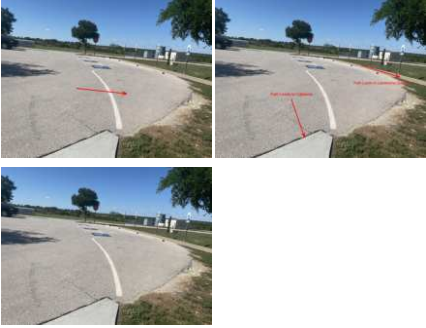
Finding Number	Area Description	Finding	As Built	Recommendation	Citation	Photos	Figure
5	Exterior of Property (Public Tour) : Parking Lot- 2 Van 2 Car spots (Cafeteria) - Path of Travel to Cafeteria from Parking Lot	The striping for the accessible parking stalls loading/unloading access aisle is missing. Access aisles shall be marked so as to discourage parking in them.	Side walk leading to cafeteria has access aisle area with no parking markings missing. Cafeteria parking lot side walks leads to leadership quarters, there is no direct path to main cafeteria entrance.	<a href="https://www.access-board.gov/ada/#ada-502_3_3">https://www.access-board.gov/ada/#ada-502_3_3</a>	2012 TAS Section: 502.3.3  2010 ADAS Section: 502.3.3

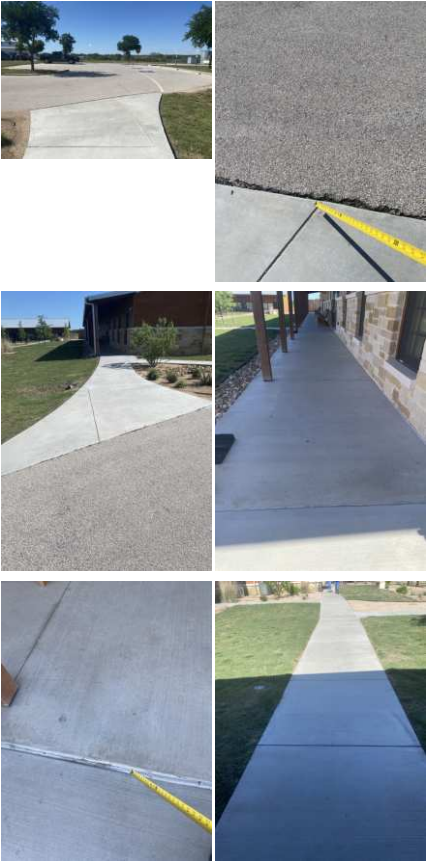
6	Exterior of Property (Public Tour) : Parking Lot- 2 Van 2 Car spots (Cafeteria) - Path of Travel to Cafeteria from Parking Lot	The route contains openings greater than 1/2 inch. Openings in floor or ground surfaces shall not allow passage of a sphere more than 1/2 inch diameter. Elongated openings shall be placed so that the long dimension is perpendicular to the dominant direction of travel.	There are several locations where exterior pathway gap exceeds 1/2" tolerance. This section of pathway leads from cafeteria parking lot to cafeteria main entrance. See additional photos for location of gap non compliance on accessible pathway to building.	<a href="https://www.access-board.gov/ada/#ada-302_3">https://www.access-board.gov/ada/#ada-302_3</a>	2012 TAS Section: 302.3  2010 ADAS Section: 302.3

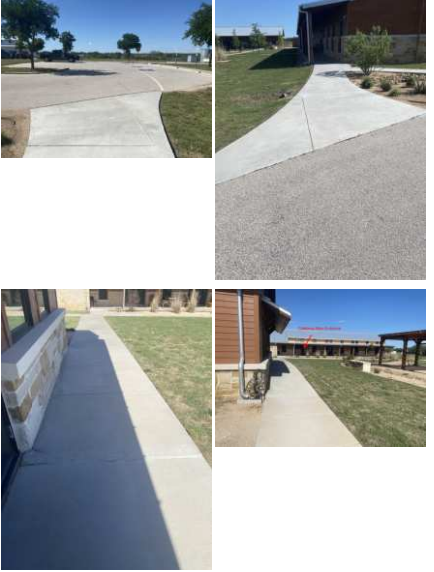
Finding Number	Area Description	Finding	As Built	Recommendation	Citation	Photos	Figure
7	Exterior of Property (Public Tour) : Parking Lot- 2 Van 2 Car spots (Cafeteria) - Path of Travel to Cafeteria from Parking Lot	The access aisle is not located on an accessible route of travel to the accessible building entrance. Accessible parking spaces serving a particular building shall be located on the shortest accessible route of travel from parking to an accessible entrance. In buildings with multiple accessible entrances with adjacent parking, accessible parking spaces shall be dispersed and located closest to the accessible entrances.	There is no direct accessible route to cafeteria main entrance at this time. Path should be located on shortest accessible route.	<a href="https://www.access-board.gov/ada/#ada-208_3_1">https://www.access-board.gov/ada/#ada-208_3_1</a>	2012 TAS Section: 208.3.1  2010 ADAS Section: 208.3.1, 502.3

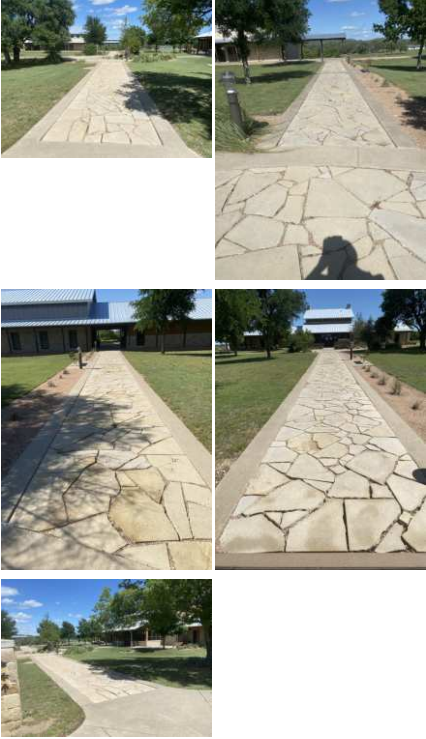
Finding Number	Area Description	Finding	As Built	Recommendation	Citation	Photos	Figure
9	Exterior Pathways (Public Tour) : Exterior Walkways - Exterior Pathway (Admin Building to Courtyard)	The route contains openings greater than 1/2 inch. Openings in floor or ground surfaces shall not allow passage of a sphere more than 1/2 inch diameter. Elongated openings shall be placed so that the long dimension is perpendicular to the dominant direction of travel.	Stone pathway The courtyard behind admin building is not accessible due to route gaps and deterioration. Stone and mortar combo. Accessible pathways (concrete) around courtyard leading to other elements is mostly accessible.	<a href="https://www.access-board.gov/ada/#ada-302_3">https://www.access-board.gov/ada/#ada-302_3</a>	2012 TAS Section: 302.3  2010 ADAS Section: 302.3

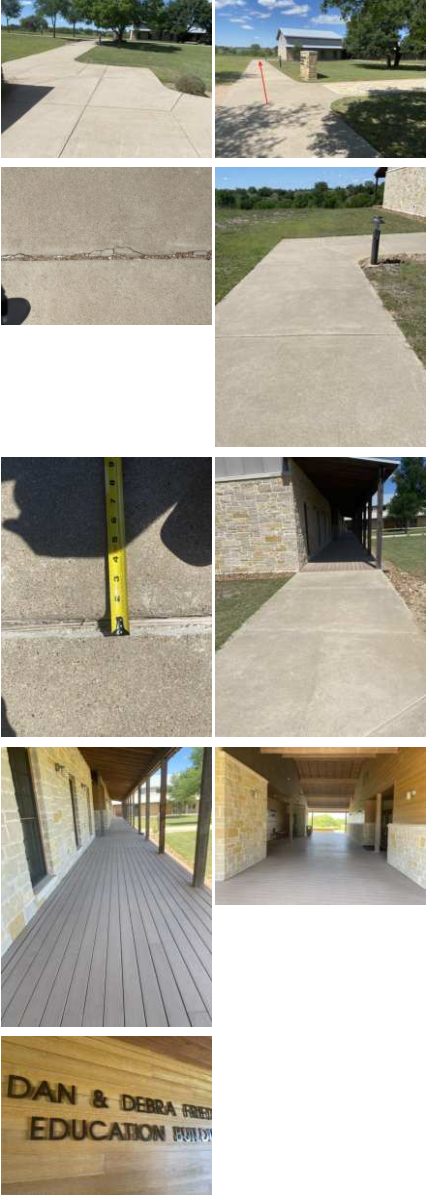
Finding Number	Area Description	Finding	As Built	Recommendation	Citation	Photos	Figure
10	Exterior Pathways (Public Tour) : Exterior Walkways - Exterior Pathway (Admin Building to Auditorium)	The route contains openings greater than 1/2 inch. Openings in floor or ground surfaces shall not allow passage of a sphere more than 1/2 inch diameter. Elongated openings shall be placed so that the long dimension is perpendicular to the dominant direction of travel.	Concrete to wood plank. Wood plank pathways meet compliance. There are a few locations where exterior pathway (concrete) gap exceeds 1/2" tolerance. This section of pathway leads from admin building to auditorium entrance. See additional photos for location of gap non compliance on accessible pathway to building.	<a href="https://www.access-board.gov/ada/#ada-302_3">https://www.access-board.gov/ada/#ada-302_3</a>	2012 TAS Section: 302.3  2010 ADAS Section: 302.3

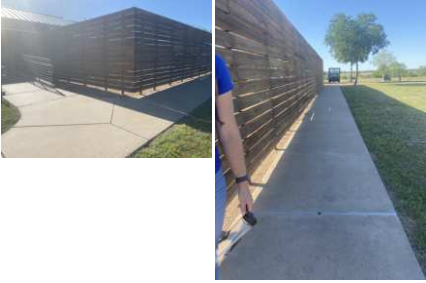
Finding Number	Area Description	Finding	As Built	Recommendation	Citation	Photos	Figure
11	Exterior Pathways (Public Tour) : Exterior Walkways - Exterior Pathway (Granite Path to Rear Cafeteria Entrance)	The route contains openings greater than 1/2 inch. Openings in floor or ground surfaces shall not allow passage of a sphere more than 1/2 inch diameter. Elongated openings shall be placed so that the long dimension is perpendicular to the dominant direction of travel.	Crushed granite to concrete There are a few locations where gap exceeds 1/2" allowance. These are located on concrete path leading to cafeteria rear entrance and ramp.	<a href="https://www.access-board.gov/ada/#ada-302_3">https://www.access-board.gov/ada/#ada-302_3</a>	2012 TAS Section: 302.3 2010 ADAS Section: 302.3

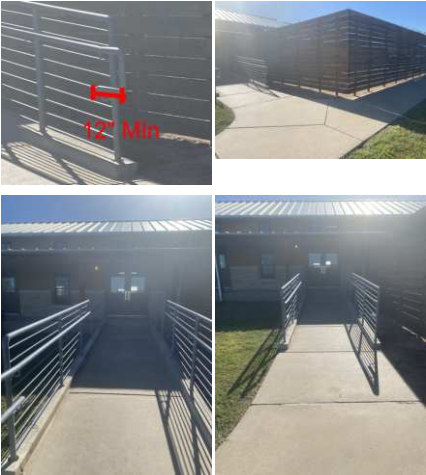
12	Exterior Pathways (Public Tour) : Exterior Walkways - Exterior Pathway (Granite Path to Rear Cafeteria Entrance)	The handrail extension is not a minimum 12 inches. Handrails must be between 34 inches and 38 inches above the ramp surface and must extend beyond the top and bottom of the ramp run 12 inches horizontally. The 12 inches horizontal extensions must not include the radius at the top end of round handrails. Extensions shall return to a wall, guard, or the landing surface, or shall be continuous to the handrail of an adjacent ramp run.	Ramp extension does not look to meet 12" * Needs verification All other ramp components meet compliance.	N/A - Refer to Finding	2012 TAS Section: 505.10.1 2010 ADAS Section: 505.10.1

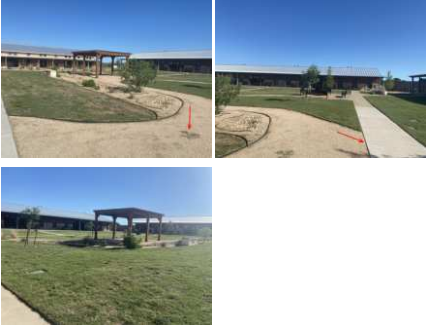
Finding Number	Area Description	Finding	As Built	Recommendation	Citation	Photos	Figure
13	Exterior Pathways (Public Tour) : Exterior Walkways - Exterior Pathway (Cafeteria to Gravel Courtyard)	There is no accessible route to the accessible element. At least one accessible route shall connect accessible buildings, accessible facilities, accessible elements, and accessible spaces that are on the same site.	Concrete to crushed granite There is no accessible route to exterior courtyard. Granite path needs some maintenance, abrupt elevation change from concrete path to granite path, and removal of overgrowth. Surrounding concrete path has some areas with large gaps exceeding 1/2". * Only the route leading from cafeteria to cafeteria parking lot to exterior courtyard was evaluated. Alternate routes to exterior courtyard were not evaluated at this time.	<a href="https://www.access-board.gov/ada/#ada-206_2_2">https://www.access-board.gov/ada/#ada-206_2_2</a>	2012 TAS Section: 206.2.2  2010 ADAS Section: 206.2.2

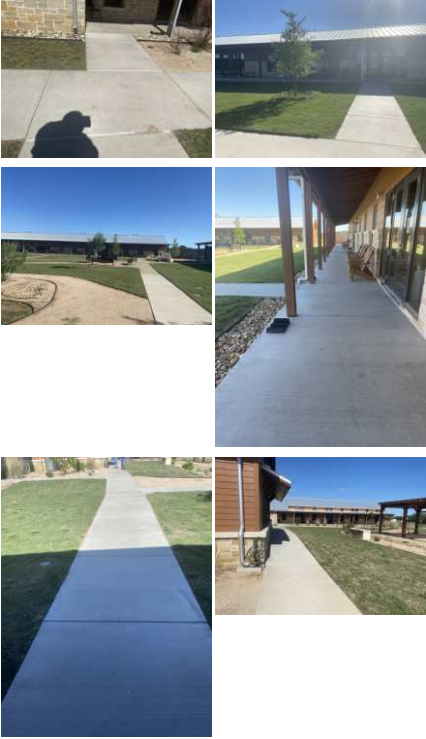
Finding Number	Area Description	Finding	As Built	Recommendation	Citation	Photos	Figure
14	Exterior Pathways (Public Tour) : Exterior Walkways - Exterior Pathway (Cafeteria to Bunk Halls)	The route contains openings greater than 1/2 inch. Openings in floor or ground surfaces shall not allow passage of a sphere more than 1/2 inch diameter. Elongated openings shall be placed so that the long dimension is perpendicular to the dominant direction of travel.	Concrete There are several locations where exterior pathway gap exceeds 1/2" tolerance. This section of concrete pathway leads around cafeteria and living quarter areas. See additional photos for location of gap non compliance on accessible pathway around buildings.	<a href="https://www.access-board.gov/ada/#ada-302_3">https://www.access-board.gov/ada/#ada-302_3</a>	2012 TAS Section: 302.3  2010 ADAS Section: 302.3

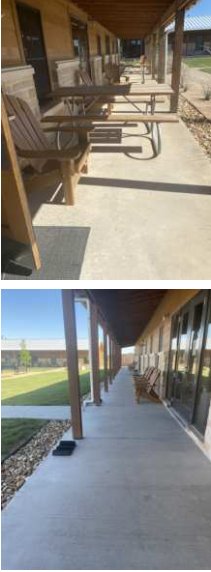
Finding Number	Area Description	Finding	As Built	Recommendation	Citation	Photos	Figure
15	Exterior Pathways (Public Tour) : Exterior Walkways - Exterior Pathway (Cafeteria to Bunk Halls)	The walking surface is obstructed. A 36 inch wide minimum walking surface is required.	Some pathways are obstructed with outdoor furniture, narrowing route to less than 36"	<a href="https://www.access-board.gov/ada/#ada-403_5_1">https://www.access-board.gov/ada/#ada-403_5_1</a>	2012 TAS Section: 403.5.1  2010 ADAS Section: 403.5.1

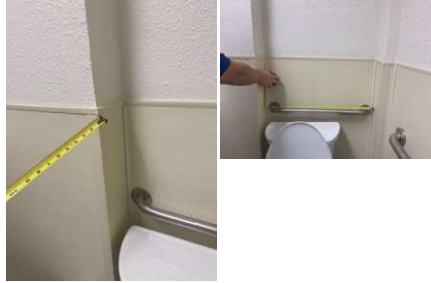
25	First Floor Building Interior (Public Tour) : Cafeteria Meeting Area (Tour) - Restroom (Men's)	The rear grab bar does not extend adequately past the toilet on the wide side. The rear grab bar must be a minimum of 36 inches long and extend from the centerline of the toilet 12 inches minimum on wall side and 24 inches minimum on the wide side. Grab bars shall be installed in a horizontal position, 33 inches minimum and 36 inches maximum above the finish floor measured to the top of the gripping surface and the space between the grab bar and the top of the tank shall be 1-1/2 inches minimum.	Rear grab bar does not extend required length in either direction due to wall barrier. Rear grab bar can be 24" due to exemption but needs to be centered over toilet. Wall does not allow rear grab bar installation to be centered on toilet.	N/A - Refer to Finding	2012 TAS Section: 604.5.2  2010 ADAS Section: 604.5.2

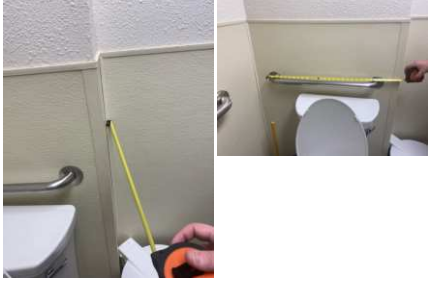
27	First Floor Building Interior (Public Tour) : Cafeteria Meeting Area (Tour) - Restroom (Women's)	The rear grab bar does not extend adequately past the toilet on the wide side. The rear grab bar must be a minimum of 36 inches long and extend from the centerline of the toilet 12 inches minimum on wall side and 24 inches minimum on the wide side. Grab bars shall be installed in a horizontal position, 33 inches minimum and 36 inches maximum above the finish floor measured to the top of the gripping surface and the space between the grab bar and the top of the tank shall be 1-1/2 inches minimum.	Rear grab bar does not extend required length in either direction due to wall barrier. Rear grab bar can be 24" due to exemption but needs to be centered over toilet. Wall does not allow rear grab bar installation to be centered on toilet.	N/A - Refer to Finding		2012 TAS Section: 604.5.2  2010 ADAS Section: 604.5.2

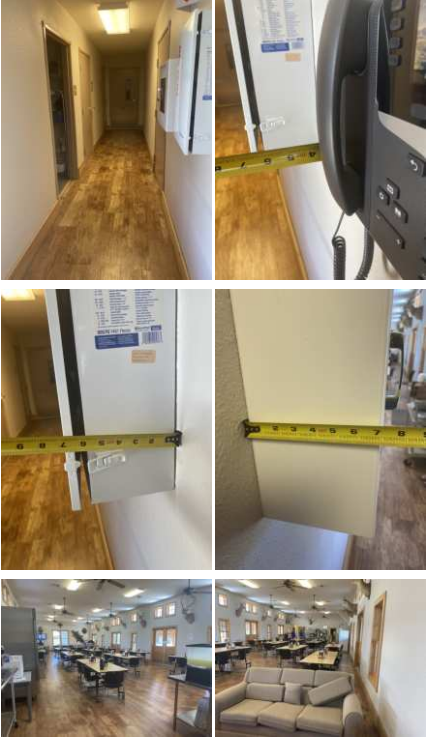
Finding Number	Area Description	Finding	As Built	Recommendation	Citation	Photos	Figure
29	First Floor Building Interior (Public Tour) : Cafeteria Meeting Area (Tour) - Interior Space of Building	The element projects more than 4 inches into the circulation path. Wall-mounted objects that have leading edges between 27 inches and 80 inches from the floor must not project more than 4 inches into the circulation path. Protruding objects that extend to the floor or within 27 inches of the floor are cane detectable and are therefore not hazardous. Where it is necessary or desirable to have objects protrude from the wall, a manner of cane detection must be provided.	There are 3 protruding objects total located in bathroom hallway. See additional photos for details. ADA Accessibility Guidelines (ADAAG) specify that objects such as automated external defibrillator wall cabinets shall not protrude more than 4 inches from the wall into walks, corridors, passageways, or aisles.	<a href="https://www.access-board.gov/ada/#ada-307_2">https://www.access-board.gov/ada/#ada-307_2</a>	2012 TAS Section: 307.2  2010 ADAS Section: 307.2

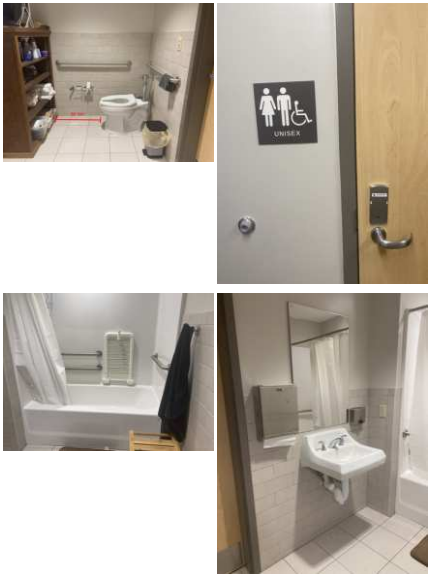
35	First Floor Leadership Quarters (Public/Staff) : Infirmary Restroom	The clear floor space around the toilet is obstructed by storage shelf. No fixtures are allowed in the clear floor space required for the toilet. The required clearance around the water closet shall be permitted to overlap the water closet, associated grab bars, dispensers, sanitary napkin disposal units, coat hooks, shelves, accessible routes, clear floor space and clearances required at other fixtures, and the turning space. No other fixtures or obstructions shall be located within the required water closet clearance.	N/A	<a href="https://www.access-board.gov/ada/#ada-604_3_2">https://www.access-board.gov/ada/#ada-604_3_2</a>	2012 TAS Section: 604.3.2  2010 ADAS Section: 604.3.2

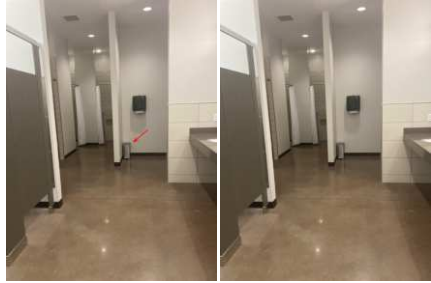
37	First Floor Bunk Buildings- 2 Total (STAFF): Restroom/Showe r	The paper towel dispenser is not accessible because there is not adequate clear floor space for either a forward or side approach. The clear floor or ground space shall be 30 inches minimum by 48 inches minimum.	N/A		<a href="https://www.access-board.gov/ada/#ada-305_3">https://www.access-board.gov/ada/#ada-305_3</a>  2012 TAS Section: 305.3  2010 ADAS Section: 305.3

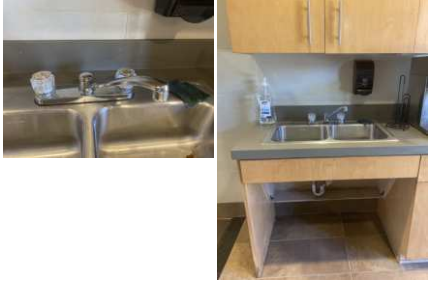
Finding Number	Area Description	Finding	As Built	Recommendation	Citation	Photos	Figure	
49	First Floor Auxiliary Classroom (STAFF): Interior Hallways of Building - Kitchenette	The sink controls requires tight grasping, tight pinching or twisting of the wrist to operate. Controls and operating mechanisms shall be operable with one hand and shall not require tight grasping, pinching or twisting of the wrist. The force required to activate controls shall be no greater than 5 pounds of force.	N/A		<a href="https://www.access-board.gov/ada/#ada-309_4">https://www.access-board.gov/ada/#ada-309_4</a>	2012 TAS Section: 309.4 2010 ADAS Section: 309.4

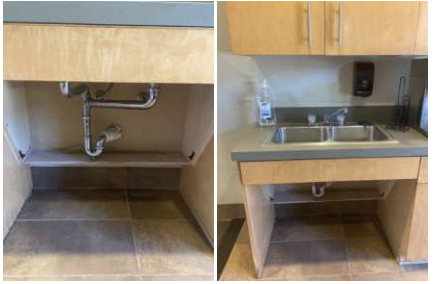
50	First Floor Auxiliary Classroom (STAFF): Interior Hallways of Building - Kitchenette	The sink drain pipes are exposed. Water supply and drain pipes under lavatories and sinks shall be insulated or otherwise configured to protect against contact. There shall be no sharp or abrasive surfaces under lavatories and sinks.	Sink pipes are exposed Sink is accessible via front or parallel approach.		<a href="https://www.access-board.gov/ada/#ada-606_5">https://www.access-board.gov/ada/#ada-606_5</a>	2012 TAS Section: 606.5 2010 ADAS Section: 606.5

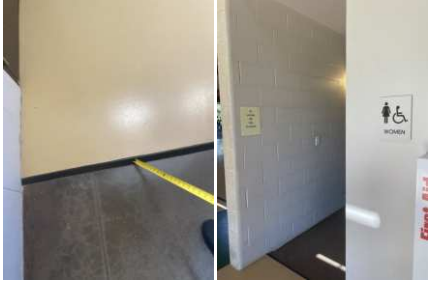
Finding Number	Area Description	Finding	As Built	Recommendation	Citation	Photos	Figure
54	First Floor Gymnasium (STAFF): Restrooms/Water Fountains - Restroom (Women's Locker Room)	There is a change in level that exceeds the allowable range. A 1/4 inch is the maximum vertical rise. Changes in level between 1/4 inch and 1/2 inch must be beveled at 1:2 or less. Changes in level greater than 1/2 inch must be by way of a ramp.	Interior pathway leading to locker room exceeds 1/4" threshold.	<a href="https://www.access-board.gov/ada/#ada-303_2">https://www.access-board.gov/ada/#ada-303_2</a>	2012 TAS Section: 303.3  2010 ADAS Section: 303.3

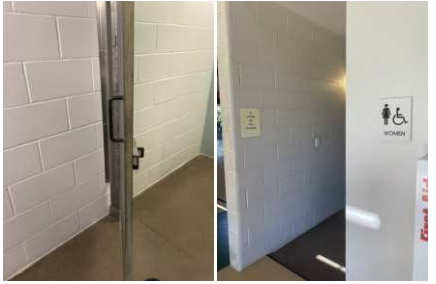
55	First Floor Gymnasium (STAFF): Restrooms/Water Fountains - Restroom (Women's Locker Room)	The water closet compartment is missing a loop handle on the one side of the door. Water closet compartments must be equipped with a door that has a loop or U-shaped handle on both sides of the door near the latch. The latch must be flip-over style, sliding or other hardware not requiring the user to grasp or twist.	N/A	<a href="https://www.access-board.gov/ada/#ada-604_8_1_2">https://www.access-board.gov/ada/#ada-604_8_1_2</a>	2012 TAS Section: 604.8.1.2  2010 ADAS Section: 604.8.1.2

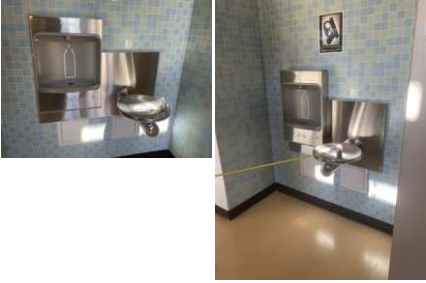
Finding Number	Area Description	Finding	As Built	Recommendation	Citation	Photos	Figure
57	First Floor Gymnasium (STAFF): Restrooms/Water Fountains - Water Fountain	There is no drinking fountain for standing persons. No fewer than two drinking fountains shall be provided. One drinking fountain shall meet requirements for wheelchair accessibility and one drinking fountain shall meet requirements for standing persons. Where a single drinking fountain complies with both wheelchair accessibility and requirements for standing persons, it shall be permitted to be substituted for two separate drinking fountains. Spout outlets of drinking fountains for standing persons shall be 38 inches minimum and 43 inches maximum above the finish floor or ground.	Standing water fountain is not provided. Its required that if one is provided then the other option is as well. Water refill station cannot take the place of either water fountain unless only water refill station is provided and no water fountains. Option pictured is not compliant. The Building Code may only require one drinking fountain be provided, but the Accessibility Standards require at least two. One at a lower height and the other at standing height.	Minimum number <a href="https://www.access-board.gov/ada/#ada-211_2">https://www.access-board.gov/ada/#ada-211_2</a> Standing person requirements <a href="https://www.access-board.gov/ada/#ada-602_7">https://www.access-board.gov/ada/#ada-602_7</a>	2012 TAS Section: 602.7, 211.2  2010 ADAS Section: 602.7, 211.2
