# Garland LE- ADA Evaluation

Report Date: 01/14/2024

**LE- Garland TX, ADA Evaluation**  
**346 Oaks Trail Suite 100**  
**Garland, TX 75043**  
**Accessibility Evaluation**  
**Inspection Date: 03/23/2023**  
**Inspectors: Christopher Meza**

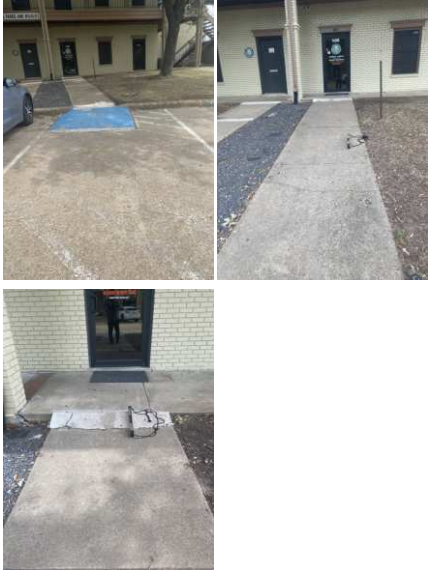
Finding Number	Area Description	Finding	As Built	Recommendation	Citation	Photos	Figure
1	Exterior of Property (Public): Parking Lot (1 Space) Unlabeled	The access aisle is not located on an accessible route of travel to the accessible building entrance. Accessible parking spaces serving a particular building shall be located on the shortest accessible route of travel from parking to an accessible entrance. In buildings with multiple accessible entrances with adjacent parking, accessible parking spaces shall be dispersed and located closest to the accessible entrances.	Due to curb ramp, pathway deterioration, and sloping there is no accessible route from parking lot to building.	<a href="https://www.access-board.gov/ada/#ada-208_3_1">https://www.access-board.gov/ada/#ada-208_3_1</a>	2012 TAS Section: 208.3.1  2010 ADAS Section: 208.3.1, 502.3

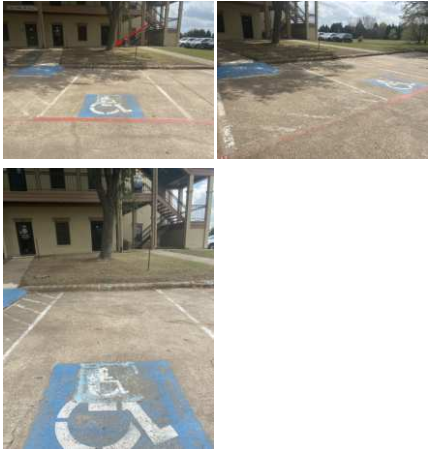
2	Exterior of Property (Public): Parking Lot (1 Space) Unlabeled - Accessible Parking Stall (Unlabeled)	The van stall is missing a sign identifying it as a van accessible stall. Parking space identification signs shall include the International Symbol of Accessibility. Signs identifying van parking spaces shall contain the designation "van accessible."	Accessible parking stall meets dimension requirements but missing signage. Markings beginning to fade.	<a href="https://www.access-board.gov/ada/#ada-502_6">https://www.access-board.gov/ada/#ada-502_6</a>	2012 TAS Section: 502.6  2010 ADAS Section: 502.6

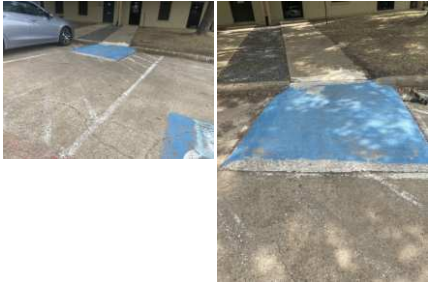
3	Exterior of Property (Public): Parking Lot (1 Space) Unlabeled - Access Aisle (Unlabeled Stall)	The accessible parking stall's access aisle contains a built up curb ramp which results in significant slopes greater than 2 percent. Surface slopes of accessible parking spaces and access aisles shall be the minimum possible and shall not exceed one unit vertical in 50 units, horizontal (2-percent slope) in any direction.	Obstructions, changes in elevation, abrupt edges, and curb ramps are prohibited from being placed in access aisle. Floor or Ground Surfaces. Access aisles are required to be nearly level in all directions to provide a surface for wheelchair transfer to and from vehicles.	<a href="https://www.access-board.gov/ada/#ada-502_4">https://www.access-board.gov/ada/#ada-502_4</a>	2012 TAS Section: 502.4  2010 ADAS Section: 502.4

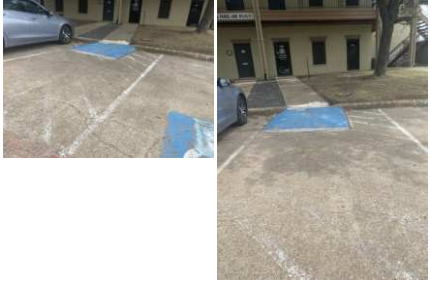
Finding Number	Area Description	Finding	As Built	Recommendation	Citation	Photos	Figure	
4	Exterior of Property (Public): Parking Lot (1 Space) Unlabeled - Access Aisle (Unlabeled Stall)	The striping and markings for the accessible parking stalls, loading/unloading access aisle are dilapidated and in need of repair and/or maintenance. Access aisles shall be marked so as to discourage parking in them. Where parking spaces are marked with lines, width measurements of parking spaces and access aisles shall be made from the centerline of the markings.	N/A		<a href="https://www.access-board.gov/ada/#ada-502_3_3">https://www.access-board.gov/ada/#ada-502_3_3</a>	2012 TAS Section: 502.3.3  2010 ADAS Section: 502.3.3

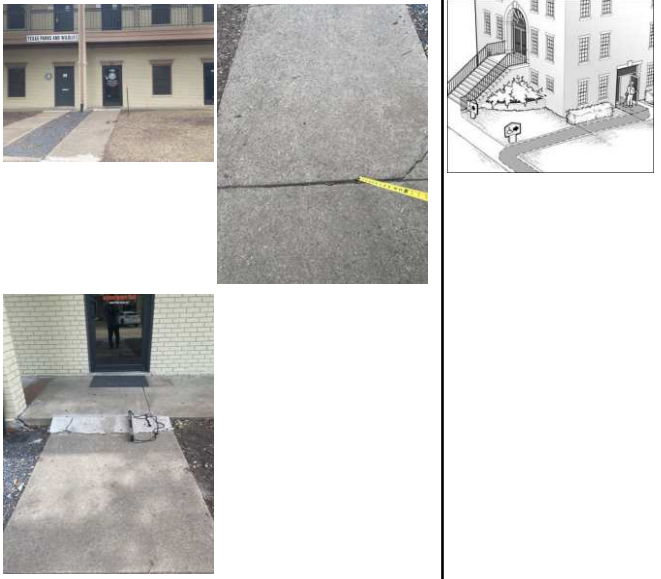
5	Exterior of Property (Public): Path of Travel to Building - Path of Travel (Main Route)	The building entrance is not located on an accessible route. When a building, or portion of a building, is required to be accessible, an accessible route of travel shall be provided to all portions of the building, to accessible building entrances and between the building and the public way. At least one accessible route within the boundary of the site must be provided from public transportation stops, accessible parking and accessible passenger loading zones and public streets or sidewalks to the accessible building entrance they serve. The accessible route shall, to the maximum extent feasible, coincide with the route for the general public. At least one accessible route shall connect accessible buildings, facilities, elements and spaces that are on the same site. At least one accessible route shall connect accessible building or facility entrances with all accessible spaces and elements.	Due to sloping, pathway deterioration, and changes in level, there is no accessible pathway to enter building.		<a href="https://www.access-board.gov/ada/#ada-206_2_1">https://www.access-board.gov/ada/#ada-206_2_1</a>	2012 TAS Section: 206.2.1  2010 ADAS Section: 206.2.1

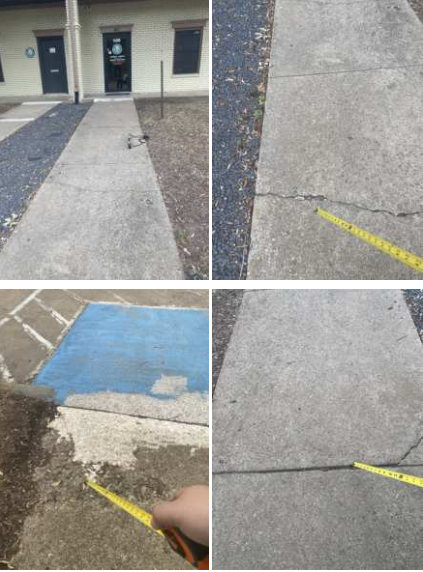
Finding Number	Area Description	Finding	As Built	Recommendation	Citation	Photos	Figure
6	Exterior of Property (Public): Path of Travel to Building - Path of Travel (Main Route)	The route contains openings greater than 1/2 inch. Openings in floor or ground surfaces shall not allow passage of a sphere more than 1/2 inch diameter. Elongated openings shall be placed so that the long dimension is perpendicular to the dominant direction of travel.	There are several locations where exterior pathway gap exceeds 1/2" tolerance. See additional photos for location of gap noncompliance on accessible pathway to building.	<a href="https://www.access-board.gov/ada/#ada-302_3">https://www.access-board.gov/ada/#ada-302_3</a>	2012 TAS Section: 302.3 2010 ADAS Section: 302.3

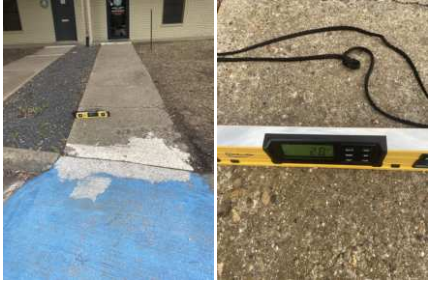
Finding Number	Area Description	Finding	As Built	Recommendation	Citation	Photos	Figure
9	Exterior of Property (Public): Path of Travel to Building - Curb Ramp (Main Route)	The landing of the ramp has a slope greater than 2 percent. Landings shall have a slope of less than 1:48 (2 percent) in any direction.	Cross slope at top of curb ramp landing is 2.8%		<a href="https://www.access-board.gov/ada/#ada-406_4">https://www.access-board.gov/ada/#ada-406_4</a>  2012 TAS Section: 406.4, 406.4 Exception  2010 ADAS Section: 406.4, 406.4 Exception

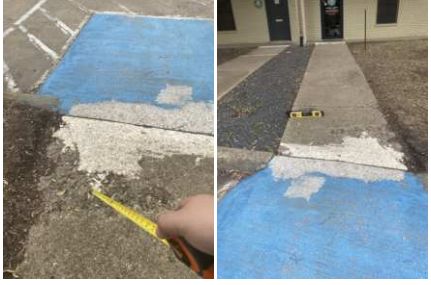
10	Exterior of Property (Public): Path of Travel to Building - Curb Ramp (Main Route)	The top of the curb ramp does not have a level landing. A level landing 36 inches in length shall be provided at the upper end of each curb. The landing clear width shall be at least as wide as the curb ramp, excluding flared sides, leading to the landing.	There is no top landing provided from curb ramp.		<a href="https://www.access-board.gov/ada/#ada-406_4">https://www.access-board.gov/ada/#ada-406_4</a>  2012 TAS Section: 406.4  2010 ADAS Section: 406.4

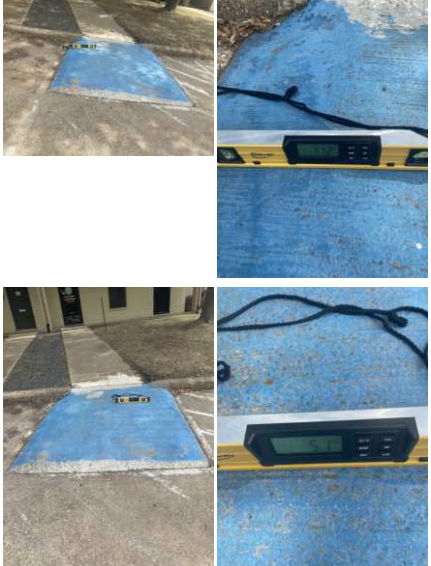
11	Exterior of Property (Public): Path of Travel to Building - Curb Ramp (Main Route)	The curb ramp on the accessible route has cross slopes greater than 2%. Surface cross slopes shall not exceed one unit vertical in 48 units horizontal (2-percent slope).	Curb ramp cross slopes exceeds 2% in 2 locations. Cross slope on (L) side of curb ramp is 11.2%. Cross slope on (R) side of curb ramp is 5.1% Curb ramp running slope meets requirements.		<a href="https://www.access-board.gov/ada/#ada-405_3">https://www.access-board.gov/ada/#ada-405_3</a>  2012 TAS Section: 405.3, 406.1  2010 ADAS Section: 405.3, 406.1

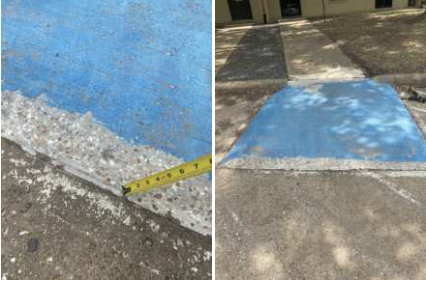
Finding Number	Area Description	Finding	As Built	Recommendation	Citation	Photos	Figure
12	Exterior of Property (Public): Path of Travel to Building - Curb Ramp (Main Route)	The change in level where the gutter meets the curb ramp is greater than 1/4 inch. 1/4 inch is the maximum vertical rise. Changes in level between 1/4 inch and 1/2 inch must be beveled at 1:2 or less. Changes in level greater than 1/2 inch must be by way of a ramp.	Transition to access curb ramp exceeds 1/4"	<a href="https://www.access-board.gov/ada/#ada-303_2">https://www.access-board.gov/ada/#ada-303_2</a>	2012 TAS Section: 303.3  2010 ADAS Section: 303.3

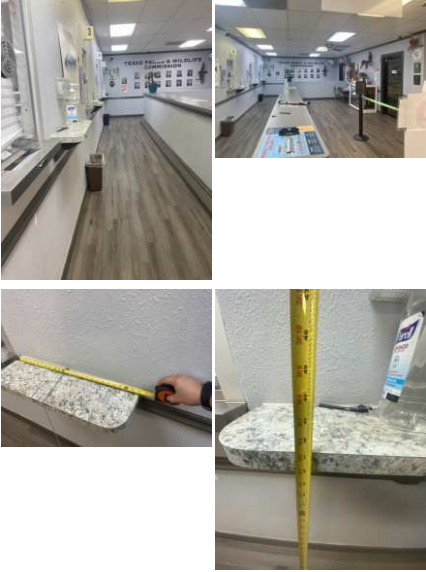
Finding Number	Area Description	Finding	As Built	Recommendation	Citation	Photos	Figure
15	First Floor Main Building LOBBY (Public): Lobby Area - Service Counter	Accessible counters are not provided for all the different types of sales and service counters available. At least one of each type of sales counter and service counter shall be accessible.	There are 5 service counters total, none of them have correct depth or width for front or parallel approach. 1 service desk at compliant height but writing space not wide enough or useable.	<a href="https://www.access-board.gov/ada/#ada-227_3">https://www.access-board.gov/ada/#ada-227_3</a>	2012 TAS Section: 227.3  2010 ADAS Section: 227.3

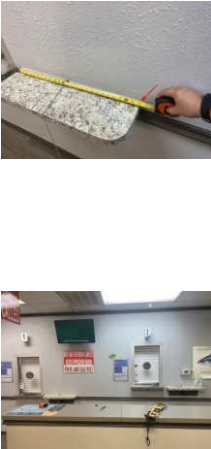
16	First Floor Main Building LOBBY (Public): Lobby Area - Service Counter	The sales and service counter is not a minimum 36 inches wide. A portion of the counter surface that is 36 inches long minimum and 36 inches high maximum above the finish floor shall be provided. A clear floor space on an accessible route must be provided for either a forward or parallel approach.	Service desk width is 26"	<a href="https://www.access-board.gov/ada/#ada-904_4">https://www.access-board.gov/ada/#ada-904_4</a>	2012 TAS Section: 904.3.1  2010 ADAS Section: 904.4

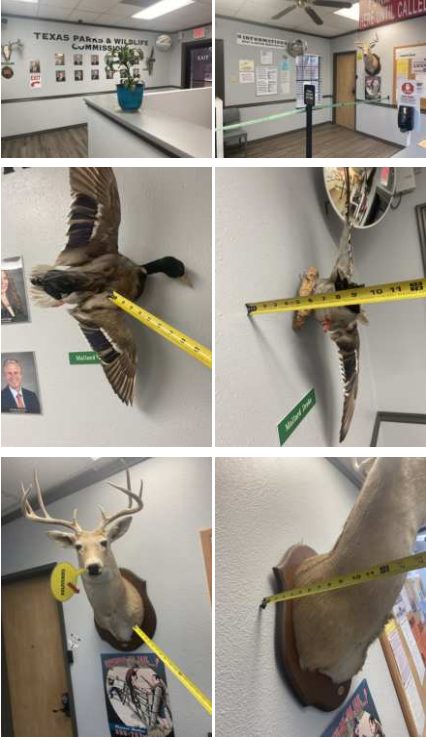
Finding Number	Area Description	Finding	As Built	Recommendation	Citation	Photos	Figure
17	First Floor Main Building LOBBY (Public): Lobby Area - Interior Hallways of Building	The element projects more than 4 inches into the circulation path. Wall-mounted objects that have leading edges between 27 inches and 80 inches from the floor must not project more than 4 inches into the circulation path. Protruding objects that extend to the floor or within 27 inches of the floor are cane detectable and are therefore not hazardous. Where it is necessary or desirable to have objects protrude from the wall, a manner of cane detection must be provided.	There are 2 mounts that are not protected by office furniture and cause protruding object non compliance. Deer mount near door leading to staff hallway and duck mount near building exit door.	<a href="https://www.access-board.gov/ada/#ada-307_2">https://www.access-board.gov/ada/#ada-307_2</a>	2012 TAS Section: 307.2  2010 ADAS Section: 307.2

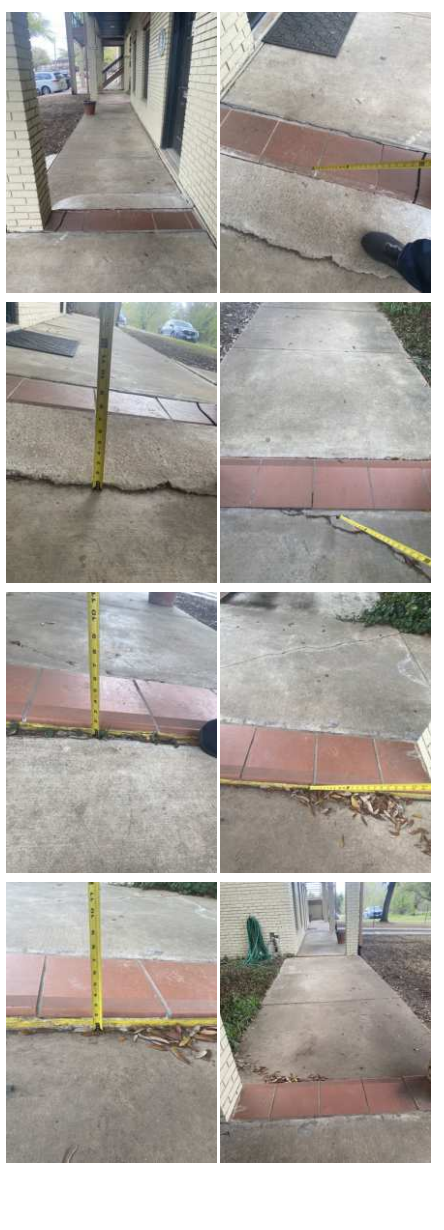
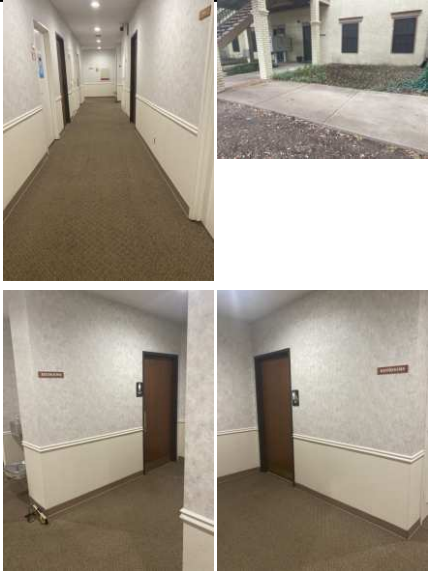
Finding Number	Area Description	Finding	As Built	Recommendation	Citation	Photos	Figure
18	First Floor Main Building LOBBY (Public): Exterior Route To Public Restroom	The public / common use restrooms serving the facility are not on an accessible route. Bathing and toilet facilities that serve buildings, facilities or portions of buildings or facilities that are required to be accessible to persons with disabilities, shall be on an accessible route.	Pathway leading to public restroom has changes in level making this pathway not accessible.	<a href="https://www.access-board.gov/ada/#ada-213_1">https://www.access-board.gov/ada/#ada-213_1</a> <a href="https://www.access-board.gov/ada/#ada-206_2_2">https://www.access-board.gov/ada/#ada-206_2_2</a>	2012 TAS Section: 213.1  2010 ADAS Section: 213.1

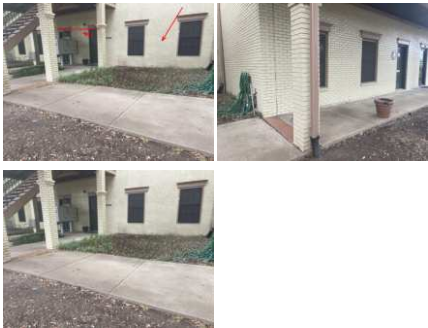
19	First Floor Main Building LOBBY (Public): Exterior Route To Public Restroom	Provide directional signage to the nearest accessible restrooms. Signs that identify, direct to or give information about accessible elements and features of a building or site, shall have a non-glare finish, contrast with their background, be selected from fonts where the width of the uppercase letter "O" is 55 percent minimum and 110 percent maximum of the height of the uppercase letter "I". Characters shall be uppercase or lowercase or a combination of both, conventional in form and shall not be italic, oblique, script, highly decorative, or of other unusual forms and be sized according to the viewing distance.	There are no signs posted outside building identifying public use restroom location. Signs that provide direction to or information about interior spaces and facilities must meet visual requirements but are not required to be tactile	<a href="https://www.access-board.gov/ada/#ada-216_8">https://www.access-board.gov/ada/#ada-216_8</a>	2012 TAS Section: 216.8  2010 ADAS Section: 216.8

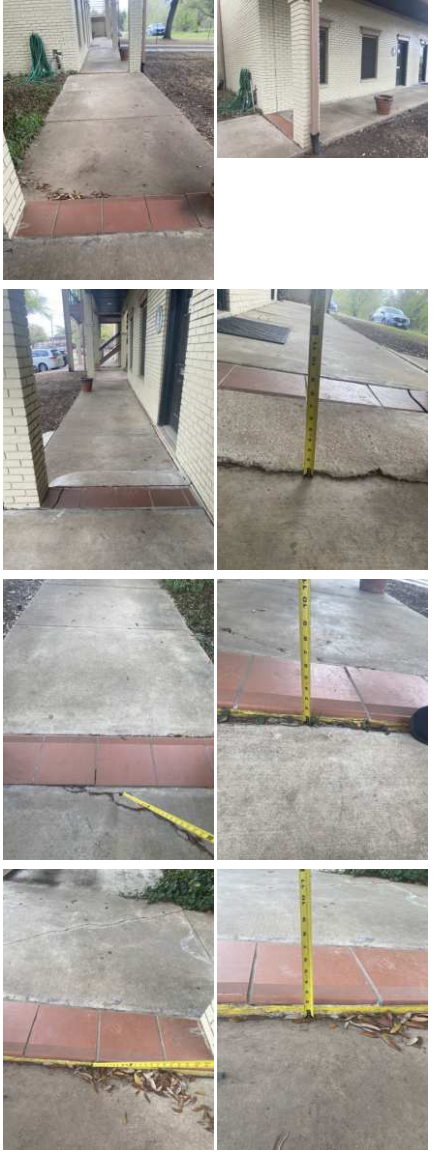
Finding Number	Area Description	Finding	As Built	Recommendation	Citation	Photos	Figure
20	First Floor Main Building LOBBY (Public): Exterior Route To Public Restroom	The walkway contains abrupt vertical edges and/or variations over 1/4 inch. 1/4 inch is the maximum vertical rise. Changes in level between 1/4 inch and 1/2 inch must be beveled at 1:2 or less. Changes in level greater than 1/2 inch must be by way of a ramp.	There are several locations where pathway exceeds 1/4" or 1/2" change in elevation. See additional photos for location of elevation changes in accessible pathway or sidewalk.	<a href="https://www.access-board.gov/ada/#ada-303_2">https://www.access-board.gov/ada/#ada-303_2</a> <a href="https://www.access-board.gov/ada/#ada-303_3">https://www.access-board.gov/ada/#ada-303_3</a>	2012 TAS Section: 303.3, 303.2  2010 ADAS Section: 303.3, 303.2

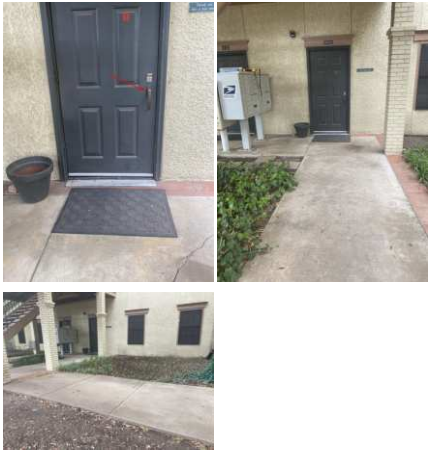
21	First Floor Main Building LOBBY (Public): Exterior Route To Public Restroom - Entrance into Public Restroom Location	The door operating hardware requires tight grasping, pinching or twisting of the wrist to operate. Hand-activated hardware, handles, pulls, latches, locks, and other operating devices on accessible elements shall have a shape that is easy to grasp with one hand and does not require tight grasping, pinching or twisting of the wrist to operate.	N/A	<a href="https://www.access-board.gov/ada/#ada-309_4">https://www.access-board.gov/ada/#ada-309_4</a>	2012 TAS Section: 309.4 2010 ADAS Section: 309.4

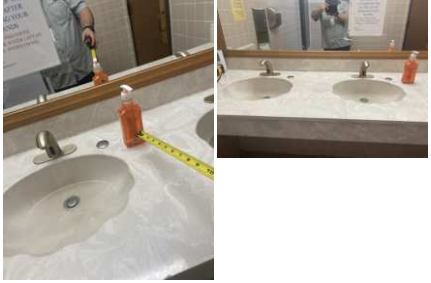
Finding Number	Area Description	Finding	As Built	Recommendation	Citation	Photos	Figure
37	First Floor Main Building LOBBY (Public): Exterior Route To Public Restroom - Restroom (Men's) Public/Staff	The element is not accessible because it requires tight grasping, pinching or twisting of the wrist. Controls and operating mechanisms shall be operable with one hand and shall not require tight grasping, pinching or twisting of the wrist. The force required to activate controls shall be no greater than 5 pounds of force.	Soap dispenser not provided. Free standing soap bottle is not accessible option.	<a href="https://www.access-board.gov/ada/#ada-309_4">https://www.access-board.gov/ada/#ada-309_4</a>	2012 TAS Section: 309.4  2010 ADAS Section: 309.4

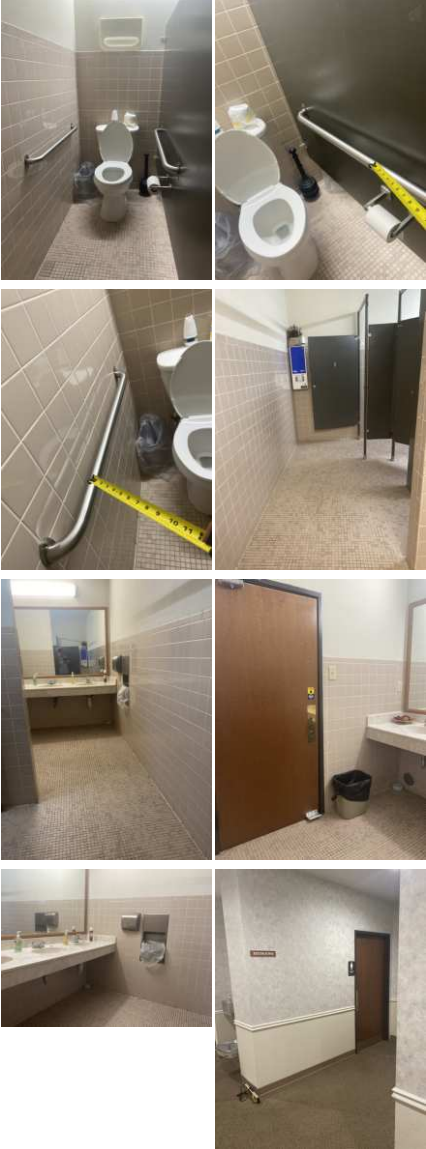
Finding Number	Area Description	Finding	As Built	Recommendation	Citation	Photos	Figure
39	First Floor Main Building LOBBY (Public): Exterior Route To Public Restroom - Restroom (Women's) Public/Staff	The restrooms is not nearly compliant. - The restroom does not have the required minimum clear floor space or maneuvering clearances for the toilet. - The restroom does not have the required minimum clear floor space or maneuvering clearances for the lavatory. - The entry door does not contain the required minimum 60 inches maneuvering space on the pull side - The entry door encroach into the required clear floor space for fixtures. - Door opening pressure was measured at greater than 5 pounds. - Grab bars are incorrectly installed. - Accessories, such as toilet seat covers, paper towel holders, garbage cans, hand dryers and mirrors are either too high or without clear floor space or both. - The restroom contain floor level changes greater than a 1/2 inch at the floor drains.	This restroom is for public use and does not have an accessible stall that meets compliance. The stall pictured is an ambulatory stall and does not take the place of accessible stall. There is no accessible public use restroom for women at this location.	<a href="https://www.access-board.gov/ada/#ada-213_2">https://www.access-board.gov/ada/#ada-213_2</a> Review restrooms componets to make accessible. <a href="https://www.access-board.gov/ada/#ada-603">https://www.access-board.gov/ada/#ada-603</a>	2012 TAS Section: 213.2  2010 ADAS Section: 213.2

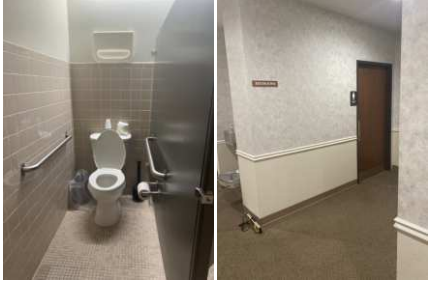
Finding Number	Area Description	Finding	As Built	Recommendation	Citation	Photos	Figure
40	First Floor Main Building LOBBY (Public): Exterior Route To Public Restroom - Restroom (Women's) Public/Staff	There are not enough accessible toilet compartments. Where toilet compartments are provided, at least one toilet compartment shall be wheelchair accessible. The room contains 3 toilet compartments. A minimum of one must be wheelchair accessible .	There is no accessible public use restroom for Women at this location.		<a href="https://www.access-board.gov/ada/#ada-213_3_1">https://www.access-board.gov/ada/#ada-213_3_1</a>  2012 TAS Section: 213.3.1  2010 ADAS Section: 213.3.1

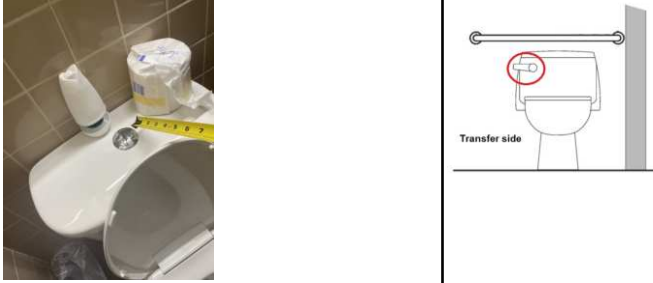
Finding Number	Area Description	Finding	As Built	Recommendation	Citation	Photos	Figure
43	First Floor Main Building LOBBY (Public): Exterior Route To Public Restroom - Restroom (Women's) Public/Staff	The flush handle is located on the wrong side of the toilet. Controls shall be operable with one hand and shall not require tight grasping, pinching or twisting. Controls for the flush valves shall be mounted on the wide side of toilet areas, no more than 48 inches above the floor.	Flusher located on top of toilet. Meets technical compliance but is not the most accessible option, consider replacing.	<a href="https://www.access-board.gov/ada/#ada-604_6">https://www.access-board.gov/ada/#ada-604_6</a>	2012 TAS Section: 604.6 2010 ADAS Section: 604.6

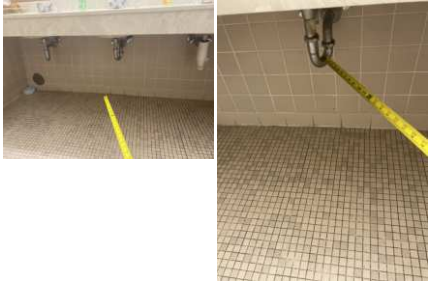
45	First Floor Main Building LOBBY (Public): Exterior Route To Public Restroom - Restroom (Women's) Public/Staff	The water and drain pipes under the lavatory are not adequately insulated. Water supply and drain pipes under lavatories and sinks shall be insulated or otherwise configured to protect against contact. There shall be no sharp or abrasive surfaces under lavatories and sinks.	N/A	<a href="https://www.access-board.gov/ada/#ada-606_5">https://www.access-board.gov/ada/#ada-606_5</a>	2012 TAS Section: 606.5 2010 ADAS Section: 606.5

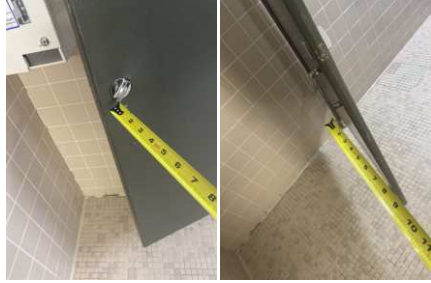
Finding Number	Area Description	Finding	As Built	Recommendation	Citation	Photos	Figure
50	First Floor Main Building LOBBY (Public): Exterior Route To Public Restroom - Restroom (Women's) Public/Staff	The locking/latching hardware is not accessible. Hand-activated door opening hardware, handles, pulls, latches, locks, and other operating devices on accessible doors shall have a shape that is easy to grasp with one hand and does not require tight grasping, tight pinching or twisting of the wrist to operate.	N/A	<a href="https://www.access-board.gov/ada/#ada-604_8_1_2">https://www.access-board.gov/ada/#ada-604_8_1_2</a>	2012 TAS Section: 604.8.1.2 2010 ADAS Section: 604.8.1.2

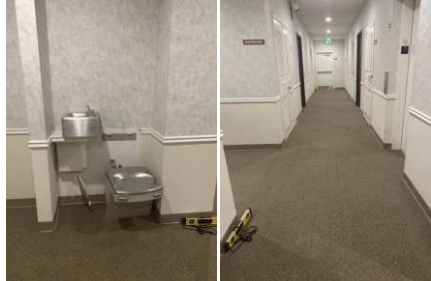
51	First Floor Main Building LOBBY (Public): Exterior Route To Public Restroom - Water Fountain	The drinking fountain has multiple violations. Drinking fountains must be on an accessible route that provides a 30 inch by 48 inch clear floor space centered on the low unit, allowing a forward approach. Spout outlets shall be 36 inches maximum above the finish floor or ground. Spout outlets of drinking fountains for standing persons shall be 38 inches minimum and 43 inches maximum above the finish floor or ground. The spout shall be located 15 inches minimum from the vertical support and 5 inches maximum from the front edge of the unit, including bumpers. The spout shall provide a flow of water 4 inches high minimum and shall be located 5 inches maximum from the front of the unit. The angle of the water stream shall be measured horizontally relative to the front face of the unit. Where spouts are located less than 3 inches of the front of the unit, the angle of the water stream shall be 30 degrees maximum. Where spouts are located between 3 inches and 5 inches maximum from the front of the unit, the angle of the water stream shall be 15 degrees maximum. Operable parts shall comply with applicable standards.	Drinking fountains were under construction. Visually fountains do not look to be of accessible type. Does not look like there will be enough space to access fountains once they are installed.	Clear floor space <a href="https://www.access-board.gov/ada/#ada-403_5_1">https://www.access-board.gov/ada/#ada-403_5_1</a> Drinking fountain requirements, general <a href="https://www.access-board.gov/ada/#ada-602_1">https://www.access-board.gov/ada/#ada-602_1</a> Minimum number <a href="https://www.access-board.gov/ada/#ada-211_2">https://www.access-board.gov/ada/#ada-211_2</a>	2012 TAS Section: 403.5.1, 602.1 2010 ADAS Section: 403.5.1, 602.1

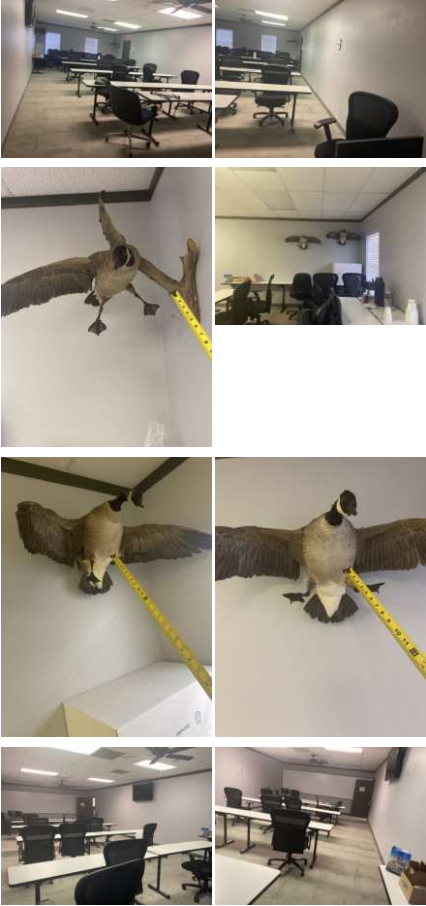
Finding Number	Area Description	Finding	As Built	Recommendation	Citation	Photos	Figure
52	First Floor Main Building (STAFF): Conference Room	The element projects more than 4 inches into the circulation path. Wall-mounted objects that have leading edges between 27 inches and 80 inches from the floor must not project more than 4 inches into the circulation path. Protruding objects that extend to the floor or within 27 inches of the floor are cane detectable and are therefore not hazardous. Where it is necessary or desirable to have objects protrude from the wall, a manner of cane detection must be provided.	Protruding object duck mounts are sufficiently guarded by office furniture.	<a href="https://www.access-board.gov/ada/#ada-307_2">https://www.access-board.gov/ada/#ada-307_2</a>	2012 TAS Section: 307.2  2010 ADAS Section: 307.2
