# Kerrville LE- ADA Evaluation

**LE- Kerrville TX, ADA Evaluation**  
**309 Sidney Baker St S**  
**Kerrville, TX 78028**  
**Accessibility Evaluation**  
**Inspection Date: 03/06/2023**  
**Inspectors: Christopher Meza**

Report Date: 01/14/2024

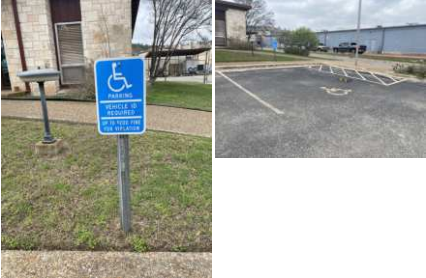
Finding Number	Area Description	Finding	As Built	Recommendation	Citation	Photos	Figure
1	Exterior of Property (Public): Parking Lot (1 Space) 1 Car - Car Accessible Stall	The van stall is missing a sign identifying it as a van accessible stall. Parking space identification signs shall include the International Symbol of Accessibility. Signs identifying van parking spaces shall contain the designation "van accessible."	Incorrect sign, this accessible parking space needs van designation. Space has correct dimensions and enough access aisle space to right of stall	<a href="https://www.access-board.gov/ada/#ada-502_6">https://www.access-board.gov/ada/#ada-502_6</a>	2012 TAS Section: 502.6  2010 ADAS Section: 502.6

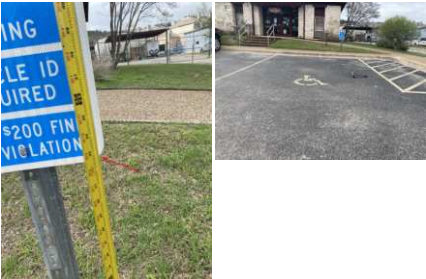
2	Exterior of Property (Public): Parking Lot (1 Space) 1 Car - Car Accessible Stall	The parking sign is mounted too low. Parking space identification signs shall include the International Symbol of Accessibility. Signs identifying van parking spaces shall contain the designation "van accessible." Signs shall be 60 inches minimum above the finish floor or ground surface measured to the bottom of the sign.	Sign height is less than 33"	<a href="https://www.access-board.gov/ada/#ada-502_6">https://www.access-board.gov/ada/#ada-502_6</a>	2012 TAS Section: 502.6  2010 ADAS Section: 502.6

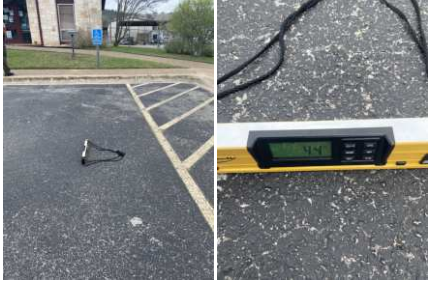
Finding Number	Area Description	Finding	As Built	Recommendation	Citation	Photos	Figure
3	Exterior of Property (Public): Parking Lot (1 Space) 1 Car - Car Accessible Stall	The running slope (long dimension) of the accessible parking stall exceeds 2%. The running slope in an accessible parking stall and the access aisle must not exceed 2%.	Accessible parking stall running slope is 4.4%, located near bottom right of stall.	<a href="https://www.access-board.gov/ada/#ada-502_4">https://www.access-board.gov/ada/#ada-502_4</a>	2012 TAS Section: 502.4  2010 ADAS Section: 502.4

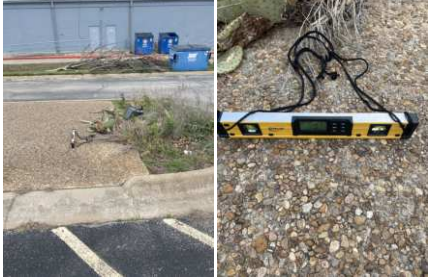
4	Exterior of Property (Public): Path of Travel to Building - Curb Ramp (Main Route)	The curb ramp exceeds the maximum running slope (parallel to the direction of travel) allowable of 8.33%. Curb ramps should have the least possible slope but in no case more than 8.33% (1:12).	Curb ramp running slope is 10.7%	<a href="https://www.access-board.gov/ada/#ada-406_1">https://www.access-board.gov/ada/#ada-406_1</a> <a href="https://www.access-board.gov/ada/#ada-405_2">https://www.access-board.gov/ada/#ada-405_2</a>	2012 TAS Section: 406.1  2010 ADAS Section: 406.1

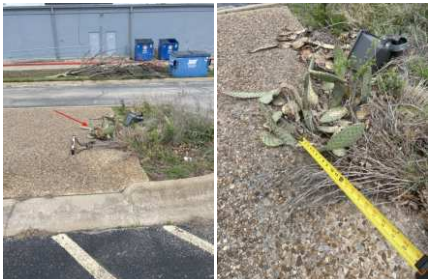
5	Exterior of Property (Public): Path of Travel to Building - Curb Ramp (Main Route)	The top of the curb ramp does not have a level landing that is a minimum of 36 inches in width. A level landing 36 inches minimum in length and 36 inches minimum in width shall be provided at the upper end of each curb ramp. The landing clear width shall be at least as wide as the curb ramp, excluding flared sides, leading to the landing.	Curb ramp landing (top) has an obstruction. Width meets specifications. Shrubbery overgrowth needs to be removed.	<a href="https://www.access-board.gov/ada/#ada-406_4">https://www.access-board.gov/ada/#ada-406_4</a>	2012 TAS Section: 406.4  2010 ADAS Section: 406.4

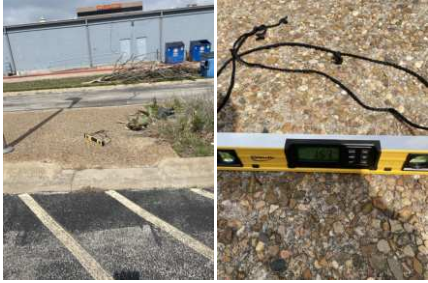
Finding Number	Area Description	Finding	As Built	Recommendation	Citation	Photos	Figure
6	Exterior of Property (Public): Path of Travel to Building - Curb Ramp (Main Route)	The curb ramp side flares exceed maximum slope allowances. The sides of curb ramps (curb ramp flares) where provided, shall not be steeper than 1:10.	Curb ramp running slope flares is 15.3%	<a href="https://www.access-board.gov/ada/#ada-406_3">https://www.access-board.gov/ada/#ada-406_3</a>	2012 TAS Section: 406.1  2010 ADAS Section: 406.3

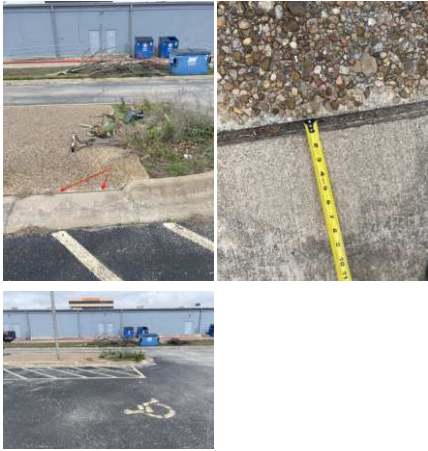
7	Exterior of Property (Public): Path of Travel to Building - Curb Ramp (Main Route)	The curb ramp surface has openings that are greater than 1/2 inch. Openings in floor or ground surfaces shall not allow passage of a sphere more than 1/2 inch diameter. Elongated openings shall be placed so that the long dimension is perpendicular to the dominant direction of travel.	Gap greater than 1/2' and plant overgrowth limits accessibility. Located at bottom of curb ramp landing.	<a href="https://www.access-board.gov/ada/#ada-302_3">https://www.access-board.gov/ada/#ada-302_3</a>	2012 TAS Section: 302.3  2010 ADAS Section: 302.3

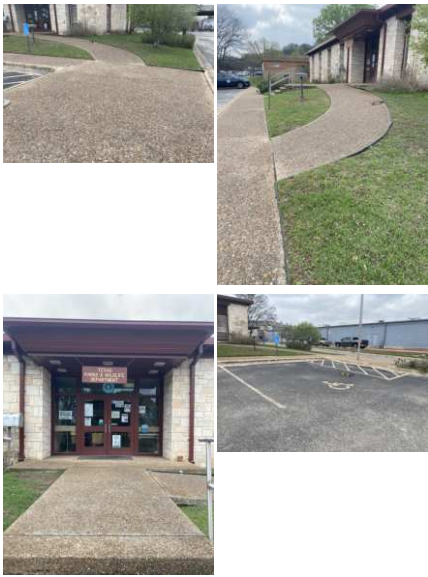
Finding Number	Area Description	Finding	As Built	Recommendation	Citation	Photos	Figure
8	Exterior of Property (Public): Path of Travel to Building - Path of Travel (Main Route)	The building entrance is not located on an accessible route. When a building, or portion of a building, is required to be accessible, an accessible route of travel shall be provided to all portions of the building, to accessible building entrances and between the building and the public way. At least one accessible route within the boundary of the site must be provided from public transportation stops, accessible parking and accessible passenger loading zones and public streets or sidewalks to the accessible building entrance they serve. The accessible route shall, to the maximum extent feasible, coincide with the route for the general public. At least one accessible route shall connect accessible buildings, facilities, elements and spaces that are on the same site. At least one accessible route shall connect accessible building or facility entrances with all accessible spaces and elements.	Due to rise, running slope, cross slope, and gaps in pathway, this route is not considered accessible. Ramp would need to be installed with compliant handrails.	<a href="https://www.access-board.gov/ada/#ada-206_2_1">https://www.access-board.gov/ada/#ada-206_2_1</a>	2012 TAS Section: 206.2.1  2010 ADAS Section: 206.2.1

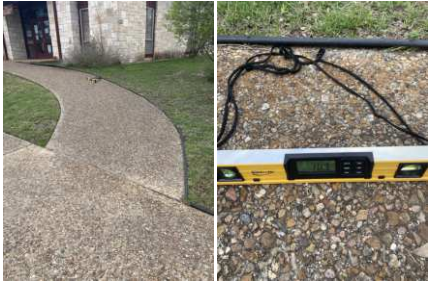
9	Exterior of Property (Public): Path of Travel to Building - Path of Travel (Main Route)	The accessible route between the building entrance and the accessible parking has running slopes greater than 5% and has not been constructed as a ramp (i.e. handrails, edge protection, etc.). When the slope in the direction of travel of any walk exceeds 1 unit vertical in 20 units horizontal (5-percent slope), it must be constructed as a ramp. Surface cross slopes must not exceed one unit vertical in 48 units horizontal (2-percent slope).	Running slope for pathway 10.9% in location pictured.	<a href="https://www.access-board.gov/ada/#ada-403_3">https://www.access-board.gov/ada/#ada-403_3</a>	2012 TAS Section: 403.3  2010 ADAS Section: 403.3

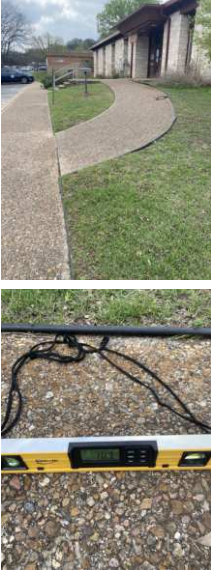
Finding Number	Area Description	Finding	As Built	Recommendation	Citation	Photos	Figure
10	Exterior of Property (Public): Path of Travel to Building - Path of Travel (Main Route)	The accessible route of travel exceeds 5% running slope and therefore must be considered a ramp. Where the slope is greater than one unit vertical in 20 units horizontal (5-percent slope), ramps shall be used.	Pathway requires ramp to be installed. Ramp needs to be constructed with compliant guardrails.	<a href="https://www.access-board.gov/ada/#ada-403_3">https://www.access-board.gov/ada/#ada-403_3</a>	2012 TAS Section: 403.3  2010 ADAS Section: 403.3

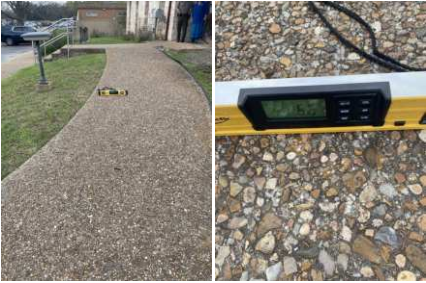
11	Exterior of Property (Public): Path of Travel to Building - Path of Travel (Main Route)	The accessible path of travel between the building entrance and the accessible parking has cross slopes greater than 2%. Surface cross slopes shall not exceed 1 unit vertical in 48 units horizontal (2-percent slope).	Cross slope for pathway 6.6% in location pictured.	<a href="https://www.access-board.gov/ada/#ada-403_3">https://www.access-board.gov/ada/#ada-403_3</a>	2012 TAS Section: 403.3  2010 ADAS Section: 403.3

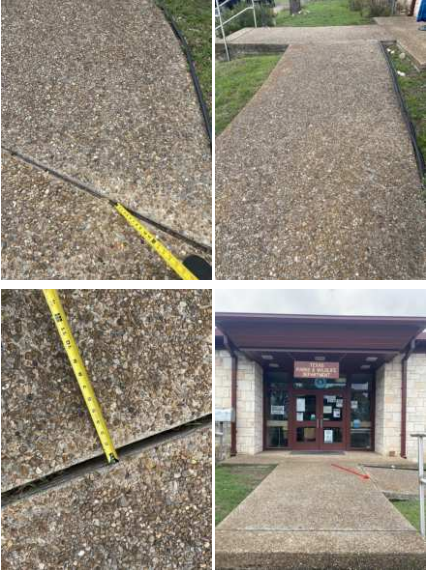
Finding Number	Area Description	Finding	As Built	Recommendation	Citation	Photos	Figure
12	Exterior of Property (Public): Path of Travel to Building - Path of Travel (Main Route)	The route contains openings greater than 1/2 inch. Openings in floor or ground surfaces shall not allow passage of a sphere more than 1/2 inch diameter. Elongated openings shall be placed so that the long dimension is perpendicular to the dominant direction of travel.	There are a few spots on pathway with gaps larger than 1/2". See additional photos for location of gap non compliance on accessible pathway to building.	<a href="https://www.access-board.gov/ada/#ada-302_3">https://www.access-board.gov/ada/#ada-302_3</a>	2012 TAS Section: 302.3  2010 ADAS Section: 302.3

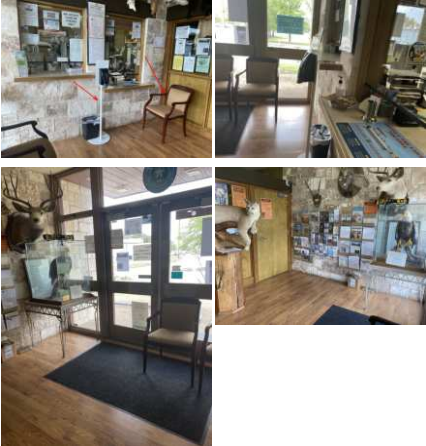
Finding Number	Area Description	Finding	As Built	Recommendation	Citation	Photos	Figure
13	First Floor Main Building LOBBY (Public): Lobby Area - Service Counter	Clear floor space has not be provided. A portion of the counter surface that is 36 inches long minimum for a parallel approach or 30 inches long minimum for a forward approach and 36 inches high maximum above the finish floor shall be provided. A 30 inch by 48 inch clear floor space on an accessible route must be provided for either a forward or parallel approach. Additionally, if a forward approach is desired, knee and toe space must be provided.	Parallel approach to service desk blocked by obstructions. Remove obstructions to provide parallel approach.	Parallel approach <a href="https://www.access-board.gov/ada/#ada-904_4_1">https://www.access-board.gov/ada/#ada-904_4_1</a>	2012 TAS Section: 904.4.1, 904.4.2  2010 ADAS Section: 904.4.2, 904.4.1

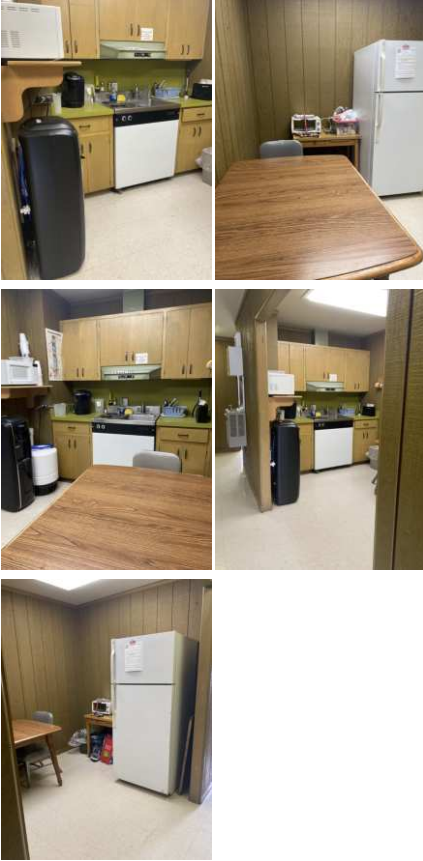
Finding Number	Area Description	Finding	As Built	Recommendation	Citation	Photos	Figure
14	First Floor Main Building (STAFF): Kitchenette	Knee and toe space has not been provided at the sink. Kitchen sinks must be provided with a clear floor space positioned for a forward approach including knee and toe clearance.	Knee and toe must be provided since kitchenette contain stove top range. In kitchens, kitchenettes, and breakrooms without a cooktop or conventional range, a parallel approach is permitted at kitchen sinks	<a href="https://www.access-board.gov/ada/#ada-606_2">https://www.access-board.gov/ada/#ada-606_2</a> <a href="https://www.access-board.gov/ada/#ada-804_4">https://www.access-board.gov/ada/#ada-804_4</a>	2012 TAS Section: 606.2, 804.4  2010 ADAS Section: 606.2, 804.4

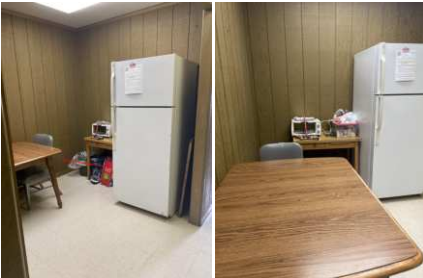
15	First Floor Main Building (STAFF): Kitchenette	The centerline of the parallel clear floor space is not offset 24 inches maximum to the space dedicated to the refrigerator/freezer. Combination refrigerators and freezers shall have at least 50 percent of the freezer space 54 inches maximum above the finish floor or ground. The clear floor or ground space shall be positioned for a parallel approach to the space dedicated to a refrigerator/freezer with the centerline of the clear floor or ground space offset 24 inches maximum from the centerline of the dedicated space.	N/A	<a href="https://www.access-board.gov/ada/#ada-804_6_6">https://www.access-board.gov/ada/#ada-804_6_6</a>	2012 TAS Section: 804.6.6  2010 ADAS Section: 804.6.6

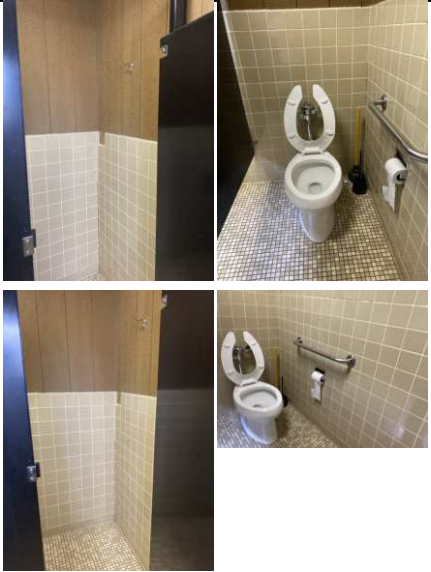
Finding Number	Area Description	Finding	As Built	Recommendation	Citation	Photos	Figure
16	First Floor Main Building (STAFF): Restrooms/Water Fountains - Restroom (Men's)	The restroom is not nearly compliant. The restroom does not have the required minimum clear floor space or maneuvering clearances for the toilet. The restroom does not have the required minimum clear floor space or maneuvering clearances for the lavatory. The entry door does not contain the required minimum maneuvering spaces on the pull/push sides. The entry door encroach into the required clear floor space for fixtures. Grab bars are missing and/or incorrectly installed. Accessories, such as toilet seat covers, paper towel holders, garbage cans, hand dryers, and mirrors are either too high or without clear floor space or both. The restroom contain floor level changes greater than a 1/2 inch of the floor drains and is slope (XX) - (XX), the shower is too small and missing numerous accessible elements.	This restroom is for staff only and would need a number of elements installed to gain compliance. - Rear grab bar missing - Side grab bar less than 42" - Stall dimensions width less than 36" - Toilet paper dispenser location- too close - Handle on both sides of stall door - Urinal height - Partition obstruction to sink- not enough width required at 36" - Pipes need to be fully insulated - Mirror height - Paper towel dispenser height - Light switch height - Coat hook height - Door hardware- door knobs - Sign/room identification non compliant	<a href="https://www.access-board.gov/ada/#ada-213_2">https://www.access-board.gov/ada/#ada-213_2</a> Review restrooms componets to make accessible. <a href="https://www.access-board.gov/ada/#ada-603">https://www.access-board.gov/ada/#ada-603</a>	2012 TAS Section: 213.2  2010 ADAS Section: 213.2
