# Lubbock LE- ADA Evaluation

**LE-Lubbock TX, ADA Evaluation**  
**1702 Landmark Ln Suite 1**  
**Lubbock, TX 79415**  
**Accessibility Evaluation**  
**Inspection Date: 01/17/2023**  
**Inspectors: Jessica Burke**

Report Date: 01/12/2024

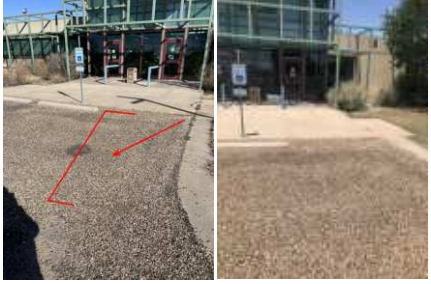
Finding Number	Area Description	Finding	As Built	Recommendation	Citation	Photos	Figure
4	Exterior of Property (Public) : Parking Lot (1 Space) 1 Van - Access Aisle Requirments (Van)	The access aisle is missing at the accessible parking stall. Access aisles serving parking spaces shall adjoin an accessible route. Two parking spaces shall be permitted to share a common access aisle.	N/A	<a href="https://www.access-board.gov/ada/#ada-502_2">https://www.access-board.gov/ada/#ada-502_2</a>	2012 TAS Section: 502.2  2010 ADAS Section: 502.2

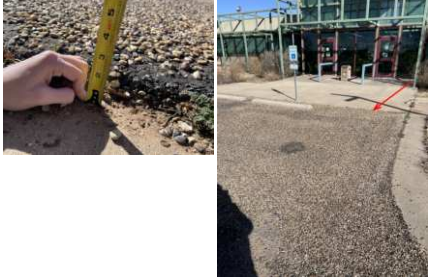
5	Exterior of Property (Public) : Path of Travel to Building - Path of Travel (Main Route)	The walkway contains abrupt vertical edges and/or variations over 1/4 inch. 1/4 inch is the maximum vertical rise. Changes in level between 1/4 inch and 1/2 inch must be beveled at 1:2 or less. Changes in level greater than 1/2 inch must be by way of a ramp.	Exterior walkway leading to entrance has change in elevation exceeding 1/4"	<a href="https://www.access-board.gov/ada/#ada-303_2">https://www.access-board.gov/ada/#ada-303_2</a>	2012 TAS Section: 303.3, 303.2  2010 ADAS Section: 303.3, 303.2

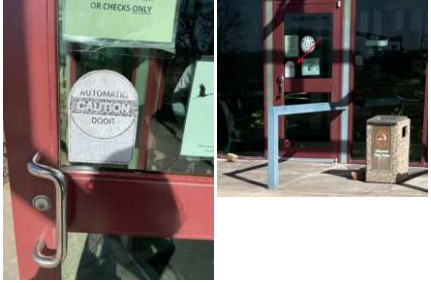
Finding Number	Area Description	Finding	As Built	Recommendation	Citation	Photos	Figure
6	First Floor Main Building LOBBY (Public): Entrance into Lobby - Entrance Doors (L) Side	All low energy power operated (Automatic) doors shall be marked with a sign, visible from both sides of the door, with the words "AUTOMATIC CAUTION DOOR" The sign shall be a minimum of 6 inches in diameter and with minimum 5/8" tall black lettering on a yellow background. When a separate wall switch is used to initiate the operation of the door the door shall also be provided with additional signs on each side of the door where the switch is located, with the message "ACTIVATE SWITCH TO OPERATE". The lettering shall be white and the background shall be blue.	Current signage on door is faded and difficult to read, needs to be replaced.	<a href="https://www.access-board.gov/ada/#ada-404_3">https://www.access-board.gov/ada/#ada-404_3</a>	2012 TAS Section: 404.3  2010 ADAS Section: 404.3

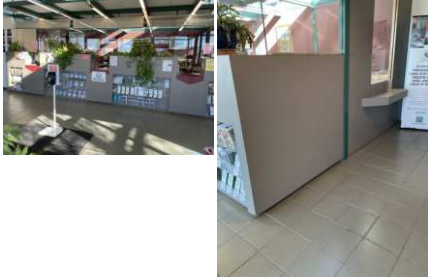
7	First Floor Main Building LOBBY (Public): Lobby Area - Service Counter	Accessible counters are not provided for all the different types of sales and service counters available. At least one of each type of sales counter and service counter shall be accessible.	There are no accessible service desks provided at this location.	<a href="https://www.access-board.gov/ada/#ada-227_3">https://www.access-board.gov/ada/#ada-227_3</a>	2012 TAS Section: 227.3  2010 ADAS Section: 227.3

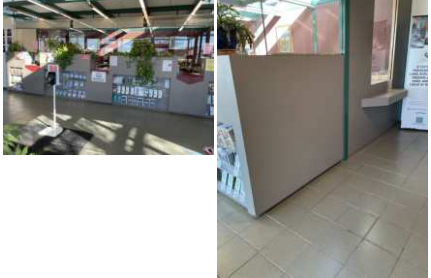
8	First Floor Main Building LOBBY (Public): Lobby Area - Service Counter	The counter surface is greater than 36 inches off the finished floor. A portion of the counter surface that is 36 inches long minimum and 36 inches high maximum above the finish floor shall be provided. Where the provided counter surface is less than 36 inches long, the entire counter surface shall be 36 inches high maximum above the finish floor.	The front facing service desks are not accessible. Not correct dimensions, height, or knee/toe space.	<a href="https://www.access-board.gov/ada/#ada-904_4">https://www.access-board.gov/ada/#ada-904_4</a> Parallel approach <a href="https://www.access-board.gov/ada/#ada-904_4_1">https://www.access-board.gov/ada/#ada-904_4_1</a> Forward approach <a href="https://www.access-board.gov/ada/#ada-904_4_2">https://www.access-board.gov/ada/#ada-904_4_2</a>	2012 TAS Section: 904.4.1  2010 ADAS Section: 904.4.1

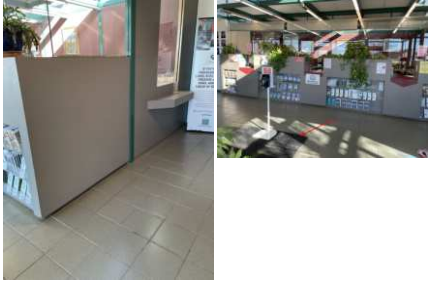
Finding Number	Area Description	Finding	As Built	Recommendation	Citation	Photos	Figure
9	First Floor Main Building LOBBY (Public): Lobby Area - Service Counter	The sales and service counter is not a minimum 30 inches wide. A portion of the counter surface that is 30 inches long (wide) minimum and 36 inches high maximum shall be provided. Knee and toe space shall be provided under the counter. A clear floor or ground space shall be positioned for a forward approach to the counter.	The accessible service desk provided on site does not meet requirements for compliance. Width of writing surface must be 30" wide for entire writing surface.	Service desks approach requirements <a href="https://www.access-board.gov/ada/#ada-904_4">https://www.access-board.gov/ada/#ada-904_4</a> Parallel approach <a href="https://www.access-board.gov/ada/#ada-904_4_1">https://www.access-board.gov/ada/#ada-904_4_1</a> Forward approach <a href="https://www.access-board.gov/ada/#ada-904_4_2">https://www.access-board.gov/ada/#ada-904_4_2</a>	2012 TAS Section: 904.4.2  2010 ADAS Section: 904.4.2

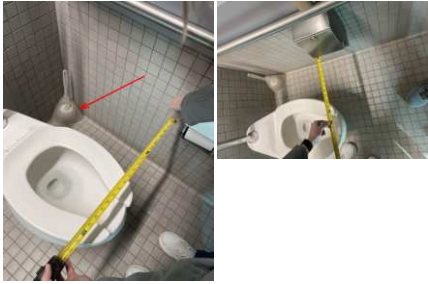
13	First Floor Main Building LOBBY (Public): Lobby Area - Restroom (Men's)	The clear floor space around the toilet is obstructed by toilet bowl cleaner. No fixtures are allowed in the clear floor space required for the toilet. The required clearance around the water closet shall be permitted to overlap the water closet, associated grab bars, dispensers, sanitary napkin disposal units, coat hooks, shelves, accessible routes, clear floor space and clearances required at other fixtures, and the turning space. No other fixtures or obstructions shall be located within the required water closet clearance.	N/A	<a href="https://www.access-board.gov/ada/#ada-604_3_2">https://www.access-board.gov/ada/#ada-604_3_2</a>	2012 TAS Section: 604.3.2  2010 ADAS Section: 604.3.2

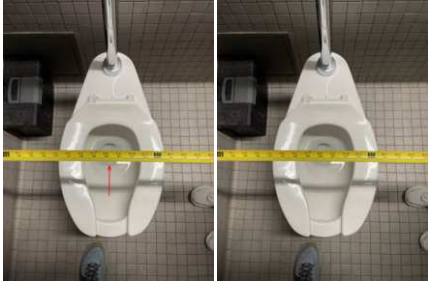
20	First Floor Main Building LOBBY (Public): Lobby Area - Restroom (Women's)	The toilet is not located within the range allowed from the side wall or partition. The centerline of the toilet must be 16 to 18 inches from the side wall.	Toilet midline is over 20" from side wall.	<a href="https://www.access-board.gov/ada/#ada-604_2">https://www.access-board.gov/ada/#ada-604_2</a>	2012 TAS Section: 604.2  2010 ADAS Section: 604.2

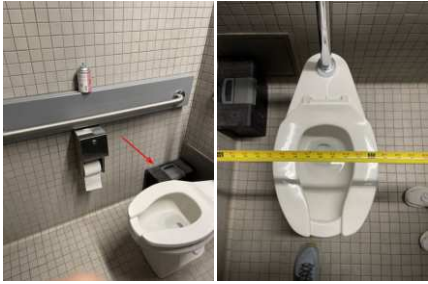
22	First Floor Main Building LOBBY (Public): Lobby Area - Restroom (Women's)	The clear floor space around the toilet is obstructed by storage box. No fixtures are allowed in the clear floor space required for the toilet. The required clearance around the water closet shall be permitted to overlap the water closet, associated grab bars, dispensers, sanitary napkin disposal units, coat hooks, shelves, accessible routes, clear floor space and clearances required at other fixtures, and the turning space. No other fixtures or obstructions shall be located within the required water closet clearance.	N/A	<a href="https://www.access-board.gov/ada/#ada-604_3_2">https://www.access-board.gov/ada/#ada-604_3_2</a>	2012 TAS Section: 604.3.2 2010 ADAS Section: 604.3.2

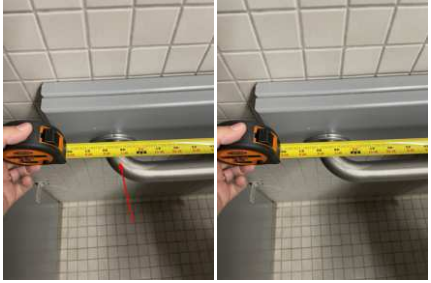
Finding Number	Area Description	Finding	As Built	Recommendation	Citation	Photos	Figure
24	First Floor Main Building LOBBY (Public): Lobby Area - Restroom (Women's)	The side grab bar does not extend far enough from the rear wall. The side grab bar must extend at least 54 inches minimum beyond the rear wall and start a maximum of 12 inches from the rear wall. A 42 inch grab bar installed the maximum distance from the rear wall (12 inches) will leave the leading end 54 inches from the rear wall. Grab bars shall be installed in a horizontal position, 33 inches minimum and 36 inches maximum above the finish floor measured to the top of the gripping surface.	Side grab bar extends 49.5" from rear wall.	<a href="https://www.access-board.gov/ada/#ada-604_5_1">https://www.access-board.gov/ada/#ada-604_5_1</a>	2012 TAS Section: 604.5.1  2010 ADAS Section: 604.5.1

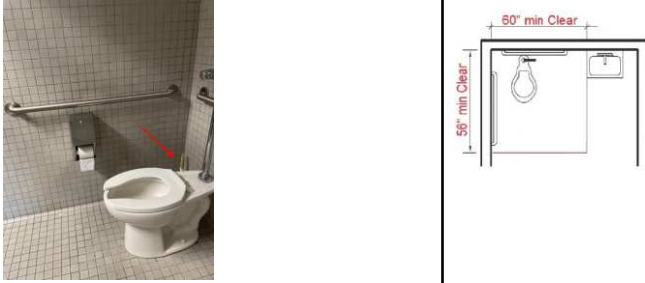
Finding Number	Area Description	Finding	As Built	Recommendation	Citation	Photos	Figure
30	First Floor Main Building (STAFF): Restrooms/Water Fountains - Restroom (Unisex)	The clear floor space around the toilet is obstructed by toilet bowl cleaner. No fixtures are allowed in the clear floor space required for the toilet. The required clearance around the water closet shall be permitted to overlap the water closet, associated grab bars, dispensers, sanitary napkin disposal units, coat hooks, shelves, accessible routes, clear floor space and clearances required at other fixtures, and the turning space. No other fixtures or obstructions shall be located within the required water closet clearance.	N/A		<a href="https://www.access-board.gov/ada/#ada-604_3_2">https://www.access-board.gov/ada/#ada-604_3_2</a>	2012 TAS Section: 604.3.2  2010 ADAS Section: 604.3.2

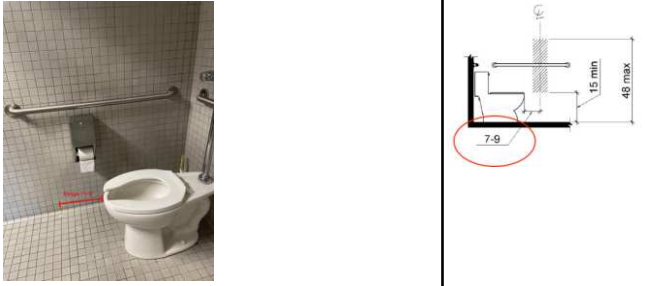
31	First Floor Main Building (STAFF): Restrooms/Water Fountains - Restroom (Unisex)	The toilet paper is not installed within the compliant range in front of the toilet. Toilet paper dispensers shall be 7 inches minimum and 9 inches maximum in front of the water closet measured to the centerline of the dispenser. The outlet of the dispenser shall be 15 inches minimum and 48 inches maximum above the finish floor and shall not be located behind grab bars. Dispensers shall not be of a type that controls delivery or that does not allow continuous paper flow. There shall be a clearance of 1 1/2 inches minimum below the grab bar.	TP dispenser is located too close to front of toilet.		<a href="https://www.access-board.gov/ada/#ada-604_7">https://www.access-board.gov/ada/#ada-604_7</a>	2012 TAS Section: 604.7  2010 ADAS Section: 604.7

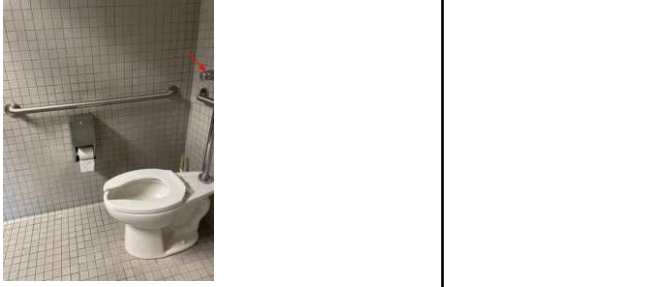
32	First Floor Main Building (STAFF): Restrooms/Water Fountains - Restroom (Unisex)	The flush handle is too high. Controls shall be operable with one hand and shall not require tight grasping, pinching or twisting. Controls for the flush valves shall be mounted on the wide side of toilet areas, no more than 48 inches above the floor.	Verify flush handle is within 48" reach range and on open side of stall.		<a href="https://www.access-board.gov/ada/#ada-308_1">https://www.access-board.gov/ada/#ada-308_1</a>	2012 TAS Section: 605.4  2010 ADAS Section: 605.4
