# Midland LE- ADA Evaluation

**LE-Midland TX, ADA Evaluation**  
**4500 W Illinois Ave**  
**Wilshire Park, TX 79703**  
**Accessibility Evaluation**  
**Inspection Date: 01/17/2023**  
**Inspectors: Jessica Burke**

Report Date: 01/12/2024

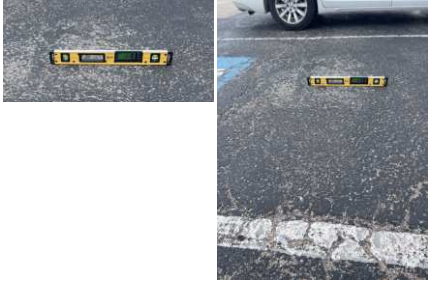
Finding Number	Area Description	Finding	As Built	Recommendation	Citation	Photos	Figure	
1	Exterior of Property (Public) : Parking Lot (2 Spaces) 1 Car 1 Van - Van Accessible Stall (L) Side	The running slope (long dimension) of the accessible parking stall exceeds 2%. The running slope in an accessible parking stall and the access aisle must not exceed 2%.	Van accessible stall running slope is 3.4%		<a href="https://www.access-board.gov/ada/#ada-502_4">https://www.access-board.gov/ada/#ada-502_4</a>	2012 TAS Section: 502.4  2010 ADAS Section: 502.4

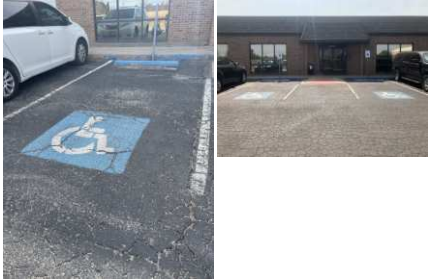
2	Exterior of Property (Public) : Parking Lot (2 Spaces) 1 Car 1 Van - Van Accessible Stall (L) Side	The accessible parking space and/or access aisle contains loose gravel and/or surface materials that do not provide for a stable, firm slip resistant surface. Parking spaces and access aisles serving them shall comply with floor or ground surface requirements. The ground surface shall be stable, firm, and slip resistant. Access aisles shall be at the same level as the parking spaces they serve. Changes in level, slopes exceeding 1:48, and detectable warnings shall not be permitted.	Parking lot and parking spaces beginning to degrade causing large gaps and loose gravel.		<a href="https://www.access-board.gov/ada/#ada-502_4">https://www.access-board.gov/ada/#ada-502_4</a> <a href="https://www.access-board.gov/ada/#ada-302_3">https://www.access-board.gov/ada/#ada-302_3</a>	2012 TAS Section: 502.4  2010 ADAS Section: 502.4

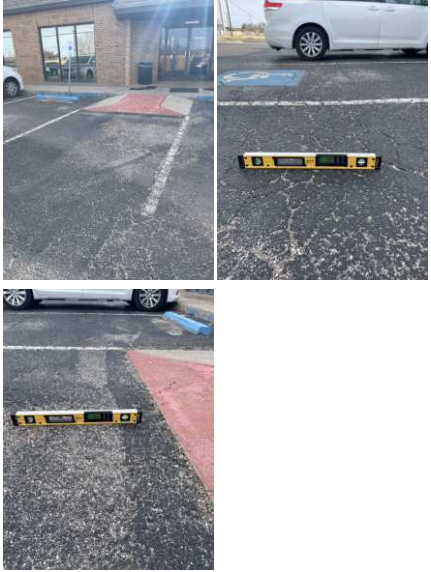
Finding Number	Area Description	Finding	As Built	Recommendation	Citation	Photos	Figure
4	Exterior of Property (Public) : Parking Lot (2 Spaces) 1 Car 1 Van - Access Aisle (Shared)	The running slope of the access aisle (long dimension) exceeds 2%. The running slope in an accessible parking stall and the access aisle must not exceed 2%.	Access aisle running slope, before curb ramp, is 3% and 4.2%	<a href="https://www.access-board.gov/ada/#ada-502_4">https://www.access-board.gov/ada/#ada-502_4</a>	2012 TAS Section: 502.4 2010 ADAS Section: 502.4

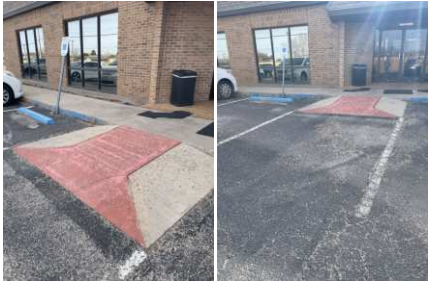
5	Exterior of Property (Public) : Parking Lot (2 Spaces) 1 Car 1 Van - Access Aisle (Shared)	The accessible parking stall's access aisle contains a built up curb ramp which results in significant slopes greater than 2 percent. Surface slopes of accessible parking spaces and access aisles shall be the minimum possible and shall not exceed one unit vertical in 50 units, horizontal (2-percent slope) in any direction.	Obstructions, changes in elevation, abrupt edges, and curb ramps are prohibited from being placed in access aisle. Floor or Ground Surfaces. Access aisles are required to be nearly level in all directions to provide a surface for wheelchair transfer to and from vehicles.	<a href="https://www.access-board.gov/ada/#ada-502_4">https://www.access-board.gov/ada/#ada-502_4</a>	2012 TAS Section: 502.4 2010 ADAS Section: 502.4

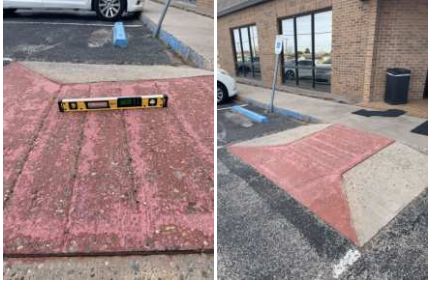
Finding Number	Area Description	Finding	As Built	Recommendation	Citation	Photos	Figure
6	Exterior of Property (Public) : Path of Travel to Building - Curb Ramp (Main Route)	The curb ramp exceeds the maximum running slope (parallel to the direction of travel) allowable of 8.33%. Curb ramps should have the least possible slope but in no case more than 8.33% (1:12).	Curb ramp running slope 10.2%	<a href="https://www.access-board.gov/ada/#ada-406_1">https://www.access-board.gov/ada/#ada-406_1</a> <a href="https://www.access-board.gov/ada/#ada-405_2">https://www.access-board.gov/ada/#ada-405_2</a>	2012 TAS Section: 406.1  2010 ADAS Section: 406.1

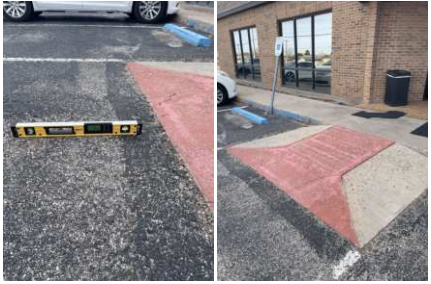
7	Exterior of Property (Public) : Path of Travel to Building - Curb Ramp (Main Route)	The landing of the ramp has a slope greater than 2 percent. Landings shall have a slope of less than 1:48 (2 percent) in any direction.	Bottom landing of slope is 4.2%	<a href="https://www.access-board.gov/ada/#ada-406_4">https://www.access-board.gov/ada/#ada-406_4</a> <a href="https://www.access-board.gov/ada/#ada-405_7_1">https://www.access-board.gov/ada/#ada-405_7_1</a>	2012 TAS Section: 406.4, 406.4 Exception  2010 ADAS Section: 406.4, 406.4 Exception

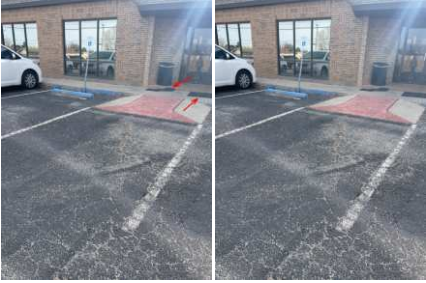
Finding Number	Area Description	Finding	As Built	Recommendation	Citation	Photos	Figure
9	Exterior of Property (Public) : Path of Travel to Building - Path of Travel (Main Route)	The floor mat or carpet pile height is too high. Carpet or carpet tile shall be securely attached and shall have a firm cushion, pad, or backing or no cushion or pad. Carpet or carpet tile shall have a level loop, textured loop, level cut pile, or level cut/uncut pile texture. Pile height shall be 1/2 inch maximum. Exposed edges of carpet shall be fastened to floor surfaces and shall have trim on the entire length of the exposed edge.	Door mat is not of compliant size or durability and does not meet compliance.	<a href="https://www.access-board.gov/ada/#ada-302_2">https://www.access-board.gov/ada/#ada-302_2</a>	2012 TAS Section: 302.2  2010 ADAS Section: 302.2

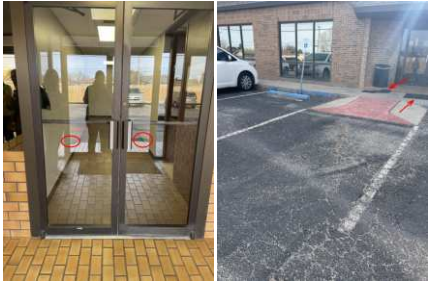
11	First Floor Main Building LOBBY (Public): Exterior Entrance/Exit into Lobby - Exterior Vestibule Doors	The floor mat at the door is not secured in place. If carpet or carpet tile is used on a ground or floor surface, then it shall be securely attached; have a firm cushion, pad or backing or no cushion or pad; and have a level loop, textured loop, level-cut pile or level-cut/uncut pile texture. The maximum pile height shall be 1/2 inch. Exposed edges of carpet shall be fastened to floor surfaces and have trim along the entire length of the exposed edge. Recessed doormats shall be adequately anchored to prevent interference with wheelchair traffic.	Same door mat pieces on path of travel to front entrance. Door mat is not of compliant size or durability and does not meet compliance.	<a href="https://www.access-board.gov/ada/#ada-302_2">https://www.access-board.gov/ada/#ada-302_2</a>	2012 TAS Section: 302.2  2010 ADAS Section: 302.2

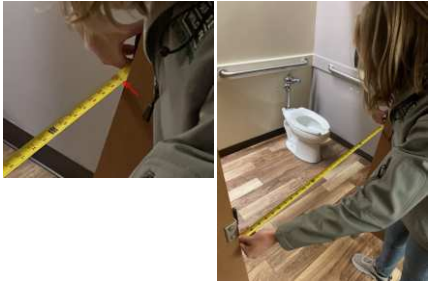
17	First Floor Main Building LOBBY (Public): Lobby Area - Restroom (Men's)	The compartment door does not have an unobstructed clear opening width of 32 inches. The water closet compartment shall be equipped with a door that has an automatic-closing device, and must have a clear, unobstructed opening width 32 inches.	Stall door width is 31"	<a href="https://www.access-board.gov/ada/#ada-404_2_3">https://www.access-board.gov/ada/#ada-404_2_3</a>	2012 TAS Section: 404.2.3  2010 ADAS Section: 404.2.3

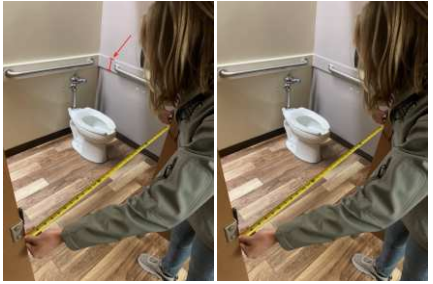
20	First Floor Main Building LOBBY (Public): Lobby Area - Restroom (Men's)	The wall extension does provide compliance for wall to midline of toilet but this is not a recognized form of best practices. Side wall should be flush and unobstructed midline to toilet measuring between 16-18"	N/A	N/A - Refer to Finding	2012 TAS Section: Recommended  2010 ADAS Section: Recommended

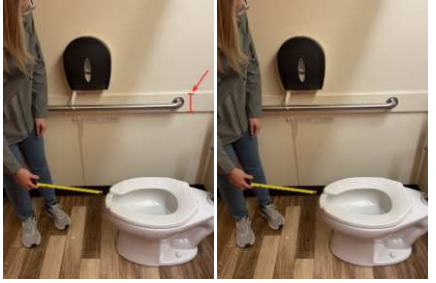
33	First Floor Main Building LOBBY (Public): Lobby Area - Restroom (Women's)	The wall extension does provide compliance for wall to midline of toilet but this is not a recognized form of best practices. Side wall should be flush and unobstructed midline to toilet measuring between 16-18"	N/A	N/A - Refer to Finding	2012 TAS Section: Recommended  2010 ADAS Section: Recommended

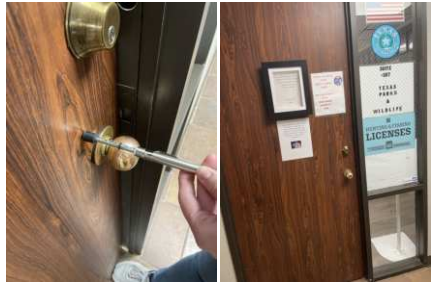
36	First Floor Main Building LOBBY (Public): LE Office Interior - Entrance Doors into LE Office	The door exceeds the maximum allowable opening force. Interior doors shall have a maximum opening force of 5 pounds. These forces do not apply to the force required to retract latch bolts or disengage other devices that hold the door or gate in a closed position.	Entrance doors into LE office measure at 15lbs of operating force.	<a href="https://www.access-board.gov/ada/#ada-404_2_9">https://www.access-board.gov/ada/#ada-404_2_9</a>	2012 TAS Section: 404.2.9  2010 ADAS Section: 404.2.9

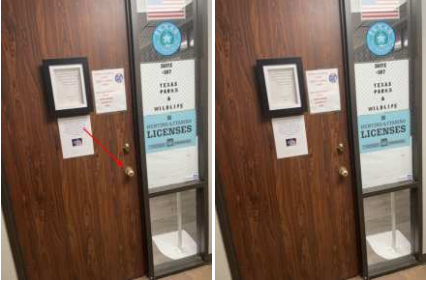
Finding Number	Area Description	Finding	As Built	Recommendation	Citation	Photos	Figure
37	First Floor Main Building LOBBY (Public): LE Office Interior - Entrance Doors into LE Office	The door/gate operating hardware is not accessible. Hand-activated door/gate opening hardware, handles, pulls, latches, locks, and other operating devices on accessible doors shall have a shape that is easy to grasp with one hand and does not require tight grasping, pinching or twisting of the wrist to operate. Hardware shall be 34 inches minimum and 48 inches maximum above the finish floor or ground.	Door knob requires grasping and twisting.	<a href="https://www.access-board.gov/ada/#ada-404_2_7">https://www.access-board.gov/ada/#ada-404_2_7</a>	2012 TAS Section: 404.2.7  2010 ADAS Section: 404.2.7

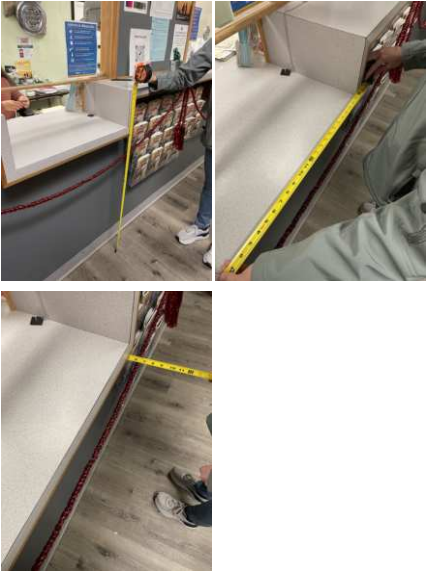
38	First Floor Main Building LOBBY (Public): LE Office Interior - Service Counter	Accessible counters are not provided for all the different types of sales and service counters available. At least one of each type of sales counter and service counter shall be accessible.	There are no accessible service desk at this location. Service desk does not provide knee or toe space for front approach and does not meet requirements for parallel approach.	<a href="https://www.access-board.gov/ada/#ada-227_3">https://www.access-board.gov/ada/#ada-227_3</a>	2012 TAS Section: 227.3  2010 ADAS Section: 227.3

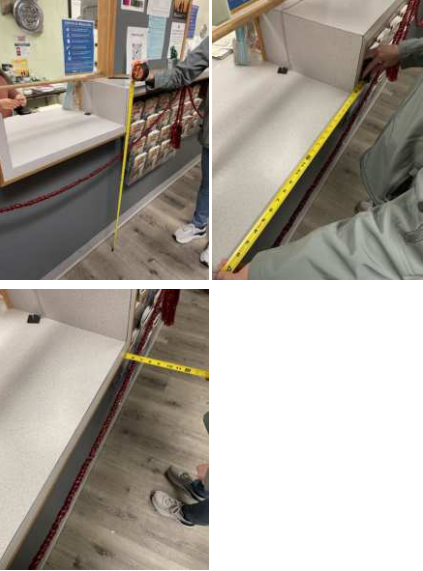
Finding Number	Area Description	Finding	As Built	Recommendation	Citation	Photos	Figure
39	First Floor Main Building LOBBY (Public): LE Office Interior - Service Counter	The sales or service counter does not allow for a forward or parallel approach. Accessible counters must provide a compliant forward or parallel approach. Space under an element between the finish floor or ground and 9 inches above the finish floor or ground shall be considered toe clearance. Toe clearance shall extend 25 inches maximum and 17 inches minimum under an element. Space extending greater than 6 inches beyond the available knee clearance at 9 inches above the finish floor or ground shall not be considered toe clearance. Toe clearance shall be 30 inches wide minimum. Space under an element between 9 inches and 27 inches above the finish floor or ground shall be considered knee clearance. Knee clearance shall extend 25 inches maximum under an element at 9 inches above the finish floor or ground. Knee clearance shall be 11 inches deep minimum at 9 inches above the finish floor or ground, and 8 inches deep minimum at 27 inches above the finish floor or ground. Knee clearance shall be 30 inches wide minimum. Parallel approach requirements A portion of the counter surface that is 36 inches long minimum and 36 inches high maximum above the finish floor shall be provided.	There is no forward or parallel approach for service desk. Compliant knee and/or toe space is not provided for forward approach. Desk height and width are not within compliance for parallel approach.	Service desks approach requirements <a href="https://www.access-board.gov/ada/#ada-904_4">https://www.access-board.gov/ada/#ada-904_4</a> Parallel approach <a href="https://www.access-board.gov/ada/#ada-904_4_1">https://www.access-board.gov/ada/#ada-904_4_1</a> Forward approach <a href="https://www.access-board.gov/ada/#ada-904_4_2">https://www.access-board.gov/ada/#ada-904_4_2</a>	2012 TAS Section: 904.4  2010 ADAS Section: 904.4

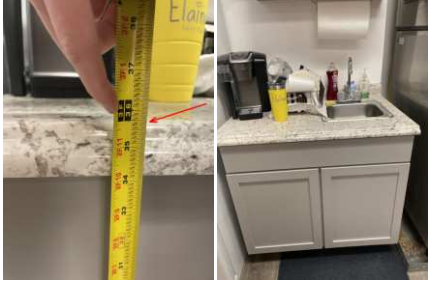
Finding Number	Area Description	Finding	As Built	Recommendation	Citation	Photos	Figure
42	First Floor Main Building (STAFF): Conference Room/Kitchenette - Kitchenette	The kitchen counter top is too high. The kitchen work surface shall be 34 inches maximum above the finish floor or ground.	Sink counter exceeds height requirements for parallel approach. Sink height close to 36". Knee and toe must be provided since kitchenette contain stove top range. In kitchens, kitchenettes, and breakrooms without a cooktop or conventional range, a parallel approach is permitted at kitchen sinks	<a href="https://www.access-board.gov/ada/#ada-804_3_2">https://www.access-board.gov/ada/#ada-804_3_2</a>	2012 TAS Section: 804.3.2  2010 ADAS Section: 804.3.2
