LE- Mount Pleasant TX, ADA Evaluation

212 S Johnson Ave

Accessibility Evaluation

Inspection Date: 01/17/2023

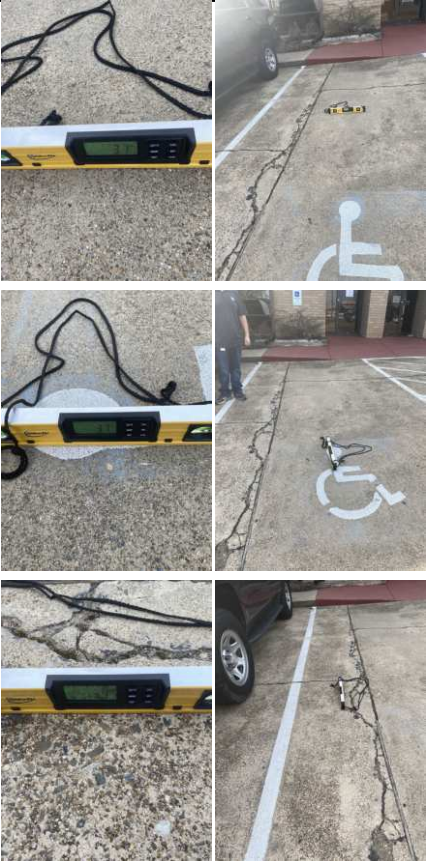
Finding Number	Area Description	Finding	As Built	Recommendation	Citation	Photos	Figure
1	Exterior of Property (Public): Parking Lot (2 Spaces) 1 Car 1 Van - Van Accessible Stall	The parking sign is mounted too low. Parking space identification signs shall include the International Symbol of Accessibility. Signs identifying van parking spaces shall contain the designation "van accessible." Signs shall be 60 inches minimum above the finish floor or ground surface measured to the bottom of the sign.	Van sign mounted less than 40"	https://www.access-board.gov/ada/#ada-502_6	2012 TAS Section: 502.6 2010 ADAS Section: 502.6		
2	Exterior of Property (Public): Parking Lot (2 Spaces) 1 Car 1 Van - Van Accessible Stall	The cross slopes (narrow dimension) and/or running slopes (long dimension) of the accessible stall exceeds 2%. The running slope and the cross slope in an accessible parking stall and the access aisle must not exceed 2%.	Accessible van stall exceeds cross and running slope requirements. There are a few locations where van parking stall cross slope more than 2%, no more than 5.9%. There are a few locations where van parking stall running slope more than 2%, no more than 3.7%. Locations can be found in additional photos.	https://www.access-board.gov/ada/#ada-502_4	2012 TAS Section: 502.4 2010 ADAS Section: 502.4

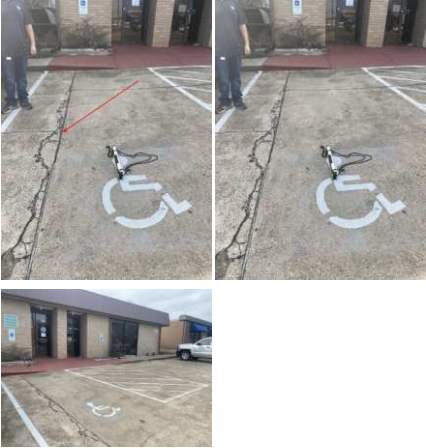
Finding Number	Area Description	Finding	As Built	Recommendation	Citation	Photos	Figure
3	Exterior of Property (Public): Parking Lot (2 Spaces) 1 Car 1 Van - Van Accessible Stall	The accessible parking space and/or access aisle contains loose gravel and/or surface materials that do not provide for a stable, firm slip resistant surface. Parking spaces and access aisles serving them shall comply with floor or ground surface requirements. The ground surface shall be stable, firm, and slip resistant. Access aisles shall be at the same level as the parking spaces they serve. Changes in level, slopes exceeding 1:48, and detectable warnings shall not be permitted.	There is a large crack in van parking stall decreasing access.	https://www.access-board.gov/ada/#ada-502_4 https://www.access-board.gov/ada/#ada-302_3	2012 TAS Section: 502.4 2010 ADAS Section: 502.4

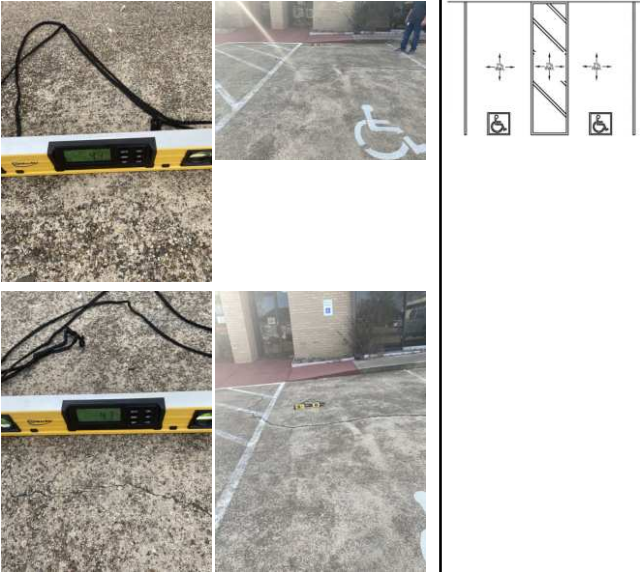
4	Exterior of Property (Public): Parking Lot (2 Spaces) 1 Car 1 Van - Car Accessible Stall	The cross slopes (narrow dimension) and/or running slopes (long dimension) of the accessible stall exceeds 2%. The running slope and the cross slope in an accessible parking stall and the access aisle must not exceed 2%.	Car accessible stall has 2 locations of cross slope over 2% no more than 4.4% Car accessible stall has 1 location where running slope over 2% no more than 3.8% See additional photos for location of slope non compliance in car accessible stall.	https://www.access-board.gov/ada/#ada-502_4	2012 TAS Section: 502.4 2010 ADAS Section: 502.4

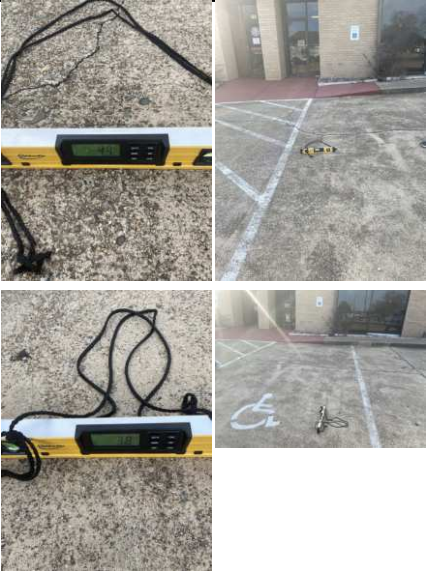
5	Exterior of Property (Public): Parking Lot (2 Spaces) 1 Car 1 Van - Car Accessible Stall	The accessible parking space and/or access aisle contains loose gravel and/or surface materials that do not provide for a stable, firm slip resistant surface. Parking spaces and access aisles serving them shall comply with floor or ground surface requirements. The ground surface shall be stable, firm, and slip resistant. Access aisles shall be at the same level as the parking spaces they serve. Changes in level, slopes exceeding 1:48, and detectable warnings shall not be permitted.	There is a large crack in accessible car stall decreasing access.	https://www.access-board.gov/ada/#ada-502_4 https://www.access-board.gov/ada/#ada-302_3	2012 TAS Section: 502.4 2010 ADAS Section: 502.4

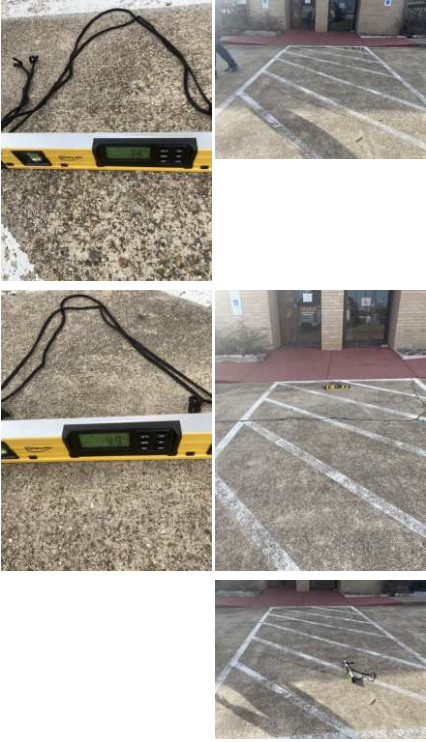
7	Exterior of Property (Public): Parking Lot (2 Spaces) 1 Car 1 Van - Access Aisle (Shared)	The cross slopes (narrow dimension) and/or running slopes (long dimension) of the access aisle exceeds 2%. The running slope and the cross slope in an accessible parking stall and the access aisle must not exceed 2%.	Shared access Aisle has 2 locations of cross slope over 2% no more than 4.4% Shared access aisle has 2 location where running slope over 2% no more than 4.0% See additional photos for location of slope non compliance in shared access aisle. Running slope near bottom of aisle cross slope near top.	https://www.access-board.gov/ada/#ada-502_4	2012 TAS Section: 502.4 2010 ADAS Section: 502.4

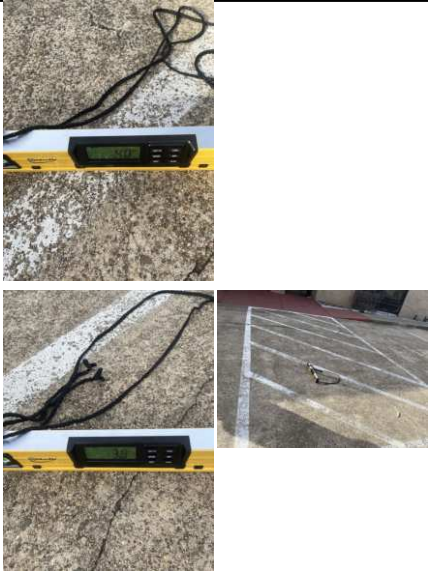
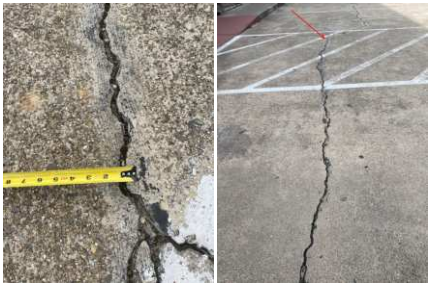
8	Exterior of Property (Public): Parking Lot (2 Spaces) 1 Car 1 Van - Access Aisle (Shared)	The access aisle contains loose gravel and/or surface materials that do not provide for a stable, firm slip resistant surface. Parking spaces and access aisles serving them shall comply with floor or ground surface requirements. The ground surface shall be stable, firm, and slip resistant. Access aisles shall be at the same level as the parking spaces they serve. Changes in level, slopes exceeding 1:48, and detectable warnings shall not be permitted.	There is a large crack in access aisle decreasing access.	https://www.access-board.gov/ada/#ada-502_4 https://www.access-board.gov/ada/#ada-302_3	2012 TAS Section: 502.4 2010 ADAS Section: 502.4

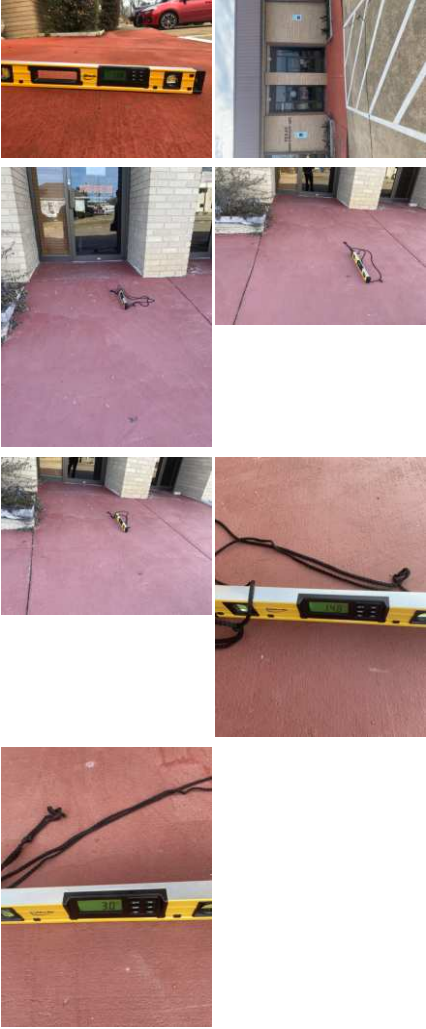
Finding Number	Area Description	Finding	As Built	Recommendation	Citation	Photos	Figure
9	Exterior of Property (Public): Path of Travel to Building - Entrance Ramps (Non Curb Ramp)	The ramps exceeds the maximum running slope (direction of travel) allowable of 8.33%. Ramps should have the least possible slope but in no case more than 8.3% (1:12).	Running slope of ramp exceeds 8.33% in several locations, max 15%.	https://www.access-board.gov/ada/#ada-405_2	2012 TAS Section: 405.2 2010 ADAS Section: 405.2

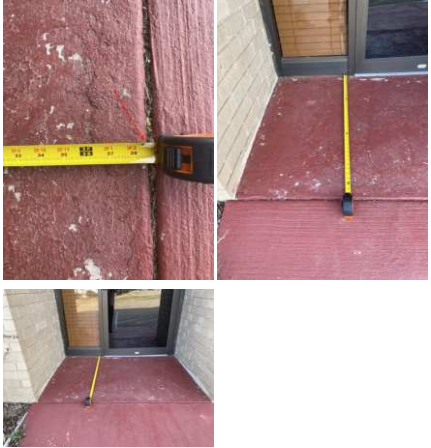
Finding Number	Area Description	Finding	As Built	Recommendation	Citation	Photos	Figure
10	Exterior of Property (Public): Path of Travel to Building - Entrance Ramps (Non Curb Ramp)	The top landing of the ramp does not meet minimum size requirements. The landing clear width shall be at least as wide as the widest ramp run leading to the landing (36 inches minimum) and a minimum of 60 inches in length.	Top of ramp landing length less than 39"	https://www.access-board.gov/ada/#ada-405_7_3	2012 TAS Section: 405.7.3, 405.7.2 2010 ADAS Section: 405.7.3, 405.7.2

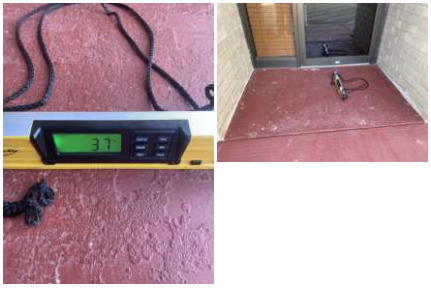
11	Exterior of Property (Public): Path of Travel to Building - Entrance Ramps (Non Curb Ramp)	The landing at the top of the ramp has a slope greater than 2%. Top landings shall have a dimension in the direction of ramp run of not less than 60 inches and have a slope of 2% maximum in any direction.	Top of ramp landing running slope is 3.7%	https://www.access-board.gov/ada/#ada-405_7_1	2012 TAS Section: 405.7.1 2010 ADAS Section: 405.7.1, 405.7.1 Exception

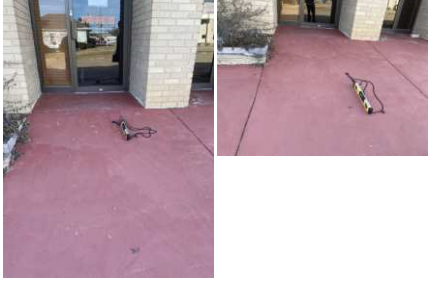
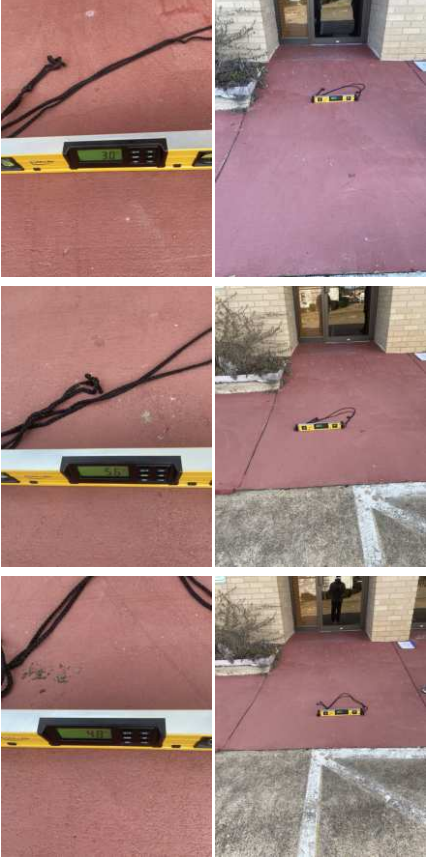
12	Exterior of Property (Public): Path of Travel to Building - Entrance Ramps (Non Curb Ramp)	The accessible route has running slopes greater than 5% and has not been constructed as a ramp (i.e. handrails, edge protection, etc.). Cross slopes are greater than 2% across the width of the walk. When the slope in the direction of travel of any walk exceeds 1 unit vertical in 20 units horizontal (5-percent slope), it must be constructed as a ramp. Surface cross slopes must not exceed 1 unit vertical in 48 units horizontal (2-percent slope).	The accessible route is not compliant due to running and cross slope compliance. There are several location on accessible route were running slope is higher than 8.33% no more than 15% There are a few locations on accessible route were cross slope is over 2% no more than 6% See	https://www.access-board.gov/ada/#ada-403_3	2012 TAS Section: 403.3 2010 ADAS Section: 403.3

Finding Number	Area Description	Finding	As Built	Recommendation	Citation	Photos	Figure
			additional photos for locations of non compliant slopes.

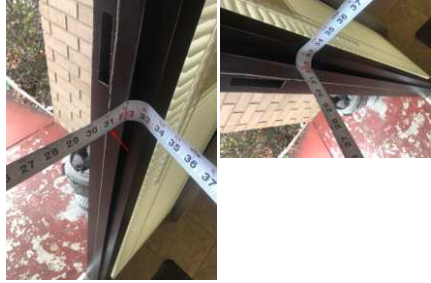
Finding Number	Area Description	Finding	As Built	Recommendation	Citation	Photos	Figure
13	First Floor Main Building LOBBY (Public): Entrance into Lobby - Entrance Doors	The door opening does not provide at least 32 inches between the face of the door and the opposite stop. Door openings shall provide a clear width of 32 inches minimum. Clear openings of doorways with swinging doors shall be measured between the face of the door and the stop, with the door open 90 degrees.	Door way width leading to lobby is 31"	https://www.access-board.gov/ada/#ada-404_2_3	2012 TAS Section: 404.2.3 2010 ADAS Section: 404.2.3

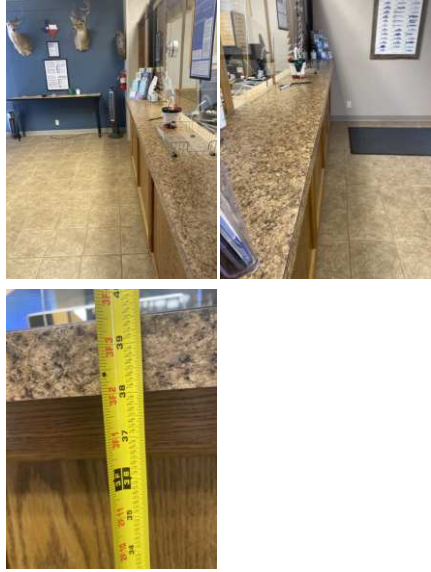
<p>Hinged Door</p>
14	First Floor Main Building LOBBY (Public): Lobby Area - Service Counter	Accessible counters are not provided for all the different types of sales and service counters available. At least one of each type of sales counter and service counter shall be accessible.	There are no accessible service counters provided at this location.	https://www.access-board.gov/ada/#ada-227_3	2012 TAS Section: 227.3 2010 ADAS Section: 227.3

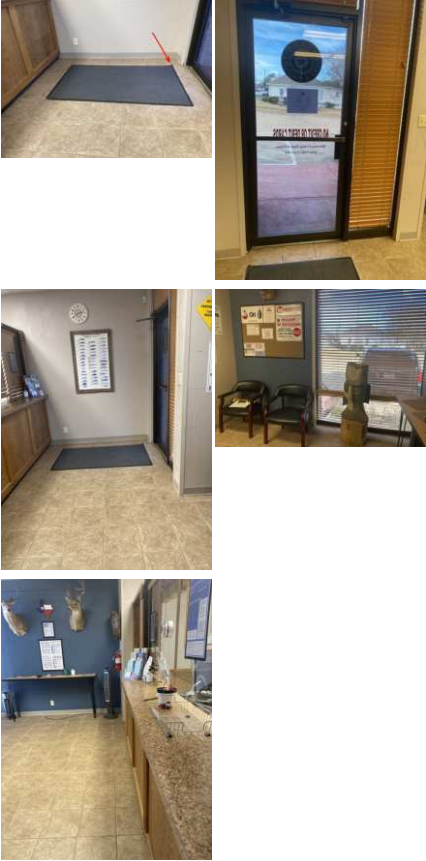
Finding Number	Area Description	Finding	As Built	Recommendation	Citation	Photos	Figure
16	First Floor Main Building LOBBY (Public): Lobby Area - Interior Hallways of Building	The floor mat at the door is not secured in place. If carpet or carpet tile is used on a ground or floor surface, then it shall be securely attached; have a firm cushion, pad or backing or no cushion or pad; and have a level loop, textured loop, level-cut pile or level-cut/uncut pile texture. The maximum pile height shall be 1/2 inch. Exposed edges of carpet shall be fastened to floor surfaces and have trim along the entire length of the exposed edge. Recessed doormats shall be adequately anchored to prevent interference with wheelchair traffic.	Floor mat is not in good working condition and is not secured to floor.	https://www.access-board.gov/ada/#ada-302_2	2012 TAS Section: 302.2 2010 ADAS Section: 302.2

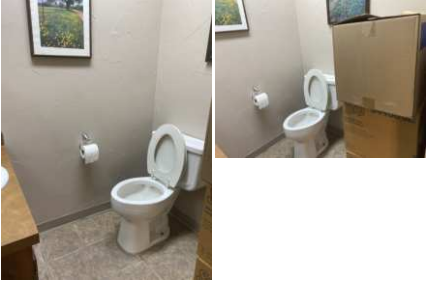
Finding Number	Area Description	Finding	As Built	Recommendation	Citation	Photos	Figure
23	First Floor Main Building (STAFF): Restrooms/Water Fountains - Restroom (Men's)	Accessible toilets must have grab bars installed. The side grab bar must extend at least 54 inches minimum beyond the rear wall and start a maximum of 12 inches from the rear wall. The rear grab bar must be a minimum of 36 inches long and extend from the centerline of the toilet 12 inches minimum on one side and 24 inches minimum on the other side. Grab bars shall be installed in a horizontal position, 33 inches minimum and 36 inches maximum above the finish floor measured to the top of the gripping surface.	There are no grab bars installed at this time.	https://www.access-board.gov/ada/#ada-604_5 Review grab bar componets to make accessible https://www.access-board.gov/ada/#ada-609	2012 TAS Section: 604.5 2010 ADAS Section: 604.5

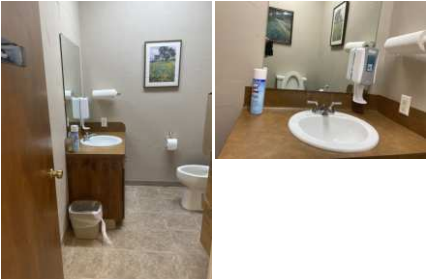
24	First Floor Main Building (STAFF): Restrooms/Water Fountains - Restroom (Men's)	There are not enough accessible lavatories. Where lavatories are provided, at least one shall be accessible and shall not be located in a toilet compartment.	Clear space to access sink is not compliant. Sink accessories are not compliant.	https://www.access-board.gov/ada/#ada-213_3_4 Review lavatory componets to make accessible. https://www.access-board.gov/ada/#ada-606 https://www.access-board.gov/ada/#ada-603_3	2012 TAS Section: 213.3.4 2010 ADAS Section: 213.3.4

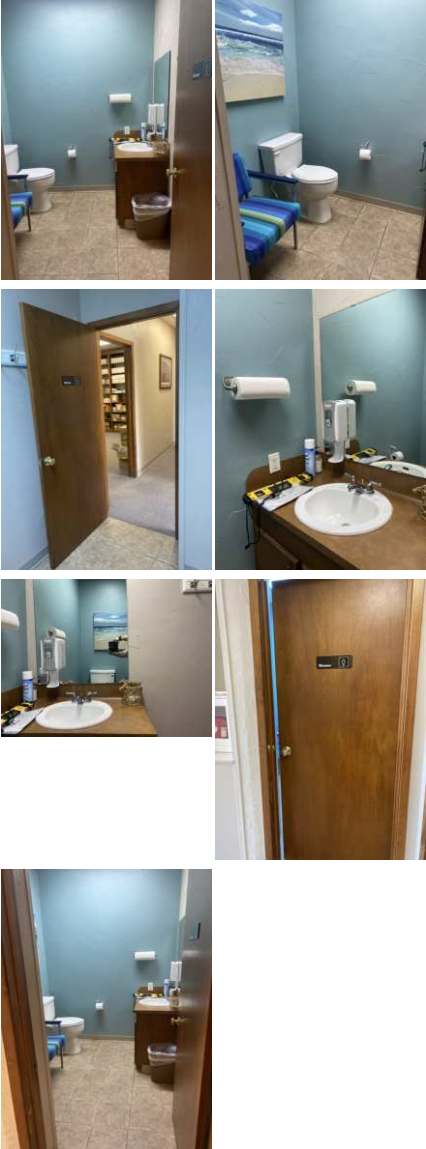
Finding Number	Area Description	Finding	As Built	Recommendation	Citation	Photos	Figure
25	First Floor Main Building (STAFF): Restrooms/Water Fountains - Restroom (Women's)	The restroom is not nearly compliant. The restroom does not have the required minimum clear floor space or maneuvering clearances for the toilet. The restroom does not have the required minimum clear floor space or maneuvering clearances for the lavatory. The entry door does not contain the required minimum maneuvering spaces on the pull/push sides. The entry door encroach into the required clear floor space for fixtures. Grab bars are missing and/or incorrectly installed. Accessories, such as toilet seat covers, paper towel holders, garbage cans, hand dryers, and mirrors are either too high or without clear floor space or both. The restroom contain floor level changes greater than a 1/2 inch of the floor drains and is slope (XX) - (XX), the shower is too small and missing numerous accessible elements.	This restroom if for staff only and would need a number of elements installed to gain compliance. - There are no grab bars - There is not enough accessible space - There is no access to lavatory or accessories - Toilet paper dispenser not in correct location - Door hardware not complaint	https://www.access-board.gov/ada/#ada-213_2 Review restrooms componets to make accessible. https://www.access-board.gov/ada/#ada-603	2012 TAS Section: 213.2 2010 ADAS Section: 213.2

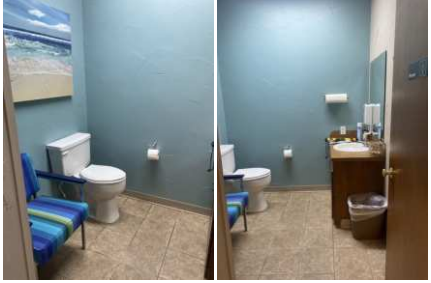
Finding Number	Area Description	Finding	As Built	Recommendation	Citation	Photos	Figure
26	First Floor Main Building (STAFF): Restrooms/Water Fountains - Restroom (Women's)	Accessible toilets must have grab bars installed. The side grab bar must extend at least 54 inches minimum beyond the rear wall and start a maximum of 12 inches from the rear wall. The rear grab bar must be a minimum of 36 inches long and extend from the centerline of the toilet 12 inches minimum on one side and 24 inches minimum on the other side. Grab bars shall be installed in a horizontal position, 33 inches minimum and 36 inches maximum above the finish floor measured to the top of the gripping surface.	There are no grab bars installed at this time.	https://www.access-board.gov/ada/#ada-604_5 Review grab bar componets to make accessible https://www.access-board.gov/ada/#ada-609	2012 TAS Section: 604.5 2010 ADAS Section: 604.5

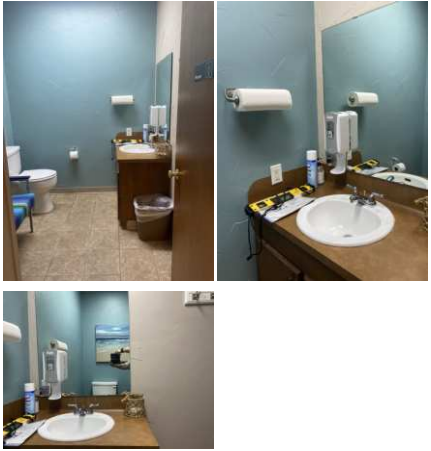
27	First Floor Main Building (STAFF): Restrooms/Water Fountains - Restroom (Women's)	There are not enough accessible lavatories. Where lavatories are provided, at least one shall be accessible and shall not be located in a toilet compartment.	Clear space to access sink is not compliant. Sink accessories are not compliant.	https://www.access-board.gov/ada/#ada-213_3_4 Review lavatory componets to make accessible. https://www.access-board.gov/ada/#ada-606 https://www.access-board.gov/ada/#ada-603_3	2012 TAS Section: 213.3.4 2010 ADAS Section: 213.3.4

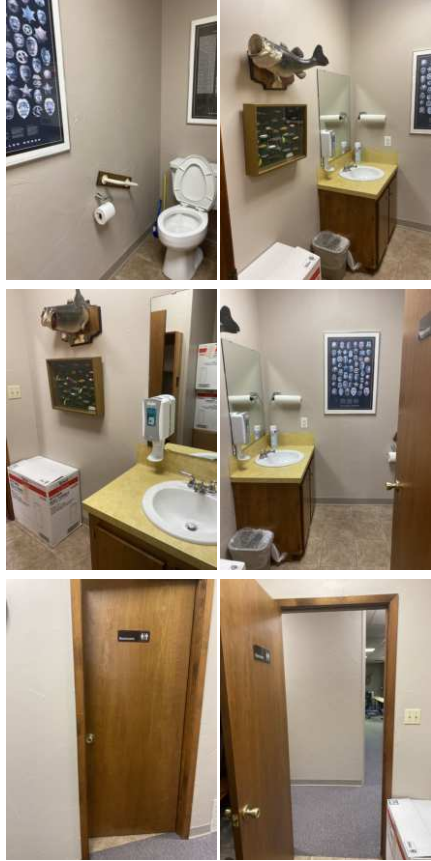
Finding Number	Area Description	Finding	As Built	Recommendation	Citation	Photos	Figure
28	First Floor Main Building (STAFF): Restrooms/Water Fountains - Restroom (Unisex)	The restroom is not nearly compliant. The restroom does not have the required minimum clear floor space or maneuvering clearances for the toilet. The restroom does not have the required minimum clear floor space or maneuvering clearances for the lavatory. The entry door does not contain the required minimum maneuvering spaces on the pull/push sides. The entry door encroach into the required clear floor space for fixtures. Grab bars are missing and/or incorrectly installed. Accessories, such as toilet seat covers, paper towel holders, garbage cans, hand dryers, and mirrors are either too high or without clear floor space or both. The restroom contain floor level changes greater than a 1/2 inch of the floor drains and is slope (XX) - (XX), the shower is too small and missing numerous accessible elements.	This restroom if for staff only and would need a number of elements installed to gain compliance. - Incorrect grab bars - There is not enough accessible space - There is no access to lavatory or accessories - Flush handle on wrong side - Toilet paper dispenser not in correct location - Door hardware not complaint	https://www.access-board.gov/ada/#ada-213_2 Review restrooms componets to make accessible. https://www.access-board.gov/ada/#ada-603	2012 TAS Section: 213.2 2010 ADAS Section: 213.2

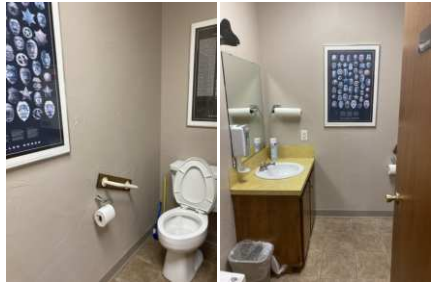
29	First Floor Main Building (STAFF): Restrooms/Water Fountains - Restroom (Unisex)	Accessible toilets must have grab bars installed. The side grab bar must extend at least 54 inches minimum beyond the rear wall and start a maximum of 12 inches from the rear wall. The rear grab bar must be a minimum of 36 inches long and extend from the centerline of the toilet 12 inches minimum on one side and 24 inches minimum on the other side. Grab bars shall be installed in a horizontal position, 33 inches minimum and 36 inches maximum above the finish floor measured to the top of the gripping surface.	There are no grab bars installed at this time.	https://www.access-board.gov/ada/#ada-604_5 Review grab bar componets to make accessible https://www.access-board.gov/ada/#ada-609	2012 TAS Section: 604.5 2010 ADAS Section: 604.5
