Rockport LE- ADA Evaluation

Report Date: 01/15/2024

LE-Rockport TX, ADA Evaluation

Accessibility Evaluation

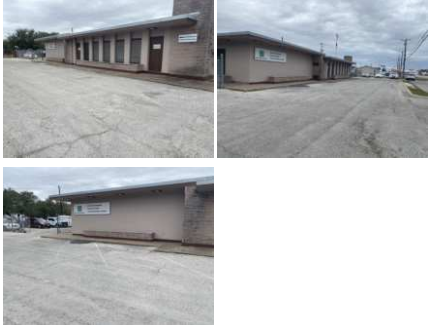
Finding Number	Area Description	Finding	As Built	Recommendation	Citation	Photos	Figure																								
1	Exterior of Property (Public): Parking Lot (0 Spaces)	There are no accessible parking stalls. Each lot where parking is provided for the public as clients, guests or employees, shall provide accessible parking and shall be located on the shortest accessible route of travel from adjacent parking to an accessible entrance. A minimum of one accessible stall is required and it must be sized and designated as a van accessible stall.	There is no accessible parking at this location.	https://www.access-board.gov/ada/#ada-208_2_4	2012 TAS Section: 208.2.4 2010 ADAS Section: 208.2.4

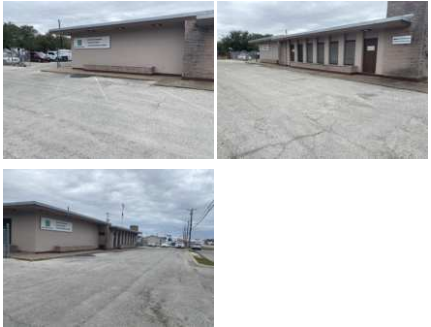
Total Number of Parking Spaces Provided in Parking Facility	Minimum Number of Required Accessible Parking Spaces	1 to 25	1	26 to 50	2	51 to 75	3	76 to 100	4	101 to 150	5	151 to 200	6	201 to 300	7	301 to 400	8	401 to 500	9	501 to 1000	2 percent of total	1001 and over	20, plus 1 for each 100, or fraction thereof, over 1000
Total Number of Parking Spaces Provided in Parking Facility	Minimum Number of Required Accessible Parking Spaces																														
1 to 25	1																														
26 to 50	2																														
51 to 75	3																														
76 to 100	4																														
101 to 150	5																														
151 to 200	6																														
201 to 300	7																														
301 to 400	8																														
401 to 500	9																														
501 to 1000	2 percent of total																														
1001 and over	20, plus 1 for each 100, or fraction thereof, over 1000																														
2	Exterior of Property (Public): Parking Lot (0 Spaces) - Accessible Van Stall Requirements	The parking space is in not nearly compliant. The parking space the minimum width. The floor or ground surface is not firm stable or slip resistant. The parking space contains changes in level and/or gaps that exceed the maximum allowable requirements. The parking space does not have the proper identifications signs or the signs are not installed at the correct height. The parking space is missing an adjacent access aisle.	There are no accessible parking spaces provided, required to have 1 van accessible space to meet compliance. Space needs a number of elements to be designated as accessible van parking.	van stall 11' access aisle 5' or van stall 8' access aisle 8' Review parking stall and access aisle requirements https://www.access-board.gov/ada/#ada-208_2 https://www.access-board.gov/ada/#ada-502 https://www.access-board.gov/ada/#ada-502_1	2012 TAS Section: 502.1, 502.1 Exception 2010 ADAS Section: 502.1, 502.1 Exception

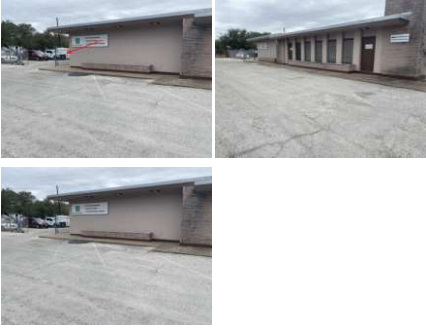
Finding Number	Area Description	Finding	As Built	Recommendation	Citation	Photos	Figure
4	Exterior of Property (Public): Parking Lot (0 Spaces) - Accessible Van Stall Requirments	The van stall is missing a sign identifying it as a van accessible stall. Parking space identification signs shall include the International Symbol of Accessibility. Signs identifying van parking spaces shall contain the designation "van accessible."	N/A	https://www.access-board.gov/ada/#ada-502_6	2012 TAS Section: 502.6 2010 ADAS Section: 502.6

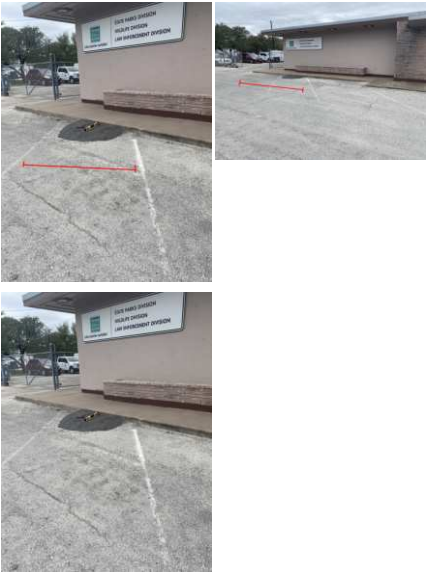
5	Exterior of Property (Public): Parking Lot (0 Spaces) - Access Aisle Requirments (Van)	The access aisle is in not nearly compliant. The access ai the minimum width. The access aisle is not as long as the parking space it serves. There are no markings to discourage parking. The floor or ground surface is not firm stable or slip resistant. The parking space contains changes in level and/or gaps that exceed the maximum allowable requirements.	Access aisle width requirments depend on van stall size. van stall 11' access aisle 5' or van stall 8' access aisle 8'	N/A - Refer to Finding	2012 TAS Section: 502.3 2010 ADAS Section: 502.3

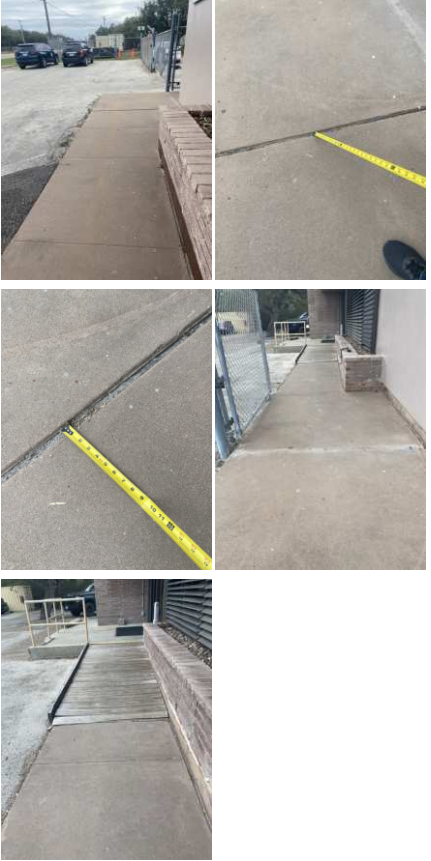
Finding Number	Area Description	Finding	As Built	Recommendation	Citation	Photos	Figure
10	Exterior of Property (Public): Path of Travel to Building - Path of Travel (Main Route)	The route contains openings greater than 1/2 inch. Openings in floor or ground surfaces shall not allow passage of a sphere more than 1/2 inch diameter. Elongated openings shall be placed so that the long dimension is perpendicular to the dominant direction of travel.	There are 2 gaps greater than 1/2 inch on public pathway to LE entrance. See additional photos for location of gaps in accessible pathway.	https://www.access-board.gov/ada/#ada-302_3	2012 TAS Section: 302.3 2010 ADAS Section: 302.3

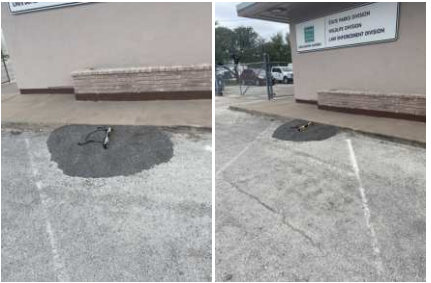
11	Exterior of Property (Public): Path of Travel to Building - Curb Ramp (Main Route Near Parking Lot)	The ramp projects into a prohibited area. Ramps shall be located so that they do not project into vehicular traffic lanes, parking spaces, or parking access aisles.	N/A	https://www.access-board.gov/ada/#ada-406_5	2012 TAS Section: 406.5 2010 ADAS Section: 406.5

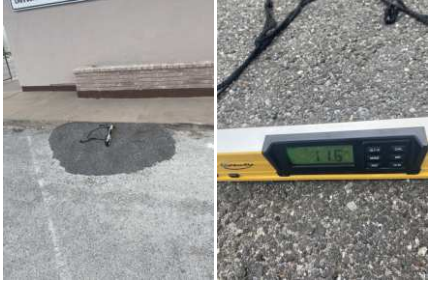
Finding Number	Area Description	Finding	As Built	Recommendation	Citation	Photos	Figure
12	Exterior of Property (Public): Path of Travel to Building - Curb Ramp (Main Route Near Parking Lot)	The curb ramp exceeds the maximum running slope (parallel to the direction of travel) allowable of 8.33%. Curb ramps should have the least possible slope but in no case more than 8.33% (1:12).	Curb ramp slope is 11.6% and is not clearly marked or installed correctly.	https://www.access-board.gov/ada/#ada-406_1	2012 TAS Section: 406.1 2010 ADAS Section: 406.1

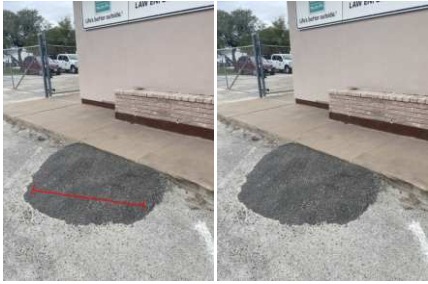
13	Exterior of Property (Public): Path of Travel to Building - Curb Ramp (Main Route Near Parking Lot)	Curb ramp dimensions and useable space are incorrect. Ramp cannot be placed within access aisle.	Curb ramp is not compliant	Review curb ramp specifications https://www.access-board.gov/ada/#ada-406	2012 TAS Section: Recommended 2010 ADAS Section: Recommended

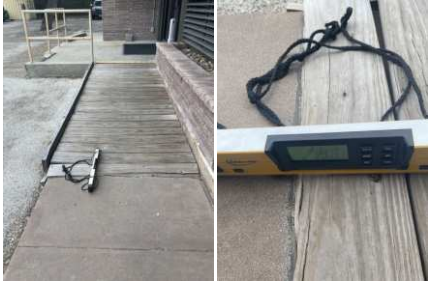
14	Exterior of Property (Public): Path of Travel to Building - Wood Entrance Ramp (Non Curb Ramp Near LE Entrance)	The ramps exceeds the maximum running slope (direction of travel) allowable of 8.33%. Ramps should have the least possible slope but in no case more than 8.3% (1:12).	Non curb ramp entrance running slope is 9.8%. Located at bottom of ramp. From parking lot to entrance.	https://www.access-board.gov/ada/#ada-405_2	2012 TAS Section: 405.2 2010 ADAS Section: 405.2

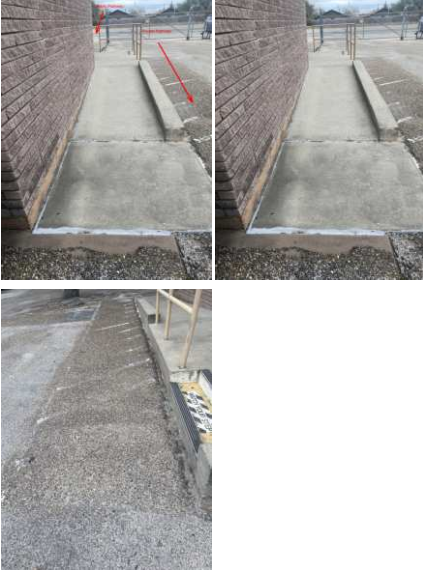
Finding Number	Area Description	Finding	As Built	Recommendation	Citation	Photos	Figure
15	Exterior of Property (Public): Path of Travel to Building - Concrete Entrance Ramp (Non Curb Ramp Near LE Entrance)	The curb ramp surface has openings that are greater than 1/2 inch. Openings in floor or ground surfaces shall not allow passage of a sphere more than 1/2 inch diameter. Elongated openings shall be placed so that the long dimension is perpendicular to the dominant direction of travel.	curb ramp entrance has a few large gaps in ramp run path. All other requirements meet specifications. There is no way for public to access this ramp entrance at this time due to location.	https://www.access-board.gov/ada/#ada-302_3	2012 TAS Section: 302.3 2010 ADAS Section: 302.3

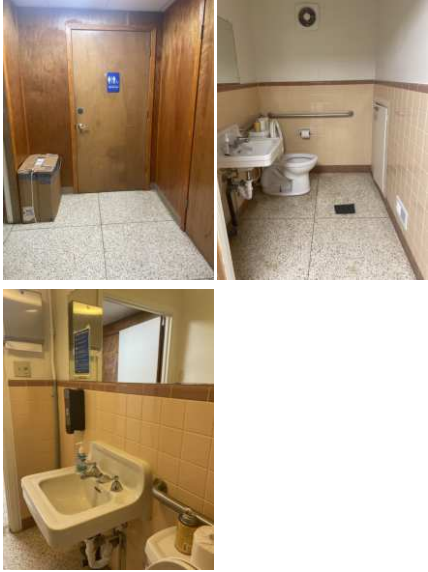
Finding Number	Area Description	Finding	As Built	Recommendation	Citation	Photos	Figure
19	First Floor Main Building LOBBY (Public): Lobby Area - Restroom (Unisex)	The restroom is not nearly compliant. The restroom does not have the required minimum clear floor space or maneuvering clearances for the toilet. The restroom does not have the required minimum clear floor space or maneuvering clearances for the lavatory. The entry door does not contain the required minimum maneuvering spaces on the pull/push sides. The entry door encroach into the required clear floor space for fixtures. Grab bars are missing and/or incorrectly installed. Accessories, such as toilet seat covers, paper towel holders, garbage cans, hand dryers, and mirrors are either too high or without clear floor space or both. The restroom contain floor level changes greater than a 1/2 inch of the floor drains and is slope (XX) - (XX), the shower is too small and missing numerous accessible elements.	This public use restroom would need a number of elements installed to gain compliance.	https://www.access-board.gov/ada/#ada-213_2	2012 TAS Section: 213.2 2010 ADAS Section: 213.2

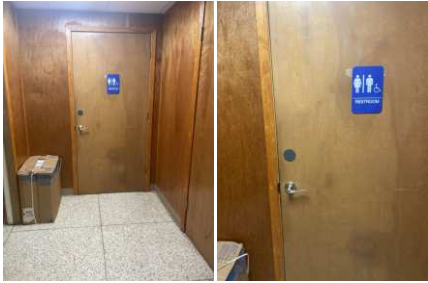
20	First Floor Main Building LOBBY (Public): Lobby Area - Restroom (Unisex)	The wall sign is incorrectly located. Where permanent identification signs are provided for rooms and spaces, signs shall be installed on the wall adjacent to the latch side of the door. Where there is no wall space on the latch side, including at double leaf doors, signs shall be placed on the nearest adjacent wall, preferably on the right. Mounting location shall be located so that a person may approach within 3 inches of the sign and that a clear floor space of 18 inches minimum by 18 inches minimum, centered on the tactile Characters, is provided beyond the arc of any door swing between the closed position and 45 degree open position.	N/A	Height Above Finish Floor or Ground https://www.access-board.gov/ada/#ada-703_4_1 Location https://www.access-board.gov/ada/#ada-703_4_2	2012 TAS Section: 703.4.1 2010 ADAS Section: 703.4.1

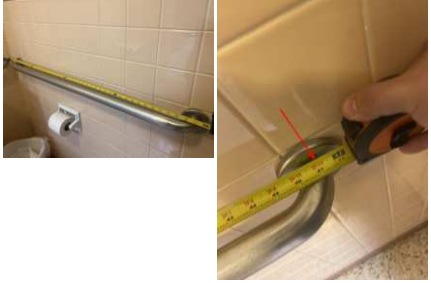
Finding Number	Area Description	Finding	As Built	Recommendation	Citation	Photos	Figure
30	First Floor Main Building LOBBY (Public): Lobby Area - Restroom (Unisex)	The side grab bar does not extend far enough from the rear wall. The side grab bar must extend at least 54 inches minimum beyond the rear wall and start a maximum of 12 inches from the rear wall. A 42 inch grab bar installed the maximum distance from the rear wall (12 inches) will leave the leading end 54 inches from the rear wall. Grab bars shall be installed in a horizontal position, 33 inches minimum and 36 inches maximum above the finish floor measured to the top of the gripping surface.	Side grab measure is 47" from rear wall	https://www.access-board.gov/ada/#ada-604_5_1	2012 TAS Section: 604.5.1 2010 ADAS Section: 604.5.1

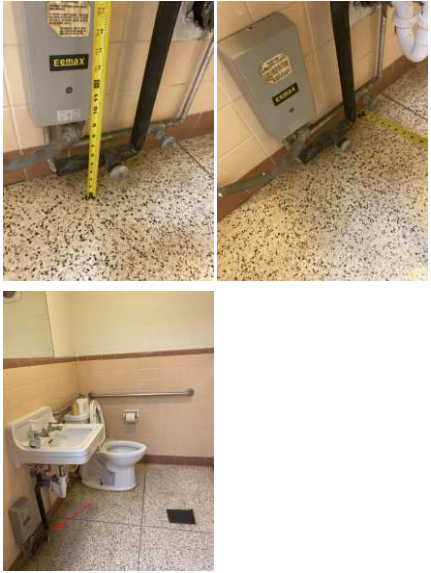
31	First Floor Main Building LOBBY (Public): Lobby Area - Restroom (Unisex)	There is not sufficient toe clearance under the lavatory. Space under an element between the finish floor or ground and 9 inches above the finish floor or ground shall be considered toe clearance. Toe clearance shall extend 17 inches minimum to 25 inches maximum deep under lavatories required to be accessible and 30 inches wide minimum.	N/A	https://www.access-board.gov/ada/#ada-306_2_1	2012 TAS Section: 306.2.1 2010 ADAS Section: 306.2.1

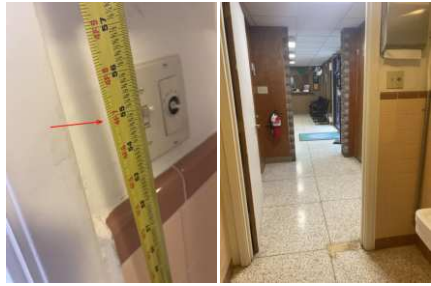
Finding Number	Area Description	Finding	As Built	Recommendation	Citation	Photos	Figure
32	First Floor Main Building LOBBY (Public): Lobby Area - Restroom (Unisex)	The receptacle/switch is not positioned correctly for either a side or front approach. Where a clear floor or ground space allows a parallel or front approach to a switch or receptacle and the side reach is unobstructed, the high side reach shall be 48 inches maximum above the finish floor or ground and the low side reach shall be 15 inches minimum above the finish floor or ground.	Light switch is 55"	https://www.access-board.gov/ada/#ada-308_2_1	2012 TAS Section: 308.2.1, 308.3.1 2010 ADAS Section: 308.2.1

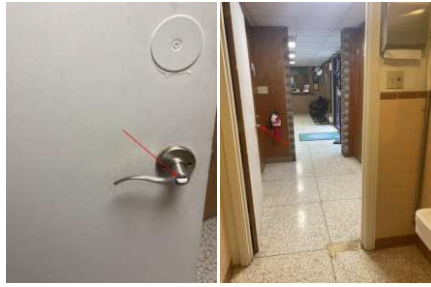
33	First Floor Main Building LOBBY (Public): Lobby Area - Restroom (Unisex)	The locking/latching hardware is not accessible. Hand-activated door opening hardware, handles, pulls, latches, locks, and other operating devices on accessible doors shall have a shape that is easy to grasp with one hand and does not require tight grasping, tight pinching or twisting of the wrist to operate.	N/A	https://www.access-board.gov/ada/#ada-604_8_1_2	2012 TAS Section: 604.8.1.2 2010 ADAS Section: 604.8.1.2

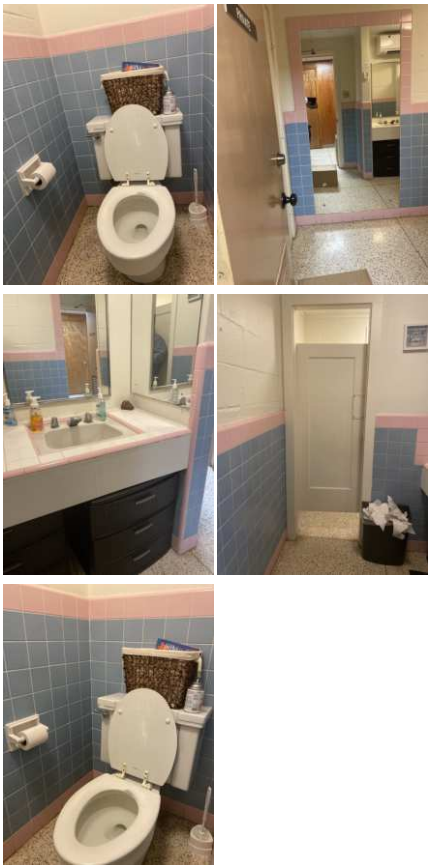
Finding Number	Area Description	Finding	As Built	Recommendation	Citation	Photos	Figure
34	First Floor Main Building LOBBY (Public): Lobby Area - Restroom (Unisex) - PRIVATE/STAFF ONLY	The restroom is not nearly compliant. The restroom does not have the required minimum clear floor space or maneuvering clearances for the toilet. The restroom does not have the required minimum clear floor space or maneuvering clearances for the lavatory. The entry door does not contain the required minimum maneuvering spaces on the pull/push sides. The entry door encroach into the required clear floor space for fixtures. Grab bars are missing and/or incorrectly installed. Accessories, such as toilet seat covers, paper towel holders, garbage cans, hand dryers, and mirrors are either too high or without clear floor space or both. The restroom contain floor level changes greater than a 1/2 inch of the floor drains and is slope (XX) - (XX), the shower is too small and missing numerous accessible elements.	Restroom is located in public lobby area. This restroom is for staff only, is marked private. Restroom would need a number of elements installed to gain compliance. - Door hardware- knob - Stall door not accessible width, less than 32" - Missing handles on stall door - No knee or toe space provided to access lavatory due to obstruction - Not enough space for parallel approach to lavatory - Lavatory hardware requires twisting - Missing rear grab bars - Missing side grab bars - Stall dimensions are not accessible - Flusher not on open side - TP dispenser location incorrect	https://www.access-board.gov/ada/#ada-213_2 Review restrooms componets to make accessible. https://www.access-board.gov/ada/#ada-603	2012 TAS Section: 213.2 2010 ADAS Section: 213.2

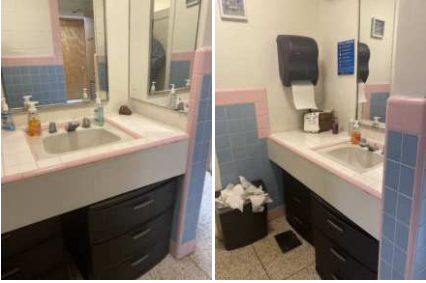
Finding Number	Area Description	Finding	As Built	Recommendation	Citation	Photos	Figure
36	First Floor Main Building LOBBY (Public): Lobby Area - Restroom (Unisex) - PRIVATE/STAFF ONLY	There are not enough accessible lavatories. Where lavatories are provided, at least one shall be accessible and shall not be located in a toilet compartment.	The lavatory and accessories are not complaint. There is no forward approach provided.	https://www.access-board.gov/ada/#ada-213_3_4 Review lavatory componets to make accessible. https://www.access-board.gov/ada/#ada-606	2012 TAS Section: 213.3.4 2010 ADAS Section: 213.3.4

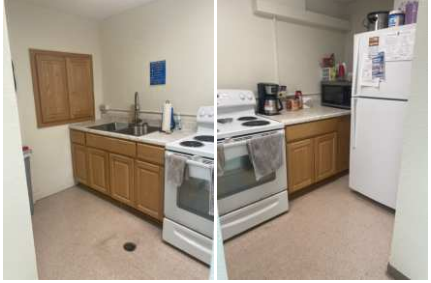
Finding Number	Area Description	Finding	As Built	Recommendation	Citation	Photos	Figure
37	First Floor Main Building (STAFF): Kitchenette	Knee and toe space has not been provided at the sink. Kitchen sinks must be provided with a clear floor space positioned for a forward approach including knee and toe clearance.	Knee and toe must be provided since kitchenette contain stove top range. In kitchens, kitchenettes, and breakrooms without a cooktop or conventional range, a parallel approach is permitted at kitchen sinks.	https://www.access-board.gov/ada/#ada-606_2 https://www.access-board.gov/ada/#ada-804_4	2012 TAS Section: 606.2, 804.4 2010 ADAS Section: 606.2, 804.4

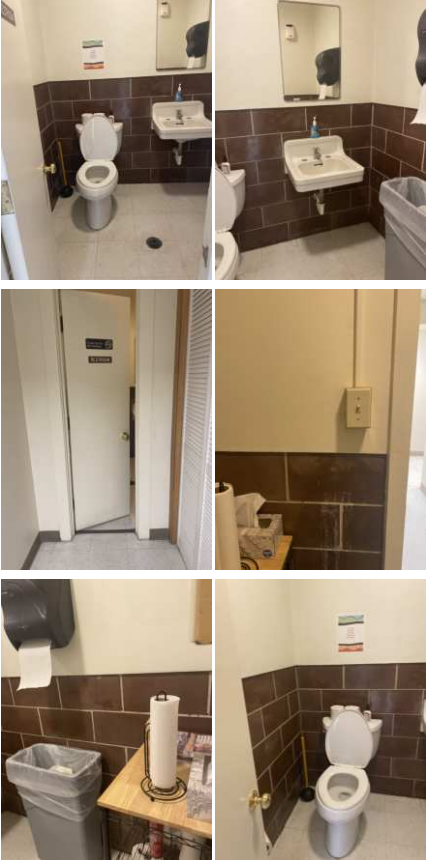
Finding Number	Area Description	Finding	As Built	Recommendation	Citation	Photos	Figure
40	First Floor Main Building (STAFF): Restrooms/Water Fountains - Restroom (Unisex)	The restroom is not nearly compliant. The restroom does not have the required minimum clear floor space or maneuvering clearances for the toilet. The restroom does not have the required minimum clear floor space or maneuvering clearances for the lavatory. The entry door does not contain the required minimum maneuvering spaces on the pull/push sides. The entry door encroach into the required clear floor space for fixtures. Grab bars are missing and/or incorrectly installed. Accessories, such as toilet seat covers, paper towel holders, garbage cans, hand dryers, and mirrors are either too high or without clear floor space or both. The restroom contain floor level changes greater than a 1/2 inch of the floor drains and is slope (XX) - (XX), the shower is too small and missing numerous accessible elements.	This restroom is located in staff area and for staff only. Restroom would need a number of elements installed to gain compliance. - Door hardware- knob - Lavatory hardware requires twisting - Missing rear grab bars - Missing side grab bars - TP does not allow continuous flow - Missing TP dispenser - Mirror height - Paper towel dispenser height - Light switch height - Trashcan encroaches on lavatory use space	https://www.access-board.gov/ada/#ada-213_2 Review restrooms componets to make accessible. https://www.access-board.gov/ada/#ada-603	2012 TAS Section: 213.2 2010 ADAS Section: 213.2
