Rusk LE- ADA Evaluation

LE- Rusk TX, ADA Evaluation
580 W 6th St
Rusk, TX 75785
Accessibility Evaluation
Inspection Date: 04/10/2023
Inspectors: Christopher Meza

Report Date: 01/15/2024

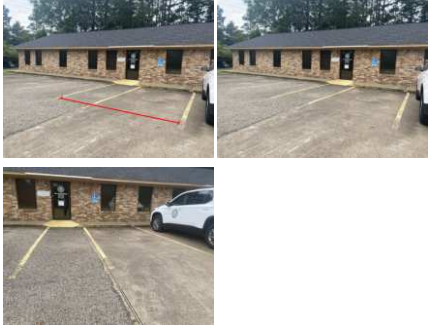
Finding Number	Area Description	Finding	As Built	Recommendation	Citation	Photos	Figure
1	Exterior of Property (Public): Parking Lot (1 Space) 1 Car	There are no van accessible parking stalls. 1 in every 6, minimum of one, required accessible stalls must be a van accessible stall.	Current dimensions of parking space and access aisle together do not meet compliance for accessible van parking.	https://www.access-board.gov/ada/#ada-208_2 https://www.access-board.gov/ada/#ada-208_2_4	2012 TAS Section: 208.2, 208.2.4 2010 ADAS Section: 208.2, 208.2.4

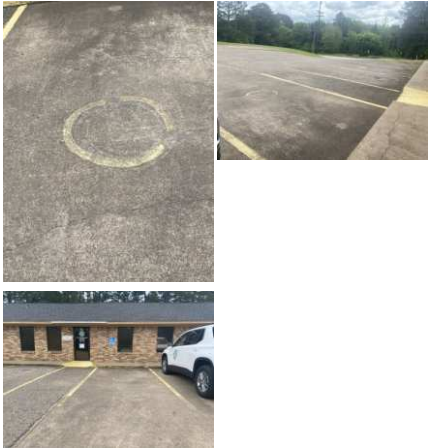
3	Exterior of Property (Public): Parking Lot (1 Space) 1 Car - Car Accessible Stall	The accessible parking space is missing the required ISA marking. A paved accessible parking space must include the International Symbol of Accessibility painted conspicuously on the surface in a color that contrasts the pavement.	Accessible parking space markings are faded or missing.	N/A - Refer to Finding	2020 TDLR Section: 68.104 (a)(1)

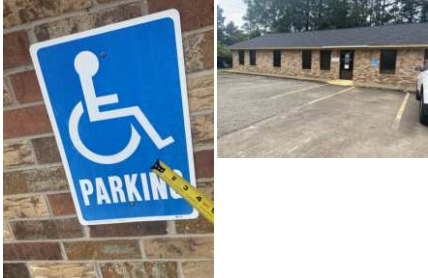
Finding Number	Area Description	Finding	As Built	Recommendation	Citation	Photos	Figure
4	Exterior of Property (Public): Parking Lot (1 Space) 1 Car - Car Accessible Stall	The van stall is missing a sign identifying it as a van accessible stall. Parking space identification signs shall include the International Symbol of Accessibility. Signs identifying van parking spaces shall contain the designation "van accessible."	A accessible van parking space required. Currently space missing van sign designation.	https://www.access-board.gov/ada/#ada-502_6	2012 TAS Section: 502.6 2010 ADAS Section: 502.6

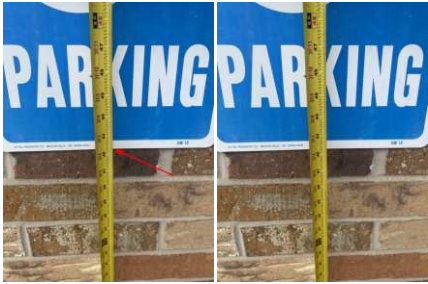
5	Exterior of Property (Public): Parking Lot (1 Space) 1 Car - Car Accessible Stall	The parking sign is mounted too low. Parking space identification signs shall include the International Symbol of Accessibility. Signs identifying van parking spaces shall contain the designation "van accessible." Signs shall be 60 inches minimum above the finish floor or ground surface measured to the bottom of the sign.	Accessible parking sign is under 43"	https://www.access-board.gov/ada/#ada-502_6	2012 TAS Section: 502.6 2010 ADAS Section: 502.6

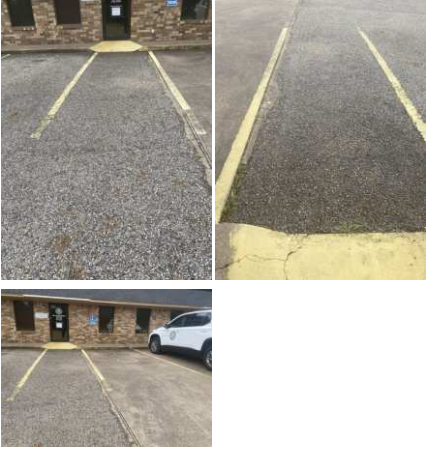
Finding Number	Area Description	Finding	As Built	Recommendation	Citation	Photos	Figure	
8	Exterior of Property (Public): Parking Lot (1 Space) 1 Car - Access Aisle (Car)	The striping for the accessible parking stalls loading/unloading access aisle is missing. Access aisles shall be marked so as to discourage parking in them.	No markings provided		https://www.access-board.gov/ada/#ada-502_3_3	2012 TAS Section: 502.3.3 2010 ADAS Section: 502.3.3

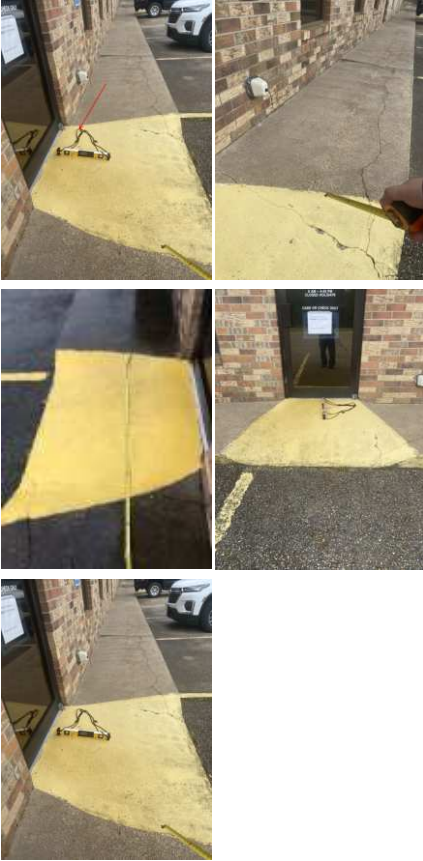
Finding Number	Area Description	Finding	As Built	Recommendation	Citation	Photos	Figure
10	Exterior of Property (Public): Path of Travel to Building - Entrance Ramps (Non Curb Ramp)	The ramp is missing the required top landing. Ramps shall have landings at the top and the bottom of each ramp run.	This ramp does not comply with curb ramp or ramp specifications.	https://www.access-board.gov/ada/#ada-405_1 https://www.access-board.gov/ada/#ada-405_7	2012 TAS Section: 405.7 2010 ADAS Section: 405.7

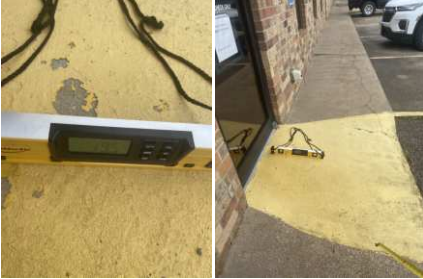
11	Exterior of Property (Public): Path of Travel to Building - Entrance Ramps (Non Curb Ramp)	The ramps exceeds the maximum running slope (direction of travel) allowable of 8.33%. Ramps should have the least possible slope but in no case more than 8.3% (1:12).	Entrance ramp running slope is 19.5%	https://www.access-board.gov/ada/#ada-405_2	2012 TAS Section: 405.2 2010 ADAS Section: 405.2

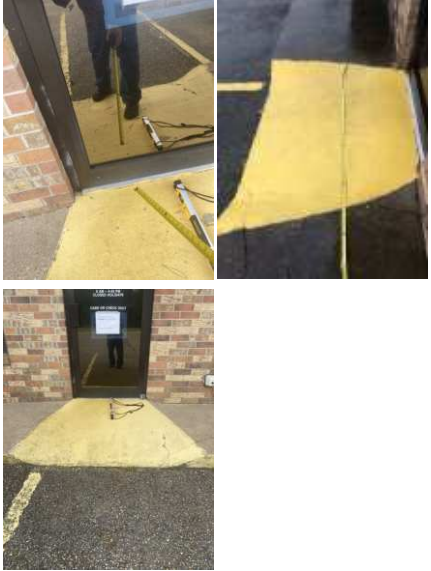
Finding Number	Area Description	Finding	As Built	Recommendation	Citation	Photos	Figure
12	First Floor Main Building LOBBY (Public): Entrance into Lobby	The door maneuvering clearance contains changes in level. Floor or ground surface within required maneuvering clearances shall comply with Floor or Ground Surfaces. Changes in level are not permitted. The entire maneuvering clearance must be free of obstructions and must be flat (2% max. slope is considered flat in any direction).	Doorway entrance not accessible due to entrance ramp slope.	https://www.access-board.gov/ada/#ada-404_2_4_4	2012 TAS Section: 404.2.4.4 2010 ADAS Section: 404.2.4.4

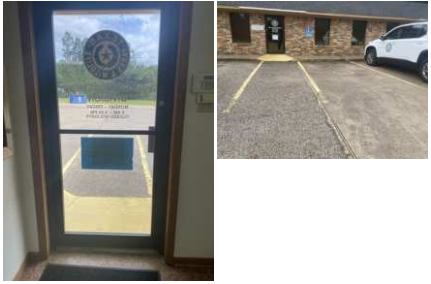
13	First Floor Main Building LOBBY (Public): Entrance into Lobby - Entrance Door	The door does not open at least 90 degrees. Door openings shall provide a clear width of 32 inches minimum. Clear openings of doorways with swinging doors shall be measured between the face of the door and the stop, with the door open 90 degrees. There shall be no projections into the required clear opening width lower than 34 inches above the finish floor or ground. Projections into the clear opening width between 34 inches and 80 inches above the finish floor or ground shall not exceed 4 inches.	N/A	https://www.access-board.gov/ada/#ada-404_2_3	2012 TAS Section: 404.2.3 2010 ADAS Section: 404.2.3

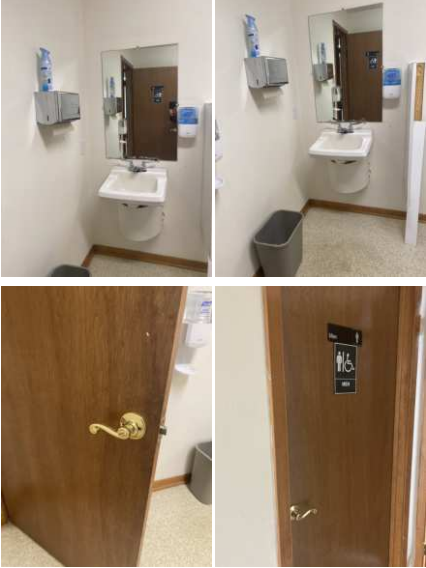
Finding Number	Area Description	Finding	As Built	Recommendation	Citation	Photos	Figure
14	First Floor Main Building (STAFF): Kitchenette	The route of travel does not provide a minimum width of 36 inches. The clear width shall be permitted to be reduced to 32 inches minimum for a length of 24 inches maximum provided that reduced width segments are separated by segments that are 48 inches long minimum and 36 inches wide minimum.	The clear width shall be permitted to be reduced to 32 inches (815 mm) minimum for a length of 24 inches (610 mm) maximum Route to sink is not accessible, route is less than 36"	https://www.access-board.gov/ada/#ada-403_5_1	2012 TAS Section: 403.5.1 2010 ADAS Section: 403.5.1		
15	First Floor Main Building (STAFF): Restrooms/Water Fountains - Restroom (Men's)	The restroom is not nearly compliant. The restroom does not have the required minimum clear floor space or maneuvering clearances for the toilet. The restroom does not have the required minimum clear floor space or maneuvering clearances for the lavatory. The entry door does not contain the required minimum maneuvering spaces on the pull/push sides. The entry door encroach into the required clear floor space for fixtures. Grab bars are missing and/or incorrectly installed. Accessories, such as toilet seat covers, paper towel holders, garbage cans, hand dryers, and mirrors are either too high or without clear floor space or both. The restroom contain floor level changes greater than a 1/2 inch of the floor drains and is slope (XX) - (XX), the shower is too small and missing numerous accessible elements.	This restroom if for staff only and would need a number of elements installed to gain compliance. - No rear grab bar - Side bar incorrectly placed and wrong type - Stall door closes to quickly - Door mechanism requires pinching and twisting for entrance door and stall - Not enough accessible space provided in stall - Paper towel dispenser height	https://www.access-board.gov/ada/#ada-213_2 Review restrooms componets to make accessible. https://www.access-board.gov/ada/#ada-603	2012 TAS Section: 213.2 2010 ADAS Section: 213.2
