San Angelo LE- ADA Evaluation

Report Date: 01/12/2024

LE-San Angelo TX, ADA Evaluation
3407 S Chadbourne St
San Angelo, TX 76904
Accessibility Evaluation
Inspection Date: 01/17/2023
Inspectors: Jessica Burke

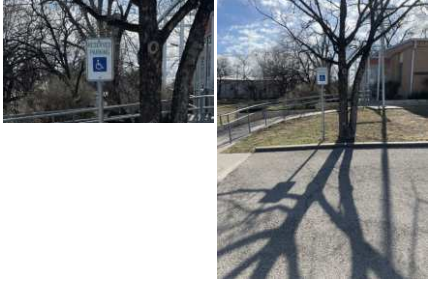
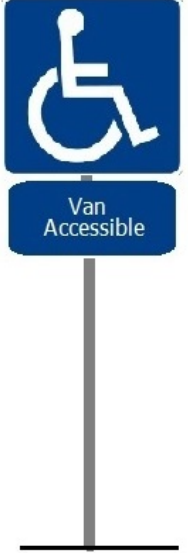
2	Exterior of Property (Public) : Parking Lot (1 Space) 1 Labeled - Accessible Stall (Labeled)	The van stall is missing a sign identifying it as a van accessible stall. Parking space identification signs shall include the International Symbol of Accessibility. Signs identifying van parking spaces shall contain the designation "van accessible."	N/A	https://www.access-board.gov/ada/#ada-502_6	2012 TAS Section: 502.6 2010 ADAS Section: 502.6 2015 ABAAS Section: 502.6

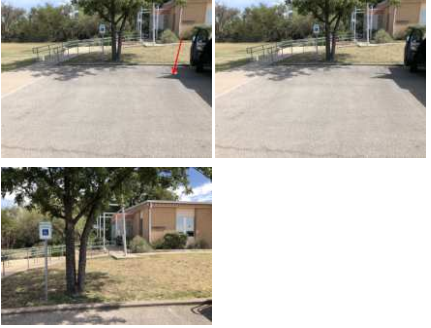
Finding Number	Area Description	Finding	As Built	Recommendation	Citation	Photos	Figure
3	Exterior of Property (Public) : Parking Lot (1 Space) 1 Labeled - Accessible Stall (Labeled)	The accessible parking space is missing the required markings. Vehicle spaces shall be marked to define the width, and shall have an adjacent access aisle.	Accessible parking stall borders faded on (R) side and missing on (L) side.	https://www.access-board.gov/ada/#ada-502_2	2012 TAS Section: 502.2 2010 ADAS Section: 502.2 2015 ABAAS Section: 502.1, 502.2

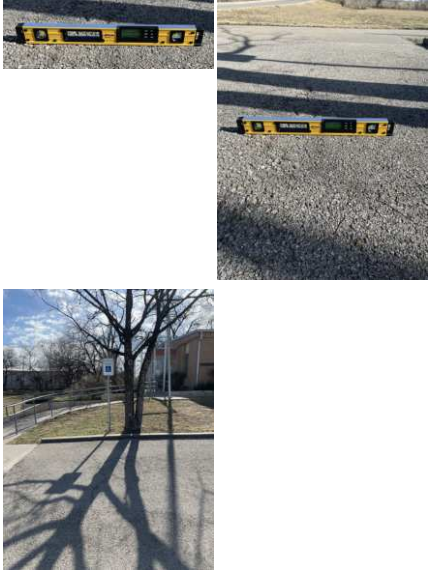
Finding Number	Area Description	Finding	As Built	Recommendation	Citation	Photos	Figure
5	Exterior of Property (Public) : Parking Lot (1 Space) 1 Labeled - Accessible Stall (Labeled)	The running slope (long dimension) of the accessible parking stall exceeds 2%. The running slope in an accessible parking stall and the access aisle must not exceed 2%.	Accessible parking stall running slope is 4.1%		https://www.access-board.gov/ada/#ada-502_4

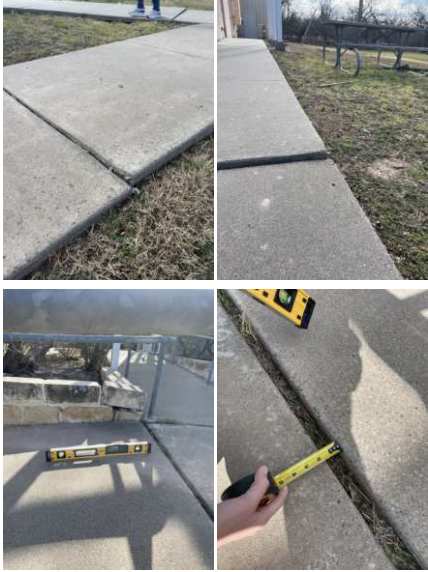
Finding Number	Area Description	Finding	As Built	Recommendation	Citation	Photos	Figure
8	Exterior of Property (Public) : Path of Travel to Building	The building entrance is not located on an accessible route. When a building, or portion of a building, is required to be accessible, an accessible route of travel shall be provided to all portions of the building, to accessible building entrances and between the building and the public way. At least one accessible route within the boundary of the site must be provided from public transportation stops, accessible parking and accessible passenger loading zones and public streets or sidewalks to the accessible building entrance they serve. The accessible route shall, to the maximum extent feasible, coincide with the route for the general public. At least one accessible route shall connect accessible buildings, facilities, elements and spaces that are on the same site. At least one accessible route shall connect accessible building or facility entrances with all accessible spaces and elements.	There is no accessible route to building due to large cracks in exterior pathway, ramp slope and gap non compliance, abrupt change in level due to pathway shifting.	https://www.access-board.gov/ada/#ada-206_2_1	2012 TAS Section: 206.2.1 2010 ADAS Section: 206.2.1 2015 ABAAS Section: F206.2.1

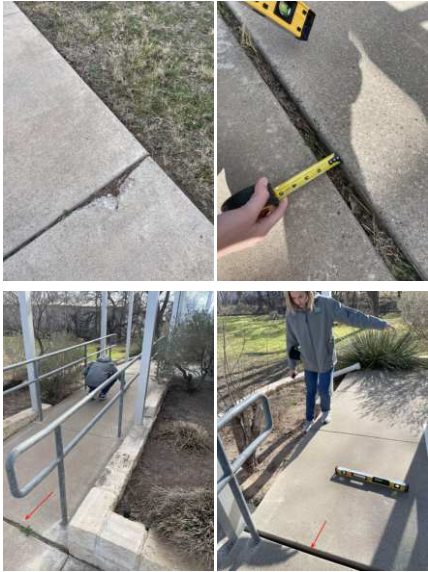
9	Exterior of Property (Public) : Path of Travel to Building - Path of Travel (Main Route)	The route contains openings greater than 1/2 inch. Openings in floor or ground surfaces shall not allow passage of a sphere more than 1/2 inch diameter. Elongated openings shall be placed so that the long dimension is perpendicular to the dominant direction of travel.	Exterior pathway has large gaps over 1/2" impending access. See additional photos for location of gap non compliance on accessible pathway to building.	https://www.access-board.gov/ada/#ada-302_3	2012 TAS Section: 302.3 2010 ADAS Section: 302.3 2015 ABAAS Section: 302.3

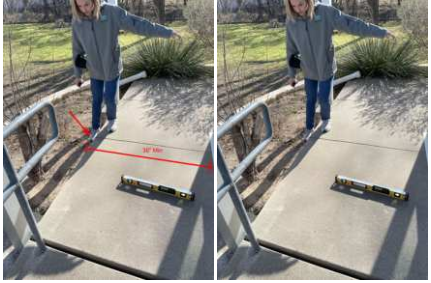
Finding Number	Area Description	Finding	As Built	Recommendation	Citation	Photos	Figure
10	Exterior of Property (Public) : Path of Travel to Building - Path of Travel (Main Route)	The walkway contains abrupt vertical edges and/or variations over 1/4 inch. 1/4 inch is the maximum vertical rise. Changes in level between 1/4 inch and 1/2 inch must be beveled at 1:2 or less. Changes in level greater than 1/2 inch must be by way of a ramp.	If walkway is 36" then meets accessible route compliance however drop off is a hazard and should be remedied with edge protection or gradual slope.	https://www.access-board.gov/ada/#ada-303_2	2012 TAS Section: 303.3, 303.2 2010 ADAS Section: 303.3, 303.2 2015 ABAAS Section: 303.2, 303.3

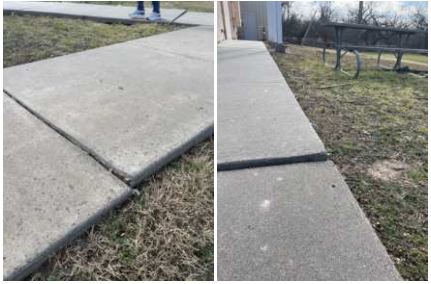
11	Exterior of Property (Public) : Path of Travel to Building - Path of Travel (Main Route)	The walkway contains abrupt vertical edges and/or variations over 1/4 inch. 1/4 inch is the maximum vertical rise. Changes in level between 1/4 inch and 1/2 inch must be beveled at 1:2 or less. Changes in level greater than 1/2 inch must be by way of a ramp.	Walkway is shifting and creates tripping hazard. See additional photos for other locations	https://www.access-board.gov/ada/#ada-303_2	2012 TAS Section: 303.3, 303.2 2010 ADAS Section: 303.3, 303.2 2015 ABAAS Section: 303.2, 303.3

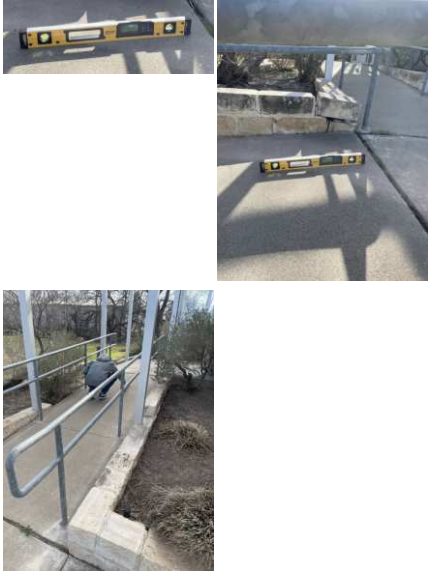
12	Exterior of Property (Public) : Path of Travel to Building - Concrete Entrance Ramp (Non Curb Ramp Main Route)	The ramps exceeds the maximum running slope (direction of travel) allowable of 8.33%. Ramps should have the least possible slope but in no case more than 8.3% (1:12).	Entrance ramp running slope is 9.4%	https://www.access-board.gov/ada/#ada-405_2	2012 TAS Section: 405.2 2010 ADAS Section: 405.2 2015 ABAAS Section: 405.2

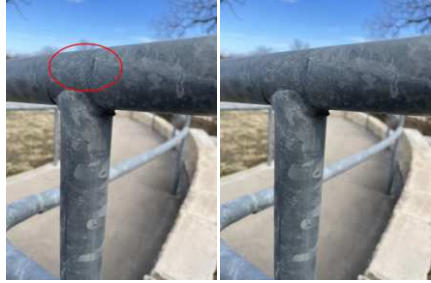
Finding Number	Area Description	Finding	As Built	Recommendation	Citation	Photos	Figure
15	Exterior of Property (Public) : Path of Travel to Building - Concrete Entrance Ramp (Non Curb Ramp Main Route)	The gripping surface of the handrail and/or the surface next to the handrail is sharp or abrasive. Handrail gripping surfaces must be free of sharp or abrasive elements and shall have rounded edges.	Entrance ramp handrails have some abrasive areas.	https://www.access-board.gov/ada/#ada-505_8	2010 ADAS Section: 505.8 2015 ABAAS Section: 505.8

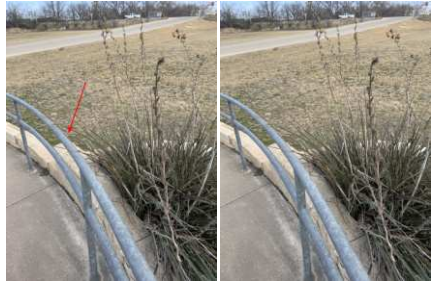
16	Exterior of Property (Public) : Path of Travel to Building - Concrete Entrance Ramp (Non Curb Ramp Main Route)	There is a horizontal projection too close to the bottom of the handrail gripping surface. Where provided, horizontal projections shall occur 1 1/2 inches minimum below the bottom of the handrail gripping surface.	Plant overgrowth impedes handrail gripping surface.	https://www.access-board.gov/ada/#ada-505_6	2012 TAS Section: 505.6 2010 ADAS Section: 505.6 2015 ABAAS Section: 505.6

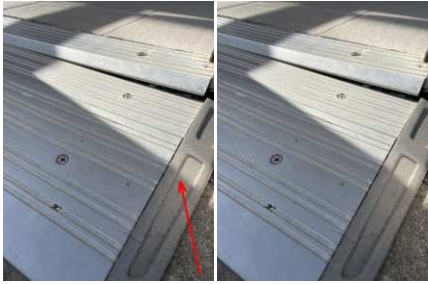
20	First Floor Main Building LOBBY (Public): Entrance into Lobby - Exterior Vestibule Door	The door maneuvering clearance contains changes in level. Floor or ground surface within required maneuvering clearances shall comply with Floor or Ground Surfaces. Changes in level are not permitted. The entire maneuvering clearance must be free of obstructions and must be flat (2% max. slope is considered flat in any direction).	Beveled ramp in front of entrance door is not compliant regarding door maneuvering space slope requirements.	https://www.access-board.gov/ada/#ada-404_2_4_4	2012 TAS Section: 404.2.4.4 2010 ADAS Section: 404.2.4.4 2015 ABAAS Section: 404.2.4.4

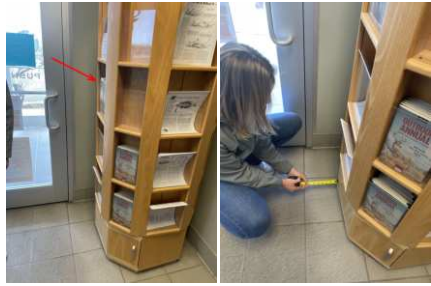
Finding Number	Area Description	Finding	As Built	Recommendation	Citation	Photos	Figure
22	First Floor Main Building LOBBY (Public): Entrance into Lobby - Interior Vestibule Door	The door is recessed greater than 8 inches deep with non-compliant latch side clearance. The width of the maneuvering clearance within a recess on the latch side greater than 8 inches deep must be as wide as the door plus an additional 18 inches on the latch side and in the same plane as the door . The maneuvering clearance must be flat (2% max. slope in any direction) and clear of obstructions.	Pamphlet shelf obstructing clear floor space requirement	https://www.access-board.gov/ada/#ada-404_2_4_3	2012 TAS Section: 404.2.4.3 2010 ADAS Section: 404.2.4.3 2015 ABAAS Section: 404.2.4.3

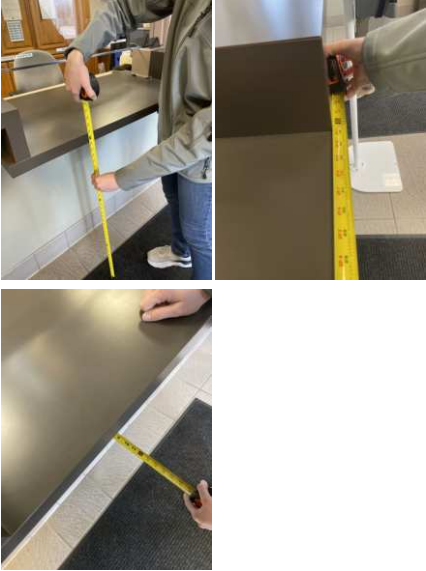
Finding Number	Area Description	Finding	As Built	Recommendation	Citation	Photos	Figure
24	First Floor Main Building LOBBY (Public): Lobby Area - Service Counter	The sales or service counter does not allow for a forward or parallel approach. Accessible counters must provide a compliant forward or parallel approach. Forward approach requirements Space under an element between the finish floor or ground and 9 inches above the finish floor or ground shall be considered toe clearance. Toe clearance shall extend 25 inches maximum and 17 inches minimum under an element. Space extending greater than 6 inches beyond the available knee clearance at 9 inches above the finish floor or ground shall not be considered toe clearance. Toe clearance shall be 30 inches wide minimum. Space under an element between 9 inches and 27 inches above the finish floor or ground shall be considered knee clearance. Knee clearance shall extend 25 inches maximum under an element at 9 inches above the finish floor or ground. Knee clearance shall be 11 inches deep minimum at 9 inches above the finish floor or ground, and 8 inches deep minimum at 27 inches above the finish floor or ground. Knee clearance shall be 30 inches wide minimum. Parallel approach requirements A portion of the counter surface that is 36 inches long minimum and 36 inches high maximum above the finish floor shall be provided.	Service counter measurements 37" high 35" wide. There is no forward or parallel approach for service desk. Compliant knee and/or toe space is not provided for forward approach. Desk height and width are not within compliance for parallel approach.	Service desks approach requirements https://www.access-board.gov/ada/#ada-904_4 Parallel approach https://www.access-board.gov/ada/#ada-904_4_1 Forward approach https://www.access-board.gov/ada/#ada-904_4_2	2012 TAS Section: 904.4 2010 ADAS Section: 904.4 2015 ABAAS Section: 904.4.1

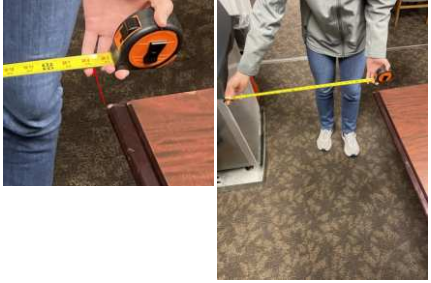
Finding Number	Area Description	Finding	As Built	Recommendation	Citation	Photos	Figure
25	First Floor Main Building (STAFF): Conference Room/Kitchenette	The route of travel does not provide a minimum width of 36 inches. The clear width shall be permitted to be reduced to 32 inches minimum for a length of 24 inches maximum provided that reduced width segments are separated by segments that are 48 inches long minimum and 36 inches wide minimum.	Accessible pathway to navigate conference room narrows to 26" due to obstruction, between table and ice machine.	https://www.access-board.gov/ada/#ada-403_5_1	2012 TAS Section: 403.5.1 2010 ADAS Section: 403.5.1 2015 ABAAS Section: 403.5.1

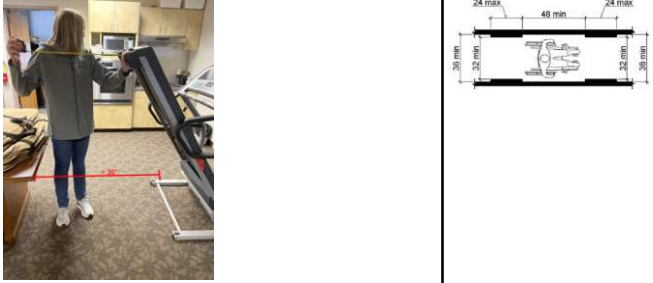
Finding Number	Area Description	Finding	As Built	Recommendation	Citation	Photos	Figure
28	First Floor Main Building (STAFF): Conference Room/Kitchenette	The route of travel does not provide a minimum width of 36 inches. The clear width shall be permitted to be reduced to 32 inches minimum for a length of 24 inches maximum provided that reduced width segments are separated by segments that are 48 inches long minimum and 36 inches wide minimum.	Treadmill narrows path of travel to less than 36" and is a hazard protruding object.		https://www.access-board.gov/ada/#ada-403_5_1	2012 TAS Section: 403.5.1 2010 ADAS Section: 403.5.1 2015 ABAAS Section: 403.5.1

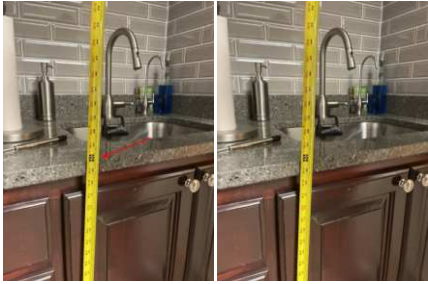
29	First Floor Main Building (STAFF): Conference Room/Kitchenette - Kitchenette	The top of the sink is above the allowable height requirement. Sinks shall be installed with the front of the higher of the rim or counter surface 34 inches maximum above the finish floor or ground.	Sinks are not accessible via frontal or parallel approach due to rim height. Sinks do not require knee and toe space since there is no stove top oven in vicinity. Kitchen counter height is 36"		https://www.access-board.gov/ada/#ada-606_3	2012 TAS Section: 606.3 2010 ADAS Section: 606.3 2015 ABAAS Section: 606.3

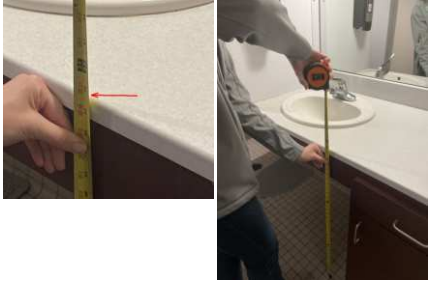
Finding Number	Area Description	Finding	As Built	Recommendation	Citation	Photos	Figure
37	First Floor Main Building (STAFF): Restrooms/Water Fountains - Restroom (Men's)	The top rim of the lavatory is too high. All lavatories that are designated to be accessible shall be a minimum 17 inches in horizontal depth and mounted with the rim or counter edge no higher than 34 inches above the finished floor.	Lavatory rim height over 34"	https://www.access-board.gov/ada/#ada-606_3	2012 TAS Section: 606.3 2010 ADAS Section: 606.3 2015 ABAAS Section: 606.3

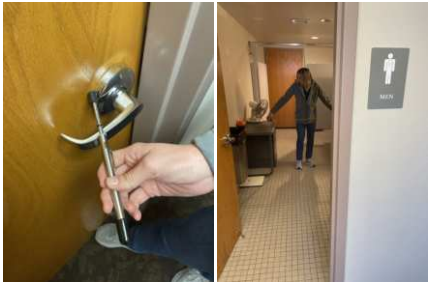
39	First Floor Main Building (STAFF): Restrooms/Water Fountains - Restroom (Men's)	The door is equipped with a door closer and returns to a closed position too quickly. Door closers and gate closers shall be adjusted so that from an open position of 90 degrees, the time required to move the door to a position of 12 degrees from the latch is 5 seconds minimum.	Entrance door closes in less than 5 seconds	https://www.access-board.gov/ada/#ada-404_2_8_1	2012 TAS Section: 404.2.8.1 2010 ADAS Section: 404.2.8.1 2015 ABAAS Section: 404.2.8.1

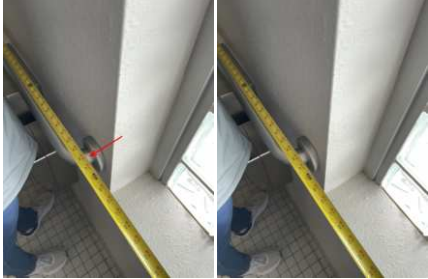
42	First Floor Main Building (STAFF): Restrooms/Water Fountains - Restroom (Women's)	The side grab bar does not extend far enough from the rear wall. The side grab bar must extend at least 54 inches minimum beyond the rear wall and start a maximum of 12 inches from the rear wall. A 42 inch grab bar installed the maximum distance from the rear wall (12 inches) will leave the leading end 54 inches from the rear wall. Grab bars shall be installed in a horizontal position, 33 inches minimum and 36 inches maximum above the finish floor measured to the top of the gripping surface.	Side grab bar extends 46" from rear wall	https://www.access-board.gov/ada/#ada-604_5_1	2012 TAS Section: 604.5.1 2010 ADAS Section: 604.5.1 2015 ABAAS Section: 604.5.1
