San Antonio LE- ADA Evaluation

Report Date: 01/15/2024

LE- San Antonio TX, ADA Evaluation
2391 NE Interstate 410 Loop Suite 409
Uptown, TX 78217

Accessibility Evaluation
Inspection Date: 06/07/2023
Inspectors: Christopher Meza

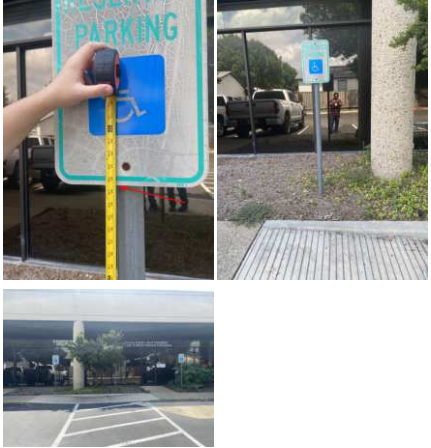
Finding Number	Area Description	Finding	As Built	Recommendation	Citation	Photos	Figure
1	Exterior of Property (Public): Parking Lot (2 Spaces) 2 Car - Car Accessible Stall (L Side)	The parking sign is mounted too low. Parking space identification signs shall include the International Symbol of Accessibility. Signs identifying van parking spaces shall contain the designation "van accessible." Signs shall be 60 inches minimum above the finish floor or ground surface measured to the bottom of the sign.	Sign height is less than 56". Sign showing signs of wear, will need to be replaced soon.	https://www.access-board.gov/ada/#ada-502_6	2012 TAS Section: 502.6 2010 ADAS Section: 502.6

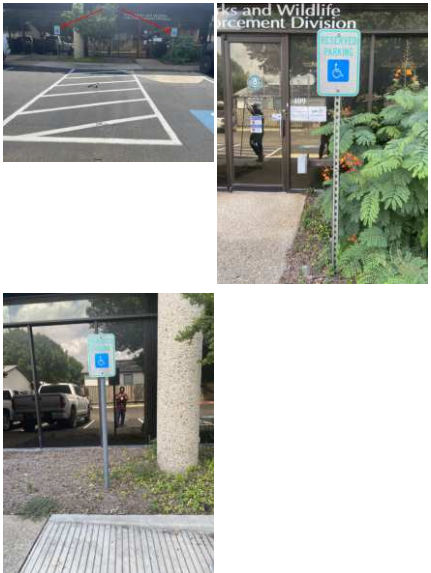
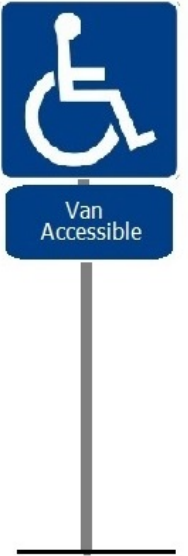
2	Exterior of Property (Public): Parking Lot (2 Spaces) 2 Car - Car Accessible Stall (L Side)	The van stall is missing a sign identifying it as a van accessible stall. Parking space identification signs shall include the International Symbol of Accessibility. Signs identifying van parking spaces shall contain the designation "van accessible."	Both accessible parking stalls are labeled but 1 needs to be designated as accessible van parking. Both spots meet dimensions required for van parking with correct access aisle.	Add van designation sign to either spot https://www.access-board.gov/ada/#ada-502_6	2012 TAS Section: 502.6 2010 ADAS Section: 502.6

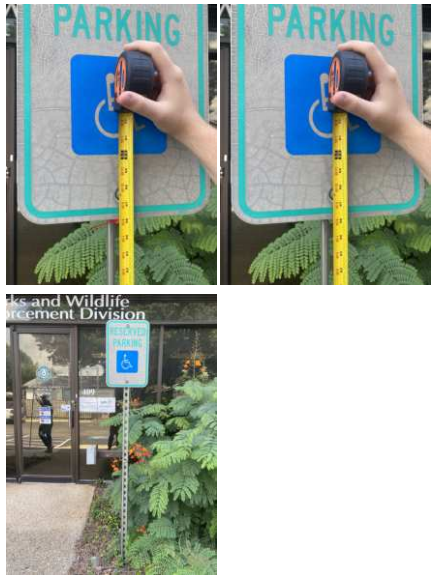
Finding Number	Area Description	Finding	As Built	Recommendation	Citation	Photos	Figure
3	Exterior of Property (Public): Parking Lot (2 Spaces) 2 Car - Car Accessible Stall (R Side)	The parking sign is mounted too low. Parking space identification signs shall include the International Symbol of Accessibility. Signs identifying van parking spaces shall contain the designation "van accessible." Signs shall be 60 inches minimum above the finish floor or ground surface measured to the bottom of the sign.	Sign height is 56" Sign showing signs of wear, will need to be replaced soon.	https://www.access-board.gov/ada/#ada-502_6	2012 TAS Section: 502.6 2010 ADAS Section: 502.6

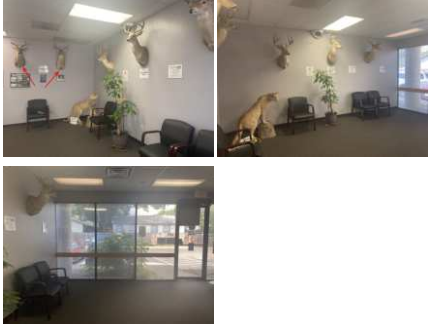
8	First Floor Main Building LOBBY (Public): Lobby Area - Interior Hallways of Building	The element projects more than 4 inches into the circulation path. Wall-mounted objects that have leading edges between 27 inches and 80 inches from the floor must not project more than 4 inches into the circulation path. Protruding objects that extend to the floor or within 27 inches of the floor are cane detectable and are therefore not hazardous. Where it is necessary or desirable to have objects protrude from the wall, a manner of cane detection must be provided.	There are 5 protruding objects in lobby area. Most are sufficiently guarded by office furniture with exception of 2 on (L) side wall.	https://www.access-board.gov/ada/#ada-307_2	2012 TAS Section: 307.2 2010 ADAS Section: 307.2

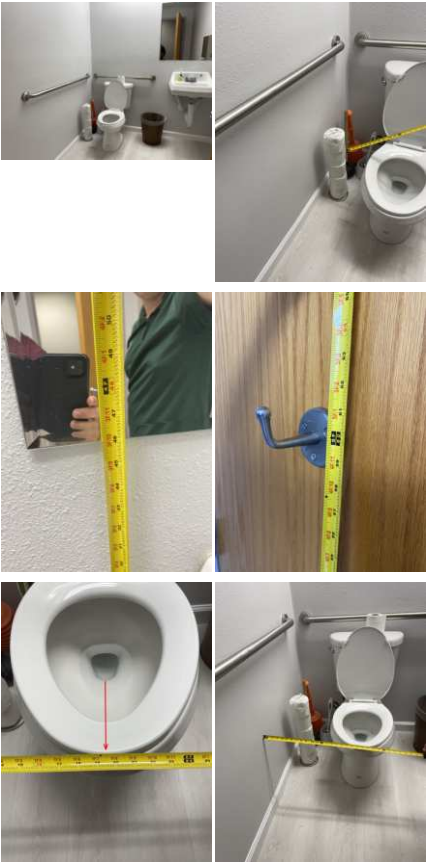
12	First Floor Main Building (STAFF): Restrooms/Water Fountains - Restroom (Women's)	The restroom is not nearly compliant. The restroom does not have the required minimum clear floor space or maneuvering clearances for the toilet. The restroom does not have the required minimum clear floor space or maneuvering clearances for the lavatory. The entry door does not contain the required minimum maneuvering spaces on the pull/push sides. The entry door encroach into the required clear floor space for fixtures. Grab bars are missing and/or incorrectly installed. Accessories, such as toilet seat covers, paper towel holders, garbage cans, hand dryers, and mirrors are either too high or without clear floor space or both. The restroom contain floor level changes greater than a 1/2 inch of the floor drains and is slope (XX) - (XX), the shower is too small and missing numerous accessible elements.	This restroom is for staff only and would need a few corrections to gain compliance. - Side wall to centerline of toilet over 18" - Height of lavatory rim - 2 Obstructions into lavatory accessible space - Missing TP dispenser - TP does not allow continuous flow - Coat hook height - Mirror height - Flush handle side	https://www.access-board.gov/ada/#ada-213_2 Review restrooms componets to make accessible. https://www.access-board.gov/ada/#ada-603	2012 TAS Section: 213.2 2010 ADAS Section: 213.2

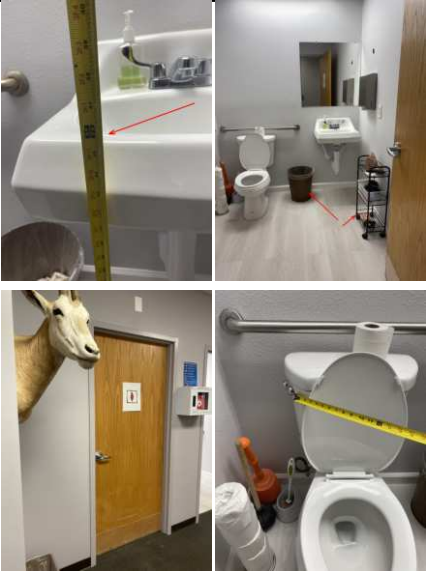
13	First Floor Main Building (STAFF): Interior Hallways of Building	The element projects more than 4 inches into the circulation path. Wall-mounted objects that have leading edges between 27 inches and 80 inches from the floor must not project more than 4 inches into the circulation path. Protruding objects that extend to the floor or within 27 inches of the floor are cane detectable and are therefore not hazardous. Where it is necessary or desirable to have objects protrude from the wall, a manner of cane detection must be provided.	There are 2 protruding objects near staff restrooms. 1 is a mount the other is AED machine. ADA Accessibility Guidelines (ADAAG) specify that objects such as automated external defibrillator wall cabinets shall not protrude more than 4 inches from the wall into walks, corridors, passageways, or aisles	https://www.access-board.gov/ada/#ada-307_2	2012 TAS Section: 307.2 2010 ADAS Section: 307.2
