LE-South Houston TX, ADA Evaluation

10101 Southwest Fwy 206

Accessibility Evaluation

Inspection Date: 01/04/2023

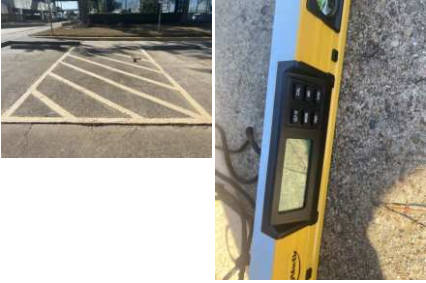
Finding Number	Area Description	Finding	As Built	Recommendation	Citation	Photos	Figure
1	Exterior of Property (Public) : Parking Lot (7 Spaces) 2 Van 5 Car 4 Access Aisles - Access Aisle (Van (L) Side)	The running slope of the access aisle (long dimension) exceeds 2%. The running slope in an accessible parking stall and the access aisle must not exceed 2%.	Van access aisle (L) side, running slope is 3%	https://www.access-board.gov/ada/#ada-502_4	2012 TAS Section: 502.4 2010 ADAS Section: 502.4

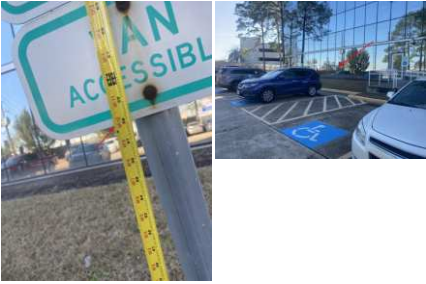
2	Exterior of Property (Public) : Parking Lot (7 Spaces) 2 Van 5 Car 4 Access Aisles - Van Accessible Stall (R) Side	The parking sign is mounted too low. Parking space identification signs shall include the International Symbol of Accessibility. Signs identifying van parking spaces shall contain the designation "van accessible." Signs shall be 60 inches minimum above the finish floor or ground surface measured to the bottom of the sign.	Accessible van stall (R) side, sign height is 58"	https://www.access-board.gov/ada/#ada-502_6	2012 TAS Section: 502.6 2010 ADAS Section: 502.6

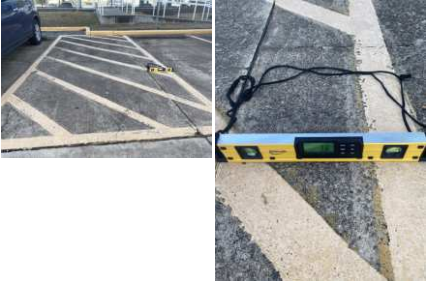
3	Exterior of Property (Public) : Parking Lot (7 Spaces) 2 Van 5 Car 4 Access Aisles - Access Aisle (Van (R) Side)	The cross slope (short dimension) of the access aisle exceeds 2%. The cross slope in an accessible parking stall and the access aisle must not exceed 2%.	Van access aisle (R) side, cross slope is 3.8%	https://www.access-board.gov/ada/#ada-502_4	2012 TAS Section: 502.4 2010 ADAS Section: 502.4

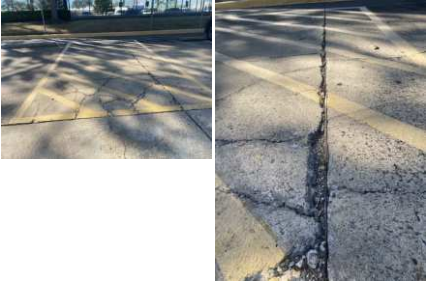
5	Exterior of Property (Public) : Parking Lot (7 Spaces) 2 Van 5 Car 4 Access Aisles - Access Aisle (Car (L) Side)	The access aisle contains loose gravel and/or surface materials that do not provide for a stable, firm slip resistant surface. Parking spaces and access aisles serving them shall comply with floor or ground surface requirements. The ground surface shall be stable, firm, and slip resistant. Access aisles shall be at the same level as the parking spaces they serve. Changes in level, slopes exceeding 1:48, and detectable warnings shall not be permitted.	Car access aisle (L) side is in advanced state of deterioration causing large cracks and creases preventing access.	https://www.access-board.gov/ada/#ada-502_4	2012 TAS Section: 502.4 2010 ADAS Section: 502.4

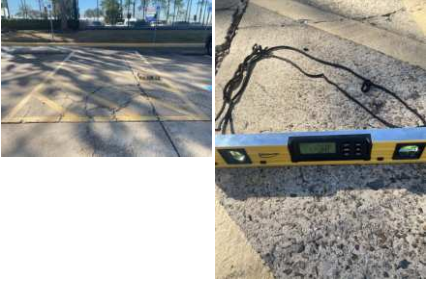
6	Exterior of Property (Public) : Parking Lot (7 Spaces) 2 Van 5 Car 4 Access Aisles - Access Aisle (Car (L) Side)	The cross slope (short dimension) of the access aisle exceeds 2%. The cross slope in an accessible parking stall and the access aisle must not exceed 2%.	Car access aisle (L) side, cross slope is 3.0%	https://www.access-board.gov/ada/#ada-502_4	2012 TAS Section: 502.4 2010 ADAS Section: 502.4

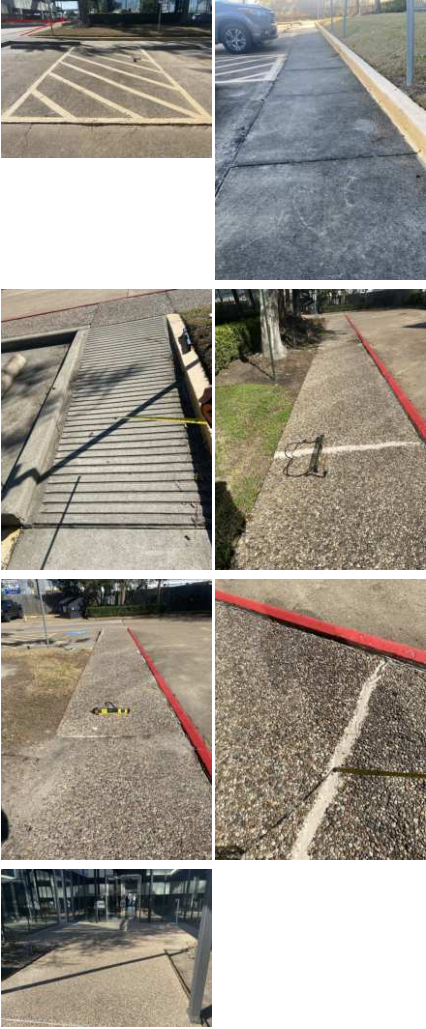
Finding Number	Area Description	Finding	As Built	Recommendation	Citation	Photos	Figure
8	Exterior of Property (Public) : Path of Travel to Building	The building entrance is not located on an accessible route. When a building, or portion of a building, is required to be accessible, an accessible route of travel shall be provided to all portions of the building, to accessible building entrances and between the building and the public way. At least one accessible route within the boundary of the site must be provided from public transportation stops, accessible parking and accessible passenger loading zones and public streets or sidewalks to the accessible building entrance they serve. The accessible route shall, to the maximum extent feasible, coincide with the route for the general public. At least one accessible route shall connect accessible buildings, facilities, elements and spaces that are on the same site. At least one accessible route shall connect accessible building or facility entrances with all accessible spaces and elements.	Due to deteriorating condition of pathways and distance needed to travel there is no accessible route from parking lot to the accessible entrance.	https://www.access-board.gov/ada/#ada-206_2_1	2012 TAS Section: 206.2.1 2010 ADAS Section: 206.2.1

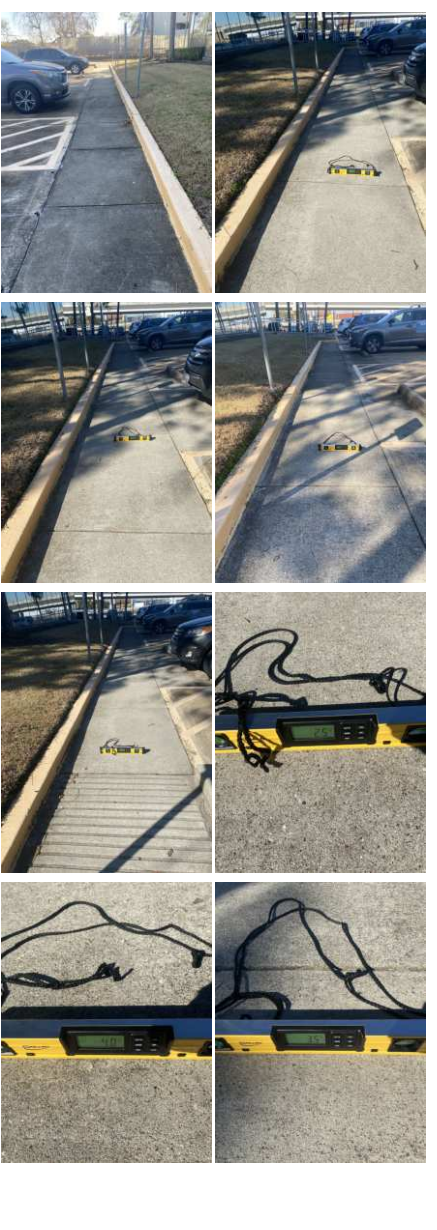
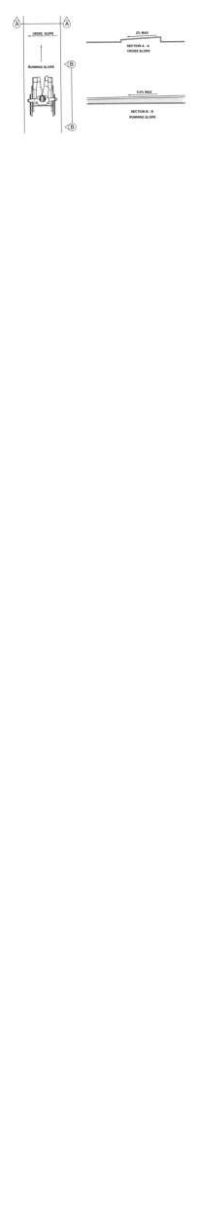
Finding Number	Area Description	Finding	As Built	Recommendation	Citation	Photos	Figure
9	Exterior of Property (Public) : Path of Travel to Building - Path of Travel (Main Route) Parking Lot Sidewalk	The accessible path of travel between the building entrance and the accessible parking has cross slopes greater than 2%. Surface cross slopes shall not exceed 1 unit vertical in 48 units horizontal (2-percent slope).	Multiple locations where side walk exceeds 2.0% cross slope. See additional photos for location of cross slope non compliance on accessible pathway to building entrance	https://www.access-board.gov/ada/#ada-403_3	2012 TAS Section: 403.3 2010 ADAS Section: 403.3

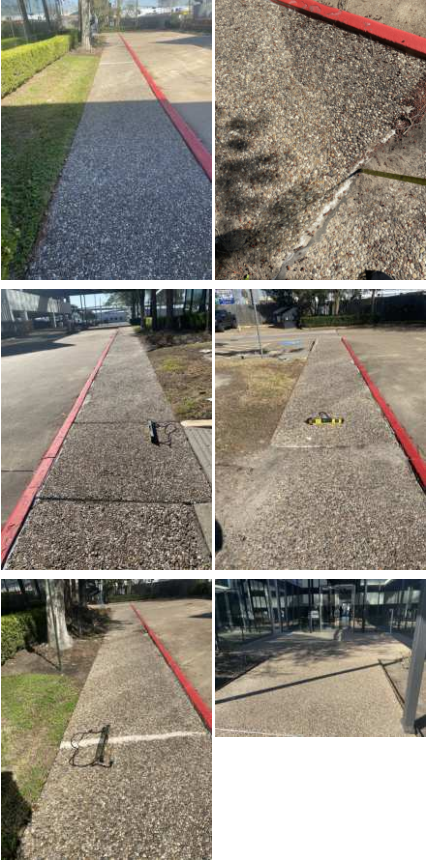
Finding Number	Area Description	Finding	As Built	Recommendation	Citation	Photos	Figure
12	Exterior of Property (Public) : Path of Travel to Building - Path of Travel (Main Route) Stone Sidewalk	The path of contains multiple issues and is not accessible. The path of travel exceeds the maximum allowable cross and running slope requirements. It also contains changes in level and/or gaps that exceed the allowable maximum requirements. The path of travel does not meet the minimum width requirements for clearances, turning spaces, and/or passing spaces. The floor or ground surface is not firm, stable, and slip resistant.	Main route (stone sidewalk) to accessible entrance of building is not accessible or compliant. There are some uneven spots causing slope compliance and gaps greater than 1/2 inch. Pathway needs to be cleaned of maintained to limit amount of debris on pathway.	https://www.access-board.gov/ada/#ada-403_1	2010 ADAS Section: 403.1

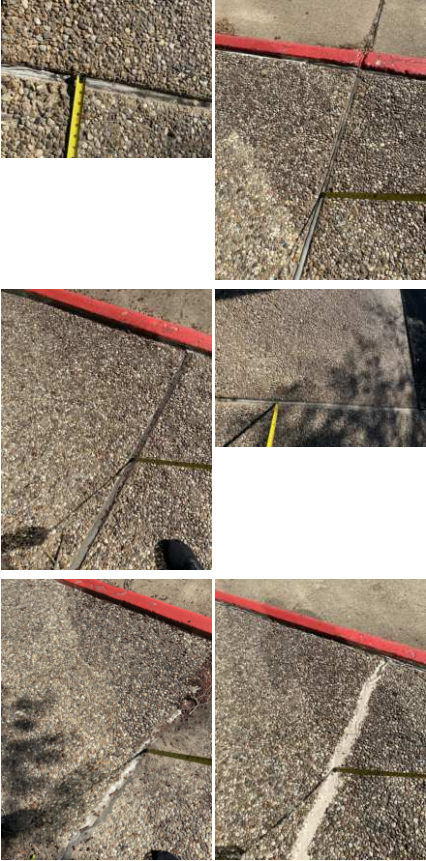
Finding Number	Area Description	Finding	As Built	Recommendation	Citation	Photos	Figure
13	Exterior of Property (Public) : Path of Travel to Building - Path of Travel (Main Route) Stone Sidewalk	The route contains openings greater than 1/2 inch. Openings in floor or ground surfaces shall not allow passage of a sphere more than 1/2 inch diameter. Elongated openings shall be placed so that the long dimension is perpendicular to the dominant direction of travel.	There are several locations where exterior pathway gap exceeds 1/2" tolerance. See additional photos for location of gap non compliance	https://www.access-board.gov/ada/#ada-302_3	2012 TAS Section: 302.3 2010 ADAS Section: 302.3

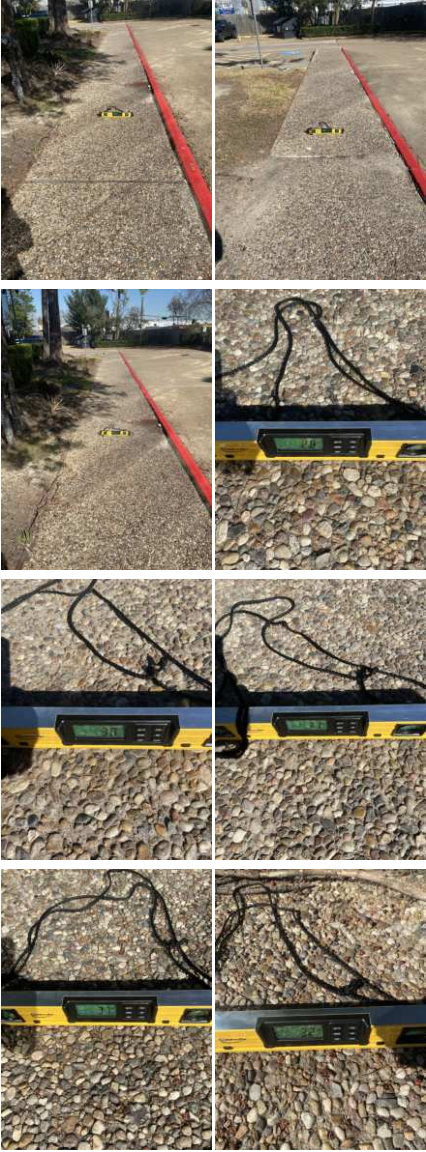
Finding Number	Area Description	Finding	As Built	Recommendation	Citation	Photos	Figure
14	Exterior of Property (Public) : Path of Travel to Building - Path of Travel (Main Route) Stone Sidewalk	The accessible path of travel between the building entrance and the accessible parking has cross slopes greater than 2%. Surface cross slopes shall not exceed 1 unit vertical in 48 units horizontal (2-percent slope).	There are several locations where exterior pathway exceeds 2% cross slope. Running slope of pathway within compliance. See additional photos for location of cross slope non compliance on accessible pathway to feature.	https://www.access-board.gov/ada/#ada-403_3	2012 TAS Section: 403.3 2010 ADAS Section: 403.3

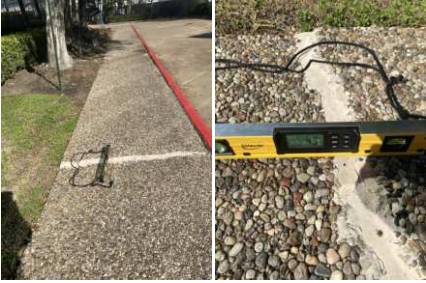
Finding Number	Area Description	Finding	As Built	Recommendation	Citation	Photos	Figure
15	Exterior of Property (Public) : Path of Travel to Building - Path of Travel (Main Route) Stone Sidewalk	The walkway contains abrupt vertical edges and/or variations over 1/4 inch. 1/4 inch is the maximum vertical rise. Changes in level between 1/4 inch and 1/2 inch must be beveled at 1:2 or less. Changes in level greater than 1/2 inch must be by way of a ramp.	There is a large bump in stone sidewalk which cause sudden change in elevation and tripping hazard.	https://www.access-board.gov/ada/#ada-303_2	2012 TAS Section: 303.3, 303.2 2010 ADAS Section: 303.3, 303.2

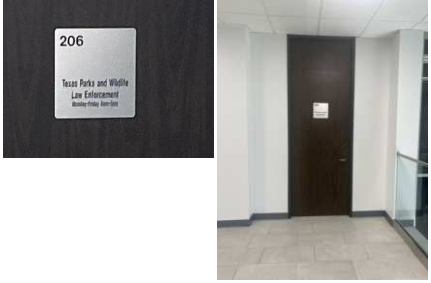
Finding Number	Area Description	Finding	As Built	Recommendation	Citation	Photos	Figure
18	Second Floor TPWD LE Office (Public): LE Office Interior - Entrance Doors into LE Office	The room identification sign is noncompliant. Wall signs identifying permanent rooms and spaces of a building shall be in a horizontal format and the characters raised 1/32 inch minimum and shall be sans serif uppercase characters a minimum of 5/8 inch and a maximum of 2 inches high. Characters and their background shall have a non-glare finish. Characters shall contrast with their background with either light characters on a dark background or dark characters on a light background. Signs with raised characters or Braille shall be located 48 inches minimum above the finish floor or ground surface, measured from the baseline of the lowest tactile character and 60 inches maximum above the finish floor or ground surface, measured from the baseline of the highest tactile character.	Signs that identify a room, space or area are required to have raised characters and Braille. This requirement includes both public access areas as well as all employee areas. Sign missing braille	Wall sign designation https://www.access-board.gov/ada/#ada-216_2 Wall signs general https://www.access-board.gov/ada/#ada-703_1	2012 TAS Section: 216.2, 703.1 2010 ADAS Section: 216.2, 703.1

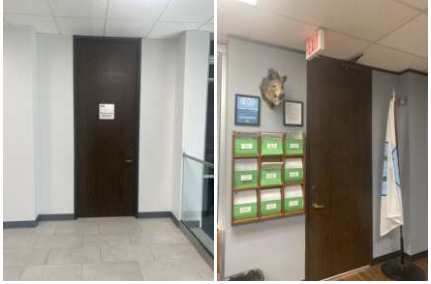
20	Second Floor TPWD LE Office (Public): LE Office Interior - Entrance Doors into LE Office	The door exceeds the maximum allowable opening force. Interior doors shall have a maximum opening force of 5 pounds. These forces do not apply to the force required to retract latch bolts or disengage other devices that hold the door or gate in a closed position.	N/A	https://www.access-board.gov/ada/#ada-404_2_9	2012 TAS Section: 404.2.9 2010 ADAS Section: 404.2.9

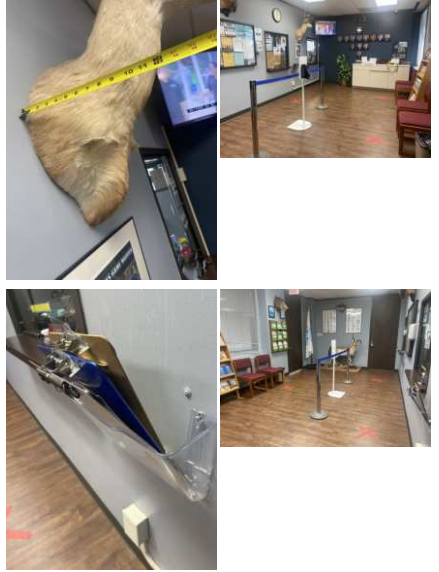
Finding Number	Area Description	Finding	As Built	Recommendation	Citation	Photos	Figure
22	Second Floor TPWD LE Office (Public): LE Office Interior - LE Office Waiting Area	The animal mount projects more than 4 inches into the circulation path. Wall-mounted objects that have leading edges between 27 inches and 80 inches from the floor must not project more than 4 inches into the circulation path. Protruding objects that extend to the floor or within 27 inches of the floor are cane detectable and are therefore not hazardous. Where it is necessary or desirable to have objects protrude from the wall, a manner of cane detection must be provided.	Animal mount is protruding object into waiting area lobby. Tray with clipboards are ok. As they are blocked by service counter	https://www.access-board.gov/ada/#ada-307_2	2012 TAS Section: 307.2 2010 ADAS Section: 307.2

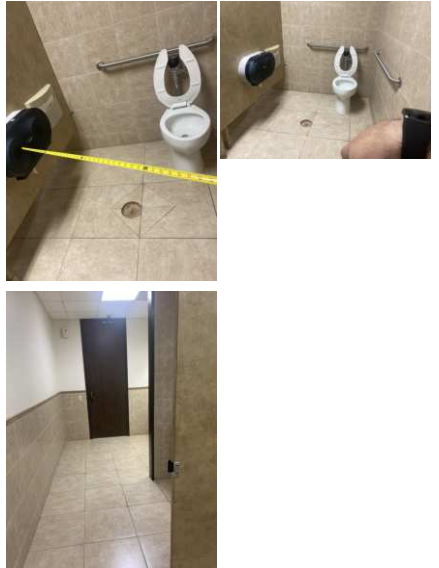
23	Second Floor TPWD LE Office (Public): Interior Hallways of Building - Restroom (Men's)	The toilet paper is not installed within the compliant range in front of the toilet. Toilet paper dispensers shall be 7 inches minimum and 9 inches maximum in front of the water closet measured to the centerline of the dispenser. The outlet of the dispenser shall be 15 inches minimum and 48 inches maximum above the finish floor and shall not be located behind grab bars. Dispensers shall not be of a type that controls delivery or that does not allow continuous paper flow. There shall be a clearance of 1 1/2 inches minimum below the grab bar.	Installed on the wrong side of stall.	https://www.access-board.gov/ada/#ada-604_7	2012 TAS Section: 604.7 2010 ADAS Section: 604.7

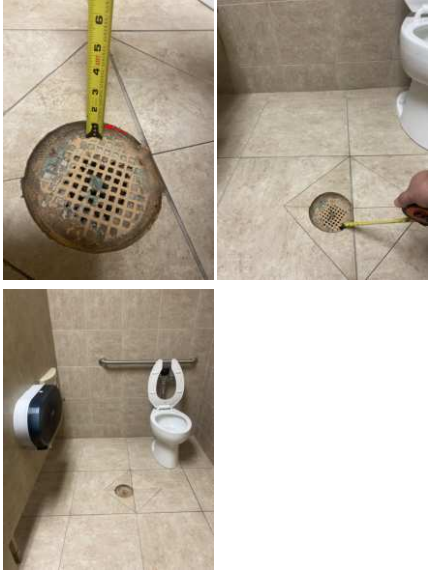
Finding Number	Area Description	Finding	As Built	Recommendation	Citation	Photos	Figure
24	Second Floor TPWD LE Office (Public): Interior Hallways of Building - Restroom (Men's)	The floor drain is set too low in the floor which causes a steep slope and/or vertical changes of elevation greater than 1/4 inch. Changes in level up to 1/4 inch may be vertical and without edge treatment. Changes in level between 1/4 inch and 1/2 inch maximum shall be beveled with a slope no greater than 1 unit vertical in 2 units horizontal (50-percent slope).	Threshold measures at 1"	https://www.access-board.gov/ada/#ada-303_2	2012 TAS Section: 303.3 2010 ADAS Section: 303.3

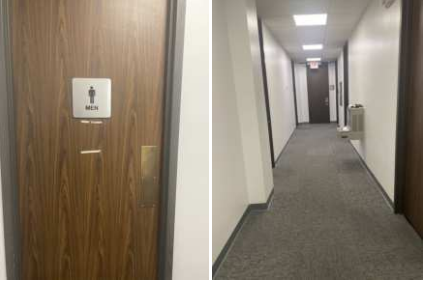
Finding Number	Area Description	Finding	As Built	Recommendation	Citation	Photos	Figure
27	Second Floor TPWD LE Office (Public): Interior Hallways of Building - Restroom (Men's)	The room identification sign is noncompliant. Wall signs identifying permanent rooms and spaces of a building shall be in a horizontal format and the characters raised 1/32 inch minimum and shall be sans serif uppercase characters a minimum of 5/8 inch and a maximum of 2 inches high. Characters and their background shall have a non-glare finish. Characters shall contrast with their background with either light characters on a dark background or dark characters on a light background. Signs with raised characters or Braille shall be located 48 inches minimum above the finish floor or ground surface, measured from the baseline of the lowest tactile character and 60 inches maximum above the finish floor or ground surface, measured from the baseline of the highest tactile character.	Signs that identify a room, space or area are required to have raised characters and Braille. This requirement includes both public access areas as well as all employee areas.	Wall sign designation https://www.access-board.gov/ada/#ada-216_2 Wall signs general https://www.access-board.gov/ada/#ada-703_1	2012 TAS Section: 216.2, 703.1 2010 ADAS Section: 216.2, 703.1

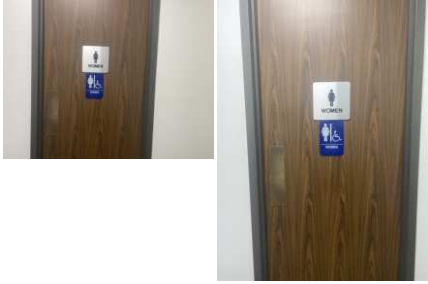
35	Second Floor TPWD LE Office (Public): Interior Hallways of Building - Restroom (Women's)	The wall sign is incorrectly located. Where permanent identification signs are provided for rooms and spaces, signs shall be installed on the wall adjacent to the latch side of the doors or Where there is no wall space on the latch side, including at double leaf doors, signs shall be placed on the nearest adjacent wall, preferably on the right. Mounting location shall be located so that a person may approach within 3 inches of the sign and that a clear floor space of 18 inches minimum by 18 inches minimum, centered on the tactile Characters, is provided beyond the arc of any door swing between the closed position and 45 degree open position.	Sign in blue is of complaint style but placed in wrong location. Remove silver sign as its not compliant style. Signs that identify a room, space or area are required to have raised characters and Braille. This requirement includes both public access areas as well as all employee area	https://www.access-board.gov/ada/#ada-703_4_1	2012 TAS Section: 703.4.1 2010 ADAS Section: 703.4.1

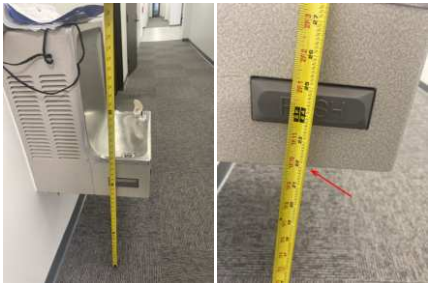
39	Second Floor TPWD LE Office (Public): Interior Hallways of Building - Water Fountain	There is not enough knee clearance under the drinking fountain. The drinking fountain must have a clear knee space between the bottom of the drinking fountain and the floor not less than 27 inches in height, 30 inches in width, and 8 inches in depth.	Water fountain height measures at 22" Water fountain is for public use.	https://www.access-board.gov/ada/#ada-602_2	2012 TAS Section: 602.2 2010 ADAS Section: 602.2

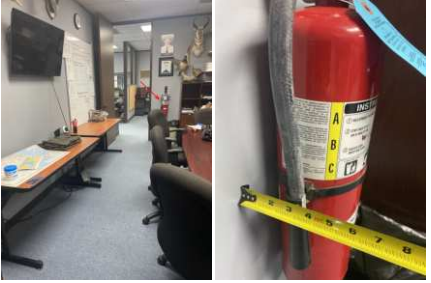
Finding Number	Area Description	Finding	As Built	Recommendation	Citation	Photos	Figure
42	Second Floor TPWD LE Office (STAFF): Conference Room	The element projects more than 4 inches into the circulation path. Wall-mounted objects that have leading edges between 27 inches and 80 inches from the floor must not project more than 4 inches into the circulation path. Protruding objects that extend to the floor or within 27 inches of the floor are cane detectable and are therefore not hazardous. Where it is necessary or desirable to have objects protrude from the wall, a manner of cane detection must be provided.	Fire extinguisher has trash can blocking from obstruction. Recommend relocating to different area. There are no official ADA fire extinguisher height or fire alarm ADA requirements. However, there are rules that govern the placement of all protruding objects, no matter their function, to accommodate blind and other visually impaired people.	https://www.access-board.gov/ada/#ada-307_2	2012 TAS Section: 307.2 2010 ADAS Section: 307.2

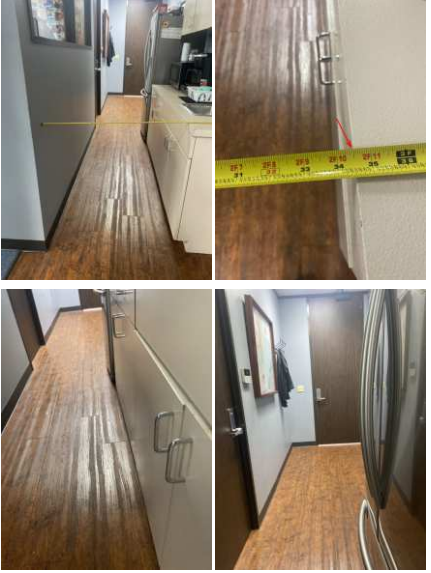
43	Second Floor TPWD LE Office (STAFF): Kitchenette	The route of travel does not provide a minimum width of 36 inches. The clear width shall be permitted to be reduced to 32 inches minimum for a length of 24 inches maximum provided that reduced width segments are separated by segments that are 48 inches long minimum and 36 inches wide minimum.	Path of travel to kitchenette narrows below 35" for longer than 24" Fridge and cabinet handles narrow access to 32"	https://www.access-board.gov/ada/#ada-403_5_1	2012 TAS Section: 403.5.1 2010 ADAS Section: 403.5.1

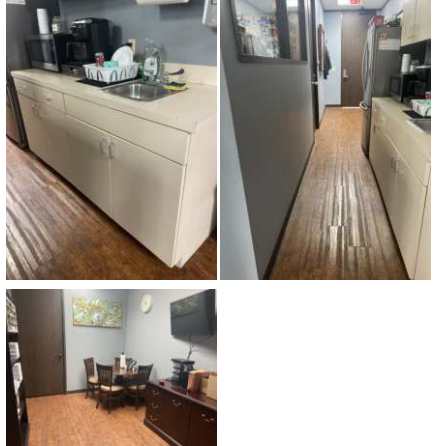
Finding Number	Area Description	Finding	As Built	Recommendation	Citation	Photos	Figure
44	Second Floor TPWD LE Office (STAFF): Kitchenette	The top of the sink is above the allowable height requirement. Sinks shall be installed with the front of the higher of the rim or counter surface 34 inches maximum above the finish floor or ground.	Sink height looks over 34" needs verification.	https://www.access-board.gov/ada/#ada-606_3	2012 TAS Section: 606.3 2010 ADAS Section: 606.3

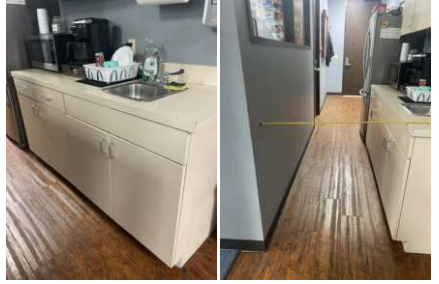
45	Second Floor TPWD LE Office (STAFF): Kitchenette	Knee and toe space has not been provided at the sink. Kitchen sinks must be provided with a clear floor space positioned for a forward approach including knee and toe clearance.	Sink cannot be accessed via frontal or parallel approach due to sink height (Pending review) and not enough clear floor space provided. In kitchens, kitchenettes, and breakrooms without a cooktop or conventional range, a parallel approach is permitted at kitchen sinks	https://www.access-board.gov/ada/#ada-606_2	2012 TAS Section: 606.2, 804.4 2010 ADAS Section: 606.2, 804.4

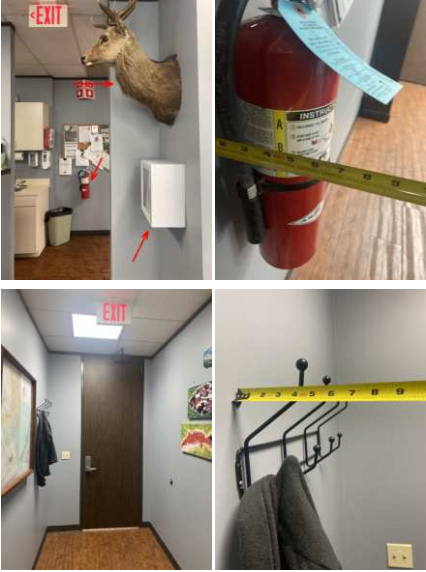
Finding Number	Area Description	Finding	As Built	Recommendation	Citation	Photos	Figure
46	Second Floor TPWD LE Office (STAFF): Interior Hallways	There are several objects which projects more than 4 inches into the circulation path. Wall-mounted objects that have leading edges between 27 inches and 80 inches from the floor must not project more than 4 inches into the circulation path. Protruding objects that extend to the floor or within 27 inches of the floor are cane detectable and are therefore not hazardous. Where it is necessary or desirable to have objects protrude from the wall, a manner of cane detection must be provided.	There are several protruding objects in staff pathways. See additional photos for locations. ADA Accessibility Guidelines (ADAAG) specify that objects such as automated external defibrillator wall cabinets shall not protrude more than 4 inches from the wall into walks, corridors, passageways, or aisles. There are no official ADA fire extinguisher height or fire alarm ADA requirements. However, there are rules that govern the placement of all protruding objects, no matter their function, to accommodate blind and other visually impaired people	https://www.access-board.gov/ada/#ada-307_2	2012 TAS Section: 307.2 2010 ADAS Section: 307.2
