Waco LE- ADA Evaluation

LE- Waco TX, ADA Evaluation

Accessibility Evaluation

Inspection Date: 05/09/2023

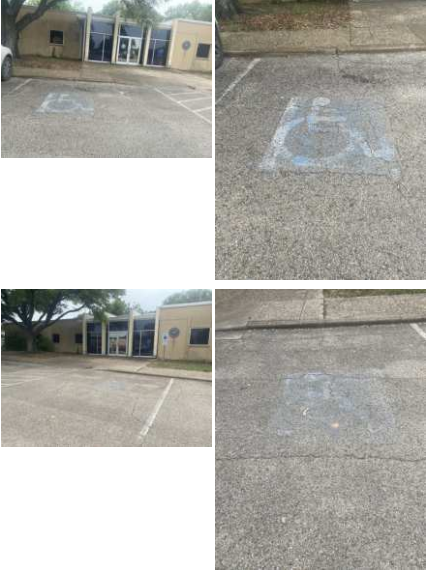
Finding Number	Area Description	Finding	As Built	Recommendation	Citation	Photos	Figure
1	Exterior of Property (Public): Parking Lot (2 Spaces) 1 Car 1 Unlabeled	The striping and markings for the accessible parking stall, loading/unloading access aisle are dilapidated and in need of repair and/or maintenance.	The identifying markers for both accessible parking stalls is faded or dilapidated.	https://www.access-board.gov/ada/#ada-502_3_3	2012 TAS Section: 502.3.3 2010 ADAS Section: 502.3.3 2015 ABAAS Section: 502.3.3, 503.3.3

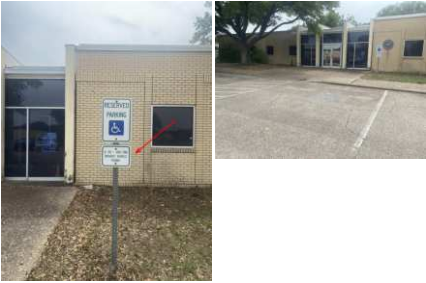
2	Exterior of Property (Public): Parking Lot (2 Spaces) 1 Car 1 Unlabeled - Accessible Stall (Labeled)	The van stall is missing a sign identifying it as a van accessible stall. Parking space identification signs shall include the International Symbol of Accessibility. Signs identifying van parking spaces shall contain the designation "van accessible."	Both accessible stall meets dimensions for van designation. Van designation sign needs to be added to stall pictured or add van designation sign to unlabeled space	https://www.access-board.gov/ada/#ada-502_6	2012 TAS Section: 502.6 2010 ADAS Section: 502.6 2015 ABAAS Section: 502.6

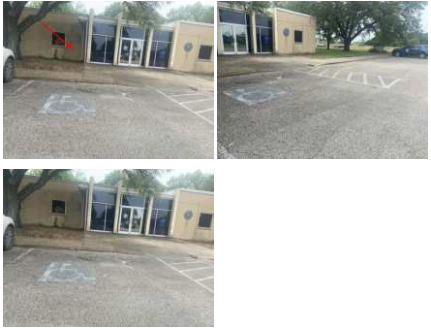
3	Exterior of Property (Public): Parking Lot (2 Spaces) 1 Car 1 Unlabeled - Accessible Stall (Unlabeled)	The required parking signage is missing. Parking space identification signs shall include the International Symbol of Accessibility (ISA). Signs identifying van parking spaces shall contain the designation "van accessible." All signs shall be 60 inches minimum above the finish floor or ground surface measured to the bottom of the sign.	Both accessible stall meets dimensions for van designation. Van designation sign needs to be added to stall pictured or add van designation sign to unlabeled space.	https://www.access-board.gov/ada/#ada-502_6	2012 TAS Section: 502.6 2010 ADAS Section: 502.6 2015 ABAAS Section: 502.6

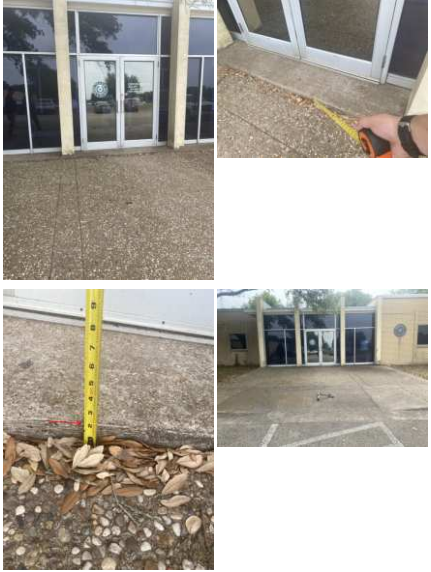
Finding Number	Area Description	Finding	As Built	Recommendation	Citation	Photos	Figure
4	Exterior of Property (Public): Path of Travel to Building - Curb Ramp (Main Route)	The building entrance is not located on an accessible route. When a building, or portion of a building, is required to be accessible, an accessible route of travel shall be provided to all portions of the building, to accessible building entrances and between the building and the public way. At least one accessible route within the boundary of the site must be provided from public transportation stops, accessible parking and accessible passenger loading zones and public streets or sidewalks to the accessible building entrance they serve. The accessible route shall, to the maximum extent feasible, coincide with the route for the general public. At least one accessible route shall connect accessible buildings, facilities, elements and spaces that are on the same site. At least one accessible route shall connect accessible building or facility entrances with all accessible spaces and elements.	Due to curb ramp slope, and entrance door threshold, there is no accessible entrance to building.	https://www.access-board.gov/ada/#ada-206_2_1	2012 TAS Section: 206.2.1 2010 ADAS Section: 206.2.1 2015 ABAAS Section: F206.2.1

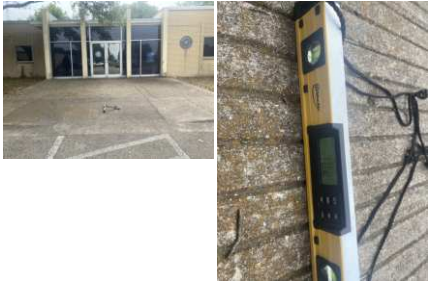
5	Exterior of Property (Public): Path of Travel to Building - Curb Ramp (Main Route)	The curb ramp exceeds the maximum running slope (parallel to the direction of travel) allowable of 8.33%. Curb ramps should have the least possible slope but in no case more than 8.33% (1:12).	Running slope is 10.2%	https://www.access-board.gov/ada/#ada-406_1 https://www.access-board.gov/ada/#ada-405_2	2012 TAS Section: 406.1 2010 ADAS Section: 406.1 2015 ABAAS Section: 406.1

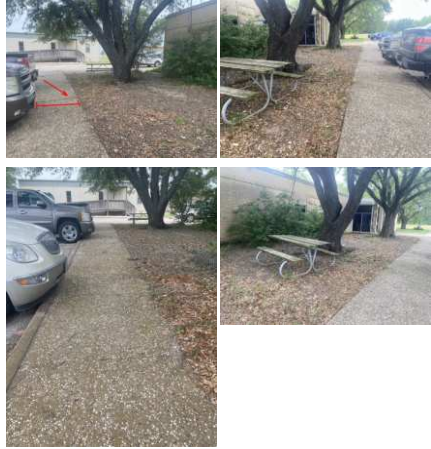
Finding Number	Area Description	Finding	As Built	Recommendation	Citation	Photos	Figure
6	Exterior of Property (Public): Outdoor Features - Picnic Area	There is no outdoor recreation access route that connects accessible elements, spaces, and facilities within the picnic unit. At least one outdoor recreation access route shall connect accessible elements, spaces, and facilities provided within picnic units with mobility features.	There is no accessible route to access picnic table, and table is not located in accessible location. Route to picnic table has pathway deterioration, sloping, large gaps, and clear width issues.	N/A - Refer to Finding	2015 ABAAS Section: F245.4.1

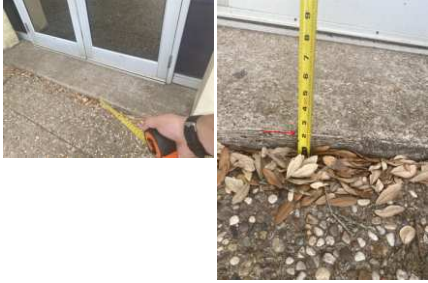
Finding Number	Area Description	Finding	As Built	Recommendation	Citation	Photos	Figure
8	First Floor Main Building LOBBY (Public): Entrance into Lobby	The walkway contains abrupt vertical edges and/or variations over a 1/2 inch. 1/4 inch is the maximum vertical rise. Changes in level between 1/4 inch and 1/2 inch must be beveled at 1:2 or less. Changes in level greater than 1/2 inch must be by way of a ramp.	Accessible pathway leading to front door entrance has change in vertical elevation over 1/2" Lip in front of entrance doors is 2"	https://www.access-board.gov/ada/#ada-303_2	2012 TAS Section: 303.3, 303.2 2010 ADAS Section: 303.3, 303.2 2015 ABAAS Section: 303.2, 303.3

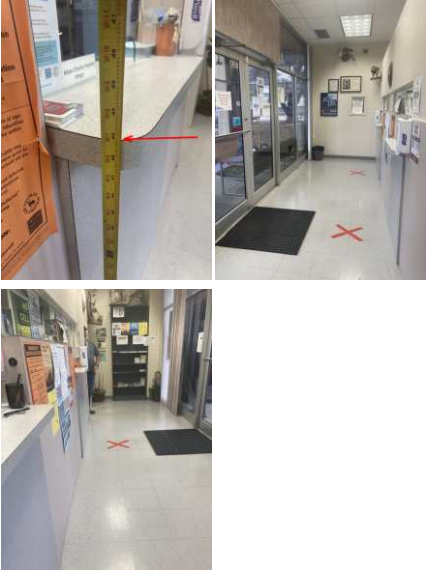
Finding Number	Area Description	Finding	As Built	Recommendation	Citation	Photos	Figure
14	First Floor Main Building LOBBY (Public): Lobby Area - Service Counter	The sales or service counter does not allow for a forward or parallel approach. Accessible counters must provide a compliant forward or parallel approach.	There is not forward or parallel approach for service desk. Compliant knee and/or toe space is not provided for forward approach. Desk height and width are not within compliance for parallel approach. Service desk is not accessible via front or parallel approach. Service desk is 43"	Service desks approach requirements https://www.access-board.gov/ada/#ada-904_4 Parallel approach https://www.access-board.gov/ada/#ada-904_4_1 Forward approach https://www.access-board.gov/ada/#ada-904_4_2	2012 TAS Section: 904.4 2010 ADAS Section: 904.4 2015 ABAAS Section: 904.4.1

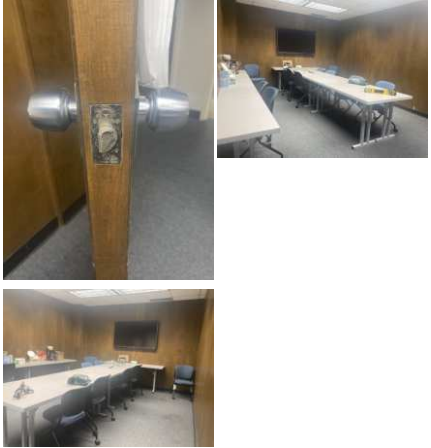
Finding Number	Area Description	Finding	As Built	Recommendation	Citation	Photos	Figure
15	First Floor Main Building (STAFF): Conference Room	The door/gate operating hardware is not accessible. Hand-activated door/gate opening hardware, handles, pulls, latches, locks, and other operating devices on accessible doors shall have a shape that is easy to grasp with one hand and does not require tight grasping, pinching or twisting of the wrist to operate. Hardware shall be 34 inches minimum and 48 inches maximum above the finish floor or ground.	Conference room meeting area is compliant. Entrance door to access conference room is not compliant due to hardware.		https://www.access-board.gov/ada/#ada-404_2_7 2012 TAS Section: 404.2.7 2010 ADAS Section: 404.2.7 2015 ABAAS Section: 404.2.7

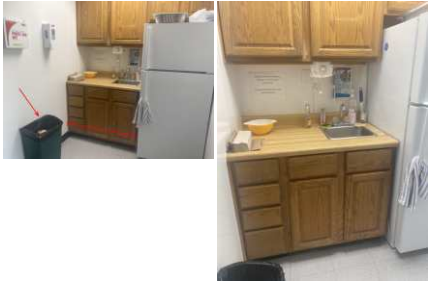
17	First Floor Main Building (STAFF): Kitchenette	The sink is not accessible because there is not adequate clear floor space for either a forward or side approach. The clear floor or ground space shall be 30 inches minimum by 48 inches minimum.	Kitchenette sink is not accessible via front or parallel approach. Clear floor space is obstructed by trash can placement and fridge overlap. Not enough space provided for parallel approach.		https://www.access-board.gov/ada/#ada-305_3 https://www.access-board.gov/ada/#ada-305_5 2012 TAS Section: 305.3 2010 ADAS Section: 305.3 2015 ABAAS Section: 305.3

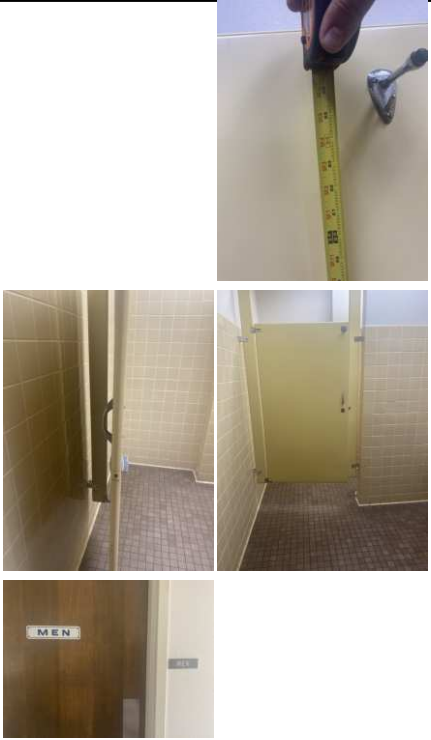
20	First Floor Main Building (STAFF): Restrooms/Water Fountains - Restroom (Men's)	The restroom is not nearly compliant. The restroom does not have the required minimum clear floor space or maneuvering clearances for the toilet. The restroom does not have the required minimum clear floor space or maneuvering clearances for the lavatory. The entry door does not contain the required minimum maneuvering spaces on the pull/push sides. The entry door encroach into the required clear floor space for fixtures. Grab bars are missing and/or incorrectly installed. Accessories, such as toilet seat covers, paper towel holders, garbage cans, hand dryers, and mirrors are either too high or without clear floor space or both. The restroom contain floor level changes greater than a 1/2 inch of the floor drains and is slope (XX) - (XX), the shower is too small and missing numerous accessible elements.	This restroom is for staff only and would need a number of elements installed to gain compliance. - No rear grab bars - Side grab bars are not valid type, length, or location - Clear floor space and dimensions of stall non compliant - Toilet flusher height 41" and location incorrect - TP dispenser not mounted in correct location - Stall door missing loop on one side and locking mechanism requires		https://www.access-board.gov/ada/#ada-213_2 Review restrooms componets to make accessible. https://www.access-board.gov/ada/#ada-603	2012 TAS Section: 213.2 2010 ADAS Section: 213.2 2015 ABAAS Section: F213.2

Finding Number	Area Description	Finding	As Built	Recommendation	Citation	Photos	Figure
			fine motor manipulation. - Coat hook height 56" - Mirror height out of compliance range - sink pipes not insulated - Clear floor space to access urinal is non complaint - Light switch height out of compliance range - Paper towel dispenser height - Not correct sign or location

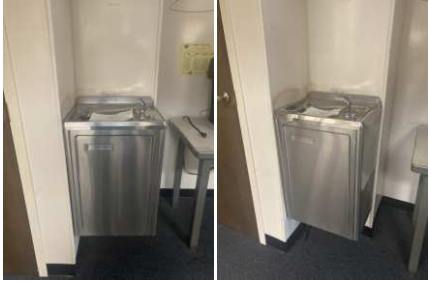
Finding Number	Area Description	Finding	As Built	Recommendation	Citation	Photos	Figure
22	First Floor Main Building (STAFF): Restrooms/Water Fountains - Water Fountains	The drinking fountain has multiple violations. Drinking fountains must be on an accessible route that provides a 30 inch by 48 inch clear floor space centered on the low unit, allowing a forward approach. Spout outlets shall be 36 inches maximum above the finish floor or ground. Spout outlets of drinking fountains for standing persons shall be 38 inches minimum and 43 inches maximum above the finish floor or ground. The spout shall be located 15 inches minimum from the vertical support and 5 inches maximum from the front edge of the unit, including bumpers. The spout shall provide a flow of water 4 inches high minimum and shall be located 5 inches maximum from the front of the unit. The angle of the water stream shall be measured horizontally relative to the front face of the unit. Where spouts are located less than 3 inches of the front of the unit, the angle of the water stream shall be 30 degrees maximum. Where spouts are located between 3 inches and 5 inches maximum from the front of the unit, the angle of the water stream shall be 15 degrees maximum. Operable parts shall comply with applicable standards.	Drinking fountain type and placement do not meet compliance. * Water does not work, no water supply	Clear floor space https://www.access-board.gov/ada/#ada-403_5_1 Drinking fountain requirements, general https://www.access-board.gov/ada/#ada-602_1	2012 TAS Section: 403.5.1, 602.1 2010 ADAS Section: 403.5.1, 602.1 2015 ABAAS Section: 403.5.1, 602.1

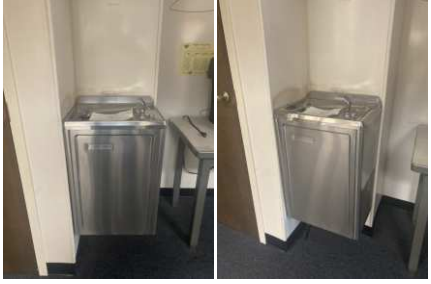
23	First Floor Main Building (STAFF): Restrooms/Water Fountains - Water Fountains	There is no drinking fountain for standing persons. No fewer than two drinking fountains shall be provided. One drinking fountain shall meet requirements for wheelchair accessibility and one drinking fountain shall meet requirements for standing persons. Where a single drinking fountain complies with both wheelchair accessibility and requirements for standing persons, it shall be permitted to be substituted for two separate drinking fountains. Spout outlets of drinking fountains for standing persons shall be 38 inches minimum and 43 inches maximum above the finish floor or ground.	N/A	Minimum number https://www.access-board.gov/ada/#ada-211_2 Standing person requirements https://www.access-board.gov/ada/#ada-602_7	2012 TAS Section: 602.7, 211.2 2010 ADAS Section: 602.7, 211.2 2015 ABAAS Section: 602.7, F211.2
