Witchita Falls LE- ADA Evaluation

LE- Witchita Falls TX, ADA Evaluation
4822 Kemp Blvd Suite 1300
Wichita Falls, TX 76308
Accessibility Evaluation
Inspection Date: 03/20/2023
Inspectors: Christopher Meza

Report Date: 01/15/2024

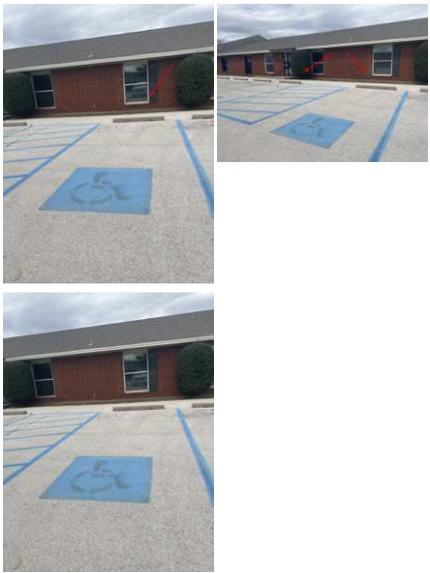
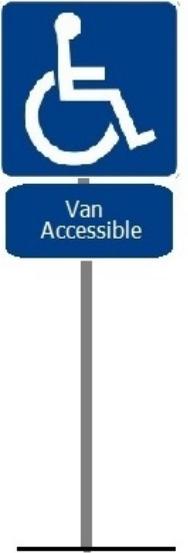
Finding Number	Area Description	Finding	As Built	Recommendation	Citation	Photos	Figure
2	Exterior of Property (Public): Parking Lot (2 Spaces) Both Unlabeled - Unlabeled Stall (R) Side	The van stall is missing a sign identifying it as a van accessible stall. Parking space identification signs shall include the International Symbol of Accessibility. Signs identifying van parking spaces shall contain the designation "van accessible."	Accessible parking stall missing designated signage. Both accessible parking stalls serving TPWD LE office meet dimensions to be designated as van parking.	https://www.access-board.gov/ada/#ada-502_6	2012 TAS Section: 502.6 2010 ADAS Section: 502.6

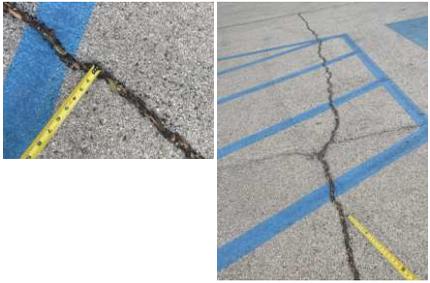
3	Exterior of Property (Public): Parking Lot (2 Spaces) Both Unlabeled - Access Aisle (Shared)	The access aisle contains loose gravel and/or surface materials that do not provide for a stable, firm slip resistant surface. Parking spaces and access aisles serving them shall comply with floor or ground surface requirements. The ground surface shall be stable, firm, and slip resistant. Access aisles shall be at the same level as the parking spaces they serve. Changes in level, slopes exceeding 1:48, and detectable warnings shall not be permitted.	There is a large crack in access aisle decreasing access.	https://www.access-board.gov/ada/#ada-302_3 https://www.access-board.gov/ada/#ada-502_4	2012 TAS Section: 502.4 2010 ADAS Section: 502.4

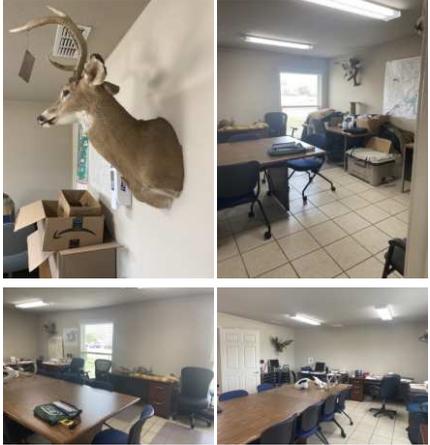
Finding Number	Area Description	Finding	As Built	Recommendation	Citation	Photos	Figure
7	First Floor Main Building (STAFF): Conference Room	The deer mount projects more than 4 inches into the circulation path. Wall-mounted objects that have leading edges between 27 inches and 80 inches from the floor must not project more than 4 inches into the circulation path. Protruding objects that extend to the floor or within 27 inches of the floor are cane detectable and are therefore not hazardous. Where it is necessary or desirable to have objects protrude from the wall, a manner of cane detection must be provided.	There are 4 mounts causing protruding objects in staff conference room. Most are sufficiently guarded by furniture. 4 mounts, majority are blocked by obstruction. Deer pictured is not compliant, located to right of entrance.	https://www.access-board.gov/ada/#ada-307_2	2012 TAS Section: 307.2 2010 ADAS Section: 307.2

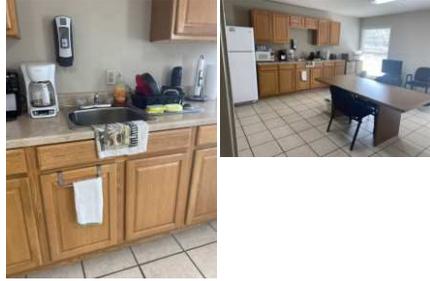
Finding Number	Area Description	Finding	As Built	Recommendation	Citation	Photos	Figure
10	First Floor Main Building (STAFF): Kitchenette	The element is not accessible because it requires tight grasping, pinching or twisting of the wrist. Controls and operating mechanisms shall be operable with one hand and shall not require tight grasping, pinching or twisting of the wrist. The force required to activate controls shall be no greater than 5 pounds of force.	Cabinets are not accessible.		https://www.access-board.gov/ada/#ada-309_4 2012 TAS Section: 309.4 2010 ADAS Section: 309.4

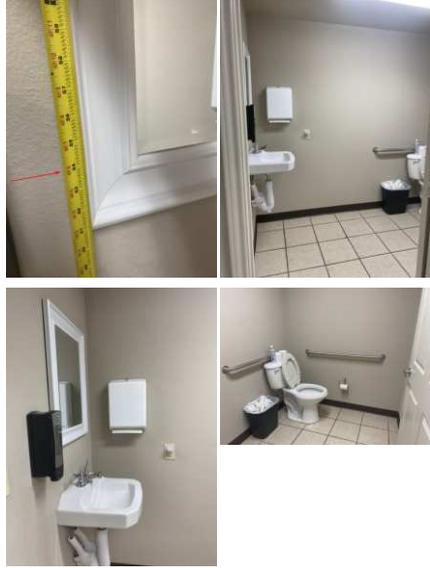
11	First Floor Main Building (STAFF): Restrooms/Water Fountains - Unisex Not Labeled Restroom (Near Water Fountains)	The mirror is mounted above the maximum allowable height. Mirrors must have the bottom edge of the reflecting surface a maximum of 40 inches above the floor if above a sink or counter. Mirrors not located above lavatories or countertops shall be installed with the bottom edge of the reflecting surface 35 inches maximum above the finish floor or ground.	Mirror reflecting height is 54"		2012 TAS Section: 603.3 2010 ADAS Section: 603.3

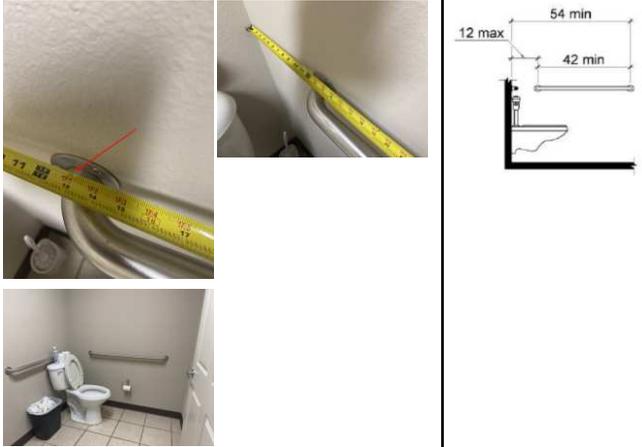
13	First Floor Main Building (STAFF): Restrooms/Water Fountains - Unisex Not Labeled Restroom (Near Water Fountains)	The side grab bar is located greater than 12 inches from the rear wall. The side grab bar must extend at least 54 inches minimum beyond the rear wall and start a maximum of 12 inches from the rear wall. A 42 inch grab bar installed the maximum distance from the rear wall (12 inches) will leave the leading end 54 inches from the rear wall. Grab bars shall be installed in a horizontal position, 33 inches minimum and 36 inches maximum above the finish floor measured to the top of the gripping surface.	Side grab bar starts 13" from rear wall.		https://www.access-board.gov/ada/#ada-604_5_1	2012 TAS Section: 604.5.1 2010 ADAS Section: 604.5.1

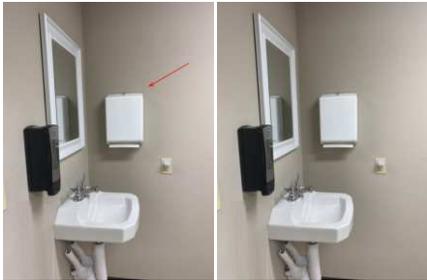
14	First Floor Main Building (STAFF): Restrooms/Water Fountains - Unisex Not Labeled Restroom (Near Water Fountains)	The paper towel dispenser's operation mechanism is too high off the floor. Dispensers must have all operable parts a maximum of 48 inches above the floor.	Paper towel dispenser access point over 48"		https://www.access-board.gov/ada/#ada-308_2_1	2012 TAS Section: 308.2.1 2010 ADAS Section: 308.2.1

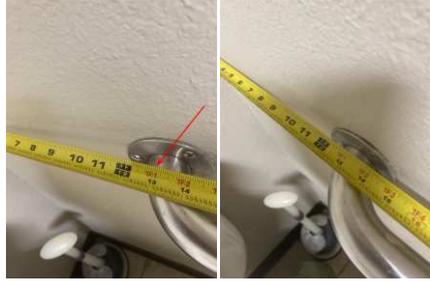
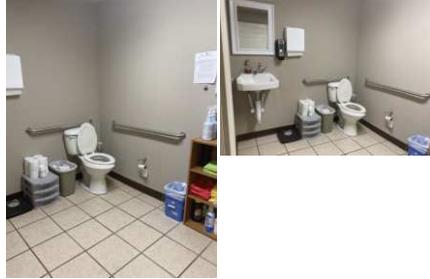
Finding Number	Area Description	Finding	As Built	Recommendation	Citation	Photos	Figure
15	First Floor Main Building (STAFF): Restrooms/Water Fountains - Unisex Restroom Not Labeled (Cleaning Supply)	The side grab bar is located greater than 12 inches from the rear wall. The side grab bar must extend at least 54 inches minimum beyond the rear wall and start a maximum of 12 inches from the rear wall. A 42 inch grab bar installed the maximum distance from the rear wall (12 inches) will leave the leading end 54 inches from the rear wall. Grab bars shall be installed in a horizontal position, 33 inches minimum and 36 inches maximum above the finish floor measured to the top of the gripping surface.	Side grab bar starts 13" from rear wall.	https://www.access-board.gov/ada/#ada-604_5_1	2012 TAS Section: 604.5.1 2010 ADAS Section: 604.5.1

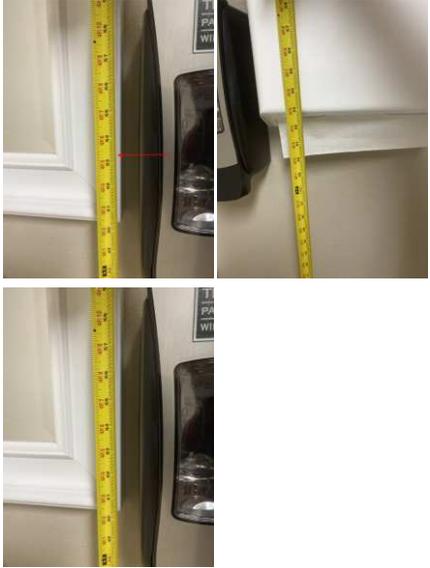
Finding Number	Area Description	Finding	As Built	Recommendation	Citation	Photos	Figure
17	First Floor Main Building (STAFF): Restrooms/Water Fountains - Unisex Restroom Not Labeled (Cleaning Supply)	The mirror is mounted above the maximum allowable height. Mirrors must have the bottom edge of the reflecting surface a maximum of 40 inches above the floor if above a sink or counter. Mirrors not located above lavatories or countertops shall be installed with the bottom edge of the reflecting surface 35 inches maximum above the finish floor or ground.	The mirror reflecting edge is over 53"	https://www.access-board.gov/ada/#ada-603_3	2012 TAS Section: 603.3 2010 ADAS Section: 603.3

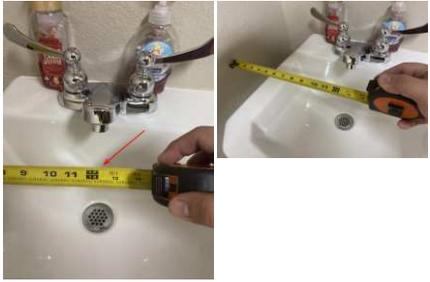
18	First Floor Main Building (STAFF): Restrooms/Water Fountains - Unisex Restroom Not Labeled (Cleaning Supply)	The lavatory is too close to the side wall. There must be a minimum of 15 inches from the centerline of the lavatory to the nearest side wall or side partition to allow for an unobstructed 30 inches by 48 inches clear floor space.	Lavatory midline is 12" from side wall	https://www.access-board.gov/ada/#ada-606_2	2012 TAS Section: 606.2 2010 ADAS Section: 606.2

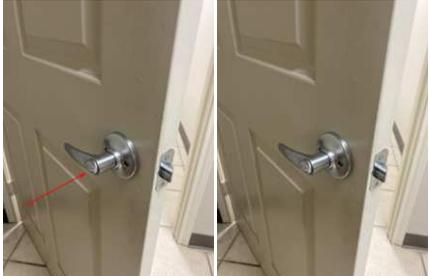
19	First Floor Main Building (STAFF): Restrooms/Water Fountains - Unisex Restroom Not Labeled (Cleaning Supply)	The operating hardware requires tight grasping, pinching or twisting of the wrist to operate. Hand-activated hardware, handles, pulls, latches, locks, and other operating devices on accessible elements shall have a shape that is easy to grasp with one hand and does not require tight grasping, pinching or twisting of the wrist to operate.	The door lock mechanism is not compliant.	https://www.access-board.gov/ada/#ada-309_4	2012 TAS Section: 309.4 2010 ADAS Section: 309.4
