Alazan Bayou WMA- ADA Evaluation

WMA- Alazan Bayou, Nacogdoches TX, ADA Evaluation

Accessibility Evaluation

Inspection Date: 07/13/2022

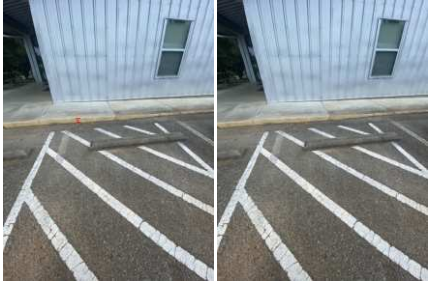
2	Exterior of Property (Public): Parking Lot (2 Spaces) 1 Van 1 Unlabeled - Access Aisle (Unlabeled Stall)	The access aisle is not located on an accessible route of travel to the accessible building entrance. Accessible parking spaces serving a particular building shall be located on the shortest accessible route of travel from parking to an accessible entrance. In buildings with multiple accessible entrances with adjacent parking, accessible parking spaces shall be dispersed and located closest to the accessible entrances.	Access aisle does not provide access to sidewalk due to change in elevation to curb. Access aisle dimensions and markings are compliant.		https://www.access-board.gov/ada/#ada-208_3_1	2012 TAS Section: 208.3.1 2010 ADAS Section: 208.3.1, 502.3 2015 ABAAS Section: F208.3.1, 502.3

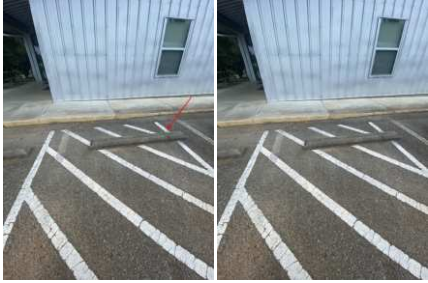
Finding Number	Area Description	Finding	As Built	Recommendation	Citation	Photos	Figure
4	Exterior of Property (Public): Parking Lot (2 Spaces) 1 Van 1 Unlabeled - Access Aisle (Unlabeled Stall)	The access aisle contains abrupt edges and surface irregularities over a 1/4 inches. Parking spaces and access aisles serving them shall be stable, firm, and slip resistant. Access aisles shall be at the same level as the parking spaces they serve. Changes in level are not permitted and shall not be sloped steeper than 2% in any direction.	Parking stopper placed in access aisle. Obstructions, changes in elevation, abrupt edges, and curb ramps are prohibited from being placed in access aisle. Floor or Ground Surfaces. Access aisles are required to be nearly level in all directions to provide a surface for wheelchair transfer to and from vehicles.	https://www.access-board.gov/ada/#ada-502_4	2012 TAS Section: 502.4 2010 ADAS Section: 502.4 2015 ABAAS Section: 502.4

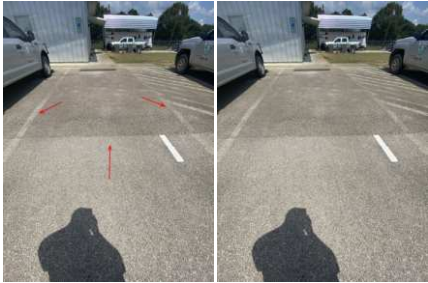
5	Exterior of Property (Public): Parking Lot (2 Spaces) 1 Van 1 Unlabeled - Van Accessible Stall (R) Side	The accessible parking space is missing the required markings. Vehicle spaces shall be marked to define the width, and shall have an adjacent access aisle.	Space is missing ISA symbol and parking stall borders are faded.	https://www.access-board.gov/ada/#ada-502_1 https://www.access-board.gov/ada/#ada-502_2	2012 TAS Section: 502.2 2010 ADAS Section: 502.2 2015 ABAAS Section: 502.1, 502.2

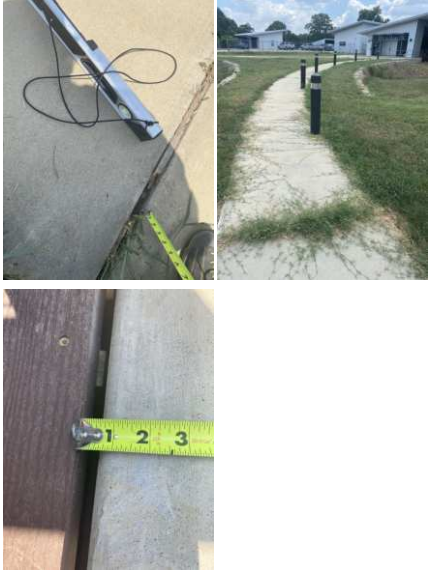
Finding Number	Area Description	Finding	As Built	Recommendation	Citation	Photos	Figure
10	Structures on Property (Public) : Cleaning/Check Station - Path of Travel to Cleaning Stations	The route contains openings greater than 1/2 inch. Openings in floor or ground surfaces shall not allow passage of a sphere more than 1/2 inch diameter. Elongated openings shall be placed so that the long dimension is perpendicular to the dominant direction of travel.	Expansion joint wood pushed out due to grass in joint. Several areas where gap exceeds 1/2" tolerance due to overgrowth.	https://www.access-board.gov/ada/#ada-302_3	2012 TAS Section: 302.3 2010 ADAS Section: 302.3 2015 ABAAS Section: 302.3

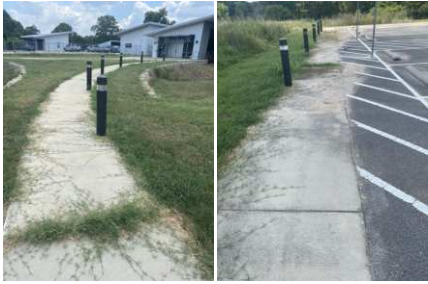
11	Structures on Property (Public) : Cleaning/Check Station - Path of Travel to Cleaning Stations	The walking surface is obstructed. A 36 inch wide minimum walking surface is required.	Grass overgrowth narrows accessible pathway.	https://www.access-board.gov/ada/#ada-403_5_1	2012 TAS Section: 403.5.1 2010 ADAS Section: 403.5.1 2015 ABAAS Section: 403.5.1

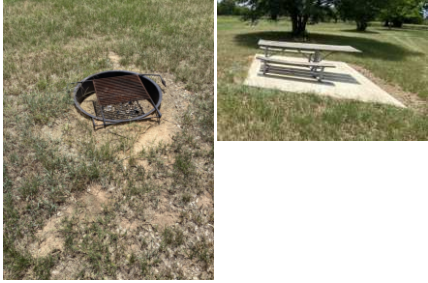
Finding Number	Area Description	Finding	As Built	Recommendation	Citation	Photos	Figure
12	Outdoor Features (Public) : Campsites	A minimum of 20% of the outdoor constructed feature do not have mobility features. Where provided in common use and public use areas that serve camping units with mobility features, at least 20 percent, but not less than one, of each type of outdoor constructed feature provided at each location shall comply.	Sites with made structures like fire pits, picnic tables, concrete slab are not considered primitive and should meet ADA scoping requirements.	Link provided below outlines the best practices guidelines. https://www.access-board.gov/aba/#aba-1014 Upgrade ADA camp site	2015 ABAAS Section: F244.3

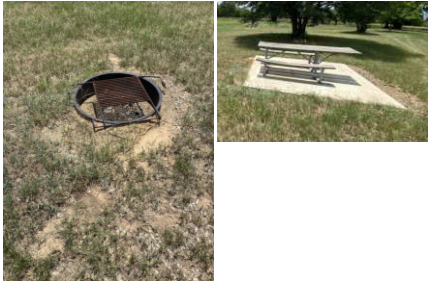
13	Outdoor Features (Public) : Campsites	The parking space/pull up space is not firm and stable. The surface of parking spaces and pull-up spaces shall be firm and stable.	There is no accessible parking provided.	N/A - Refer to Finding	2015 ABAAS Section: 1012.4

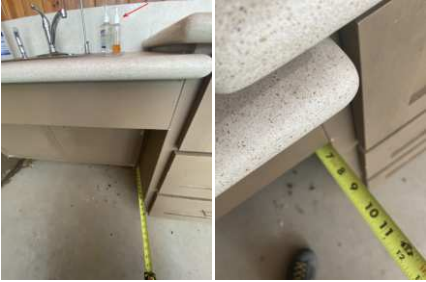
18	Outdoor Features (Public) : Outdoor Assembly Area - Kitchenette	Knee and toe clearance has not been provided at the sink. The knee clearance shall be 11 inches deep minimum at 9 inches above the finish floor or ground, and 8 inches deep minimum at 27 inches above the finish floor or ground. The toe clearance is the space under the sink between the finish floor or ground and 9 inches above the finish floor 30 inches wide minimum. The toe clearance shall extend a minimum of 17 inches and a maximum of 25 inches underneath the sink.	Knee space not 9" at 27" from ground. Knee and toe must be provided if kitchenette contain stove top range. In kitchens, kitchenettes, and breakrooms without a cooktop or conventional range, a parallel approach is permitted at kitchen sinks. Area maybe considered compliant depending on if stove top range is in area.	https://www.access-board.gov/ada/#ada-606_2	2012 TAS Section: 606.2 2010 ADAS Section: 606.2 2015 ABAAS Section: 606.2
