Black Gap WMA- ADA Evaluation

WMA- Black Gap, Alpine TX, ADA Evaluation
55 miles south of Marathon, 18mi down FM 2627

Accessibility Evaluation

Inspection Date: 06/22/2022

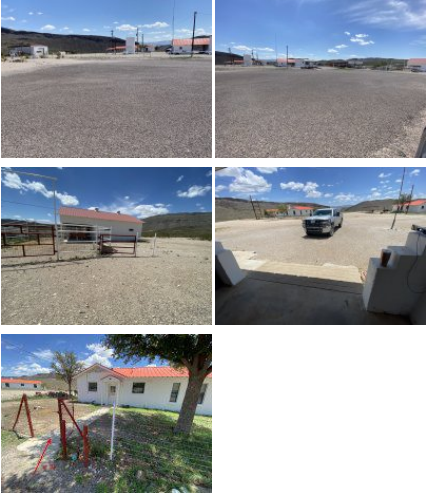
Finding Number	Area Description	Finding	As Built	Recommendation	Citation	Photos	Figure
1	Exterior of Property (Public): All Parking Lots at Facility (0 Spaces)	There are no accessible parking stalls. Each lot where parking is provided for the public as clients, guests or employees, shall provide accessible parking and shall be located on the shortest accessible route of travel from adjacent parking to an accessible entrance. There are a total of (XX) parking stalls in the parking lot that could be reasonably associated with this facility. There should be a minimum of (XX) accessible stalls with a minimum of (XX) being designed as van accessible.	There is no accessible parking provided at property. Each building would need to install a van accessible stall with appropriate access aisle nearby or have buildings connected by accessible pathway. This includes bunk house area, offices, registration station, and coral. There is no compliant ADA parking provided at this time.	Review parking stall and access aisle requirements https://www.access-board.gov/ada/#ada-208_2 https://www.access-board.gov/ada/#ada-502	2012 TAS Section: 208.2 2010 ADAS Section: 208.2 2015 ABAAS Section: F208.2

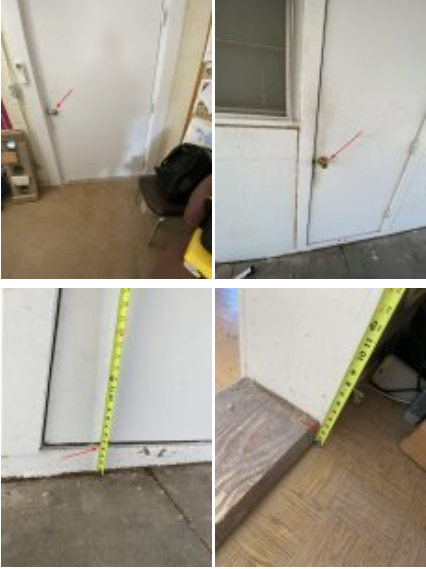
Finding Number	Area Description	Finding	As Built	Recommendation	Citation	Photos	Figure
4	Structures on Property (Public) : Car Port	<p>Minimum maneuvering clearances at doors and gates shall comply with 404.2.4. Maneuvering clearances shall extend the full width of the doorway and the required latch side or hinge side clearance. Maneuvering clearances shall have a max slope of 2.08%. Door openings shall provide a clear width of 32 inches (815 mm) minimum. Clear openings of doorways with swinging doors shall be measured between the face of the door and the stop, with the door open 90 degrees. Openings more than 24 inches (610 mm) deep shall provide a clear opening of 36 inches (915 mm) minimum. There shall be no projections into the required clear opening width lower than 34 inches (865 mm) above the finish floor or ground. Projections into the clear opening width between 34 inches (865 mm) and 80 inches (2030 mm) above the finish floor or ground shall not exceed 4 inches (100 mm). The threshold has a vertical change greater than 1/4 inch high. The threshold has a gap greater than 1/2 inch wide. The threshold at a doorway shall be no higher than 1/2 inch. Changes in level between 1/4 inch and 1/2 inch must be beveled at 1:2 or less. 1/4 inch is the maximum vertical rise. All interior doors must be maintained so that the operating pressure does not exceed 5 lbf to open. The sweep period for doors with closers shall be adjusted so that from an open position of 70 degrees, the door will take at least 3 seconds to move to a point 3 inches from the latch, measured to the leading edge of the door. Exterior doors are recommended to be maintained at 8.5 lbf as a smart practice. Force is to be measured at the operating hardware or 30 inches from the hinges, whichever is greater. Hand-activated door opening hardware, handles, pulls, latches, locks, and other operating devices on accessible doors shall have a shape that is easy to grasp with one hand and does not require tight grasping, tight pinching or twisting of the wrist to operate. Hardware shall be 34 inches minimum and 48 inches maximum above the finish floor or ground. The bottom 10 inches on the push side must be smooth and free of obstructions (hold open devices). Doors, gates, and side lights adjacent to doors or gates, containing one or more glazing</p>	<p>Door hardware and locking mechanism are not complaint. More than 60% doors/entrances are equipped with non-compliant hardware. Most doorway thresholds in exceed 1/2" tolerance.</p>	<p>Review door and threshold componets to make accessible https://www.access-board.gov/ada/#ada-404</p>	<p>2010 ADAS Section: 404.2.3, 404.2.7, 404.2.4, 404.2.11, 404.2.11 Exception</p>

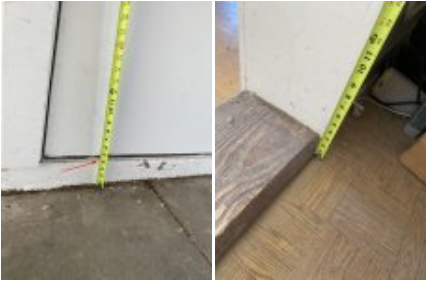
7	Structures on Property (Public) : Car Port - Car Port Doorways	The threshold is greater than 1/2 inch high. The threshold at a doorway shall be no higher than 1/2 inch. Changes in level between 1/4 inch and 1/2 inch must be beveled at 1:2 or less. 1/4 inch is the maximum vertical rise.	Threshold at 4"	https://www.access-board.gov/ada/#ada-404_2_5	2012 TAS Section: 404.2.5 2010 ADAS Section: 404.2.5 2015 ABAAS Section: 404.2.5

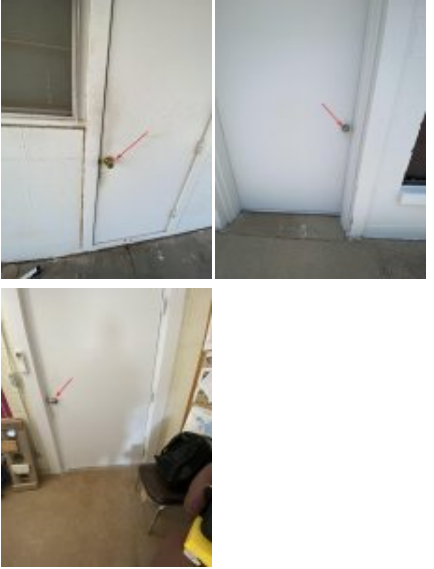
Finding Number	Area Description	Finding	As Built	Recommendation	Citation	Photos	Figure
8	Structures on Property (Public) : Car Port - Car Port Doorways	The door/gate operating hardware is not accessible. Hand-activated door/gate opening hardware, handles, pulls, latches, locks, and other operating devices on accessible doors shall have a shape that is easy to grasp with one hand and does not require tight grasping, pinching or twisting of the wrist to operate. Hardware shall be 34 inches minimum and 48 inches maximum above the finish floor or ground.	Door hardware and locking mechanisms are not compliant.	https://www.access-board.gov/ada/#ada-404_2_7	2012 TAS Section: 404.2.7 2010 ADAS Section: 404.2.7 2015 ABAAS Section: 404.2.7

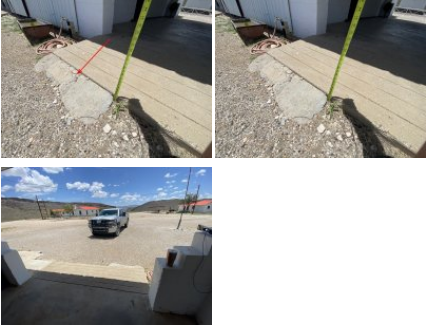
Finding Number	Area Description	Finding	As Built	Recommendation	Citation	Photos	Figure
13	Structures on Property (Public) : Office (Exterior) - Pathway to Office	The curb ramp does not meet minimum width requirements. Curb ramps must be a minimum 36 inches in width.	Curb ramp pictured is not compliant. Curb ramp does not meet width, slope, and surfacing material specifications.	Review all cub ramp componets https://www.access-board.gov/ada/#ada-406	2010 ADAS Section: 405.5, 406.1 2015 ABAAS Section: 405.5, 406.1

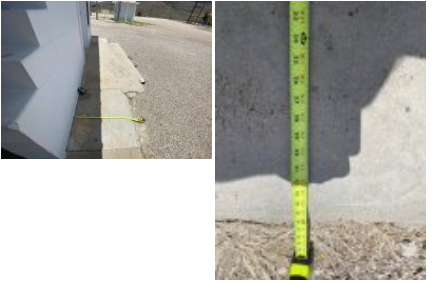
14	Structures on Property (Public) : Office (Exterior) - Pathway Leading to Side Entrance	The route of travel does not provide the required minimum width. The minimum clear width for sidewalks and walks is 36 inches. However, clear width shall be permitted to be reduced to 32 inches minimum for a length of 24 inches maximum provided that reduced width segments are separated by segments that are 48 inches long minimum and 36 inches wide minimum.	Accessibly pathway to side entrance does not meet width specifications. The clear width can be permitted to be reduced to 32 inches (815 mm) minimum for a length of 24 inches (610 mm) maximum Surface material is not ideal and has some lose gravel but visually compliant at this time.	https://www.access-board.gov/ada/#ada-403_5_1	2012 TAS Section: 403.5.1, 403.5.1 Exception 2010 ADAS Section: 403.5.1, 403.5.1 Exception 2015 ABAAS Section: 403.5.1, 403.5.1 EXCEPTION

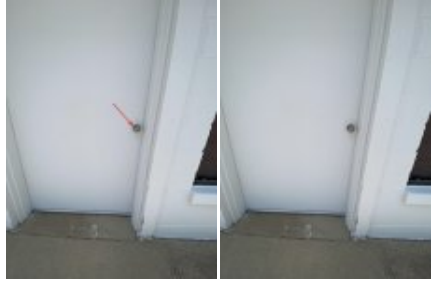
Finding Number	Area Description	Finding	As Built	Recommendation	Citation	Photos	Figure
16	Structures on Property (Public) : Office (Interior) - Entrance Doors	The door/gate operating hardware is not accessible. Hand-activated door/gate opening hardware, handles, pulls, latches, locks, and other operating devices on accessible doors shall have a shape that is easy to grasp with one hand and does not require tight grasping, pinching or twisting of the wrist to operate. Hardware shall be 34 inches minimum and 48 inches maximum above the finish floor or ground.	Door hardware in not compliant.	https://www.access-board.gov/ada/#ada-404_2_7	2012 TAS Section: 404.2.7 2010 ADAS Section: 404.2.7 2015 ABAAS Section: 404.2.7

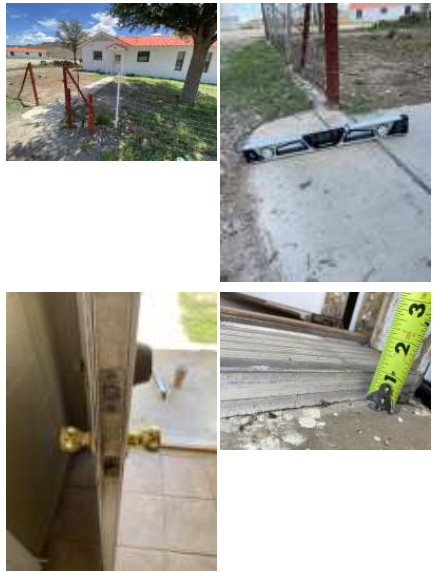
17	Structures on Property (Public) : Bunk Areas (Exterior)	The building entrance is not located on an accessible route. When a building, or portion of a building, is required to be accessible, an accessible route of travel shall be provided to all portions of the building, to accessible building entrances and between the building and the public way. At least one accessible route within the boundary of the site must be provided from public transportation stops, accessible parking and accessible passenger loading zones and public streets or sidewalks to the accessible building entrance they serve. The accessible route shall, to the maximum extent feasible, coincide with the route for the general public. At least one accessible route shall connect accessible buildings, facilities, elements and spaces that are on the same site. At least one accessible route shall connect accessible building or facility entrances with all accessible spaces and elements.	Due to pathway terrain type, lack of accessible pathway, and door hardware or thresholds there is no way to access this building at this time. This building is not accessible	Review accessible pathway componets to make accessible https://www.access-board.gov/ada/#ada-402 https://www.access-board.gov/ada/#ada-403_1	2012 TAS Section: 206.2.1 2010 ADAS Section: 206.2.1 2015 ABAAS Section: F206.2.1

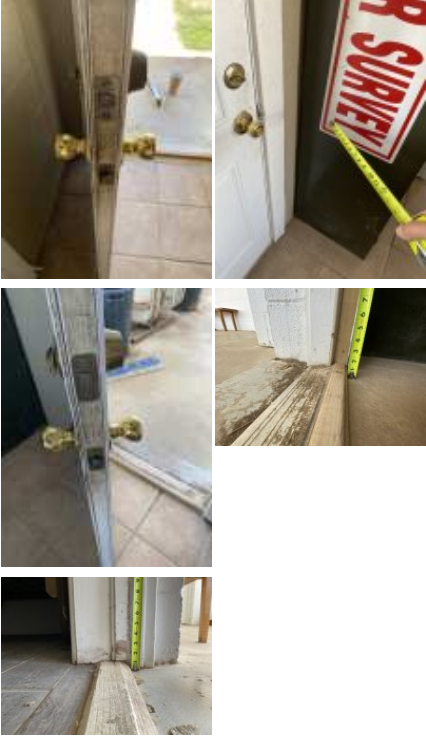
Finding Number	Area Description	Finding	As Built	Recommendation	Citation	Photos	Figure
21	Structures on Property (Public) : Bunk Areas (Interior)	Minimum maneuvering clearances at doors and gates shall comply with 404.2.4. Maneuvering clearances shall extend the full width of the doorway and the required latch side or hinge side clearance. Maneuvering clearances shall have a max slope of 2.08%. Door openings shall provide a clear width of 32 inches (815 mm) minimum. Clear openings of doorways with swinging doors shall be measured between the face of the door and the stop, with the door open 90 degrees. Openings more than 24 inches (610 mm) deep shall provide a clear opening of 36 inches (915 mm) minimum. There shall be no projections into the required clear opening width lower than 34 inches (865 mm) above the finish floor or ground. Projections into the clear opening width between 34 inches (865 mm) and 80 inches (2030 mm) above the finish floor or ground shall not exceed 4 inches (100 mm). The threshold has a vertical change greater than 1/4 inch high. The threshold has a gap greater than 1/2 inch wide. The threshold at a doorway shall be no higher than 1/2 inch. Changes in level between 1/4 inch and 1/2 inch must be beveled at 1:2 or less. 1/4 inch is the maximum vertical rise. All interior doors must be maintained so that the operating pressure does not exceed 5 lbf to open. The sweep period for doors with closers shall be adjusted so that from an open position of 70 degrees, the door will take at least 3 seconds to move to a point 3 inches from the latch, measured to the leading edge of the door. Exterior doors are recommended to be maintained at 8.5 lbf as a smart practice. Force is to be measured at the operating hardware or 30 inches from the hinges, whichever is greater. Hand-activated door opening hardware, handles, pulls, latches, locks, and other operating devices on accessible doors shall have a shape that is easy to grasp with one hand and does not require tight grasping, tight pinching or twisting of the wrist to operate. Hardware shall be 34 inches minimum and 48 inches maximum above the finish floor or ground. The bottom 10 inches on the push side must be smooth and free of obstructions (hold open devices). Doors, gates, and side lights adjacent to doors or gates, containing one or more glazing	More than 60% doors/entrances are equipped with non-compliant hardware. Most doorway thresholds in exceed 1/2" tolerance.	Review door and threshold componets to make accessible https://www.access-board.gov/ada/#ada-404	2010 ADAS Section: 404.2.3, 404.2.7, 404.2.4, 404.2.11, 404.2.11 Exception

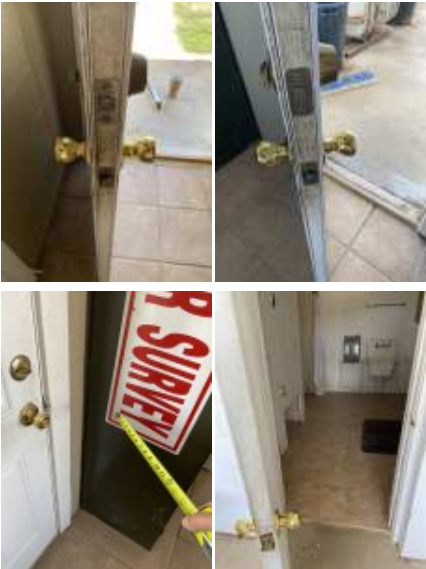
Finding Number	Area Description	Finding	As Built	Recommendation	Citation	Photos	Figure
		panels that permit viewing through the panels shall have the bottom of at least one glazed panel located 43 inches (1090 mm) maximum above the finish floor. EXCEPTION: Vision lights with the lowest part more than 66 inches (1675 mm) from the finish floor or ground shall not be required to comply with 404.2.11. Egress doors shall provide a continuous and unobstructed way of egress travel from any point in a building or facility that provides an accessible route to an area of refuge, a horizontal exit, or a public way.					
22	Structures on Property (Public) : Bunk Areas (Interior) - Entrance/Exit Doors	The door/gate operating hardware is not accessible. Hand-activated door/gate opening hardware, handles, pulls, latches, locks, and other operating devices on accessible doors shall have a shape that is easy to grasp with one hand and does not require tight grasping, pinching or twisting of the wrist to operate. Hardware shall be 34 inches minimum and 48 inches maximum above the finish floor or ground.	Door hardware and locking mechanisms are not compliant.	https://www.access-board.gov/ada/#ada-404_2_7	2012 TAS Section: 404.2.7 2010 ADAS Section: 404.2.7 2015 ABAAS Section: 404.2.7

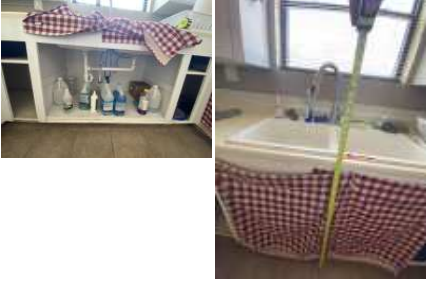
Finding Number	Area Description	Finding	As Built	Recommendation	Citation	Photos	Figure
26	Structures on Property (Public) : Bunk Areas (Interior) - Kitchenette	Knee and toe space has not been provided at the sink. Kitchen sinks must be provided with a clear floor space positioned for a forward approach including knee and toe clearance.	Knee and toe must be provided since kitchenette contain stove top range. In kitchens, kitchenettes, and breakrooms without a cooktop or conventional range, a parallel approach is permitted at kitchen sinks.	https://www.access-board.gov/ada/#ada-606_2 https://www.access-board.gov/ada/#ada-804_4	2012 TAS Section: 606.2, 804.4 2010 ADAS Section: 606.2, 804.4 2015 ABAAS Section: 606.2, 804.4

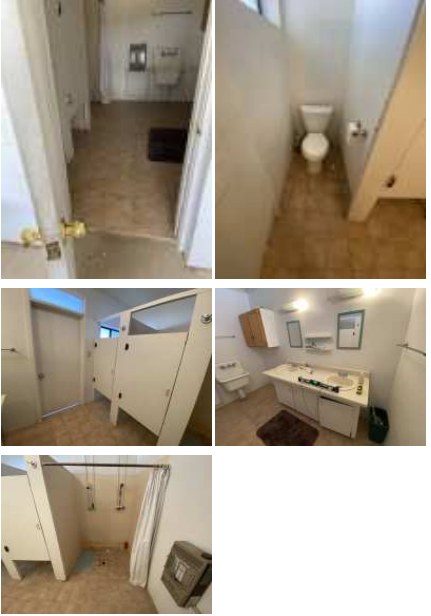
Finding Number	Area Description	Finding	As Built	Recommendation	Citation	Photos	Figure
28	Structures on Property (Public) : Bunk Areas (Interior) - Restroom/Showers	The restrooms is not nearly compliant. - The restroom does not have the required minimum clear floor space or maneuvering clearances for the toilet. - The restroom does not have the required minimum clear floor space or maneuvering clearances for the lavatory. - The entry door does not contain the required minimum 60 inches maneuvering space on the pull side - The entry door encroach into the required clear floor space for fixtures. - Door opening pressure was measured at greater than 5 pounds. - Grab bars are incorrectly installed. - Accessories, such as toilet seat covers, paper towel holders, garbage cans, hand dryers and mirrors are either too high or without clear floor space or both. - The restroom contain floor level changes greater than a 1/2 inch at the floor drains.	No accessible stalls requires a number of componets to gain compliance.	https://www.access-board.gov/ada/#ada-213_2 Review restrooms componets to make accessible. https://www.access-board.gov/ada/#ada-603	2012 TAS Section: 213.2 2010 ADAS Section: 213.2 2015 ABAAS Section: F213.2

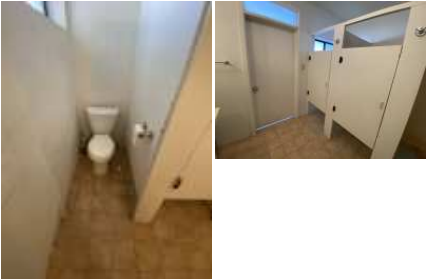
29	Structures on Property (Public) : Bunk Areas (Interior) - Restroom/Showers	Accessible toilets must have grab bars installed. The side grab bar must extend at least 54 inches minimum beyond the rear wall and start a maximum of 12 inches from the rear wall. The rear grab bar must be a minimum of 36 inches long and extend from the centerline of the toilet 12 inches minimum on one side and 24 inches minimum on the other side. Grab bars shall be installed in a horizontal position, 33 inches minimum and 36 inches maximum above the finish floor measured to the top of the gripping surface.	There are no grab bars installed at this time.	https://www.access-board.gov/ada/#ada-604_5 Review grab bar componets to make accessible https://www.access-board.gov/ada/#ada-609	2012 TAS Section: 604.5 2010 ADAS Section: 604.5 2015 ABAAS Section: 604.5

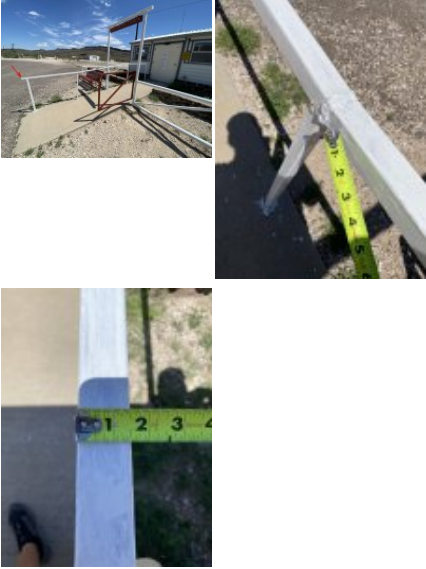
Finding Number	Area Description	Finding	As Built	Recommendation	Citation	Photos	Figure
37	Structures on Property (Public) : Registration Station (Exterior) - Pathway to Registration Station (Ramp)	The ramp does not have compliant handrails. Handrails are required on both sides of all surfaces that are sloped greater than 5 percent (1:20). Handrails must be between 34 inches and 38 inches above the ramp surface, and must extend horizontally 12 inches beyond the top and bottom of the ramp. The diameter of the handrails must be 1 1/4 inches minimum and 2 inches maximum in cross-sectional nominal dimension for circular handrails. Handrail gripping surfaces with a non-circular cross section shall have a perimeter dimension of 4 inches minimum and 6 1/4 inches maximum, and a cross-section dimension of 2 1/4 inches maximum. The space between handrails and walls must be 1-1/2 inches minimum.	Handrails type, style, and installation are not compliant. Handrail missing on (R) side.	Review handrail components to make accessible https://www.access-board.gov/aba/#aba-505_1	2012 TAS Section: 505.1 2010 ADAS Section: 505.1 2015 ABAAS Section: 505.1

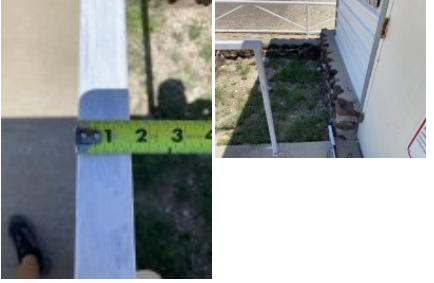
Finding Number	Area Description	Finding	As Built	Recommendation	Citation	Photos	Figure
42	Structures on Property (Public) : Registration Station (Exterior) - Pathway to Registration Station (Ramp)	The handrail gripping surface outside perimeter is not within the allowable required range. Handrail gripping surfaces with a non-circular cross section shall have a perimeter dimension of 4 inches minimum and 6 1/4 inches maximum, and a cross-section dimension of 2 1/4 inches maximum.	Not wide enough		https://www.access-board.gov/ada/#ada-505_7_2	2012 TAS Section: 505.7.2 2010 ADAS Section: 505.7.2 2015 ABAAS Section: 505.7.2

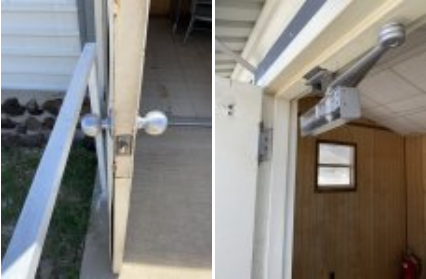
46	Structures on Property (Public) : Registration Station (Interior) - Entrance Doors	The door is equipped with a door closer and returns to a closed position too quickly. Door closers and gate closers shall be adjusted so that from an open position of 90 degrees, the time required to move the door to a position of 12 degrees from the latch is 5 seconds minimum.	N/A	https://www.access-board.gov/ada/#ada-404_2_8_1	2012 TAS Section: 404.2.8.1 2010 ADAS Section: 404.2.8.1 2015 ABAAS Section: 404.2.8.1

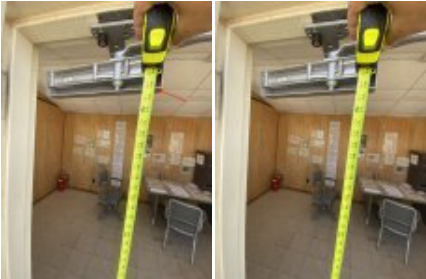
47	Structures on Property (Public) : Registration Station (Interior) - Entrance Doors	The door closer is less than 78 inches off the finished floor. Door closers and door stops shall be permitted to be 78 inches minimum above the finish floor or ground.	Door closer height less than 74"	https://www.access-board.gov/ada/#ada-404_2_3	2012 TAS Section: 404.2.3 Exception 2 2010 ADAS Section: 404.2.3 Exception 2 2015 ABAAS Section: 404.2.3 EXCEPTIONS: 2

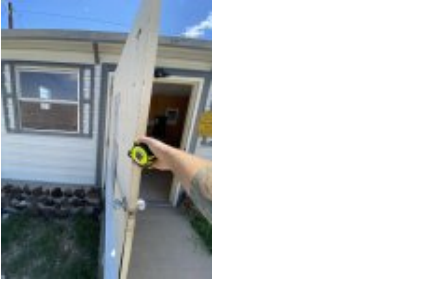
Finding Number	Area Description	Finding	As Built	Recommendation	Citation	Photos	Figure
48	Structures on Property (Public) : Registration Station (Interior) - Entrance Doors	The door does not open at least 90 degrees. Door openings shall provide a clear width of 32 inches minimum. Clear openings of doorways with swinging doors shall be measured between the face of the door and the stop, with the door open 90 degrees. There shall be no projections into the required clear opening width lower than 34 inches above the finish floor or ground. Projections into the clear opening width between 34 inches and 80 inches above the finish floor or ground shall not exceed 4 inches.	N/A		https://www.access-board.gov/ada/#ada-404_2_3	2012 TAS Section: 404.2.3 2010 ADAS Section: 404.2.3 2015 ABAAS Section: 404.2.3

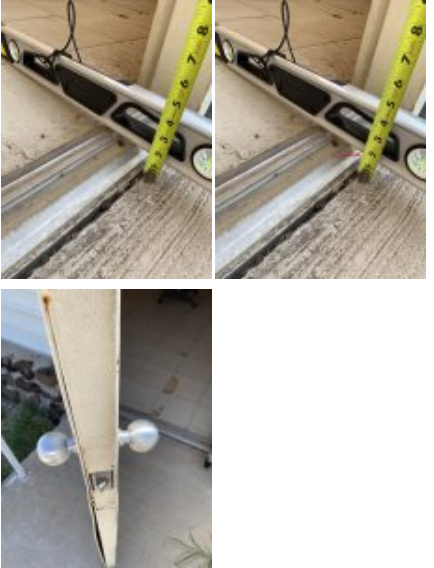
49	Structures on Property (Public) : Registration Station (Interior) - Entrance Doors	The threshold is greater than 1/2 inch high. The threshold at a doorway shall be no higher than 1/2 inch. Changes in level between 1/4 inch and 1/2 inch must be beveled at 1:2 or less. 1/4 inch is the maximum vertical rise.	Door threshold over 1/2"		https://www.access-board.gov/ada/#ada-404_2_5	2012 TAS Section: 404.2.5 2010 ADAS Section: 404.2.5 2015 ABAAS Section: 404.2.5

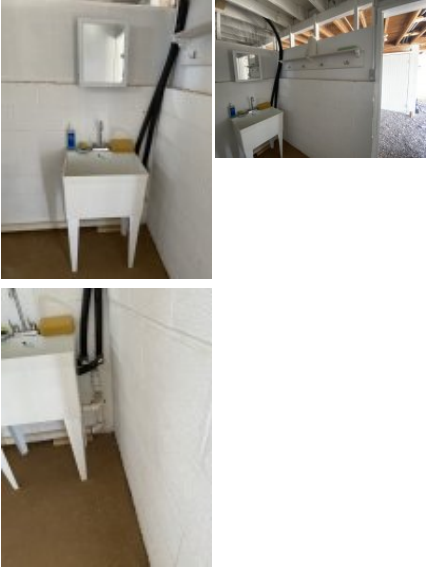
Finding Number	Area Description	Finding	As Built	Recommendation	Citation	Photos	Figure
54	Structures on Property (Public) : Coral (Interior) - Shower	There are not enough accessible lavatories. Where lavatories are provided, at least one shall be accessible and shall not be located in a toilet compartment.	Restroom sinks are required to have front approach with knee and toe space provided. Sink hardware and accessories are not complaint	https://www.access-board.gov/ada/#ada-213_3_4 Review lavatory componets to make accessible. https://www.access-board.gov/ada/#ada-606	2012 TAS Section: 213.3.4 2010 ADAS Section: 213.3.4 2015 ABAAS Section: F213.3.4

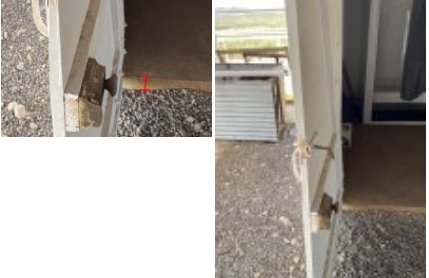
55	Structures on Property (Public) : Coral (Interior) - Entrance Doors	The threshold is greater than 1/2 inch high. The threshold at a doorway shall be no higher than 1/2 inch. Changes in level between 1/4 inch and 1/2 inch must be beveled at 1:2 or less. 1/4 inch is the maximum vertical rise.	N/A	https://www.access-board.gov/ada/#ada-404_2_5	2012 TAS Section: 404.2.5 2010 ADAS Section: 404.2.5 2015 ABAAS Section: 404.2.5

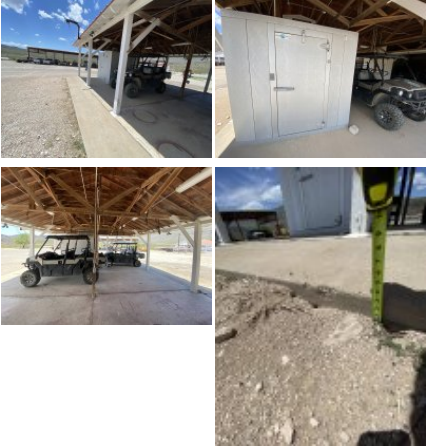
Finding Number	Area Description	Finding	As Built	Recommendation	Citation	Photos	Figure
56	Structures on Property (Public) : Cleaning/Check Station - Pathway Leading to Cleaning/Check Station	The accessible route contains loose gravel and/or surface materials that do not provide for a stable, firm slip resistant surface. Floor and ground surfaces shall be stable, firm, and slip resistant.	Route to cleaning station has loose gravel and large debris.	https://www.access-board.gov/ada/#ada-302_1	2012 TAS Section: 302.1 2010 ADAS Section: 302.1 2015 ABAAS Section: 302.1

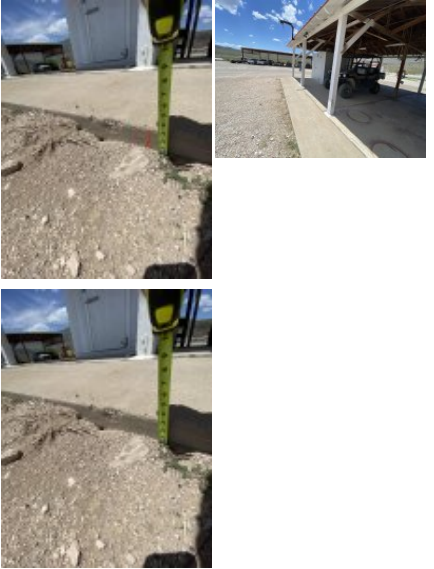
57	Structures on Property (Public) : Cleaning/Check Station - Pathway Leading to Cleaning/Check Station	The walkway contains abrupt vertical edges and/or variations over a 1/2 inch. 1/4 inch is the maximum vertical rise. Changes in level between 1/4 inch and 1/2 inch must be beveled at 1:2 or less. Changes in level greater than 1/2 inch must be by way of a ramp.	Concrete lip measures at 3"	https://www.access-board.gov/ada/#ada-303_2 https://www.access-board.gov/ada/#ada-303_3	2012 TAS Section: 303.3, 303.2 2010 ADAS Section: 303.3, 303.2 2015 ABAAS Section: 303.2, 303.3

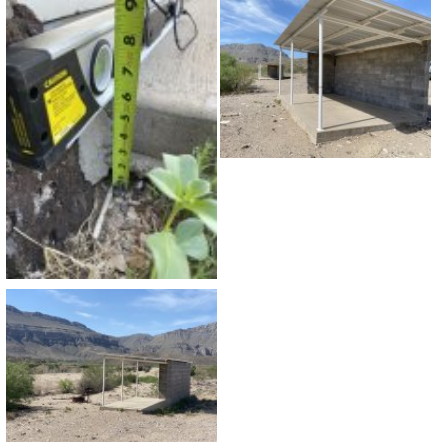
60	Outdoor Features (Public) : Shelters - Fishing Shelter	The walkway contains changes in level greater than a 1/2 inch high that should be ramped. Changes in level greater than 1/2 inch high shall be constructed as a ramp or curb ramp.	access to shelter pad is not accessible, due to change in elevation over 1/2"	https://www.access-board.gov/ada/#ada-303_4	2012 TAS Section: 303.4 2010 ADAS Section: 303.4 2015 ABAAS Section: 303.4
