Chaparral WMA- ADA Evaluation

WMA- Chaparral, Cotulla TX, ADA Evaluation

Accessibility Evaluation

Inspection Date: 01/01/2019

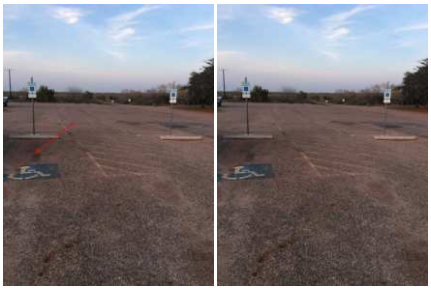
Finding Number	Area Description	Finding	As Built	Recommendation	Citation	Photos	Figure
1	Exterior of Property (Public): Visitors Centers Parking Lot (2 Spaces) 2 Labeled - Accessible Stall (L) Side	The surfaces of the accessible parking spaces and access aisles are not firm, stable, and slip resistant. Floor and ground surfaces shall be stable, firm, and slip resistant Parking spaces and access aisles serving them shall comply with 302. Access aisles shall be at the same level as the parking spaces they serve. Changes in level are not permitted.	Parking spot in need of upkeep, gravel is loose and not stable.	https://www.access-board.gov/ada/#ada-302_1 https://www.access-board.gov/ada/#ada-502_4	2012 TAS Section: 502.4, 302.1 2010 ADAS Section: 502.4, 302.1 2015 ABAAS Section: 502.4, 302.1

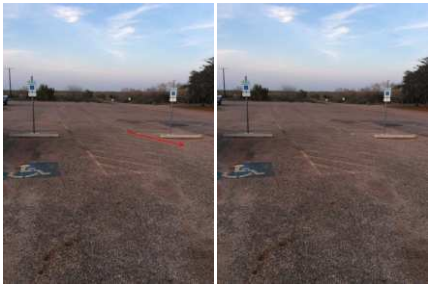
3	Exterior of Property (Public): Visitors Centers Parking Lot (2 Spaces) 2 Labeled - Accessible Stall (R) Side	The surfaces of the accessible parking spaces and access aisles are not firm, stable, and slip resistant. Floor and ground surfaces shall be stable, firm, and slip resistant Parking spaces and access aisles serving them shall comply with 302. Access aisles shall be at the same level as the parking spaces they serve. Changes in level are not permitted.	Parking spot in need of upkeep, gravel is loose and not stable.	https://www.access-board.gov/ada/#ada-302_1 https://www.access-board.gov/ada/#ada-502_4	2012 TAS Section: 502.4, 302.1 2010 ADAS Section: 502.4, 302.1 2015 ABAAS Section: 502.4, 302.1

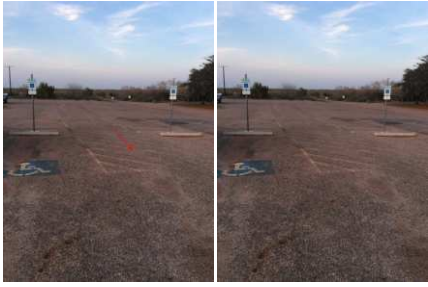
5	Exterior of Property (Public): Visitors Centers Parking Lot (2 Spaces) 2 Labeled - Access Aisle (Shared)	The access aisle contains loose gravel and/or surface materials that do not provide for a stable, firm slip resistant surface. Parking spaces and access aisles serving them shall comply with floor or ground surface requirements. The ground surface shall be stable, firm, and slip resistant. Access aisles shall be at the same level as the parking spaces they serve. Changes in level, slopes exceeding 1:48, and detectable warnings shall not be permitted.	Access Aisle in need of upkeep, gravel is loose and not stable.	https://www.access-board.gov/ada/#ada-502_4	2012 TAS Section: 502.4 2010 ADAS Section: 502.4 2015 ABAAS Section: 502.4

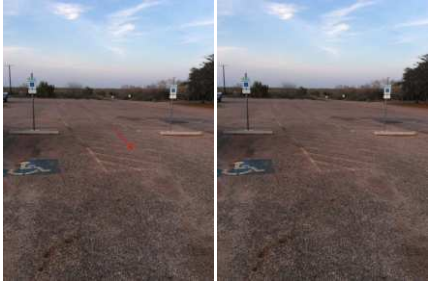
6	Exterior of Property (Public): Visitors Centers Parking Lot (2 Spaces) 2 Labeled - Access Aisle (Shared)	The striping and markings for the accessible parking stalls, loading/unloading access aisle are dilapidated and in need of repair and/or maintenance. Access aisles shall be marked so as to discourage parking in them. Where parking spaces are marked with lines, width measurements of parking spaces and access aisles shall be made from the centerline of the markings.	Access aisle striping is faded and in need of upkeep.	https://www.access-board.gov/ada/#ada-502_3_3	2012 TAS Section: 502.3.3 2010 ADAS Section: 502.3.3 2015 ABAAS Section: 502.3.3, 503.3.3

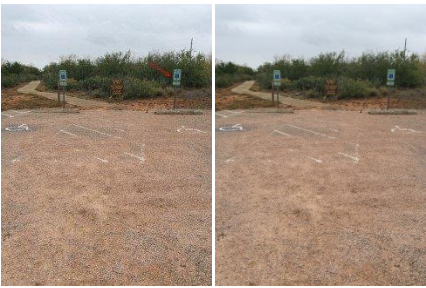
Finding Number	Area Description	Finding	As Built	Recommendation	Citation	Photos	Figure
10	Exterior of Property (Public): Main Office Parking Lot (2 Spaces) 2 Labeled - Accessible Stall (R) Side	The parking sign is mounted too low. Parking space identification signs shall include the International Symbol of Accessibility. Signs identifying van parking spaces shall contain the designation "van accessible." Signs shall be 60 inches minimum above the finish floor or ground surface measured to the bottom of the sign.	This needs to be verified, bottom of sign needs to be min 60" off ground.	https://www.access-board.gov/ada/#ada-502_6	2012 TAS Section: 502.6 2010 ADAS Section: 502.6 2015 ABAAS Section: 502.6

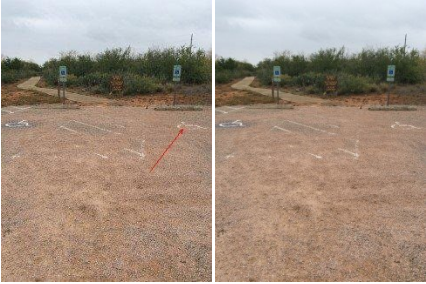
11	Exterior of Property (Public): Main Office Parking Lot (2 Spaces) 2 Labeled - Accessible Stall (R) Side	The surfaces of the accessible parking spaces and access aisles are not firm, stable, and slip resistant. Floor and ground surfaces shall be stable, firm, and slip resistant. Parking spaces and access aisles serving them shall comply with 302. Access aisles shall be at the same level as the parking spaces they serve. Changes in level are not permitted.	Parking spot in need of upkeep, gravel is loose and not stable.	https://www.access-board.gov/ada/#ada-302_1 https://www.access-board.gov/ada/#ada-502_4	2012 TAS Section: 502.4, 302.1 2010 ADAS Section: 502.4, 302.1 2015 ABAAS Section: 502.4, 302.1

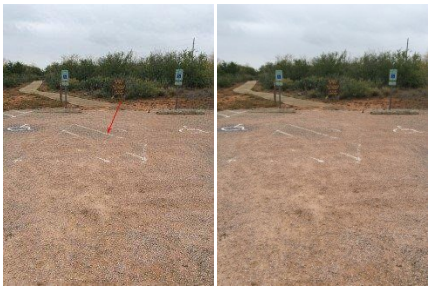
Finding Number	Area Description	Finding	As Built	Recommendation	Citation	Photos	Figure
13	Exterior of Property (Public): Main Office Parking Lot (2 Spaces) 2 Labeled - Access Aisle (Shared)	The access aisle contains loose gravel and/or surface materials that do not provide for a stable, firm slip resistant surface. Parking spaces and access aisles serving them shall comply with floor or ground surface requirements. The ground surface shall be stable, firm, and slip resistant. Access aisles shall be at the same level as the parking spaces they serve. Changes in level, slopes exceeding 1:48, and detectable warnings shall not be permitted.	Access Aisle in need of upkeep, gravel is loose and not stable.	https://www.access-board.gov/ada/#ada-502_4	2012 TAS Section: 502.4 2010 ADAS Section: 502.4 2015 ABAAS Section: 502.4

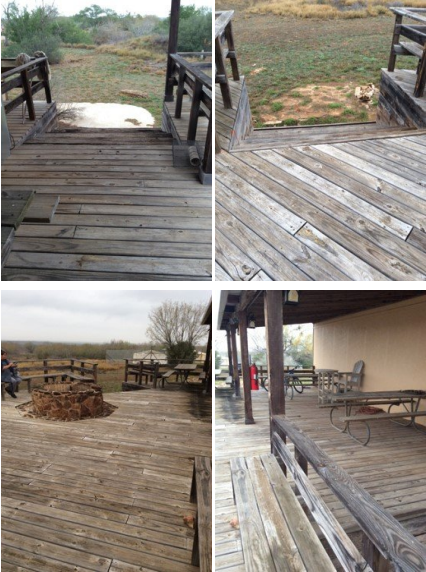
Finding Number	Area Description	Finding	As Built	Recommendation	Citation	Photos	Figure
18	Structures on Property (Public) : Research Center (Exterior)	Non-accessible entrance/s signage missing. Directional signage pointing to the accessible entrance is required. If an accessible entrance is not available and is not "readily achievable" to provide, signage is recommended indicating that curb side service is available upon request or that services may be provided at a different accessible location. It is recommended that this sign have a working phone number that is always answered during regular business hours. Another option for consideration would be the installation of a door bell at an accessible location on the exterior of the business that will alert an attendant.	Back porch does not have accessible exit, and directional sign needs to be added signifying accessible entrance. Signs that provide direction to or information about interior spaces and facilities must meet visual requirements but are not required to be tactile	https://www.access-board.gov/ada/#ada-216_6	2010 ADAS Section: 216.6 2015 ABAAS Section: F216.6

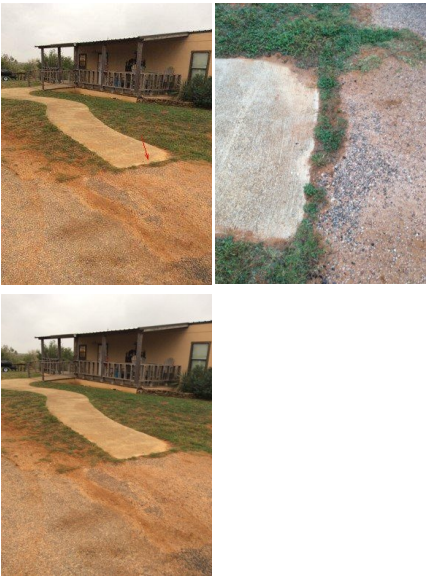
19	Structures on Property (Public) : Research Center (Exterior) - Pathway to Research Center	The route contains openings greater than 1/2 inch. Openings in floor or ground surfaces shall not allow passage of a sphere more than 1/2 inch diameter. Elongated openings shall be placed so that the long dimension is perpendicular to the dominant direction of travel.	Large gap in pathway due to overgrowth.	https://www.access-board.gov/ada/#ada-302_3	2012 TAS Section: 302.3 2010 ADAS Section: 302.3 2015 ABAAS Section: 302.3

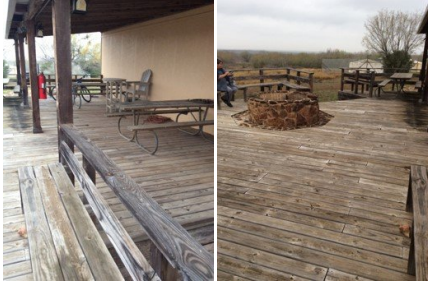
Finding Number	Area Description	Finding	As Built	Recommendation	Citation	Photos	Figure
20	Structures on Property (Public) : Research Center (Exterior) - Outdoor Deck	All of the picnic units do not provide mobility features. Where picnic facilities contain two or fewer picnic units, each picnic unit shall provide mobility features.	This needs to be verified. Based on size of deck and number of tables provided at least 2 picnic tables need to meet ADA specifications There are no accessible picnic tables provided	Provide compliant picnic table Knee space for wheelchair seating must be at least 30 inches wide, 19 inches deep, and 27 inches high, as measured from the ground or floor to the bottom of the tabletop. Toe clearance of at least 9 inches above the ground or floor must extend at least an additional 5 inches beyond the knee clearance.	2015 ABAAS Section: F245.2.1
