# Elephant Mt. WMA- ADA Evaluation

## WMA- Elephant Mountain, Alpine TX, ADA Evaluation

Accessibility Evaluation

Inspection Date: 06/20/2022

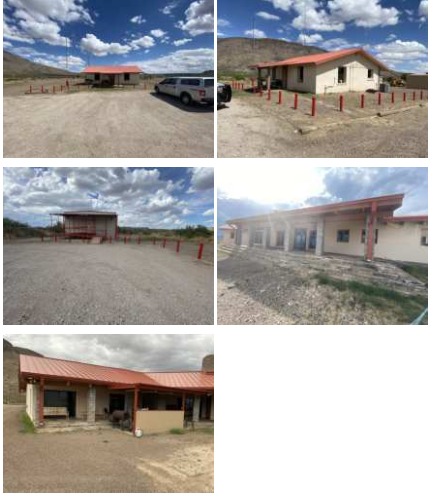
Finding Number	Area Description	Finding	As Built	Recommendation	Citation	Photos	Figure
1	Exterior of Property (Public): All Parking Lots at Facility (O Spaces)	There are no accessible parking stalls. Each lot where parking is provided for the public as clients, guests or employees, shall provide accessible parking and shall be located on the shortest accessible route of travel from adjacent parking to an accessible entrance. There are a total of (XX) parking stalls in the parking lot that could be reasonably associated with this facility. There should be a minimum of (XX) accessible stalls with a minimum of (XX) being designed as van accessible.	There is no accessible parking provided at property. Each building would need to install a van accessible stall with appropriate access aisle nearby or have buildings connected by accessible pathway.	Review parking stall and access aisle requirements <a href="https://www.access-board.gov/ada/#ada-208_2">https://www.access-board.gov/ada/#ada-208_2</a> <a href="https://www.access-board.gov/ada/#ada-502">https://www.access-board.gov/ada/#ada-502</a>	2012 TAS Section: 208.2  2010 ADAS Section: 208.2  2015 ABAAS Section: F208.2

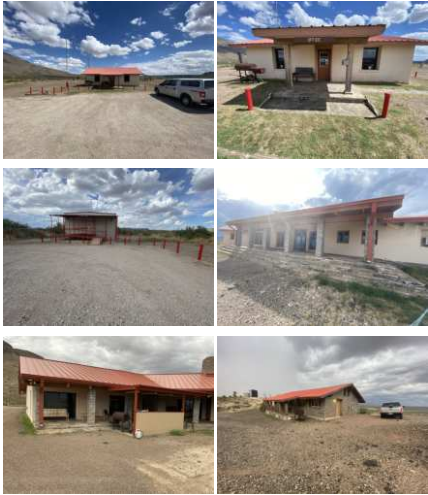
2	Exterior of Property (Public): All Parking Lots at Facility (O Spaces) - Van Spot Requirements (For Each Parking Lot)	The parking space is in not nearly compliant. The parking space the minimum width. The floor or ground surface is not firm stable or slip resistant. The parking space contains changes in level and/or gaps that exceed the maximum allowable requirements. The parking space does not have the proper identification signs or the signs are not installed at the correct height. The parking space is missing an adjacent access aisle.	The parking stall is missing border markings and has non compliant surfacing material. Gravel is not compliant surfacing for parking stall or access aisles. This applies to each parking lot.	<a href="https://www.access-board.gov/ada/#ada-502_1">https://www.access-board.gov/ada/#ada-502_1</a> <a href="https://www.access-board.gov/ada/#ada-502_2">https://www.access-board.gov/ada/#ada-502_2</a>	2012 TAS Section: 502.1, 502.1 Exception  2010 ADAS Section: 502.1, 502.1 Exception  2015 ABAAS Section: 502.1, 502.1 Exception

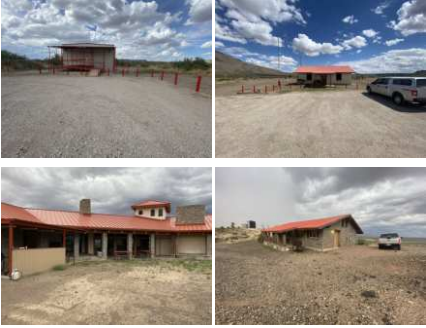
Finding Number	Area Description	Finding	As Built	Recommendation	Citation	Photos	Figure
3	Exterior of Property (Public): All Parking Lots at Facility (O Spaces) - Access Aisle Requirments Van (For Each Parking Lot)	The access aisle is in not nearly compliant. The access ai the minimum width. The access aisle is not as long as the parking space it serves. There are no markings to discourage parking. The floor or ground surface is not firm stable or slip resistant. The parking space contains changes in level and/or gaps that exceed the maximum allowable requirements.	There is no access aisle provided. Gravel surfacing material is not compliant for access aisle and missing boundary markings. Access aisle width requirments depend on van stall size. van stall 11' access aisle 5' or van stall 8' access aisle 8' This applies to each parking lot.	<a href="https://www.access-board.gov/ada/#ada-502_3">https://www.access-board.gov/ada/#ada-502_3</a>	2012 TAS Section: 502.3  2010 ADAS Section: 502.3  2015 ABAAS Section: 502.3

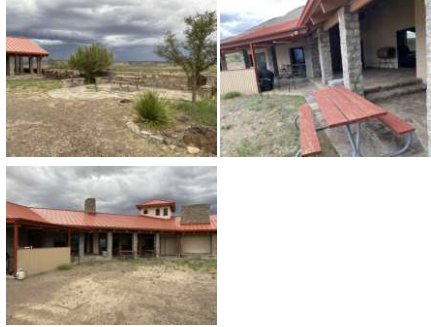
11	Structures on Property (Public) : Education Center (Exterior)	There are not enough picnic units with mobility features. Where picnic facilities contain more than two picnic units, at least 20 percent, but not less than two, of the picnic units shall provide mobility features.	Ground/surface material not compliant around picnic tables. Exterior pathway leading to tables non-compliant. concrete is compliant surface for picnic table, near outdoor cooking pit. There are no accessible picnic tables provided	Provide compliant picnic table at ratio requirements. Knee space for wheelchair seating must be at least 30 inches wide, 19 inches deep, and 27 inches high, as measured from the ground or floor to the bottom of the tabletop. Toe clearance of at least 9 inches above the ground or floor must extend at least an additional 5 inches beyond the knee clearance.	2015 ABAAS Section: F245.2.2

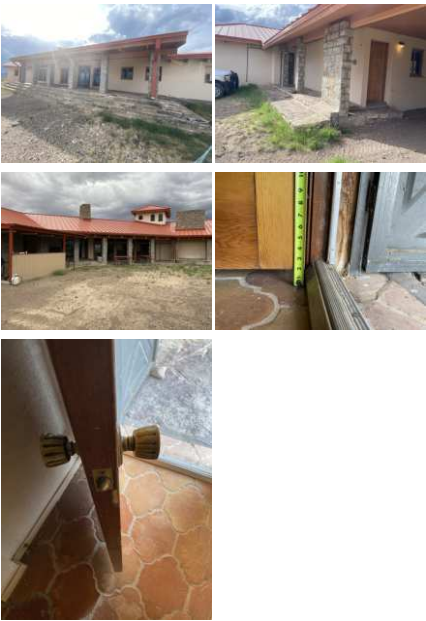
Finding Number	Area Description	Finding	As Built	Recommendation	Citation	Photos	Figure
13	Structures on Property (Public) : Education Center (Exterior) - Pathways to Education Center	The building entrance is not located on an accessible route. When a building, or portion of a building, is required to be accessible, an accessible route of travel shall be provided to all portions of the building, to accessible building entrances and between the building and the public way. At least one accessible route within the boundary of the site must be provided from public transportation stops, accessible parking and accessible passenger loading zones and public streets or sidewalks to the accessible building entrance they serve. The accessible route shall, to the maximum extent feasible, coincide with the route for the general public. At least one accessible route shall connect accessible buildings, facilities, elements and spaces that are on the same site. At least one accessible route shall connect accessible building or facility entrances with all accessible spaces and elements.	Due to terrain type, lack of accessible pathway, stairs, and door hardware or thresholds there is no way to gain access to building. This building is not accessible	<a href="https://www.access-board.gov/ada/#ada-206_2_1">https://www.access-board.gov/ada/#ada-206_2_1</a>	2012 TAS Section: 206.2.1  2010 ADAS Section: 206.2.1  2015 ABAAS Section: F206.2.1

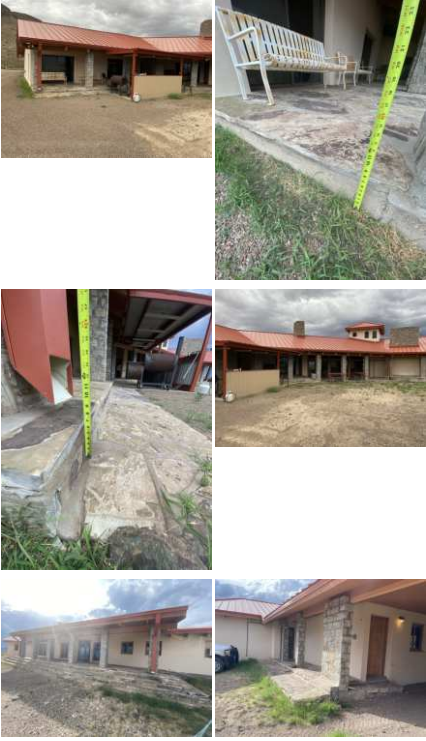
Finding Number	Area Description	Finding	As Built	Recommendation	Citation	Photos	Figure
14	Structures on Property (Public) : Education Center (Exterior) - Pathways to Education Center	The path of contains multiple issues and is not accessible. The path of travel exceeds the maximum allowable cross and running slope requirements. It also contains changes in level and/or gaps that exceed the allowable maximum requirements. The path of travel does not meet the minimum width requirements for clearances, turning spaces, and/or passing spaces. The floor or ground surface is not firm, stable, and slip resistant.	Pathway is not compliant due to sloping, width, elevation changes, and terrain type. All of these componets would need to be reviewed to make accessible. Pathway has multiple infractions	Review accessible pathway componets to make accessible <a href="https://www.access-board.gov/ada/#ada-402">https://www.access-board.gov/ada/#ada-402</a> <a href="https://www.access-board.gov/ada/#ada-403_1">https://www.access-board.gov/ada/#ada-403_1</a>	2010 ADAS Section: 403.1  2015 ABAAS Section: 403.1

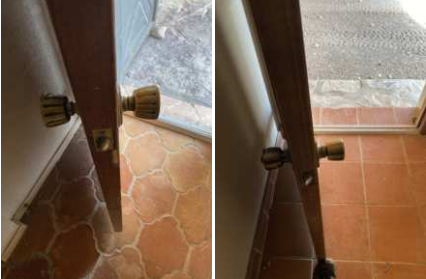
15	Structures on Property (Public) : Education Center (Interior)	Minimum maneuvering clearances at doors and gates shall comply with 404.2.4. Maneuvering clearances shall extend the full width of the doorway and the required latch side or hinge side clearance. Maneuvering clearances shall have a max slope of 2.08%. Door openings shall provide a clear width of 32 inches (815 mm) minimum. Clear openings of doorways with swinging doors shall be measured between the face of the door and the stop, with the door open 90 degrees. Openings more than 24 inches (610 mm) deep shall provide a clear opening of 36 inches (915 mm) minimum. There shall be no projections into the required clear opening width lower than 34 inches (865 mm) above the finish floor or ground. Projections into	More than 60% doors/entrances are equipped with non-compliant hardware. Most doorway thresholds exceed 1/2" tolerance.	<a href="https://www.access-board.gov/ada/#ada-404">https://www.access-board.gov/ada/#ada-404</a>	2010 ADAS Section: 404.2.3, 404.2.7, 404.2.4, 404.2.11, 404.2.11 Exception

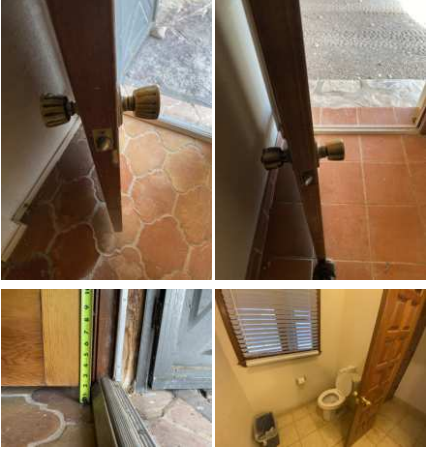
Finding Number	Area Description	Finding	As Built	Recommendation	Citation	Photos	Figure
19	Structures on Property (Public) : Education Center (Interior) - Entrance/Exit Doors	The door/gate operating hardware is not accessible. Hand-activated door/gate opening hardware, handles, pulls, latches, locks, and other operating devices on accessible doors shall have a shape that is easy to grasp with one hand and does not require tight grasping, pinching or twisting of the wrist to operate. Hardware shall be 34 inches minimum and 48 inches maximum above the finish floor or ground.	Door hardware is not compliant.	Review door and threshold componets to make accessible <a href="https://www.access-board.gov/ada/#ada-404">https://www.access-board.gov/ada/#ada-404</a>	2012 TAS Section: 404.2.7 2010 ADAS Section: 404.2.7 2015 ABAAS Section: 404.2.7

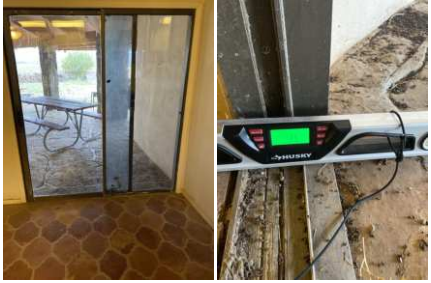
Finding Number	Area Description	Finding	As Built	Recommendation	Citation	Photos	Figure
21	Structures on Property (Public) : Education Center (Interior) - Entrance/Exit Doors	The maneuvering clearance at the sliding door exceeds 2% slope. Sliding doors must have a landing on both sides that is a minimum of 48 inches in depth perpendicular to the door. The entire landing must be free of obstructions and must be flat (2% max. slope is considered flat in any direction).	Sliding door threshold over 2% allowance.	<a href="https://www.access-board.gov/ada/#ada-404_2_4_4">https://www.access-board.gov/ada/#ada-404_2_4_4</a>	2010 ADAS Section: 404.2.4.4  2015 ABAAS Section: 404.2.4.4

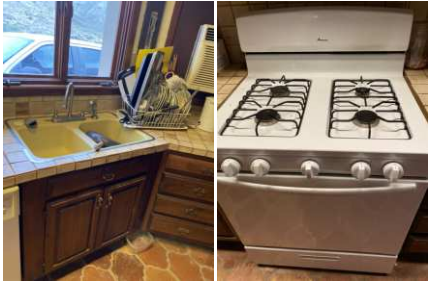
22	Structures on Property (Public) : Education Center (Interior) - Kitchenette	Knee and toe space has not been provided at the sink. Kitchen sinks must be provided with a clear floor space positioned for a forward approach including knee and toe clearance.	Knee and toe must be provided since kitchenettes contain stove top range. In kitchens, kitchenettes, and breakrooms without a cooktop or conventional range, a parallel approach is permitted at kitchen sinks.	<a href="https://www.access-board.gov/ada/#ada-606_2">https://www.access-board.gov/ada/#ada-606_2</a> <a href="https://www.access-board.gov/ada/#ada-804_4">https://www.access-board.gov/ada/#ada-804_4</a>	2012 TAS Section: 606.2, 804.4  2010 ADAS Section: 606.2, 804.4  2015 ABAAS Section: 606.2, 804.4

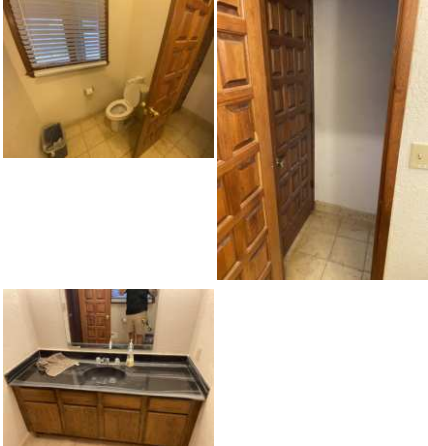
Finding Number	Area Description	Finding	As Built	Recommendation	Citation	Photos	Figure
26	Structures on Property (Public) : Education Center (Interior) - Restroom Near Front Entrance (Unisex)	The restroom is not nearly compliant. The restroom does not have the required minimum clear floor space or maneuvering clearances for the toilet. The restroom does not have the required minimum clear floor space or maneuvering clearances for the lavatory. The entry door does not contain the required minimum maneuvering spaces on the pull/push sides. The entry door encroach into the required clear floor space for fixtures. Grab bars are missing and/or incorrectly installed. Accessories, such as toilet seat covers, paper towel holders, garbage cans, hand dryers, and mirrors are either too high or without clear floor space or both. The restroom contain floor level changes greater than a 1/2 inch of the floor drains and is slope (XX) - (XX), the shower is too small and missing numerous accessible elements.	This restroom requires a number of componets to gain compliance.	<a href="https://www.access-board.gov/ada/#ada-213_2">https://www.access-board.gov/ada/#ada-213_2</a> Review restrooms componets to make accessible. <a href="https://www.access-board.gov/ada/#ada-603">https://www.access-board.gov/ada/#ada-603</a>	2012 TAS Section: 213.2  2010 ADAS Section: 213.2  2015 ABAAS Section: F213.2

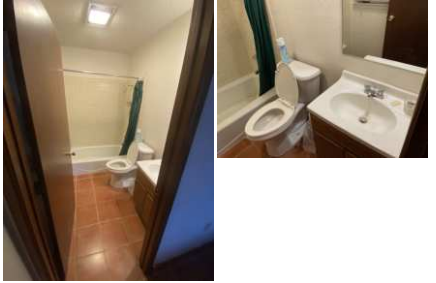
33	Structures on Property (Public) : Education Center (Interior) - Restroom #2, Near Rear Exit (Unisex)	The restroom is not nearly compliant. The restroom does not have the required minimum clear floor space or maneuvering clearances for the toilet. The restroom does not have the required minimum clear floor space or maneuvering clearances for the lavatory. The entry door does not contain the required minimum maneuvering spaces on the pull/push sides. The entry door encroach into the required clear floor space for fixtures. Grab bars are missing and/or incorrectly installed. Accessories, such as toilet seat covers, paper towel holders, garbage cans, hand dryers, and mirrors are either too high or without clear floor space or both. The restroom contain floor level changes greater than a 1/2 inch of the floor drains and is slope (XX) - (XX), the shower is too small and missing numerous accessible elements.	This restroom requires a number of componets to gain compliance.	Review restrooms componets to make accessible. <a href="https://www.access-board.gov/ada/#ada-213_2">https://www.access-board.gov/ada/#ada-213_2</a> <a href="https://www.access-board.gov/ada/#ada-603">https://www.access-board.gov/ada/#ada-603</a>	2012 TAS Section: 213.2 2010 ADAS Section: 213.2 2015 ABAAS Section: F213.2

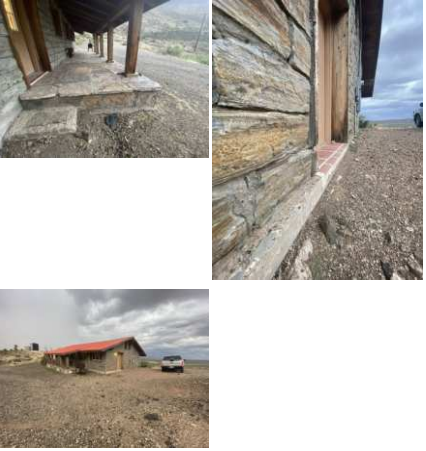
39	Structures on Property (Public) : Bunk House (Exterior) - Pathway to Bunk House	The building entrance is not located on an accessible route. When a building, or portion of a building, is required to be accessible, an accessible route of travel shall be provided to all portions of the building, to accessible building entrances and between the building and the public way. At least one accessible route within the boundary of the site must be provided from public transportation stops, accessible parking and accessible passenger loading zones and public streets or sidewalks to the accessible building entrance they serve. The accessible route shall, to the maximum extent feasible, coincide with the route for the general public. At least one accessible route shall connect accessible buildings, facilities, elements and spaces that are on the same site. At least one accessible route shall connect accessible building or facility entrances with all accessible spaces and elements.	Due to terrain type, lack of accessible pathway, stairs, and door hardware or thresholds there is no way to gain access to building. This building is not accessible	<a href="https://www.access-board.gov/ada/#ada-206_2_1">https://www.access-board.gov/ada/#ada-206_2_1</a>	2012 TAS Section: 206.2.1  2010 ADAS Section: 206.2.1  2015 ABAAS Section: F206.2.1

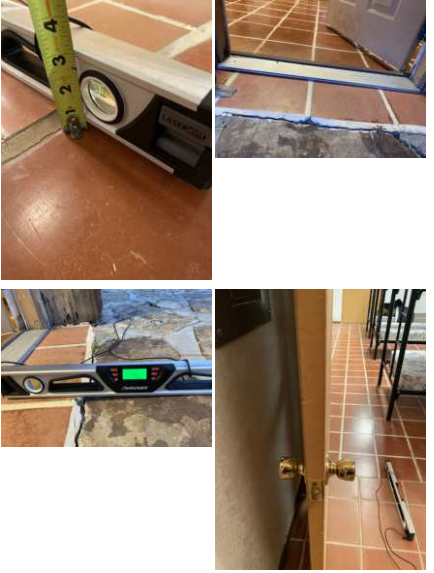
41	Structures on Property (Public) : Bunk House (Interior)	There is a change in level greater than 1/4 inch. 1/4 inch is the maximum vertical rise. Changes in level between 1/4 inch and 1/2 inch must be beveled at 1:2 or less. Changes in level greater than 1/2 inch must be by way of a ramp.	Interior of bunk house has inaccessible locations due to floor sloping or changes in elevation. See additional photos for location details.	<a href="https://www.access-board.gov/ada/#ada-303">https://www.access-board.gov/ada/#ada-303</a>	2012 TAS Section: 303.3  2010 ADAS Section: 303.3  2015 ABAAS Section: 303.3

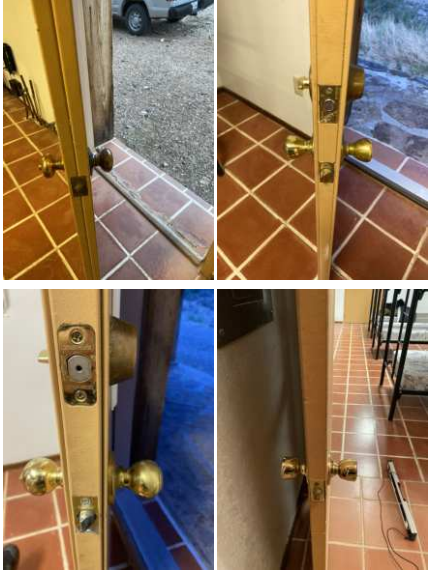
Finding Number	Area Description	Finding	As Built	Recommendation	Citation	Photos	Figure
44	Structures on Property (Public) : Bunk House (Interior) - Entrance/Exit Doors	The door operating hardware requires tight grasping, pinching or twisting of the wrist to operate. Hand-activated hardware, handles, pulls, latches, locks, and other operating devices on accessible elements shall have a shape that is easy to grasp with one hand and does not require tight grasping, pinching or twisting of the wrist to operate.	Door hardware and locking mechanism is not compliant. All doors in bunk house have non compliant hardware.	Review door and threshold componets to make accessible <a href="https://www.access-board.gov/ada/#ada-404">https://www.access-board.gov/ada/#ada-404</a>	2012 TAS Section: 309.4 2010 ADAS Section: 309.4 2015 ABAAS Section: 309.4

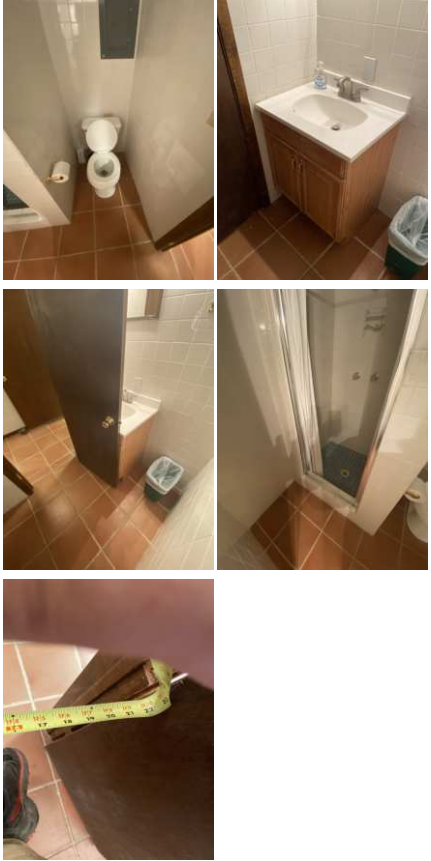
Finding Number	Area Description	Finding	As Built	Recommendation	Citation	Photos	Figure
49	Structures on Property (Public) : Bunk House (Interior) - Restroom Near Kitchen (L) Side (Unisex)	The restroom is not nearly compliant. The restroom does not have the required minimum clear floor space or maneuvering clearances for the toilet. The restroom does not have the required minimum clear floor space or maneuvering clearances for the lavatory. The entry door does not contain the required minimum maneuvering spaces on the pull/push sides. The entry door encroach into the required clear floor space for fixtures. Grab bars are missing and/or incorrectly installed. Accessories, such as toilet seat covers, paper towel holders, garbage cans, hand dryers, and mirrors are either too high or without clear floor space or both. The restroom contain floor level changes greater than a 1/2 inch of the floor drains and is slope (XX) - (XX), the shower is too small and missing numerous accessible elements.	This restroom requires a number of componets to gain compliance. Restroom door hardware not compliant. Near Kitchen (L) side	<a href="https://www.access-board.gov/ada/#ada-213_2">https://www.access-board.gov/ada/#ada-213_2</a> Review restrooms componets to make accessible. <a href="https://www.access-board.gov/ada/#ada-603">https://www.access-board.gov/ada/#ada-603</a>	2012 TAS Section: 213.2  2010 ADAS Section: 213.2  2015 ABAAS Section: F213.2

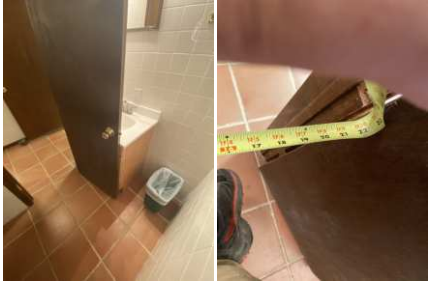
53	Structures on Property (Public) : Bunk House (Interior) - Restroom Near Kitchen (L) Side (Unisex)	The door opening does not provide at least 32 inches between the face of the door and the opposite stop. Door openings shall provide a clear width of 32 inches minimum. Clear openings of doorways with swinging doors shall be measured between the face of the door and the stop, with the door open 90 degrees.	Restroom door hardware and width not compliant.	<a href="https://www.access-board.gov/ada/#ada-404_2_3">https://www.access-board.gov/ada/#ada-404_2_3</a> <a href="https://www.access-board.gov/ada/#ada-404_2_7">https://www.access-board.gov/ada/#ada-404_2_7</a>	2012 TAS Section: 404.2.3  2010 ADAS Section: 404.2.3  2015 ABAAS Section: 404.2.3

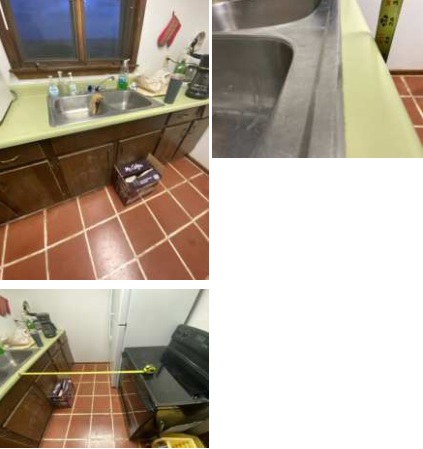
59	Structures on Property (Public) : Bunk House (Interior) - Kitchenette	Knee and toe clearance has not been provided at the sink. The knee clearance shall be 11 inches deep minimum at 9 inches above the finish floor or ground, and 8 inches deep minimum at 27 inches above the finish floor or ground. The toe clearance is the space under the sink between the finish floor or ground and 9 inches above the finish floor 30 inches wide minimum. The toe clearance shall extend a minimum of 17 inches and a maximum of 25 inches underneath the sink.	Knee and toe space is not provided. Knee and toe must be provided since kitchenettes contain stove top range. In kitchens, kitchenettes, and breakrooms without a cooktop or conventional range, a parallel approach is permitted at kitchen sinks.	<a href="https://www.access-board.gov/ada/#ada-606_2">https://www.access-board.gov/ada/#ada-606_2</a>	2012 TAS Section: 606.2  2010 ADAS Section: 606.2  2015 ABAAS Section: 606.2

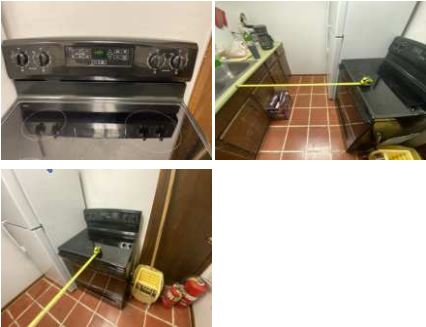
62	Structures on Property (Public) : Bunk House (Interior) - Kitchenette	The controls are located such that operation require reaching across burners. Where knee and toe space is provided, the underside of the range or cooktop shall be insulated or otherwise configured to prevent burns, abrasions, or electrical shock. The location of controls shall not require reaching across burners	Non compliant stove due to reaching across burners.	<a href="https://www.access-board.gov/ada/#ada-804_6_4">https://www.access-board.gov/ada/#ada-804_6_4</a>	2012 TAS Section: 804.6.4  2010 ADAS Section: 804.6.4  2015 ABAAS Section: 804.6.4

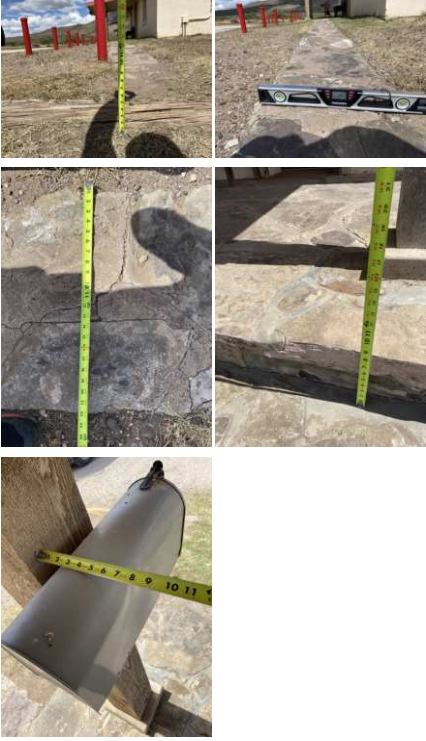
Finding Number	Area Description	Finding	As Built	Recommendation	Citation	Photos	Figure
65	Structures on Property (Public) : Office (Exterior) - Pathway to Office	The path of contains multiple issues and is not accessible. The path of travel exceeds the maximum allowable cross and running slope requirements. It also contains changes in level and/or gaps that exceed the allowable maximum requirements. The path of travel does not meet the minimum width requirements for clearances, turning spaces, and/or passing spaces. The floor or ground surface is not firm, stable, and slip resistant.	Pathway is not compliant due to sloping, width, elevation changes, obstructions, and terrain type. All of these componets would need to be reviewed to make accessible. Pathway has multiple infractions	Review accessible pathway componets to make accessible <a href="https://www.access-board.gov/ada/#ada-402">https://www.access-board.gov/ada/#ada-402</a> <a href="https://www.access-board.gov/ada/#ada-403_1">https://www.access-board.gov/ada/#ada-403_1</a>	2010 ADAS Section: 403.1  2015 ABAAS Section: 403.1

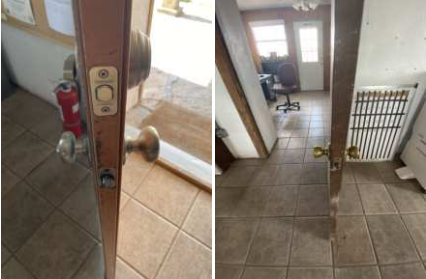
66	Structures on Property (Public) : Office (Interior)	Minimum maneuvering clearances at doors and gates shall comply with 404.2.4. Maneuvering clearances shall extend the full width of the doorway and the required latch side or hinge side clearance. Maneuvering clearances shall have a max slope of 2.08%. Door openings shall provide a clear width of 32 inches (815 mm) minimum. Clear openings of doorways with swinging doors shall be measured between the face of the door and the stop, with the door open 90 degrees. Openings more than 24 inches (610 mm) deep shall provide a clear opening of 36 inches (915 mm) minimum. There shall be no projections into the required clear opening width lower than 34 inches (865 mm) above the finish floor or ground. Projections into	Doors General Requirments- Multiple Violations More than 60% doors/entrances are equipped with non-compliant hardware. Most doorway thresholds in exceed 1/2" tolerance.	Review all door and doorway componets <a href="https://www.access-board.gov/ada/#ada-404">https://www.access-board.gov/ada/#ada-404</a>	2010 ADAS Section: 404.2.3, 404.2.7, 404.2.4, 404.2.11, 404.2.11 Exception

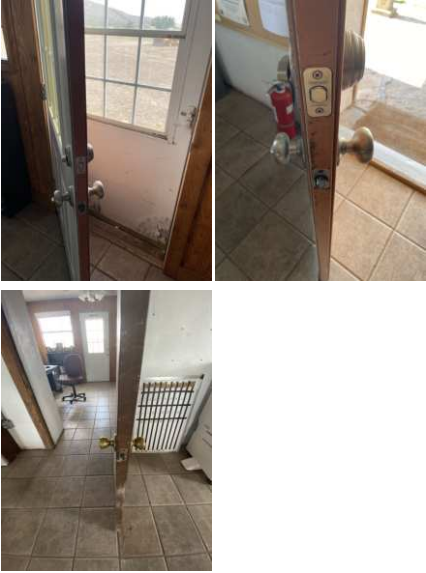
68	Structures on Property (Public) : Office (Interior) - Entrance/Exit Doors	The door operating hardware requires tight grasping, pinching or twisting of the wrist to operate. Hand-activated hardware, handles, pulls, latches, locks, and other operating devices on accessible elements shall have a shape that is easy to grasp with one hand and does not require tight grasping, pinching or twisting of the wrist to operate.	Door hardware is not compliant.	Review door and threshold componets to make accessible <a href="https://www.access-board.gov/ada/#ada-404">https://www.access-board.gov/ada/#ada-404</a>	2012 TAS Section: 309.4  2010 ADAS Section: 309.4  2015 ABAAS Section: 309.4

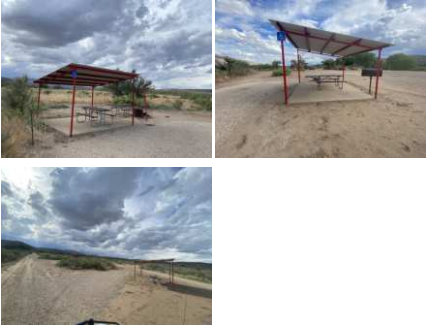
73	Outdoor Features (Public) : Campsites	A minimum of one of each type of outdoor constructed feature does not have mobility features. Where provided, at least one of each type of outdoor constructed features with mobility features must be provided.	This campsite is considered accessible option and efforts made to increase access. Install needed items to gain full compliance. 3 of the 12 campsites are marked accessible. Sites feature compliant concrete pad, with compliant picnic table. Fire rings and accessible routes to camping pads are not compliant or need review.	Link provided below outlines the best practices guidelines. <a href="https://www.access-board.gov/aba/#aba-1014">https://www.access-board.gov/aba/#aba-1014</a> Upgrade ADA camp site	2015 ABAAS Section: F244.2.3.1, F245.2.5.1

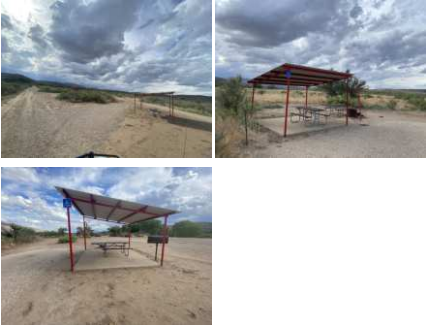
74	Outdoor Features (Public) : Campsites	The parking space/pull up space is not firm and stable. The surface of parking spaces and pull-up spaces shall be firm and stable.	There is no accessible parking provided.	N/A - Refer to Finding	2015 ABAAS Section: 1012.4

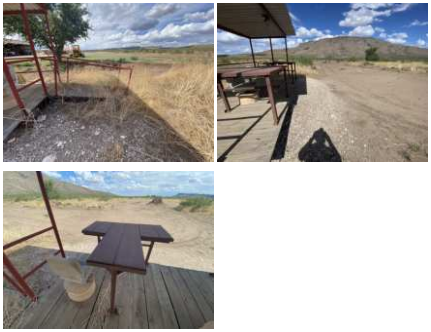
Finding Number	Area Description	Finding	As Built	Recommendation	Citation	Photos	Figure
75	Outdoor Features (Public) : Gun Range	There is not one of each type of outdoor constructed features with mobility features located in the common uses and public use areas. Where provided in common use and public use areas that serve picnic units with mobility features, at least 20 percent, but not less than one, of each type of outdoor constructed feature must be provided at each location.	No accessible version provided.	There are no enforceable standards for shooting range at this time. Best practices recommend installing 20% accessible features. Clear floor space, stable surface, and shooting surface deck height. Provide accessible shooting station to extent possible. Including provide accessible route to element area.	2015 ABAAS Section: F245.3
