# Guadalupe Delta WMA- ADA Evaluation

**WMA- Guadalupe Delta, Port LaVaca Tx, ADA Evaluati**

**Accessibility Evaluation**

**Inspection Date: 01/05/2022**

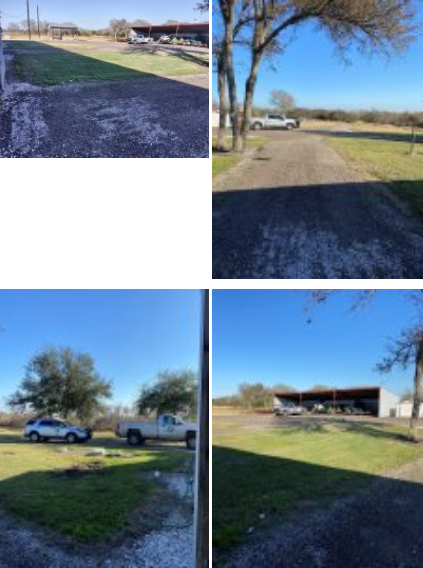
2	Exterior of Property (Public): Parking Lot ( 0 Spaces) - Van Spot Requirements	The parking space is in not nearly compliant. The parking space the minimum width. The floor or ground surface is not firm stable or slip resistant. The parking space contains changes in level and/or gaps that exceed the maximum allowable requirements. The parking space does not have the proper identifications signs or the signs are not installed at the correct height. The parking space is missing an adjacent access aisle.	There is no compliant ADA parking provided at this time.	<a href="https://www.access-board.gov/aba/#aba-502_1">https://www.access-board.gov/aba/#aba-502_1</a> <a href="https://www.access-board.gov/aba/#aba-502_2">https://www.access-board.gov/aba/#aba-502_2</a>	2012 TAS Section: 502.1, 502.1 Exception  2010 ADAS Section: 502.1, 502.1 Exception  2015 ABAAS Section: 502.1, 502.1 Exception

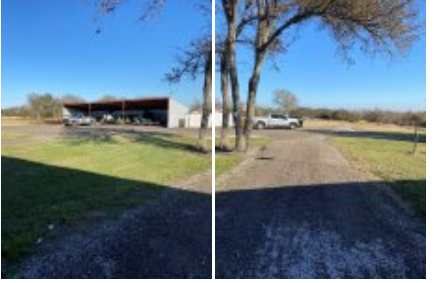
Finding Number	Area Description	Finding	As Built	Recommendation	Citation	Photos	Figure
3	Exterior of Property (Public): Parking Lot ( 0 Spaces) - Access Aisle Requirments (Van)	The access aisle is in not nearly compliant. The access ai the minimum width. The access aisle is not as long as the parking space it serves. There are no markings to discourage parking. The floor or ground surface is not firm stable or slip resistant. The parking space contains changes in level and/or gaps that exceed the maximum allowable requirements.	There is no access aisle provided. Gravel surfacing material is not compliant for access aisle and missing boundary markings. Access aisle width requirments depend on van stall size. van stall 11' access aisle 5' or van stall 8' access aisle 8'	https://www.access-board.gov/ada/#ada-502_3	2012 TAS Section: 502.3 2010 ADAS Section: 502.3 2015 ABAAS Section: 502.3

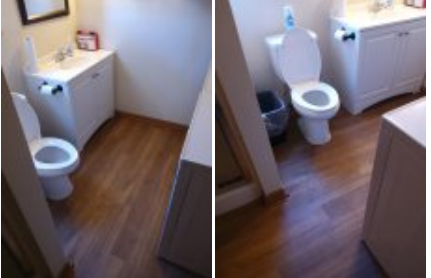
Finding Number	Area Description	Finding	As Built	Recommendation	Citation	Photos	Figure
8	Structures on Property (Public) : HQ Building - Restroom/Laundry Room	The restroom is not nearly compliant. The restroom does not have the required minimum clear floor space or maneuvering clearances for the toilet. The restroom does not have the required minimum clear floor space or maneuvering clearances for the lavatory. The entry door does not contain the required minimum maneuvering spaces on the pull/push sides. The entry door encroach into the required clear floor space for fixtures. Grab bars are missing and/or incorrectly installed. Accessories, such as toilet seat covers, paper towel holders, garbage cans, hand dryers, and mirrors are either too high or without clear floor space or both. The restroom contain floor level changes greater than a 1/2 inch of the floor drains and is slope (XX) - (XX), the shower is too small and missing numerous accessible elements.	This restroom requires a number of componets to gain compliance.	Review restrooms componets of chapter 6 to make accessible. <a href="https://www.access-board.gov/ada/#ada-213_2">https://www.access-board.gov/ada/#ada-213_2</a> <a href="https://www.access-board.gov/ada/#ada-601">https://www.access-board.gov/ada/#ada-601</a>	2012 TAS Section: 213.2 2010 ADAS Section: 213.2 2015 ABAAS Section: F213.2

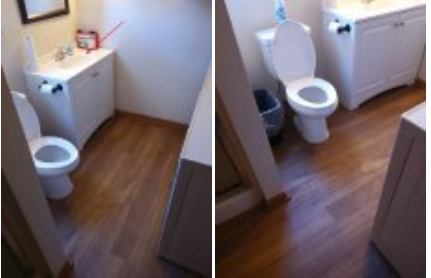
9	Structures on Property (Public) : HQ Building - Restroom/Laundry Room	There are not enough accessible lavatories. Where lavatories are provided, at least one shall be accessible and shall not be located in a toilet compartment.	Restroom sinks are required to have front approach with knee and toe space provided. Sink accessories are not accessible.	Review lavatory componets to make accessible. <a href="https://www.access-board.gov/ada/#ada-213_3_4">https://www.access-board.gov/ada/#ada-213_3_4</a> <a href="https://www.access-board.gov/ada/#ada-606">https://www.access-board.gov/ada/#ada-606</a>	2012 TAS Section: 213.3.4 2010 ADAS Section: 213.3.4 2015 ABAAS Section: F213.3.4

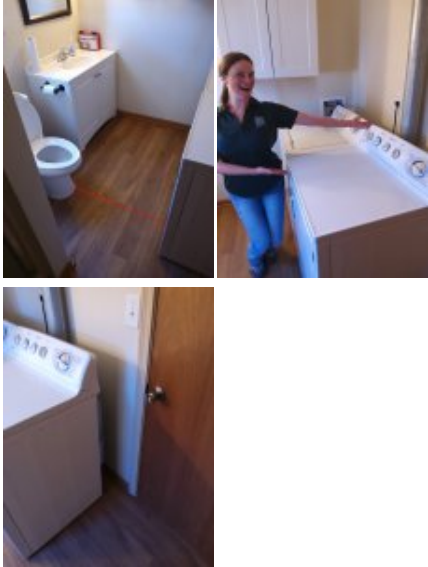
11	Structures on Property (Public) : HQ Building - Restroom/Laundry Room	There is insufficient turning space within this room or space. A Circular space or a T-shaped space must be provided. Turning space shall either be a 60" Circular Space or T-Shaped Space. Doors cannot swing into this space by more than 12 inches Circular Space. The turning space shall be a space of 60 inches diameter minimum. The space shall be permitted to include knee and toe clearance. T-Shaped Space. The turning space shall be a T-shaped space within a 60 inch square minimum with arms and base 36 inches wide minimum. Each arm of the T shall be clear of obstructions 12 inches minimum in each direction and the base shall be clear of obstructions 24 inches minimum. The space shall be permitted to include knee and toe clearance.	Restroom clear floor space limited by washer and dryer placement.	Review grab bar componets to make accessible	2012 TAS Section: 304.3.1, 304.3.2  2010 ADAS Section: 304.3.1, 304.3.2

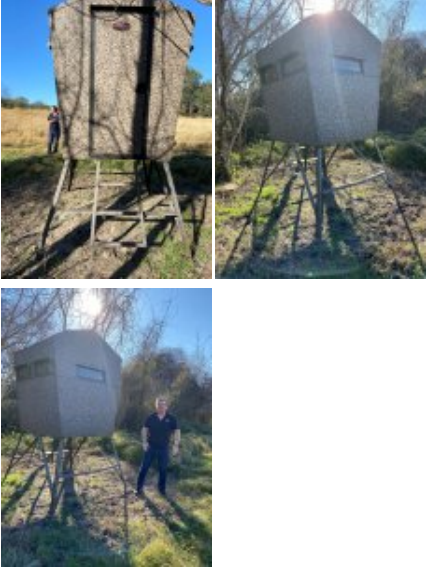
Finding Number	Area Description	Finding	As Built	Recommendation	Citation	Photos	Figure
12	Outdoor Features (Public) : Hunting Blinds	There are not enough outdoor constructed features with mobility features located in the common uses and public use areas. Where provided in common use and public use areas that serve picnic units with mobility features, at least 20 percent, but not less than one, of each type of outdoor constructed feature must be provided at each location.	There are no blinds with accessible features at this time. Hunters at this location are issued information in advance containing the following language: "All hunters should be physically able to climb and hunt out of 5-foot box blind. Hunters with mobility disabilities may hunt from a stationary motor vehicle. Please notify the hunt manager if any special requirements are needed. "	There are no enforceable standards for hunting blinds at this time. Best practices recommend installing 20% accessible features. Clear floor space, stable surface, and shooting surface deck height.	2015 ABAAS Section: F245.3
