Lower Neches WMA- ADA Evaluation

WMA- Lower Neches, Bridge City TX, ADA Evaluation

Accessibility Evaluation

Inspection Date: 07/18/2022

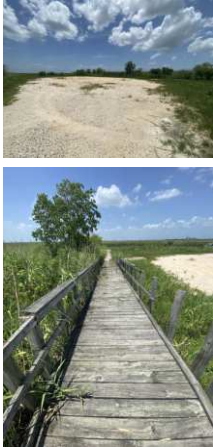
Finding Number	Area Description	Finding	As Built	Recommendation	Citation	Photos	Figure
1	Exterior of Property (Public): Wildlife Viewing Parking Lot (0 Spaces)	There are no accessible parking stalls. Each lot where parking is provided for the public as clients, guests or employees, shall provide accessible parking and shall be located on the shortest accessible route of travel from adjacent parking to an accessible entrance. There are a total of (XX) parking stalls in the parking lot that could be reasonably associated with this facility. There should be a minimum of (XX) accessible stalls with a minimum of (XX) being designed as van accessible.	Parking lot is not compliant due to surfacing material and striping requirements.	Review parking stall and access aisle requirements https://www.access-board.gov/ada/#ada-208_2 https://www.access-board.gov/ada/#ada-502	2012 TAS Section: 208.2 2010 ADAS Section: 208.2 2015 ABAAS Section: F208.2

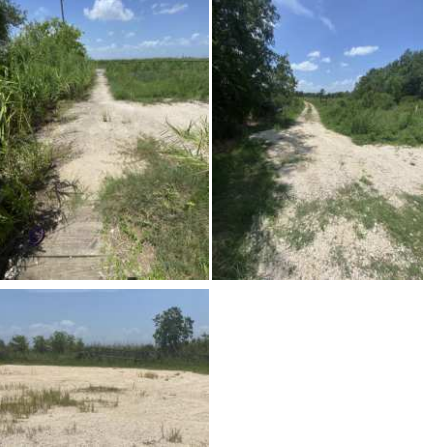
Finding Number	Area Description	Finding	As Built	Recommendation	Citation	Photos	Figure
4	Outdoor Features (Public) : Wildlife viewing Blinds/Towers	There is no accessible route to the element. At least one accessible route shall connect accessible buildings, accessible facilities, accessible elements, and accessible spaces that are on the same site.	This element is not accessible.	https://www.access-board.gov/ada/#ada-206_2_2	2012 TAS Section: 206.2.2 2010 ADAS Section: 206.2.2 2015 ABAAS Section: F206.2.2

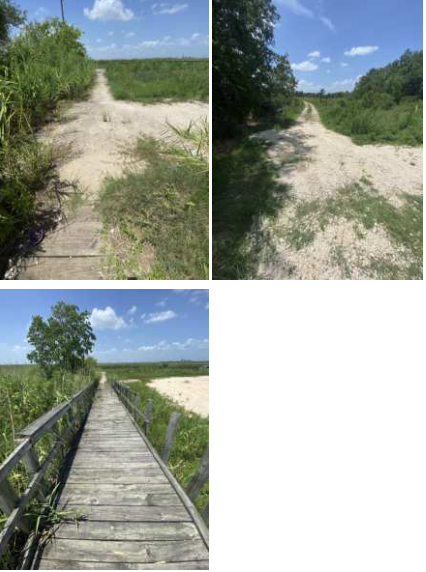
5	Outdoor Features (Public) : Wildlife viewing Blinds/Towers	The path of contains multiple issues and is not accessible. The path of travel exceeds the maximum allowable cross and running slope requirements. It also contains changes in level and/or gaps that exceed the allowable maximum requirements. The path of travel does not meet the minimum width requirements for clearances, turning spaces, and/or passing spaces. The floor or ground surface is not firm, stable, and slip resistant.	Due to terrain and change in elevation pathway is not compliant This feature is not accessible Pathway has multiple infractions.	Review accessible pathway componets to make accessible https://www.access-board.gov/ada/#ada-402 https://www.access-board.gov/ada/#ada-403_1	2010 ADAS Section: 403.1 2015 ABAAS Section: 403.1

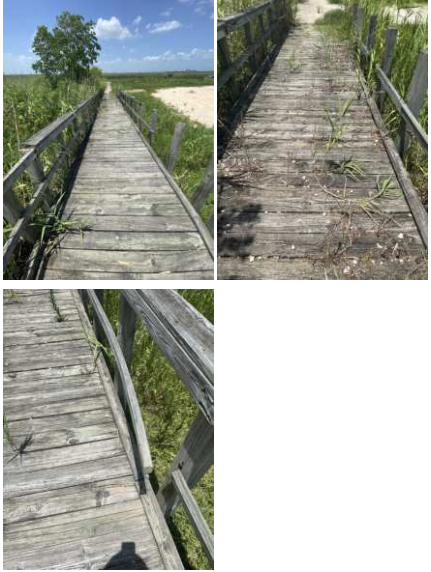
Finding Number	Area Description	Finding	As Built	Recommendation	Citation	Photos	Figure
6	Outdoor Features (Public) : Wildlife viewing Blinds/Towers - Ramp/Boardwalk	The required edge protection is missing from the ramp run and/or ramp landing. Edge protection shall be provided on each side of ramp runs and at each side of ramp landings. The floor or ground surface of the ramp run or landing shall extend 12 inches minimum beyond the inside face of a handrail or a curb or barrier shall be provided that prevents the passage of a 4 inch diameter sphere, where any portion of the sphere is within 4 inches of the finish floor or ground surface.	Edge protection and other elements of ramp are not compliant. Ramp has multiple infractions. Ramp in need of repair and upgrade.	Review ramp componets to make accessible. https://www.access-board.gov/aba/#aba-405 Edge protection https://www.access-board.gov/ada/#ada-405_9 Extended ground or floor surface https://www.access-board.gov/ada/#ada-405_9_1 Curb or barrier https://www.access-board.gov/ada/#ada-405_9_2	2012 TAS Section: 405.9.1, 405.9.2, 405.9 2010 ADAS Section: 405.9.2, 405.9.1, 405.9 2015 ABAAS Section: 405.9, 405.9.1, 405.9.2
