Mad Island WMA- ADA Evaluation

WMA- Mad Island, Palacios TX, ADA Evaluation

Accessibility Evaluation

Inspection Date: 07/28/2022

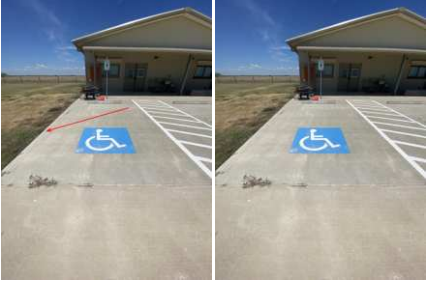
Finding Number	Area Description	Finding	As Built	Recommendation	Citation	Photos	Figure
1	Exterior of Property (Public): HQ Parking Lot (1 Space) ! Van - Van Accessible Stall	The stripe is missing at the left side of the left parking stall which identifies its border. Vehicle spaces shall be marked to define the width, and shall have an adjacent access aisle.	(L) side missing, required to measure full width of parking stall.	https://www.access-board.gov/aba/#aba-502_2	2012 TAS Section: 502.2 2010 ADAS Section: 502.2 2015 ABAAS Section: 502.2

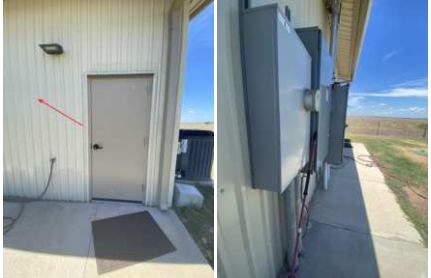
Finding Number	Area Description	Finding	As Built	Recommendation	Citation	Photos	Figure
2	Structures on Property (Public) : HQ Building (Exterior)	Where existing toilet rooms or bathing rooms do not comply, directional signs indicating the location of the nearest accessible toilet room or bathing room within the facility shall be provided. Signs shall include the International Symbol of Accessibility. Where existing toilet rooms or bathing rooms do comply, the accessible toilet rooms or bathing rooms shall be identified by the International Symbol of Accessibility. Where clustered single user toilet rooms or bathing facilities are permitted, accessible toilet rooms or bathing facilities shall be identified by the International Symbol of Accessibility unless all toilet rooms and bathing facilities are accessible.	There is no directional sign identifying accessible restroom. There is no sign identifying this is restroom Signs that provide direction to or information about interior spaces and facilities must meet visual requirements but are not required to be tactile	https://www.access-board.gov/aba/#aba-f216_8	2010 ADAS Section: 216.8 2015 ABAAS Section: F216.8

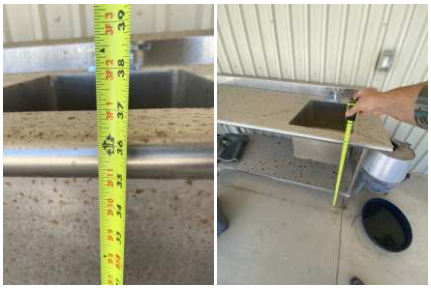
Finding Number	Area Description	Finding	As Built	Recommendation	Citation	Photos	Figure
5	Structures on Property (Public) : HQ Building (Exterior) - Outdoor Sink	The top of the sink is above the allowable height requirement. Sinks shall be installed with the front of the higher of the rim or counter surface 34 inches maximum above the finish floor or ground.	Sinks are not accessible via frontal or parallel approach due to rim height. Sinks do not require knee and toe space since there is no stove top oven in vicinity. sink rim height measures at 36"	https://www.access-board.gov/aba/#aba-606_3	2012 TAS Section: 606.3 2010 ADAS Section: 606.3 2015 ABAAS Section: 606.3

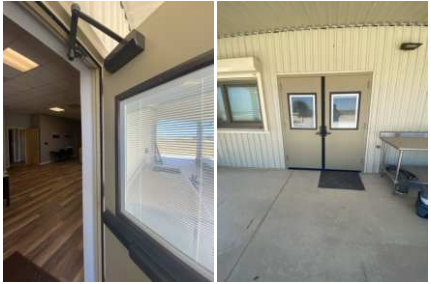
7	Structures on Property (Public) : HQ Building (Interior) - Entrance/Exit Doors	The door is equipped with a door closer and returns to a closed position too quickly. Door closers and gate closers shall be adjusted so that from an open position of 90 degrees, the time required to move the door to a position of 12 degrees from the latch is 5 seconds minimum.	Door closes faster than 5 second allowance	https://www.access-board.gov/aba/#aba-404_2_8_1	2012 TAS Section: 404.2.8.1 2010 ADAS Section: 404.2.8.1 2015 ABAAS Section: 404.2.8.1

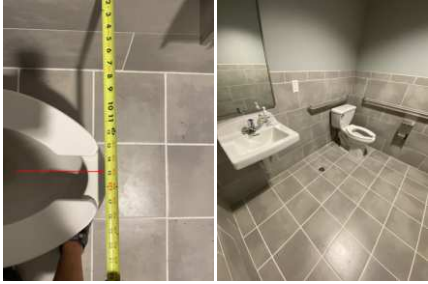
12	Structures on Property (Public) : HQ Building (Interior) - Restroom (Unisex)	The toilet is not located within the range allowed from the side wall or partition. The centerline of the toilet must be 16 to 18 inches from the side wall.	Less than 16", measures at 15"	https://www.access-board.gov/ada/#ada-604_2	2012 TAS Section: 604.2 2010 ADAS Section: 604.2 2015 ABAAS Section: 604.2

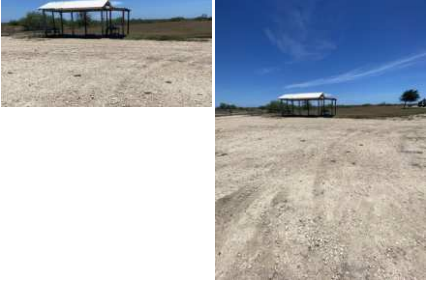
Finding Number	Area Description	Finding	As Built	Recommendation	Citation	Photos	Figure
19	Structures on Property (Public) : Cleaning/Check Station - Pathway to Cleaning/Check Station	The path of contains multiple issues and is not accessible. The path of travel exceeds the maximum allowable cross and running slope requirements. It also contains changes in level and/or gaps that exceed the allowable maximum requirements. The path of travel does not meet the minimum width requirements for clearances, turning spaces, and/or passing spaces. The floor or ground surface is not firm, stable, and slip resistant.	Due to terrain and change in elevation pathway is not compliant This element is not accessible	Review accessible pathway componets to make accessible https://www.access-board.gov/ada/#ada-402 https://www.access-board.gov/ada/#ada-403_1	2010 ADAS Section: 403.1 2015 ABAAS Section: 403.1

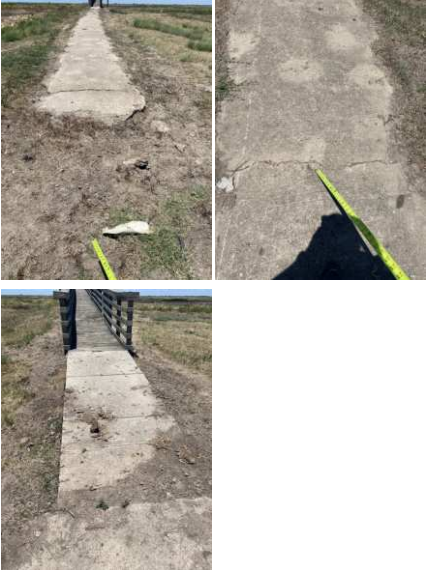
Finding Number	Area Description	Finding	As Built	Recommendation	Citation	Photos	Figure
23	Outdoor Features (Public) : Wildlife Viewing Deck - Pathway to Wildlife Viewing Deck	The path of contains multiple issues and is not accessible. The path of travel exceeds the maximum allowable cross and running slope requirements. It also contains changes in level and/or gaps that exceed the allowable maximum requirements. The path of travel does not meet the minimum width requirements for clearances, turning spaces, and/or passing spaces. The floor or ground surface is not firm, stable, and slip resistant.	Pathway has multiple infractions Pathway is not compliant due to sloping, width, elevation changes, and terrain type. This element is not accessible.	Review accessible pathway componets to make accessible https://www.access-board.gov/ada/#ada-402 https://www.access-board.gov/ada/#ada-403_1	2010 ADAS Section: 403.1 2015 ABAAS Section: 403.1

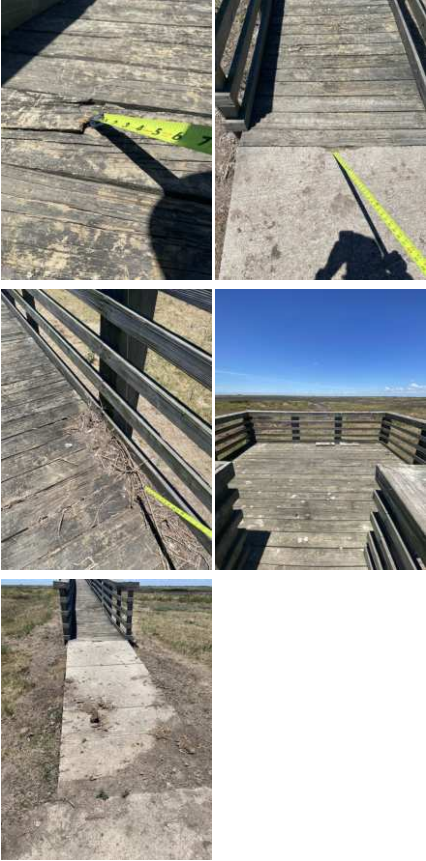
Finding Number	Area Description	Finding	As Built	Recommendation	Citation	Photos	Figure
24	Outdoor Features (Public) : Wildlife Viewing Deck - Ramp/Boardwalk	The ramp contains surface materials that do not provide for a stable, firm slip resistant surface. Floor and ground surfaces shall be stable, firm, and slip resistant.	Boardwalk is in need of repair, broken boards and has debris limiting access. Ramp slope and surfacing material need review and look to be non complaint. Edge protection and other elements of ramp are not compliant. Ramp has multiple infractions	Review ramp componets to make accessible. https://www.access-board.gov/aba/#aba-405	2012 TAS Section: 302.1, 405.4 2010 ADAS Section: 302.1, 405.4 2015 ABAAS Section: 302.1, 405.4
