Mason Mt WMA- ADA Evaluation

WMA- Mason Mt, Mason TX, ADA Evaluation

Accessibility Evaluation

Inspection Date: 06/16/2022

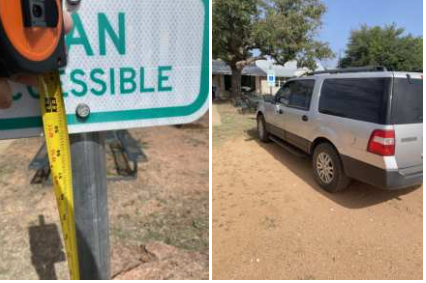
Finding Number	Area Description	Finding	As Built	Recommendation	Citation	Photos	Figure
4	Exterior of Property (Public): Lodge Parking Lot (2 Spaces) 2 Van - Van Accessible Stall (R) Side	The parking sign is mounted too low. Parking space identification signs shall include the International Symbol of Accessibility. Signs identifying van parking spaces shall contain the designation "van accessible." Signs shall be 60 inches minimum above the finish floor or ground surface measured to the bottom of the sign.	Measures under 60"		https://www.access-board.gov/aba/#aba-502_6 2012 TAS Section: 502.6 2010 ADAS Section: 502.6 2015 ABAAS Section: 502.6

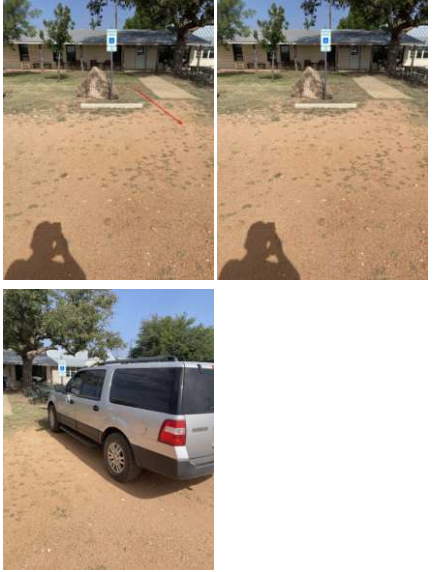
Finding Number	Area Description	Finding	As Built	Recommendation	Citation	Photos	Figure
6	Exterior of Property (Public): Lodge Parking Lot (2 Spaces) 2 Van - Access Aisle (Shared)	The access aisle is in not nearly compliant. The access ai the minimum width. The access aisle is not as long as the parking space it serves. There are no markings to discourage parking. The floor or ground surface is not firm stable or slip resistant. The parking space contains changes in level and/or gaps that exceed the maximum allowable requirements.	There is no access aisle provided. Gravel surfacing material is not compliant for access aisle and missing boundary markings. Access aisle width requirments depend on van stall size. van stall 11' access aisle 5' or van stall 8' access aisle 8'	https://www.access-board.gov/aba/#aba-502_3	2012 TAS Section: 502.3 2010 ADAS Section: 502.3 2015 ABAAS Section: 502.3

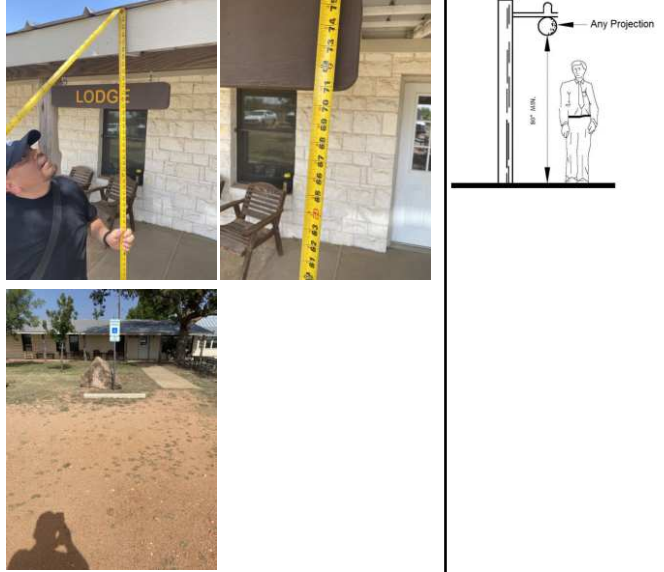
Finding Number	Area Description	Finding	As Built	Recommendation	Citation	Photos	Figure
7	Structures on Property (Public) : Lodge/TPWD Office (Exterior) - Pathway to Lodge/TPWD Office Building	The element extends down too close to the route of travel. Any obstruction that overhangs a route of travel must be a minimum of 80 inches above the walking surface as measured to the bottom of the obstruction.	Obstruction at 71" high		https://www.access-board.gov/aba/#aba-307_3	2012 TAS Section: 307.3 2010 ADAS Section: 307.3 2015 ABAAS Section: 307.3

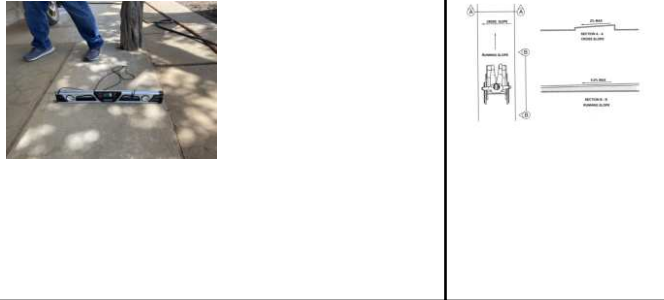
8	Structures on Property (Public) : Lodge/TPWD Office (Exterior) - Pathway to Lodge/TPWD Office Building	The accessible route between the building entrance and the accessible parking has running slopes greater than 5% and has not been constructed as a ramp (i.e. handrails, edge protection, etc.). When the slope in the direction of travel of any walk exceeds 1 unit vertical in 20 units horizontal (5-percent slope), it must be constructed as a ramp. Surface cross slopes must not exceed one unit vertical in 48 units horizontal (2-percent slope).	slope measured at 6.5%		https://www.access-board.gov/aba/#aba-403_3	2012 TAS Section: 403.3 2010 ADAS Section: 403.3 2015 ABAAS Section: 403.3

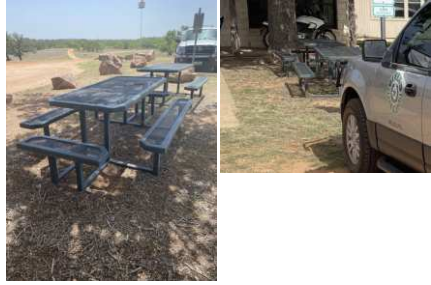
9	Structures on Property (Public) : Lodge/TPWD Office (Exterior) - Picnic Area (Front)	All of the picnic units do not provide mobility features. Where picnic facilities contain two or fewer picnic units, each picnic unit shall provide mobility features.	Ground/surface material not compliant around picnic tables. Exterior pathway leading to tables non-compliant. There are no accessible picnic tables provided	Provide compliant picnic table Knee space for wheelchair seating must be at least 30 inches wide, 19 inches deep, and 27 inches high, as measured from the ground or floor to the bottom of the tabletop. Toe clearance of at least 9 inches above the ground or floor must extend at least an additional 5 inches beyond the knee clearance.	2015 ABAAS Section: F245.2.1

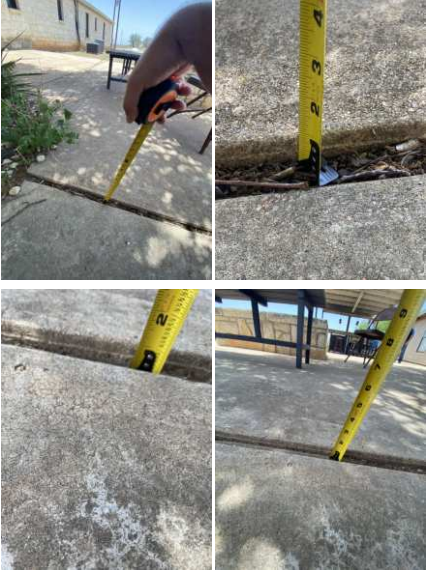
Finding Number	Area Description	Finding	As Built	Recommendation	Citation	Photos	Figure
10	Structures on Property (Public) : Lodge/TPWD Office (Exterior) - Back Porch Area	The route contains openings greater than 1/2 inch. Openings in floor or ground surfaces shall not allow passage of a sphere more than 1/2 inch diameter. Elongated openings shall be placed so that the long dimension is perpendicular to the dominant direction of travel.	There are several locations where exterior pathway gap exceeds 1/2" tolerance. See additional photos for location of gap noncompliance on accessible pathway around back porch area.	https://www.access-board.gov/aba/#aba-302_3	2012 TAS Section: 302.3 2010 ADAS Section: 302.3 2015 ABAAS Section: 302.3

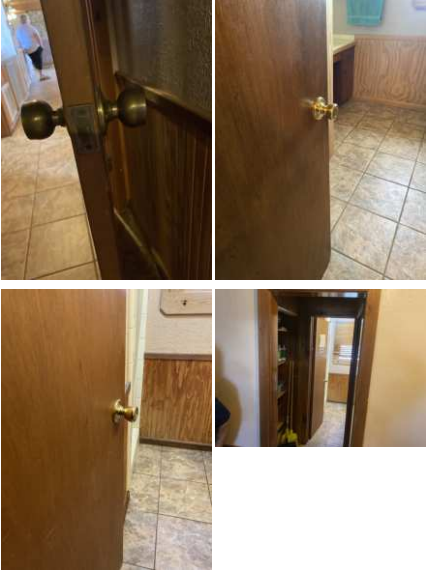
Finding Number	Area Description	Finding	As Built	Recommendation	Citation	Photos	Figure	
12	Structures on Property (Public) : Lodge/TWPD Office (Interior)	The door/gate operating hardware is not accessible. Hand-activated door/gate opening hardware, handles, pulls, latches, locks, and other operating devices on accessible doors shall have a shape that is easy to grasp with one hand and does not require tight grasping, pinching or twisting of the wrist to operate. Hardware shall be 34 inches minimum and 48 inches maximum above the finish floor or ground.	All interior doors are equipped with non accessible hardware. More than 60% doors/entrances are equipped with non-compliant hardware.		https://www.access-board.gov/aba/#aba-404_2_7 https://www.access-board.gov/aba/#aba-309_4	2012 TAS Section: 404.2.7 2010 ADAS Section: 404.2.7 2015 ABAAS Section: 404.2.7

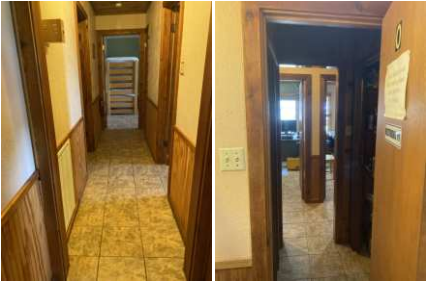
13	Structures on Property (Public) : Lodge/TWPD Office (Interior)	The public restrooms serving the facility are not on an accessible route. Bathing and toilet facilities that serve buildings, facilities or portions of buildings or facilities that are required to be accessible to persons with disabilities, shall be on an accessible route.	Routes to restrooms are not accessible due to doorway narrowing and non compliant hardware.		https://www.access-board.gov/aba/#aba-f206_2_4	2012 TAS Section: 206.2.4 2010 ADAS Section: 206.2.4 2015 ABAAS Section: F206.2.4

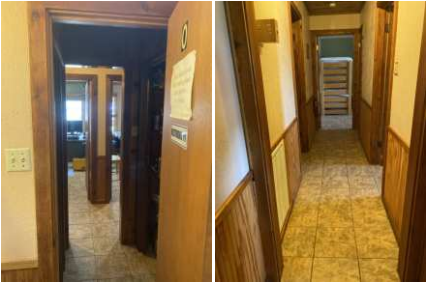
14	Structures on Property (Public) : Lodge/TWPD Office (Interior)	The path of contains multiple issues and is not accessible. The path of travel exceeds the maximum allowable cross and running slope requirements. It also contains changes in level and/or gaps that exceed the allowable maximum requirements. The path of travel does not meet the minimum width requirements for clearances, turning spaces, and/or passing spaces. The floor or ground surface is not firm, stable, and slip resistant.	Routes are impeded by threshold narrowing, door knobs, or protruding objects.		https://www.access-board.gov/ada/#ada-403_1	2012 TAS Section: 403.1 2010 ADAS Section: 403.1 2015 ABAAS Section: 403.1

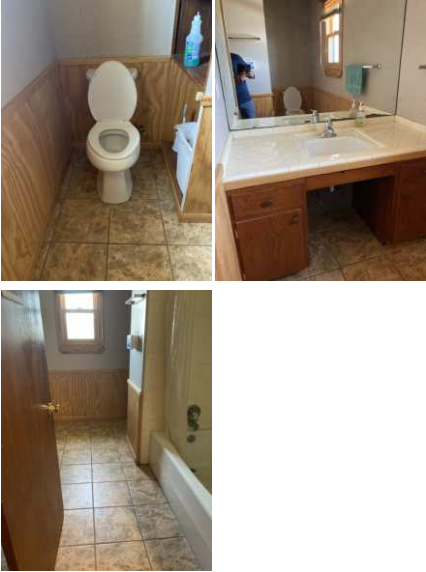
20	Structures on Property (Public) : Lodge/TWPD Office (Interior) - Restroom #2 (Unisex)	The restroom is not nearly compliant. The restroom does not have the required minimum clear floor space or maneuvering clearances for the toilet. The restroom does not have the required minimum clear floor space or maneuvering clearances for the lavatory. The entry door does not contain the required minimum maneuvering spaces on the pull/push sides. The entry door encroach into the required clear floor space for fixtures. Grab bars are missing and/or incorrectly installed. Accessories, such as toilet seat covers, paper towel holders, garbage cans, hand dryers, and mirrors are either too high or without clear floor space or both. The restroom contain floor level changes greater than a 1/2 inch of the floor drains and is slope (XX) - (XX), the shower is too small and missing numerous accessible elements.	This restroom requires a number of componets to gain compliance.	https://www.access-board.gov/ada/#ada-213_2 Review restrooms componets to make accessible. https://www.access-board.gov/ada/#ada-603	2012 TAS Section: 213.2 2010 ADAS Section: 213.2 2015 ABAAS Section: F213.2

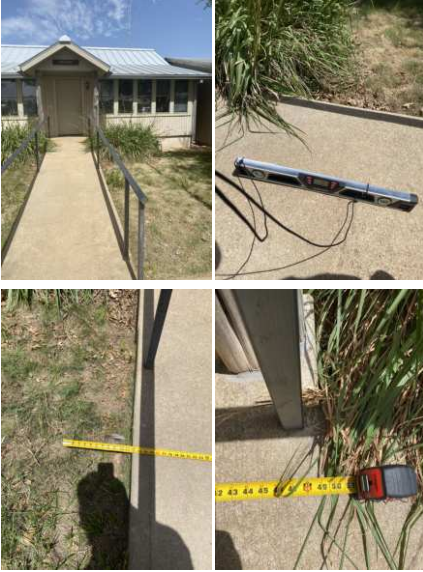
Finding Number	Area Description	Finding	As Built	Recommendation	Citation	Photos	Figure
24	Structures on Property (Public) : Public Office (Exterior) - Path of Travel Ramp Run (Main Route)	The ramps exceeds the maximum running slope (direction of travel) allowable of 8.33%. Ramps should have the least possible slope but in no case more than 8.3% (1:12).	Ramp run has multiple infractions, including no edge protection, slope non compliance, and no ramp landings.	Review ramp componets to make accessible. https://www.access-board.gov/aba/#aba-405 Edge protection https://www.access-board.gov/ada/#ada-405_9 Extended ground or floor surface https://www.access-board.gov/ada/#ada-405_9_1 Curb or barrier https://www.access-board.gov/ada/#ada-405_9_2	2012 TAS Section: 405.2 2010 ADAS Section: 405.2 2015 ABAAS Section: 405.2

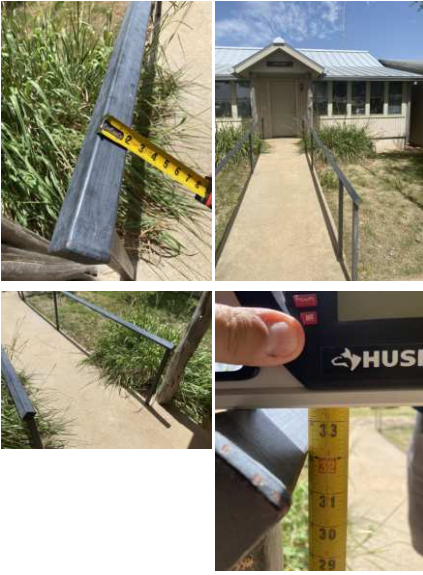
25	Structures on Property (Public) : Public Office (Exterior) - Path of Travel Ramp Run (Main Route)	The ramp does not have compliant handrails. Handrails are required on both sides of all surfaces that are sloped greater than 5 percent (1:20). Handrails must be between 34 inches and 38 inches above the ramp surface, and must extend horizontally 12 inches beyond the top and bottom of the ramp. The diameter of the handrails must be 1 1/4 inches minimum and 2 inches maximum in cross-sectional nominal dimension for circular handrails. Handrail gripping surfaces with a non-circular cross section shall have a perimeter dimension of 4 inches minimum and 6 1/4 inches maximum, and a cross-section dimension of 2 1/4 inches maximum. The space between handrails and walls must be 1-1/2 inches minimum.	Handrails type, style, and instillation are not compliant.	Review handrail componets to make accessible https://www.access-board.gov/aba/#aba-505_1	2012 TAS Section: 505.1 2010 ADAS Section: 505.1 2015 ABAAS Section: 505.1

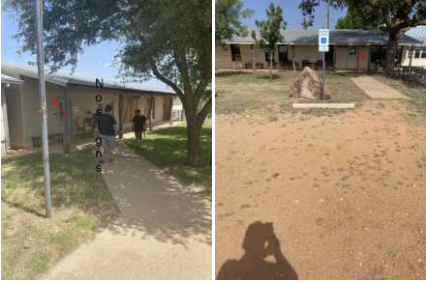
Finding Number	Area Description	Finding	As Built	Recommendation	Citation	Photos	Figure
26	Structures on Property (Public) : Pavilion (Exterior) - Pathway to Pavilion	Provide directional signage to the nearest accessible restrooms. Where existing toilet rooms or bathing rooms are not accessible, directional signs indicating the location of the nearest accessible toilet room or bathing room within the facility shall be provided. The signs shall include the International Symbol of Accessibility (ISA). Where existing toilet rooms or bathing rooms are not accessible, accessible toilet rooms or bathing rooms shall be identified by an ISA.	There are no posterior signs indicating where accessible restrooms are located. Sign can be placed on Lodge or Pavilion building.	https://www.access-board.gov/aba/#aba-f216_8	2012 TAS Section: 216.8 2010 ADAS Section: 216.8 2015 ABAAS Section: F216.8

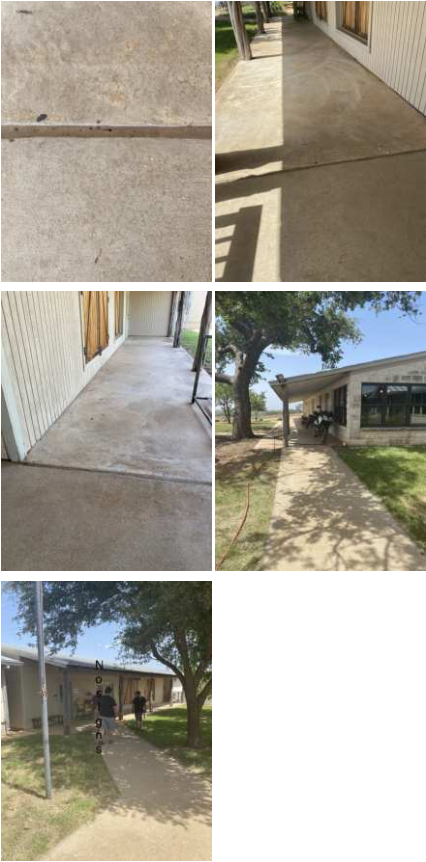
27	Structures on Property (Public) : Pavilion (Exterior) - Pathway to Pavilion	The route contains openings greater than 1/2 inch. Openings in floor or ground surfaces shall not allow passage of a sphere more than 1/2 inch diameter. Elongated openings shall be placed so that the long dimension is perpendicular to the dominant direction of travel.	There are several locations where exterior pathway gap exceeds 1/2" tolerance. See additional photos for location of gap noncompliance on accessible pathway to pavilion.	https://www.access-board.gov/aba/#aba-302_3	2012 TAS Section: 302.3 2010 ADAS Section: 302.3 2015 ABAAS Section: 302.3

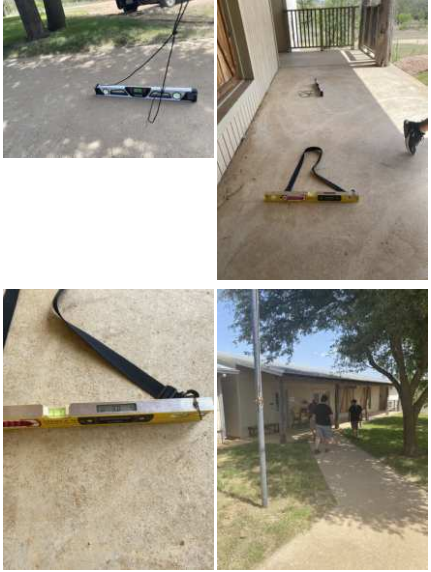
Finding Number	Area Description	Finding	As Built	Recommendation	Citation	Photos	Figure
28	Structures on Property (Public) : Pavilion (Exterior) - Pathway to Pavilion	The accessible route has running slopes greater than 5% and has not been constructed as a ramp (i.e. handrails, edge protection, etc.). Cross slopes are greater than 2% across the width of the walk. When the slope in the direction of travel of any walk exceeds 1 unit vertical in 20 units horizontal (5-percent slope), it must be constructed as a ramp. Surface cross slopes must not exceed 1 unit vertical in 48 units horizontal (2-percent slope).	There are a few locations where exterior pathway exceed tolerance of cross or running slopes. See additional photos for location of slope noncompliance.	https://www.access-board.gov/aba/#aba-403_3	2012 TAS Section: 403.3 2010 ADAS Section: 403.3 2015 ABAAS Section: 403.3

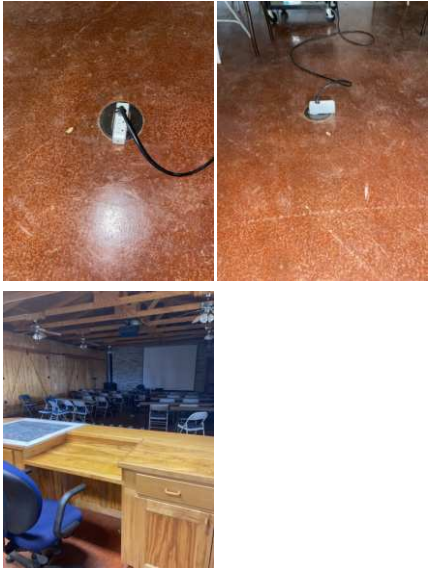
29	Structures on Property (Public) : Pavilion (Interior)	There is a change in level that exceeds the allowable range. A 1/4 inch is the maximum vertical rise. Changes in level between 1/4 inch and 1/2 inch must be beveled at 1:2 or less. Changes in level greater than 1/2 inch must be by way of a ramp.	There are outlets on floor creating tripping hazard.	https://www.access-board.gov/aba/#aba-303_2 https://www.access-board.gov/aba/#aba-303_3	2012 TAS Section: 303.3 2010 ADAS Section: 303.3 2015 ABAAS Section: 303.3

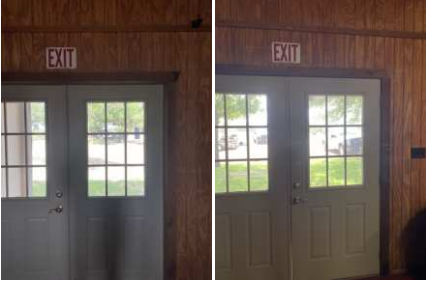
Finding Number	Area Description	Finding	As Built	Recommendation	Citation	Photos	Figure
31	Structures on Property (Public) : Pavilion (Interior) - Entrance/Exit Doors	The tactile EXIT sign is missing at the door. Wall signs identifying exits shall have characters raised 1/32 inch minimum and shall be uppercase characters a minimum of 5/8 inch and a maximum of 2 inches high. Braille shall be placed directly below the tactile characters; flush left or centered. Signs shall be located a minimum of 48 inches above the floor, measured from the baseline of the lowest tactile characters and 60 inches maximum above the finish floor or ground surface, measured from the baseline of the highest tactile characters. Where a tactile sign is provided at a door, the sign shall be located on the latch side. Where a tactile sign is provided at double doors the sign shall be located to the right of the right-hand door. Where there is no wall space at the latch side of a single door or at the right side of double doors, signs shall be located on the nearest adjacent wall.	This applies to doors marked with visual exit sign. Where visual EXIT is provided, accompanying tactile EXIT sign must also be provided for same doorway. Doorway exit signs and emergency exits with emergency exit signs that are overhead or visual only, or pictograms only, must have an accompanying ADA Braille sign. Exit passages, including doors, stairs and routes, must be identified with tactile ADA signage. Signs must include braille and raised characters. Pictograms are optional.	https://www.access-board.gov/aba/#aba-f216_4_1	2012 TAS Section: 216.4.1 2010 ADAS Section: 216.4.1 2015 ABAAS Section: F216.4.1

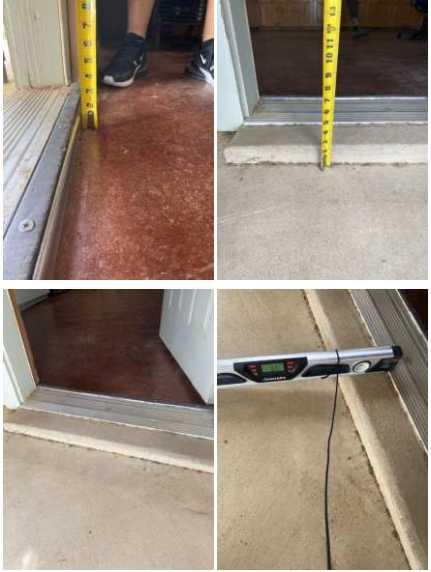
Finding Number	Area Description	Finding	As Built	Recommendation	Citation	Photos	Figure
32	Structures on Property (Public) : Pavilion (Interior) - Entrance/Exit Doors	The threshold is greater than 1/2 inch high. The threshold at a doorway shall be no higher than 1/2 inch. Changes in level between 1/4 inch and 1/2 inch must be beveled at 1:2 or less. 1/4 inch is the maximum vertical rise.	Door thresholds pictured are not complaint. Thresholds exceed height, and sloping tolerance. Multiple door threshold used for pavilion building.	https://www.access-board.gov/aba/#aba-404_2_5	2012 TAS Section: 404.2.5 2010 ADAS Section: 404.2.5 2015 ABAAS Section: 404.2.5

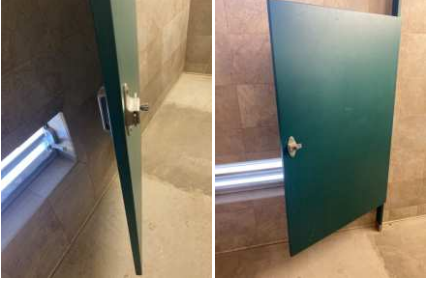
39	Structures on Property (Public) : Accessible Restroom (Men's)	The water closet compartment is missing a loop handle on the one side of the door. Water closet compartments must be equipped with a door that has a loop or U-shaped handle on both sides of the door near the latch. The latch must be flip-over style, sliding or other hardware not requiring the user to grasp or twist.	N/A	https://www.access-board.gov/aba/#aba-604_8_1_2	2012 TAS Section: 604.8.1.2 2010 ADAS Section: 604.8.1.2 2015 ABAAS Section: 604.8.1.2

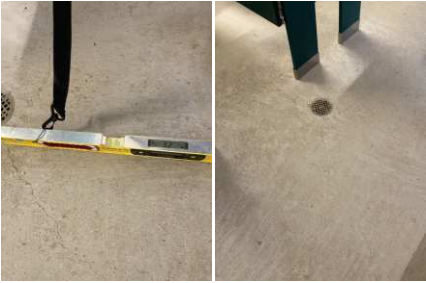
47	Structures on Property (Public) : Accessible Restroom (Women's)	The floor drain is set too low in the floor which causes a slope over 2 percent. Changes in level are not permitted in clear floor or ground spaces or surfaces of a turning spaces and shall not slope greater than 1:48.	Slope 3.2%	https://www.access-board.gov/aba/#aba-303_3 https://www.access-board.gov/aba/#aba-304_2	2012 TAS Section: 303.3, 304.2, 304.2 Exception 2010 ADAS Section: 303.3, 304.2, 304.2 Exception 2015 ABAAS Section: 303.3, 304.2, 304.2 EXCEPTION, 305.2 EXCEPTION

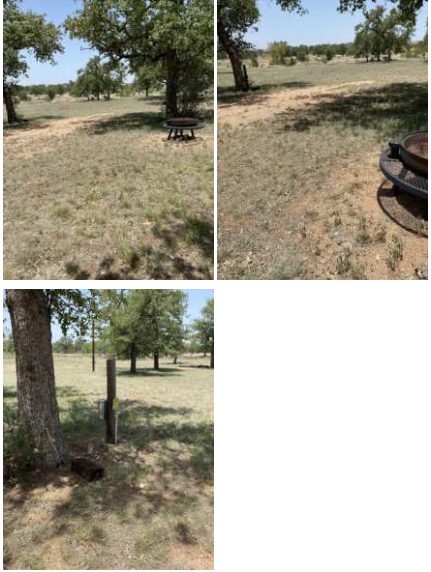
Finding Number	Area Description	Finding	As Built	Recommendation	Citation	Photos	Figure
48	Outdoor Features (Public) : Campsites	A minimum of 20% of the outdoor constructed feature do not have mobility features. Where provided in common use and public use areas that serve camping units with mobility features, at least 20 percent, but not less than one, of each type of outdoor constructed feature provided at each location shall comply.	Sites with made structures like fire pits, picnic tables, concrete slab are not considered primitive and should meet ADA scoping requirements.	Link provided below outlines the best practices guidelines. https://www.access-board.gov/aba/#aba-1014 Upgrade ADA camp site	2015 ABAAS Section: F244.3

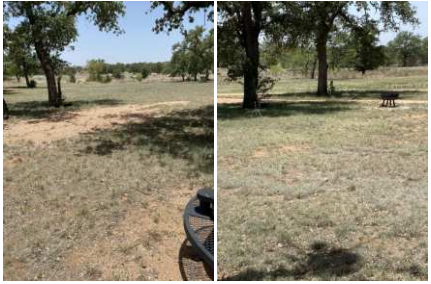
49	Outdoor Features (Public) : Campsites	The parking space/pull up space is not firm and stable. The surface of parking spaces and pull-up spaces shall be firm and stable.	Parking is not accessible.	N/A - Refer to Finding	2015 ABAAS Section: 1012.4
