N.M. Stringfellow WMA- ADA Evaluation

WMA- Nannie M. Stringfellow, Brazoria TX, ADA Eval

Accessibility Evaluation

Inspection Date: 06/30/2022

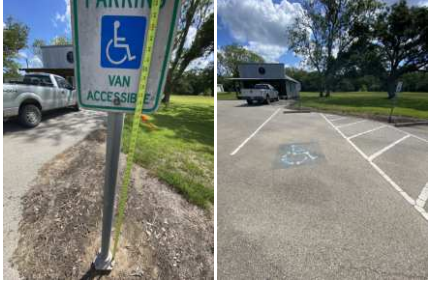
| Finding Number | Area Description | Finding | As Built | Recommendation | Citation | Photos | Figure |
|---|---|---|---|---|---|---|---|
| 1 | Exterior of Property (Public): HQ Parking Lot (2 Spaces) 1 Van 1 Car - Van Accessible Stall | The parking sign is mounted too low. Parking space identification signs shall include the International Symbol of Accessibility. Signs identifying van parking spaces shall contain the designation "van accessible." Signs shall be 60 inches minimum above the finish floor or ground surface measured to the bottom of the sign. | Sign mounted under 54" | https://www.access-board.gov/aba/#aba-502_6 | 2012 TAS Section: 502.6 2010 ADAS Section: 502.6 2015 ABAAS Section: 502.6 | | |

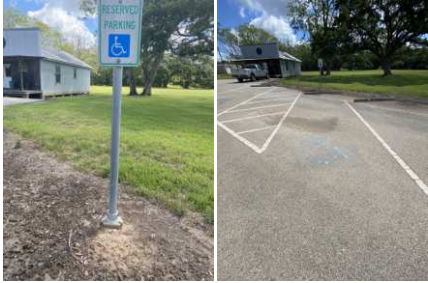
| Finding Number | Area Description | Finding | As Built | Recommendation | Citation | Photos | Figure |
|---|---|---|---|---|---|---|---|
| 2 | Exterior of Property (Public): HQ Parking Lot (2 Spaces) 1 Van 1 Car - Car Accessible Stall | The parking sign is mounted too low. Parking space identification signs shall include the International Symbol of Accessibility. Signs identifying van parking spaces shall contain the designation "van accessible." Signs shall be 60 inches minimum above the finish floor or ground surface measured to the bottom of the sign. | Sign mounted to low in previous assessment. needs photo verification. | https://www.access-board.gov/aba/#aba-502_6 | 2012 TAS Section: 502.6 2010 ADAS Section: 502.6 2015 ABAAS Section: 502.6 | | |

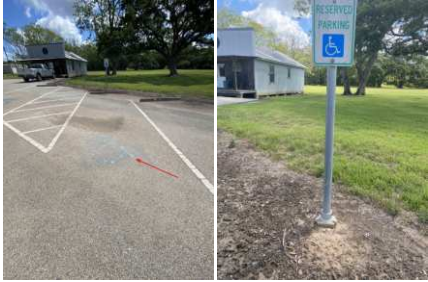
| Finding Number | Area Description | Finding | As Built | Recommendation | Citation | Photos | Figure |
|---|---|---|---|---|---|---|---|
| 3 | Exterior of Property (Public): HQ Parking Lot (2 Spaces) 1 Van 1 Car - Car Accessible Stall | The striping and markings for the accessible parking stall, loading/unloading access aisle are dilapidated and in need of repair and/or maintenance. | ISA symbol is faded and needs to be repainted. | https://www.access-board.gov/aba/#aba-502_3_3 | 2012 TAS Section: 502.3.3 2010 ADAS Section: 502.3.3 2015 ABAAS Section: 502.3.3, 503.3.3 | | |

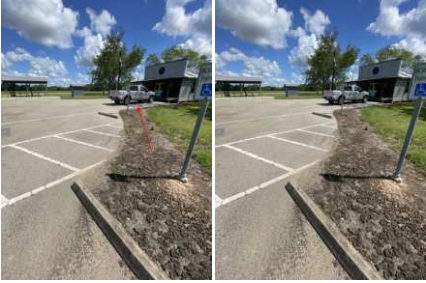
| Finding Number | Area Description | Finding | As Built | Recommendation | Citation | Photos | Figure |
|---|---|---|---|---|---|---|---|
| 4 | Exterior of Property (Public): HQ Parking Lot (2 Spaces) 1 Van 1 Car - Access Aisle (Shared) | The access aisle contains loose gravel and/or surface materials that do not provide for a stable, firm slip resistant surface. Parking spaces and access aisles serving them shall comply with floor or ground surface requirements. The ground surface shall be stable, firm, and slip resistant. Access aisles shall be at the same level as the parking spaces they serve. Changes in level, slopes exceeding 1:48, and detectable warnings shall not be permitted. | No route from stall to building without traveling through lot. Access aisle does not lead to accessible pathway. Access aisle has debris in top corner limiting access. | https://www.access-board.gov/aba/#aba-502_4 | 2012 TAS Section: 502.4 2010 ADAS Section: 502.4 2015 ABAAS Section: 502.4 | | |

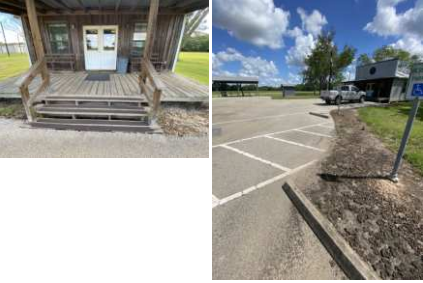
| Finding Number | Area Description | Finding | As Built | Recommendation | Citation | Photos | Figure |
|---|---|---|---|---|---|---|---|
| 5 | Structures on Property (Public) : HQ Building (Exterior) | The entrance is not accessible and is missing signage. An identification sign identifying that this entrance is not accessible and directional signage pointing to the accessible entrance is required. When a directional sign is required, it should be located to minimize backtracking. In some cases, this could mean locating a sign at the beginning of a route, not just at the inaccessible entrances to a building. | Steps only means to access building, building has no accessible approach or means of entry. Signs that provide direction to or information about interior spaces and facilities must meet visual requirements but are not required to be tactile | https://www.access-board.gov/aba/#aba-f216_6 | 2010 ADAS Section: 216.6 2015 ABAAS Section: F216.6 | | |

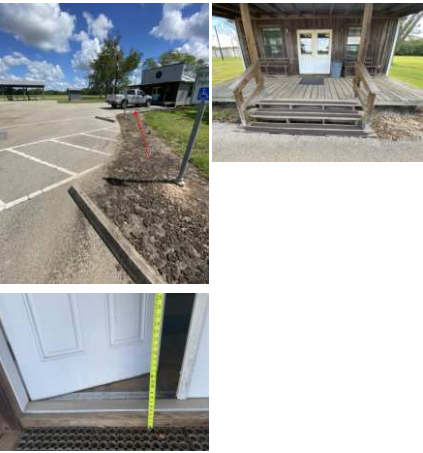
| Finding Number | Area Description | Finding | As Built | Recommendation | Citation | Photos | Figure |
|---|---|---|---|---|---|---|---|
| 6 | Structures on Property (Public) : HQ Building (Exterior) | The building entrance is not located on an accessible route. When a building, or portion of a building, is required to be accessible, an accessible route of travel shall be provided to all portions of the building, to accessible building entrances and between the building and the public way. At least one accessible route within the boundary of the site must be provided from public transportation stops, accessible parking and accessible passenger loading zones and public streets or sidewalks to the accessible building entrance they serve. The accessible route shall, to the maximum extent feasible, coincide with the route for the general public. At least one accessible route shall connect accessible buildings, facilities, elements and spaces that are on the same site. At least one accessible route shall connect accessible building or facility entrances with all accessible spaces and elements. | Due to pathway terrain type, lack of accessible pathway, stairs, and door hardware or thresholds there is no way to access this building at this time. | https://www.access-board.gov/aba/#aba-f206_2_1 | 2012 TAS Section: 206.2.1 2010 ADAS Section: 206.2.1 2015 ABAAS Section: F206.2.1 | | |

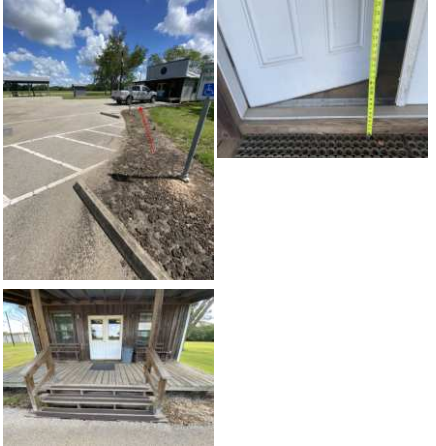
| Finding Number | Area Description | Finding | As Built | Recommendation | Citation | Photos | Figure |
|---|---|---|---|---|---|---|---|
| 7 | Structures on Property (Public) : HQ Building (Exterior) - Pathway to HQ Building | The path of contains multiple issues and is not accessible. The path of travel exceeds the maximum allowable cross and running slope requirements. It also contains changes in level and/or gaps that exceed the allowable maximum requirements. The path of travel does not meet the minimum width requirements for clearances, turning spaces, and/or passing spaces. The floor or ground surface is not firm, stable, and slip resistant. | Pathway has multiple infractions | Review accessible pathway componets to make accessible https://www.access-board.gov/ada/#ada-402 https://www.access-board.gov/ada/#ada-403_1 | 2010 ADAS Section: 403.1 2015 ABAAS Section: 403.1 | | |

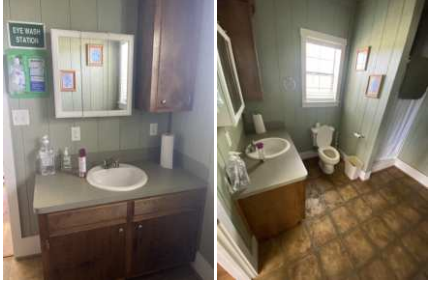
| Finding Number | Area Description | Finding | As Built | Recommendation | Citation | Photos | Figure |
|---|---|---|---|---|---|---|---|
| 13 | Structures on Property (Public) : HQ Building (Interior) - Restroom/Shower (Unisex) | There are not enough accessible lavatories. Where lavatories are provided, at least one shall be accessible and shall not be located in a toilet compartment. | The lavatory and accessories are not complaint. | https://www.access-board.gov/ada/#ada-213_3_4 Review lavatory componets to make accessible. https://www.access-board.gov/ada/#ada-606 | 2012 TAS Section: 213.3.4 2010 ADAS Section: 213.3.4 2015 ABAAS Section: F213.3.4 | | |
