# Old Sabine Bottom WMA- ADA Evaluation

**WMA- Old Sabine Bottom, Lindale TX, ADA Evaluation**

**Accessibility Evaluation**

**Inspection Date: 07/12/2022**

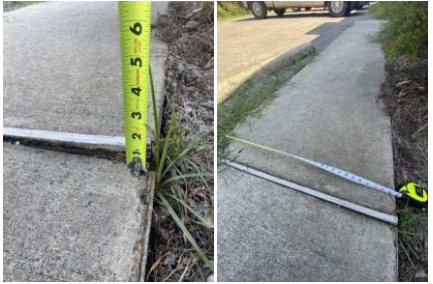
4	Structures on Property (Public) : HQ Building (Exterior) - Pathway to HQ Building	The walkway contains abrupt vertical edges and/or variations over a 1/2 inch. 1/4 inch is the maximum vertical rise. Changes in level between 1/4 inch and 1/2 inch must be beveled at 1:2 or less. Changes in level greater than 1/2 inch must be by way of a ramp.	Concrete not level due to change in elevation.	<a href="https://www.access-board.gov/ada/#ada-303_2">https://www.access-board.gov/ada/#ada-303_2</a>	2012 TAS Section: 303.3, 303.2  2010 ADAS Section: 303.3, 303.2  2015 ABAAS Section: 303.2, 303.3

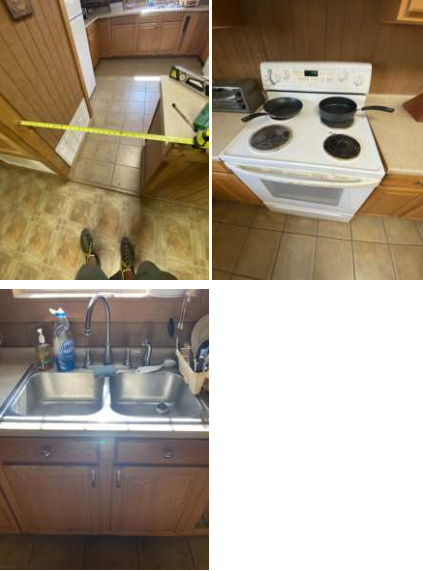
Finding Number	Area Description	Finding	As Built	Recommendation	Citation	Photos	Figure
8	Structures on Property (Public) : HQ Offices (Interior) - Kitchenette	The route of travel at this location does not provide a minimum width of 36 inches. The clear width shall be permitted to be reduced to 32 inches minimum for a length of 24 inches maximum provided that reduced width segments are separated by segments that are 48 inches long minimum and 36 inches wide minimum.	Entry to kitchen not 36", less than 32" The clear width shall be permitted to be reduced to 32 inches (815 mm) minimum for a length of 24 inches (610 mm) maximum	<a href="https://www.access-board.gov/ada/#ada-403_5_1">https://www.access-board.gov/ada/#ada-403_5_1</a>	2012 TAS Section: 403.5.1  2010 ADAS Section: 403.5.1  2015 ABAAS Section: 403.5.1

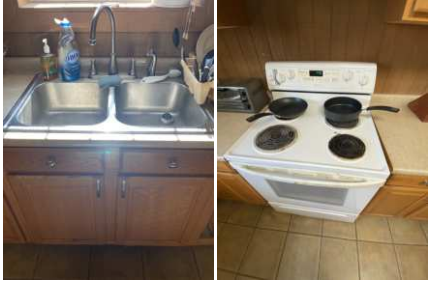
Finding Number	Area Description	Finding	As Built	Recommendation	Citation	Photos	Figure
10	Structures on Property (Public) : HQ Offices (Interior) - Kitchenette	Knee and toe clearance has not been provided at the sink. The knee clearance shall be 11 inches deep minimum at 9 inches above the finish floor or ground, and 8 inches deep minimum at 27 inches above the finish floor or ground. The toe clearance is the space under the sink between the finish floor or ground and 9 inches above the finish floor 30 inches wide minimum. The toe clearance shall extend a minimum of 17 inches and a maximum of 25 inches underneath the sink.	No knee or toe clearance provided.. Knee and toe must be provided since kitchenette contain stove top range. In kitchens, kitchenettes, and breakrooms without a cooktop or conventional range, a parallel approach is permitted at kitchen sinks.	<a href="https://www.access-board.gov/ada/#ada-606_2">https://www.access-board.gov/ada/#ada-606_2</a>	2012 TAS Section: 606.2  2010 ADAS Section: 606.2  2015 ABAAS Section: 606.2

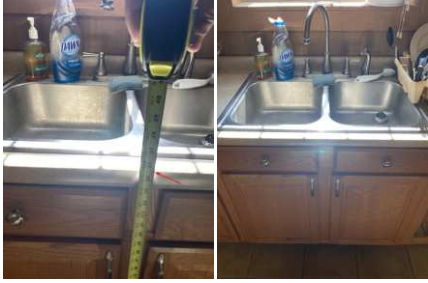
11	Structures on Property (Public) : HQ Offices (Interior) - Kitchenette	The top of the sink is above the allowable height requirement. Sinks shall be installed with the front of the higher of the rim or counter surface 34 inches maximum above the finish floor or ground.	Sink rim height over 34" tolerance. Sinks are not accessible via frontal or parallel approach due to rim height.	<a href="https://www.access-board.gov/ada/#ada-606_3">https://www.access-board.gov/ada/#ada-606_3</a>	2012 TAS Section: 606.3  2010 ADAS Section: 606.3  2015 ABAAS Section: 606.3

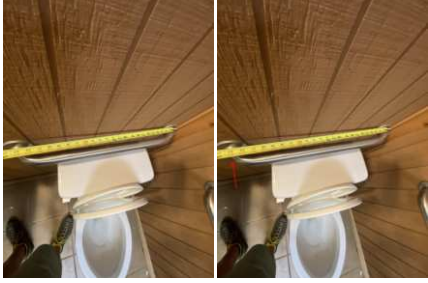
12	Structures on Property (Public) : HQ Offices (Interior) - Restroom/Showe r (Unisex)	The rear grab bar is not a minimum 36 inches in length. Grab bars shall be installed in a horizontal position, 33 inches minimum and 36 inches maximum above the finish floor measured to the top of the gripping surface and the space between the grab bar and the top of the tank (any obstruction) shall be 1-1/2 inches minimum.	Rear grab bar 24"	<a href="https://www.access-board.gov/ada/#ada-604_5_2">https://www.access-board.gov/ada/#ada-604_5_2</a>	2012 TAS Section: 604.5.2  2010 ADAS Section: 604.5.2  2015 ABAAS Section: 604.5.2

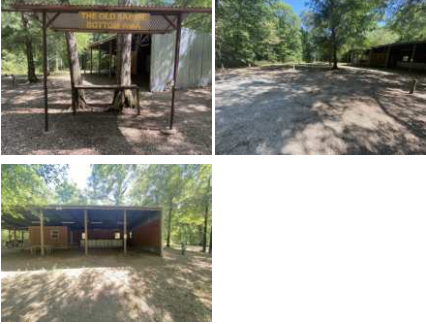
17	Structures on Property (Public) : Cleaning/Check Station	There is no accessible route to the element. At least one accessible route shall connect accessible buildings, accessible facilities, accessible elements, and accessible spaces that are on the same site.	The check station area, and ground surfacing are not compliant. Check station ground is loose rock. There is no way to access cleaning station	<a href="https://www.access-board.gov/ada/#ada-206_2_2">https://www.access-board.gov/ada/#ada-206_2_2</a>	2012 TAS Section: 206.2.2  2010 ADAS Section: 206.2.2  2015 ABAAS Section: F206.2.2

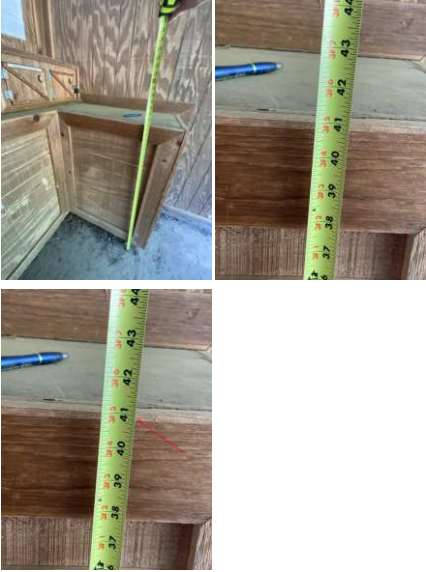
Finding Number	Area Description	Finding	As Built	Recommendation	Citation	Photos	Figure
19	Structures on Property (Public) : Cleaning/Check Station	The top of the work surface is not within a compliant height range. The tops of tables and counters shall be 28 inches to 34 inches from the floor or ground.	work surface height over 34", measured at 41"	<a href="https://www.access-board.gov/ada/#ada-902_3">https://www.access-board.gov/ada/#ada-902_3</a>	2012 TAS Section: 902.3 2010 ADAS Section: 902.3 2015 ABAAS Section: 902.3

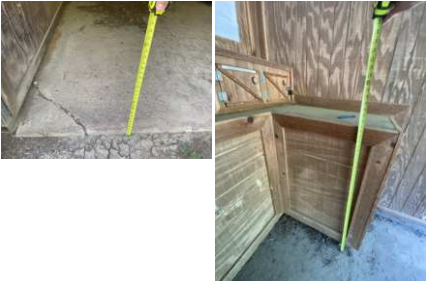
<p>Dining or Work Surface © 2003 by Access Board, Inc.</p>
20	Structures on Property (Public) : Cleaning/Check Station	The walkway contains abrupt vertical edges and/or variations over a 1/2 inch. 1/4 inch is the maximum vertical rise. Changes in level between 1/4 inch and 1/2 inch must be beveled at 1:2 or less. Changes in level greater than 1/2 inch must be by way of a ramp.	walkway towards check station	<a href="https://www.access-board.gov/ada/#ada-303_2">https://www.access-board.gov/ada/#ada-303_2</a>	2012 TAS Section: 303.3, 303.2 2010 ADAS Section: 303.3, 303.2 2015 ABAAS Section: 303.2, 303.3

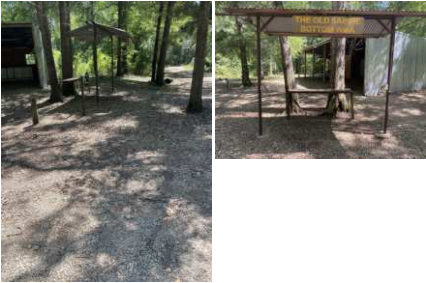
21	Structures on Property (Public) : Cleaning/Check Station - Pathway to Cleaning/Check Station	The path of contains multiple issues and is not accessible. The path of travel exceeds the maximum allowable cross and running slope requirements. It also contains changes in level and/or gaps that exceed the allowable maximum requirements. The path of travel does not meet the minimum width requirements for clearances, turning spaces, and/or passing spaces. The floor or ground surface is not firm, stable, and slip resistant.	Due to terrain and change in elevation pathway is not compliant. Gravel uneven routes to the check station	<a href="https://www.access-board.gov/ada/#ada-403_1">https://www.access-board.gov/ada/#ada-403_1</a> <a href="https://www.access-board.gov/ada/#ada-302">https://www.access-board.gov/ada/#ada-302</a>	2010 ADAS Section: 403.1 2015 ABAAS Section: 403.1
