Playa Lakes WMA- ADA Evaluation

WMA- Playa Lakes/Taylor Unit, Lelia Lake TX, ADA E

Accessibility Evaluation

Inspection Date: 06/28/2022

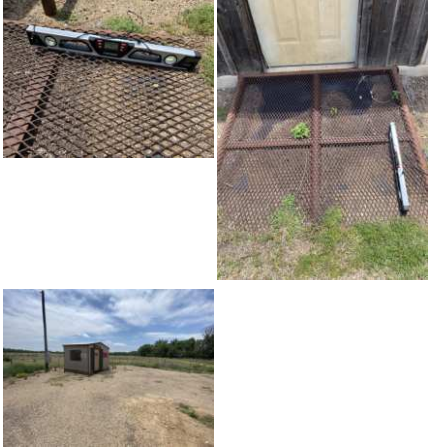
Finding Number	Area Description	Finding	As Built	Recommendation	Citation	Photos	Figure
6	Structures on Property (Public) : Registration Station (Exterior) - Pathway to Registration Station (Ramp)	The accessible route of travel exceeds 5% running slope and therefore must be considered a ramp. Where the slope is greater than one unit vertical in 20 units horizontal (5-percent slope), ramps shall be used.	Ramp running slope 7.3%	https://www.access-board.gov/aba/#aba-403_3	2012 TAS Section: 403.3 2010 ADAS Section: 403.3 2015 ABAAS Section: 403.3

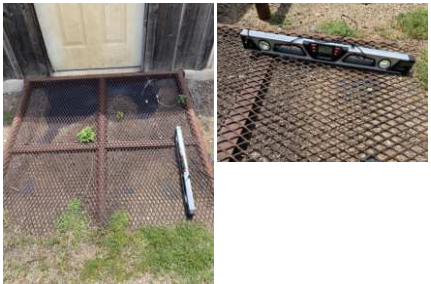
7	Structures on Property (Public) : Registration Station (Exterior) - Pathway to Registration Station (Ramp)	The ramp does not have compliant handrails. Handrails are required on both sides of all surfaces that are sloped greater than 5 percent (1:20). Handrails must be between 34 inches and 38 inches above the ramp surface, must extend 12 inches beyond the top and bottom of the ramp and be parallel to the floor or ground surface. The diameter of the handrails must be between 1 1/4 inches and 2 inches in cross-sectional nominal dimension for circular handrails. Handrail gripping surfaces with a non-circular cross section shall have a perimeter dimension of 4 inches minimum and 6 1/4 inches maximum, and a cross-section dimension of 2 1/4 inches maximum. The space between handrails and walls must be 1 1/2 inches minimum.	Ramp requires handrails due to slope exceeding 5%	https://www.access-board.gov/aba/#aba-505_1	2012 TAS Section: 505.1 2010 ADAS Section: 505.1 2015 ABAAS Section: 505.1

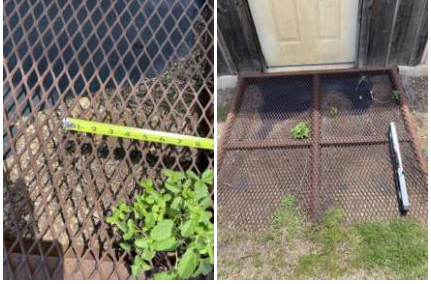
8	Structures on Property (Public) : Registration Station (Exterior) - Pathway to Registration Station (Ramp)	The grate openings are greater than 1/2 inch and are parallel to the direction of travel. Openings in floor or ground surfaces shall not allow passage of a sphere more than 1/2 inch diameter. Elongated openings shall be placed so that the long dimension is perpendicular to the dominant direction of travel.	Grated ramp does not meet surfacing material compliance.	https://www.access-board.gov/aba/#aba-302_3	2012 TAS Section: 302.3 2010 ADAS Section: 302.3 2015 ABAAS Section: 302.3

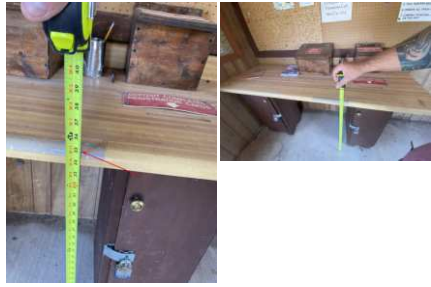
Finding Number	Area Description	Finding	As Built	Recommendation	Citation	Photos	Figure
9	Structures on Property (Public) : Registration Station (Interior)	The work surface is not within the allowable range. The tops of work surfaces provided for public use or common use shall be 28 inches minimum and 34 inches maximum above the finish floor or ground.	Work surface at 35"	https://www.access-board.gov/aba/#aba-902_3	2012 TAS Section: 226.1 2010 ADAS Section: 902.3 2015 ABAAS Section: 902.3

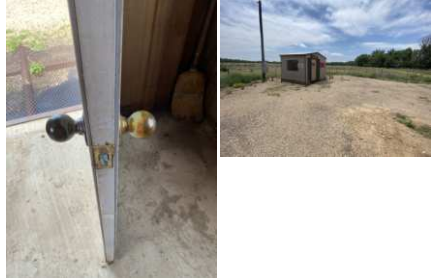
10	Structures on Property (Public) : Registration Station (Interior) - Entrance Doors	The door/gate operating hardware is not accessible. Hand-activated door/gate opening hardware, handles, pulls, latches, locks, and other operating devices on accessible doors shall have a shape that is easy to grasp with one hand and does not require tight grasping, pinching or twisting of the wrist to operate. Hardware shall be 34 inches minimum and 48 inches maximum above the finish floor or ground.	Entrance door hardware is not compliant.	https://www.access-board.gov/aba/#aba-404_2_7 https://www.access-board.gov/aba/#aba-309_4	2012 TAS Section: 404.2.7 2010 ADAS Section: 404.2.7 2015 ABAAS Section: 404.2.7
