Richland Creek WMA- ADA Evaluation

WMA- Richland Creek, Streetman TX, ADA Evaluation

Accessibility Evaluation

Inspection Date: 07/08/2022

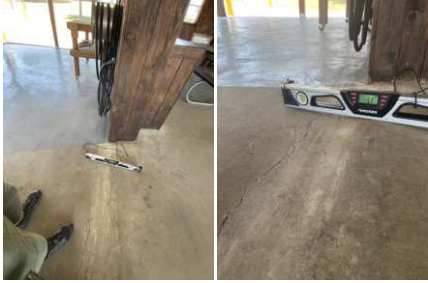
Finding Number	Area Description	Finding	As Built	Recommendation	Citation	Photos	Figure
8	Structures on Property (Public) : Pavilion (Interior)	The accessible route has running slopes greater than 5% and has not been constructed as a ramp (i.e. handrails, edge protection, etc.). When the slope in the direction of travel of any walk exceeds 1 unit vertical in 20 units horizontal (5-percent slope), it must be constructed as a ramp. Surface cross slopes must not exceed one unit vertical in 48 units horizontal (2-percent slope).	Unsure of location pictured Running slope exceeds 5.0% tolerance at 5.3%	https://www.access-board.gov/ada/#ada-206_2_4 https://www.access-board.gov/ada/#ada-403_3	2012 TAS Section: 206.2.4, 403.3 2010 ADAS Section: 206.2.4, 403.3 2015 ABAAS Section: F206.2.4, 403.3

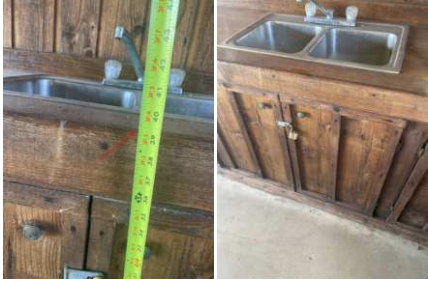
9	Structures on Property (Public) : Pavilion (Interior)	The top of the sink is above the allowable height requirement. Sinks shall be installed with the front of the higher of the rim or counter surface 34 inches maximum above the finish floor or ground.	Sink height over 39" Sink is not accessible via frontal or parallel approach due to rim height. Sinks do not require knee and toe space since there is no stove top oven in vicinity.	https://www.access-board.gov/ada/#ada-606_3	2012 TAS Section: 606.3 2010 ADAS Section: 606.3 2015 ABAAS Section: 606.3

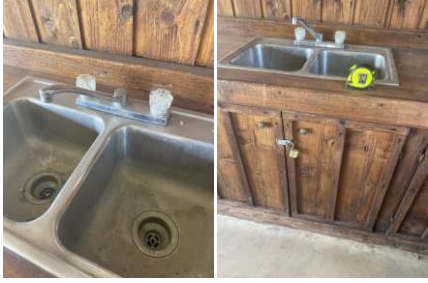
10	Structures on Property (Public) : Pavilion (Interior)	The faucet controls require twisting of the wrist. Faucet controls and operating mechanisms shall be operable with one hand and shall not require tight grasping, pinching or twisting of the wrist. The force required to activate controls shall be no greater than 5 lb. Lever-operated, push-type and electronically controlled mechanisms are examples of acceptable designs.	Non compliant hardware	https://www.access-board.gov/ada/#ada-606_4	2012 TAS Section: 606.4 2010 ADAS Section: 606.4 2015 ABAAS Section: 606.4

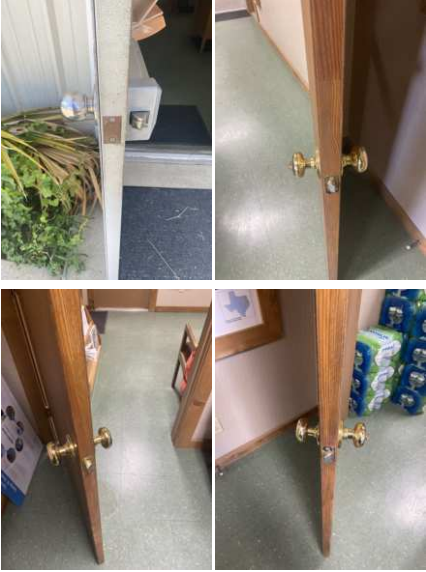
Finding Number	Area Description	Finding	As Built	Recommendation	Citation	Photos	Figure
11	Structures on Property (Public) : HQ Building (Interior)	<p>Minimum maneuvering clearances at doors and gates shall comply with 404.2.4. Maneuvering clearances shall extend the full width of the doorway and the required latch side or hinge side clearance. Maneuvering clearances shall have a max slope of 2.08%. Door openings shall provide a clear width of 32 inches (815 mm) minimum. Clear openings of doorways with swinging doors shall be measured between the face of the door and the stop, with the door open 90 degrees. Openings more than 24 inches (610 mm) deep shall provide a clear opening of 36 inches (915 mm) minimum. There shall be no projections into the required clear opening width lower than 34 inches (865 mm) above the finish floor or ground. Projections into the clear opening width between 34 inches (865 mm) and 80 inches (2030 mm) above the finish floor or ground shall not exceed 4 inches (100 mm). The threshold has a vertical change greater than 1/4 inch high. The threshold has a gap greater than 1/2 inch wide. The threshold at a doorway shall be no higher than 1/2 inch. Changes in level between 1/4 inch and 1/2 inch must be beveled at 1:2 or less. 1/4 inch is the maximum vertical rise. All interior doors must be maintained so that the operating pressure does not exceed 5 lbf to open. The sweep period for doors with closers shall be adjusted so that from an open position of 70 degrees, the door will take at least 3 seconds to move to a point 3 inches from the latch, measured to the leading edge of the door. Exterior doors are recommended to be maintained at 8.5 lbf as a smart practice. Force is to be measured at the operating hardware or 30 inches from the hinges, whichever is greater. Hand-activated door opening hardware, handles, pulls, latches, locks, and other operating devices on accessible doors shall have a shape that is easy to grasp with one hand and does not require tight grasping, tight pinching or twisting of the wrist to operate. Hardware shall be 34 inches minimum and 48 inches maximum above the finish floor or ground. The bottom 10 inches on the push side must be smooth and free of obstructions (hold open devices). Doors, gates, and side lights adjacent to doors or gates, containing one or more glazing</p>	More than 60% doors/entrances are equipped with non-compliant hardware.	Review door and threshold componets to make accessible https://www.access-board.gov/ada/#ada-404	2010 ADAS Section: 404.2.3, 404.2.7, 404.2.4, 404.2.11, 404.2.11 Exception

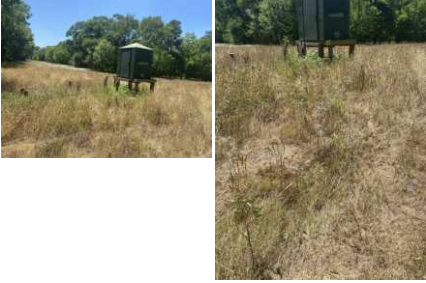
Finding Number	Area Description	Finding	As Built	Recommendation	Citation	Photos	Figure																				
29	Outdoor Features (Public) : Wildlife Viewing Blind	There are not enough outdoor constructed features with mobility features located in the common uses and public use areas. Where provided in common use and public use areas that serve picnic units with mobility features, at least 20 percent, but not less than one, of each type of outdoor constructed feature must be provided at each location.	There are no blinds with accessible features at this time.	There are no enforceable standards for blinds at this time. Best practices recommend installing 20% accessible features. Clear floor space, stable surface, and surface deck height.	2015 ABAAS Section: F245.3
