Tyler Nature Center- ADA Evaluation

WMA- Tyler Nature Center, Tyler TX, ADA Evaluation

Accessibility Evaluation

Inspection Date: 11/16/2022

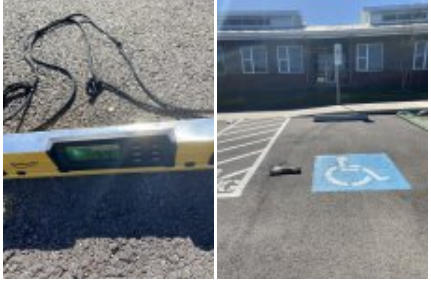
Finding Number	Area Description	Finding	As Built	Recommendation	Citation	Photos	Figure
1	Exterior of Property (Public): Public Entrance- Main Building Parking Lot (4 Spaces) 3 Van 1 Car - Van Accessible Stall (Far (R) Side)	The cross slope (narrow dimension) of the parking stall exceeds 2%. The running and cross slope in an accessible parking stall and the access aisle must not exceed 2%.	Back left corner of parking stall cross slope 5.9%	https://www.access-board.gov/ada/#ada-502_4	2012 TAS Section: 502.4 2010 ADAS Section: 502.4 2015 ABAAS Section: 502.4

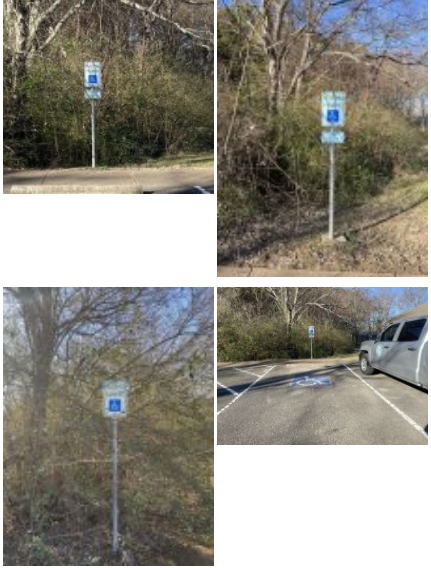
2	Exterior of Property (Public): Parking Lot- After Hours (3 Spaces) 2 Van 1 Car - All Accessible Stalls (2 Van 1 Car)	Signage is partially blocked by tree branches for 2 of the 3 parking spaces.	N/A	Manage tree branch obstructions to improve access.	2012 TAS Section: Recommended 2010 ADAS Section: Recommended 2015 ABAAS Section: Recommended

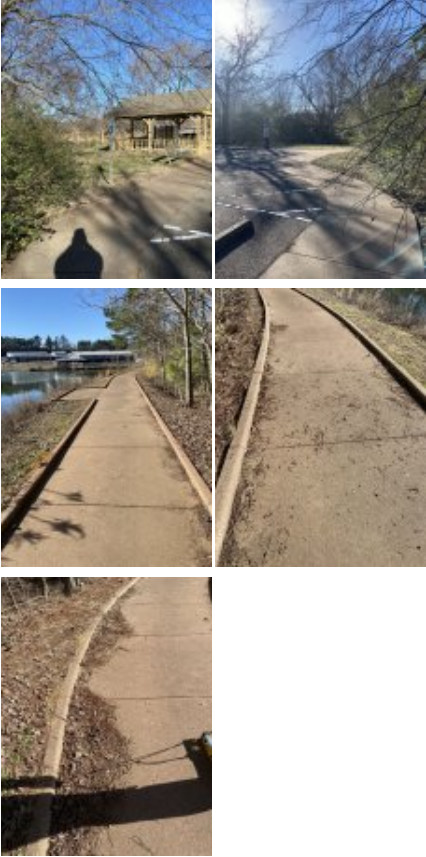
Finding Number	Area Description	Finding	As Built	Recommendation	Citation	Photos	Figure
3	Exterior of Property (Public): Parking Lot- After Hours (3 Spaces) 2 Van 1 Car - Pathway to Fishing Pier (After Hours Parking Lot to Pier)	The element projects more than 4 inches into the circulation path. Wall-mounted objects that have leading edges between 27 inches and 80 inches from the floor must not project more than 4 inches into the circulation path. Protruding objects that extend to the floor or within 27 inches of the floor are cane detectable and are therefore not hazardous. Where it is necessary or desirable to have objects protrude from the wall, a manner of cane detection must be provided.	Tree branches and debris along trail impede access.	https://www.access-board.gov/ada/#ada-307_2	2012 TAS Section: 307.2 2010 ADAS Section: 307.2 2015 ABAAS Section: 307.2

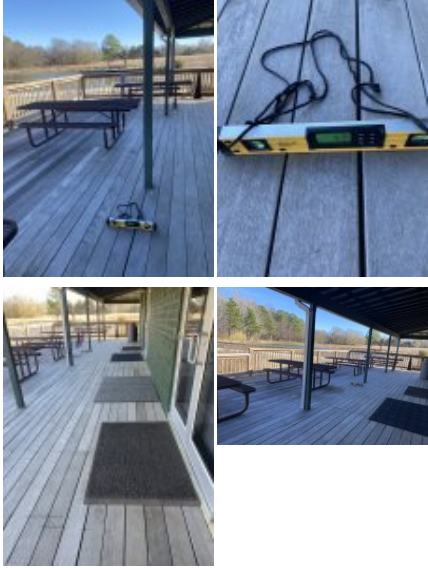
5	Structures on Property (Public) : Visitors Center (Exterior)	The clear floor space required at the element is not flat (2% or 1:48 maximum slope) in all directions. Changes in level are not permitted at required clear floor or ground space except that slopes not steeper than 1:48 shall be permitted.	Ratio of compliant picnic tables satisfied. Few infractions include, deck sloping pictured exceeds 2% tolerance and floor mats look worn and should be replaced.	https://www.access-board.gov/ada/#ada-305_2 https://www.access-board.gov/ada/#ada-302_2	2012 TAS Section: 305.2 2010 ADAS Section: 305.2 2015 ABAAS Section: 305.2

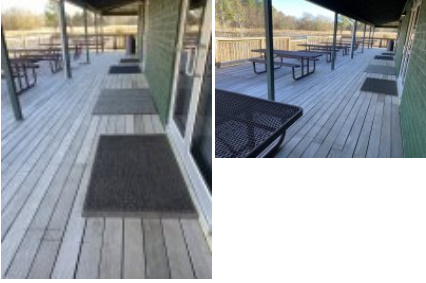
Finding Number	Area Description	Finding	As Built	Recommendation	Citation	Photos	Figure
6	Structures on Property (Public) : Visitors Center (Exterior)	The floor mat or carpet pile height is too high. Carpet or carpet tile shall be securely attached and shall have a firm cushion, pad, or backing or no cushion or pad. Carpet or carpet tile shall have a level loop, textured loop, level cut pile, or level cut/uncut pile texture. Pile height shall be 1/2 inch maximum. Exposed edges of carpet shall be fastened to floor surfaces and shall have trim on the entire length of the exposed edge.	Door mats look worn and not in good working condition, should be replaced.	https://www.access-board.gov/ada/#ada-302_2	2012 TAS Section: 302.2 2010 ADAS Section: 302.2 2015 ABAAS Section: 302.2

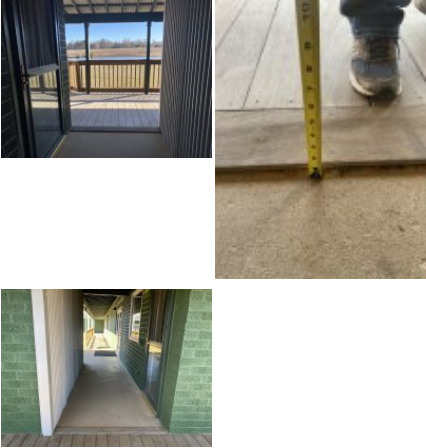
7	Structures on Property (Public) : Visitors Center (Exterior) - Pathway to Visitors Center (Parking to Front of Building)	The walkway contains abrupt vertical edges and/or variations over 1/4 inch. 1/4 inch is the maximum vertical rise. Changes in level between 1/4 inch and 1/2 inch must be beveled at 1:2 or less. Changes in level greater than 1/2 inch must be by way of a ramp.	Pathway meets most compliance standards and is considered accessible. Area of non compliance leading from parking lot to visitors centers double door entrance. Change in elevation over 1/4"	https://www.access-board.gov/ada/#ada-303_2 https://www.access-board.gov/ada/#ada-303_3	2012 TAS Section: 303.3, 303.2 2010 ADAS Section: 303.3, 303.2 2015 ABAAS Section: 303.2, 303.3

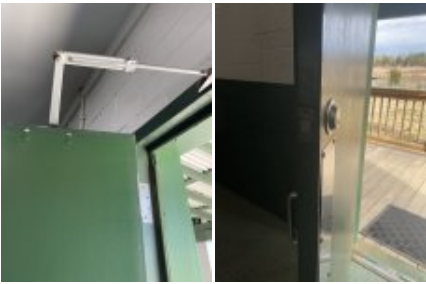
8	Structures on Property (Public) : Visitors Center (Exterior) - Restroom (Men's)	The door exceeds the maximum allowable opening force. Interior doors shall have a maximum opening force of 5 pounds. These forces do not apply to the force required to retract latch bolts or disengage other devices that hold the door or gate in a closed position.	Door requires more than 5lbs pressure to open. The ADA Standards do not specify the opening force for exterior doors, though some state and local building codes may have requirements. Typical maximum opening force for exterior doors ranges from 8.5 to 10 lbs	https://www.access-board.gov/ada/#ada-404_2_9	2012 TAS Section: 404.2.9 2010 ADAS Section: 404.2.9 2015 ABAAS Section: 404.2.9

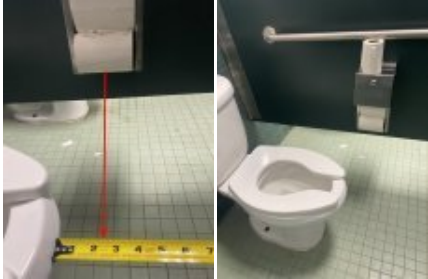
10	Structures on Property (Public) : Visitors Center (Exterior) - Restroom (Men's)	The toilet paper is not installed within the compliant range. Toilet paper dispensers shall be 7 inches minimum and 9 inches maximum in front of the water closet measured to the centerline of the dispenser. The outlet of the dispenser shall be 15 inches minimum and 48 inches maximum above the finish floor and shall not be located behind grab bars. Dispensers shall not be of a type that controls delivery or that does not allow continuous paper flow. There shall be a clearance of 1 1/2 inches minimum below the grab bar.	TP dispenser mounted too close.	https://www.access-board.gov/ada/#ada-604_7	2012 TAS Section: 604.7 2010 ADAS Section: 604.7 2015 ABAAS Section: 604.7

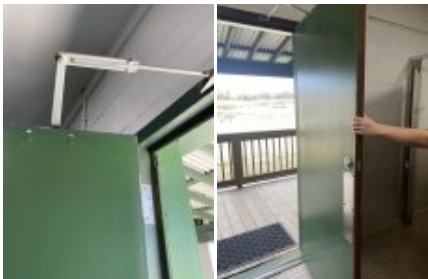
11	Structures on Property (Public) : Visitors Center (Exterior) - Restroom (Women's)	The door is equipped with a door closer and returns to a closed position too quickly. Door closers and gate closers shall be adjusted so that from an open position of 90 degrees, the time required to move the door to a position of 12 degrees from the latch is 5 seconds minimum.	closes too fast	https://www.access-board.gov/ada/#ada-404_2_8_1	2012 TAS Section: 404.2.8.1 2010 ADAS Section: 404.2.8.1 2015 ABAAS Section: 404.2.8.1

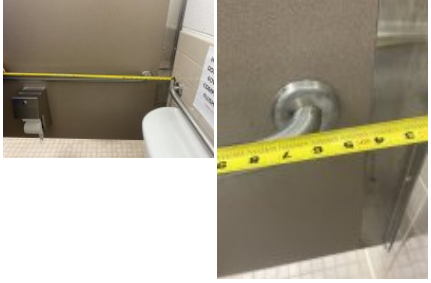
Finding Number	Area Description	Finding	As Built	Recommendation	Citation	Photos	Figure
12	Structures on Property (Public) : Visitors Center (Exterior) - Restroom (Women's)	The side grab bar does not extend far enough from the rear wall. The side grab bar must extend at least 54 inches minimum beyond the rear wall and start a maximum of 12 inches from the rear wall. A 42 inch grab bar installed the maximum distance from the rear wall (12 inches) will leave the leading end 54 inches from the rear wall. Grab bars shall be installed in a horizontal position, 33 inches minimum and 36 inches maximum above the finish floor measured to the top of the gripping surface.	Side grab mounted to close to rear wall and does not extend 54" min	https://www.access-board.gov/ada/#ada-604_5_1	2012 TAS Section: 604.5.1 2010 ADAS Section: 604.5.1 2015 ABAAS Section: 604.5.1

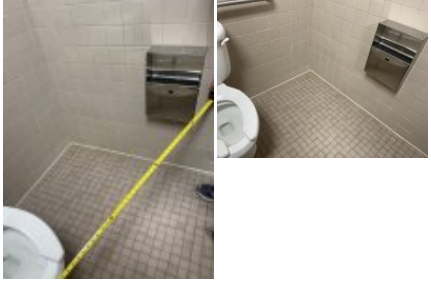
13	Structures on Property (Public) : Visitors Center (Exterior) - Restroom (Women's)	The clear floor space at the toilet is noncompliant. Wheelchair accessible compartments shall be 60 inches wide minimum measured perpendicular to the side wall, and 59 inches deep minimum for floor mounted water closets measured perpendicular to the rear wall.	Tampon receptacle is not within accessible range and impedes stall clear floor space.	https://www.access-board.gov/ada/#ada-604_8_1_1	2012 TAS Section: 604.8.1.1 2010 ADAS Section: 604.8.1.1 2015 ABAAS Section: 604.8.1.1

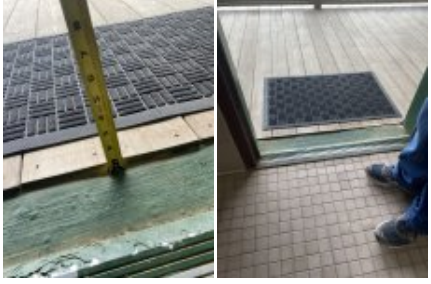
14	Structures on Property (Public) : Visitors Center (Exterior) - Restroom (Women's)	The threshold has a vertical change greater than 1/4 inch. The threshold at a doorway shall be no higher than 1/2 inch. Changes in level between 1/4 inch and 1/2 inch must be beveled at 1:2 or less. The maximum vertical rise shall be 1/4 inch.	N/A	https://www.access-board.gov/ada/#ada-404_2_5	2012 TAS Section: 404.2.5 2010 ADAS Section: 404.2.5 2015 ABAAS Section: 404.2.5

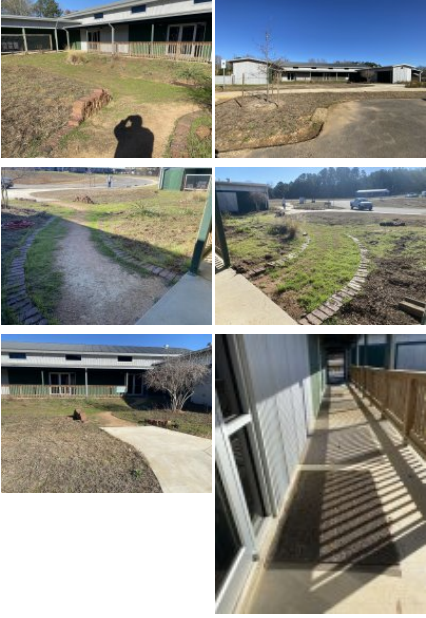
Finding Number	Area Description	Finding	As Built	Recommendation	Citation	Photos	Figure
15	Structures on Property (Public) : Visitors Center (Exterior) - Garden Area	There is no accessible route to the accessible element. At least one accessible route shall connect accessible buildings, accessible facilities, accessible elements, and accessible spaces that are on the same site.	Due to terrain and non compliant floor mats pathway is not compliant This element is not accessible	https://www.access-board.gov/ada/#ada-206_2_2	2012 TAS Section: 206.2.2 2010 ADAS Section: 206.2.2 2015 ABAAS Section: F206.2.2

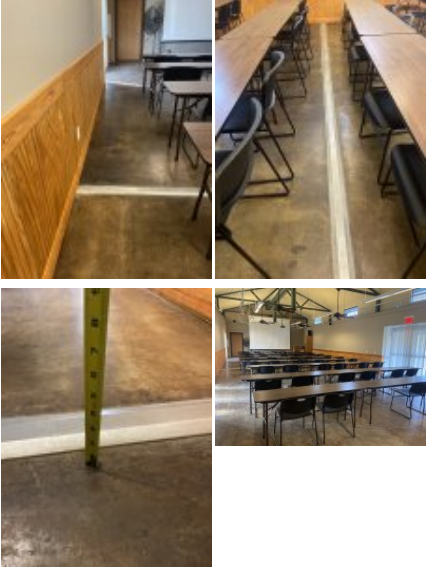
Finding Number	Area Description	Finding	As Built	Recommendation	Citation	Photos	Figure
17	Structures on Property (Public) : Visitors Center (Interior) - Conference Room	There is a change in level that exceeds the allowable range. A 1/4 inch is the maximum vertical rise. Changes in level between 1/4 inch and 1/2 inch must be beveled at 1:2 or less. Changes in level greater than 1/2 inch must be by way of a ramp.	There is a large crease in ground limiting access.	https://www.access-board.gov/ada/#ada-303_3	2012 TAS Section: 303.3 2010 ADAS Section: 303.3 2015 ABAAS Section: 303.3

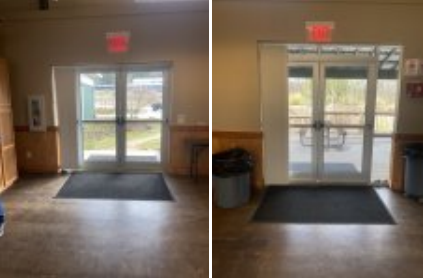
Finding Number	Area Description	Finding	As Built	Recommendation	Citation	Photos	Figure
18	Structures on Property (Public) : Visitors Center (Interior) - Conference Room	The tactile EXIT sign is missing at the door. Wall signs identifying exits shall have characters raised 1/32 inch minimum and shall be uppercase characters a minimum of 5/8 inch and a maximum of 2 inches high. Braille shall be placed directly below the tactile characters; flush left or centered. Signs shall be located a minimum of 48 inches above the floor, measured from the baseline of the lowest tactile characters and 60 inches maximum above the finish floor or ground surface, measured from the baseline of the highest tactile characters. Where a tactile sign is provided at a door, the sign shall be located on the latch side. Where a tactile sign is provided at double doors the sign shall be located to the right of the right-hand door. Where there is no wall space at the latch side of a single door or at the right side of double doors, signs shall be located on the nearest adjacent wall.	This applies to all doors featuring overhead exit sign. Where visual EXIT is provided, accompanying tactile EXIT sign must also be provided for same doorway. Doorway exit signs and emergency exits with emergency exit signs that are overhead or visual only, or pictograms only, must have an accompanying ADA Braille sign. Exit passages, including doors, stairs and routes, must be identified with tactile ADA signage. Signs must include braille and raised characters. Pictograms are optional.	https://www.access-board.gov/ada/#ada-216_4_1	2012 TAS Section: 216.4.1 2010 ADAS Section: 216.4.1 2015 ABAAS Section: F216.4.1

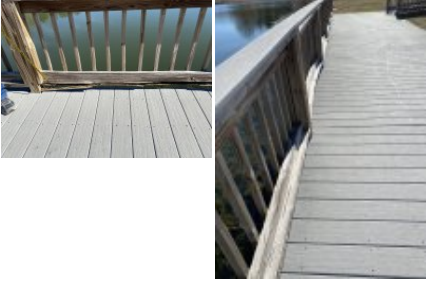
Finding Number	Area Description	Finding	As Built	Recommendation	Citation	Photos	Figure
19	Outdoor Features (Public) : Fishing Pier (Visitor Center)	The curb or barrier does not extend 2 inches minimum above the surface. Where compliant railings, guards, or handrails are provided, edge protection shall also be provided. Curbs or barriers shall extend 2 inches minimum above the surface of the fishing pier or platform or The ground or deck surface shall extend 12 inches minimum beyond the inside face of the railing. Toe clearance shall be provided and shall be 30 inches wide minimum and 9 inches minimum above the ground or deck surface beyond the railing.	Edge protection around fishing pier is provided but in need of repair. Boards are decaying and losing integrity.	Fishing pier edge protection https://www.access-board.gov/ada/#ada-1005_3 Curb or barrier https://www.access-board.gov/ada/#ada-1005_3_1 Extended ground or floor surface https://www.access-board.gov/ada/#ada-1005_3_2	2010 ADAS Section: 1005.3.1 2015 ABAAS Section: 1005.3.1

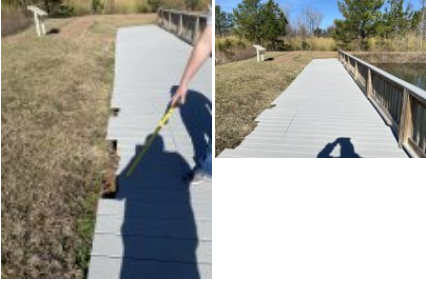
20	Outdoor Features (Public) : Fishing Pier (Visitor Center)	The accessible route contains loose gravel and/or surfaces that do not provide for a stable, firm slip resistant surface.	walkway has unlevel spots due to wood flexing, pieces broken off.	Resurface accessible route where deterioration occurs.	2012 TAS Section: 302.1 2010 ADAS Section: 302.1 2015 ABAAS Section: 302.1

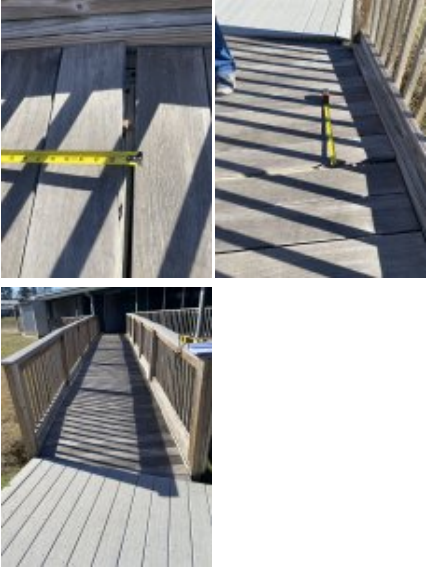
21	Outdoor Features (Public) : Fishing Pier (Visitor Center) - Pathway to Pier (Ramp)	The ramp contains surface materials that do not provide for a stable, firm slip resistant surface. Floor and ground surfaces shall be stable, firm, and slip resistant.	Large gaps and rotting wood planks limiting access.	https://www.access-board.gov/ada/#ada-302_1 https://www.access-board.gov/ada/#ada-405_4 Review ramp components to make accessible. https://www.access-board.gov/aba/#aba-405	2012 TAS Section: 302.1, 405.4 2010 ADAS Section: 302.1, 405.4 2015 ABAAS Section: 302.1, 405.4

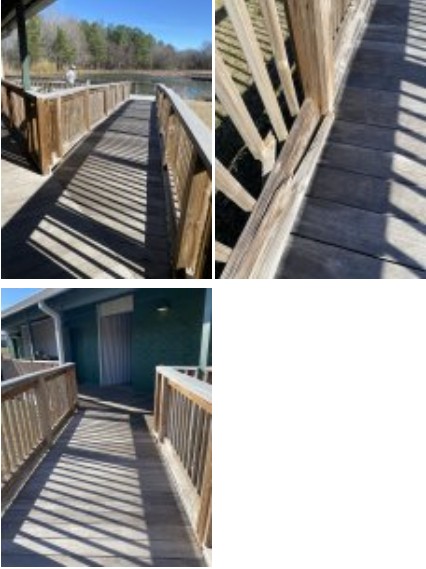
Finding Number	Area Description	Finding	As Built	Recommendation	Citation	Photos	Figure
22	Outdoor Features (Public) : Fishing Pier (Visitor Center) - Pathway to Pier (Ramp)	The ramp run has not been provided with edge protection. The floor or ground surface of the ramp run or landing shall extend 12 inches minimum beyond the inside face of a handrail or a curb or barrier shall be provided that prevents the passage of a 4 inch diameter sphere, where any portion of the sphere is within 4 inches of the finish floor or ground surface.	Edge protection for ramp is provided but in need of repair. Boards are decaying and losing integrity.	Edge protection https://www.access-board.gov/ada/#ada-405_9 Extended ground or floor surface https://www.access-board.gov/ada/#ada-405_9_1 Curb or barrier https://www.access-board.gov/ada/#ada-405_9_2	2012 TAS Section: 405.9.1, 405.9.2 2010 ADAS Section: 405.9.1, 405.9.2 2015 ABAAS Section: 405.9.1, 405.9.2

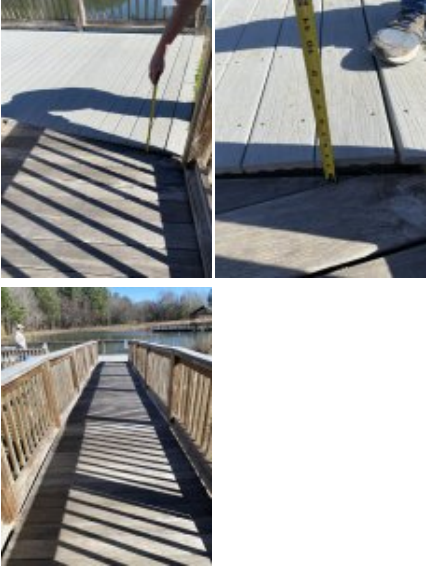
23	Outdoor Features (Public) : Fishing Pier (Visitor Center) - Pathway to Pier (Ramp)	The ramp run contains changes in level. Floor and ground surfaces shall be stable, firm, and slip resistant. Changes in level other than the running slope and cross slope are not permitted on ramp runs.	Bottom landing has lip exceeding 1/2" tolerance	https://www.access-board.gov/ada/#ada-405_4	2012 TAS Section: 405.4 2010 ADAS Section: 405.4 2015 ABAAS Section: 405.4

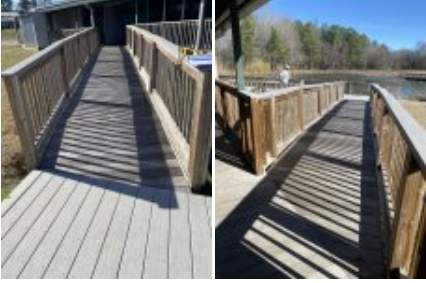
Finding Number	Area Description	Finding	As Built	Recommendation	Citation	Photos	Figure
24	Outdoor Features (Public) : Fishing Pier (Visitor Center) - Pathway to Pier (Ramp)	The ramp does not have compliant handrails. Handrails are required on both sides of all surfaces that are sloped greater than 5 percent (1:20). Handrails must be between 34 inches and 38 inches above the ramp surface, must extend 12 inches beyond the top and bottom of the ramp and be parallel to the floor or ground surface. The diameter of the handrails must be between 1 1/4 inches and 2 inches in cross-sectional nominal dimension for circular handrails. Handrail gripping surfaces with a non-circular cross section shall have a perimeter dimension of 4 inches minimum and 6 1/4 inches maximum, and a cross-section dimension of 2 1/4 inches maximum. The space between handrails and walls must be 1 1/2 inches minimum.	Ramp requires compliant handrails.	Review handrail componets to make accessible https://www.access-board.gov/aba/#aba-505_1	2012 TAS Section: 505.1 2010 ADAS Section: 505.1 2015 ABAAS Section: 505.1

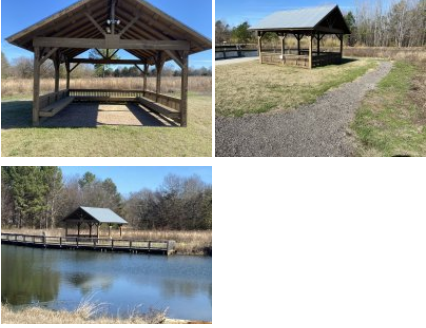
25	Outdoor Features (Public) : Fishing Pier (Pavilion #1)	An accessible access route is not provided between elements, spaces and the facilities provided within the accessible camping unit. At least one outdoor recreation access route shall connect accessible elements, spaces and facilities provided within camping units with mobility features.	There is no accessible route to pavilion. Packed earth is not compliant surfacing type.	N/A - Refer to Finding	2015 ABAAS Section: F244.5.1

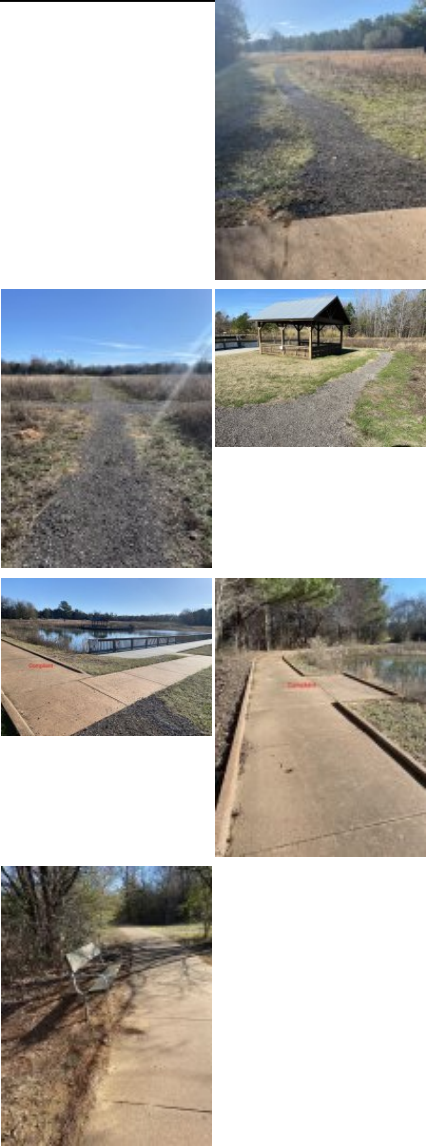
28	Outdoor Features (Public) : Nature Trail #1 (Around Fishing Pond)	The trail is missing the trailhead sign. Where new trail information signs are provided at trailheads on newly constructed or altered trails designed for use by hikers or pedestrians, the signs include the following: 1. Length of the trail or trail segment; 2. Surface type; 3. Typical and minimum tread width; 4. Typical and maximum running slope; and 5. Typical and maximum cross slope.	Trail provides some access but missing components for full compliance including accessible trail head. Trail leading from overnight parking to pier meets	Provide trail head sign listing accessibility levels as best practice.	2015 ABAAS Section: F216.13

Finding Number	Area Description	Finding	As Built	Recommendation	Citation	Photos	Figure
			<p>compliance but needs to be maintained and kept from debris.</p>

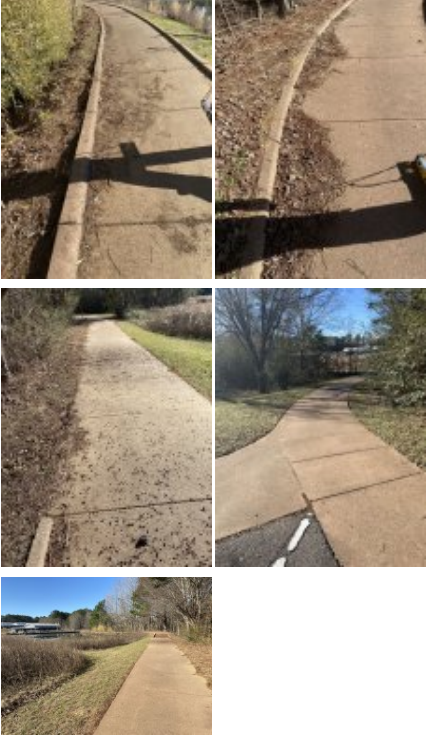
Finding Number	Area Description	Finding	As Built	Recommendation	Citation	Photos	Figure
29	Outdoor Features (Public) : Nature Trail #1 (Around Fishing Pond)	There are obstacles on the trails, passing spaces, and resting intervals that exceed 1/2 inches in height Tread obstacles on trails, passing spaces, and resting intervals shall not exceed 1/2 inch in height measured vertically to the highest point.	Trail componets are compliant but needs to remain debris free	Trail meets ADA compliance when clear of debris.	2015 ABAAS Section: 1017.5

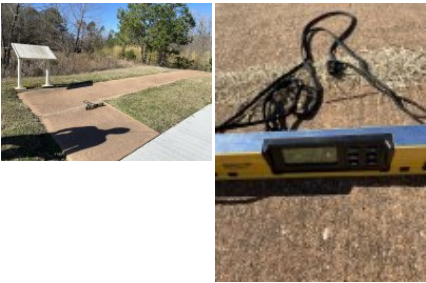
30	Outdoor Features (Public) : Nature Trail #1 (Around Fishing Pond)	The cross slope of the surface of the trail exceeds the maximum. The cross slope shall be not be steeper than 1:48.	Portion of trail from overnight parking to pier has cross slope exceeding 2.0%	N/A - Refer to Finding	2015 ABAAS Section: 1017.7.2

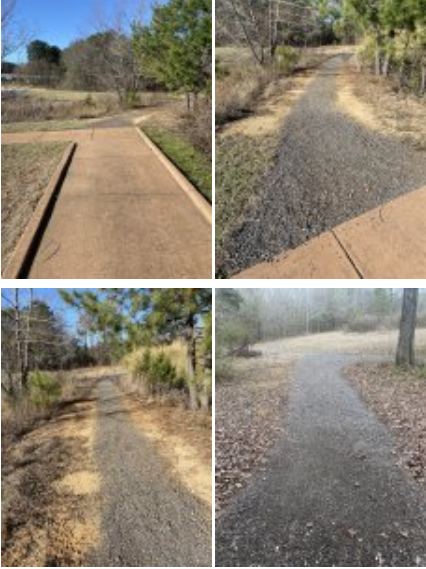
Finding Number	Area Description	Finding	As Built	Recommendation	Citation	Photos	Figure
31	Outdoor Features (Public) : Nature Trail #2 (Pavilion/ Restrooms)	The trail is missing the trailhead sign. Where new trail information signs are provided at trailheads on newly constructed or altered trails designed for use by hikers or pedestrians, the signs include the following: 1. Length of the trail or trail segment; 2. Surface type; 3. Typical and minimum tread width; 4. Typical and maximum running slope; and 5. Typical and maximum cross slope.	Trail provides some access but missing componets for full compliance including accessible trail head. Trail from fishing pier to outdoor pavilion and restroom.	Provide trail head sign listing accessibility levels as best practice.	2015 ABAAS Section: F216.13

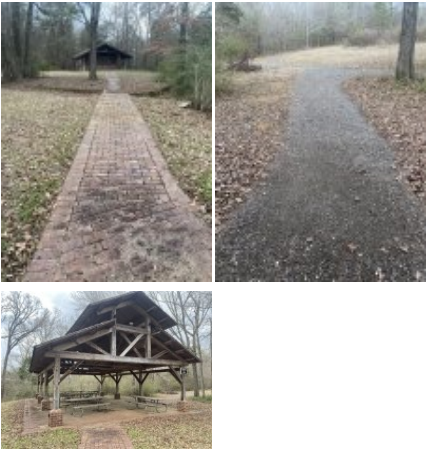
32	Outdoor Features (Public) : Nature Trail #2 (Pavilion/ Restrooms) - Pavilion #2 (Trail)	The surface of the outdoor recreation access route, passing spaces, and/or resting intervals are not firm and stable. The surface of outdoor recreation access route, passing spaces, and resting intervals shall be firm and stable	Route from restroom to pavilion and trail to pavilion features some accessible componets but overgrowth/sloping prevents access.	N/A - Refer to Finding	2015 ABAAS Section: 1016.2

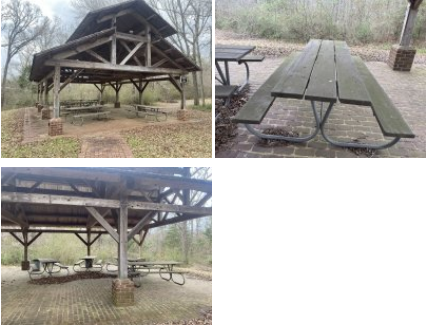
Finding Number	Area Description	Finding	As Built	Recommendation	Citation	Photos	Figure
33	Outdoor Features (Public) : Nature Trail #2 (Pavilion/ Restrooms) - Pavilion #2 (Trail)	All of the picnic units do not provide mobility features. Where picnic facilities contain two or fewer picnic units, each picnic unit shall provide mobility features.	There are no accessible picnic tables provided. Ground/surface material not compliant around picnic tables. Exterior pathway leading to tables non-compliant.	Knee space for wheelchair seating must be at least 30 inches wide, 19 inches deep, and 27 inches high, as measured from the ground or floor to the bottom of the tabletop. Toe clearance of at least 9 inches above the ground or floor must extend at least an additional 5 inches beyond the knee clearance.	2015 ABAAS Section: F245.2.1

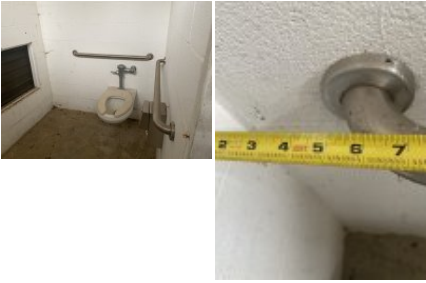
34	Outdoor Features (Public) : Nature Trail #2 (Pavilion/ Restrooms) - Restroom (Men's)	The side grab bar does not extend far enough from the rear wall. The side grab bar must extend at least 54 inches minimum beyond the rear wall and start a maximum of 12 inches from the rear wall. A 42 inch grab bar installed the maximum distance from the rear wall (12 inches) will leave the leading end 54 inches from the rear wall. Grab bars shall be installed in a horizontal position, 33 inches minimum and 36 inches maximum above the finish floor measured to the top of the gripping surface.	Grab bar mounted to close to rear wall and doesn't extend 54" Min	https://www.access-board.gov/ada/#ada-604_5_1	2012 TAS Section: 604.5.1 2010 ADAS Section: 604.5.1 2015 ABAAS Section: 604.5.1

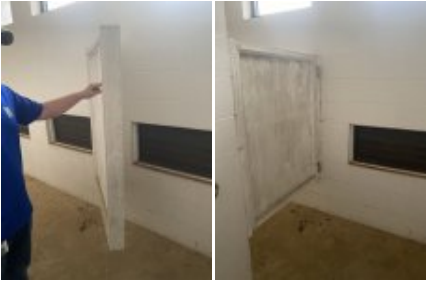
35	Outdoor Features (Public) : Nature Trail #2 (Pavilion/ Restrooms) - Restroom (Men's)	The water closet compartment is missing a loop handle on both sides of the door. Water closet compartments must be equipped with a door that has a loop or U-shaped handle on both sides of the door immediately below the latch. The latch must be flip-over style, sliding or other hardware not requiring the user to grasp or twist.	No handles	https://www.access-board.gov/ada/#ada-604_8_1_2	2012 TAS Section: 604.8.1.2 2010 ADAS Section: 604.8.1.2 2015 ABAAS Section: 604.8.1.2

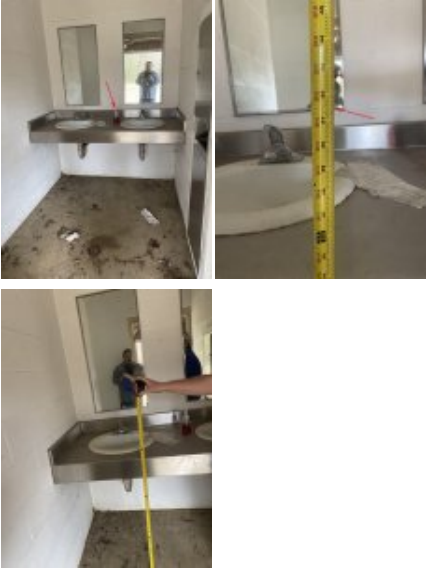
37	Outdoor Features (Public) : Nature Trail #2 (Pavilion/ Restrooms) - Restroom (Men's)	The mirror is mounted above the maximum allowable height. Mirrors must have the bottom edge of the reflecting surface a maximum of 40 inches above the floor if above a sink or counter. Mirrors not located above lavatories or countertops shall be installed with the bottom edge of the reflecting surface 35 inches maximum above the finish floor or ground.	Mirror height over 40" Restroom floor has debris limiting access. Soap dispenser not accessible.	https://www.access-board.gov/ada/#ada-603_3	2012 TAS Section: 603.3 2010 ADAS Section: 603.3 2015 ABAAS Section: 603.3

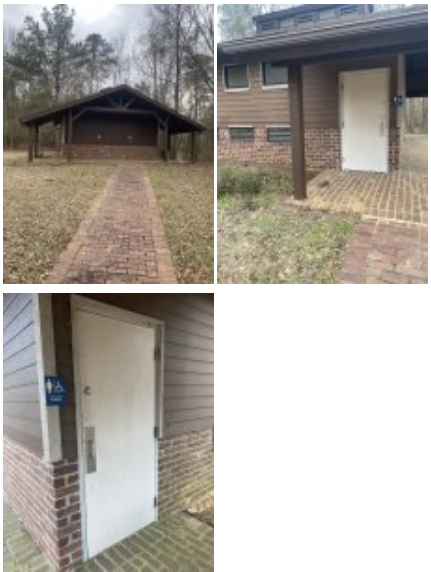
Finding Number	Area Description	Finding	As Built	Recommendation	Citation	Photos	Figure
38	Outdoor Features (Public) : Nature Trail #2 (Pavilion/ Restrooms) - Restroom (Men's)	The building entrance is not located on an accessible route. When a building, or portion of a building, is required to be accessible, an accessible route of travel shall be provided to all portions of the building, to accessible building entrances and between the building and the public way. At least one accessible route within the boundary of the site must be provided from public transportation stops, accessible parking and accessible passenger loading zones and public streets or sidewalks to the accessible building entrance they serve. The accessible route shall, to the maximum extent feasible, coincide with the route for the general public. At least one accessible route shall connect accessible buildings, facilities, elements and spaces that are on the same site. At least one accessible route shall connect accessible building or facility entrances with all accessible spaces and elements.	Exterior Route serving restroom features some accessible components but overgrowth/sloping prevents access.	https://www.access-board.gov/ada/#ada-206_2_1	2012 TAS Section: 206.2.1 2010 ADAS Section: 206.2.1 2015 ABAAS Section: F206.2.1

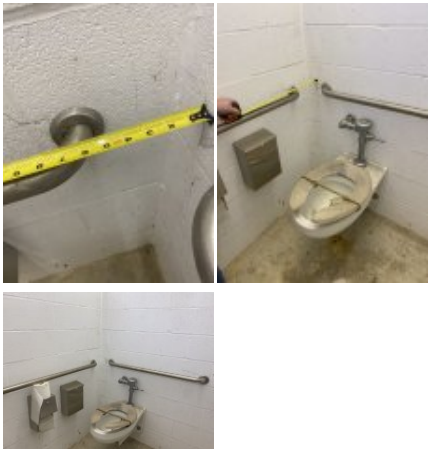
39	Outdoor Features (Public) : Nature Trail #2 (Pavilion/ Restrooms) - Restroom (Women's)	The side grab bar does not extend far enough from the rear wall. The side grab bar must extend at least 54 inches minimum beyond the rear wall and start a maximum of 12 inches from the rear wall. A 42 inch grab bar installed the maximum distance from the rear wall (12 inches) will leave the leading end 54 inches from the rear wall. Grab bars shall be installed in a horizontal position, 33 inches minimum and 36 inches maximum above the finish floor measured to the top of the gripping surface.	Grab bar mounted to close to rear wall and doesn't extend 54" Min	https://www.access-board.gov/ada/#ada-604_5_1	2012 TAS Section: 604.5.1 2010 ADAS Section: 604.5.1 2015 ABAAS Section: 604.5.1

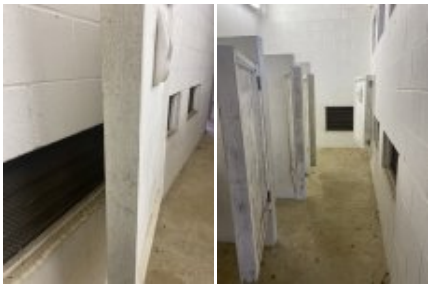
Finding Number	Area Description	Finding	As Built	Recommendation	Citation	Photos	Figure
40	Outdoor Features (Public) : Nature Trail #2 (Pavilion/ Restrooms) - Restroom (Women's)	The water closet compartment is missing a loop handle on both sides of the door. Water closet compartments must be equipped with a door that has a loop or U-shaped handle on both sides of the door immediately below the latch. The latch must be flip-over style, sliding or other hardware not requiring the user to grasp or twist.	No handles	https://www.access-board.gov/ada/#ada-604_8_1_2	2012 TAS Section: 604.8.1.2 2010 ADAS Section: 604.8.1.2 2015 ABAAS Section: 604.8.1.2

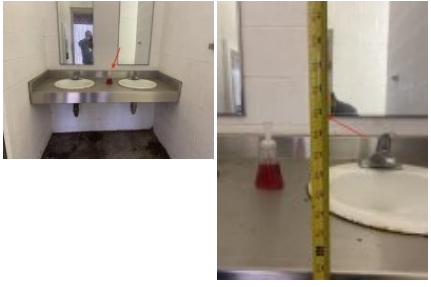
41	Outdoor Features (Public) : Nature Trail #2 (Pavilion/ Restrooms) - Restroom (Women's)	The mirror is mounted above the maximum allowable height. Mirrors must have the bottom edge of the reflecting surface a maximum of 40 inches above the floor if above a sink or counter. Mirrors not located above lavatories or countertops shall be installed with the bottom edge of the reflecting surface 35 inches maximum above the finish floor or ground.	Mirror height over 40" Restroom floor has debris limiting access. Soap dispenser not accessible.	https://www.access-board.gov/ada/#ada-603_3	2012 TAS Section: 603.3 2010 ADAS Section: 603.3 2015 ABAAS Section: 603.3

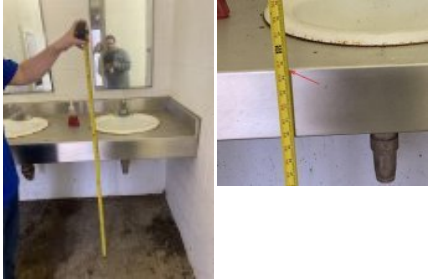
42	Outdoor Features (Public) : Nature Trail #2 (Pavilion/ Restrooms) - Restroom (Women's)	The top rim of the lavatory is too high. All lavatories that are designated to be accessible shall be a minimum 17 inches in horizontal depth and mounted with the rim or counter edge no higher than 34 inches above the finished floor.	Rim height over 34" tolerance	https://www.access-board.gov/ada/#ada-606_3	2012 TAS Section: 606.3 2010 ADAS Section: 606.3 2015 ABAAS Section: 606.3

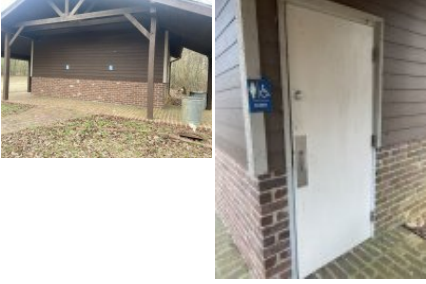
Finding Number	Area Description	Finding	As Built	Recommendation	Citation	Photos	Figure
43	Outdoor Features (Public) : Nature Trail #2 (Pavilion/ Restrooms) - Restroom (Women's)	The building entrance is not located on an accessible route. When a building, or portion of a building, is required to be accessible, an accessible route of travel shall be provided to all portions of the building, to accessible building entrances and between the building and the public way. At least one accessible route within the boundary of the site must be provided from public transportation stops, accessible parking and accessible passenger loading zones and public streets or sidewalks to the accessible building entrance they serve. The accessible route shall, to the maximum extent feasible, coincide with the route for the general public. At least one accessible route shall connect accessible buildings, facilities, elements and spaces that are on the same site. At least one accessible route shall connect accessible building or facility entrances with all accessible spaces and elements.	Exterior Route serving restroom features some accessible componets but overgrowth/sloping prevents access.	https://www.access-board.gov/ada/#ada-206_2_1	2012 TAS Section: 206.2.1 2010 ADAS Section: 206.2.1 2015 ABAAS Section: F206.2.1

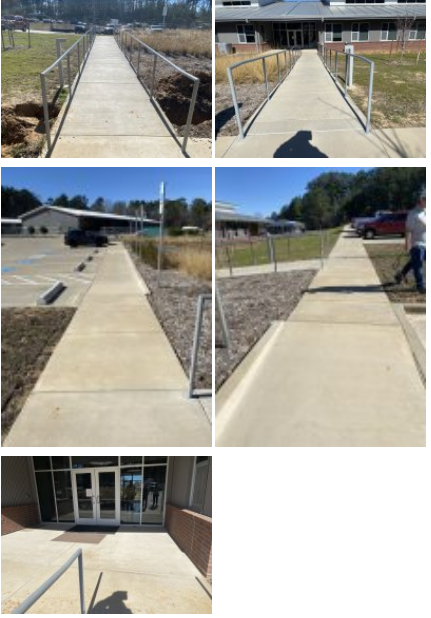
45	Exterior of Property (STAFF): Staff Parking Lot (4 Spaces) 2 Van 2 Car - Pathway to Building (Staff Parking to Staff Entrance)	The handrail extension is not a minimum 12 inches. Handrails must be between 34 inches and 38 inches above the ramp surface and must extend beyond the top and bottom of the ramp run 12 inches horizontally. The 12 inches horizontal extensions must not include the radius at the top end of round handrails. Extensions shall return to a wall, guard, or the landing surface, or shall be continuous to the handrail of an adjacent ramp run.	Handrails are missing extensions. ramp slopes, landings, and surface material are compliant. Exterior pathway leading to staff entrance compliant.	https://www.access-board.gov/ada/#ada-505_10_1	2012 TAS Section: 505.10.1 2010 ADAS Section: 505.10.1 2015 ABAAS Section: 505.10.1

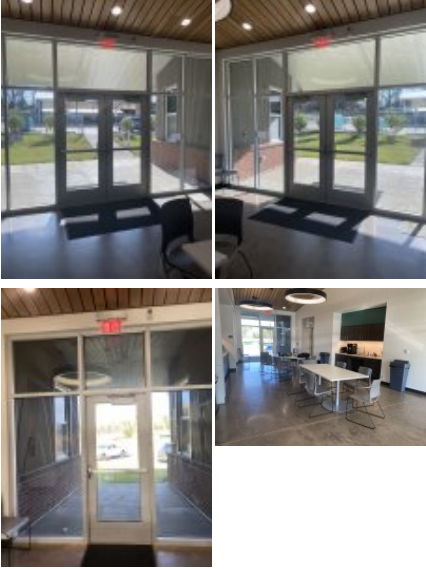
Finding Number	Area Description	Finding	As Built	Recommendation	Citation	Photos	Figure
47	Structures on Property (STAFF): Main Building- Office Spaces (Interior) - Kitchenettes - 2 total	The tactile EXIT sign is missing at the door. Wall signs identifying exits shall have characters raised 1/32 inch minimum and shall be uppercase characters a minimum of 5/8 inch and a maximum of 2 inches high. Braille shall be placed directly below the tactile characters; flush left or centered. Signs shall be located a minimum of 48 inches above the floor, measured from the baseline of the lowest tactile characters and 60 inches maximum above the finish floor or ground surface, measured from the baseline of the highest tactile characters. Where a tactile sign is provided at a door, the sign shall be located on the latch side. Where a tactile sign is provided at double doors the sign shall be located to the right of the right-hand door. Where there is no wall space at the latch side of a single door or at the right side of double doors, signs shall be located on the nearest adjacent wall.	This applies to all doors with overhead exits sign. Where visual EXIT is provided, accompanying tactile EXIT sign must also be provided for same doorway. Doorway exit signs and emergency exits with emergency exit signs that are overhead or visual only, or pictograms only, must have an accompanying ADA Braille sign. Exit passages, including doors, stairs and routes, must be identified with tactile ADA signage. Signs must include braille and raised characters. Pictograms are optional.	https://www.access-board.gov/ada/#ada-216_4_1	2012 TAS Section: 216.4.1 2010 ADAS Section: 216.4.1 2015 ABAAS Section: F216.4.1

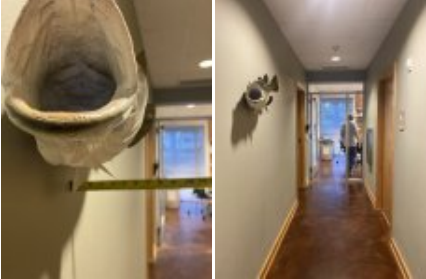
48	Structures on Property (STAFF): Regional Offices- Fishing (Interior)	The bas mount projects more than 4 inches into the circulation path. Wall-mounted objects that have leading edges between 27 inches and 80 inches from the floor must not project more than 4 inches into the circulation path. Protruding objects that extend to the floor or within 27 inches of the floor are cane detectable and are therefore not hazardous. Where it is necessary or desirable to have objects protrude from the wall, a manner of cane detection must be provided.	Hallway has 1 protruding object, bass mount	https://www.access-board.gov/ada/#ada-307_2	2012 TAS Section: 307.2 2010 ADAS Section: 307.2 2015 ABAAS Section: 307.2

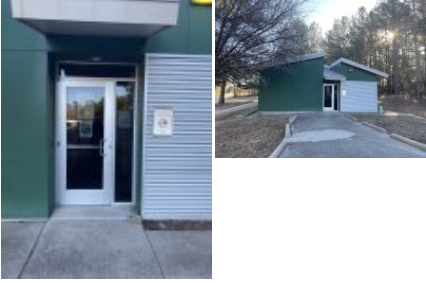
Finding Number	Area Description	Finding	As Built	Recommendation	Citation	Photos	Figure
49	Structures on Property (STAFF): Regional Offices-Fishing (Interior) - Entrance Doors	The door is equipped with a door closer and returns to a closed position too quickly. Door closers and gate closers shall be adjusted so that from an open position of 90 degrees, the time required to move the door to a position of 12 degrees from the latch is 5 seconds minimum.	Exterior door closes too quickly	https://www.access-board.gov/ada/#ada-404_2_8_1	2012 TAS Section: 404.2.8.1 2010 ADAS Section: 404.2.8.1 2015 ABAAS Section: 404.2.8.1

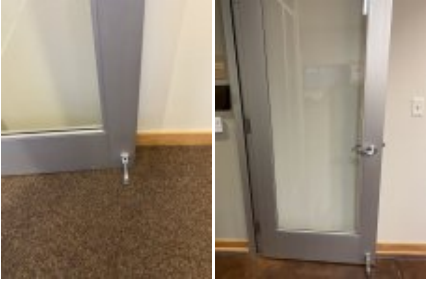
50	Structures on Property (STAFF): Regional Offices-Fishing (Interior) - Entrance Doors	The door must have a smooth surface within 10 inches of the floor on the push side. Swinging door surfaces within 10 inches of the finish floor or ground measured vertically must have a smooth surface on the push side extending the full width of the door. Parts creating horizontal or vertical joints in these surfaces shall be within 1/16 inch of the same plane as the other. All gates, including ticket gates, shall meet all applicable specifications for doors.	Multiple interior doors have stopper limiting access.	https://www.access-board.gov/ada/#ada-404_2_10	2012 TAS Section: 404.2.10 2010 ADAS Section: 404.2.10 2015 ABAAS Section: 404.2.10

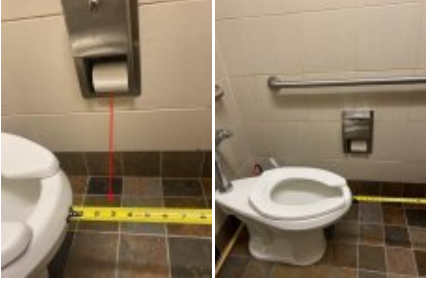
51	Structures on Property (STAFF): Regional Offices-Fishing (Interior) - Restroom (Men's)	The toilet paper is not installed within the compliant range in front of the toilet. Toilet paper dispensers shall be 7 inches minimum and 9 inches maximum in front of the water closet measured to the centerline of the dispenser. The outlet of the dispenser shall be 15 inches minimum and 48 inches maximum above the finish floor and shall not be located behind grab bars. Dispensers shall not be of a type that controls delivery or that does not allow continuous paper flow. There shall be a clearance of 1 1/2 inches minimum below the grab bar.	Installed to close to toilet	https://www.access-board.gov/ada/#ada-604_7	2012 TAS Section: 604.7 2010 ADAS Section: 604.7 2015 ABAAS Section: 604.7

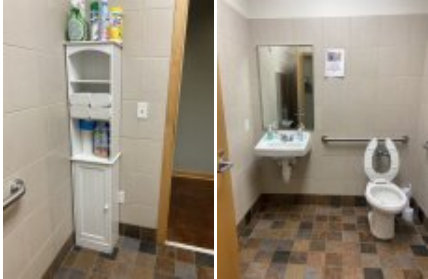
53	Structures on Property (STAFF): Regional Offices-Fishing (Interior) - Restroom (Men's)	The restroom contains storage items and/or supplies which obstruct the clear floor and/or turning space within the restroom. A clear space measured from the floor to a height of 27 inches above the floor, within the restroom, of sufficient size to inscribe a circle with a diameter not less than 60 inches in size or a "T" turning space must be provided.	storage shelf impedes access.	https://www.access-board.gov/ada/#ada-603_2_1	2012 TAS Section: 603.2.1 2010 ADAS Section: 603.2.1 2015 ABAAS Section: 603.2.1 , 803.2, 805.2

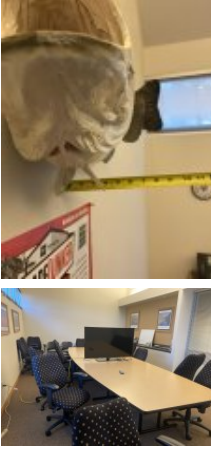
Finding Number	Area Description	Finding	As Built	Recommendation	Citation	Photos	Figure
58	Structures on Property (STAFF): Regional Offices-Fishing (Interior) - Conference Room	The element projects more than 4 inches into the circulation path. Wall-mounted objects that have leading edges between 27 inches and 80 inches from the floor must not project more than 4 inches into the circulation path. Protruding objects that extend to the floor or within 27 inches of the floor are cane detectable and are therefore not hazardous. Where it is necessary or desirable to have objects protrude from the wall, a manner of cane detection must be provided.	Protruding object limits interior space. Conference room meets most accessibility standards	https://www.access-board.gov/ada/#ada-307_2	2012 TAS Section: 307.2 2010 ADAS Section: 307.2 2015 ABAAS Section: 307.2

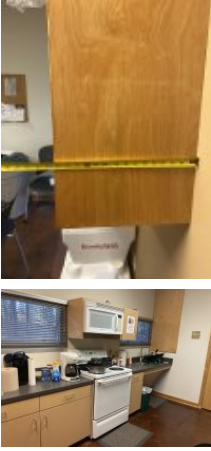
59	Structures on Property (STAFF): Regional Offices-Fishing (Interior) - Kitchnette	The cabinet projects more than 4 inches into the circulation path. Wall-mounted objects that have leading edges between 27 inches and 80 inches from the floor must not project more than 4 inches into the circulation path. Protruding objects that extend to the floor or within 27 inches of the floor are cane detectable and are therefore not hazardous. Where it is necessary or desirable to have objects protrude from the wall, a manner of cane detection must be provided.	Cabinet protrudes into walking space	https://www.access-board.gov/ada/#ada-307_2	2012 TAS Section: 307.2 2010 ADAS Section: 307.2 2015 ABAAS Section: 307.2

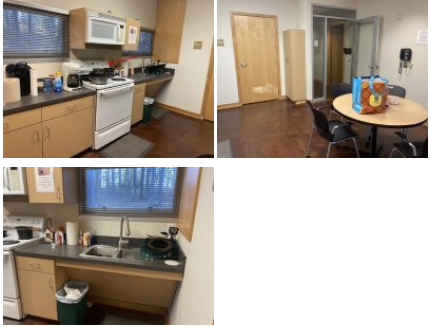
Finding Number	Area Description	Finding	As Built	Recommendation	Citation	Photos	Figure
60	Structures on Property (STAFF): Regional Offices-Fishing (Interior) - Kitchenette	The controls are located such that operation require reaching across burners. Where knee and toe space is provided, the underside of the range or cooktop shall be insulated or otherwise configured to prevent burns, abrasions, or electrical shock. The location of controls shall not require reaching across burners	Controls require reaching across burners.	https://www.access-board.gov/ada/#ada-804_6_4	2012 TAS Section: 804.6.4 2010 ADAS Section: 804.6.4 2015 ABAAS Section: 804.6.4
