# Yoakum Dunes WMA- ADA Evaluation

**WMA- Yoakum Dunes, Whiteface TX, ADA Evaluation**

**Accessibility Evaluation**

**Inspection Date: 06/24/2022**

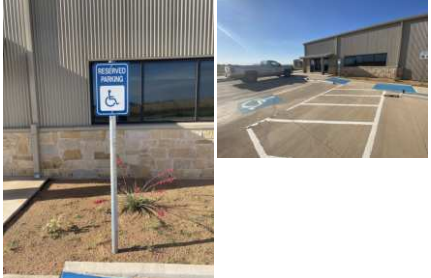
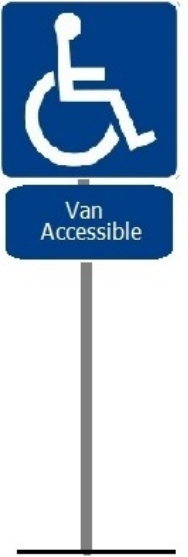
Finding Number	Area Description	Finding	As Built	Recommendation	Citation	Photos	Figure
1	Exterior of Property (Public): HQ Parking Lot (1 Space) 1 Labeled - Accessible Stall (Labeled)	The accessible parking stall signage is incorrect and/or missing from each accessible parking space. Parking space identification signs shall include the International Symbol of Accessibility. Signs identifying van parking spaces shall contain the designation "van accessible." Signs shall be 60 inches minimum above the finish floor or ground surface measured to the bottom of the sign.	Missing van designation		<a href="https://www.access-board.gov/ada/#ada-502_6">https://www.access-board.gov/ada/#ada-502_6</a>	2012 TAS Section: 502.6  2015 ABAAS Section: 502.6

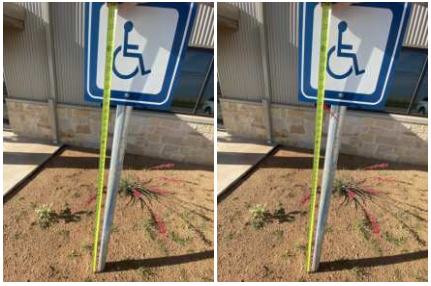
2	Exterior of Property (Public): HQ Parking Lot (1 Space) 1 Labeled - Accessible Stall (Labeled)	The parking sign is mounted too low. Parking space identification signs shall include the International Symbol of Accessibility. Signs identifying van parking spaces shall contain the designation "van accessible." Signs shall be 60 inches minimum above the finish floor or ground surface measured to the bottom of the sign.	Sign height at 54"		<a href="https://www.access-board.gov/ada/#ada-502_6">https://www.access-board.gov/ada/#ada-502_6</a>	2012 TAS Section: 502.6  2010 ADAS Section: 502.6  2015 ABAAS Section: 502.6

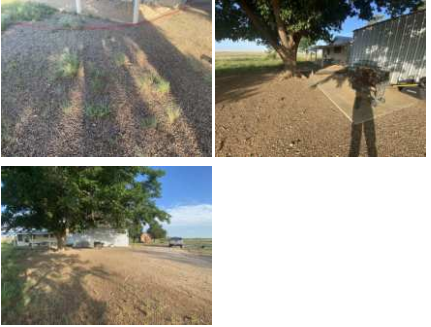
7	Structures on Property (Public) : Bunk Areas (Exterior) - Pathway to Bunk House	The path of contains multiple issues and is not accessible. The path of travel exceeds the maximum allowable cross and running slope requirements. It also contains changes in level and/or gaps that exceed the allowable maximum requirements. The path of travel does not meet the minimum width requirements for clearances, turning spaces, and/or passing spaces. The floor or ground surface is not firm, stable, and slip resistant.	Pathway has multiple infractions	Review accessible pathway componets to make accessible <a href="https://www.access-board.gov/ada/#ada-402">https://www.access-board.gov/ada/#ada-402</a> <a href="https://www.access-board.gov/ada/#ada-403_1">https://www.access-board.gov/ada/#ada-403_1</a>	2010 ADAS Section: 403.1  2015 ABAAS Section: 403.1

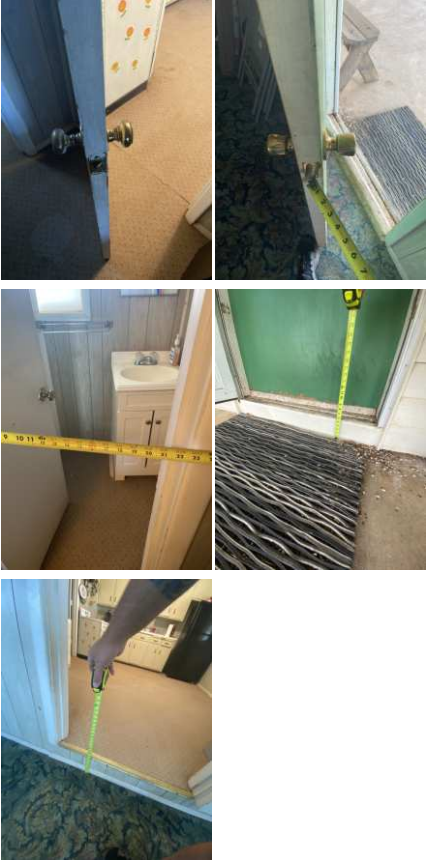
Finding Number	Area Description	Finding	As Built	Recommendation	Citation	Photos	Figure
8	Structures on Property (Public) : Bunk Areas (Interior)	Minimum maneuvering clearances at doors and gates shall comply with 404.2.4. Maneuvering clearances shall extend the full width of the doorway and the required latch side or hinge side clearance. Maneuvering clearances shall have a max slope of 2.08%. Door openings shall provide a clear width of 32 inches (815 mm) minimum. Clear openings of doorways with swinging doors shall be measured between the face of the door and the stop, with the door open 90 degrees. Openings more than 24 inches (610 mm) deep shall provide a clear opening of 36 inches (915 mm) minimum. There shall be no projections into the required clear opening width lower than 34 inches (865 mm) above the finish floor or ground. Projections into the clear opening width between 34 inches (865 mm) and 80 inches (2030 mm) above the finish floor or ground shall not exceed 4 inches (100 mm). The threshold has a vertical change greater than 1/4 inch high. The threshold has a gap greater than 1/2 inch wide. The threshold at a doorway shall be no higher than 1/2 inch. Changes in level between 1/4 inch and 1/2 inch must be beveled at 1:2 or less. 1/4 inch is the maximum vertical rise. All interior doors must be maintained so that the operating pressure does not exceed 5 lbf to open. The sweep period for doors with closers shall be adjusted so that from an open position of 70 degrees, the door will take at least 3 seconds to move to a point 3 inches from the latch, measured to the leading edge of the door. Exterior doors are recommended to be maintained at 8.5 lbf as a smart practice. Force is to be measured at the operating hardware or 30 inches from the hinges, whichever is greater. Hand-activated door opening hardware, handles, pulls, latches, locks, and other operating devices on accessible doors shall have a shape that is easy to grasp with one hand and does not require tight grasping, tight pinching or twisting of the wrist to operate. Hardware shall be 34 inches minimum and 48 inches maximum above the finish floor or ground. The bottom 10 inches on the push side must be smooth and free of obstructions (hold open devices). Doors, gates, and side lights adjacent to doors or gates, containing one or more glazing	More than 60% doors/entrances are equipped with non-compliant hardware. Most doorway thresholds in exceed 1/2" tolerance.	Review door and threshold componets to make accessible <a href="https://www.access-board.gov/ada/#ada-404">https://www.access-board.gov/ada/#ada-404</a>	2010 ADAS Section: 404.2.3, 404.2.7, 404.2.4, 404.2.11, 404.2.11 Exception

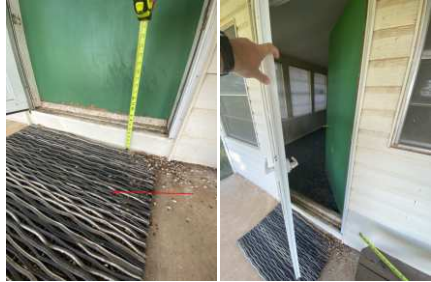
Finding Number	Area Description	Finding	As Built	Recommendation	Citation	Photos	Figure
		panels that permit viewing through the panels shall have the bottom of at least one glazed panel located 43 inches (1090 mm) maximum above the finish floor. EXCEPTION: Vision lights with the lowest part more than 66 inches (1675 mm) from the finish floor or ground shall not be required to comply with 404.2.11. Egress doors shall provide a continuous and unobstructed way of egress travel from any point in a building or facility that provides an accessible route to an area of refuge, a horizontal exit, or a public way.					
9	Structures on Property (Public) : Bunk Areas (Interior) - Entrance/Exit Doors	The floor mat at the door is not secured in place. If carpet or carpet tile is used on a ground or floor surface, then it shall be securely attached; have a firm cushion, pad or backing or no cushion or pad; and have a level loop, textured loop, level-cut pile or level-cut/uncut pile texture. The maximum pile height shall be 1/2 inch. Exposed edges of carpet shall be fastened to floor surfaces and have trim along the entire length of the exposed edge. Recessed doormats shall be adequately anchored to prevent interference with wheelchair traffic.	Door mat is not of compliant size or durability and does not meet compliance.	<a href="https://www.access-board.gov/ada/#ada-302_2">https://www.access-board.gov/ada/#ada-302_2</a>	2012 TAS Section: 302.2 2010 ADAS Section: 302.2 2015 ABAAS Section: 302.2

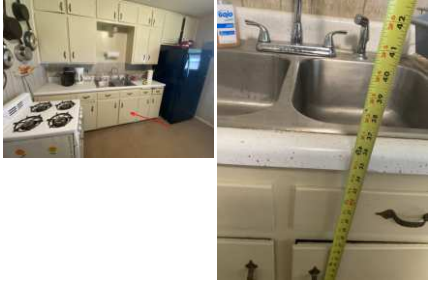
Finding Number	Area Description	Finding	As Built	Recommendation	Citation	Photos	Figure
14	Structures on Property (Public) : Bunk Areas (Interior) - Kitchenette	Knee and toe clearance has not been provided at the sink. The knee clearance shall be 11 inches deep minimum at 9 inches above the finish floor or ground, and 8 inches deep minimum at 27 inches above the finish floor or ground. The toe clearance is the space under the sink between the finish floor or ground and 9 inches above the finish floor 30 inches wide minimum. The toe clearance shall extend a minimum of 17 inches and a maximum of 25 inches underneath the sink.	Knee and toe must be provided since kitchenette contain stove top range. In kitchens, kitchenettes, and breakrooms without a cooktop or conventional range, a parallel approach is permitted at kitchen sinks.	<a href="https://www.access-board.gov/ada/#ada-606_2">https://www.access-board.gov/ada/#ada-606_2</a>	2012 TAS Section: 606.2  2010 ADAS Section: 606.2  2015 ABAAS Section: 606.2

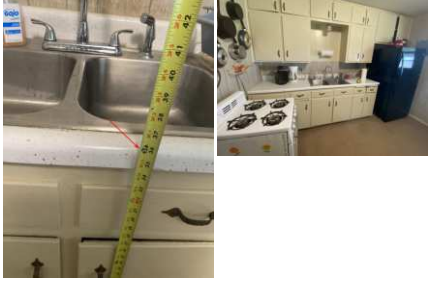
15	Structures on Property (Public) : Bunk Areas (Interior) - Kitchenette	The top of the sink is above the allowable height requirement. Sinks shall be installed with the front of the higher of the rim or counter surface 34 inches maximum above the finish floor or ground.	Sink height at 36" Sink required to have frontal approach due to stove top in kitchenette	N/A - Refer to Finding	2012 TAS Section: 606.3  2010 ADAS Section: 606.3  2015 ABAAS Section: 606.3

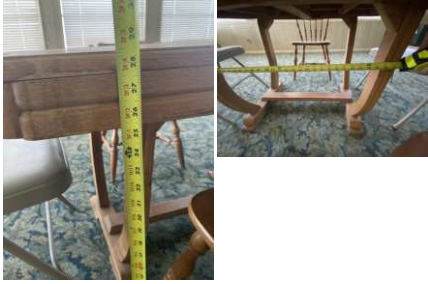
16	Structures on Property (Public) : Bunk Areas (Interior) - Kitchenette	Compliant knee and/or toe clearance is not provided. When seating for persons in wheelchairs is provided at fixed tables or counters, knee spaces at least 27 inches high, 30 inches wide, 11 inches deep, and toe clearance extending an additional 6 inches at 9 inches high shall be provided. The toe clearance shall extend 17" minimum under the element.	Kitchen table is not accessible and does not provide knee or toe space.	<a href="https://www.access-board.gov/ada/#ada-306_2_1">https://www.access-board.gov/ada/#ada-306_2_1</a>	2012 TAS Section: 306.2.1  2010 ADAS Section: 306.2.1  2015 ABAAS Section: 306.2.1, 306.3.1

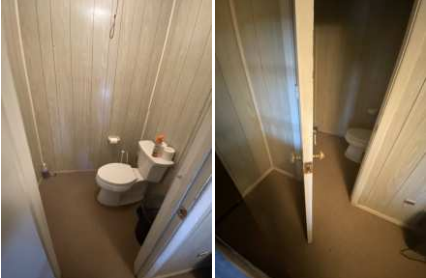
Finding Number	Area Description	Finding	As Built	Recommendation	Citation	Photos	Figure
17	Structures on Property (Public) : Bunk Areas (Interior) - Restroom (Toilet)	The restroom is not nearly compliant. The restroom does not have the required minimum clear floor space or maneuvering clearances for the toilet. The restroom does not have the required minimum clear floor space or maneuvering clearances for the lavatory. The entry door does not contain the required minimum maneuvering spaces on the pull/push sides. The entry door encroach into the required clear floor space for fixtures. Grab bars are missing and/or incorrectly installed. Accessories, such as toilet seat covers, paper towel holders, garbage cans, hand dryers, and mirrors are either too high or without clear floor space or both. The restroom contain floor level changes greater than a 1/2 inch of the floor drains and is slope (XX) - (XX), the shower is too small and missing numerous accessible elements.	Toilet room separate from shower room. This restroom requires a number of componets to gain compliance.	<a href="https://www.access-board.gov/ada/#ada-213_2">https://www.access-board.gov/ada/#ada-213_2</a> Review restrooms componets to make accessible. <a href="https://www.access-board.gov/ada/#ada-603">https://www.access-board.gov/ada/#ada-603</a>	2012 TAS Section: 213.2  2010 ADAS Section: 213.2  2015 ABAAS Section: F213.2

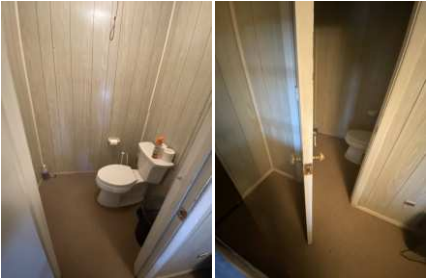
18	Structures on Property (Public) : Bunk Areas (Interior) - Restroom (Toilet)	Accessible toilets must have grab bars installed. The side grab bar must extend at least 54 inches minimum beyond the rear wall and start a maximum of 12 inches from the rear wall. The rear grab bar must be a minimum of 36 inches long and extend from the centerline of the toilet 12 inches minimum on one side and 24 inches minimum on the other side. Grab bars shall be installed in a horizontal position, 33 inches minimum and 36 inches maximum above the finish floor measured to the top of the gripping surface.	There are no grab bars installed at this time.	<a href="https://www.access-board.gov/ada/#ada-604_5">https://www.access-board.gov/ada/#ada-604_5</a> Review grab bar componets to make accessible <a href="https://www.access-board.gov/ada/#ada-609">https://www.access-board.gov/ada/#ada-609</a>	2012 TAS Section: 604.5  2010 ADAS Section: 604.5  2015 ABAAS Section: 604.5

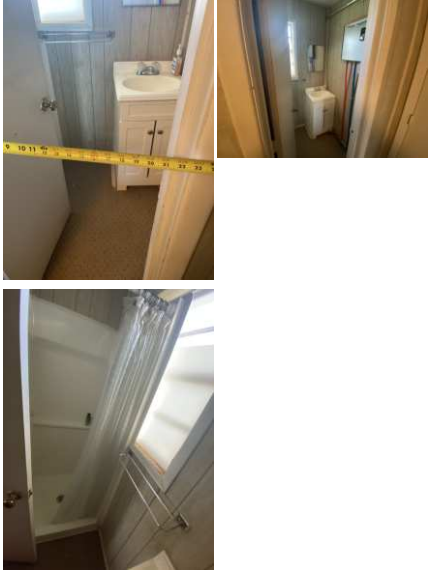
Finding Number	Area Description	Finding	As Built	Recommendation	Citation	Photos	Figure
19	Structures on Property (Public) : Bunk Areas (Interior) - Restroom (Shower)	The door opening does not provide at least 32 inches between the face of the door and the opposite stop. Door openings shall provide a clear width of 32 inches minimum. Clear openings of doorways with swinging doors shall be measured between the face of the door and the stop, with the door open 90 degrees.	Door to sink and shower room does not open to 90°. Shower and sink in separate room from toilet.	<a href="https://www.access-board.gov/ada/#ada-404_2_3">https://www.access-board.gov/ada/#ada-404_2_3</a>	2012 TAS Section: 404.2.3  2010 ADAS Section: 404.2.3  2015 ABAAS Section: 404.2.3

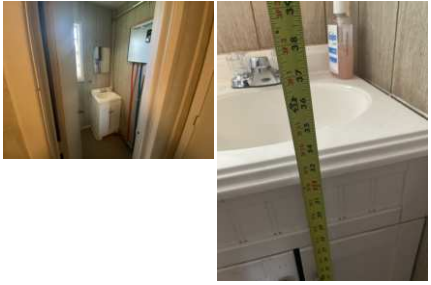
Hinged Door
20	Structures on Property (Public) : Bunk Areas (Interior) - Restroom (Shower)	There are not enough accessible lavatories. Where lavatories are provided, at least one shall be accessible and shall not be located in a toilet compartment.	The lavatory and accessories are not complaint.	<a href="https://www.access-board.gov/ada/#ada-213_3_4">https://www.access-board.gov/ada/#ada-213_3_4</a> Review lavatory componets to make accessible. <a href="https://www.access-board.gov/ada/#ada-606">https://www.access-board.gov/ada/#ada-606</a>	2012 TAS Section: 213.3.4  2010 ADAS Section: 213.3.4  2015 ABAAS Section: F213.3.4

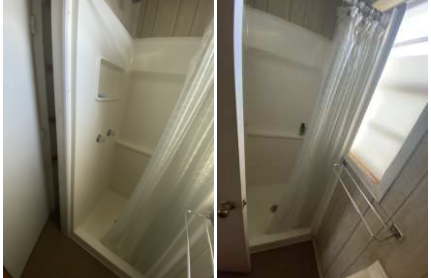
21	Structures on Property (Public) : Bunk Areas (Interior) - Restroom (Shower)	There are no accessible bathing and shower facilities. Where bathtubs or showers are provided, at least one accessible bathtub or at least one accessible shower shall be provided.	There is no accessible shower at this time	<a href="https://www.access-board.gov/ada/#ada-213_3_6">https://www.access-board.gov/ada/#ada-213_3_6</a> Review shower or tub componets to make accessible <a href="https://www.access-board.gov/ada/#ada-607">https://www.access-board.gov/ada/#ada-607</a> <a href="https://www.access-board.gov/ada/#ada-608">https://www.access-board.gov/ada/#ada-608</a>	2012 TAS Section: 213.3.6  2010 ADAS Section: 213.3.6  2015 ABAAS Section: F213.3.6

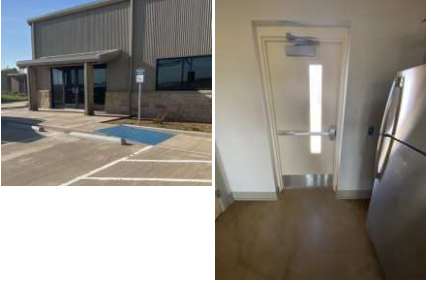
Finding Number	Area Description	Finding	As Built	Recommendation	Citation	Photos	Figure
22	Structures on Property (Public) : HQ Building (Interior) - Entrance/Exit Doors	The door is equipped with a door closer and returns to a closed position too quickly. Door closers and gate closers shall be adjusted so that from an open position of 90 degrees, the time required to move the door to a position of 12 degrees from the latch is 5 seconds minimum.	Doors pictured closes in less than 5 secs, front double door entrance and rear exit door.	<a href="https://www.access-board.gov/ada/#ada-404_2_8_1">https://www.access-board.gov/ada/#ada-404_2_8_1</a>	2012 TAS Section: 404.2.8.1 2010 ADAS Section: 404.2.8.1 2015 ABAAS Section: 404.2.8.1

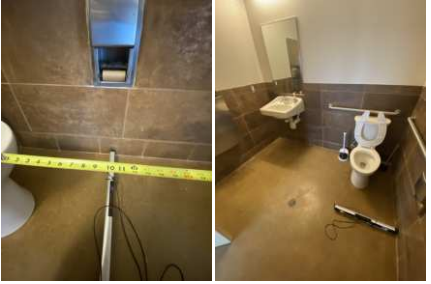
24	Structures on Property (Public) : HQ Building (Interior) - Restroom (Unisex)	The toilet paper is not installed within the compliant range in front of the toilet. Toilet paper dispensers shall be 7 inches minimum and 9 inches maximum in front of the water closet measured to the centerline of the dispenser. The outlet of the dispenser shall be 15 inches minimum and 48 inches maximum above the finish floor and shall not be located behind grab bars. Dispensers shall not be of a type that controls delivery or that does not allow continuous paper flow. There shall be a clearance of 1 1/2 inches minimum below the grab bar.	TP dispenser at 10"	<a href="https://www.access-board.gov/ada/#ada-604_7">https://www.access-board.gov/ada/#ada-604_7</a>	2012 TAS Section: 604.7 2010 ADAS Section: 604.7 2015 ABAAS Section: 604.7
