AE Wood IF- ADA Evaluation

IF-San Marcos TX, AE Wood ADA Evaluation

Accessibility Evaluation

Inspection Date: 12/05/2022

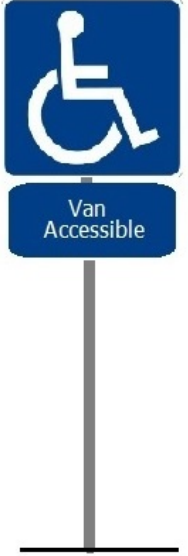
Finding Number	Area Description	Finding	As Built	Recommendation	Citation	Photos	Figure
1	Exterior of Property (Public) : AE Wood Parking Lot (1 Space) 1 Van - Van Accessible Stall	The van stall is missing a sign identifying it as a van accessible stall. Parking space identification signs shall include the International Symbol of Accessibility. Signs identifying van parking spaces shall contain the designation "van accessible."	Van sign looks to be missing. Needs photo verification		https://www.access-board.gov/ada/#ada-502_6	2012 TAS Section: 502.6 2010 ADAS Section: 502.6 2015 ABAAS Section: 502.6

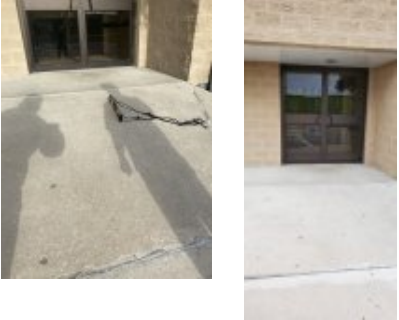
Finding Number	Area Description	Finding	As Built	Recommendation	Citation	Photos	Figure
3	Exterior of Property (Public) : AE Wood Parking Lot (1 Space) 1 Van - Pathway to Building (Van Accessible Stall to Main Entrance)	The building entrance is not located on an accessible route. When a building, or portion of a building, is required to be accessible, an accessible route of travel shall be provided to all portions of the building, to accessible building entrances and between the building and the public way. At least one accessible route within the boundary of the site must be provided from public transportation stops, accessible parking and accessible passenger loading zones and public streets or sidewalks to the accessible building entrance they serve. The accessible route shall, to the maximum extent feasible, coincide with the route for the general public. At least one accessible route shall connect accessible buildings, facilities, elements and spaces that are on the same site. At least one accessible route shall connect accessible building or facility entrances with all accessible spaces and elements.	Due to lack of accessible pathway, there is no way to access this building at this time. Curb ramp used to gain entry into building is not compliant. This building is not accessible.	https://www.access-board.gov/ada/#ada-206_2_1	2012 TAS Section: 206.2.1 2010 ADAS Section: 206.2.1 2015 ABAAS Section: F206.2.1

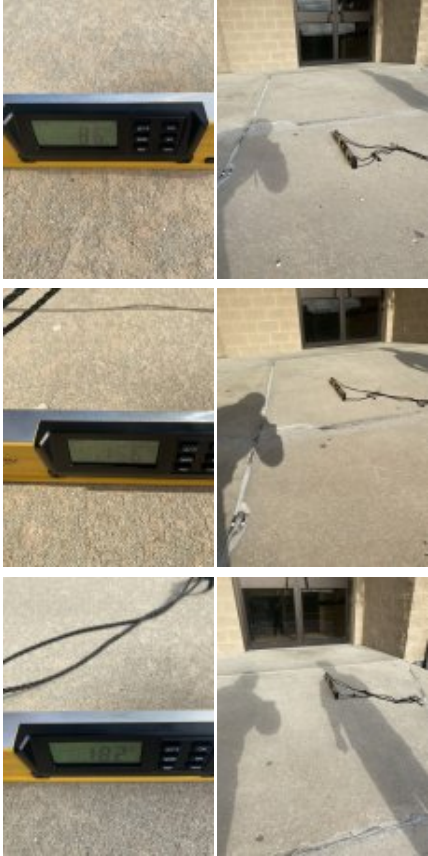
Finding Number	Area Description	Finding	As Built	Recommendation	Citation	Photos	Figure
4	Exterior of Property (Public) : AE Wood Parking Lot (1 Space) 1 Van - Pathway to Building (Van Accessible Stall to Main Entrance)	Significant sloping in curb ramp. The curb ramp exceeds the maximum running slope (parallel to the direction of travel) allowable of 8.33%.	N/A		https://www.access-board.gov/ada/#ada-406_1

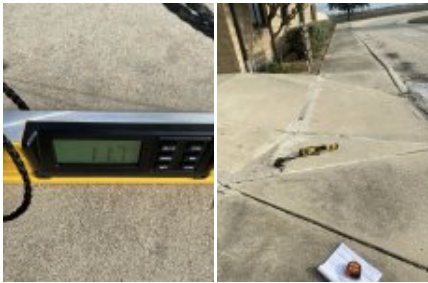
5	Exterior of Property (Public) : AE Wood Parking Lot (1 Space) 1 Van - Pathway to Building (Van Accessible Stall to Main Entrance)	The curb ramp side flares exceed maximum slope allowances. The sides of curb ramps (curb ramp flares) where provided, shall not be steeper than 1:10.	Located on (L) side of curb ramp.		https://www.access-board.gov/ada/#ada-406_3

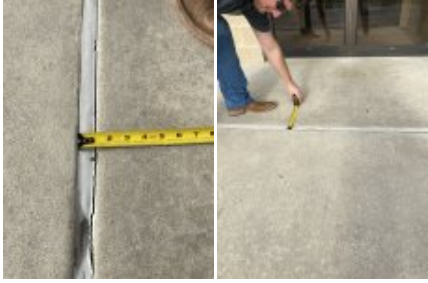
Finding Number	Area Description	Finding	As Built	Recommendation	Citation	Photos	Figure
6	Exterior of Property (Public) : AE Wood Parking Lot (1 Space) 1 Van - Pathway to Building (Van Accessible Stall to Main Entrance)	The route contains openings greater than 1/2 inch. Openings in floor or ground surfaces shall not allow passage of a sphere more than 1/2 inch diameter. Elongated openings shall be placed so that the long dimension is perpendicular to the dominant direction of travel.	on exterior pathway leading to front entrance.	https://www.access-board.gov/ada/#ada-302_3	2012 TAS Section: 302.3 2010 ADAS Section: 302.3 2015 ABAAS Section: 302.3

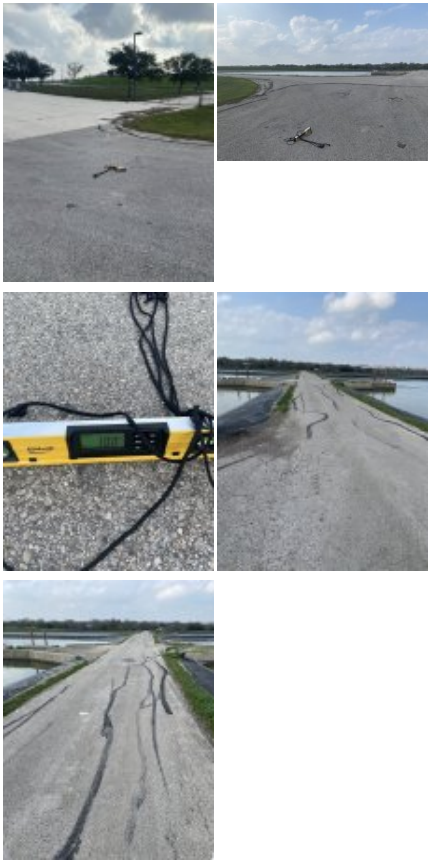
7	Exterior of Property (Public) : Pathway to Holding Ponds - TOUR	The accessible route on the site has running slopes greater than 5 percent and has not been constructed as a ramp (i.e. handrails, edge protection, etc.). When the slope in the direction of travel of any walk exceeds 1 unit vertical in 20 units horizontal (5-percent slope), it must be constructed as a ramp. Surface cross slopes must not exceed one unit vertical in 48 units horizontal (2-percent slope).	Running slope near access point is not compliant. Exterior route meets majority of requirements for compliance and is considered accessible.	https://www.access-board.gov/ada/#ada-403_3	2012 TAS Section: 403.3 2010 ADAS Section: 403.3 2015 ABAAS Section: 403.3

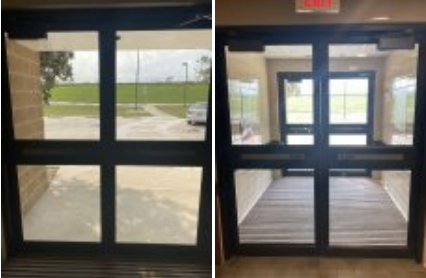
Finding Number	Area Description	Finding	As Built	Recommendation	Citation	Photos	Figure
8	Structures on Property (Public) - Tour/Public Componets : AE Wood/Public Restrooms (Interior) - Entrance Doors	The door is equipped with a door closer and returns to a closed position too quickly. Door closers and gate closers shall be adjusted so that from an open position of 90 degrees, the time required to move the door to a position of 12 degrees from the latch is 5 seconds minimum.	Interior vestibule door on (R) side closes too fast	https://www.access-board.gov/ada/#ada-404_2_8_1	2012 TAS Section: 404.2.8.1 2010 ADAS Section: 404.2.8.1 2015 ABAAS Section: 404.2.8.1

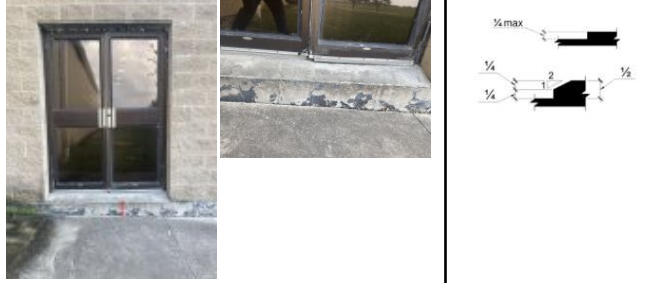
Finding Number	Area Description	Finding	As Built	Recommendation	Citation	Photos	Figure
10	Structures on Property (Public) - Tour/Public Componets : AE Wood/Public Restrooms (Interior) - Side Exit (Near Restrooms)	The walkway contains abrupt vertical edges and/or variations over a 1/2 inch. 1/4 inch is the maximum vertical rise. Changes in level between 1/4 inch and 1/2 inch must be beveled at 1:2 or less. Changes in level greater than 1/2 inch must be by way of a ramp.	Change in elevation over 1/2"		https://www.access-board.gov/ada/#ada-303_2	2012 TAS Section: 303.3, 303.2 2010 ADAS Section: 303.3, 303.2 2015 ABAAS Section: 303.2, 303.3

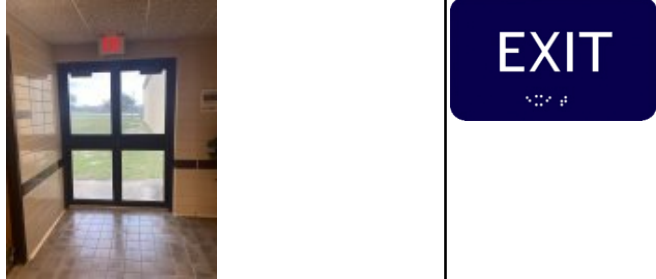
11	Structures on Property (Public) - Tour/Public Componets : AE Wood/Public Restrooms (Interior) - Side Exit (Near Restrooms)	The tactile EXIT sign is missing at the door. Wall signs identifying exits shall have characters raised 1/32 inch minimum and shall be uppercase characters a minimum of 5/8 inch and a maximum of 2 inches high. Braille shall be placed directly below the tactile characters; flush left or centered. Signs shall be located a minimum of 48 inches above the floor, measured from the baseline of the lowest tactile characters and 60 inches maximum above the finish floor or ground surface, measured from the baseline of the highest tactile characters. Where a tactile sign is provided at a door, the sign shall be located on the latch side. Where a tactile sign is provided at double doors the sign shall be located to the right of the right-hand door. Where there is no wall space at the latch side of a single door or at the right side of double doors, signs shall be located on the nearest adjacent wall.	Where visual EXIT is provided, accompanying tactile EXIT sign must also be provided for same doorway. Doorway exit signs and emergency exits with emergency exit signs that are overhead or visual only, or pictograms only, must have an accompanying ADA Braille sign. Exit passages, including doors, stairs and routes, must be identified with tactile ADA signage. Signs must include braille and raised characters. Pictograms are optional. This applies to all doors marked with visual exit sign.		https://www.access-board.gov/ada/#ada-216_4_1	2012 TAS Section: 216.4.1 2010 ADAS Section: 216.4.1 2015 ABAAS Section: F216.4.1

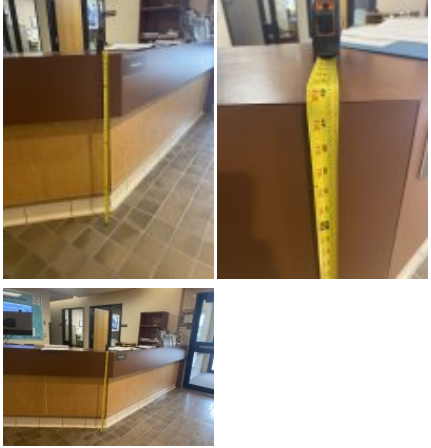
Finding Number	Area Description	Finding	As Built	Recommendation	Citation	Photos	Figure
12	Structures on Property (Public) - Tour/Public Componets : AE Wood/Public Restrooms (Interior) - Service Counter	The sales or service counter does not allow for a forward or parallel approach. Accessible counters must provide a compliant forward or parallel approach.	Service counter height is not compliant for front or parallel approach. Service counter is not accessible. This site does not process or accept transaction from public, service counter not in use.	Remove service counter since not used or provide accessible option. Service desks approach requirments https://www.access-board.gov/ada/#ada-904_4 Parallel approach https://www.access-board.gov/ada/#ada-904_4_1 Forward approach https://www.access-board.gov/ada/#ada-904_4_2	2012 TAS Section: 904.4 2010 ADAS Section: 904.4 2015 ABAAS Section: 904.4.1

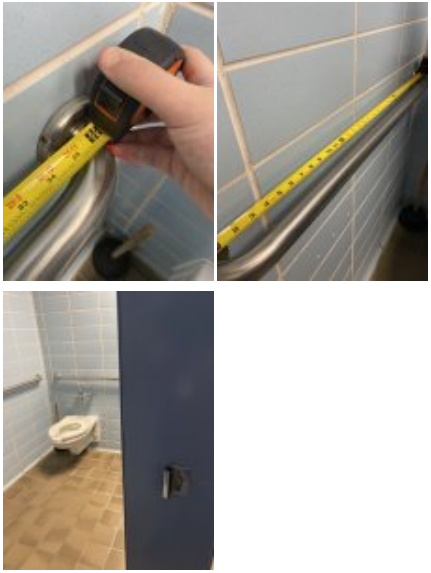
13	Structures on Property (Public) - Tour/Public Componets : AE Wood/Public Restrooms (Interior) - Restroom (Men's)	The side grab bar is not long enough. The side grab bar must extend at least 54 inches minimum beyond the rear wall and start a maximum of 12 inches from the rear wall. A 42 inch grab bar installed the maximum distance from the rear wall (12 inches) will leave the leading end 54 inches from the rear wall. Grab bars shall be installed in a horizontal position, 33 inches minimum and 36 inches maximum above the finish floor measured to the top of the gripping surface.	Measures at 36"	https://www.access-board.gov/ada/#ada-604_5_1	2012 TAS Section: 604.5.1 2010 ADAS Section: 604.5.1 2015 ABAAS Section: 604.5.1

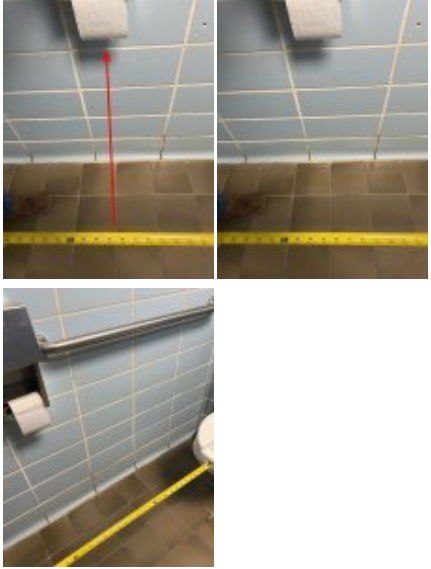
Finding Number	Area Description	Finding	As Built	Recommendation	Citation	Photos	Figure
17	Structures on Property (Public) - Tour/Public Componets : AE Wood/Public Restrooms (Interior) - Restroom (Men's)	The toilet paper is not installed within the compliant range. Toilet paper dispensers shall be 7 inches minimum and 9 inches maximum in front of the water closet measured to the centerline of the dispenser. The outlet of the dispenser shall be 15 inches minimum and 48 inches maximum above the finish floor and shall not be located behind grab bars. Dispensers shall not be of a type that controls delivery or that does not allow continuous paper flow. There shall be a clearance of 1 1/2 inches minimum below the grab bar.	TP dispenser over 20"	https://www.access-board.gov/ada/#ada-604_7	2012 TAS Section: 604.7 2010 ADAS Section: 604.7 2015 ABAAS Section: 604.7

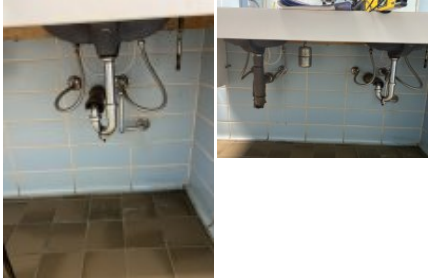
21	Structures on Property (Public) - Tour/Public Components : AE Wood/Public Restrooms (Interior) - Restroom (Men's)	The water and drain pipes under the lavatory are not adequately insulated. Water supply and drain pipes under lavatories and sinks shall be insulated or otherwise configured to protect against contact. There shall be no sharp or abrasive surfaces under lavatories and sinks.	(R) side lavatory pipes are exposed	https://www.access-board.gov/ada/#ada-606_5	2012 TAS Section: 606.5 2010 ADAS Section: 606.5 2015 ABAAS Section: 606.5

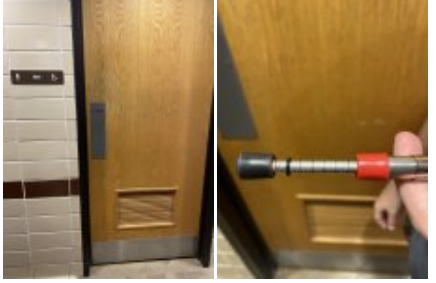
Finding Number	Area Description	Finding	As Built	Recommendation	Citation	Photos	Figure	
22	Structures on Property (Public) - Tour/Public Componets : AE Wood/Public Restrooms (Interior) - Restroom (Men's)	The door exceeds the maximum allowable opening force. Interior doors shall have a maximum opening force of 5 pounds. These forces do not apply to the force required to retract latch bolts or disengage other devices that hold the door or gate in a closed position.	More than 5lbs of force needed to operate.		https://www.access-board.gov/ada/#ada-404_2_9	2012 TAS Section: 404.2.9 2010 ADAS Section: 404.2.9 2015 ABAAS Section: 404.2.9

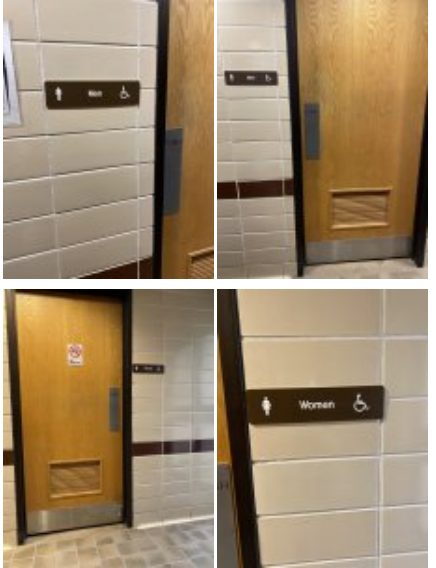
23	Structures on Property (Public) - Tour/Public Componets : AE Wood/Public Restrooms (Interior) - Restroom (Men's)	The restroom sign does not comply with one or more applicable requirements for the location, height, and properties of the sign.	Wall sign is non compliant, multiple comments.	Wall sign designation https://www.access-board.gov/ada/#ada-216_2 Wall signs general/review all componets https://www.access-board.gov/ada/#ada-703_1 Height Above Finish Floor or Ground https://www.access-board.gov/ada/#ada-703_4_1 Location https://www.access-board.gov/ada/#ada-703_4_2	2012 TAS Section: 216.2, 703.1, 703.2, 703.5, 703.6 2010 ADAS Section: 216.2, 703.1, 703.2, 703.5, 703.6 2015 ABAAS Section: F216.2, 703.1, 703.2, 703.5, 703.6

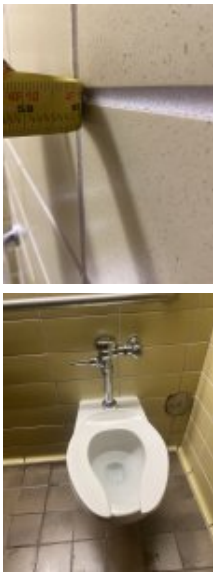
Finding Number	Area Description	Finding	As Built	Recommendation	Citation	Photos	Figure
24	Structures on Property (Public) - Tour/Public Componets : AE Wood/Public Restrooms (Interior) - Restroom (Women's)	The toilet compartment is not wide enough. Wheelchair accessible compartments shall be 60 inches wide minimum measured perpendicular to the side wall, and 56 inches deep minimum for wall hung water closets and 59 inches deep minimum for floor mounted water closets measured perpendicular to the rear wall.	stall width measures at 59", required to be 60" in width.	https://www.access-board.gov/ada/#ada-604_8_1_1	2012 TAS Section: 604.8.1.1 2010 ADAS Section: 604.8.1.1 2015 ABAAS Section: 604.8.1.1

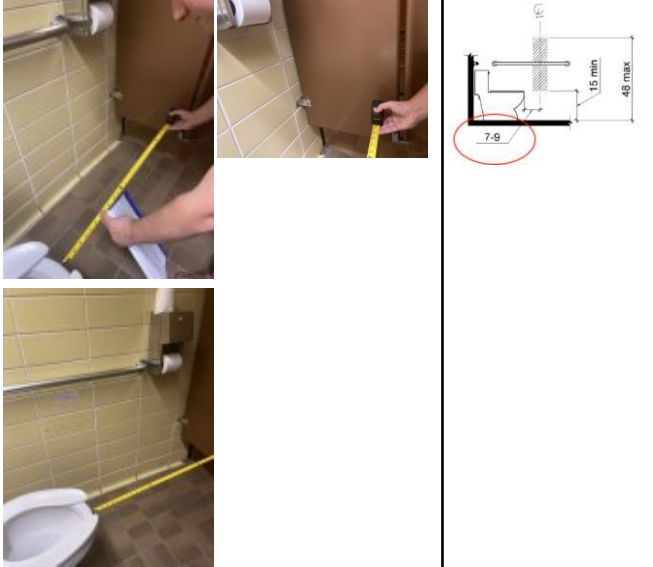
Finding Number	Area Description	Finding	As Built	Recommendation	Citation	Photos	Figure
26	Structures on Property (Public) - Tour/Public Componets : AE Wood/Public Restrooms (Interior) - Restroom (Women's)	The toilet paper is not installed within the compliant range. Toilet paper dispensers shall be 7 inches minimum and 9 inches maximum in front of the water closet measured to the centerline of the dispenser. The outlet of the dispenser shall be 15 inches minimum and 48 inches maximum above the finish floor and shall not be located behind grab bars. Dispensers shall not be of a type that controls delivery or that does not allow continuous paper flow. There shall be a clearance of 1 1/2 inches minimum below the grab bar.	TP dispenser is not compliant in distance or location.		https://www.access-board.gov/ada/#ada-604_7	2012 TAS Section: 604.7 2010 ADAS Section: 604.7 2015 ABAAS Section: 604.7

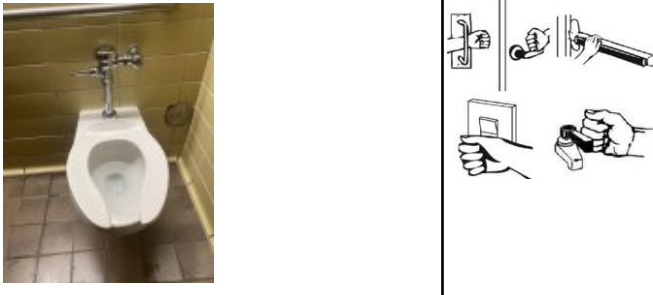
27	Structures on Property (Public) - Tour/Public Componets : AE Wood/Public Restrooms (Interior) - Restroom (Women's)	The force required to operate the element exceeds the maximum allowable force. The force required to activate operable parts is 5 pounds maximum.	Flush handle exceeds 5lbs force to operate.		https://www.access-board.gov/ada/#ada-309_4	2012 TAS Section: 309.4 2010 ADAS Section: 309.4 2015 ABAAS Section: 309.4

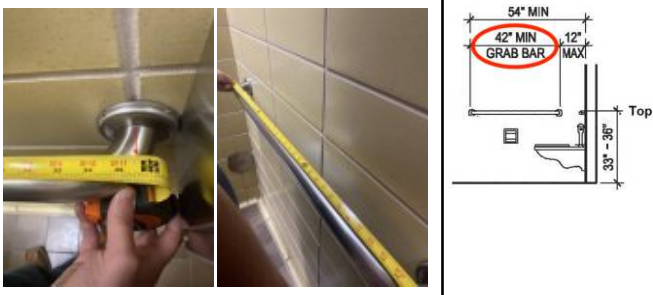
28	Structures on Property (Public) - Tour/Public Componets : AE Wood/Public Restrooms (Interior) - Restroom (Women's)	The side grab bar is not long enough. The side grab bar must extend at least 54 inches minimum beyond the rear wall and start a maximum of 12 inches from the rear wall. A 42 inch grab bar installed the maximum distance from the rear wall (12 inches) will leave the leading end 54 inches from the rear wall. Grab bars shall be installed in a horizontal position, 33 inches minimum and 36 inches maximum above the finish floor measured to the top of the gripping surface.	Measures at less than 36"		https://www.access-board.gov/ada/#ada-604_5_1	2012 TAS Section: 604.5.1 2010 ADAS Section: 604.5.1 2015 ABAAS Section: 604.5.1

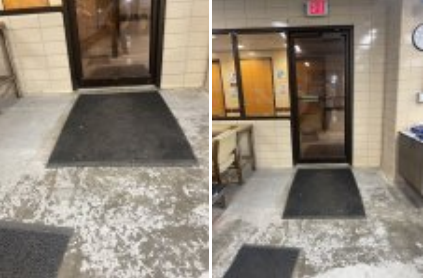
Finding Number	Area Description	Finding	As Built	Recommendation	Citation	Photos	Figure
35	Structures on Property (Public) - Tour/Public Componets : Incubator Area (Interior)- TOUR - Entrance Door	The floor mat at the door is not secured in place. If carpet or carpet tile is used on a ground or floor surface, then it shall be securely attached; have a firm cushion, pad or backing or no cushion or pad; and have a level loop, textured loop, level-cut pile or level-cut/uncut pile texture. The maximum pile height shall be 1/2 inch. Exposed edges of carpet shall be fastened to floor surfaces and have trim along the entire length of the exposed edge. Recessed doormats shall be adequately anchored to prevent interference with wheelchair traffic.	Door mat is not of compliant size or durability and does not meet compliance.	https://www.access-board.gov/ada/#ada-302_2	2012 TAS Section: 302.2 2010 ADAS Section: 302.2 2015 ABAAS Section: 302.2

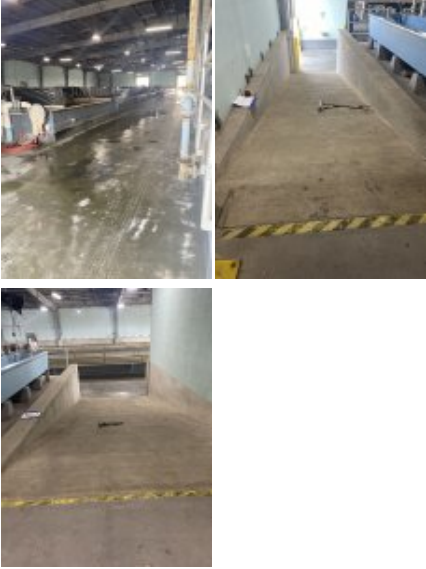
Finding Number	Area Description	Finding	As Built	Recommendation	Citation	Photos	Figure
38	Structures on Property (Public) - Tour/Public Components : Raceway/Production Area (Interior) - TOUR	State and local governments have an obligation to make their programs and services accessible to persons with disabilities. This may or may not require the alteration, addition or construction of existing facilities which predate The Americans with Disabilities Act (ADA) of 1990. Under the Code of Federal Regulations Section 35.151(b)(2) State and Local Government Title II entities may provide programmatic access where alterations to existing facilities would result in undue financial and administrative burdens. For Example, A public entity has six courtrooms in two existing buildings and determines that only three of those courtrooms and the public use and common use areas serving those courtrooms in one building are needed to be made accessible in order to satisfy its program access obligations. The entity must comply with 2010 Standards unless compliance would result in undue financial and administrative burdens and must take other actions that would not result in an undue financial burden to ensure access to persons with disabilities. This may include the scheduling of the various types of cases, hearings etc. in accessible courtrooms and relocating them where necessary to accommodate persons with disabilities. Having a defined program and effective communication process in place to ensure the public and employees can request accommodations is necessary to ensure equal access to the county's court system. Program access is not part of this evaluation and this information is being provided as an advisory only.	Element can be accessed as majority pathways are accessible. This element is considered accessible.	Provide reasonable modifications to programs and services, to bypass areas of non compliance.	2010 ADAS Section: Advisory

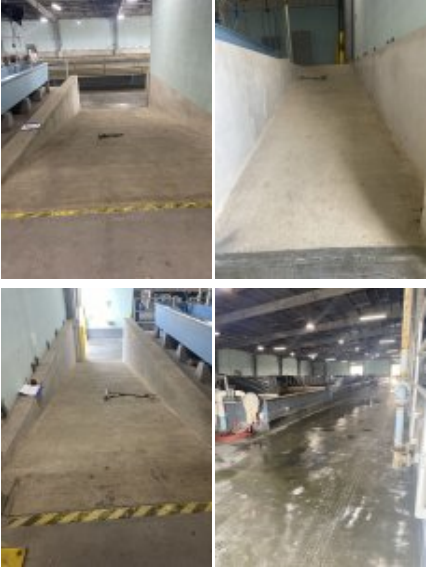
Finding Number	Area Description	Finding	As Built	Recommendation	Citation	Photos	Figure
39	Structures on Property (Public) - Tour/Public Components : Raceway/Production Area (Interior) - TOUR	The path of contains multiple issues and is not accessible. The path of travel exceeds the maximum allowable cross and running slope requirements. It also contains changes in level and/or gaps that exceed the allowable maximum requirements. The path of travel does not meet the minimum width requirements for clearances, turning spaces, and/or passing spaces. The floor or ground surface is not firm, stable, and slip resistant.	Ramps, floor grating, in raceway/production area are not compliant but necessary for building infrastructure. Clear standing water to ensure accessibility.	Route around raceways does not need to be accessible but tour program does need to meet Title II requirements for accessible programs/services. Finding route which bypasses grating and ramps or covering grating on floor are examples of program modification.	2012 TAS Section: 403.1 2010 ADAS Section: 403.1 2015 ABAAS Section: 403.1

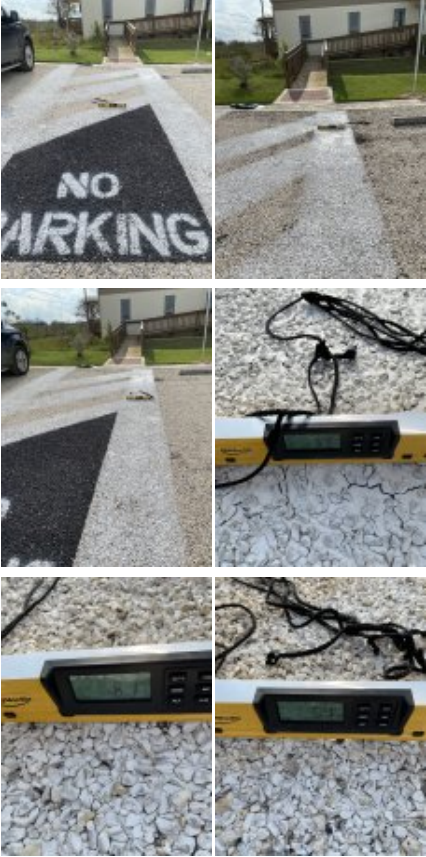
Finding Number	Area Description	Finding	As Built	Recommendation	Citation	Photos	Figure
40	Exterior of Property (STAFF) : TX River Studies Parking Lot (2 Spaces) 2 Van - Access Aisle (Van) Near Ramp	The cross slope (short dimension) of the access aisle exceeds 2%. The cross slope in an accessible parking stall and the access aisle must not exceed 2%.	Significant cross slope in access aisle, multiple locations are not compliant. See additional photos for details.	https://www.access-board.gov/ada/#ada-502_4	2012 TAS Section: 502.4 2010 ADAS Section: 502.4 2015 ABAAS Section: 502.4

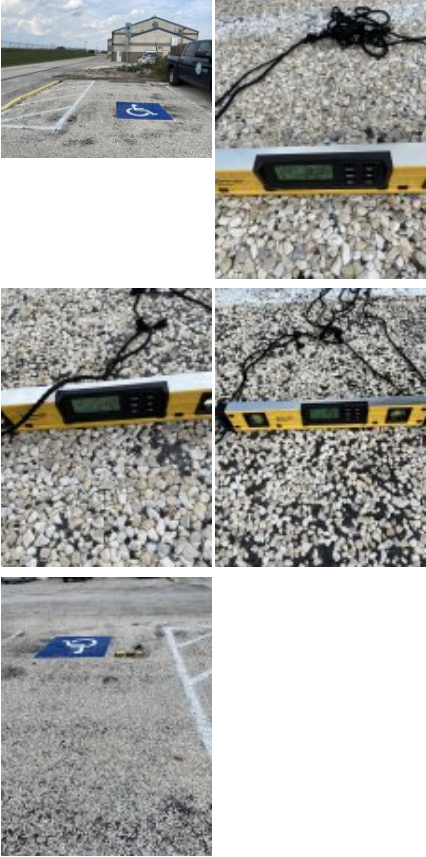
Finding Number	Area Description	Finding	As Built	Recommendation	Citation	Photos	Figure
41	Exterior of Property (STAFF) : TX River Studies Parking Lot (2 Spaces) 2 Van - Van Accessible Stall (Rear of Parking Lot)	The cross slopes (narrow dimension) and/or running slopes (long dimension) of the accessible stall exceeds 2%. The running slope and the cross slope in an accessible parking stall and the access aisle must not exceed 2%.	Significant cross slope in van accessible parking stall, multiple locations are not compliant. See additional photos for details.	https://www.access-board.gov/ada/#ada-502_4	2012 TAS Section: 502.4 2010 ADAS Section: 502.4 2015 ABAAS Section: 502.4

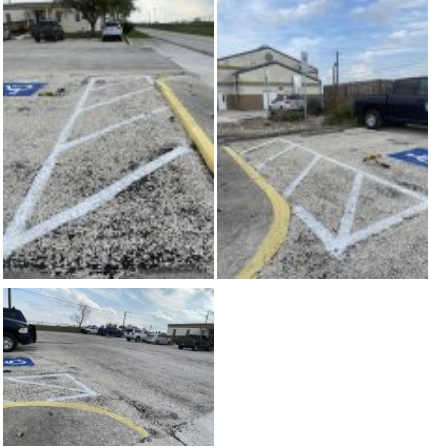
Finding Number	Area Description	Finding	As Built	Recommendation	Citation	Photos	Figure
42	Exterior of Property (STAFF) : TX River Studies Parking Lot (2 Spaces) 2 Van - Access Aisle (Van) Rear of Parking Lot	The access aisle is not located on an accessible route of travel to the accessible building entrance. Accessible parking spaces serving a particular building shall be located on the shortest accessible route of travel from parking to an accessible entrance. In buildings with multiple accessible entrances with adjacent parking, accessible parking spaces shall be dispersed and located closest to the accessible entrances.	Access aisle does not connect to accessible route.	https://www.access-board.gov/ada/#ada-208_3_1 https://www.access-board.gov/ada/#ada-502_3	2012 TAS Section: 208.3.1 2010 ADAS Section: 208.3.1, 502.3 2015 ABAAS Section: F208.3.1, 502.3

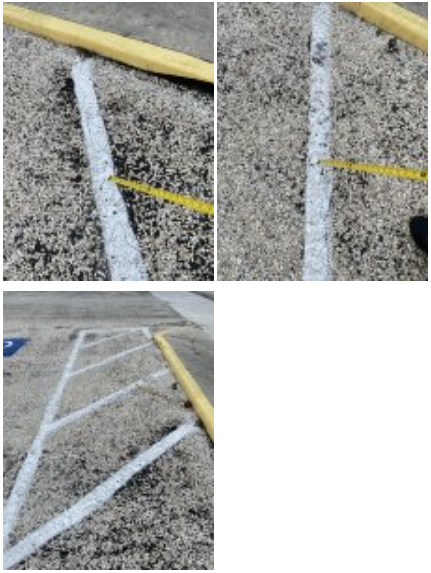
43	Exterior of Property (STAFF) : TX River Studies Parking Lot (2 Spaces) 2 Van - Access Aisle (Van) Rear of Parking Lot	The access aisle contains hump in surface materials that do not provide for a stable, firm slip resistant surface. Parking spaces and access aisles serving them shall comply with floor or ground surface requirements. The ground surface shall be stable, firm, and slip resistant. Access aisles shall be at the same level as the parking spaces they serve. Changes in level, slopes exceeding 1:48, and detectable warnings shall not be permitted.	Slight humps in access aisle that make it not flat and out of compliance slope with accessible surface	Van accessible space near entrance satisfies accessible parking requirements for parking lot this size. Remove this spot or create accessible route towards building. https://www.access-board.gov/ada/#ada-502_4	2012 TAS Section: 502.4 2010 ADAS Section: 502.4 2015 ABAAS Section: 502.4

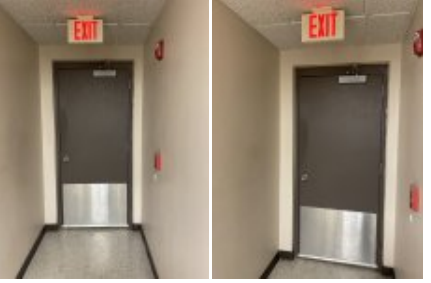
Finding Number	Area Description	Finding	As Built	Recommendation	Citation	Photos	Figure
47	Structures on Property (STAFF) : AE Wood (Interior) - Entrance/Exit Doors	The tactile EXIT sign is missing at the door. Wall signs identifying exits shall have characters raised 1/32 inch minimum and shall be uppercase characters a minimum of 5/8 inch and a maximum of 2 inches high. Braille shall be placed directly below the tactile characters; flush left or centered. Signs shall be located a minimum of 48 inches above the floor, measured from the baseline of the lowest tactile characters and 60 inches maximum above the finish floor or ground surface, measured from the baseline of the highest tactile characters. Where a tactile sign is provided at a door, the sign shall be located on the latch side. Where a tactile sign is provided at double doors the sign shall be located to the right of the right-hand door. Where there is no wall space at the latch side of a single door or at the right side of double doors, signs shall be located on the nearest adjacent wall.	Where visual EXIT is provided, accompanying tactile EXIT sign must also be provided for same doorway. Doorway exit signs and emergency exits with emergency exit signs that are overhead or visual only, or pictograms only, must have an accompanying ADA Braille sign. Exit passages, including doors, stairs and routes, must be identified with tactile ADA signage. Signs must include braille and raised characters. Pictograms are optional. This applies to all doors marked with visual exit	https://www.access-board.gov/ada/#ada-216_4_1	2012 TAS Section: 216.4.1 2010 ADAS Section: 216.4.1 2015 ABAAS Section: F216.4.1

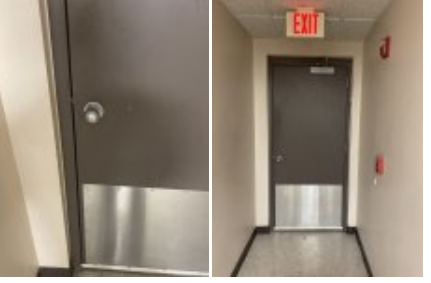
48	Structures on Property (STAFF) : AE Wood (Interior) - Entrance/Exit Doors	The door/gate operating hardware is not accessible. Hand-activated door/gate opening hardware, handles, pulls, latches, locks, and other operating devices on accessible doors shall have a shape that is easy to grasp with one hand and does not require tight grasping, pinching or twisting of the wrist to operate. Hardware shall be 34 inches minimum and 48 inches maximum above the finish floor or ground.	N/A	https://www.access-board.gov/ada/#ada-404_2_7	2012 TAS Section: 404.2.7 2010 ADAS Section: 404.2.7 2015 ABAAS Section: 404.2.7

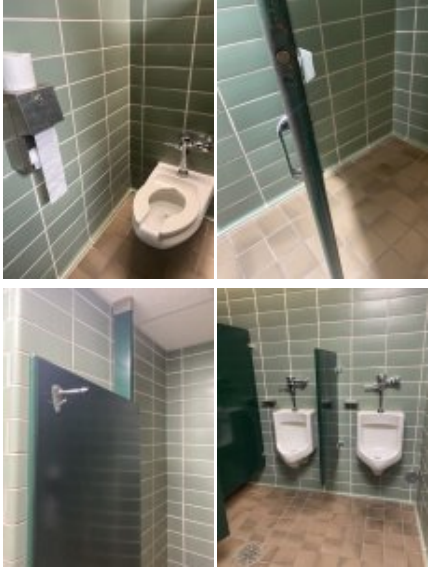
Finding Number	Area Description	Finding	As Built	Recommendation	Citation	Photos	Figure
49	Structures on Property (STAFF) : AE Wood (Interior) - Restroom/Showe r (Men's)	The restrooms is not nearly compliant. - The restroom does not have the required minimum clear floor space or maneuvering clearances for the toilet. - The restroom does not have the required minimum clear floor space or maneuvering clearances for the lavatory. - The entry door does not contain the required minimum 60 inches maneuvering space on the pull side - The entry door encroach into the required clear floor space for fixtures. - Door opening pressure was measured at greater than 5 pounds. - Grab bars are incorrectly installed. - Accessories, such as toilet seat covers, paper towel holders, garbage cans, hand dryers and mirrors are either too high or without clear floor space or both. - The restroom contain floor level changes greater than a 1/2 inch at the floor drains.	This restroom requires a number of componets to gain compliance. Missing grab bars, door compliance, flush handle location, toilet stall dimensions, TP dispenser location and coat hook reach are not compliant	Review restrooms componets to make accessible. https://www.access-board.gov/ada/#ada-213_2 https://www.access-board.gov/ada/#ada-603	2012 TAS Section: 213.2 2010 ADAS Section: 213.2 2015 ABAAS Section: F213.2

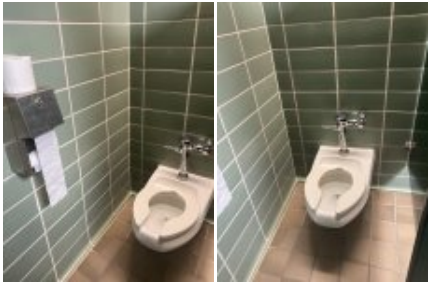
50	Structures on Property (STAFF) : AE Wood (Interior) - Restroom/Showe r (Men's)	Accessible toilets must have grab bars installed. The side grab bar must extend at least 54 inches minimum beyond the rear wall and start a maximum of 12 inches from the rear wall. The rear grab bar must be a minimum of 36 inches long and extend from the centerline of the toilet 12 inches minimum on one side and 24 inches minimum on the other side. Grab bars shall be installed in a horizontal position, 33 inches minimum and 36 inches maximum above the finish floor measured to the top of the gripping surface.	There are no grab bars installed at this time.	Review grab bar componets to make accessible https://www.access-board.gov/ada/#ada-604_5 https://www.access-board.gov/ada/#ada-609	2012 TAS Section: 604.5 2010 ADAS Section: 604.5 2015 ABAAS Section: 604.5

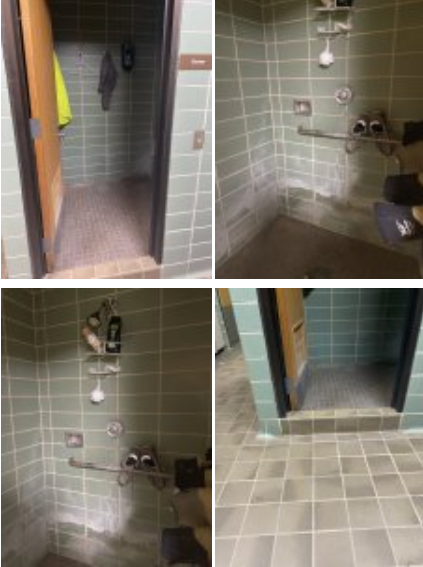
Finding Number	Area Description	Finding	As Built	Recommendation	Citation	Photos	Figure
53	Structures on Property (STAFF) : AE Wood (Interior) - Restroom/Showers (Men's)	There are no accessible bathing and shower facilities. Where bathtubs or showers are provided, at least one accessible bathtub or at least one accessible shower shall be provided.	There is no ADA accessible shower at this time. Multiple comments. Not enough bars, threshold entrance, complaint ranges for controls	https://www.access-board.gov/ada/#ada-213_3_6 Review shower or tub components to make accessible https://www.access-board.gov/ada/#ada-607 https://www.access-board.gov/ada/#ada-608	2012 TAS Section: 213.3.6 2010 ADAS Section: 213.3.6 2015 ABAAS Section: F213.3.6

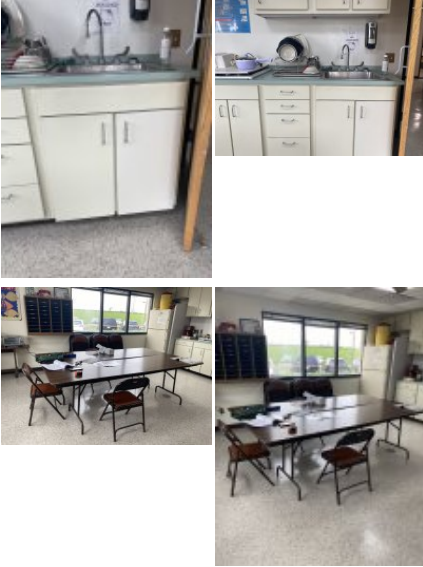
54	Structures on Property (STAFF) : AE Wood (Interior) - Kitchenette	Knee and toe space has not been provided at the sink. Kitchen sinks must be provided with a clear floor space positioned for a forward approach including knee and toe clearance.	In kitchens, kitchenettes, and breakrooms without a cooktop or conventional range, a parallel approach is permitted at kitchen sinks. Sink height too high for parallel approach. Best practice to make sinks accessible via front approach in any areas where food prep is done. Kitchenette eating area meets compliance.	https://www.access-board.gov/ada/#ada-606_2 https://www.access-board.gov/ada/#ada-804_4	2012 TAS Section: 606.2, 804.4 2010 ADAS Section: 606.2, 804.4 2015 ABAAS Section: 606.2, 804.4

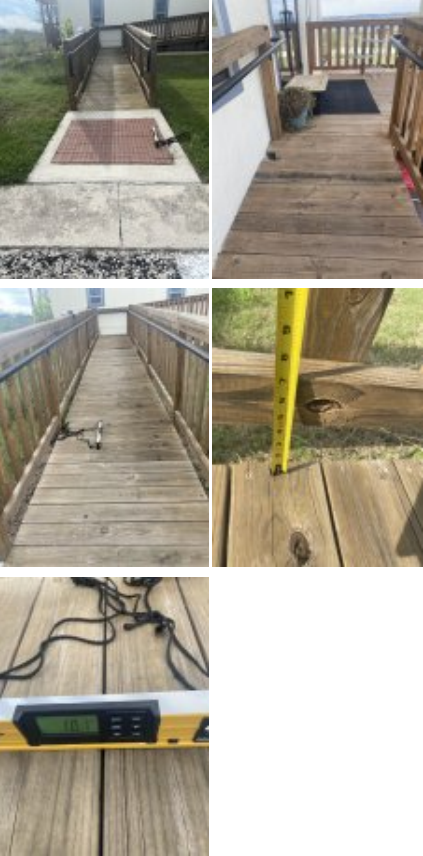
Finding Number	Area Description	Finding	As Built	Recommendation	Citation	Photos	Figure
55	Structures on Property (STAFF) : TX River Studies (Exterior)	The building entrance is not located on an accessible route. When a building, or portion of a building, is required to be accessible, an accessible route of travel shall be provided to all portions of the building, to accessible building entrances and between the building and the public way. At least one accessible route within the boundary of the site must be provided from public transportation stops, accessible parking and accessible passenger loading zones and public streets or sidewalks to the accessible building entrance they serve. The accessible route shall, to the maximum extent feasible, coincide with the route for the general public. At least one accessible route shall connect accessible buildings, facilities, elements and spaces that are on the same site. At least one accessible route shall connect accessible building or facility entrances with all accessible spaces and elements.	Ramp used to access main entrance has multiple findings. Upgrades needed to meet full compliance. Ramp slop and landings do not meet compliance.	https://www.access-board.gov/ada/#ada-206_2_1	2012 TAS Section: 206.2.1 2010 ADAS Section: 206.2.1 2015 ABAAS Section: F206.2.1

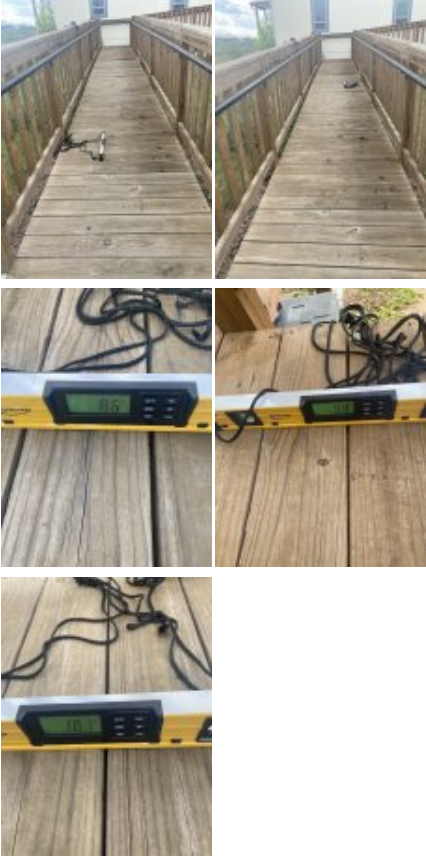
Finding Number	Area Description	Finding	As Built	Recommendation	Citation	Photos	Figure
56	Structures on Property (STAFF) : TX River Studies (Exterior) - Entrance Ramp (Non Curb Ramp)	The ramps exceeds the maximum running slope (direction of travel) allowable of 8.33%. Ramps should have the least possible slope but in no case more than 8.3% (1:12).	Ramp running slope measured at 10.1% See additional photos for locations of non compliance	https://www.access-board.gov/ada/#ada-405_2	2012 TAS Section: 405.2 2010 ADAS Section: 405.2 2015 ABAAS Section: 405.2

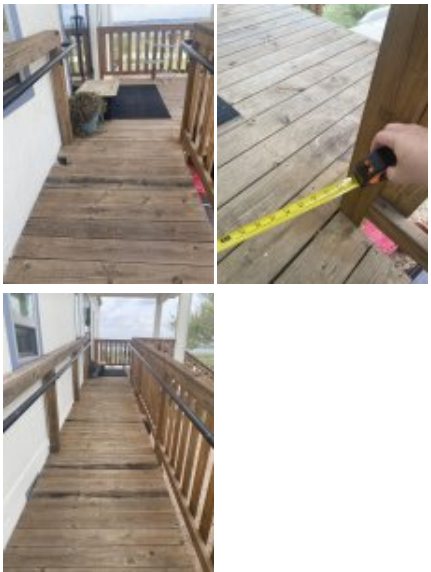
Finding Number	Area Description	Finding	As Built	Recommendation	Citation	Photos	Figure
57	Structures on Property (STAFF) : TX River Studies (Exterior) - Entrance Ramp (Non Curb Ramp)	The top landing of the ramp does not meet minimum size requirements. The landing clear width shall be at least as wide as the widest ramp run leading to the landing (36 inches minimum) and a minimum of 60 inches in length.	Obstructions prevent clear space requirements for top of landing.	https://www.access-board.gov/ada/#ada-405_7_2 https://www.access-board.gov/ada/#ada-405_7_3	2012 TAS Section: 405.7.3, 405.7.2 2010 ADAS Section: 405.7.3, 405.7.2 2015 ABAAS Section: 405.7.2, 405.7.3

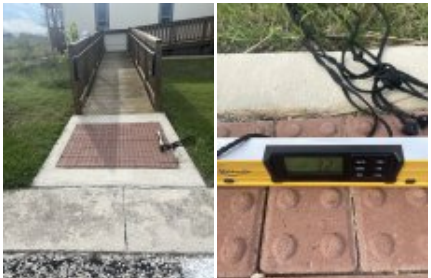
58	Structures on Property (STAFF) : TX River Studies (Exterior) - Entrance Ramp (Non Curb Ramp)	The landing at the bottom of the ramp has a slope greater than 2%. Bottom landings shall have a dimension in the direction of ramp run of not less than 60 inches and have a slope of 2% maximum in any direction.	Bottom of ramp landing slope exceeds 2% tolerance in any direction. Landing dimension meet compliance.	https://www.access-board.gov/ada/#ada-405_7 https://www.access-board.gov/ada/#ada-405_7_1	2012 TAS Section: 405.7.1, 405.7.1 Exception 2010 ADAS Section: 405.7.1, 405.7.1 Exception 2015 ABAAS Section: 405.7.1, 405.7.1 EXCEPTION

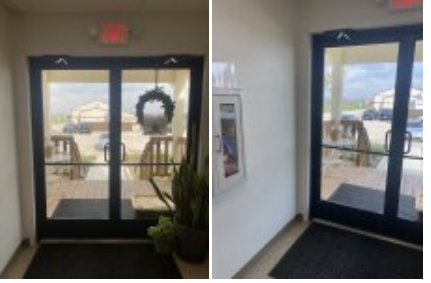
Finding Number	Area Description	Finding	As Built	Recommendation	Citation	Photos	Figure
61	Structures on Property (STAFF) : TX River Studies (Interior) - Entrance/Exit Doors	The tactile EXIT sign is missing at the door. Wall signs identifying exits shall have characters raised 1/32 inch minimum and shall be uppercase characters a minimum of 5/8 inch and a maximum of 2 inches high. Braille shall be placed directly below the tactile characters; flush left or centered. Signs shall be located a minimum of 48 inches above the floor, measured from the baseline of the lowest tactile characters and 60 inches maximum above the finish floor or ground surface, measured from the baseline of the highest tactile characters. Where a tactile sign is provided at a door, the sign shall be located on the latch side. Where a tactile sign is provided at double doors the sign shall be located to the right of the right-hand door. Where there is no wall space at the latch side of a single door or at the right side of double doors, signs shall be located on the nearest adjacent wall.	Where visual EXIT is provided, accompanying tactile EXIT sign must also be provided for same doorway. Doorway exit signs and emergency exits with emergency exit signs that are overhead or visual only, or pictograms only, must have an accompanying ADA Braille sign. Exit passages, including doors, stairs and routes, must be identified with tactile ADA signage. Signs must include braille and raised characters. Pictograms are optional. This applies to all doors marked with visual exit signs	https://www.access-board.gov/ada/#ada-216_4_1	2012 TAS Section: 216.4.1 2010 ADAS Section: 216.4.1 2015 ABAAS Section: F216.4.1

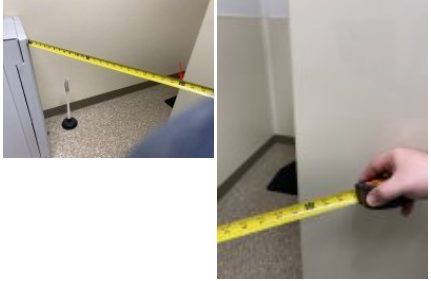
Finding Number	Area Description	Finding	As Built	Recommendation	Citation	Photos	Figure
63	Structures on Property (STAFF) : TX River Studies (Interior) - Restroom (Men's)	The route of travel does not provide a minimum width of 36 inches. The clear width shall be permitted to be reduced to 32 inches minimum for a length of 24 inches maximum provided that reduced width segments are separated by segments that are 48 inches long minimum and 36 inches wide minimum.	Access route narrowed by storage containers, passing space provided is not compliant, measured at 24" The clear width shall be permitted to be reduced to 32 inches (815 mm) minimum for a length of 24 inches (610 mm) maximum	https://www.access-board.gov/ada/#ada-403_5_1	2012 TAS Section: 403.5.1 2010 ADAS Section: 403.5.1 2015 ABAAS Section: 403.5.1

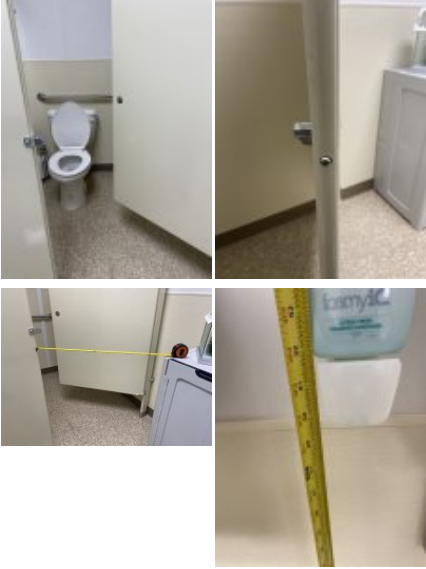
Finding Number	Area Description	Finding	As Built	Recommendation	Citation	Photos	Figure
65	Structures on Property (STAFF) : TX River Studies (Interior) - Restroom (Women's)	The restroom has been found to be in substantial compliance with accessibility codes, standards, and regulations.	Restroom specs meet most requirements. Improve accessibility by moving storage space, adding handles on stall door, and lowering soap dispenser.	N/A	2012 TAS Section: Advisory 2010 ADAS Section: Advisory 2015 ABAAS Section: Advisory

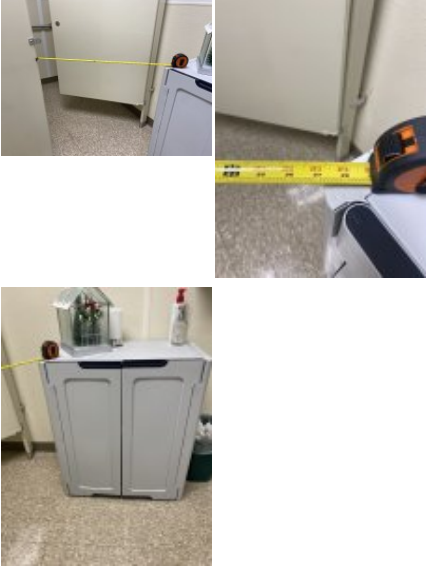
66	Structures on Property (STAFF) : TX River Studies (Interior) - Restroom (Women's)	The route of travel does not provide a minimum width of 36 inches. The clear width shall be permitted to be reduced to 32 inches minimum for a length of 24 inches maximum provided that reduced width segments are separated by segments that are 48 inches long minimum and 36 inches wide minimum.	Access route narrowed by storage containers, passing space provided is not compliant, measured less than 28". The clear width shall be permitted to be reduced to 32 inches (815 mm) minimum for a length of 24 inches (610 mm) maximum	https://www.access-board.gov/ada/#ada-403_5_1	2012 TAS Section: 403.5.1 2010 ADAS Section: 403.5.1 2015 ABAAS Section: 403.5.1

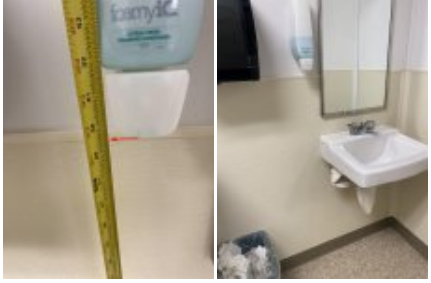
Finding Number	Area Description	Finding	As Built	Recommendation	Citation	Photos	Figure
67	Structures on Property (STAFF) : TX River Studies (Interior) - Restroom (Women's)	The soap dispenser's operation mechanism is too high off the floor. Dispensers must have all operable parts a maximum of 48 inches above the floor.	Soap dispenser out of reach range ,measured over 49" Trash can placement prevents access	https://www.access-board.gov/ada/#ada-308_2_1 https://www.access-board.gov/ada/#ada-308_2_2	2012 TAS Section: 308.2.1 2010 ADAS Section: 308.2.1 2015 ABAAS Section: 308.2.1

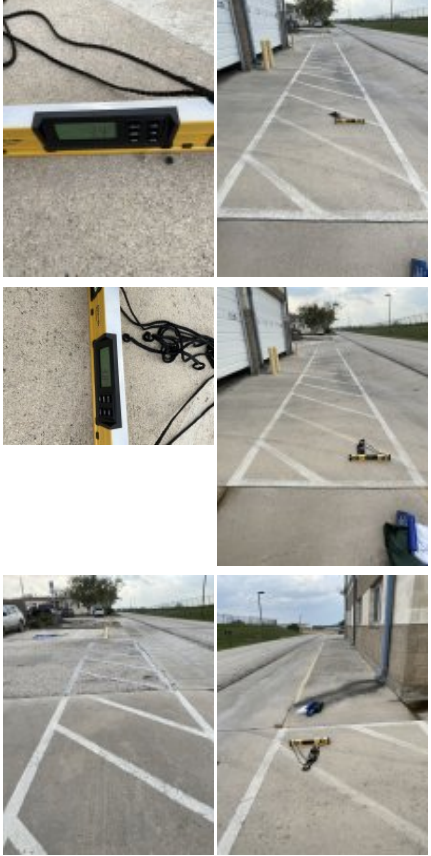
68	Structures on Property (STAFF) : Analytical Studies (Exterior)	The accessible path of travel between the building entrance and the accessible parking has cross slopes greater than 2%. Surface cross slopes shall not exceed 1 unit vertical in 48 units horizontal (2-percent slope).	Significant cross slope findings due to embankment for water run off in accessible pathway to building. See additional photos for locations	https://www.access-board.gov/ada/#ada-403_3	2012 TAS Section: 403.3 2010 ADAS Section: 403.3 2015 ABAAS Section: 403.3

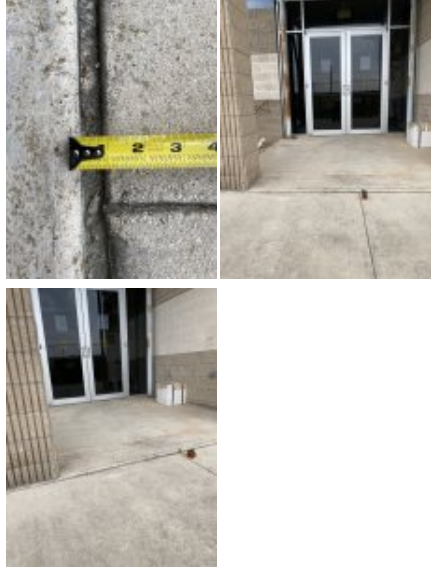
Finding Number	Area Description	Finding	As Built	Recommendation	Citation	Photos	Figure	
69	Structures on Property (STAFF) : Analytical Studies (Exterior)	The route contains openings greater than 1/2 inch. Openings in floor or ground surfaces shall not allow passage of a sphere more than 1/2 inch diameter. Elongated openings shall be placed so that the long dimension is perpendicular to the dominant direction of travel.	Located in on pathway to main entrance		https://www.access-board.gov/ada/#ada-302_3	2012 TAS Section: 302.3 2010 ADAS Section: 302.3 2015 ABAAS Section: 302.3

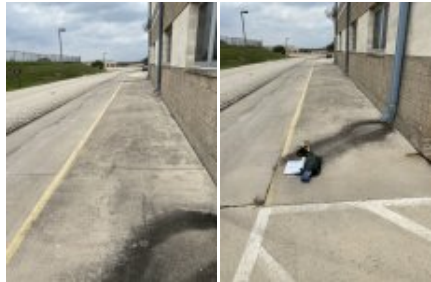
70	Structures on Property (STAFF) : Analytical Studies (Exterior) - Curb Ramp (Main Route)	The ramp run has a rise greater than 6 inches. Ramp runs with a rise greater than 6 inches shall have handrails	If total ramp rises higher than 6" than handrails must be provided. Slope measure under 5% and width is 60", both of these elements meet compliance. Pending review of total rise for this element.		https://www.access-board.gov/ada/#ada-405_8	2012 TAS Section: 405.8 2010 ADAS Section: 405.8 2015 ABAAS Section: 405.8

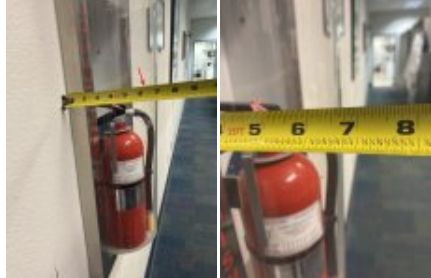
Finding Number	Area Description	Finding	As Built	Recommendation	Citation	Photos	Figure
71	Structures on Property (STAFF) : Analytical Studies (Interior)	The element projects more than 4 inches into the circulation path. Wall-mounted objects that have leading edges between 27 inches and 80 inches from the floor must not project more than 4 inches into the circulation path. Protruding objects that extend to the floor or within 27 inches of the floor are cane detectable and are therefore not hazardous. Where it is necessary or desirable to have objects protrude from the wall, a manner of cane detection must be provided.	There are no official ADA fire extinguisher height or fire alarm ADA requirements. However, there are rules that govern the placement of all protruding objects, no matter their function, to accommodate blind and other visually impaired people. Measures over 4"	https://www.access-board.gov/ada/#ada-307_2	2012 TAS Section: 307.2 2010 ADAS Section: 307.2 2015 ABAAS Section: 307.2

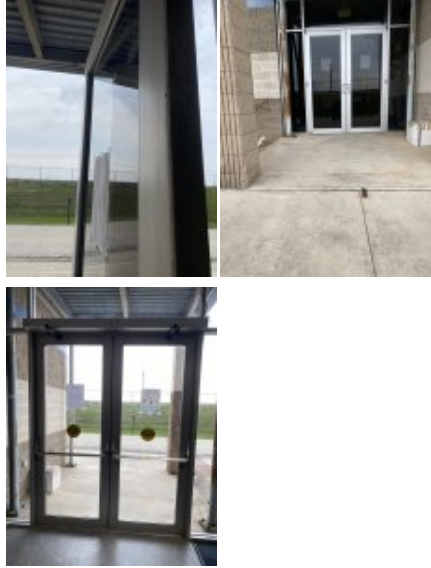
72	Structures on Property (STAFF) : Analytical Studies (Interior) - Entrance/Exit Doors	The door does not open at least 90 degrees. Door openings shall provide a clear width of 32 inches minimum. Clear openings of doorways with swinging doors shall be measured between the face of the door and the stop, with the door open 90 degrees. There shall be no projections into the required clear opening width lower than 34 inches above the finish floor or ground. Projections into the clear opening width between 34 inches and 80 inches above the finish floor or ground shall not exceed 4 inches.	Neither door opens to 90 degrees	https://www.access-board.gov/ada/#ada-404_2_3	2012 TAS Section: 404.2.3 2010 ADAS Section: 404.2.3 2015 ABAAS Section: 404.2.3

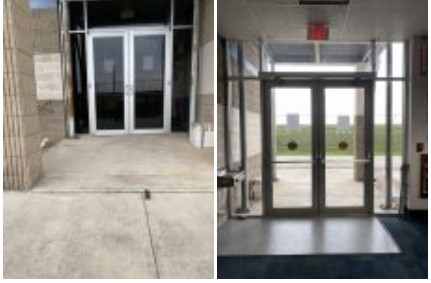
Finding Number	Area Description	Finding	As Built	Recommendation	Citation	Photos	Figure
73	Structures on Property (STAFF) : Analytical Studies (Interior) - Entrance/Exit Doors	The height of the push plate is not within the compliant range. Automatic door actuators must have an installation height of a minimum of 36 inches and a maximum of 48 inches, and be located a maximum distance of 12 feet from the center of the door; and the door shall remain open for a minimum of 5 seconds after release of the activating device;	No push plates were accessed, needs verification they are in correct place and that they work properly. Pending review of element	N/A - Refer to Finding	2012 TAS Section: 404.3 2010 ADAS Section: 404.3 2015 ABAAS Section: 404.3

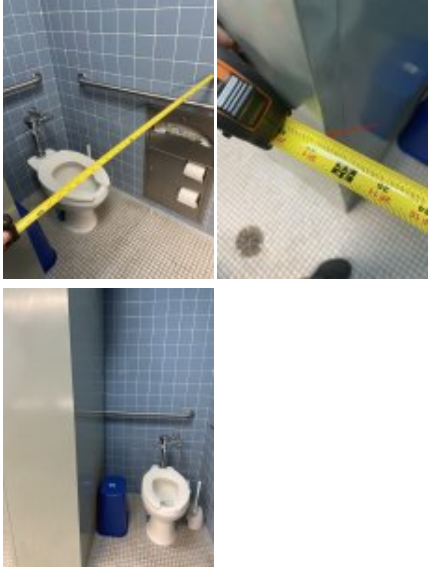
Finding Number	Area Description	Finding	As Built	Recommendation	Citation	Photos	Figure
75	Structures on Property (STAFF) : Analytical Studies (Interior) - Restroom/Showe r (Men's)	The toilet compartment is not wide enough. Wheelchair accessible compartments shall be 60 inches wide minimum measured perpendicular to the side wall, and 56 inches deep minimum for wall hung water closets and 59 inches deep minimum for floor mounted water closets measured perpendicular to the rear wall.	The accessible stall meets most ADA requirements, including grab bar componets. Due to cabinet obstruction, stall width does not meet compliance. Measured at 37". Cabinet also obstructs use of rear grab bar. Clear floor space obstructed by trashcan placement.	Stall width requirments https://www.access-board.gov/ada/#ada-604_8_1_1 Stall clear floor space requirments https://www.access-board.gov/ada/#ada-604_3_1 Rear grab bar requirments https://www.access-board.gov/ada/#ada-604_5_2	2012 TAS Section: 604.8.1.1 2010 ADAS Section: 604.8.1.1 2015 ABAAS Section: 604.8.1.1

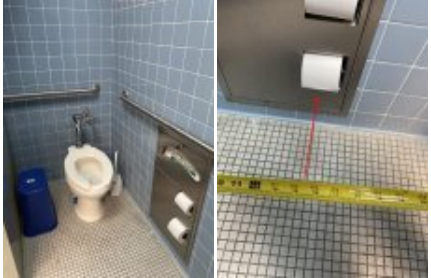
76	Structures on Property (STAFF) : Analytical Studies (Interior) - Restroom/Showe r (Men's)	The toilet paper is not installed within the compliant range. Toilet paper dispensers shall be 7 inches minimum and 9 inches maximum in front of the water closet measured to the centerline of the dispenser. The outlet of the dispenser shall be 15 inches minimum and 48 inches maximum above the finish floor and shall not be located behind grab bars. Dispensers shall not be of a type that controls delivery or that does not allow continuous paper flow. There shall be a clearance of 1 1/2 inches minimum below the grab bar.	TP dispenser out of reach range compliance, measured over 14"	https://www.access-board.gov/ada/#ada-604_7	2012 TAS Section: 604.7 2010 ADAS Section: 604.7 2015 ABAAS Section: 604.7

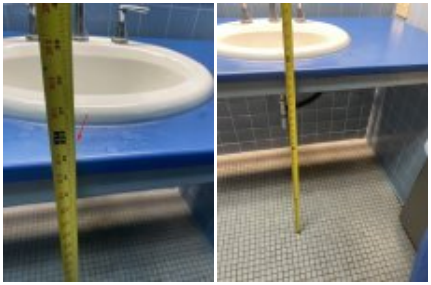
77	Structures on Property (STAFF) : Analytical Studies (Interior) - Restroom/Showe r (Men's)	The top rim of the lavatory is too high. All lavatories that are designated to be accessible shall be a minimum 17 inches in horizontal depth and mounted with the rim or counter edge no higher than 34 inches above the finished floor.	Sink rim height over 34"	https://www.access-board.gov/ada/#ada-606_3	2012 TAS Section: 606.3 2010 ADAS Section: 606.3 2015 ABAAS Section: 606.3
