AE Wood IF- ADA Evaluation

IF-San Marcos TX, AE Wood ADA Evaluation

Accessibility Evaluation

Inspection Date: 12/05/2022

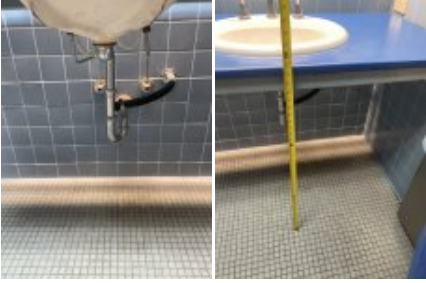
Finding Number	Area Description	Finding	As Built	Recommendation	Citation	Photos	Figure
78	Structures on Property (STAFF) : Analytical Studies (Interior) - Restroom/Showe r (Men's)	The water and drain pipes under the lavatory are not adequately insulated. Water supply and drain pipes under lavatories and sinks shall be insulated or otherwise configured to protect against contact. There shall be no sharp or abrasive surfaces under lavatories and sinks.	Pipes are not insulated	https://www.access-board.gov/ada/#ada-606_5	2012 TAS Section: 606.5 2010 ADAS Section: 606.5 2015 ABAAS Section: 606.5

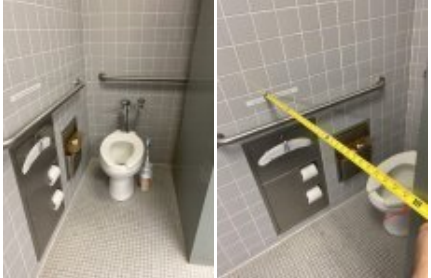
Finding Number	Area Description	Finding	As Built	Recommendation	Citation	Photos	Figure
80	Structures on Property (STAFF) : Analytical Studies (Interior) - Restroom/Shower (Women's)	The toilet compartment is not wide enough. Wheelchair accessible compartments shall be 60 inches wide minimum measured perpendicular to the side wall, and 56 inches deep minimum for wall hung water closets and 59 inches deep minimum for floor mounted water closets measured perpendicular to the rear wall.	The accessible stall meets most ADA requirements, including grab bar components. Due to cabinet obstruction, stall width does not meet compliance. Measured at less than 36". Cabinet also obstructs use of rear grab bar. Cleaning materials obstruct clear floor space.	Stall width requirements https://www.access-board.gov/ada/#ada-604_8_1_1 Stall clear floor space requirements https://www.access-board.gov/ada/#ada-604_3_1 Rear grab bar requirements https://www.access-board.gov/ada/#ada-604_5_2	2012 TAS Section: 604.8.1.1 2010 ADAS Section: 604.8.1.1 2015 ABAAS Section: 604.8.1.1

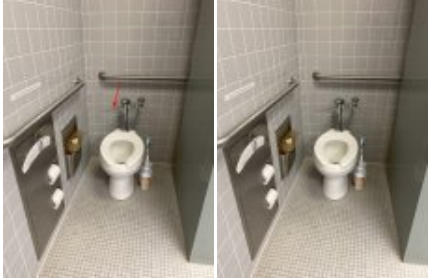
81	Structures on Property (STAFF) : Analytical Studies (Interior) - Restroom/Shower (Women's)	The flush handle is located on the wrong side of the toilet. Controls shall be operable with one hand and shall not require tight grasping, pinching or twisting. Controls for the flush valves shall be mounted on the wide side of toilet areas, no more than 48 inches above the floor.	flusher not on open side	https://www.access-board.gov/ada/#ada-604_6	2012 TAS Section: 604.6 2010 ADAS Section: 604.6 2015 ABAAS Section: 604.6

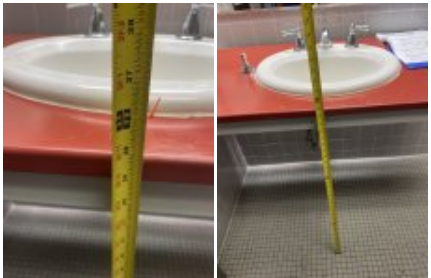
82	Structures on Property (STAFF) : Analytical Studies (Interior) - Restroom/Shower (Women's)	The top rim of the lavatory is too high. All lavatories that are designated to be accessible shall be a minimum 17 inches in horizontal depth and mounted with the rim or counter edge no higher than 34 inches above the finished floor.	Sink rim height over 34"	https://www.access-board.gov/ada/#ada-606_3	2012 TAS Section: 606.3 2010 ADAS Section: 606.3 2015 ABAAS Section: 606.3

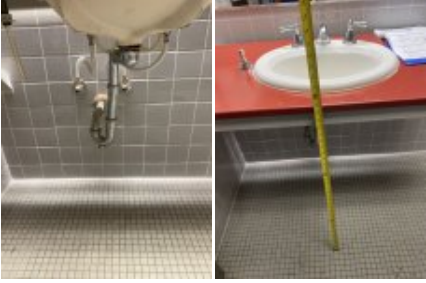
Finding Number	Area Description	Finding	As Built	Recommendation	Citation	Photos	Figure
83	Structures on Property (STAFF) : Analytical Studies (Interior) - Restroom/Showe r (Women's)	The water and drain pipes under the lavatory are not adequately insulated. Water supply and drain pipes under lavatories and sinks shall be insulated or otherwise configured to protect against contact. There shall be no sharp or abrasive surfaces under lavatories and sinks.	Pipes are not insulated	https://www.access-board.gov/ada/#ada-606_5	2012 TAS Section: 606.5 2010 ADAS Section: 606.5 2015 ABAAS Section: 606.5

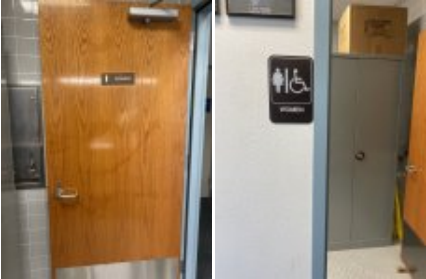
84	Structures on Property (STAFF) : Analytical Studies (Interior) - Restroom/Showe r (Women's)	The room identification sign is noncompliant. Wall signs identifying permanent rooms and spaces of a building shall be in a horizontal format and the characters raised 1/32 inch minimum and shall be sans serif uppercase characters a minimum of 5/8 inch and a maximum of 2 inches high. Characters and their background shall have a non-glare finish. Characters shall contrast with their background with either light characters on a dark background or dark characters on a light background. Signs with raised characters or Braille shall be located 48 inches minimum above the finish floor or ground surface, measured from the baseline of the lowest tactile character and 60 inches maximum above the finish floor or ground surface, measured from the baseline of the highest tactile character.	wall sign is not compliant	Remove non compliant sign as compliant option is provided.	2012 TAS Section: 216.2, 703.1 2010 ADAS Section: 216.2, 703.1 2015 ABAAS Section: F216.2, 703.1
