# Dundee IF- ADA Evaluation

**IF- Electra TX, Dundee ADA Evaluation**

**Accessibility Evaluation**

**Inspection Date: 03/21/2023**

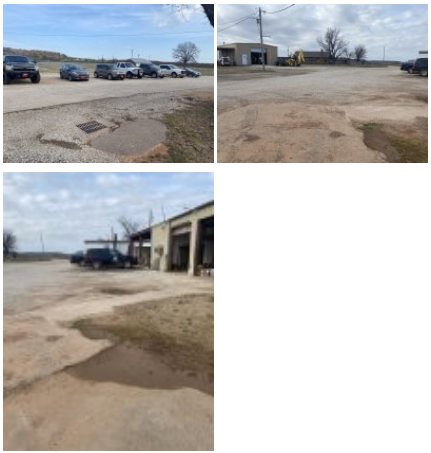
| Finding Number | Area Description | Finding | As Built | Recommendation | Citation | Photos | Figure |
|---|--|--|--|--|---|---|---|
| 1 | Exterior of Property (Public): Parking Lot ( 0 Spaces) | There are no accessible parking spaces provided, required to have 1 van accessible space to meet compliance. Space needs several elements to be designated as accessible van parking. Van accessible space requires ISA marking and defined borders with access aisle. | Parking lot is not compliant due to no marking or designations of accessible parking. | Review parking stall and access aisle requirements<br><a href="https://www.access-board.gov/ada/#ada-208_2">https://www.access-board.gov/ada/#ada-208_2</a><br><a href="https://www.access-board.gov/ada/#ada-502">https://www.access-board.gov/ada/#ada-502</a> | 2012 TAS Section: 208.2<br><br>2010 ADAS Section: 208.2<br><br>2015 ABAAS Section: F208.2 | | |

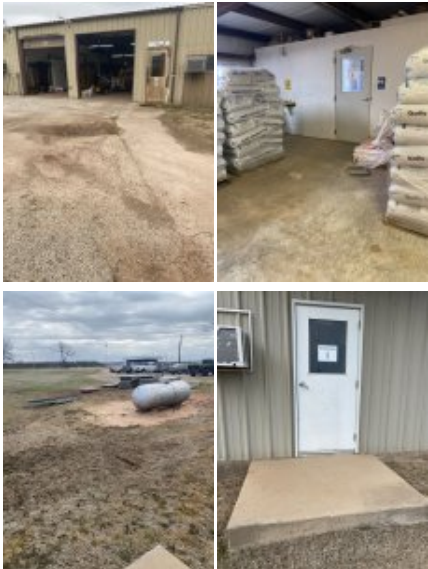
| Finding Number | Area Description | Finding | As Built | Recommendation | Citation | Photos | Figure |
|---|--|---|---|---|---|--|--|
| 4 | Exterior of Property (Public): Shop (Exterior) - TOUR | The building entrance is not located on an accessible route. When a building, or portion of a building, is required to be accessible, an accessible route of travel shall be provided to all portions of the building, to accessible building entrances and between the building and the public way. At least one accessible route within the boundary of the site must be provided from public transportation stops, accessible parking and accessible passenger loading zones and public streets or sidewalks to the accessible building entrance they serve. The accessible route shall, to the maximum extent feasible, coincide with the route for the general public. At least one accessible route shall connect accessible buildings, facilities, elements and spaces that are on the same site. At least one accessible route shall connect accessible building or facility entrances with all accessible spaces and elements. | There is no accessible route via primary or secondary entrance to public restrooms. Due to no access aisle provided, and clearly marked accessible pathway there is not a way to access this building at this time. This building is not accessible | <a href="https://www.access-board.gov/ada/#ada-206_2_1">https://www.access-board.gov/ada/#ada-206_2_1</a><br>Review accessible pathway componets to make accessible <a href="https://www.access-board.gov/ada/#ada-402">https://www.access-board.gov/ada/#ada-402</a> <a href="https://www.access-board.gov/ada/#ada-403_1">https://www.access-board.gov/ada/#ada-403_1</a> | 2012 TAS Section: 206.2.1<br><br>2010 ADAS Section: 206.2.1<br><br>2015 ABAAS Section: F206.2.1 | | |

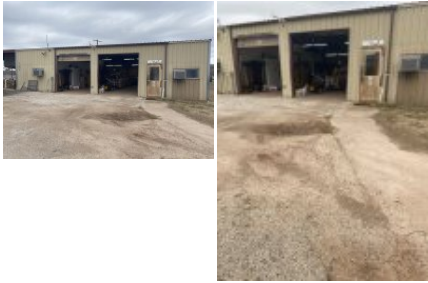
| Finding Number | Area Description | Finding | As Built | Recommendation | Citation | Photos | Figure |
|---|--|---|---|---|---|--|--|
| 5 | Exterior of Property (Public): Shop (Exterior) - TOUR - Pathway to Public Restrooms/Shop | The accessible route contains loose gravel and/or surface materials that do not provide for a stable, firm slip resistant surface. Floor and ground surfaces shall be stable, firm, and slip resistant. | Primary Entrance Exterior pathway to primary entrance for restroom is not compliant. | <a href="https://www.access-board.gov/ada/#ada-302_1">https://www.access-board.gov/ada/#ada-302_1</a> | 2012 TAS Section: 302.1<br><br>2010 ADAS Section: 302.1<br><br>2015 ABAAS Section: 302.1 | | |

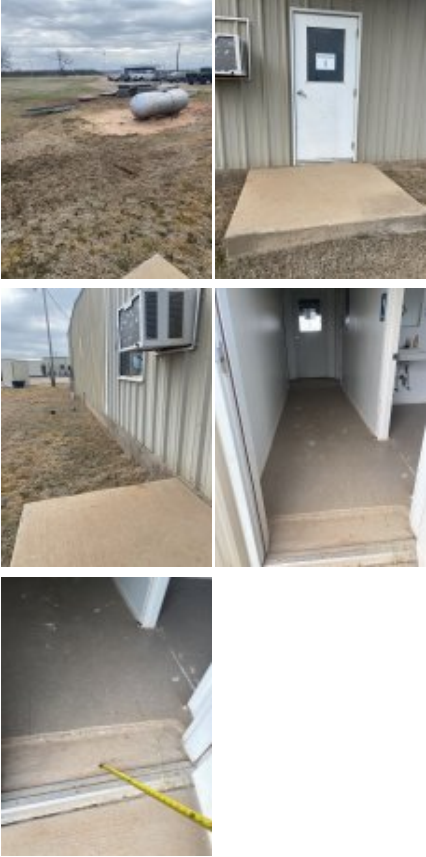
| Finding Number | Area Description | Finding | As Built | Recommendation | Citation | Photos | Figure |
|---|--|--|---|---|---|--|---|
| 6 | Exterior of Property (Public): Shop (Exterior) - TOUR - Pathway to Public Restrooms/Shop | The path of contains multiple issues and is not accessible. The path of travel exceeds the maximum allowable cross and running slope requirements. It also contains changes in level and/or gaps that exceed the allowable maximum requirements. The path of travel does not meet the minimum width requirements for clearances, turning spaces, and/or passing spaces. The floor or ground surface is not firm, stable, and slip resistant. | Secondary entrance<br>Due to no accessible pathway provided, changes in elevation and non accessible door this route is not compliant, considered secondary entrance. | <a href="https://www.access-board.gov/ada/#ada-403_1">https://www.access-board.gov/ada/#ada-403_1</a> | 2010 ADAS Section: 403.1<br><br>2015 ABAAS Section: 403.1 | | |

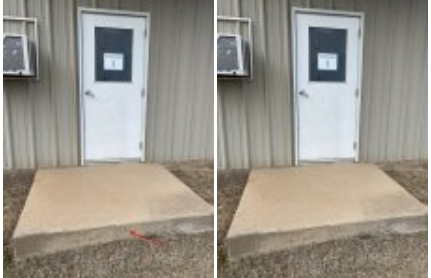
| Finding Number | Area Description | Finding | As Built | Recommendation | Citation | Photos | Figure |
|---|--|--|--|---|---|---|---|
| 7 | Exterior of Property (Public): Shop (Exterior) - TOUR - Pathway to Public Restrooms/Shop | The walkway contains changes in level greater than a 1/2 inch high that should be ramped. Changes in level greater than 1/2 inch high shall be constructed as a ramp or curb ramp. | Secondary entrance Door platform is raised and not compliant. Due to change in elevation a curb ramp with accessible pathway would need to be installed. This entrance bypasses need for patrons to travel through interior of shop. | <a href="https://www.access-board.gov/ada/#ada-303_4">https://www.access-board.gov/ada/#ada-303_4</a> | 2012 TAS Section: 303.4<br>2010 ADAS Section: 303.4<br>2015 ABAAS Section: 303.4 | | |

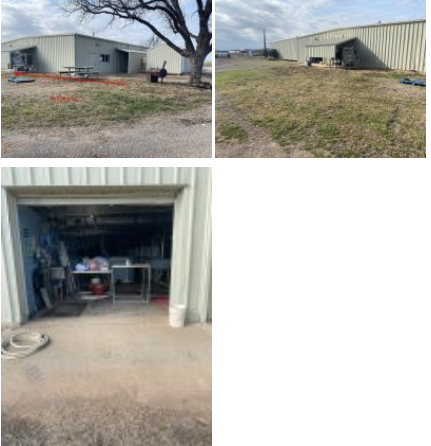
| Finding Number | Area Description | Finding | As Built | Recommendation | Citation | Photos | Figure |
|---|---|---|--|--|---|--|---|
| 9 | Exterior of Property (Public): Holding Tanks (Exterior) - TOUR | The building entrance is not located on an accessible route. When a building, or portion of a building, is required to be accessible, an accessible route of travel shall be provided to all portions of the building, to accessible building entrances and between the building and the public way. At least one accessible route within the boundary of the site must be provided from public transportation stops, accessible parking and accessible passenger loading zones and public streets or sidewalks to the accessible building entrance they serve. The accessible route shall, to the maximum extent feasible, coincide with the route for the general public. At least one accessible route shall connect accessible buildings, facilities, elements and spaces that are on the same site. At least one accessible route shall connect accessible building or facility entrances with all accessible spaces and elements. | Route to building is not compliant. This building is not accessible. | Review accessible pathway componets to make accessible <a href="https://www.access-board.gov/ada/#ada-206_2_1">https://www.access-board.gov/ada/#ada-206_2_1</a> <a href="https://www.access-board.gov/ada/#ada-402">https://www.access-board.gov/ada/#ada-402</a> <a href="https://www.access-board.gov/ada/#ada-403_1">https://www.access-board.gov/ada/#ada-403_1</a> | 2012 TAS Section: 206.2.1<br><br>2010 ADAS Section: 206.2.1<br><br>2015 ABAAS Section: F206.2.1 | | |

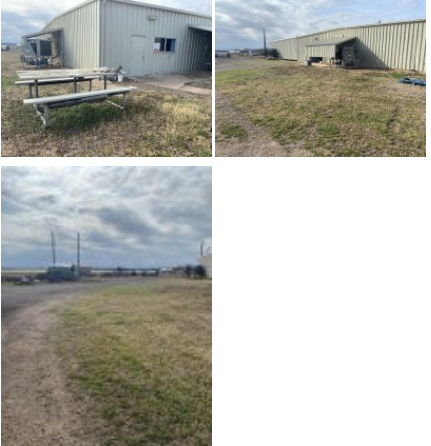
| Finding Number | Area Description | Finding | As Built | Recommendation | Citation | Photos | Figure |
|---|---|---|--|--|---|--|---|
| 10 | Exterior of Property (Public): Holding Tanks (Exterior) - TOUR - Pathway to Holding Tanks | The path of contains multiple issues and is not accessible. The path of travel exceeds the maximum allowable cross and running slope requirements. It also contains changes in level and/or gaps that exceed the allowable maximum requirements. The path of travel does not meet the minimum width requirements for clearances, turning spaces, and/or passing spaces. The floor or ground surface is not firm, stable, and slip resistant. | Due to terrain and change in elevation this element is not accessible. Packed earth is not considered a compliant surface. | Review accessible pathway componets to make accessible <a href="https://www.access-board.gov/ada/#ada-402">https://www.access-board.gov/ada/#ada-402</a> <a href="https://www.access-board.gov/ada/#ada-403_1">https://www.access-board.gov/ada/#ada-403_1</a> | 2010 ADAS Section: 403.1<br><br>2015 ABAAS Section: 403.1 | | |

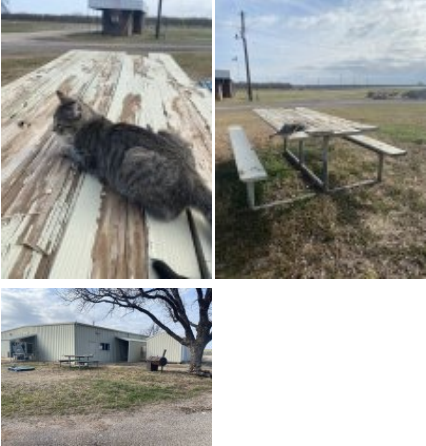
| Finding Number | Area Description | Finding | As Built | Recommendation | Citation | Photos | Figure |
|---|--|--|--|---|---|---|---|
| 11 | Exterior of Property (Public): Holding Tanks (Exterior) - TOUR - Picnic Area | There are not enough picnic units with mobility features. Where picnic facilities contain more than two picnic units, at least 20 percent, but not less than two, of the picnic units shall provide mobility features. | Ground/surface material not compliant around picnic tables. Exterior pathway leading to tables non-compliant. There are no accessible picnic tables provided | Provide compliant picnic table Knee space for wheelchair seating must be at least 30 inches wide, 19 inches deep, and 27 inches high, as measured from the ground or floor to the bottom of the tabletop. Toe clearance of at least 9 inches above the ground or floor must extend at least an additional 5 inches beyond the knee clearance. | 2015 ABAAS Section: F245.2.2 | | |

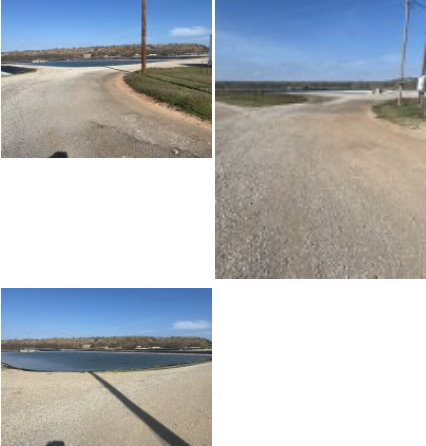
| Finding Number | Area Description | Finding | As Built | Recommendation | Citation | Photos | Figure |
|---|--|--|--|--|---|---|---|
| 12 | Exterior of Property (Public): Pathway to Holding Ponds - TOUR | State and local governments have an obligation to make their programs and services accessible to persons with disabilities. This may or may not require the alteration, addition or construction of existing facilities which predate The Americans with Disabilities Act (ADA) of 1990. Under the Code of Federal Regulations Section 35.151(b)(2) State and Local Government Title II entities may provide programmatic access where alterations to existing facilities would result in undue financial and administrative burdens. For Example, A public entity has six courtrooms in two existing buildings and determines that only three of those courtrooms and the public use and common use areas serving those courtrooms in one building are needed to be made accessible in order to satisfy its program access obligations. The entity must comply with 2010 Standards unless compliance would result in undue financial and administrative burdens and must take other actions that would not result in an undue financial burden to ensure access to persons with disabilities. This may include the scheduling of the various types of cases, hearings etc. in accessible courtrooms and relocating them where necessary to accommodate persons with disabilities. Having a defined program and effective communication process in place to ensure the public and employees can request accommodations is necessary to ensure equal access to the county's court system. Program access is not part of this evaluation and this information is being provided as an advisory only. | No way to access element at this time. | Provide a reasonable modification to allow tour participants an equitable experience during this part of tour. | 2010 ADAS Section: Advisory | | |

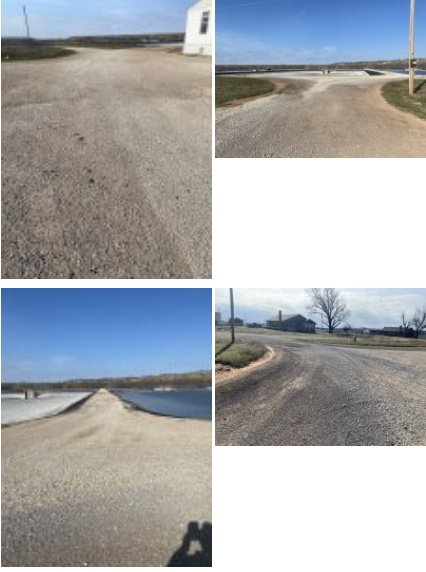
| Finding Number | Area Description | Finding | As Built | Recommendation | Citation | Photos | Figure |
|---|--|---|---|---|--|---|---|
| 13 | Exterior of Property (Public): Pathway to Holding Ponds - TOUR | The accessible route contains loose gravel and/or surface materials that do not provide for a stable, firm slip resistant surface. Floor and ground surfaces shall be stable, firm, and slip resistant. | The accessible route to holding pond is not compliant due to loose gravel and gravel size.. | <a href="https://www.access-board.gov/ada/#ada-302_1">https://www.access-board.gov/ada/#ada-302_1</a> | 2012 TAS Section: 302.1<br>2010 ADAS Section: 302.1<br>2015 ABAAS Section: 302.1 | | |

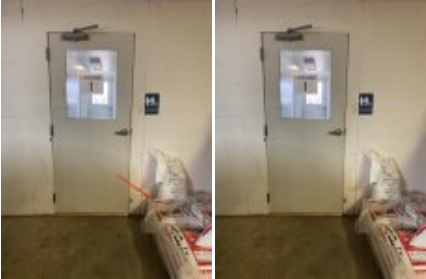
| Finding Number | Area Description | Finding | As Built | Recommendation | Citation | Photos | Figure | |
|---|--|--|--|--|---|--|---|---|
| 15 | Structures on Property (Public)<br>- Tour/Public Componets :<br>Shop/Public Restrooms (Interior) - Entrance/Exit Doors | The maneuvering clearance on the pull side of the door extends less than 18 inches beyond the latch side of the door. Maneuvering space for interior doors on the pull side with a front approach must be flat (2% max. slope in any direction) for a minimum distance of 60 inches in the direction of travel. The width of the maneuvering space must be as wide as the door plus an additional 18 inches on the latch side. This latch side clearance must also be flat (2% max. slope in any direction) and clear of obstructions. | Primary Entrance Maneuvering clearance not provided due to material placement. | <a href="https://www.access-board.gov/ada/#ada-404_2_4">https://www.access-board.gov/ada/#ada-404_2_4</a><br><a href="https://www.access-board.gov/ada/#ada-404_2_4_1">https://www.access-board.gov/ada/#ada-404_2_4_1</a> | 2012 TAS Section: 404.2.4<br><br>2010 ADAS Section: 404.2.4.1<br><br>2015 ABAAS Section: 404.2.4.1 | | | |

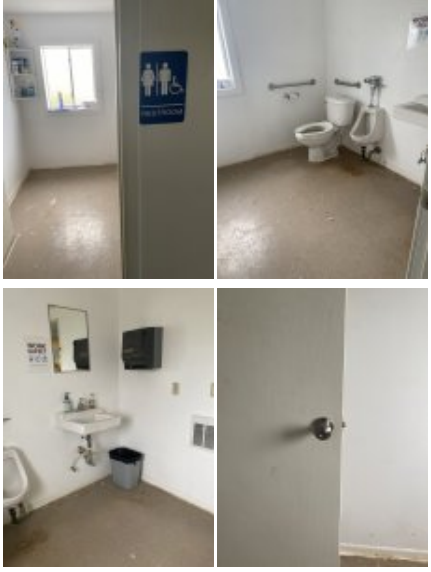
| Finding Number | Area Description | Finding | As Built | Recommendation | Citation | Photos | Figure |
|---|--|---|---|--|---|---|---|
| 17 | Structures on Property (Public)<br>- Tour/Public Componets :<br>Shop/Public Restrooms (Interior) - Restroom (Unisex) | The restroom is not nearly compliant. The restroom does not have the required minimum clear floor space or maneuvering clearances for the toilet. The restroom does not have the required minimum clear floor space or maneuvering clearances for the lavatory. The entry door does not contain the required minimum maneuvering spaces on the pull/push sides. The entry door encroach into the required clear floor space for fixtures. Grab bars are missing and/or incorrectly installed. Accessories, such as toilet seat covers, paper towel holders, garbage cans, hand dryers, and mirrors are either too high or without clear floor space or both. The restroom contain floor level changes greater than a 1/2 inch of the floor drains and is slope (XX) - (XX), the shower is too small and missing numerous accessible elements. | This restroom requires a number of componets to gain compliance. Currently there is 1 unisex and 1 women's restroom provided. | <a href="https://www.access-board.gov/ada/#ada-213_2">https://www.access-board.gov/ada/#ada-213_2</a><br>Review restrooms componets to make accessible.<br><a href="https://www.access-board.gov/ada/#ada-603">https://www.access-board.gov/ada/#ada-603</a> | 2012 TAS Section: 213.2<br><br>2010 ADAS Section: 213.2<br><br>2015 ABAAS Section: F213.2 | | |

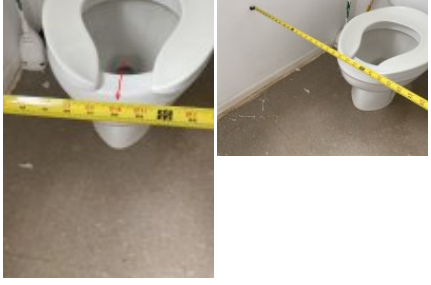
| Finding Number | Area Description | Finding | As Built | Recommendation | Citation | Photos | Figure |
|---|--|---|---|--|---|---|---|
| 18 | Structures on Property (Public)<br>- Tour/Public Componets :<br>Shop/Public Restrooms (Interior) - Restroom (Unisex) | The toilet is not located within the range allowed from the side wall or partition. The centerline of the toilet must be 16 to 18 inches from the side wall. | Measures at 22" | <a href="https://www.access-board.gov/ada/#ada-604_2">https://www.access-board.gov/ada/#ada-604_2</a> | 2012 TAS Section: 604.2<br><br>2010 ADAS Section: 604.2<br><br>2015 ABAAS Section: 604.2 | | |

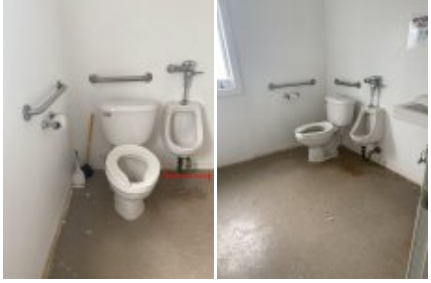
| Finding Number | Area Description | Finding | As Built | Recommendation | Citation | Photos | Figure |
|---|--|--|--|---|---|--|---|
| 23 | Structures on Property (Public)<br>- Tour/Public Componets :<br>Shop/Public Restrooms (Interior) - Restroom (Unisex) | The urinal is located in an area that does not provide the required clear floor space for a front approach. The surrounding elements of a urinal must provide a minimum of 30 by 48 inches of clear floor space for a front approach. | Not enough clear floor space provided. | Recommend removing urinal or review componets below to make accessible. <a href="https://www.access-board.gov/ada/#ada-605_3">https://www.access-board.gov/ada/#ada-605_3</a> | 2012 TAS Section: 605.3<br><br>2010 ADAS Section: 605.3<br><br>2015 ABAAS Section: 605.2, 605.3 | | |

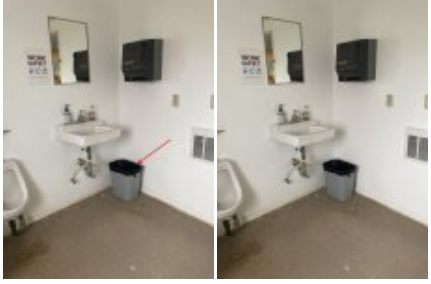
| Finding Number | Area Description | Finding | As Built | Recommendation | Citation | Photos | Figure |
|---|--|--|--|---|---|--|---|
| 24 | Structures on Property (Public)<br>- Tour/Public Componets :<br>Shop/Public Restrooms (Interior) - Restroom (Unisex) | The lavatory's clear floor space obstructed by the trash can. The wall mounted trash can projects (XX) from the wall and encroaches into the required 30 inches by 48 inches clear floor space. The maximum projection that a dispenser may project at this location is (XX) inches. | Trashcan obstructs clear floor space. | <a href="https://www.access-board.gov/ada/#ada-606_2">https://www.access-board.gov/ada/#ada-606_2</a> | 2012 TAS Section: 606.2<br><br>2010 ADAS Section: 606.2<br><br>2015 ABAAS Section: 606.2 | | |

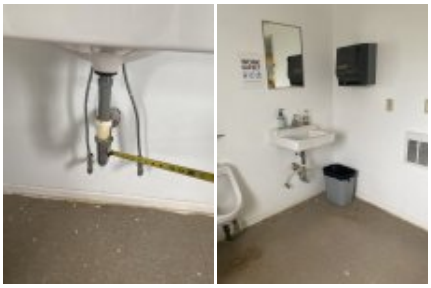
| Finding Number | Area Description | Finding | As Built | Recommendation | Citation | Photos | Figure | |
|---|--|--|---|---|---|--|--|--|
| 26 | Structures on Property (Public)<br>- Tour/Public Componets :<br>Shop/Public Restrooms (Interior) - Restroom (Unisex) | The water and drain pipes under the lavatory are not adequately insulated. Water supply and drain pipes under lavatories and sinks shall be insulated or otherwise configured to protect against contact. There shall be no sharp or abrasive surfaces under lavatories and sinks. | Pipes are not covered or insulated. | | <a href="https://www.access-board.gov/ada/#ada-606_5">https://www.access-board.gov/ada/#ada-606_5</a> | 2012 TAS Section: 606.5<br><br>2010 ADAS Section: 606.5<br><br>2015 ABAAS Section: 606.5 | | |

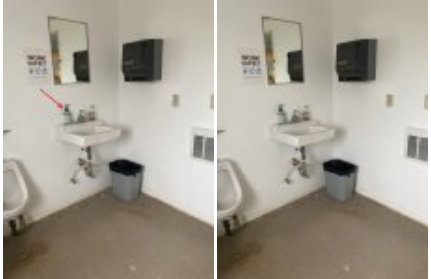
| Finding Number | Area Description | Finding | As Built | Recommendation | Citation | Photos | Figure | |
|---|--|--|---|---|---|--|--|--|
| 27 | Structures on Property (Public)<br>- Tour/Public Componets :<br>Shop/Public Restrooms (Interior) - Restroom (Unisex) | The element is not accessible because it requires tight grasping, pinching or twisting of the wrist. Controls and operating mechanisms shall be operable with one hand and shall not require tight grasping, pinching or twisting of the wrist. The force required to activate controls shall be no greater than 5 pounds of force. | Soap dispenser is not compliant option. | | <a href="https://www.access-board.gov/ada/#ada-309_4">https://www.access-board.gov/ada/#ada-309_4</a> | 2012 TAS Section: 309.4<br><br>2010 ADAS Section: 309.4<br><br>2015 ABAAS Section: 309.4 | | |

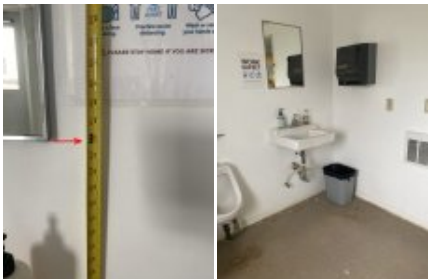
| Finding Number | Area Description | Finding | As Built | Recommendation | Citation | Photos | Figure | |
|---|--|--|---|---|---|--|--|--|
| 28 | Structures on Property (Public)<br>- Tour/Public Componets :<br>Shop/Public Restrooms (Interior) - Restroom (Unisex) | The mirror is mounted above the allowable height above the lavatory and/or counter. Mirrors must have the bottom edge of the reflecting surface a maximum of 40 inches above the floor if above a sink or counter. Mirrors not located above lavatories or countertops shall be installed with the bottom edge of the reflecting surface 35 inches maximum above the finish floor or ground. | Over 47" | | <a href="https://www.access-board.gov/ada/#ada-603_3">https://www.access-board.gov/ada/#ada-603_3</a> | 2012 TAS Section: 603.3<br><br>2010 ADAS Section: 603.3<br><br>2015 ABAAS Section: 603.3 | | |

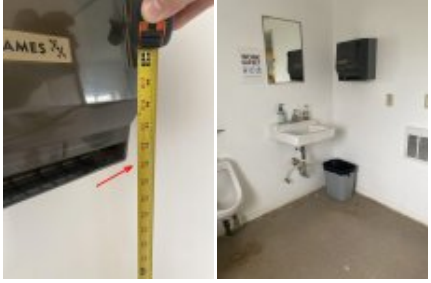
| Finding Number | Area Description | Finding | As Built | Recommendation | Citation | Photos | Figure | |
|---|--|--|---|---|---|--|--|---|
| 29 | Structures on Property (Public)<br>- Tour/Public Componets :<br>Shop/Public Restrooms (Interior) - Restroom (Unisex) | The paper towel dispenser's operation mechanism is too high off the floor. Dispensers must have all operable parts a maximum of 48 inches above the floor. | Measures at 55" | | <a href="https://www.access-board.gov/ada/#ada-308_2_1">https://www.access-board.gov/ada/#ada-308_2_1</a> | 2012 TAS Section: 308.2.1<br><br>2010 ADAS Section: 308.2.1<br><br>2015 ABAAS Section: 308.2.1 | | |

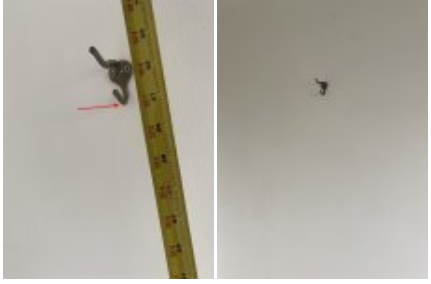
| Finding Number | Area Description | Finding | As Built | Recommendation | Citation | Photos | Figure | |
|---|--|--|---|---|---|--|--|---|
| 30 | Structures on Property (Public)<br>- Tour/Public Componets :<br>Shop/Public Restrooms (Interior) - Restroom (Unisex) | The coat hook is installed greater than 48 inches above the finished floor. Where a forward reach is unobstructed, the high forward reach shall be 48 inches maximum above the finished floor. | Measures at 67" | | <a href="https://www.access-board.gov/ada/#ada-308_2_1">https://www.access-board.gov/ada/#ada-308_2_1</a> | 2012 TAS Section: 308.2.1<br><br>2010 ADAS Section: 308.2.1<br><br>2015 ABAAS Section: 308.2.1 | <br> | |

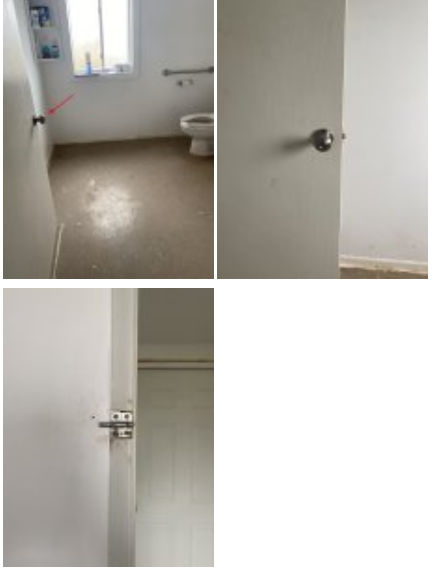
| Finding Number | Area Description | Finding | As Built | Recommendation | Citation | Photos | Figure |
|---|---|---|---|--|--|--|---|
| 31 | Structures on Property (Public)<br>- Tour/Public Componets :<br>Shop/Public Restrooms (Interior) - Restroom (Unisex) | The door/gate operating hardware is not accessible. Hand-activated door/gate opening hardware, handles, pulls, latches, locks, and other operating devices on accessible doors shall have a shape that is easy to grasp with one hand and does not require tight grasping, pinching or twisting of the wrist to operate. Hardware shall be 34 inches minimum and 48 inches maximum above the finish floor or ground. | Door hardware and locking componets are not accessible. | <a href="https://www.access-board.gov/ada/#ada-404_2_7">https://www.access-board.gov/ada/#ada-404_2_7</a> | 2012 TAS Section: 404.2.7<br><br>2010 ADAS Section: 404.2.7<br><br>2015 ABAAS Section: 404.2.7 | | |

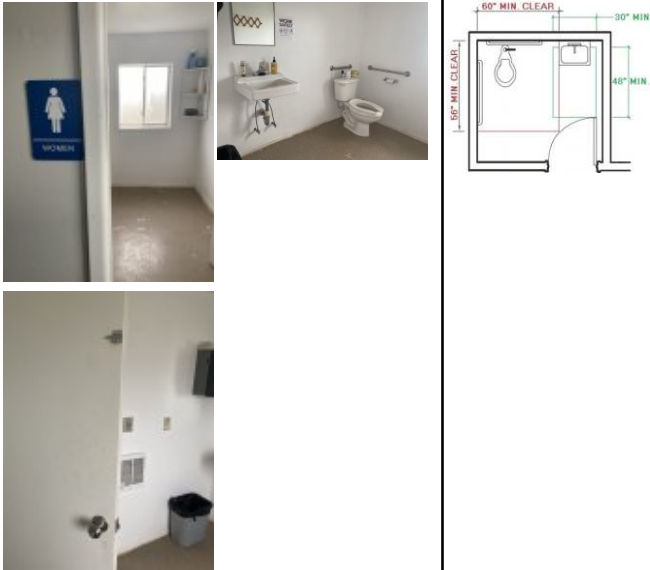
| Finding Number | Area Description | Finding | As Built | Recommendation | Citation | Photos | Figure |
|---|---|---|---|--|--|--|---|
| 32 | Structures on Property (Public)<br>- Tour/Public Componets :<br>Shop/Public Restrooms (Interior) - Restroom (Women's) | The restroom is not nearly compliant. The restroom does not have the required minimum clear floor space or maneuvering clearances for the toilet. The restroom does not have the required minimum clear floor space or maneuvering clearances for the lavatory. The entry door does not contain the required minimum maneuvering spaces on the pull/push sides. The entry door encroach into the required clear floor space for fixtures. Grab bars are missing and/or incorrectly installed. Accessories, such as toilet seat covers, paper towel holders, garbage cans, hand dryers, and mirrors are either too high or without clear floor space or both. The restroom contain floor level changes greater than a 1/2 inch of the floor drains and is slope (XX) - (XX), the shower is too small and missing numerous accessible elements. | This restroom requires a number of componets to gain compliance. Currently there is 1 unisex and 1 women's restroom provided. | <a href="https://www.access-board.gov/ada/#ada-213_2">https://www.access-board.gov/ada/#ada-213_2</a><br>Review restrooms componets to make accessible.<br><a href="https://www.access-board.gov/ada/#ada-603">https://www.access-board.gov/ada/#ada-603</a> | 2012 TAS Section: 213.2<br><br>2010 ADAS Section: 213.2<br><br>2015 ABAAS Section: F213.2 | | |

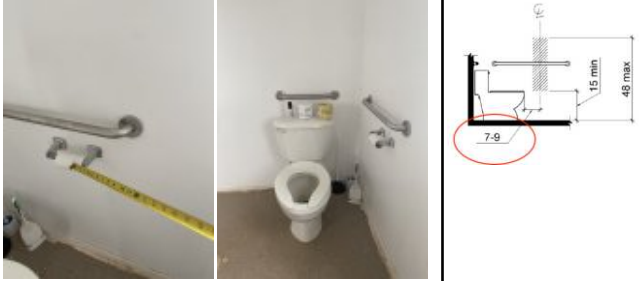
| Finding Number | Area Description | Finding | As Built | Recommendation | Citation | Photos | Figure |
|---|---|---|---|---|---|--|--|
| 36 | Structures on Property (Public)<br>- Tour/Public Componets :<br>Shop/Public Restrooms (Interior) - Restroom (Women's) | The toilet paper is not installed within the compliant range. Toilet paper dispensers shall be 7 inches minimum and 9 inches maximum in front of the water closet measured to the centerline of the dispenser. The outlet of the dispenser shall be 15 inches minimum and 48 inches maximum above the finish floor and shall not be located behind grab bars. Dispensers shall not be of a type that controls delivery or that does not allow continuous paper flow. There shall be a clearance of 1 1/2 inches minimum below the grab bar. | TP dispenser location is not compliant. | | <a href="https://www.access-board.gov/ada/#ada-604_7">https://www.access-board.gov/ada/#ada-604_7</a> | 2012 TAS Section: 604.7<br><br>2010 ADAS Section: 604.7<br><br>2015 ABAAS Section: 604.7 | |

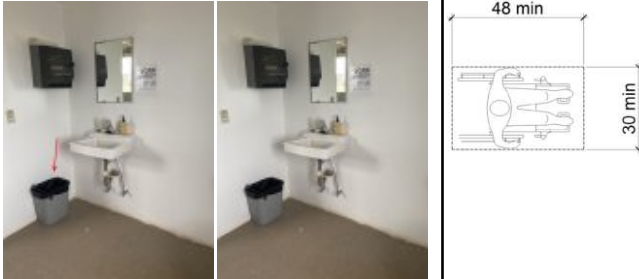
| Finding Number | Area Description | Finding | As Built | Recommendation | Citation | Photos | Figure |
|---|---|---|---|---|---|--|--|
| 37 | Structures on Property (Public)<br>- Tour/Public Componets :<br>Shop/Public Restrooms (Interior) - Restroom (Women's) | The lavatory's clear floor space obstructed by the trash can. The wall mounted trash can projects (XX) from the wall and encroaches into the required 30 inches by 48 inches clear floor space. The maximum projection that a dispenser may project at this location is (XX) inches. | Trashcan obstructs clear floor space. | | <a href="https://www.access-board.gov/ada/#ada-606_2">https://www.access-board.gov/ada/#ada-606_2</a> | 2012 TAS Section: 606.2<br><br>2010 ADAS Section: 606.2<br><br>2015 ABAAS Section: 606.2 | |

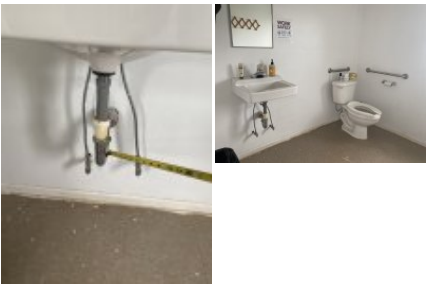
| Finding Number | Area Description | Finding | As Built | Recommendation | Citation | Photos | Figure |
|---|---|--|---|---|---|--|--|
| 39 | Structures on Property (Public)<br>- Tour/Public Componets :<br>Shop/Public Restrooms (Interior) - Restroom (Women's) | The water and drain pipes under the lavatory are not adequately insulated. Water supply and drain pipes under lavatories and sinks shall be insulated or otherwise configured to protect against contact. There shall be no sharp or abrasive surfaces under lavatories and sinks. | Pipes are not covered or insulated. | | <a href="https://www.access-board.gov/ada/#ada-606_5">https://www.access-board.gov/ada/#ada-606_5</a> | 2012 TAS Section: 606.5<br><br>2010 ADAS Section: 606.5<br><br>2015 ABAAS Section: 606.5 | |

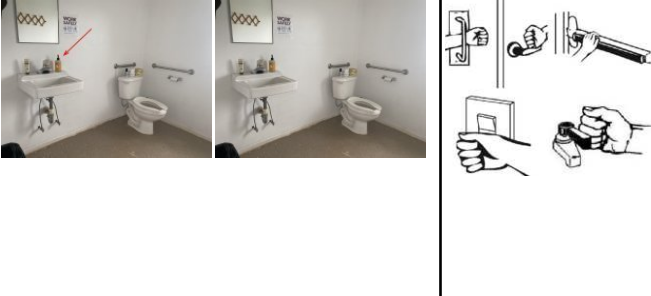
| Finding Number | Area Description | Finding | As Built | Recommendation | Citation | Photos | Figure |
|---|---|--|---|---|---|--|--|
| 40 | Structures on Property (Public)<br>- Tour/Public Componets :<br>Shop/Public Restrooms (Interior) - Restroom (Women's) | The element is not accessible because it requires tight grasping, pinching or twisting of the wrist. Controls and operating mechanisms shall be operable with one hand and shall not require tight grasping, pinching or twisting of the wrist. The force required to activate controls shall be no greater than 5 pounds of force. | Soap dispenser is not compliant option. | | <a href="https://www.access-board.gov/ada/#ada-309_4">https://www.access-board.gov/ada/#ada-309_4</a> | 2012 TAS Section: 309.4<br><br>2010 ADAS Section: 309.4<br><br>2015 ABAAS Section: 309.4 | |

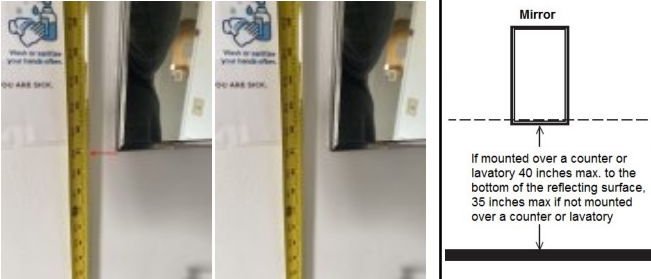
| Finding Number | Area Description | Finding | As Built | Recommendation | Citation | Photos | Figure |
|---|---|--|---|---|---|--|--|
| 41 | Structures on Property (Public)<br>- Tour/Public Componets :<br>Shop/Public Restrooms (Interior) - Restroom (Women's) | The mirror is mounted above the allowable height above the lavatory and/or counter. Mirrors must have the bottom edge of the reflecting surface a maximum of 40 inches above the floor if above a sink or counter. Mirrors not located above lavatories or countertops shall be installed with the bottom edge of the reflecting surface 35 inches maximum above the finish floor or ground. | Over 51" | | <a href="https://www.access-board.gov/ada/#ada-603_3">https://www.access-board.gov/ada/#ada-603_3</a> | 2012 TAS Section: 603.3<br><br>2010 ADAS Section: 603.3<br><br>2015 ABAAS Section: 603.3 | |

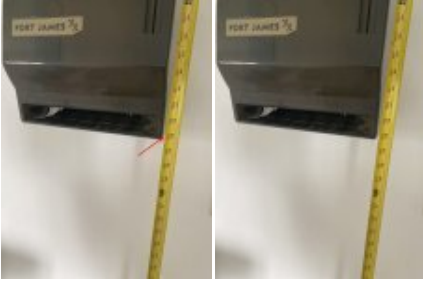
| Finding Number | Area Description | Finding | As Built | Recommendation | Citation | Photos | Figure |
|---|---|--|---|---|--|---|---|
| 42 | Structures on Property (Public)<br>- Tour/Public Componets :<br>Shop/Public Restrooms (Interior) - Restroom (Women's) | The paper towel dispenser's operation mechanism is too high off the floor. Dispensers must have all operable parts a maximum of 48 inches above the floor. | Measures at 52" | <a href="https://www.access-board.gov/ada/#ada-308_2_1">https://www.access-board.gov/ada/#ada-308_2_1</a> | 2012 TAS Section: 308.2.1<br><br>2010 ADAS Section: 308.2.1<br><br>2015 ABAAS Section: 308.2.1 | | |

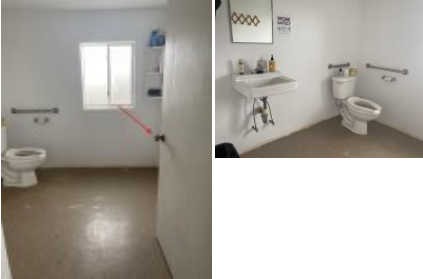
| Finding Number | Area Description | Finding | As Built | Recommendation | Citation | Photos | Figure |
|---|---|--|---|---|--|---|---|
| 43 | Structures on Property (Public)<br>- Tour/Public Componets :<br>Shop/Public Restrooms (Interior) - Restroom (Women's) | The door/gate operating hardware is not accessible. Hand-activated door/gate opening hardware, handles, pulls, latches, locks, and other operating devices on accessible doors shall have a shape that is easy to grasp with one hand and does not require tight grasping, pinching or twisting of the wrist to operate. Hardware shall be 34 inches minimum and 48 inches maximum above the finish floor or ground. | Door hardware and locking componets are not accessible. | <a href="https://www.access-board.gov/ada/#ada-404_2_7">https://www.access-board.gov/ada/#ada-404_2_7</a> | 2012 TAS Section: 404.2.7<br><br>2010 ADAS Section: 404.2.7<br><br>2015 ABAAS Section: 404.2.7 | | |

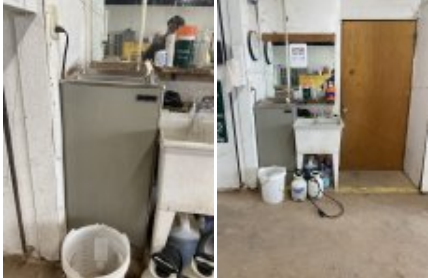
| Finding Number | Area Description | Finding | As Built | Recommendation | Citation | Photos | Figure |
|---|---|--|---|---|---|--|---|
| 44 | Structures on Property (Public)<br>- Tour/Public Componets :<br>Shop/Public Restrooms (Interior) - Water Fountain | The drinking fountain has multiple violations. Drinking fountains must be on an accessible route that provides a 30 inch by 48 inch clear floor space centered on the low unit, allowing a forward approach. Spout outlets shall be 36 inches maximum above the finish floor or ground. Spout outlets of drinking fountains for standing persons shall be 38 inches minimum and 43 inches maximum above the finish floor or ground. The spout shall be located 15 inches minimum from the vertical support and 5 inches maximum from the front edge of the unit, including bumpers. The spout shall provide a flow of water 4 inches high minimum and shall be located 5 inches maximum from the front of the unit. The angle of the water stream shall be measured horizontally relative to the front face of the unit. Where spouts are located less than 3 inches of the front of the unit, the angle of the water stream shall be 30 degrees maximum. Where spouts are located between 3 inches and 5 inches maximum from the front of the unit, the angle of the water stream shall be 15 degrees maximum. Operable parts shall comply with applicable standards. | This water fountain is not compliant. The Building Code may only require one drinking fountain be provided, but the Accessibility Standards require at least two. One at a lower height and the other at standing height. | Clear floor space <a href="https://www.access-board.gov/ada/#ada-403_5_1">https://www.access-board.gov/ada/#ada-403_5_1</a> Drinking fountain requirements, general <a href="https://www.access-board.gov/ada/#ada-602_1">https://www.access-board.gov/ada/#ada-602_1</a> Minimum number <a href="https://www.access-board.gov/ada/#ada-211_2">https://www.access-board.gov/ada/#ada-211_2</a> Standing person requirements <a href="https://www.access-board.gov/ada/#ada-602_7">https://www.access-board.gov/ada/#ada-602_7</a> | 2012 TAS Section: 403.5.1, 602.1<br><br>2010 ADAS Section: 403.5.1, 602.1<br><br>2015 ABAAS Section: 403.5.1, 602.1 | | |

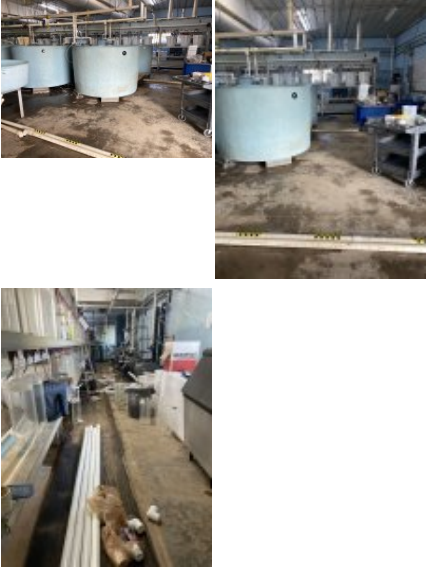
| Finding Number | Area Description | Finding | As Built | Recommendation | Citation | Photos | Figure |
|---|---|--|---|--|---|---|---|
| 48 | Structures on Property (Public)<br>- Tour/Public Componets :<br>Holding Tanks (Interior) - TOUR | State and local governments have an obligation to make their programs and services accessible to persons with disabilities. This may or may not require the alteration, addition or construction of existing facilities which predate The Americans with Disabilities Act (ADA) of 1990. Under the Code of Federal Regulations Section 35.151(b)(2) State and Local Government Title II entities may provide programmatic access where alterations to existing facilities would result in undue financial and administrative burdens. For Example, A public entity has six courtrooms in two existing buildings and determines that only three of those courtrooms and the public use and common use areas serving those courtrooms in one building are needed to be made accessible in order to satisfy its program access obligations. The entity must comply with 2010 Standards unless compliance would result in undue financial and administrative burdens and must take other actions that would not result in an undue financial burden to ensure access to persons with disabilities. This may include the scheduling of the various types of cases, hearings etc. in accessible courtrooms and relocating them where necessary to accommodate persons with disabilities. Having a defined program and effective communication process in place to ensure the public and employees can request accommodations is necessary to ensure equal access to the county's court system. Program access is not part of this evaluation and this information is being provided as an advisory only. | No way to access this element at this time. | Provide a reasonable modification to allow tour participants an equitable experience during this part of tour. | 2010 ADAS Section: Advisory | | |

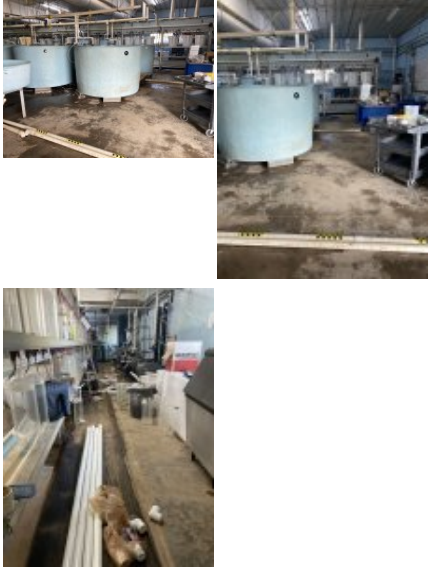
| Finding Number | Area Description | Finding | As Built | Recommendation | Citation | Photos | Figure |
|---|---|--|---|---|---|--|---|
| 49 | Structures on Property (Public)<br>- Tour/Public Componets :<br>Holding Tanks (Interior) - TOUR | There is no accessible route between elements. An accessible route of travel must connect all accessible elements and spaces within a building or facility. | Due to necessary function of these tanks, this area will remain inaccessible. Finding recorded for inventory purposes. | N/A | 2012 TAS Section: 206.2.4<br><br>2010 ADAS Section: 206.2.4<br><br>2015 ABAAS Section: F206.2.4 | | |

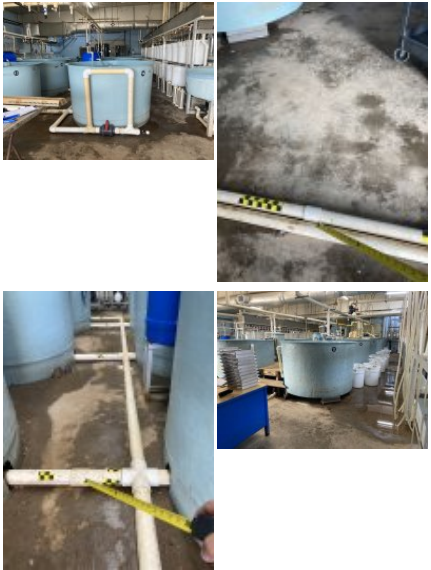
| Finding Number | Area Description | Finding | As Built | Recommendation | Citation | Photos | Figure |
|---|---|--|---|---|---|--|---|
| 50 | Structures on Property (Public)<br>- Tour/Public Componets :<br>Holding Tanks (Interior) - TOUR | The path of contains multiple issues and is not accessible. The path of travel exceeds the maximum allowable cross and running slope requirements. It also contains changes in level and/or gaps that exceed the allowable maximum requirements. The path of travel does not meet the minimum width requirements for clearances, turning spaces, and/or passing spaces. The floor or ground surface is not firm, stable, and slip resistant. | Due to tight spaces, and trip hazards there is no accessible route around tanks. Finding recorded for inventory purposes. | N/A | 2012 TAS Section: 403.1<br><br>2010 ADAS Section: 403.1<br><br>2015 ABAAS Section: 403.1 | | |

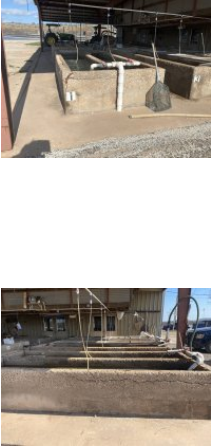
| Finding Number | Area Description | Finding | As Built | Recommendation | Citation | Photos | Figure |
|---|---|--|---|--|---|---|---|
| 51 | Structures on Property (Public)<br>- Tour/Public Componets : Raceway/Production Area - TOUR | State and local governments have an obligation to make their programs and services accessible to persons with disabilities. This may or may not require the alteration, addition or construction of existing facilities which predate The Americans with Disabilities Act (ADA) of 1990. Under the Code of Federal Regulations Section 35.151(b)(2) State and Local Government Title II entities may provide programmatic access where alterations to existing facilities would result in undue financial and administrative burdens. For Example, A public entity has six courtrooms in two existing buildings and determines that only three of those courtrooms and the public use and common use areas serving those courtrooms in one building are needed to be made accessible in order to satisfy its program access obligations. The entity must comply with 2010 Standards unless compliance would result in undue financial and administrative burdens and must take other actions that would not result in an undue financial burden to ensure access to persons with disabilities. This may include the scheduling of the various types of cases, hearings etc. in accessible courtrooms and relocating them where necessary to accommodate persons with disabilities. Having a defined program and effective communication process in place to ensure the public and employees can request accommodations is necessary to ensure equal access to the county's court system. Program access is not part of this evaluation and this information is being provided as an advisory only. | No way to access this element at this time. | Provide a reasonable modification to allow tour participants an equitable experience during this part of tour. | 2010 ADAS Section: Advisory | | |

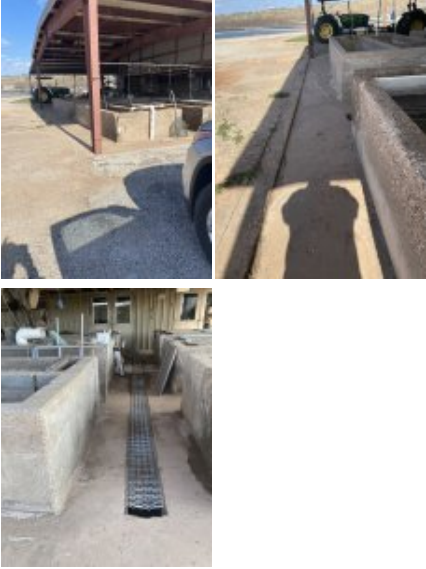
| Finding Number | Area Description | Finding | As Built | Recommendation | Citation | Photos | Figure |
|---|--|---|---|--|--|---|---|
| 52 | Structures on Property (Public)<br>- Tour/Public Components : Raceway/Production Area - TOUR | The accessible route contains loose gravel and/or surface materials that do not provide for a stable, firm slip resistant surface. Floor and ground surfaces shall be stable, firm, and slip resistant. | Route has narrow passageway, loose gravel, large gaps, elevation changes. | Accessible route should be made to outsides of raceway tanks to increase accessibility.<br><a href="https://www.access-board.gov/ada/#ada-302_1">https://www.access-board.gov/ada/#ada-302_1</a> | 2012 TAS Section: 302.1<br><br>2010 ADAS Section: 302.1<br><br>2015 ABAAS Section: 302.1 | | |

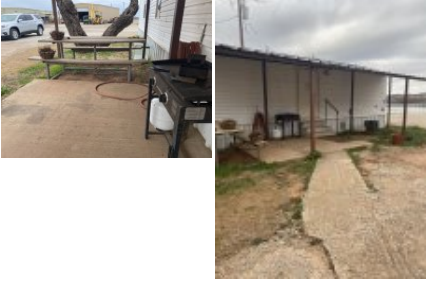
| Finding Number | Area Description | Finding | As Built | Recommendation | Citation | Photos | Figure |
|---|---|--|--|---|--|--|---|
| 55 | Structures on Property (STAFF): Staff Work Trailer (Exterior) - Picnic Table | All of the picnic units do not provide mobility features. Where picnic facilities contain two or fewer picnic units, each picnic unit shall provide mobility features. | Ground/surface material not compliant around picnic tables. Exterior pathway leading to tables non-compliant. There are no accessible picnic tables provided | Provide compliant picnic table at compliant ratio. Knee space for wheelchair seating must be at least 30 inches wide, 19 inches deep, and 27 inches high, as measured from the ground or floor to the bottom of the tabletop. Toe clearance of at least 9 inches above the ground or floor must extend at least an additional 5 inches beyond the knee clearance. | 2015 ABAAS Section: F245.2.1 | | |

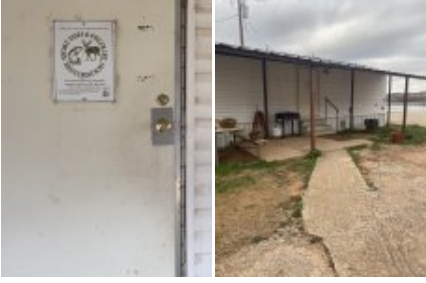
| Finding Number | Area Description | Finding | As Built | Recommendation | Citation | Photos | Figure |
|---|---|--|--|---|--|--|---|
| 56 | Structures on Property (STAFF): Staff Work Trailer (Interior) - Entrance/Exit Doors | The door/gate operating hardware is not accessible. Hand-activated door/gate opening hardware, handles, pulls, latches, locks, and other operating devices on accessible doors shall have a shape that is easy to grasp with one hand and does not require tight grasping, pinching or twisting of the wrist to operate. Hardware shall be 34 inches minimum and 48 inches maximum above the finish floor or ground. | Door hardware is not accessible | <a href="https://www.access-board.gov/ada/#ada-404_2_7">https://www.access-board.gov/ada/#ada-404_2_7</a> | 2012 TAS Section: 404.2.7<br><br>2010 ADAS Section: 404.2.7<br><br>2015 ABAAS Section: 404.2.7 | | |

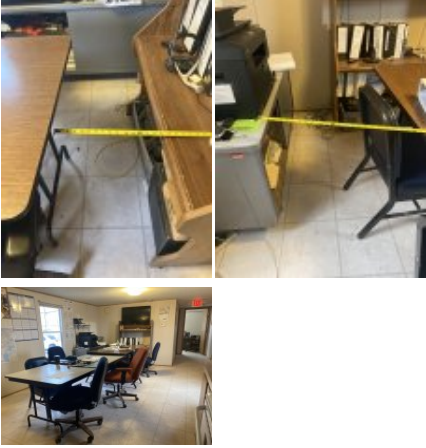
| Finding Number | Area Description | Finding | As Built | Recommendation | Citation | Photos | Figure |
|---|---|--|--|---|--|--|---|
| 57 | Structures on Property (STAFF): Staff Work Trailer (Interior) - Conference Room/Kitchenette | The walking surface is obstructed. A 36" wide minimum clear walking surface is required. The clear width shall be permitted to be reduced to 32 inches (815 mm) minimum for a length of 24 inches (610 mm) maximum | N/A | <a href="https://www.access-board.gov/ada/#ada-403_5_1">https://www.access-board.gov/ada/#ada-403_5_1</a> | 2012 TAS Section: 403.5.1<br><br>2010 ADAS Section: 403.5.1<br><br>2015 ABAAS Section: 403.5.1 | | |

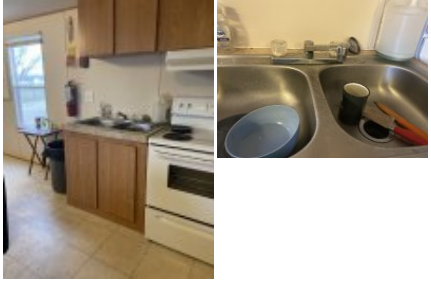
| Finding Number | Area Description | Finding | As Built | Recommendation | Citation | Photos | Figure |
|---|---|---|--|--|---|--|---|
| 58 | Structures on Property (STAFF): Staff Work Trailer (Interior) - Conference Room/Kitchenette | Knee and toe space has not been provided at the sink. Kitchen sinks must be provided with a clear floor space positioned for a forward approach including knee and toe clearance. | Knee and toe must be provided since kitchenette contain stove top range. | <a href="https://www.access-board.gov/ada/#ada-606_2">https://www.access-board.gov/ada/#ada-606_2</a><br><a href="https://www.access-board.gov/ada/#ada-804_4">https://www.access-board.gov/ada/#ada-804_4</a> | 2012 TAS Section: 606.2, 804.4<br><br>2010 ADAS Section: 606.2, 804.4<br><br>2015 ABAAS Section: 606.2, 804.4 | | |

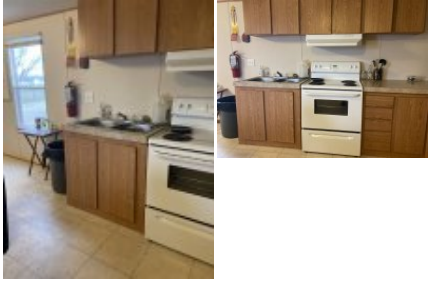
| Finding Number | Area Description | Finding | As Built | Recommendation | Citation | Photos | Figure |
|---|---|---|--|--|---|--|---|
| 59 | Structures on Property (STAFF): Staff Work Trailer (Interior) - Conference Room/Kitchenette | The top of the sink is above the allowable height requirement. Sinks shall be installed with the front of the higher of the rim or counter surface 34 inches maximum above the finish floor or ground. | Sink height looks to be non compliant. Needs verification. | <a href="https://www.access-board.gov/ada/#ada-606_3">https://www.access-board.gov/ada/#ada-606_3</a> | 2012 TAS Section: 606.3<br><br>2010 ADAS Section: 606.3<br><br>2015 ABAAS Section: 606.3 | | |

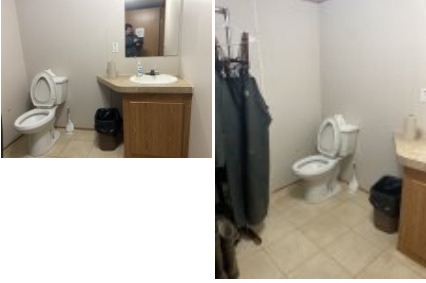
| Finding Number | Area Description | Finding | As Built | Recommendation | Citation | Photos | Figure |
|---|---|--|---|---|--|---|---|
| 64 | Structures on Property (STAFF): Staff Work Trailer (Interior) - Restroom (Unisex) | Accessible toilets must have grab bars installed. The side grab bar must extend at least 54 inches minimum beyond the rear wall and start a maximum of 12 inches from the rear wall. The rear grab bar must be a minimum of 36 inches long and extend from the centerline of the toilet 12 inches minimum on one side and 24 inches minimum on the other side. Grab bars shall be installed in a horizontal position, 33 inches minimum and 36 inches maximum above the finish floor measured to the top of the gripping surface. | There are no grab bars installed at this time. | <a href="https://www.access-board.gov/ada/#ada-604_5">https://www.access-board.gov/ada/#ada-604_5</a><br>Review grab bar components to make accessible<br><a href="https://www.access-board.gov/ada/#ada-609">https://www.access-board.gov/ada/#ada-609</a> | 2012 TAS Section: 604.5<br><br>2010 ADAS Section: 604.5<br><br>2015 ABAAS Section: 604.5 | | |
