Heart of Hills IF- ADA Evaluation

IF- Mountain Home TX, Heart of Hills ADA Evaluatio
5103 Junction Hwy
Mountain Home, TX 78058
Accessibility Evaluation
Inspection Date: 03/06/2023
Inspectors: Christopher Meza

Report Date: 02/01/2024

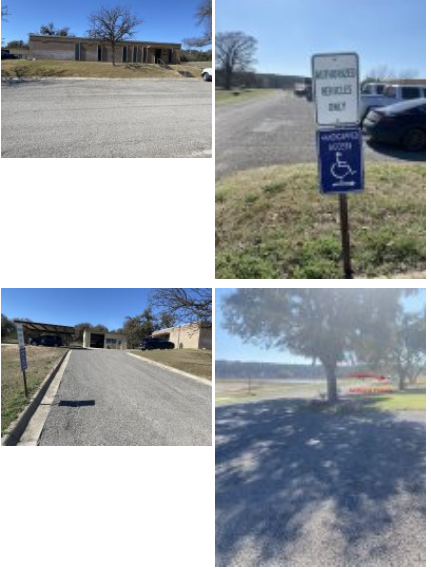
Finding Number	Area Description	Finding	As Built	Recommendation	Citation	Photos	Figure
1	Exterior of Property (Public): HQ Parking Lot (1 Space) 1 Van	There are approximately (XX) parking stalls that could be reasonably associated with this facility in the shared parking lot. There are (XX) accessible parking stalls including (XX) designated for a van. There should be a minimum of (XX) accessible stalls with a minimum of (XX) being designed as van accessible.	There is no accessible parking provided in front of HQ building. This Parking lot does not lead to accessible route to access building. Based on multiple parking lots and total number of spaces, accessible parking is not compliant with scoping requirements and additional accessible parking is required. Accessible parking spot located on (L) side of HQ building and leads to side entrance. There is a sign directing public to accessible parking space. Directional sign is compliant.	See figure for ratio details https://www.access-board.gov/ada/#ada-208_2	2012 TAS Section: 208.2 2010 ADAS Section: 208.2 2015 ABAAS Section: F208.2

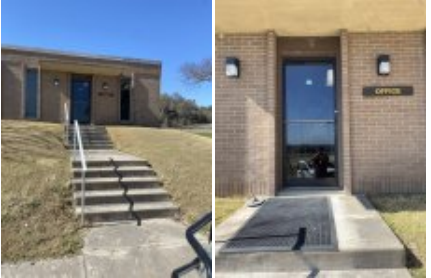
2	Exterior of Property (Public): HQ Parking Lot (1 Space) 1 Van	The entrance is not accessible and is missing signage. An identification sign identifying that this entrance is not accessible and directional signage pointing to the accessible entrance is required. When a directional sign is required, it should be located to minimize backtracking. In some cases, this could mean locating a sign at the beginning of a route, not just at the inaccessible entrances to a building.	Front entrance is not accessible. Sign would need to be placed directing patrons towards accessible entrance on (L) side of the building. Signs that provide direction to or information about interior spaces and facilities must meet visual requirements but are not required to be tactile	https://www.access-board.gov/ada/#ada-216_6	2010 ADAS Section: 216.6 2015 ABAAS Section: F216.6

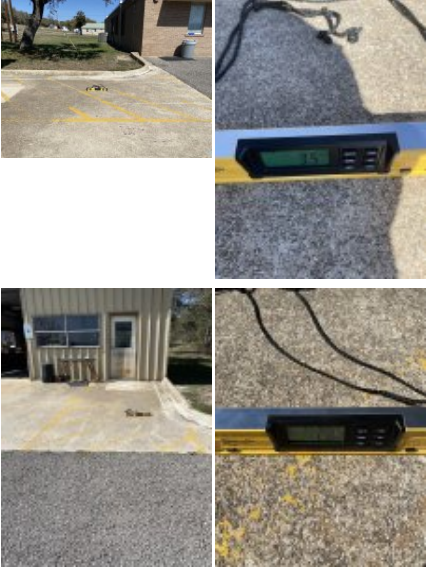
Finding Number	Area Description	Finding	As Built	Recommendation	Citation	Photos	Figure
7	Exterior of Property (Public): HQ Parking Lot (1 Space) 1 Van - Access Aisle (Van) (L) Side of Building	The cross slopes (narrow dimension) and/or running slopes (long dimension) of the access aisle exceeds 2%. The running slope and the cross slope in an accessible parking stall and the access aisle must not exceed 2%.	Cross and narrow slope for access aisle is not compliant. See photos for locations.	https://www.access-board.gov/ada/#ada-502_4	2012 TAS Section: 502.4 2010 ADAS Section: 502.4 2015 ABAAS Section: 502.4

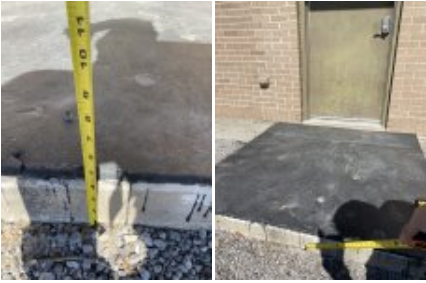
9	Exterior of Property (Public): HQ Parking Lot (1 Space) 1 Van - Pathway to Building (Van Accessible Stall to Side Entrance)	The walkway contains changes in level greater than a 1/2 inch high that should be ramped. Changes in level greater than 1/2 inch high shall be constructed as a ramp or curb ramp.	2 exposed sides of landing pad change in elevation over 4"	https://www.access-board.gov/ada/#ada-303_4	2012 TAS Section: 303.4 2010 ADAS Section: 303.4 2015 ABAAS Section: 303.4

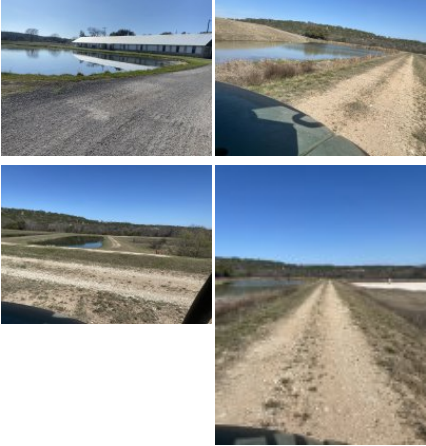
11	Exterior of Property (Public): Pathway to Holding Ponds - TOUR	State and local governments have an obligation to make their programs and services accessible to persons with disabilities. This may or may not require the alteration, addition or construction of existing facilities which predate The Americans with Disabilities Act (ADA) of 1990. Under the Code of Federal Regulations Section 35.151(b)(2) State and Local Government Title II entities may provide programmatic access where alterations to existing facilities would result in undue financial and administrative burdens. For Example, A public entity has six courtrooms in two existing buildings and determines that only three of those courtrooms and the public use and common use areas serving those courtrooms in one building are needed to be made accessible in order to satisfy its program access obligations. The entity must comply with 2010 Standards unless compliance would result in undue financial and administrative burdens and must take other actions that would not result in an undue financial burden to ensure access to persons with disabilities. This may include the scheduling of the various types of cases, hearings etc. in accessible courtrooms and relocating them where necessary to accommodate persons with disabilities. Having a defined program and effective communication process in place to ensure the public and employees can request accommodations is necessary to ensure equal access to the county's court system. Program access is not part of this evaluation and this information is being provided as an advisory only.	No way to access element at this time. These pathways also serve as birding trails.	Provide a reasonable modification to allow tour participants an equitable experience during this part of tour.	2010 ADAS Section: Advisory

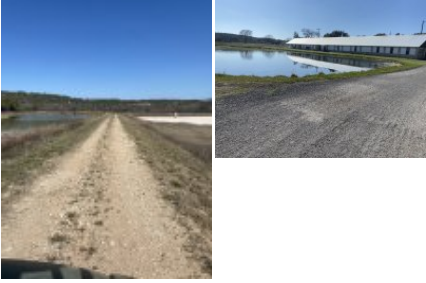
Finding Number	Area Description	Finding	As Built	Recommendation	Citation	Photos	Figure
12	Exterior of Property (Public): Pathway to Holding Ponds - TOUR	The accessible route contains loose gravel and/or surface materials that do not provide for a stable, firm slip resistant surface. Floor and ground surfaces shall be stable, firm, and slip resistant.	The accessible route to holding pond is not compliant due to loose gravel and gravel size. Phasing as smart practice (9) since trails have dual purpose	https://www.access-board.gov/ada/#ada-302_1	2012 TAS Section: 302.1 2010 ADAS Section: 302.1 2015 ABAAS Section: 302.1

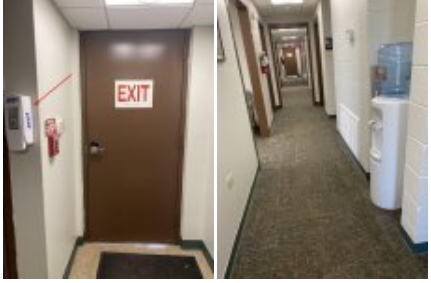
Finding Number	Area Description	Finding	As Built	Recommendation	Citation	Photos	Figure
13	Structures on Property (Public) - Tour/Public Componets : HQ Building/Public Restrooms (Interior)	The element projects more than 4 inches into the circulation path. Wall-mounted objects that have leading edges between 27 inches and 80 inches from the floor must not project more than 4 inches into the circulation path. Protruding objects that extend to the floor or within 27 inches of the floor are cane detectable and are therefore not hazardous. Where it is necessary or desirable to have objects protrude from the wall, a manner of cane detection must be provided.	Hand Sanitizer	https://www.access-board.gov/ada/#ada-307_2	2012 TAS Section: 307.2 2010 ADAS Section: 307.2 2015 ABAAS Section: 307.2

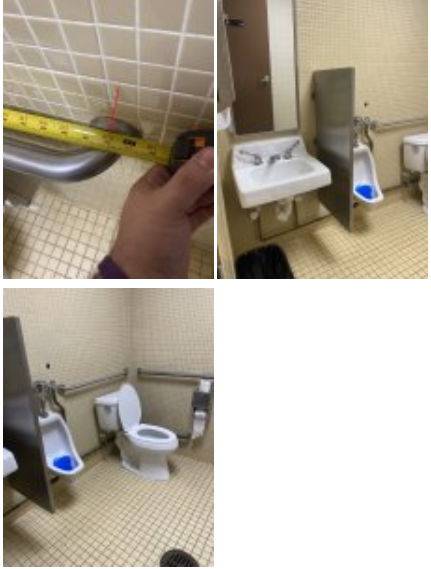
Finding Number	Area Description	Finding	As Built	Recommendation	Citation	Photos	Figure
16	Structures on Property (Public) - Tour/Public Componets : HQ Building/Public Restrooms (Interior) - Restroom (Men's) Public/Staff	The side grab bar does not extend far enough from the rear wall. The side grab bar must extend at least 54 inches minimum beyond the rear wall and start a maximum of 12 inches from the rear wall. A 42 inch grab bar installed the maximum distance from the rear wall (12 inches) will leave the leading end 54 inches from the rear wall. Grab bars shall be installed in a horizontal position, 33 inches minimum and 36 inches maximum above the finish floor measured to the top of the gripping surface.	Measures at 47"	https://www.access-board.gov/ada/#ada-604_5_1	2012 TAS Section: 604.5.1 2010 ADAS Section: 604.5.1 2015 ABAAS Section: 604.5.1

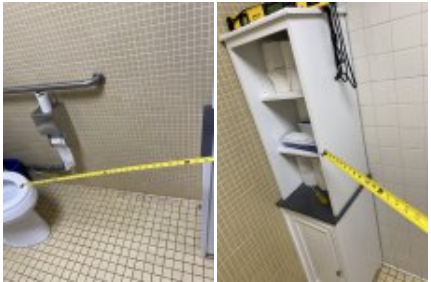
17	Structures on Property (Public) - Tour/Public Componets : HQ Building/Public Restrooms (Interior) - Restroom (Men's) Public/Staff	The restroom contains storage items and/or supplies which obstruct the clear floor and/or turning space within the restroom. A clear space measured from the floor to a height of 27 inches above the floor, within the restroom, of sufficient size to inscribe a circle with a diameter not less than 60 inches in size or a "T" turning space must be provided.	Storage shelf impedes clear floor space for toilet.	https://www.access-board.gov/ada/#ada-603_2_1	2012 TAS Section: 603.2.1 2010 ADAS Section: 603.2.1 2015 ABAAS Section: 603.2.1 , 803.2, 805.2

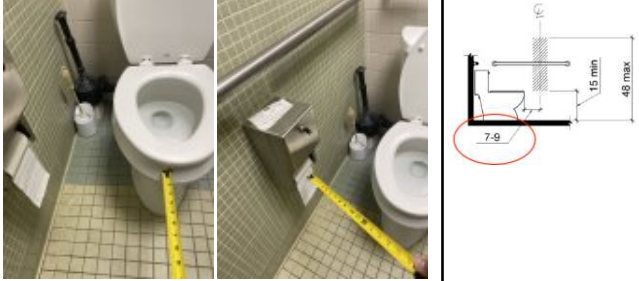
Finding Number	Area Description	Finding	As Built	Recommendation	Citation	Photos	Figure
23	Structures on Property (Public) - Tour/Public Componets : HQ Building/Public Restrooms (Interior) - Restroom (Women's) Public/Staff	The toilet paper is not installed within the compliant range in front of the toilet. Toilet paper dispensers shall be 7 inches minimum and 9 inches maximum in front of the water closet measured to the centerline of the dispenser. The outlet of the dispenser shall be 15 inches minimum and 48 inches maximum above the finish floor and shall not be located behind grab bars. Dispensers shall not be of a type that controls delivery or that does not allow continuous paper flow. There shall be a clearance of 1 1/2 inches minimum below the grab bar.	TP dispenser mounted too close to front of toilet.		https://www.access-board.gov/ada/#ada-604_7	2012 TAS Section: 604.7 2010 ADAS Section: 604.7 2015 ABAAS Section: 604.7

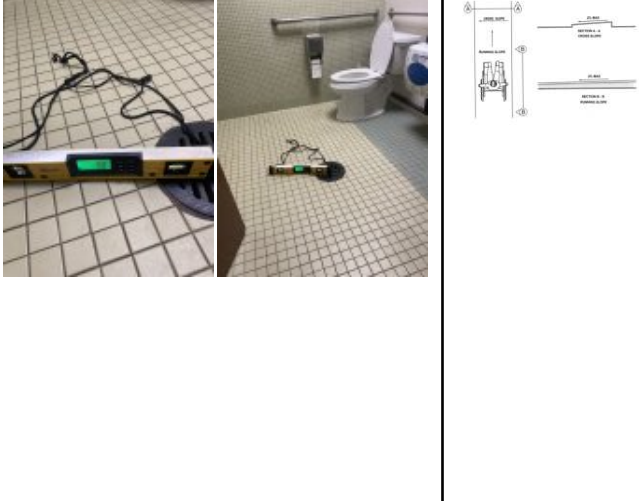
24	Structures on Property (Public) - Tour/Public Componets : HQ Building/Public Restrooms (Interior) - Restroom (Women's) Public/Staff	The floor drain is set too low in the floor which causes a slope over 2 percent. Changes in level are not permitted in clear floor or ground spaces or surfaces of a turning spaces and shall not slope greater than 1:48.	Slope measures at 3.8%		https://www.access-board.gov/ada/#ada-303_3 https://www.access-board.gov/ada/#ada-304_2	2012 TAS Section: 303.3, 304.2, 304.2 Exception 2010 ADAS Section: 303.3, 304.2, 304.2 Exception 2015 ABAAS Section: 303.3, 304.2, 304.2 EXCEPTION, 305.2 EXCEPTION

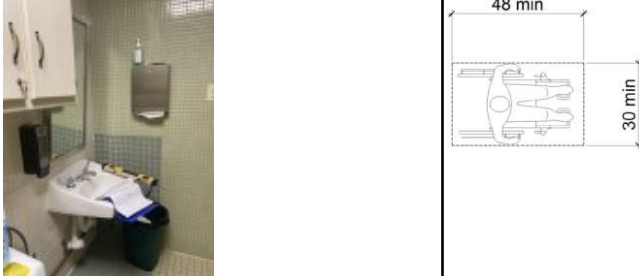
25	Structures on Property (Public) - Tour/Public Componets : HQ Building/Public Restrooms (Interior) - Restroom (Women's) Public/Staff	The lavatory's clear floor space obstructed by the trash can. The wall mounted trash can projects (XX) from the wall and encroaches into the required 30 inches by 48 inches clear floor space. The maximum projection that a dispenser may project at this location is (XX) inches.	Trashcan prevent access to lavatory.		https://www.access-board.gov/ada/#ada-606_2	2012 TAS Section: 606.2 2010 ADAS Section: 606.2 2015 ABAAS Section: 606.2

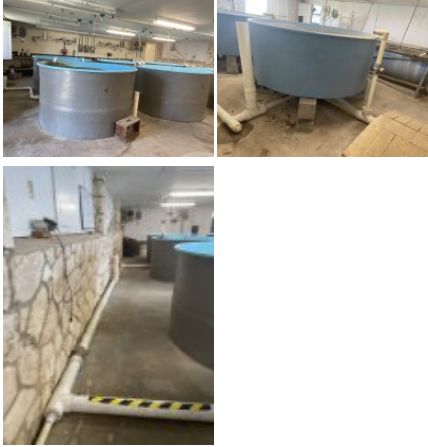
27	Structures on Property (Public) - Tour/Public Componets : Holding Tanks (Interior) - TOUR	State and local governments have an obligation to make their programs and services accessible to persons with disabilities. This may or may not require the alteration, addition or construction of existing facilities which predate The Americans with Disabilities Act (ADA) of 1990. Under the Code of Federal Regulations Section 35.151(b)(2) State and Local Government Title II entities may provide programmatic access where alterations to existing facilities would result in undue financial and administrative burdens. For Example, A public entity has six courtrooms in two existing buildings and determines that only three of those courtrooms and the public use and common use areas serving those courtrooms in one building are needed to be made accessible in order to satisfy its program access obligations. The entity must comply with 2010 Standards unless compliance would result in undue financial and administrative burdens and must take other actions that would not result in an undue financial burden to ensure access to persons with disabilities. This may include the scheduling of the various types of cases, hearings etc. in accessible courtrooms and relocating them where necessary to accommodate persons with disabilities. Having a defined program and effective communication process in place to ensure the public and employees can request accommodations is necessary to ensure equal access to the county's court system. Program access is not part of this evaluation and this information is being provided as an advisory only.	No way to access this element at this time.	Provide a reasonable modification to allow tour participants an equitable experience during this part of tour.	2010 ADAS Section: Advisory

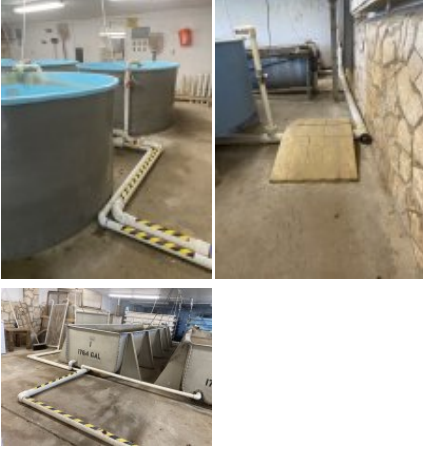
Finding Number	Area Description	Finding	As Built	Recommendation	Citation	Photos	Figure
28	Structures on Property (Public) - Tour/Public Componets : Holding Tanks (Interior) - TOUR	There is no accessible route between elements. An accessible route of travel must connect all accessible elements and spaces within a building or facility.	Due to necessary function of these tanks, this area will remain inaccessible. Finding recorded for inventory purposes.	N/A	2012 TAS Section: 206.2.4 2010 ADAS Section: 206.2.4 2015 ABAAS Section: F206.2.4

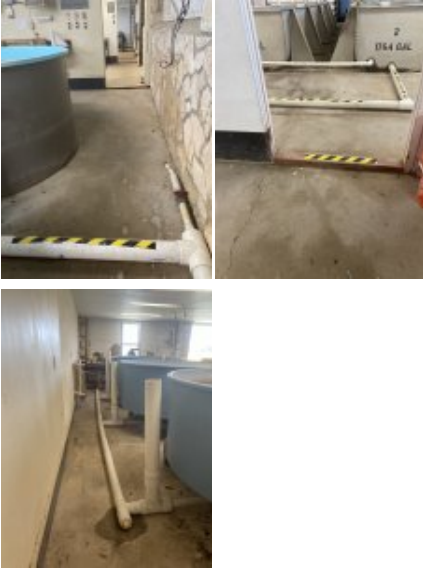
29	Structures on Property (Public) - Tour/Public Componets : Holding Tanks (Interior) - TOUR	The path of contains multiple issues and is not accessible. The path of travel exceeds the maximum allowable cross and running slope requirements. It also contains changes in level and/or gaps that exceed the allowable maximum requirements. The path of travel does not meet the minimum width requirements for clearances, turning spaces, and/or passing spaces. The floor or ground surface is not firm, stable, and slip resistant.	Due to tight spaces, and trip hazards there is no accessible route around tanks. Finding recorded for inventory purposes.	N/A	2012 TAS Section: 403.1 2010 ADAS Section: 403.1 2015 ABAAS Section: 403.1

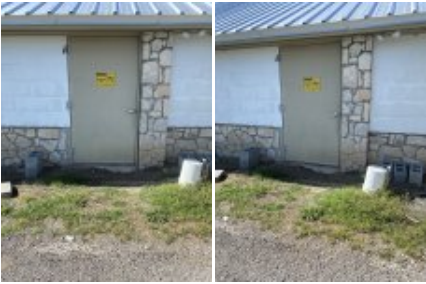
Finding Number	Area Description	Finding	As Built	Recommendation	Citation	Photos	Figure
30	Structures on Property (Public) - Tour/Public Componets : Holding Tanks (Interior) - TOUR - Entrance Doors	The building entrance is not located on an accessible route. When a building, or portion of a building, is required to be accessible, an accessible route of travel shall be provided to all portions of the building, to accessible building entrances and between the building and the public way. At least one accessible route within the boundary of the site must be provided from public transportation stops, accessible parking and accessible passenger loading zones and public streets or sidewalks to the accessible building entrance they serve. The accessible route shall, to the maximum extent feasible, coincide with the route for the general public. At least one accessible route shall connect accessible buildings, facilities, elements and spaces that are on the same site. At least one accessible route shall connect accessible building or facility entrances with all accessible spaces and elements.	There is no accessible entrance into holding tanks for tour. This building exterior and interior are not accessible.	Provide a reasonable modification to allow tour participants an equitable experience during this part of tour.	2012 TAS Section: 206.2.1 2010 ADAS Section: 206.2.1 2015 ABAAS Section: F206.2.1

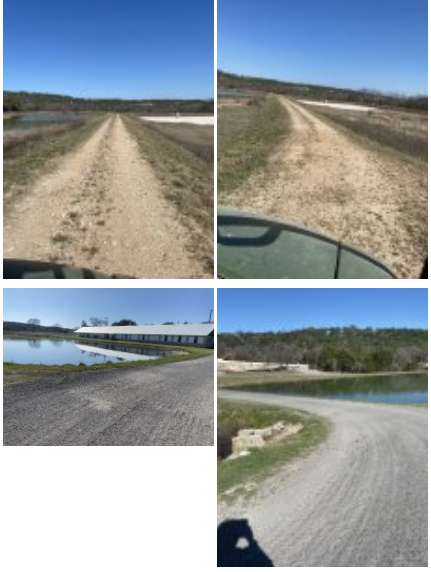
Finding Number	Area Description	Finding	As Built	Recommendation	Citation	Photos	Figure
31	Outdoor Features (Public) : Trials - Birding	The surface of the trails, passing spaces, and/or resting intervals is not firm and stable. The surface of trails, passing spaces, and resting intervals shall be firm and stable	Trails are not compliant with surfacing type, and gravel size requirements. These are used by public to bird watch. Open to public on wed only 8-4 These trails also serve as routes around holding ponds.	N/A - Refer to Finding	2015 ABAAS Section: 1017.2

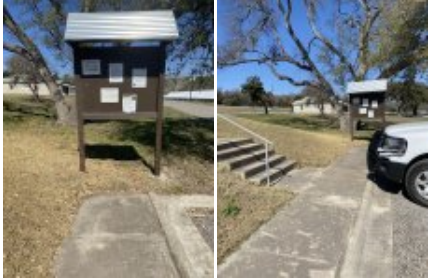
32	Outdoor Features (Public) : Trials - Birding - Trails- Birding Sign In Kiosk	The element is not accessible because it does not allow a forward or side approach. This element must be on an accessible route of travel that is 36 inches wide minimum and provides a 30 inch by 48 inch clear floor space that allows a side or forward approach.	There is no way to access this element due to no ADA parking or compliant pathway provided to kiosk. Kiosk used for visitors to sign in when using birding trails.	https://www.access-board.gov/ada/#ada-305_5	2012 TAS Section: 305.5 2010 ADAS Section: 305.5 2015 ABAAS Section: 305.5

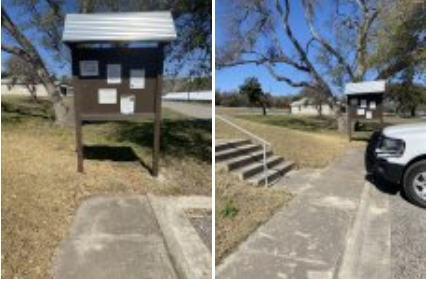
Finding Number	Area Description	Finding	As Built	Recommendation	Citation	Photos	Figure
33	Outdoor Features (Public) : Trials - Birding - Trails- Birding Sign In Kiosk	The path of contains multiple issues and is not accessible. The path of travel exceeds the maximum allowable cross and running slope requirements. It also contains changes in level and/or gaps that exceed the allowable maximum requirements. The path of travel does not meet the minimum width requirements for clearances, turning spaces, and/or passing spaces. The floor or ground surface is not firm, stable, and slip resistant.	Pathway has change in elevation (curb) with no nearby ADA parking or access point to sign in sheet. Ground around kiosk is not compliant surfacing or sloping.	Review accessible pathway componets to make accessible https://www.access-board.gov/ada/#ada-402 https://www.access-board.gov/ada/#ada-403_1	2010 ADAS Section: 403.1 2015 ABAAS Section: 403.1

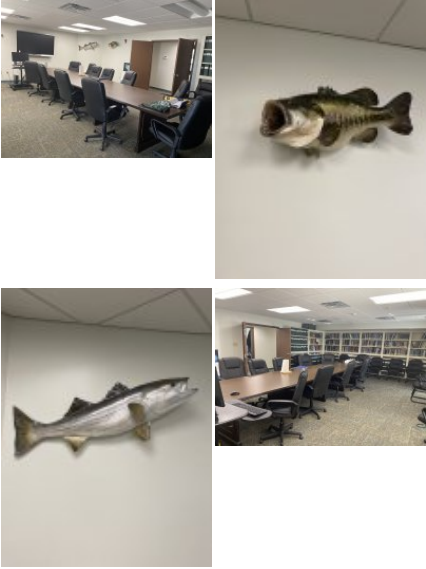
Finding Number	Area Description	Finding	As Built	Recommendation	Citation	Photos	Figure
34	Structures on Property (STAFF): HQ Building (Interior) - Conference Room	The fish mounts projects more than 4 inches into the circulation path. Wall-mounted objects that have leading edges between 27 inches and 80 inches from the floor must not project more than 4 inches into the circulation path. Protruding objects that extend to the floor or within 27 inches of the floor are cane detectable and are therefore not hazardous. Where it is necessary or desirable to have objects protrude from the wall, a manner of cane detection must be provided.	Overall conference room is spacious and compliant. The 2 mounts pictured are not in compliance and cause protruding object.	https://www.access-board.gov/ada/#ada-307_2	2012 TAS Section: 307.2 2010 ADAS Section: 307.2 2015 ABAAS Section: 307.2

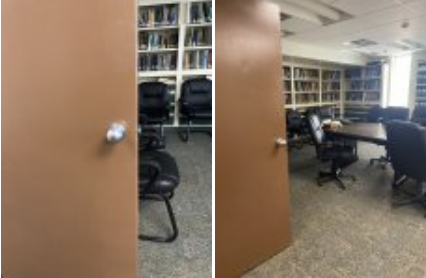
35	Structures on Property (STAFF): HQ Building (Interior) - Conference Room	The door/gate operating hardware is not accessible. Hand-activated door/gate opening hardware, handles, pulls, latches, locks, and other operating devices on accessible doors shall have a shape that is easy to grasp with one hand and does not require tight grasping, pinching or twisting of the wrist to operate. Hardware shall be 34 inches minimum and 48 inches maximum above the finish floor or ground.	N/A	https://www.access-board.gov/ada/#ada-404_2_7	2012 TAS Section: 404.2.7 2010 ADAS Section: 404.2.7 2015 ABAAS Section: 404.2.7

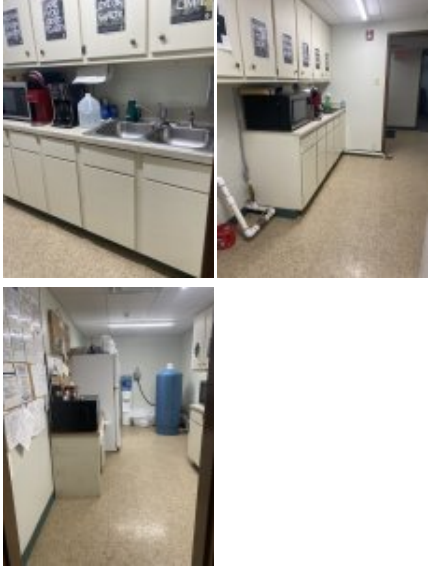
37	Structures on Property (STAFF): HQ Building (Interior) - Kitchenette	Knee and toe space has not been provided at the sink. Kitchen sinks must be provided with a clear floor space positioned for a forward approach including knee and toe clearance.	In kitchens, kitchenettes, and breakrooms without a cooktop or conventional range, a parallel approach is permitted at kitchen sinks. Best practice to make sinks accessible via front approach in any areas where food prep is done.	https://www.access-board.gov/ada/#ada-606_2 https://www.access-board.gov/ada/#ada-804_4	2012 TAS Section: 606.2, 804.4 2010 ADAS Section: 606.2, 804.4 2015 ABAAS Section: 606.2, 804.4

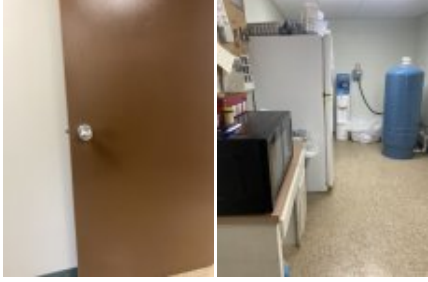
38	Structures on Property (STAFF): HQ Building (Interior) - Kitchenette	The door/gate operating hardware is not accessible. Hand-activated door/gate opening hardware, handles, pulls, latches, locks, and other operating devices on accessible doors shall have a shape that is easy to grasp with one hand and does not require tight grasping, pinching or twisting of the wrist to operate. Hardware shall be 34 inches minimum and 48 inches maximum above the finish floor or ground.	door knob on door to kitchenette area	https://www.access-board.gov/ada/#ada-404_2_7	2012 TAS Section: 404.2.7 2010 ADAS Section: 404.2.7 2015 ABAAS Section: 404.2.7

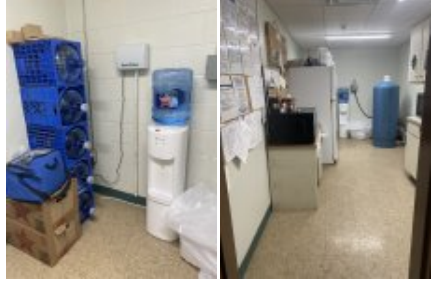
Finding Number	Area Description	Finding	As Built	Recommendation	Citation	Photos	Figure
39	Structures on Property (STAFF): HQ Building (Interior) - Kitchenette	The clear floor space required at accessible drinking fountains is not positioned for a forward approach. Units shall have a clear floor or ground space positioned for a forward approach and centered on the unit.	There is no approach to water cooler in kitchenette.	https://www.access-board.gov/ada/#ada-602_2	2012 TAS Section: 602.2 2010 ADAS Section: 602.2 2015 ABAAS Section: 602.2

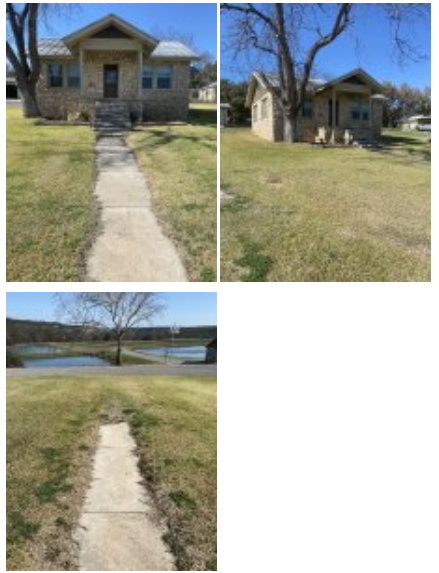
40	Structures on Property (STAFF): Office Building #1 (Exterior)	The building entrance is not located on an accessible route. When a building, or portion of a building, is required to be accessible, an accessible route of travel shall be provided to all portions of the building, to accessible building entrances and between the building and the public way. At least one accessible route within the boundary of the site must be provided from public transportation stops, accessible parking and accessible passenger loading zones and public streets or sidewalks to the accessible building entrance they serve. The accessible route shall, to the maximum extent feasible, coincide with the route for the general public. At least one accessible route shall connect accessible buildings, facilities, elements and spaces that are on the same site. At least one accessible route shall connect accessible building or facility entrances with all accessible spaces and elements.	Office building #1 Due to terrain type, lack of accessible pathway, stairs, and door hardware or thresholds there is no way to gain access to building. This building is not accessible	https://www.access-board.gov/ada/#ada-206_2_1	2012 TAS Section: 206.2.1 2010 ADAS Section: 206.2.1 2015 ABAAS Section: F206.2.1
