**IF- Brookeland TX, John D Parker ADA Evaluation
County Rd 218**

Accessibility Evaluation

Inspection Date: 04/11/2023

Report Date: 02/01/2024

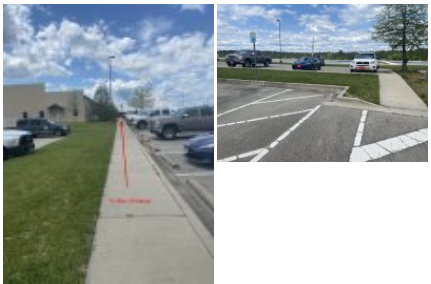
3	Exterior of Property (Public): Visitors Center Parking Lot (2 Spaces) 1 Van 1 Car - Pathway to Building (Car Accessible Stall to Main Entrance)	The accessible parking space is not located on the shortest accessible route to the building. Accessible parking spaces serving a particular building or facility entrance shall be located on the shortest accessible route of travel from the parking space to an accessible entrance.	Car accessible stall is not located on shortest route to main building entrance. Exterior pathway meets compliance in surfacing type, width, and sloping.	Recommend adding additional van accessible space near entrance of building. https://www.access-board.gov/ada/#ada-208_3_1	2012 TAS Section: 208.3.1 2010 ADAS Section: 208.3.1 2015 ABAAS Section: F208.3.1

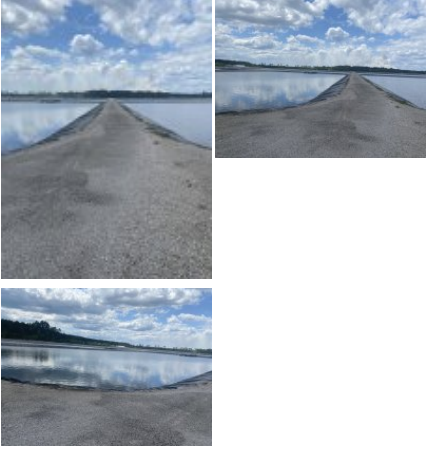
Finding Number	Area Description	Finding	As Built	Recommendation	Citation	Photos	Figure
4	Exterior of Property (Public): Pathway to Holding Ponds - TOUR	The accessible route contains loose gravel and/or surfaces that do not provide for a stable, firm slip resistant surface.	Parts of exterior pathways around holding ponds are in various states of deterioration.	https://www.access-board.gov/ada/#ada-302_1	2012 TAS Section: 302.1 2010 ADAS Section: 302.1 2015 ABAAS Section: 302.1

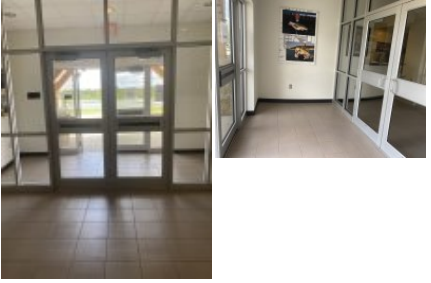
Finding Number	Area Description	Finding	As Built	Recommendation	Citation	Photos	Figure
5	Structures on Property (Public) - Tour/Public Componets : Visitors Center/Public Restrooms (Interior) - Entrance/Exit Doors	The door exceeds the maximum allowable opening force. Interior doors shall have a maximum opening force of 5 pounds. These forces do not apply to the force required to retract latch bolts or disengage other devices that hold the door or gate in a closed position.	Interior vestibule doors exceed 5lbs threshold for operation.	https://www.access-board.gov/ada/#ada-404_2_9	2012 TAS Section: 404.2.9 2010 ADAS Section: 404.2.9 2015 ABAAS Section: 404.2.9

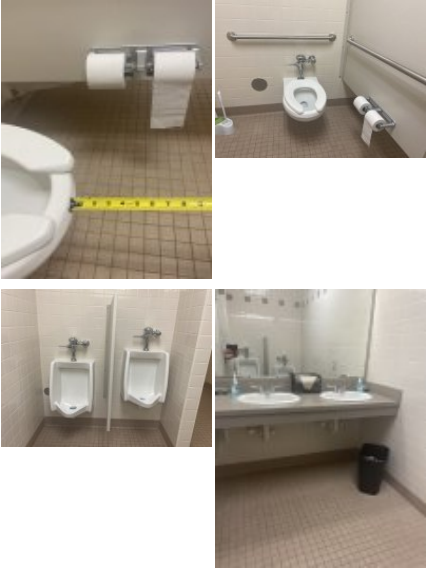
6	Structures on Property (Public) - Tour/Public Componets : Visitors Center/Public Restrooms (Interior) - Restroom (Men's)	The toilet paper is not installed within the compliant range. Toilet paper dispensers shall be 7 inches minimum and 9 inches maximum in front of the water closet measured to the centerline of the dispenser. The outlet of the dispenser shall be 15 inches minimum and 48 inches maximum above the finish floor and shall not be located behind grab bars. Dispensers shall not be of a type that controls delivery or that does not allow continuous paper flow. There shall be a clearance of 1 1/2 inches minimum below the grab bar.	Majority of restroom componets meet compliance. Finding only applies to inside dispenser, outside dispenser within compliant range.	https://www.access-board.gov/ada/#ada-604_7	2012 TAS Section: 604.7 2010 ADAS Section: 604.7 2015 ABAAS Section: 604.7

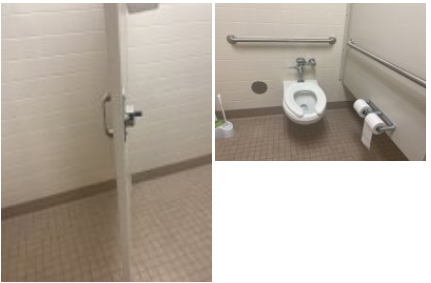
7	Structures on Property (Public) - Tour/Public Componets : Visitors Center/Public Restrooms (Interior) - Restroom (Men's)	The water closet compartment is missing a loop handle on the one side of the door. Water closet compartments must be equipped with a door that has a loop or U-shaped handle on both sides of the door near the latch. The latch must be flip-over style, sliding or other hardware not requiring the user to grasp or twist.	N/A	https://www.access-board.gov/ada/#ada-604_8_1_2	2012 TAS Section: 604.8.1.2 2010 ADAS Section: 604.8.1.2 2015 ABAAS Section: 604.8.1.2

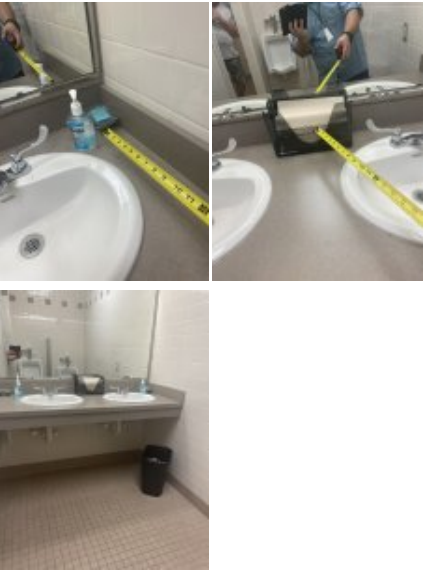
9	Structures on Property (Public) - Tour/Public Componets : Visitors Center/Public Restrooms (Interior) - Restroom (Men's)	The element is not accessible because it requires tight grasping, pinching or twisting of the wrist. Controls and operating mechanisms shall be operable with one hand and shall not require tight grasping, pinching or twisting of the wrist. The force required to activate controls shall be no greater than 5 pounds of force.	Soap and hand towel options are not accessible.		https://www.access-board.gov/ada/#ada-309_4	2012 TAS Section: 309.4 2010 ADAS Section: 309.4 2015 ABAAS Section: 309.4

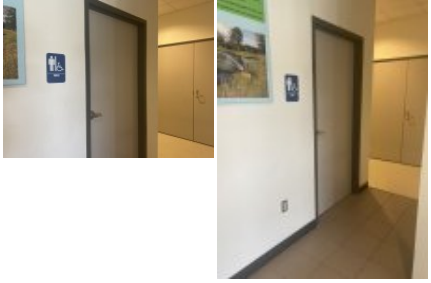
Finding Number	Area Description	Finding	As Built	Recommendation	Citation	Photos	Figure
10	Structures on Property (Public) - Tour/Public Componets : Visitors Center/Public Restrooms (Interior) - Restroom (Men's)	The door exceeds the maximum allowable opening force. Interior doors shall have a maximum opening force of 5 pounds. These forces do not apply to the force required to retract latch bolts or disengage other devices that hold the door or gate in a closed position.	restroom door exceed 5lbs pressure required to operate	https://www.access-board.gov/ada/#ada-404_2_9	2012 TAS Section: 404.2.9 2010 ADAS Section: 404.2.9 2015 ABAAS Section: 404.2.9

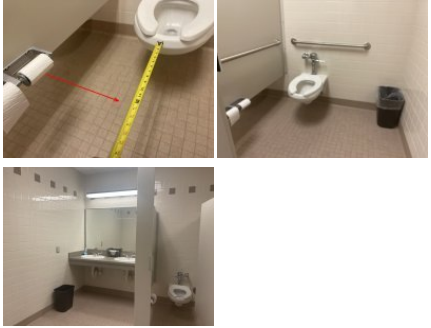
11	Structures on Property (Public) - Tour/Public Componets : Visitors Center/Public Restrooms (Interior) - Restroom (Women's)	The toilet paper is not installed within the compliant range. Toilet paper dispensers shall be 7 inches minimum and 9 inches maximum in front of the water closet measured to the centerline of the dispenser. The outlet of the dispenser shall be 15 inches minimum and 48 inches maximum above the finish floor and shall not be located behind grab bars. Dispensers shall not be of a type that controls delivery or that does not allow continuous paper flow. There shall be a clearance of 1 1/2 inches minimum below the grab bar.	Majority of restroom componets meet compliance. TP dispenser is mounted out compliant range, over 12"	https://www.access-board.gov/ada/#ada-604_7	2012 TAS Section: 604.7 2010 ADAS Section: 604.7 2015 ABAAS Section: 604.7

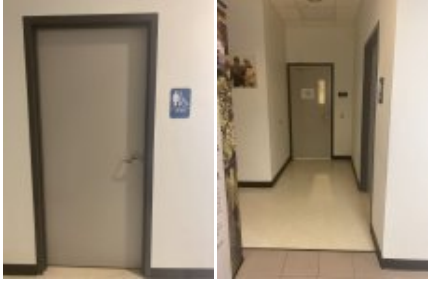
Finding Number	Area Description	Finding	As Built	Recommendation	Citation	Photos	Figure
16	Structures on Property (Public) - Tour/Public Componets : Visitors Center/Public Restrooms (Interior) - Restroom (Women's)	The door exceeds the maximum allowable opening force. Interior doors shall have a maximum opening force of 5 pounds. These forces do not apply to the force required to retract latch bolts or disengage other devices that hold the door or gate in a closed position.	restroom door exceed 5lbs pressure required to operate	https://www.access-board.gov/ada/#ada-404_2_9	2012 TAS Section: 404.2.9 2010 ADAS Section: 404.2.9 2015 ABAAS Section: 404.2.9

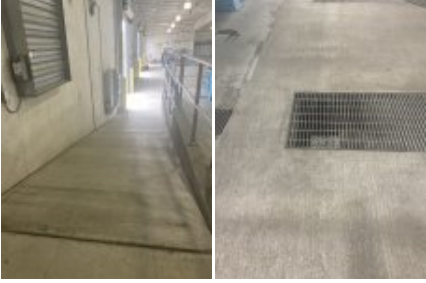
Finding Number	Area Description	Finding	As Built	Recommendation	Citation	Photos	Figure
18	Structures on Property (Public) - Tour/Public Componets : Raceway/Production Area (Interior) - TOUR - Pathways Around Raceway/Production Areas	The path of contains multiple issues and is not accessible. The path of travel exceeds the maximum allowable cross and running slope requirements. It also contains changes in level and/or gaps that exceed the allowable maximum requirements. The path of travel does not meet the minimum width requirements for clearances, turning spaces, and/or passing spaces. The floor or ground surface is not firm, stable, and slip resistant.	Ramps and floor grating in raceway/production area are not compliant but necessary for building infrastructure.	Route around raceways does not need to be accessible but tour program does need to meet Title II requirments for accessible programs/services. Finding route which bypasses ramps or covering grating on floor are examples of program modification.	2012 TAS Section: 403.1 2010 ADAS Section: 403.1 2015 ABAAS Section: 403.1
