Possum Kingdom IF- ADA Evaluation

IF- Graford TX, Possum Kingdom ADA Evaluation

Accessibility Evaluation

Inspection Date: 03/22/2023

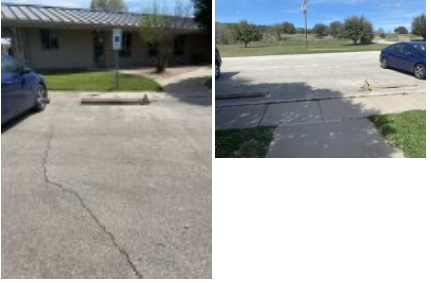
Finding Number	Area Description	Finding	As Built	Recommendation	Citation	Photos	Figure
1	Exterior of Property (Public): HQ Parking Lot (2 Spaces) 1 Van 1 Car - Van Accessible Stall	The accessible parking space is missing the required ISA marking. A paved accessible parking space must include the International Symbol of Accessibility painted conspicuously on the surface in a color that contrasts the pavement.	The van accessible designation markings are faded or missing.	This applies to TAS accessibility requirements.	2020 TDLR Section: 68.104 (a)(1)

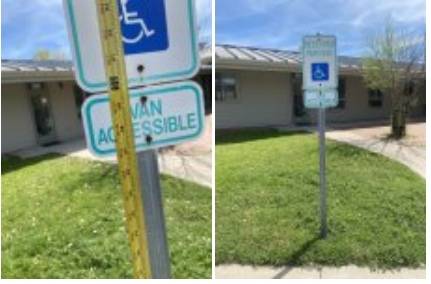
2	Exterior of Property (Public): HQ Parking Lot (2 Spaces) 1 Van 1 Car - Van Accessible Stall	The parking sign is mounted too low. Parking space identification signs shall include the International Symbol of Accessibility. Signs identifying van parking spaces shall contain the designation "van accessible." Signs shall be 60 inches minimum above the finish floor or ground surface measured to the bottom of the sign.	Measured at less than 60"	https://www.access-board.gov/ada/#ada-502_6	2012 TAS Section: 502.6 2010 ADAS Section: 502.6 2015 ABAAS Section: 502.6

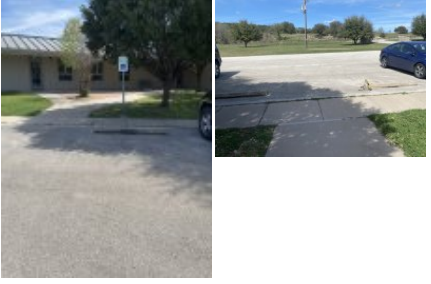
3	Exterior of Property (Public): HQ Parking Lot (2 Spaces) 1 Van 1 Car - Car Accessible Stall	The accessible parking space is missing the required ISA marking. A paved accessible parking space must include the International Symbol of Accessibility painted conspicuously on the surface in a color that contrasts the pavement.	The van accessible designation markings are faded or missing.	This applies to TAS accessibility requirements.	2020 TDLR Section: 68.104 (a)(1)

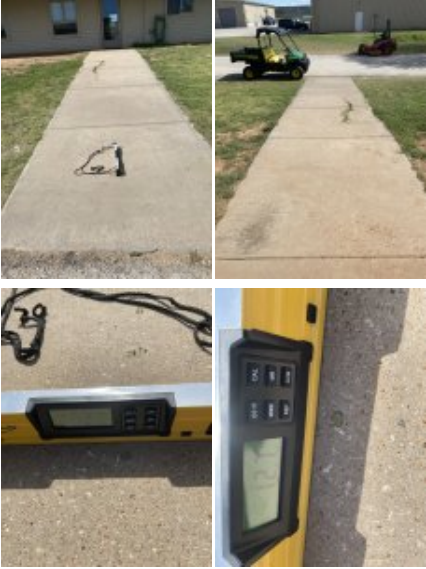
Finding Number	Area Description	Finding	As Built	Recommendation	Citation	Photos	Figure
6	Exterior of Property (Public): HQ Building (Exterior) - TOUR - HQ Rear Entrance (Exterior Ramp)	The ramps exceeds the maximum running slope (direction of travel) allowable of 8.33%. Ramps should have the least possible slope but in no case more than 8.3% (1:12).	Ramp exceeds 8.33% slope tolerance in several locations.	Review ramp componets to make accessible. https://www.access-board.gov/aba/#aba-405	2012 TAS Section: 405.2 2010 ADAS Section: 405.2 2015 ABAAS Section: 405.2

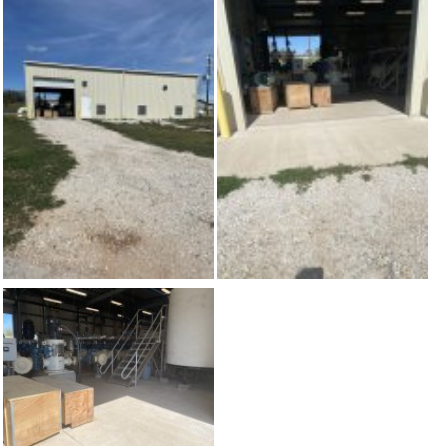
Finding Number	Area Description	Finding	As Built	Recommendation	Citation	Photos	Figure
10	Exterior of Property (Public): Water Treatment Building (Exterior) - TOUR - Pathway to Water Treatment Building	The accessible route contains loose gravel and/or surface materials that do not provide for a stable, firm slip resistant surface. Floor and ground surfaces shall be stable, firm, and slip resistant.	Exterior pathway is not accessible due to surfacing type.	https://www.access-board.gov/ada/#ada-302_1	2012 TAS Section: 302.1 2010 ADAS Section: 302.1 2015 ABAAS Section: 302.1

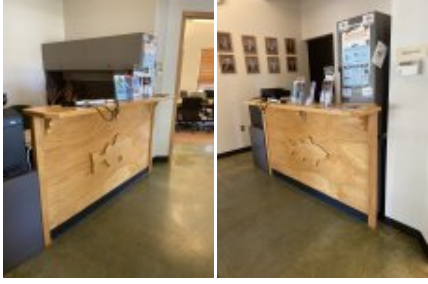
15	Structures on Property (Public) - Tour/Public Componets : HQ Building/Public Restrooms (Interior) - Service Counter	The counter is higher than 36 inches above the floor. A portion of the counter surface that is 30 inches long minimum and 36 inches high maximum shall be provided. Knee and toe space shall be provided under the counter. A clear floor or ground space shall be positioned for a forward approach to the counter.	Service counter height is not compliant for front or parallel approach. Service counter is not accessible. This site does not process or accept transaction from public, service counter not in use.	Remove service counter since not used or provide accessible option. Service desks approach requirements https://www.access-board.gov/ada/#ada-904_4 Parallel approach https://www.access-board.gov/ada/#ada-904_4_1 Forward approach https://www.access-board.gov/ada/#ada-904_4_2	2012 TAS Section: 904.4.2 2010 ADAS Section: 904.4.2 2015 ABAAS Section: 904.4.2

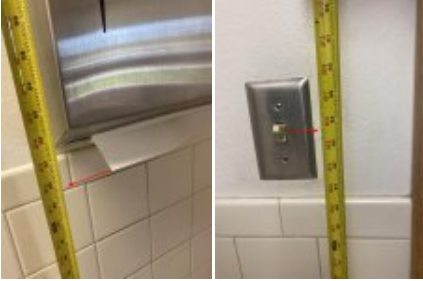
Finding Number	Area Description	Finding	As Built	Recommendation	Citation	Photos	Figure
18	Structures on Property (Public) - Tour/Public Componets : HQ Building/Public Restrooms (Interior) - Restroom (Men's) Public/Staff	The paper towel dispenser's operation mechanism is too high off the floor. Dispensers must have all operable parts a maximum of 48 inches above the floor.	Paper towel dispenser and light switch out of reach range, both over 48"	https://www.access-board.gov/ada/#ada-308_2_1	2012 TAS Section: 308.2.1 2010 ADAS Section: 308.2.1 2015 ABAAS Section: 308.2.1

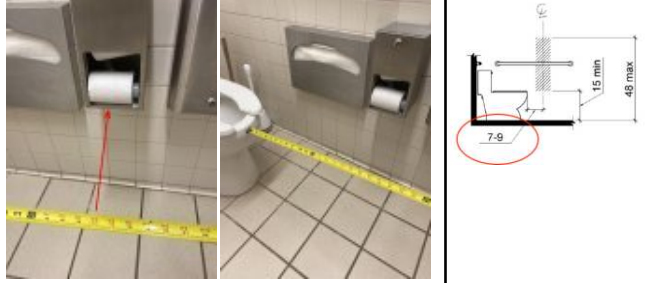
Finding Number	Area Description	Finding	As Built	Recommendation	Citation	Photos	Figure
22	Structures on Property (Public) - Tour/Public Componets : HQ Building/Public Restrooms (Interior) - Restroom (Women's) Public/Staff	The toilet paper is not installed within the compliant range in front of the toilet. Toilet paper dispensers shall be 7 inches minimum and 9 inches maximum in front of the water closet measured to the centerline of the dispenser. The outlet of the dispenser shall be 15 inches minimum and 48 inches maximum above the finish floor and shall not be located behind grab bars. Dispensers shall not be of a type that controls delivery or that does not allow continuous paper flow. There shall be a clearance of 1 1/2 inches minimum below the grab bar.	TP dispenser measures at 16"		https://www.access-board.gov/ada/#ada-604_7	2012 TAS Section: 604.7 2010 ADAS Section: 604.7 2015 ABAAS Section: 604.7

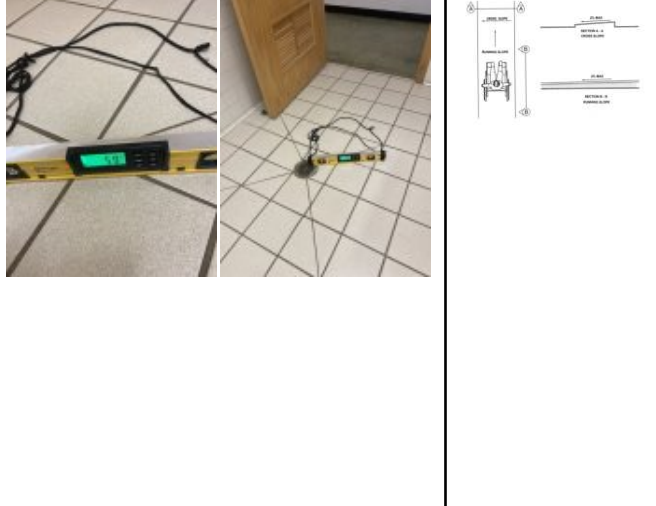
23	Structures on Property (Public) - Tour/Public Componets : HQ Building/Public Restrooms (Interior) - Restroom (Women's) Public/Staff	The floor drain is set too low in the floor which causes a slope over 2 percent. Changes in level are not permitted in clear floor or ground spaces or surfaces of a turning spaces and shall not slope greater than 1:48.	Significant drain slope, measured at 5.9%		https://www.access-board.gov/ada/#ada-303_3 https://www.access-board.gov/ada/#ada-304_2	2012 TAS Section: 303.3, 304.2, 304.2 Exception 2010 ADAS Section: 303.3, 304.2, 304.2 Exception 2015 ABAAS Section: 303.3, 304.2, 304.2 EXCEPTION, 305.2 EXCEPTION

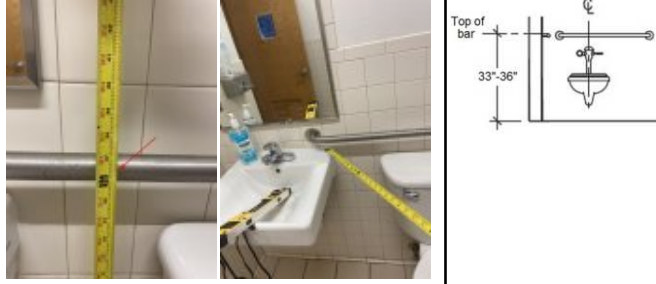
24	Structures on Property (Public) - Tour/Public Componets : HQ Building/Public Restrooms (Interior) - Restroom (Women's) Public/Staff	The rear grab bar is too high. Grab bars shall be installed in a horizontal position, 33 inches minimum and 36 inches maximum above the finish floor measured to the top of the gripping surface and the space between the grab bar and the top of the tank shall be 1-1/2 inches minimum.	Rear grab bar height over 36", due to needed clearance for the sink.		https://www.access-board.gov/ada/#ada-609_4	2012 TAS Section: 609.4 2010 ADAS Section: 609.4 2015 ABAAS Section: 609.4

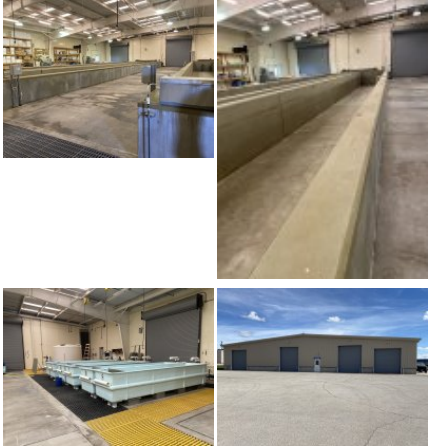
Finding Number	Area Description	Finding	As Built	Recommendation	Citation	Photos	Figure
25	Structures on Property (Public) - Tour/Public Components : Raceway/Production Area (Interior) - TOUR	State and local governments have an obligation to make their programs and services accessible to persons with disabilities. This may or may not require the alteration, addition or construction of existing facilities which predate The Americans with Disabilities Act (ADA) of 1990. Under the Code of Federal Regulations Section 35.151(b)(2) State and Local Government Title II entities may provide programmatic access where alterations to existing facilities would result in undue financial and administrative burdens. For Example, A public entity has six courtrooms in two existing buildings and determines that only three of those courtrooms and the public use and common use areas serving those courtrooms in one building are needed to be made accessible in order to satisfy its program access obligations. The entity must comply with 2010 Standards unless compliance would result in undue financial and administrative burdens and must take other actions that would not result in an undue financial burden to ensure access to persons with disabilities. This may include the scheduling of the various types of cases, hearings etc. in accessible courtrooms and relocating them where necessary to accommodate persons with disabilities. Having a defined program and effective communication process in place to ensure the public and employees can request accommodations is necessary to ensure equal access to the county's court system. Program access is not part of this evaluation and this information is being provided as an advisory only.	Element can be accessed as majority pathways are accessible. This element is considered accessible.	Provide reasonable modifications to programs and services, to bypass areas of non compliance.	2010 ADAS Section: Advisory

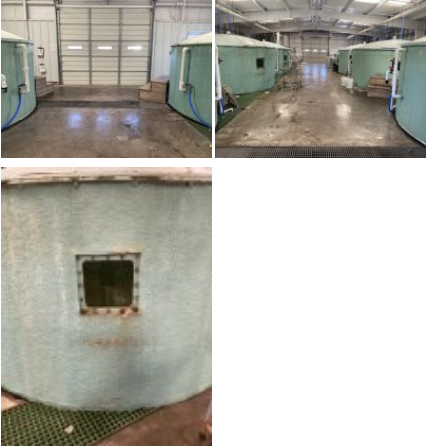
Finding Number	Area Description	Finding	As Built	Recommendation	Citation	Photos	Figure
27	Structures on Property (Public) - Tour/Public Componets : Holding Tanks (Interior) - TOUR	State and local governments have an obligation to make their programs and services accessible to persons with disabilities. This may or may not require the alteration, addition or construction of existing facilities which predate The Americans with Disabilities Act (ADA) of 1990. Under the Code of Federal Regulations Section 35.151(b)(2) State and Local Government Title II entities may provide programmatic access where alterations to existing facilities would result in undue financial and administrative burdens. For Example, A public entity has six courtrooms in two existing buildings and determines that only three of those courtrooms and the public use and common use areas serving those courtrooms in one building are needed to be made accessible in order to satisfy its program access obligations. The entity must comply with 2010 Standards unless compliance would result in undue financial and administrative burdens and must take other actions that would not result in an undue financial burden to ensure access to persons with disabilities. This may include the scheduling of the various types of cases, hearings etc. in accessible courtrooms and relocating them where necessary to accommodate persons with disabilities. Having a defined program and effective communication process in place to ensure the public and employees can request accommodations is necessary to ensure equal access to the county's court system. Program access is not part of this evaluation and this information is being provided as an advisory only.	Element can be accessed as majority pathways are accessible. Grating in floor is not compliant but can be covered to create accessible route. This element is considered accessible. Viewing window height needs verification	Provide a reasonable modification to allow tour participants an equitable experience during this part of tour. Finding route which bypasses grating or covering grating on floor are examples of program modification. Route around holding tanks does not need to be accessible but tour program does need to meet Title II requirments for accessible programs/services.	2010 ADAS Section: Advisory

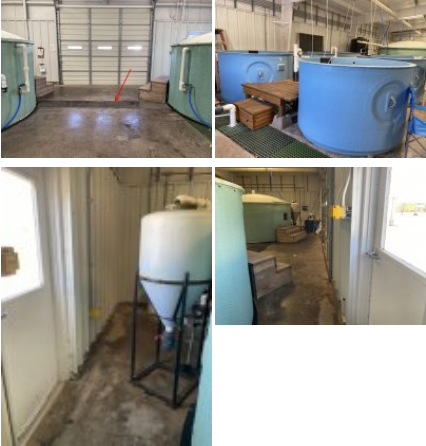
Finding Number	Area Description	Finding	As Built	Recommendation	Citation	Photos	Figure
28	Structures on Property (Public) - Tour/Public Componets : Holding Tanks (Interior) - TOUR	Gratings are spaced greater than 1/2 inch in the direction of travel. Openings in floor or ground surfaces shall not allow passage of a sphere more than 1/2 inch diameter. Elongated openings shall be placed so that the long dimension is perpendicular to the dominant direction of travel.	Floor grating and tight areas around holding tanks are not compliant but necessary for building infrastructure.	Route around holding tanks does not need to be accessible but tour program does need to meet Title II requirments for accessible programs/services. Finding route which bypasses grating or covering grating on floor are examples of program modification.	2012 TAS Section: 302.3 2010 ADAS Section: 302.3 2015 ABAAS Section: 302.3

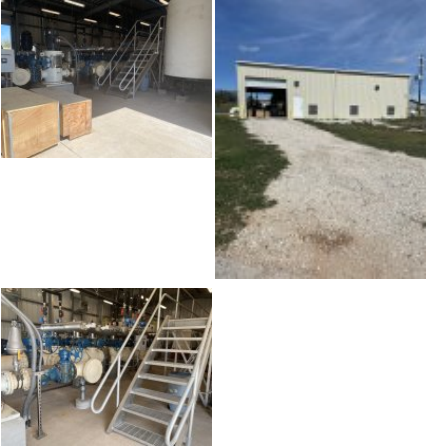
Finding Number	Area Description	Finding	As Built	Recommendation	Citation	Photos	Figure
29	Structures on Property (Public) - Tour/Public Componets : Water Treatment Building (Interior) - TOUR	State and local governments have an obligation to make their programs and services accessible to persons with disabilities. This may or may not require the alteration, addition or construction of existing facilities which predate The Americans with Disabilities Act (ADA) of 1990. Under the Code of Federal Regulations Section 35.151(b)(2) State and Local Government Title II entities may provide programmatic access where alterations to existing facilities would result in undue financial and administrative burdens. For Example, A public entity has six courtrooms in two existing buildings and determines that only three of those courtrooms and the public use and common use areas serving those courtrooms in one building are needed to be made accessible in order to satisfy its program access obligations. The entity must comply with 2010 Standards unless compliance would result in undue financial and administrative burdens and must take other actions that would not result in an undue financial burden to ensure access to persons with disabilities. This may include the scheduling of the various types of cases, hearings etc. in accessible courtrooms and relocating them where necessary to accommodate persons with disabilities. Having a defined program and effective communication process in place to ensure the public and employees can request accommodations is necessary to ensure equal access to the county's court system. Program access is not part of this evaluation and this information is being provided as an advisory only.	No way to access this element at this time. This building is optional part of tour and in not accessible.	Provide a reasonable modification to allow tour participants an equitable experience during this part of tour.	2010 ADAS Section: Advisory

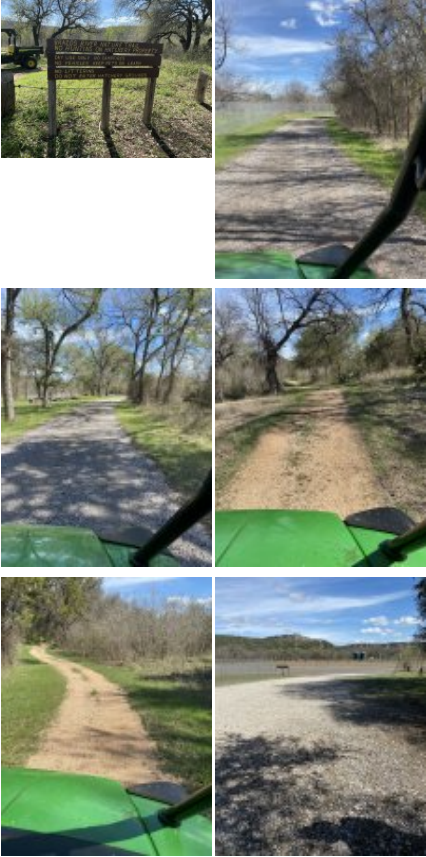
Finding Number	Area Description	Finding	As Built	Recommendation	Citation	Photos	Figure
32	Outdoor Features (Public) : Brazos River Nature Trail	The trailhead sign is missing the trail information. Trail information signs at trailheads shall include the following: 1. Length of the trail or trail segment; 2. Surface type; 3. Typical and minimum tread width; 4. Typical and maximum running slope; and 5. Typical and maximum cross slope.	Trail head sign is not compliant. Trail is overseen and maintained by TPWD personnel. Trail features some accessible componets including width and trail surface for limited distance.	N/A - Refer to Finding	2015 ABAAS Section: 1017.10

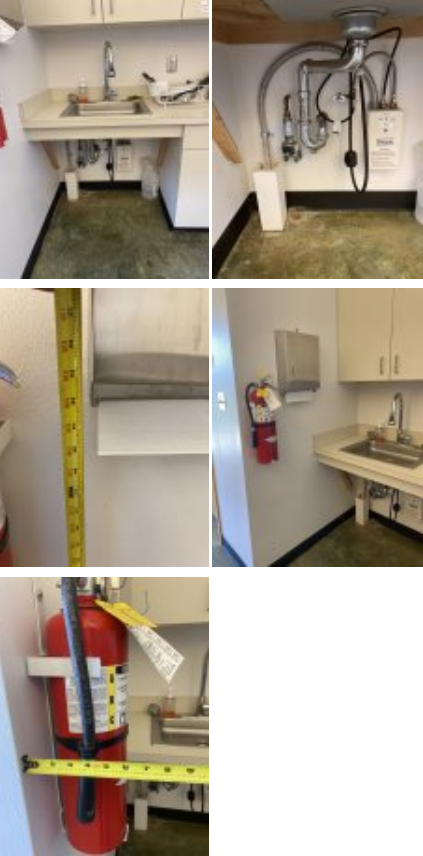
Finding Number	Area Description	Finding	As Built	Recommendation	Citation	Photos	Figure
33	Structures on Property (STAFF): HQ Building (Interior) - Kitchenette	The sink drain pipes are exposed. Hot water and drain pipes exposed under sinks shall be insulated or otherwise configured so as to protect against contact. There shall be no sharp or abrasive surfaces under sinks.	Sink pipes are not insulated. Majority of sink elements meet compliance, including forward approach.	https://www.access-board.gov/ada/#ada-606_5	2012 TAS Section: 606.5 2010 ADAS Section: 606.5 2015 ABAAS Section: 606.5

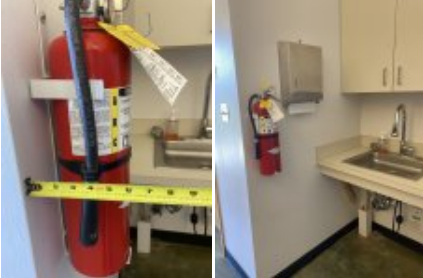
Finding Number	Area Description	Finding	As Built	Recommendation	Citation	Photos	Figure
34	Structures on Property (STAFF): HQ Building (Interior) - Kitchenette	The clear floor space for the element is obstructed. The clear floor or ground space shall be 30 inches minimum by 48 inches minimum and free of obstructions.	There are no official ADA fire extinguisher height or fire alarm ADA requirements. However, there are rules that govern the placement of all protruding objects, no matter their function, to accommodate blind and other visually impaired people. Fire extinguisher mounted in clear floor space to sink.	https://www.access-board.gov/ada/#ada-305_3	2012 TAS Section: 305.3 2010 ADAS Section: 305.3 2015 ABAAS Section: 305.3

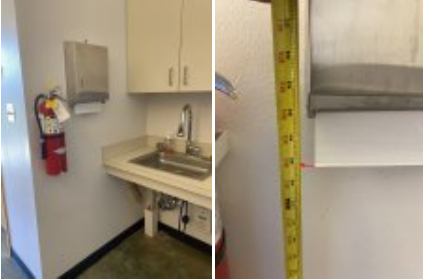
35	Structures on Property (STAFF): HQ Building (Interior) - Kitchenette	The element is not accessible because the operable parts are not within the required reach range. Operable parts on accessible elements, accessible routes, and in accessible rooms and spaces shall comply with requirements for operable parts. The requirements include complying with a clear floor space, reach range, and operation.	Paper towels over 48"	https://www.access-board.gov/ada/#ada-205_1	2012 TAS Section: 205.1 2010 ADAS Section: 205.1 2015 ABAAS Section: F205.1

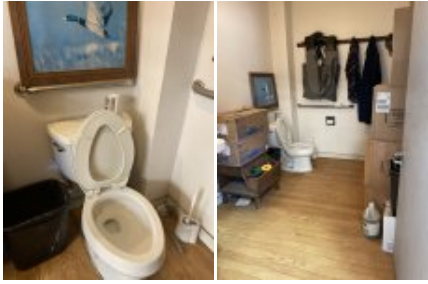
37	Structures on Property (STAFF): Garage/Work Shop (Interior) - Restroom (Unisex)	The grab bar is obstructed. Adjacent elements shall be positioned to provide unobstructed use of grab bars. The space between the grab bar and projecting objects below and at the ends shall be 1-1/2 inches minimum. The space between the grab bar and projecting objects above shall be 12 inches minimum.	Rear grab bar obstruction above	https://www.access-board.gov/ada/#ada-609_3	2012 TAS Section: 609.3 2010 ADAS Section: 609.3 2015 ABAAS Section: 609.3

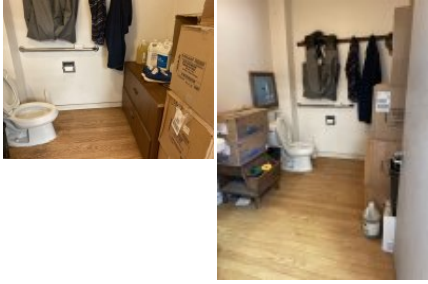
38	Structures on Property (STAFF): Garage/Work Shop (Interior) - Restroom (Unisex)	The toilet paper is not installed within the compliant range. Toilet paper dispensers shall be 7 inches minimum and 9 inches maximum in front of the water closet measured to the centerline of the dispenser. The outlet of the dispenser shall be 15 inches minimum and 48 inches maximum above the finish floor and shall not be located behind grab bars. Dispensers shall not be of a type that controls delivery or that does not allow continuous paper flow. There shall be a clearance of 1 1/2 inches minimum below the grab bar.	Mounted to close to toilet.	https://www.access-board.gov/ada/#ada-604_7	2012 TAS Section: 604.7 2010 ADAS Section: 604.7 2015 ABAAS Section: 604.7

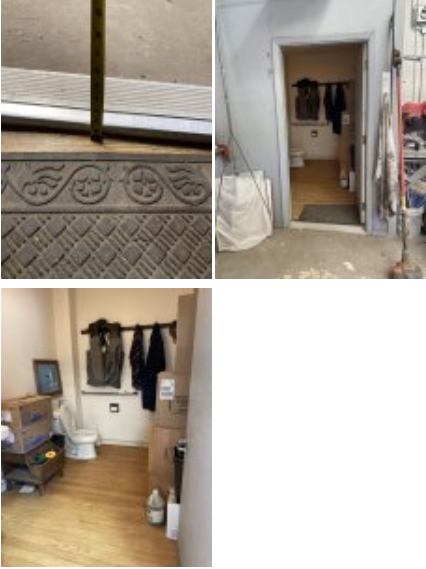
Finding Number	Area Description	Finding	As Built	Recommendation	Citation	Photos	Figure
41	Structures on Property (STAFF): Garage/Work Shop (Interior) - Restroom (Unisex)	The threshold is greater than 1/2 inch high. The threshold at a doorway shall be no higher than 1/2 inch. Changes in level between 1/4 inch and 1/2 inch must be beveled at 1:2 or less. 1/4 inch is the maximum vertical rise.	Entrance into restroom has threshold over 1/2" Floor mat looks to be in good working condition, considered compliant.	https://www.access-board.gov/ada/#ada-404_2_5	2012 TAS Section: 404.2.5 2010 ADAS Section: 404.2.5 2015 ABAAS Section: 404.2.5
