**IF-Athens TX, TFFC ADA Evaluation**

**Accessibility Evaluation**

**Inspection Date: 11/15/2022**

**Report Date: 02/04/2024**

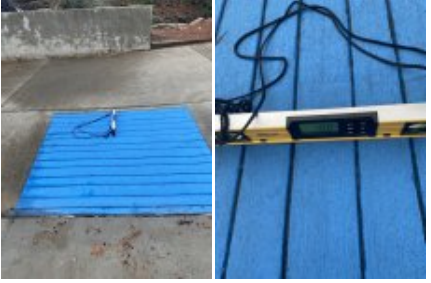
Finding Number	Area Description	Finding	As Built	Recommendation	Citation	Photos	Figure
1	Exterior of Property (Public) - Parking Lots/Walkways : Path of Travel Parking Lot to Visitors Center Admission - Curb Ramp (Main Route)	The curb ramp exceeds the maximum running slope (parallel to the direction of travel) allowable of 8.33%. Curb ramps should have the least possible slope but in no case more than 8.33% (1:12).	Curb ramp running Slope is 10% Located on accessible pathway to admission from parking lot.	<a href="https://www.access-board.gov/ada/#ada-406_1">https://www.access-board.gov/ada/#ada-406_1</a>	2012 TAS Section: 406.1 2010 ADAS Section: 406.1 2015 ABAAS Section: 406.1

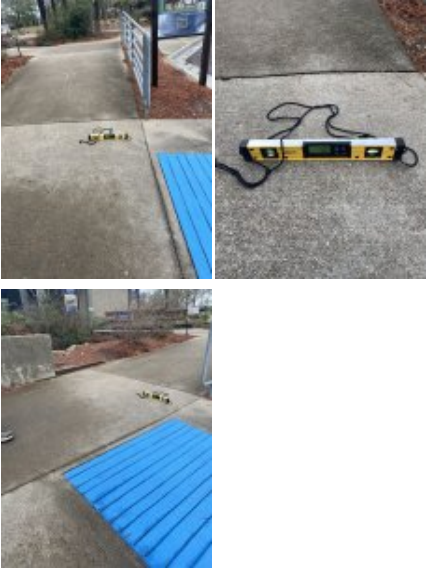
2	Exterior of Property (Public) - Parking Lots/Walkways : Path of Travel Parking Lot to Visitors Center Admission - Entrance Ramps (Non Curb Ramp)	The landing at the bottom of the ramp has a slope greater than 2%. Bottom landings shall have a dimension in the direction of ramp run of not less than 60 inches and have a slope of 2% maximum in any direction.	Non curb ramp landing (bottom) slope is 3% Non curb ramp landing dimensions are good but because it overlaps with curb ramp this entire area is treated as landing for both curb ramp and non curb ramp, cant be over 2% in any direction.	<a href="https://www.access-board.gov/ada/#ada-405_7_1">https://www.access-board.gov/ada/#ada-405_7_1</a>	2012 TAS Section: 405.7.1, 405.7.1 Exception 2010 ADAS Section: 405.7.1, 405.7.1 Exception 2015 ABAAS Section: 405.7.1, 405.7.1 EXCEPTION

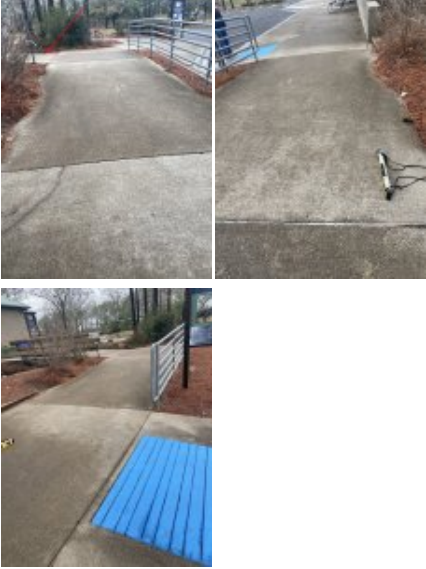
Finding Number	Area Description	Finding	As Built	Recommendation	Citation	Photos	Figure
3	Exterior of Property (Public) - Parking Lots/Walkways : Path of Travel Parking Lot to Visitors Center Admission - Entrance Ramps (Non Curb Ramp)	The ramp does not have compliant handrails. Handrails are required on both sides of all surfaces that are sloped greater than 5 percent (1:20). Handrails must be between 34 inches and 38 inches above the ramp surface, must extend 12 inches beyond the top and bottom of the ramp and be parallel to the floor or ground surface. The diameter of the handrails must be between 1 1/4 inches and 2 inches in cross-sectional nominal dimension for circular handrails. Handrail gripping surfaces with a non-circular cross section shall have a perimeter dimension of 4 inches minimum and 6 1/4 inches maximum, and a cross-section dimension of 2 1/4 inches maximum. The space between handrails and walls must be 1 1/2 inches minimum.	Handrail needs to be added to opposing side.	<a href="https://www.access-board.gov/ada/#ada-505_1">https://www.access-board.gov/ada/#ada-505_1</a>	2012 TAS Section: 505.1  2010 ADAS Section: 505.1  2015 ABAAS Section: 505.1

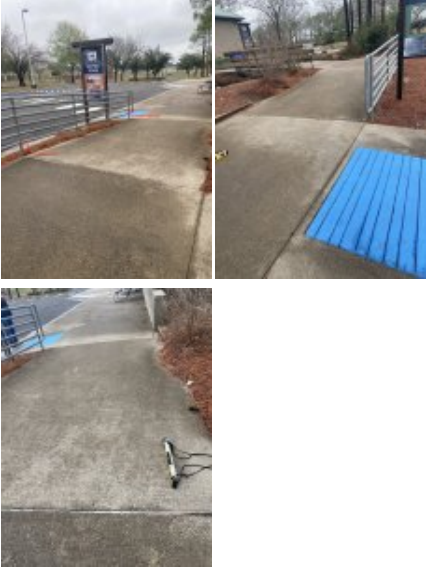
Finding Number	Area Description	Finding	As Built	Recommendation	Citation	Photos	Figure
5	Exterior of Property (Public) - Parking Lots/Walkways : Path of Travel Parking Lot to Visitors Center Admission - Entrance Ramps (Non Curb Ramp)	The handrail extension is not a minimum 12 inches. Handrails must be between 34 inches and 38 inches above the ramp surface and must extend beyond the top and bottom of the ramp run 12 inches horizontally. The 12 inches horizontal extensions must not include the radius at the top end of round handrails. Extensions shall return to a wall, guard, or the landing surface, or shall be continuous to the handrail of an adjacent ramp run.	Handrail extension looks less than 12" Both sets of handrails would need handrails with extensions at 12" minimum.	<a href="https://www.access-board.gov/ada/#ada-505_10_1">https://www.access-board.gov/ada/#ada-505_10_1</a>	2012 TAS Section: 505.10.1  2010 ADAS Section: 505.10.1  2015 ABAAS Section: 505.10.1

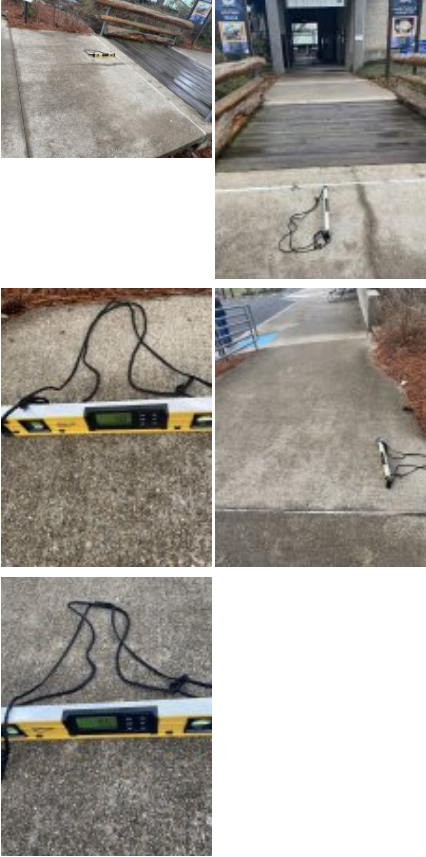
Finding Number	Area Description	Finding	As Built	Recommendation	Citation	Photos	Figure
6	Exterior of Property (Public) - Parking Lots/Walkways : Path of Travel Parking Lot to Visitors Center Admission - Exterior Walkway	The accessible route between the building entrance and the accessible parking has running slopes greater than 5% and has not been constructed as a ramp (i.e. handrails, edge protection, etc.). When the slope in the direction of travel of any walk exceeds 1 unit vertical in 20 units horizontal (5-percent slope), it must be constructed as a ramp. Surface cross slopes must not exceed one unit vertical in 48 units horizontal (2-percent slope).	Multiple locations exceed running slope of 5% Running slope as high as 12.4%, other locations at 9% See additional photos for location of slope non compliance in accessible pathway or sidewalk.	<a href="https://www.access-board.gov/ada/#ada-403_3">https://www.access-board.gov/ada/#ada-403_3</a>	2012 TAS Section: 403.3  2010 ADAS Section: 403.3  2015 ABAAS Section: 403.3

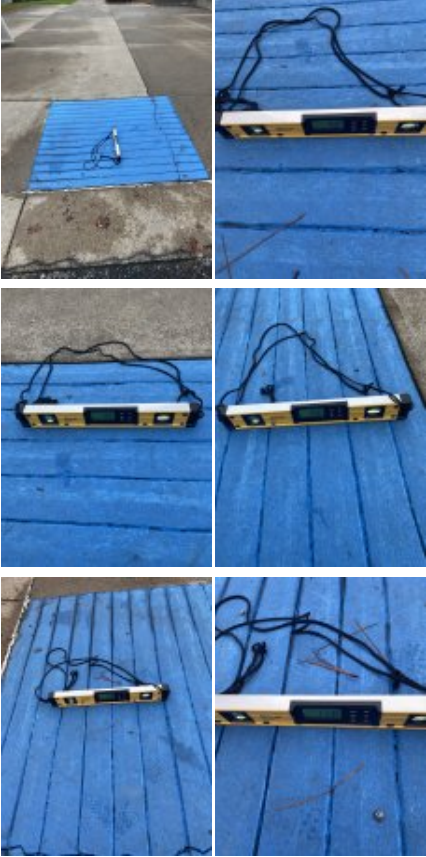
Finding Number	Area Description	Finding	As Built	Recommendation	Citation	Photos	Figure
8	Exterior of Property (Public) - Parking Lots/Walkways : Path of Travel Parking Lot to Visitors Center Gift Shop - Curb Ramp (Main Route)	The curb ramp on the accessible route has cross slopes greater than 2 percent and running slopes greater than 8.33 percent. Surface cross slopes shall not exceed one unit vertical in 48 units horizontal (2-percent slope). Surface running slopes shall not exceed one unit vertical in 12 units horizontal (8.33-percent slope).	Curb ramp running slope is 11.3% and Cross Slope 4.2%	<a href="https://www.access-board.gov/ada/#ada-405_2">https://www.access-board.gov/ada/#ada-405_2</a> <a href="https://www.access-board.gov/ada/#ada-405_3">https://www.access-board.gov/ada/#ada-405_3</a> <a href="https://www.access-board.gov/ada/#ada-406_1">https://www.access-board.gov/ada/#ada-406_1</a>	2012 TAS Section: 405.3, 405.2, 406.1  2010 ADAS Section: 405.3, 405.2, 406.1  2015 ABAAS Section: 405.2, 405.3, 406.1

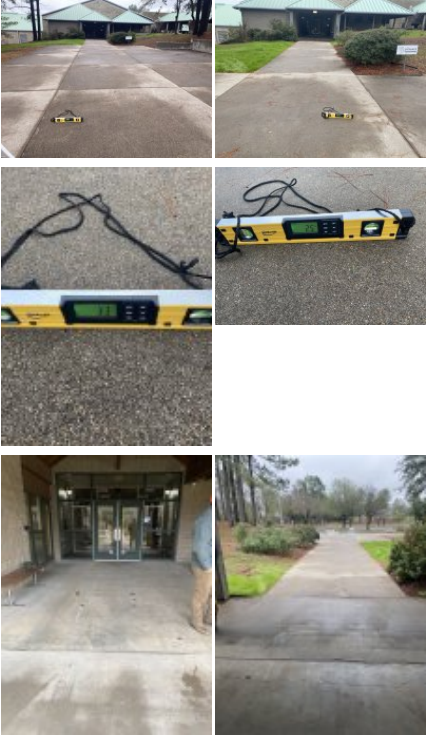
Finding Number	Area Description	Finding	As Built	Recommendation	Citation	Photos	Figure
9	Exterior of Property (Public) - Parking Lots/Walkways : Path of Travel Parking Lot to Visitors Center Gift Shop - Exterior Walkway	The accessible path of travel between building entrances has cross slopes greater than 2%. Surface cross slopes shall not exceed one unit vertical in 48 units horizontal (2-percent slope). When the slope in the direction of travel of any walk exceeds 1 unit vertical in 20 units horizontal (5-percent slope), it must be constructed as a ramp.	Exterior route cross slope is 3.3% and 2.5% both locations on pathway near parking lot. There is enough accessible space to use alternate routes when traveling to gift shop.	<a href="https://www.access-board.gov/ada/#ada-403_3">https://www.access-board.gov/ada/#ada-403_3</a>	2012 TAS Section: 403.3  2010 ADAS Section: 403.3  2015 ABAAS Section: 403.3

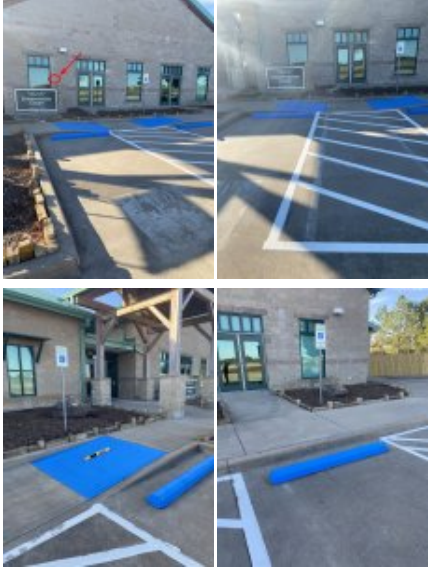
Finding Number	Area Description	Finding	As Built	Recommendation	Citation	Photos	Figure
10	Exterior of Property (Public) - Parking Lots/Walkways : Parking Lot Conservation Center (1 Van, 5 Car) - Accessible Stall (Unlabeled)	The required parking signage is missing. Parking space identification signs shall include the International Symbol of Accessibility (ISA). Signs identifying van parking spaces shall contain the designation "van accessible." All signs shall be 60 inches minimum above the finish floor or ground surface measured to the bottom of the sign.	There are 6 accessible spaces total, 1 Labeled van with 2 labeled car. Signs for other stall are missing. The dimensions provided of unlabeled stall meet van designation requirements, additional van spot can be added. Each accessible parking spot needs its own identification sign. Sign can be off centered or placed on wall.	Designate this parking space as van accessible and provide sign. <a href="https://www.access-board.gov/ada/#ada-502_6">https://www.access-board.gov/ada/#ada-502_6</a>	2012 TAS Section: 502.6  2010 ADAS Section: 502.6  2015 ABAAS Section: 502.6

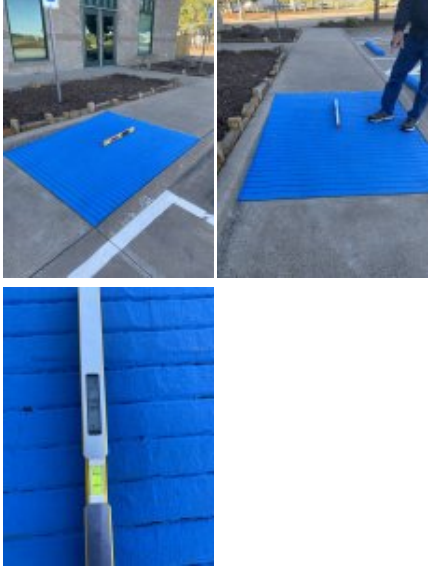
11	Exterior of Property (Public) - Parking Lots/Walkways : Path of Travel Parking Lot to CC Building Entrance - Path of Travel (From (R) Side of Parking Lot)	The curb ramp exceeds the maximum running slope (parallel to the direction of travel) allowable of 8.33%. Curb ramps should have the least possible slope but in no case more than 8.33% (1:12).	Curb ramp running slope is 9.6% This ramp does not connect to main entrance but does connect to side entrance.	<a href="https://www.access-board.gov/ada/#ada-406_1">https://www.access-board.gov/ada/#ada-406_1</a>	2012 TAS Section: 406.1  2010 ADAS Section: 406.1  2015 ABAAS Section: 406.1

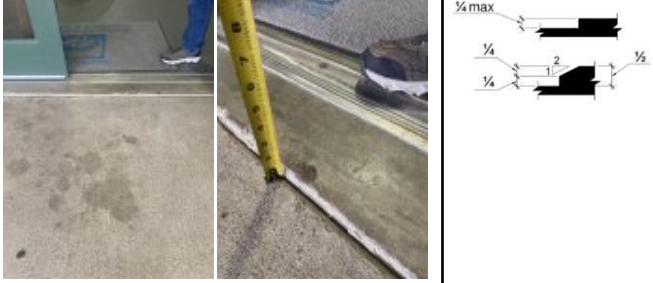
Finding Number	Area Description	Finding	As Built	Recommendation	Citation	Photos	Figure
14	Structures on Property (Public) - Visitors Center : Entrance into Visitors Center - Entrance Doors from Overlook Area to Visitors Center	The threshold has a vertical change greater than 1/4 inch. The threshold at a doorway shall be no higher than 1/2 inch. Changes in level between 1/4 inch and 1/2 inch must be beveled at 1:2 or less. The maximum vertical rise shall be 1/4 inch.	N/A		<a href="https://www.access-board.gov/ada/#ada-404_2_5">https://www.access-board.gov/ada/#ada-404_2_5</a>	2012 TAS Section: 404.2.5  2010 ADAS Section: 404.2.5  2015 ABAAS Section: 404.2.5

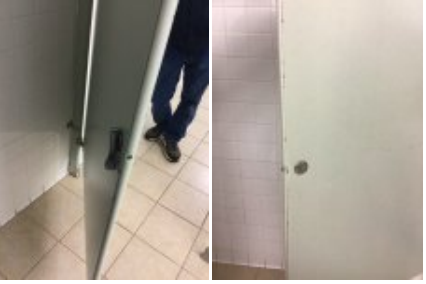
17	Structures on Property (Public) - Visitors Center : Restrooms/Water Fountains (Admission) - Restroom (Men's) Admission	The water closet compartment is missing a loop handle on both sides of the door. Water closet compartments must be equipped with a door that has a loop or U-shaped handle on both sides of the door immediately below the latch. The latch must be flip-over style, sliding or other hardware not requiring the user to grasp or twist.	N/A	<a href="https://www.access-board.gov/ada/#ada-604_8_1_2">https://www.access-board.gov/ada/#ada-604_8_1_2</a>	2012 TAS Section: 604.8.1.2  2010 ADAS Section: 604.8.1.2  2015 ABAAS Section: 604.8.1.2

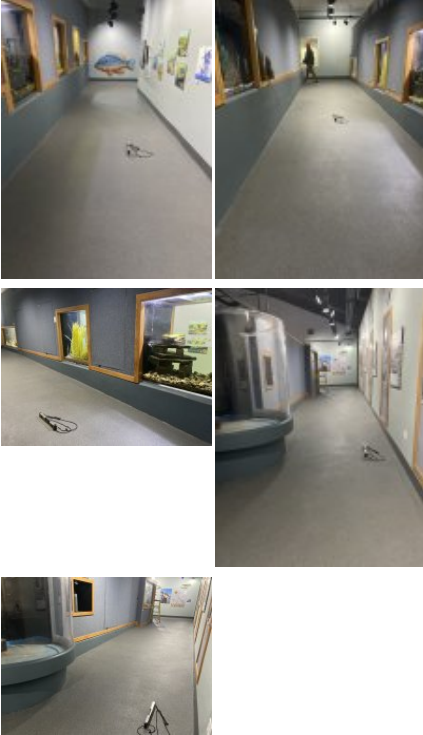
Finding Number	Area Description	Finding	As Built	Recommendation	Citation	Photos	Figure
31	Structures on Property (Public) - Visitors Center : Interior Hallways of Visitors Center - Interior Ramps (3 Total)	The ramp does not have compliant handrails. Handrails are required on both sides of all surfaces that are sloped greater than 5 percent (1:20). Handrails must be between 34 inches and 38 inches above the ramp surface, must extend 12 inches beyond the top and bottom of the ramp and be parallel to the floor or ground surface. The diameter of the handrails must be between 1 1/4 inches and 2 inches in cross-sectional nominal dimension for circular handrails. Handrail gripping surfaces with a non-circular cross section shall have a perimeter dimension of 4 inches minimum and 6 1/4 inches maximum, and a cross-section dimension of 2 1/4 inches maximum. The space between handrails and walls must be 1 1/2 inches minimum.	There are no handrails installed on all 3 interior ramps. Ramps pictured are connected and continuous. These ramps would need continuous handrails on both sides, with accompanying handrail extensions at ends of ramp. The handrails don't have to be installed on the wall. They just have to have the minimum required clearance. Ramp extensions in alterations can be minimized if they would become a hazard. * See uploaded photo for example of compliant ramp style.	Review handrail componets to make accessible <a href="https://www.access-board.gov/aba/#aba-505_1">https://www.access-board.gov/aba/#aba-505_1</a>	2012 TAS Section: 505.1  2010 ADAS Section: 505.1  2015 ABAAS Section: 505.1

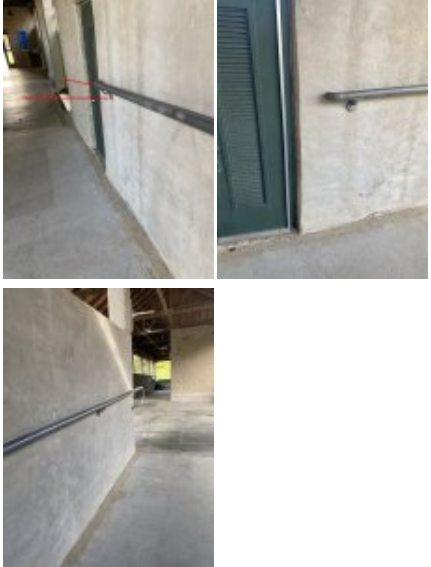
Finding Number	Area Description	Finding	As Built	Recommendation	Citation	Photos	Figure
32	Structures on Property (Public) - Visitors Center : Outdoor Exhibits - Large Reservation Ramp	The handrail is not continuous the entire length of the ramp. The handrail must be continuous. Handrails shall be placed on each side of each ramp, and shall be continuous the full length of the ramp. The inside handrail on switchback or dogleg ramps shall always be continuous.	Handrail does not extend the length of the ramp. Handrails need to be installed on both sides with compliant handrail extensions for all sets.	<a href="https://www.access-board.gov/ada/#ada-505_3">https://www.access-board.gov/ada/#ada-505_3</a>	2012 TAS Section: 505.3 2010 ADAS Section: 505.3 2015 ABAAS Section: 505.3

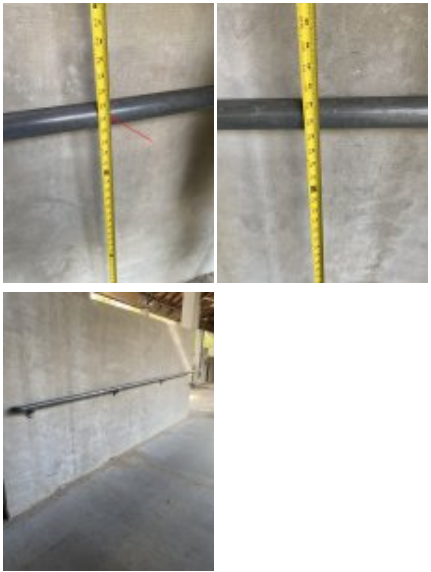
33	Structures on Property (Public) - Visitors Center : Outdoor Exhibits - Large Reservation Ramp	The handrail exceeds maximum height requirements. Handrails are measured to the top of the gripping surface and must be between 34 inches and 38 inches above the ramp surface. Handrails must extend horizontally 12 inches beyond the top and bottom of the ramp.	Handrail height is over 41"	<a href="https://www.access-board.gov/ada/#ada-505_4">https://www.access-board.gov/ada/#ada-505_4</a>	2012 TAS Section: 505.4 2010 ADAS Section: 505.4 2015 ABAAS Section: 505.4

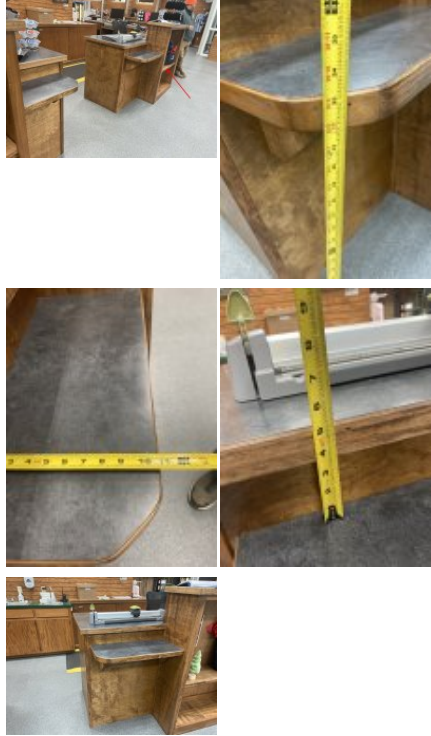
Finding Number	Area Description	Finding	As Built	Recommendation	Citation	Photos	Figure
43	Structures on Property (Public) - Visitors Center : Visitor Center Gift Shop - Service/Sales Counter Gift Shop	Clear floor space has not be provided. A portion of the counter surface that is 36 inches long minimum for a parallel approach or 30 inches long minimum for a forward approach and 36 inches high maximum above the finish floor shall be provided. A 30 inch by 48 inch clear floor space on an accessible route must be provided for either a forward or parallel approach. Additionally, if a forward approach is desired, knee and toe space must be provided.	Accessible portion of counter cannot be accessed via front or parallel approach. Remove barrier to create enough width under counter to meet compliance for parallel approach.	<a href="https://www.access-board.gov/ada/#ada-904_4_1">https://www.access-board.gov/ada/#ada-904_4_1</a> <a href="https://www.access-board.gov/ada/#ada-904_4_2">https://www.access-board.gov/ada/#ada-904_4_2</a>	2012 TAS Section: 904.4.1, 904.4.2  2010 ADAS Section: 904.4.2, 904.4.1  2015 ABAAS Section: 904.4.2, 904.4.1

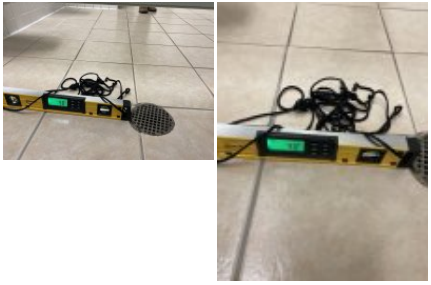
46	Structures on Property (Public) - Visitors Center : Restrooms/Water Fountains (Gift Shop) - Restroom (Men's) Gift Shop	The floor drain is set too low in the floor which causes a slope over 2 percent. Changes in level are not permitted in clear floor or ground spaces or surfaces of a turning spaces and shall not slope greater than 1:48.	Floor drain slope is 4.8%	<a href="https://www.access-board.gov/ada/#ada-303_3">https://www.access-board.gov/ada/#ada-303_3</a> <a href="https://www.access-board.gov/ada/#ada-304_2">https://www.access-board.gov/ada/#ada-304_2</a>	2012 TAS Section: 303.3, 304.2, 304.2 Exception  2010 ADAS Section: 303.3, 304.2, 304.2 Exception  2015 ABAAS Section: 303.3, 304.2, 304.2 EXCEPTION, 305.2 EXCEPTION

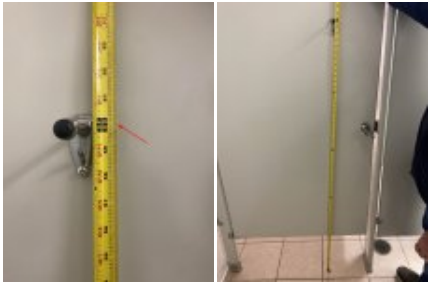
62	Structures on Property (Public) - Visitors Center : Restrooms/Water Fountains (Overlook) - Restroom (Women's) Overlook	The coat hook is installed greater than 48 inches above the finished floor. Where a forward reach is unobstructed, the high forward reach shall be 48 inches maximum above the finished floor.	Coat hook height is 60"	<a href="https://www.access-board.gov/ada/#ada-308_2_1">https://www.access-board.gov/ada/#ada-308_2_1</a>	2012 TAS Section: 308.2.1  2010 ADAS Section: 308.2.1  2015 ABAAS Section: 308.2.1

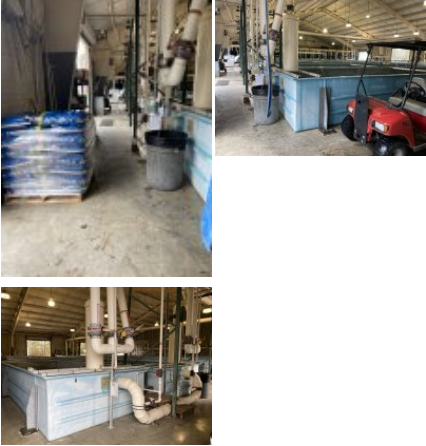
66	Structures on Property (Public) - Visitors Center : Raceways (Private Tours) - Pathways Around Raceway/Production Areas	The path of contains multiple issues and is not accessible. The path of travel exceeds the maximum allowable cross and running slope requirements. It also contains changes in level and/or gaps that exceed the allowable maximum requirements. The path of travel does not meet the minimum width requirements for clearances, turning spaces, and/or passing spaces. The floor or ground surface is not firm, stable, and slip resistant.	Route has narrow areas with storage items needed for infrastructure preventing access. Majority of pathways are accessible. This area is closed to regular public and only viewed via private tours. These areas cannot be made accessible due to the equipment and purpose of their function.	Route around raceways does not need to be accessible but tour program does need to meet Title II requirements for accessible programs/services. Finding route which bypasses tight walkways is an example of program modification.	2012 TAS Section: 403.1 2010 ADAS Section: 403.1 2015 ABAAS Section: 403.1

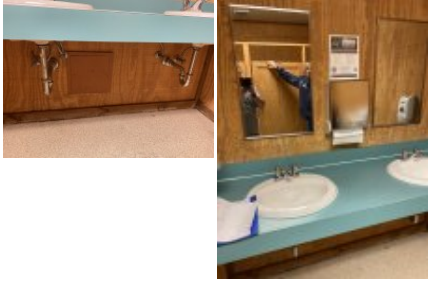
Finding Number	Area Description	Finding	As Built	Recommendation	Citation	Photos	Figure
97	Structures on Property (Pubic) - Anglers Pavilion: Restrooms/Water Fountains (Angler Pavilion) - Restroom (Men's)	The water and drain pipes under the lavatory are not adequately insulated. Water supply and drain pipes under lavatories and sinks shall be insulated or otherwise configured to protect against contact. There shall be no sharp or abrasive surfaces under lavatories and sinks.	Lavatory pipes are not insulated.	<a href="https://www.access-board.gov/ada/#ada-606_5">https://www.access-board.gov/ada/#ada-606_5</a>	2012 TAS Section: 606.5 2010 ADAS Section: 606.5 2015 ABAAS Section: 606.5

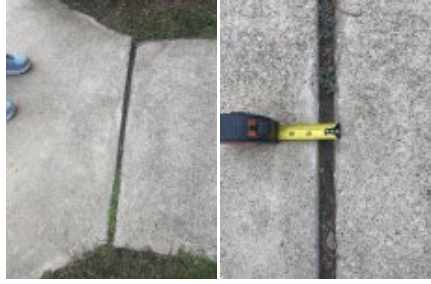
110	Outdoor Features (Public) : Fishing Piers Near Visitors Center (3 total) - Mr. Bill's Fishing Pier & Walkways	The route contains openings greater than 1/2 inch. Openings in floor or ground surfaces shall not allow passage of a sphere more than 1/2 inch diameter. Elongated openings shall be placed so that the long dimension is perpendicular to the dominant direction of travel.	Exterior pathway leading to Mr. Bills pier has gap greater than 1/2"	<a href="https://www.access-board.gov/ada/#ada-302_3">https://www.access-board.gov/ada/#ada-302_3</a>	2012 TAS Section: 302.3 2010 ADAS Section: 302.3 2015 ABAAS Section: 302.3

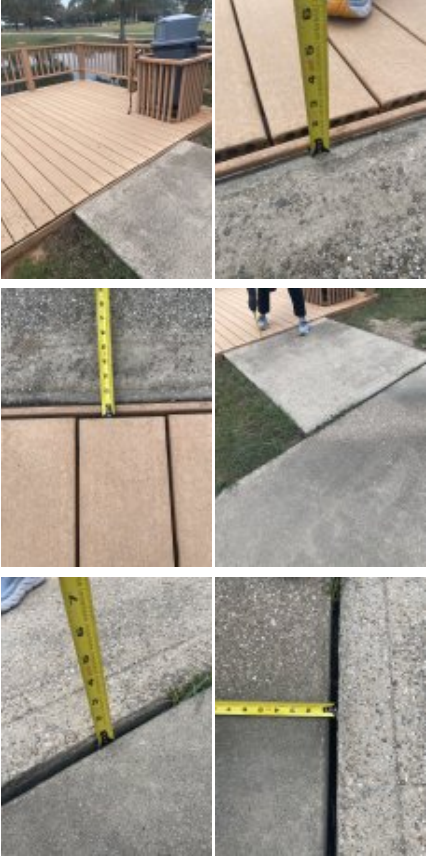
Finding Number	Area Description	Finding	As Built	Recommendation	Citation	Photos	Figure
114	Outdoor Features (Public) : Fishing Piers Near Visitors Center (3 total) - Conservation Center Fishing Pier & Walkways	The walkway contains abrupt vertical edges and/or variations over 1/4 inch. 1/4 inch is the maximum vertical rise. Changes in level between 1/4 inch and 1/2 inch must be beveled at 1:2 or less. Changes in level greater than 1/2 inch must be by way of a ramp.	Exterior pathway used to gain access to CC fishing pier has transition over 1/4" in 2 locations. Same locations also have gap greater than 1/2" See additional photos for locations.	<a href="https://www.access-board.gov/ada/#ada-303_2">https://www.access-board.gov/ada/#ada-303_2</a> <a href="https://www.access-board.gov/ada/#ada-303_3">https://www.access-board.gov/ada/#ada-303_3</a>	2012 TAS Section: 303.3, 303.2  2010 ADAS Section: 303.3, 303.2  2015 ABAAS Section: 303.2, 303.3

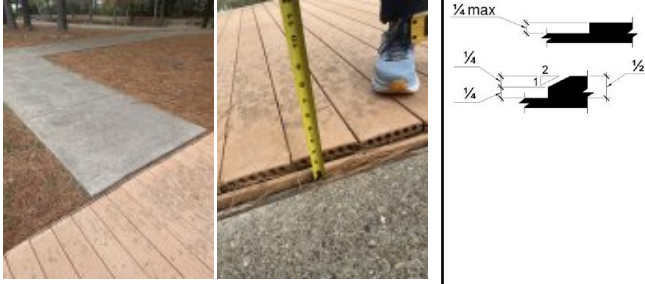
119	Outdoor Features (Public) : Fishing Piers Near Visitors Center (3 total) - Conservation Center Fishing Pier & Walkways	The walkway contains abrupt vertical edges and/or variations over 1/4 inch. 1/4 inch is the maximum vertical rise. Changes in level between 1/4 inch and 1/2 inch must be beveled at 1:2 or less. Changes in level greater than 1/2 inch must be by way of a ramp.	See previous finding for location details.	<a href="https://www.access-board.gov/ada/#ada-303_2">https://www.access-board.gov/ada/#ada-303_2</a> <a href="https://www.access-board.gov/ada/#ada-303_3">https://www.access-board.gov/ada/#ada-303_3</a>	2012 TAS Section: 303.3, 303.2 2010 ADAS Section: 303.3, 303.2 2015 ABAAS Section: 303.2, 303.3

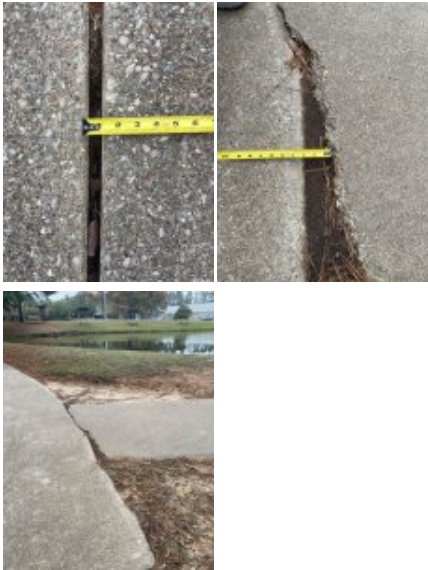
123	Outdoor Features (Public) : Fishing Piers Near Visitors Center (3 total) - Anglers Pavilion Fishing Pier & Walkways	The route contains openings greater than 1/2 inch. Openings in floor or ground surfaces shall not allow passage of a sphere more than 1/2 inch diameter. Elongated openings shall be placed so that the long dimension is perpendicular to the dominant direction of travel.	Exterior pathways leading to Angler Pavilion fishing pier have multiple locations where gap exceed 1/2"	<a href="https://www.access-board.gov/ada/#ada-302_3">https://www.access-board.gov/ada/#ada-302_3</a>	2012 TAS Section: 302.3 2010 ADAS Section: 302.3 2015 ABAAS Section: 302.3

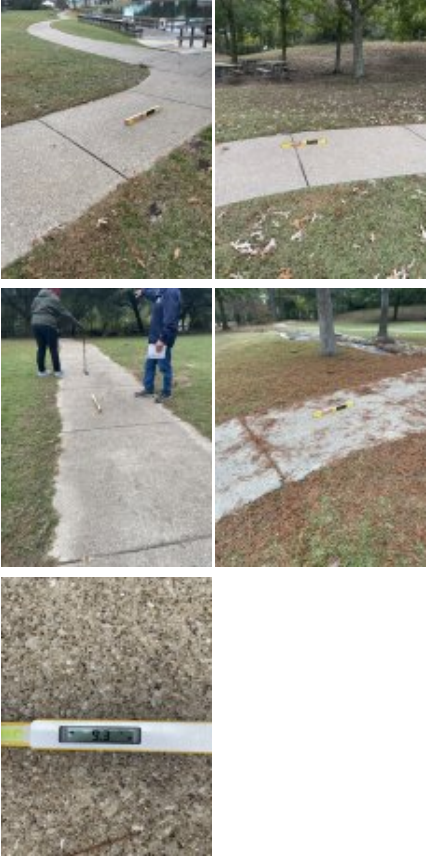
Finding Number	Area Description	Finding	As Built	Recommendation	Citation	Photos	Figure
124	Outdoor Features (Public) : Fishing Piers Near Visitors Center (3 total) - Path Of Travel Around Piers	The accessible route on the site has running slopes greater than 5 percent and has not been constructed as a ramp (i.e. handrails, edge protection, etc.). When the slope in the direction of travel of any walk exceeds 1 unit vertical in 20 units horizontal (5-percent slope), it must be constructed as a ramp. Surface cross slopes must not exceed one unit vertical in 48 units horizontal (2-percent slope).	There are several locations where exterior pathway exceeds running slope of 5%. This section of pathway accesses Mr. Bills fishing pier, maneuvers around pier heading towards outdoor picnic area. See additional photos for location of running slope non compliance on accessible pathway to feature.	<a href="https://www.access-board.gov/ada/#ada-403_3">https://www.access-board.gov/ada/#ada-403_3</a>	2012 TAS Section: 403.3 2010 ADAS Section: 403.3 2015 ABAAS Section: 403.3

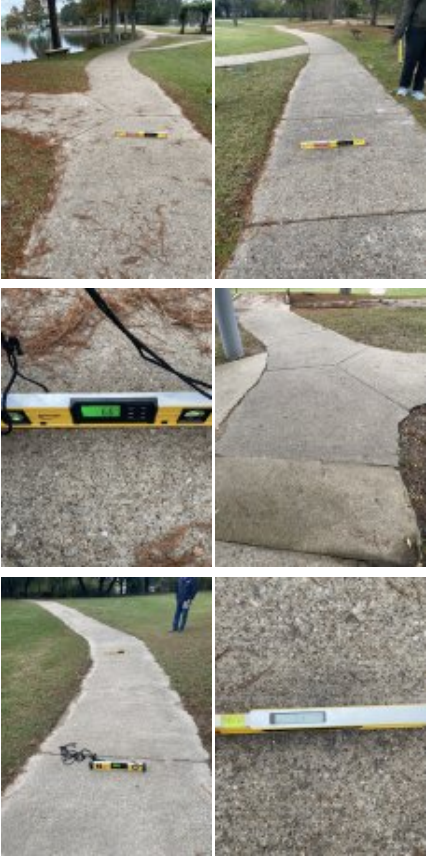
Finding Number	Area Description	Finding	As Built	Recommendation	Citation	Photos	Figure
125	Outdoor Features (Public) : Fishing Piers Near Visitors Center (3 total) - Path Of Travel Around Piers	The accessible path of travel has cross slopes greater than 2%. Surface cross slopes shall not exceed one unit vertical in 48 units horizontal (2-percent slope). When the slope in the direction of travel of any walk exceeds 1 unit vertical in 20 units horizontal (5-percent slope), it must be constructed as a ramp.	There are several locations where exterior pathway cross slope exceeds 2%. This section of pathway leads from Mr. Bills fishing pier around (R) side pathway towards Anglers Pavilion fishing pier. See additional photos for location of cross slope non compliance on accessible pathway to feature.	<a href="https://www.access-board.gov/ada/#ada-403_3">https://www.access-board.gov/ada/#ada-403_3</a>	2012 TAS Section: 403.3 2010 ADAS Section: 403.3 2015 ABAAS Section: 403.3

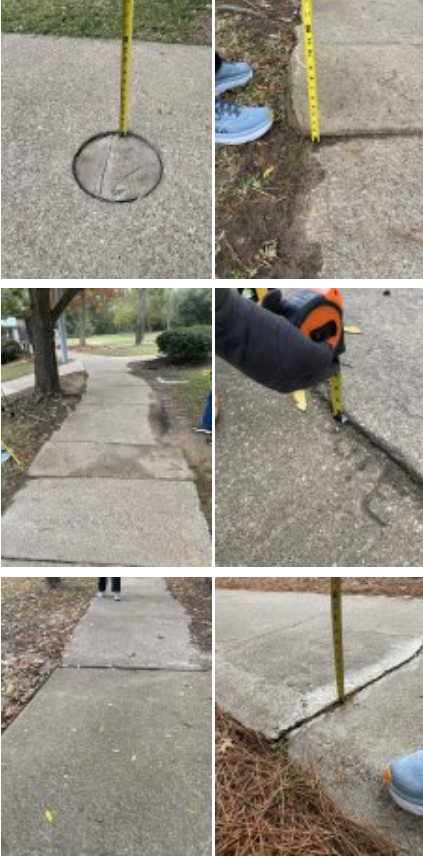
Finding Number	Area Description	Finding	As Built	Recommendation	Citation	Photos	Figure
129	Outdoor Features (Public) : Fishing Piers Near Visitors Center (3 total) - Path Of Travel Around Piers	The walkway contains abrupt vertical edges and/or variations over 1/4 inch. 1/4 inch is the maximum vertical rise. Changes in level between 1/4 inch and 1/2 inch must be beveled at 1:2 or less. Changes in level greater than 1/2 inch must be by way of a ramp.	There are several locations where change in elevation exceed 1/4" allowance. Locations are dispersed along pathways that serve both ponds and each fishing pier. Mainly located along pathways that lead to wetland trails, angler pavilion, visitors center to piers, and picnic areas to (R) of angler pavilion. See additional photos for location of vertical rise non compliance on accessible pathway to feature.	<a href="https://www.access-board.gov/ada/#ada-303_2">https://www.access-board.gov/ada/#ada-303_2</a> <a href="https://www.access-board.gov/ada/#ada-303_3">https://www.access-board.gov/ada/#ada-303_3</a>	2012 TAS Section: 303.3, 303.2  2010 ADAS Section: 303.3, 303.2  2015 ABAAS Section: 303.2, 303.3

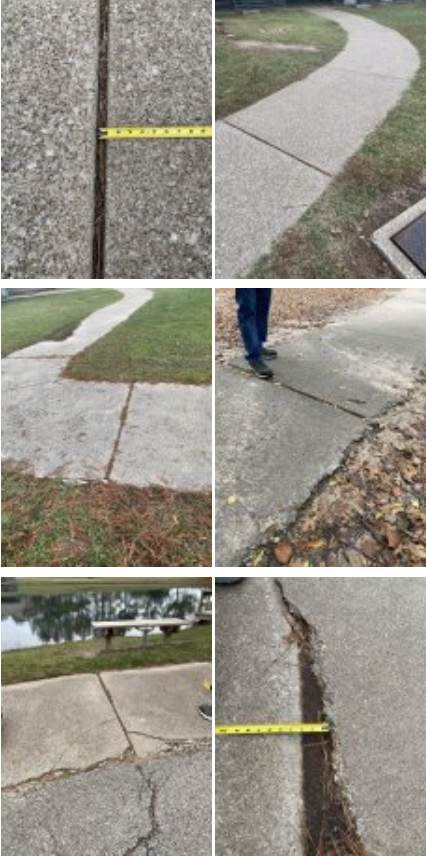
Finding Number	Area Description	Finding	As Built	Recommendation	Citation	Photos	Figure
130	Outdoor Features (Public) : Fishing Piers Near Visitors Center (3 total) - Path Of Travel Around Piers	The route contains openings greater than 1/2 inch. Openings in floor or ground surfaces shall not allow passage of a sphere more than 1/2 inch diameter. Elongated openings shall be placed so that the long dimension is perpendicular to the dominant direction of travel.	There are many locations where large gaps in pathway exceed 1/2" allowance. Locations are dispersed along pathways that serve both ponds and each fishing pier. Mainly located along pathways that lead to wetland trails, angler pavilion, visitors center to piers, and picnic areas to (R) of angler pavilion. See additional photos for location of gap non compliance on accessible pathway to feature.	<a href="https://www.access-board.gov/ada/#ada-302_3">https://www.access-board.gov/ada/#ada-302_3</a>	2012 TAS Section: 302.3 2010 ADAS Section: 302.3 2015 ABAAS Section: 302.3

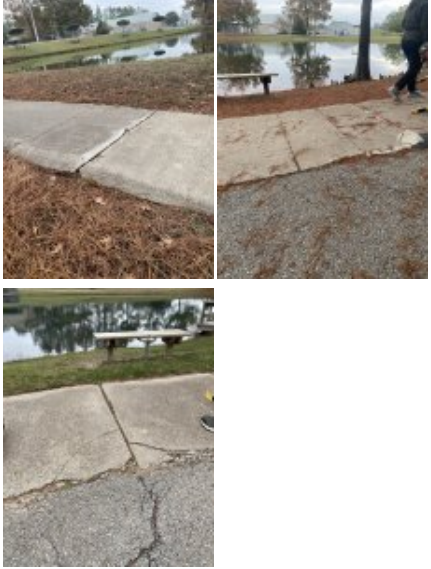
Finding Number	Area Description	Finding	As Built	Recommendation	Citation	Photos	Figure
131	Outdoor Features (Public) : Wetlands Trail - Wetlands Trail (Beginning)	An accessible access route is not provided between elements, spaces and the facilities provided within the accessible camping unit. At least one outdoor recreation access route shall connect accessible elements, spaces and facilities provided within camping units with mobility features.	There is no access routes to benches along path. Accessible bench placement should be equally dispersed in given area with accessible route. Not ever bench needs to be made accessible but scoping requires even dispersion and equal access to same feature or element. Each feature or element seating should be treated separately from other features or elements.	N/A - Refer to Finding	2015 ABAAS Section: F244.5.1

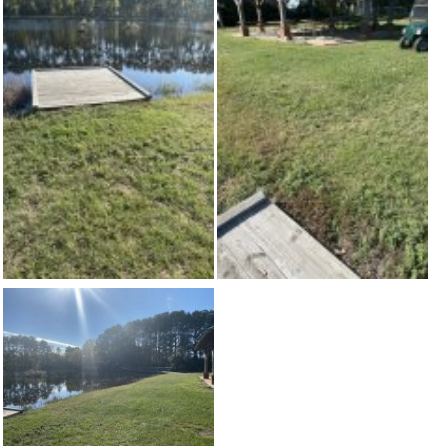
Finding Number	Area Description	Finding	As Built	Recommendation	Citation	Photos	Figure
138	Outdoor Features (Public) : Fly Fishing Area - Fly Fish Pier (4 Total)	There is no accessible route to the accessible element. At least one accessible route shall connect accessible buildings, accessible facilities, accessible elements, and accessible spaces that are on the same site.	There is no accessible route to any of the 4 floating platforms which serve this pond. Would need at least 1 to meet compliance.	https://www.access-board.gov/ada/#ada-206_2_2 Review accessible pathway components to make accessible https://www.access-board.gov/ada/#ada-402 https://www.access-board.gov/ada/#ada-403_1	2012 TAS Section: 206.2.2 2010 ADAS Section: 206.2.2 2015 ABAAS Section: F206.2.2

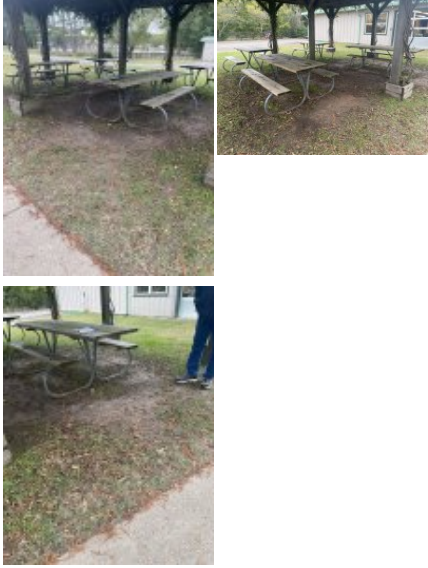
171	Outdoor Features (Public) : Picnic Spaces Near Visitors Center - Angler Pavilion Picnic Area	There is no outdoor recreation access route that connects accessible elements, spaces, and facilities within the picnic unit. At least one outdoor recreation access route shall connect accessible elements, spaces, and facilities provided within picnic units with mobility features.	Ground/surface material not compliant around picnic tables. Exterior pathway leading to tables non compliant.	N/A - Refer to Finding	2015 ABAAS Section: F245.4.1

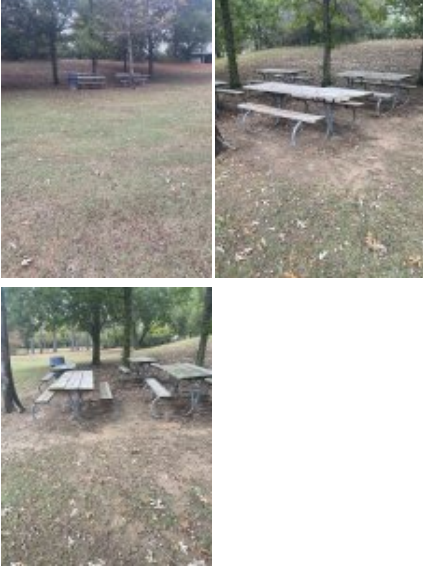
175	Outdoor Features (Public) : Picnic Spaces Near Visitors Center - Overlook Area	There is no outdoor recreation access route that connects accessible elements, spaces, and facilities within the picnic unit. At least one outdoor recreation access route shall connect accessible elements, spaces, and facilities provided within picnic units with mobility features.	Ground/surface material not compliant around picnic tables. Exterior pathway leading to tables non compliant.	N/A - Refer to Finding	2015 ABAAS Section: F245.4.1
