# Perry R Bass CF- ADA Evaluation

**CF-Palacios TX, Perry R Bass ADA Evaluation**

**Accessibility Evaluation**

**Inspection Date: 01/30/2023**

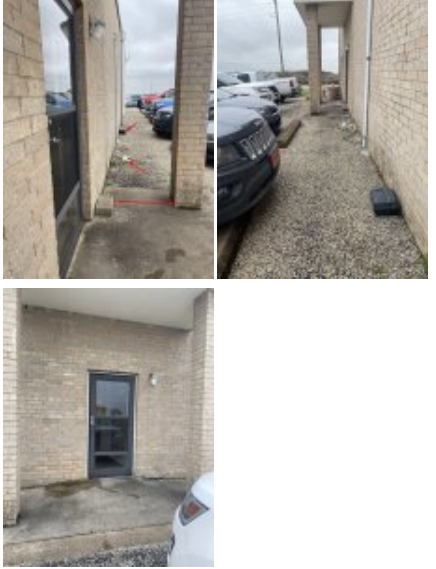
Finding Number	Area Description	Finding	As Built	Recommendation	Citation	Photos	Figure
4	Exterior of Property (Public): HQ Parking Lot (0 Spaces) - Pathway to Building (Parking Lot to Main Entrance)	The building entrance is not located on an accessible route. When a building, or portion of a building, is required to be accessible, an accessible route of travel shall be provided to all portions of the building, to accessible building entrances and between the building and the public way. At least one accessible route within the boundary of the site must be provided from public transportation stops, accessible parking and accessible passenger loading zones and public streets or sidewalks to the accessible building entrance they serve. The accessible route shall, to the maximum extent feasible, coincide with the route for the general public. At least one accessible route shall connect accessible buildings, facilities, elements and spaces that are on the same site. At least one accessible route shall connect accessible building or facility entrances with all accessible spaces and elements.	Neither the side or front exterior routes leading to building entrance are accessible. Due to no access aisle provided, and clearly marked accessible pathway, pathway narrowing, surfacing, and sloping, there is not a way to access this building at this time. This building is not accessible	<a href="https://www.access-board.gov/ada/#ada-206_2_1">https://www.access-board.gov/ada/#ada-206_2_1</a> Review accessible pathway componets to make accessible <a href="https://www.access-board.gov/ada/#ada-402">https://www.access-board.gov/ada/#ada-402</a> <a href="https://www.access-board.gov/ada/#ada-403_1">https://www.access-board.gov/ada/#ada-403_1</a>	2012 TAS Section: 206.2.1  2010 ADAS Section: 206.2.1  2015 ABAAS Section: F206.2.1

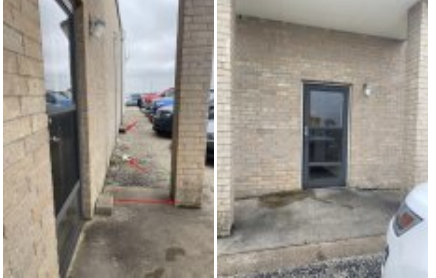
5	Exterior of Property (Public): HQ Parking Lot (0 Spaces) - Pathway to Building (Parking Lot to Main Entrance)	The path of contains multiple issues and is not accessible. The path of travel exceeds the maximum allowable cross and running slope requirements. It also contains changes in level and/or gaps that exceed the allowable maximum requirements. The path of travel does not meet the minimum width requirements for clearances, turning spaces, and/or passing spaces. The floor or ground surface is not firm, stable, and slip resistant.	Due to narrowing pathway, non compliant surfacing, obstructions on pathways, and sloping there is no accessible route to building.	<a href="https://www.access-board.gov/ada/#ada-403_1">https://www.access-board.gov/ada/#ada-403_1</a>	2010 ADAS Section: 403.1  2015 ABAAS Section: 403.1

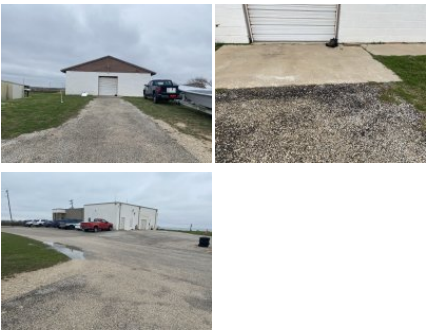
Finding Number	Area Description	Finding	As Built	Recommendation	Citation	Photos	Figure
6	Exterior of Property (Public): Wet Lab (Exterior) - TOUR	There is no accessible route between the buildings. At least one accessible route shall connect accessible buildings, facilities, elements and spaces that are on the same site.	The route leading to building does not meet compliance. Loose gravel and sloping impede access.	<a href="https://www.access-board.gov/ada/#ada-206_2_2">https://www.access-board.gov/ada/#ada-206_2_2</a>	2012 TAS Section: 206.2.2  2010 ADAS Section: 206.2.2  2015 ABAAS Section: F206.2.2

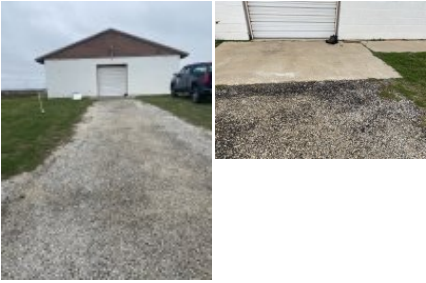
7	Exterior of Property (Public): Wet Lab (Exterior) - TOUR	The path of contains multiple issues and is not accessible. The path of travel exceeds the maximum allowable cross and running slope requirements. It also contains changes in level and/or gaps that exceed the allowable maximum requirements. The path of travel does not meet the minimum width requirements for clearances, turning spaces, and/or passing spaces. The floor or ground surface is not firm, stable, and slip resistant.	Pathway contains loose gravel, impeding access and non compliant sloping.	Review accessible pathway componets to make accessible <a href="https://www.access-board.gov/ada/#ada-402">https://www.access-board.gov/ada/#ada-402</a> <a href="https://www.access-board.gov/ada/#ada-403_1">https://www.access-board.gov/ada/#ada-403_1</a>	2010 ADAS Section: 403.1  2015 ABAAS Section: 403.1

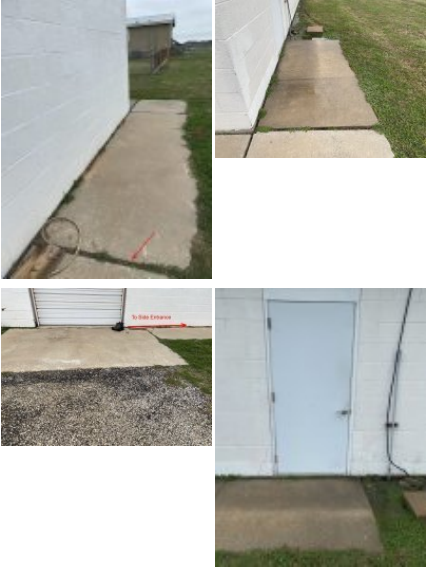
Finding Number	Area Description	Finding	As Built	Recommendation	Citation	Photos	Figure
8	Exterior of Property (Public): Wet Lab (Exterior) - TOUR - Pathway Around Building	The route contains openings greater than 1/2 inch. Openings in floor or ground surfaces shall not allow passage of a sphere more than 1/2 inch diameter. Elongated openings shall be placed so that the long dimension is perpendicular to the dominant direction of travel.	Pathway leading to side entrance door, overgrowth impedes access.	<a href="https://www.access-board.gov/ada/#ada-302_3">https://www.access-board.gov/ada/#ada-302_3</a>	2012 TAS Section: 302.3  2010 ADAS Section: 302.3  2015 ABAAS Section: 302.3

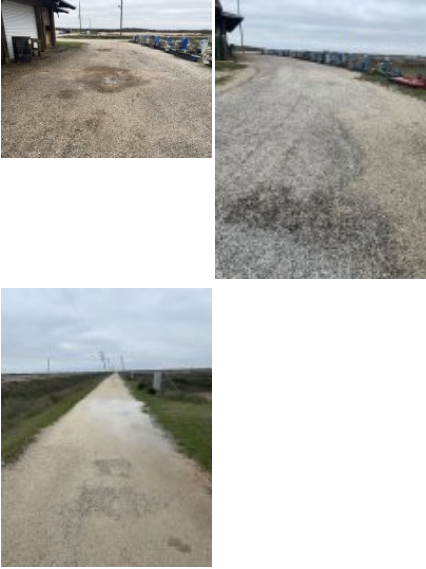
Finding Number	Area Description	Finding	As Built	Recommendation	Citation	Photos	Figure
9	Exterior of Property (Public): Pathway to Holding Ponds - TOUR	State and local governments have an obligation to make their programs and services accessible to persons with disabilities. This may or may not require the alteration, addition or construction of existing facilities which predate The Americans with Disabilities Act (ADA) of 1990. Under the Code of Federal Regulations Section 35.151(b)(2) State and Local Government Title II entities may provide programmatic access where alterations to existing facilities would result in undue financial and administrative burdens. For Example, A public entity has six courtrooms in two existing buildings and determines that only three of those courtrooms and the public use and common use areas serving those courtrooms in one building are needed to be made accessible in order to satisfy its program access obligations. The entity must comply with 2010 Standards unless compliance would result in undue financial and administrative burdens and must take other actions that would not result in an undue financial burden to ensure access to persons with disabilities. This may include the scheduling of the various types of cases, hearings etc. in accessible courtrooms and relocating them where necessary to accommodate persons with disabilities. Having a defined program and effective communication process in place to ensure the public and employees can request accommodations is necessary to ensure equal access to the county's court system. Program access is not part of this evaluation and this information is being provided as an advisory only.	No way to access element at this time.	Provide a reasonable modification to allow tour participants an equitable experience during this part of tour.	2010 ADAS Section: Advisory

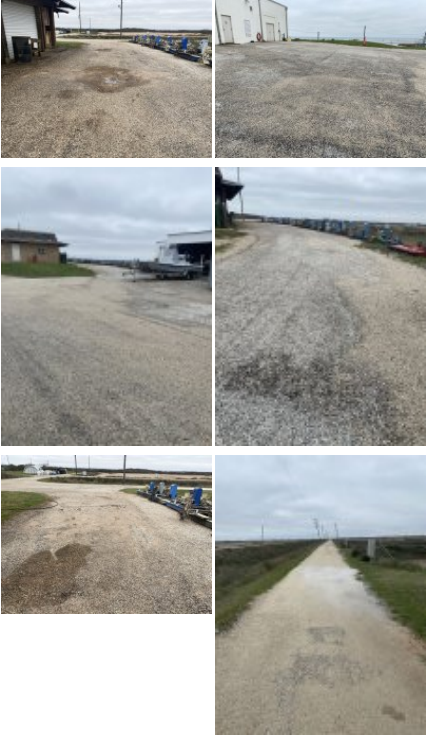
Finding Number	Area Description	Finding	As Built	Recommendation	Citation	Photos	Figure
10	Exterior of Property (Public): Pathway to Holding Ponds - TOUR	The path of contains multiple issues and is not accessible. The path of travel exceeds the maximum allowable cross and running slope requirements. It also contains changes in level and/or gaps that exceed the allowable maximum requirements. The path of travel does not meet the minimum width requirements for clearances, turning spaces, and/or passing spaces. The floor or ground surface is not firm, stable, and slip resistant.	The accessible route to holding pond is not compliant due to loose gravel and gravel size, and sloping non compliance.	Review accessible pathway componets to make accessible <a href="https://www.access-board.gov/ada/#ada-402">https://www.access-board.gov/ada/#ada-402</a> <a href="https://www.access-board.gov/ada/#ada-403_1">https://www.access-board.gov/ada/#ada-403_1</a>	2010 ADAS Section: 403.1  2015 ABAAS Section: 403.1

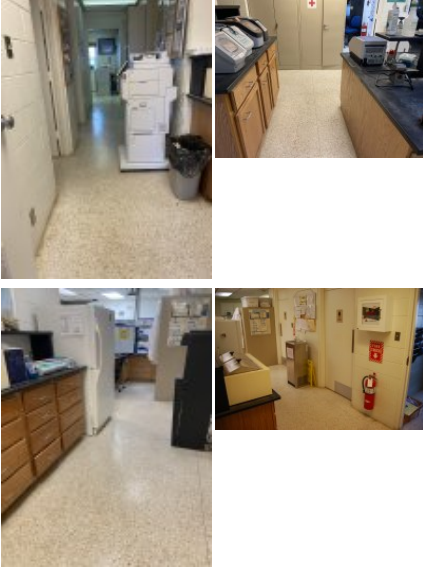
Finding Number	Area Description	Finding	As Built	Recommendation	Citation	Photos	Figure
11	Structures on Property (Public) - Tour/Public Componets : HQ Building (Interior)	The route of travel does not provide a minimum width of 36 inches. The clear width shall be permitted to be reduced to 32 inches minimum for a length of 24 inches maximum provided that reduced width segments are separated by segments that are 48 inches long minimum and 36 inches wide minimum.	Areas where route narrows to 32 for short distance. Equipment and office furniture impede access. Route leads to outdoor parts of tour. Interior of tour in areas where research is done. No more than a few people at a time in these spaces. Interior walkways do not meet compliance.	<a href="https://www.access-board.gov/ada/#ada-403_5_1">https://www.access-board.gov/ada/#ada-403_5_1</a>	2012 TAS Section: 403.5.1  2010 ADAS Section: 403.5.1  2015 ABAAS Section: 403.5.1

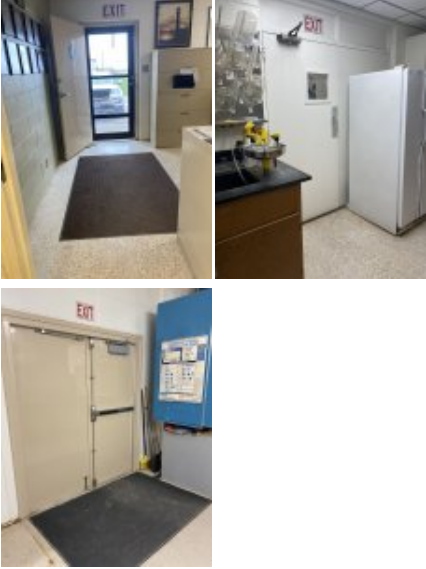
Finding Number	Area Description	Finding	As Built	Recommendation	Citation	Photos	Figure
18	Structures on Property (Public) - Tour/Public Componets : HQ Building (Interior) - Entrance/Exit Doors	The tactile EXIT sign is missing at the door. Wall signs identifying exits shall have characters raised 1/32 inch minimum and shall be uppercase characters a minimum of 5/8 inch and a maximum of 2 inches high. Braille shall be placed directly below the tactile characters; flush left or centered. Signs shall be located a minimum of 48 inches above the floor, measured from the baseline of the lowest tactile characters and 60 inches maximum above the finish floor or ground surface, measured from the baseline of the highest tactile characters. Where a tactile sign is provided at a door, the sign shall be located on the latch side. Where a tactile sign is provided at double doors the sign shall be located to the right of the right-hand door. Where there is no wall space at the latch side of a single door or at the right side of double doors, signs shall be located on the nearest adjacent wall.	Where visual EXIT is provided, accompanying tactile EXIT sign must also be provided for same doorway. Doorway exit signs and emergency exits with emergency exit signs that are overhead or visual only, or pictograms only, must have an accompanying ADA Braille sign. Exit passages, including doors, stairs and routes, must be identified with tactile ADA signage. Signs must include braille and raised characters. Pictograms are optional. This applies to all doors marked with visual exit signs	<a href="https://www.access-board.gov/ada/#ada-216_4_1">https://www.access-board.gov/ada/#ada-216_4_1</a>	2012 TAS Section: 216.4.1  2010 ADAS Section: 216.4.1  2015 ABAAS Section: F216.4.1

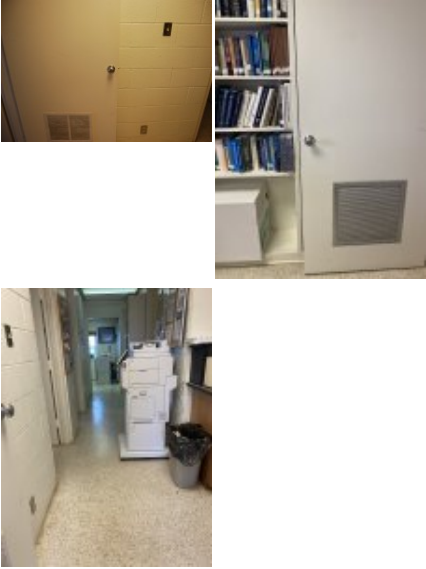
Finding Number	Area Description	Finding	As Built	Recommendation	Citation	Photos	Figure
19	Structures on Property (Public) - Tour/Public Componets : HQ Building (Interior) - Interior Doorways	The operating hardware requires tight grasping, pinching or twisting of the wrist to operate. Hand-activated hardware, handles, pulls, latches, locks, and other operating devices on accessible elements shall have a shape that is easy to grasp with one hand and does not require tight grasping, pinching or twisting of the wrist to operate.	Multiple doors used to access interior rooms have non compliant hardware, door knobs.	<a href="https://www.access-board.gov/ada/#ada-309_4">https://www.access-board.gov/ada/#ada-309_4</a>	2012 TAS Section: 309.4  2010 ADAS Section: 309.4  2015 ABAAS Section: 309.4

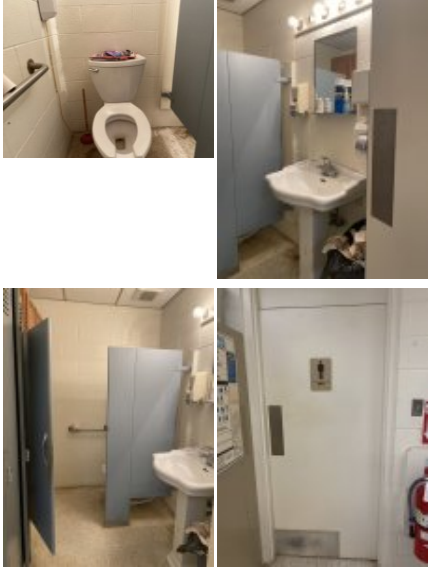
Finding Number	Area Description	Finding	As Built	Recommendation	Citation	Photos	Figure
22	Structures on Property (Public) - Tour/Public Componets : HQ Building (Interior) - Restroom (Men's) Public/Staff	The restroom is not nearly compliant. The restroom does not have the required minimum clear floor space or maneuvering clearances for the toilet. The restroom does not have the required minimum clear floor space or maneuvering clearances for the lavatory. The entry door does not contain the required minimum maneuvering spaces on the pull/push sides. The entry door encroach into the required clear floor space for fixtures. Grab bars are missing and/or incorrectly installed. Accessories, such as toilet seat covers, paper towel holders, garbage cans, hand dryers, and mirrors are either too high or without clear floor space or both. The restroom contain floor level changes greater than a 1/2 inch of the floor drains and is slope (XX) - (XX), the shower is too small and missing numerous accessible elements.	This restroom requires a number of componets to gain compliance.	<a href="https://www.access-board.gov/ada/#ada-213_2">https://www.access-board.gov/ada/#ada-213_2</a> Review restrooms componets to make accessible. <a href="https://www.access-board.gov/ada/#ada-603">https://www.access-board.gov/ada/#ada-603</a>	2012 TAS Section: 213.2  2010 ADAS Section: 213.2  2015 ABAAS Section: F213.2

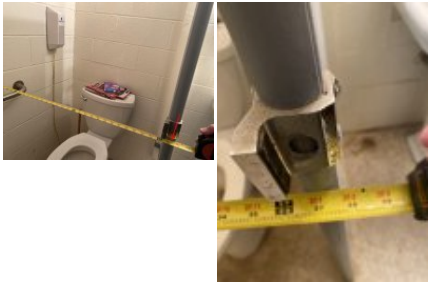
23	Structures on Property (Public) - Tour/Public Componets : HQ Building (Interior) - Restroom (Men's) Public/Staff	The toilet compartment is not wide enough. Wheelchair accessible compartments shall be 60 inches wide minimum measured perpendicular to the side wall, and 56 inches deep minimum for wall hung water closets and 59 inches deep minimum for floor mounted water closets measured perpendicular to the rear wall.	Stall width is 37"	<a href="https://www.access-board.gov/ada/#ada-604_8_1_1">https://www.access-board.gov/ada/#ada-604_8_1_1</a>	2012 TAS Section: 604.8.1.1  2010 ADAS Section: 604.8.1.1  2015 ABAAS Section: 604.8.1.1

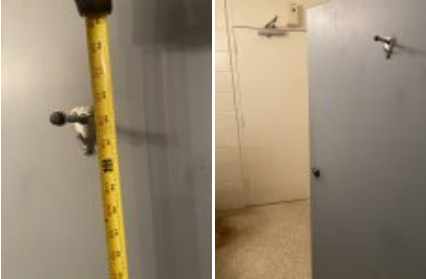
29	Structures on Property (Public) - Tour/Public Componets : HQ Building (Interior) - Restroom (Men's) Public/Staff	The coat hook is installed greater than 48 inches above the finished floor. Where a forward reach is unobstructed, the high forward reach shall be 48 inches maximum above the finished floor.	Coat hook measured at 62" Located on inside of stall door.	<a href="https://www.access-board.gov/ada/#ada-308_2_1">https://www.access-board.gov/ada/#ada-308_2_1</a>	2012 TAS Section: 308.2.1  2010 ADAS Section: 308.2.1  2015 ABAAS Section: 308.2.1

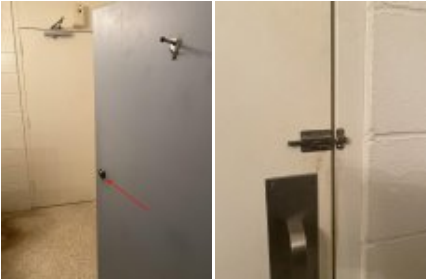
30	Structures on Property (Public) - Tour/Public Componets : HQ Building (Interior) - Restroom (Men's) Public/Staff	The locking/latching hardware is not accessible. Hand-activated door opening hardware, handles, pulls, latches, locks, and other operating devices on accessible doors shall have a shape that is easy to grasp with one hand and does not require tight grasping, tight pinching or twisting of the wrist to operate.	Turn knob lock on stall door and locking mechanism for restroom entrance door are not complaint.	<a href="https://www.access-board.gov/ada/#ada-604_8_1_2">https://www.access-board.gov/ada/#ada-604_8_1_2</a>	2012 TAS Section: 604.8.1.2  2010 ADAS Section: 604.8.1.2  2015 ABAAS Section: 604.8.1.2

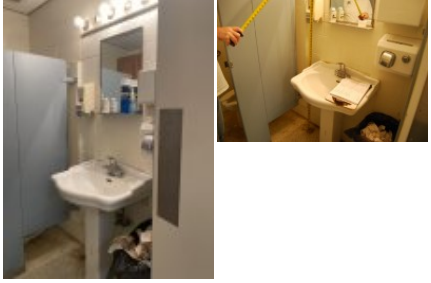
Finding Number	Area Description	Finding	As Built	Recommendation	Citation	Photos	Figure
31	Structures on Property (Public) - Tour/Public Componets : HQ Building (Interior) - Restroom (Men's) Public/Staff	There are not enough accessible lavatories. Where lavatories are provided, at least one shall be accessible and shall not be located in a toilet compartment.	The lavatory and accessories are not compliant.	Review lavatory componets to make accessible. <a href="https://www.access-board.gov/ada/#ada-213_3_4">https://www.access-board.gov/ada/#ada-213_3_4</a> <a href="https://www.access-board.gov/ada/#ada-606">https://www.access-board.gov/ada/#ada-606</a>	2012 TAS Section: 213.3.4  2010 ADAS Section: 213.3.4  2015 ABAAS Section: F213.3.4

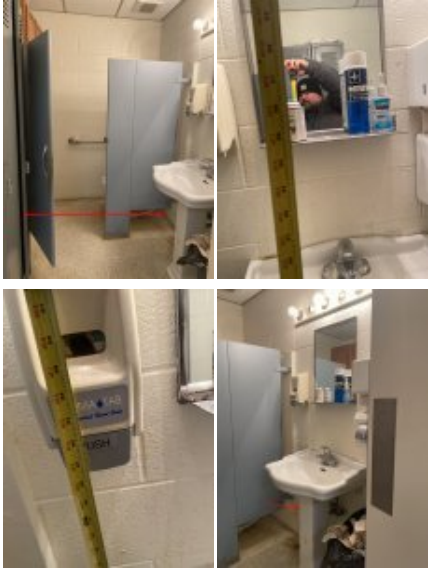
32	Structures on Property (Public) - Tour/Public Componets : HQ Building (Interior) - Restroom (Men's) Public/Staff	The lavatory contains several non compliant features, there is inadequate knee and toe space, the pipes are not wrapped or protected properly, the bowl is too low, the rim height exceed 34 inches A.F.F., and the faucet is non-requires tight grasping, pinching, or twisting of the wrist. The knee clearance, measured from the bottom of the apron or the outside bottom edge of the lavatory, must be 27 inches at a point located 8 inches back from the front edge and continuing to 11 inches minimum in depth at 9 inches above the floor. The top of the lavatory rim may be no higher than 34 inches.	Lavatory and accessories are not compliant. Entry door encroaches on clear floor space, due to sink model no knee space is provided, mirror height and soap dispenser height is not compliant, not enough clear floor space for approach to lavatory.	Review lavatory componets to make accessible. <a href="https://www.access-board.gov/ada/#ada-606">https://www.access-board.gov/ada/#ada-606</a> <a href="https://www.access-board.gov/ada/#ada-606_1">https://www.access-board.gov/ada/#ada-606_1</a>	2012 TAS Section: 606.1  2010 ADAS Section: 606.1

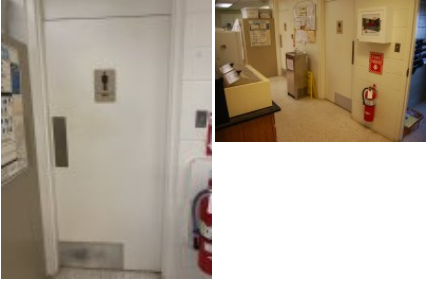
Finding Number	Area Description	Finding	As Built	Recommendation	Citation	Photos	Figure
37	Structures on Property (Public) - Tour/Public Componets : HQ Building (Interior) - Restroom (Men's) Public/Staff	The wall sign is incorrectly located. Where permanent identification signs are provided for rooms and spaces, signs shall be installed on the wall adjacent to the latch side of the door. Where there is no wall space on the latch side, including at double leaf doors, signs shall be placed on the nearest adjacent wall, preferably on the right. Mounting location shall be located so that a person may approach within 3 inches of the sign and that a clear floor space of 18 inches minimum by 18 inches minimum, centered on the tactile Characters, is provided beyond the arc of any door swing between the closed position and 45 degree open position.	Sign is placed in wrong location If there is not enough space to mount the sign in the specified location, it may be installed on the nearest adjacent wall in a clearly visible location. Generally, ADA signs should not be mounted directly on a door. Exceptions: For double doors with one active leaf, a sign should be installed on the inactive leaf.	Height Above Finish Floor or Ground <a href="https://www.access-board.gov/ada/#ada-703_4_1">https://www.access-board.gov/ada/#ada-703_4_1</a> Location <a href="https://www.access-board.gov/ada/#ada-703_4_2">https://www.access-board.gov/ada/#ada-703_4_2</a>	2012 TAS Section: 703.4.1  2010 ADAS Section: 703.4.1  2015 ABAAS Section: 703.4.1

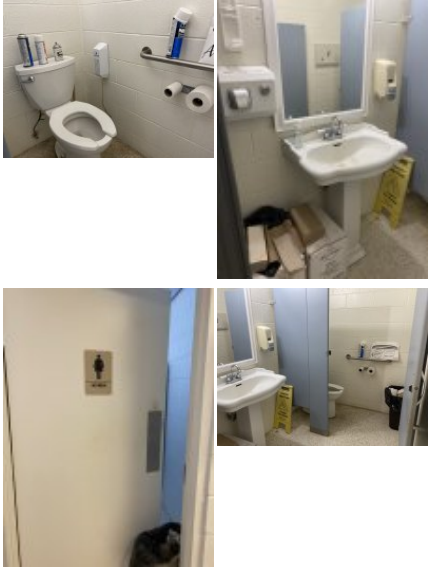
Finding Number	Area Description	Finding	As Built	Recommendation	Citation	Photos	Figure
39	Structures on Property (Public) - Tour/Public Componets : HQ Building (Interior) - Restroom (Women's) Public/Staff	The restroom is not nearly compliant. The restroom does not have the required minimum clear floor space or maneuvering clearances for the toilet. The restroom does not have the required minimum clear floor space or maneuvering clearances for the lavatory. The entry door does not contain the required minimum maneuvering spaces on the pull/push sides. The entry door encroach into the required clear floor space for fixtures. Grab bars are missing and/or incorrectly installed. Accessories, such as toilet seat covers, paper towel holders, garbage cans, hand dryers, and mirrors are either too high or without clear floor space or both. The restroom contain floor level changes greater than a 1/2 inch of the floor drains and is slope (XX) - (XX), the shower is too small and missing numerous accessible elements.	This restroom requires a number of componets to gain compliance.	<a href="https://www.access-board.gov/ada/#ada-213_2">https://www.access-board.gov/ada/#ada-213_2</a> Review restrooms componets to make accessible. <a href="https://www.access-board.gov/ada/#ada-603">https://www.access-board.gov/ada/#ada-603</a>	2012 TAS Section: 213.2  2010 ADAS Section: 213.2  2015 ABAAS Section: F213.2

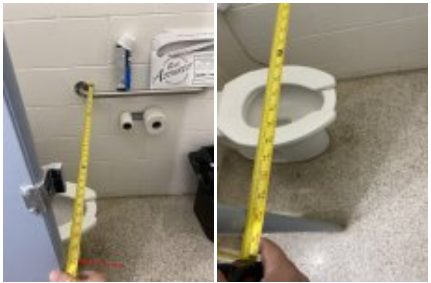
41	Structures on Property (Public) - Tour/Public Componets : HQ Building (Interior) - Restroom (Women's) Public/Staff	The toilet compartment is not wide enough. Wheelchair accessible compartments shall be 60 inches wide minimum measured perpendicular to the side wall, and 56 inches deep minimum for wall hung water closets and 59 inches deep minimum for floor mounted water closets measured perpendicular to the rear wall.	Stall width is 34"	<a href="https://www.access-board.gov/ada/#ada-604_8_1_1">https://www.access-board.gov/ada/#ada-604_8_1_1</a>	2012 TAS Section: 604.8.1.1  2010 ADAS Section: 604.8.1.1  2015 ABAAS Section: 604.8.1.1

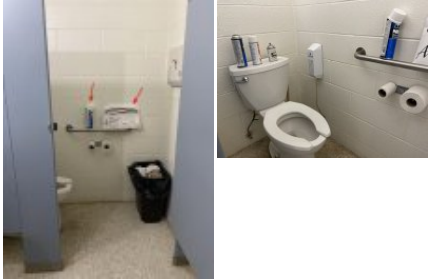
43	Structures on Property (Public) - Tour/Public Componets : HQ Building (Interior) - Restroom (Women's) Public/Staff	The side grab bars are not in the correct location. Grab bars on the side wall must be installed so that the end closest to the rear wall is maximum 12" from the rear wall. The end furthest from the rear wall must be mounted minimum 54" from the rear wall.	The grab bars are not compliant or missing. Side grab bar does not meet 42" min. There is no rear grab bar provided. Grab bar access is impeded by items placed in non compliant range above and below. Grab bars need to be installed in correct location outlined in ADA.	<a href="https://www.access-board.gov/ada/#ada-604_5">https://www.access-board.gov/ada/#ada-604_5</a> <a href="https://www.access-board.gov/ada/#ada-604_5_1">https://www.access-board.gov/ada/#ada-604_5_1</a> <a href="https://www.access-board.gov/ada/#ada-604_5_2">https://www.access-board.gov/ada/#ada-604_5_2</a> Review grab bar componets to make accessible <a href="https://www.access-board.gov/ada/#ada-609">https://www.access-board.gov/ada/#ada-609</a>	2012 TAS Section: 604.5.1  2010 ADAS Section: 604.5.1  2015 ABAAS Section: 604.5.1

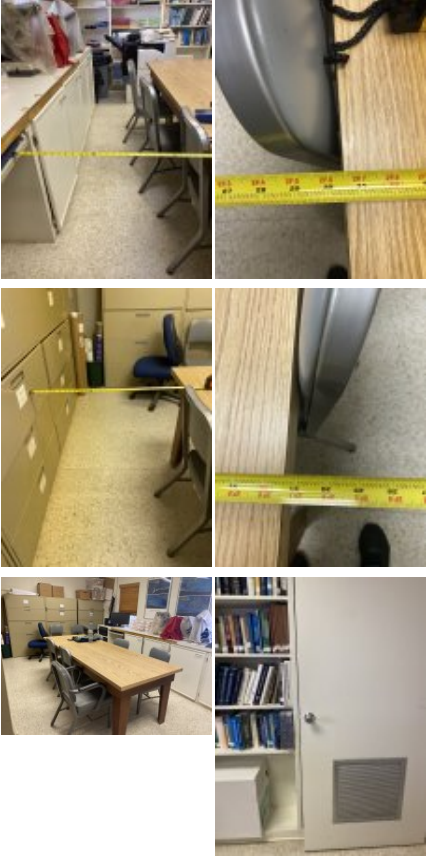
Finding Number	Area Description	Finding	As Built	Recommendation	Citation	Photos	Figure
56	Structures on Property (Public) - Tour/Public Componets : HQ Building (Interior) - Conference Room - TOUR	The route of travel at this location does not provide a minimum width of 36 inches. The clear width shall be permitted to be reduced to 32 inches minimum for a length of 24 inches maximum provided that reduced width segments are separated by segments that are 48 inches long minimum and 36 inches wide minimum.	Storage and shelving, printer impend accessible route, narrows down to less than 32 " Routes around conference room are not compliant.	<a href="https://www.access-board.gov/ada/#ada-403_5_1">https://www.access-board.gov/ada/#ada-403_5_1</a>	2012 TAS Section: 403.5.1  2010 ADAS Section: 403.5.1  2015 ABAAS Section: 403.5.1

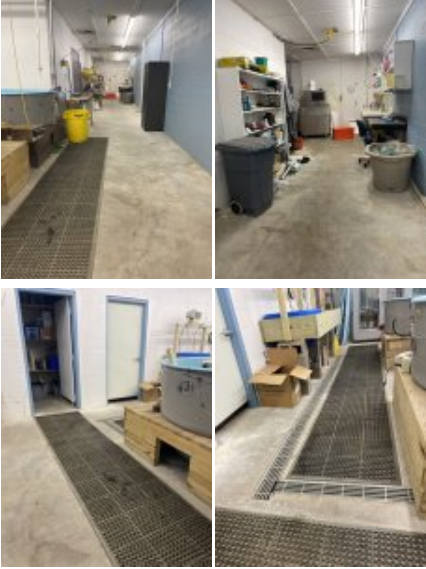
Finding Number	Area Description	Finding	As Built	Recommendation	Citation	Photos	Figure
57	Structures on Property (Public) - Tour/Public Componets : Wet Lab (Interior) - TOUR	State and local governments have an obligation to make their programs and services accessible to persons with disabilities. This may or may not require the alteration, addition or construction of existing facilities which predate The Americans with Disabilities Act (ADA) of 1990. Under the Code of Federal Regulations Section 35.151(b)(2) State and Local Government Title II entities may provide programmatic access where alterations to existing facilities would result in undue financial and administrative burdens. For Example, A public entity has six courtrooms in two existing buildings and determines that only three of those courtrooms and the public use and common use areas serving those courtrooms in one building are needed to be made accessible in order to satisfy its program access obligations. The entity must comply with 2010 Standards unless compliance would result in undue financial and administrative burdens and must take other actions that would not result in an undue financial burden to ensure access to persons with disabilities. This may include the scheduling of the various types of cases, hearings etc. in accessible courtrooms and relocating them where necessary to accommodate persons with disabilities. Having a defined program and effective communication process in place to ensure the public and employees can request accommodations is necessary to ensure equal access to the county's court system. Program access is not part of this evaluation and this information is being provided as an advisory only.	walkways are not accessible due to floor mats, grating on ground, and clutter along pathway.	Provide a reasonable modification to allow tour participants an equitable experience during this part of tour.	2010 ADAS Section: Advisory

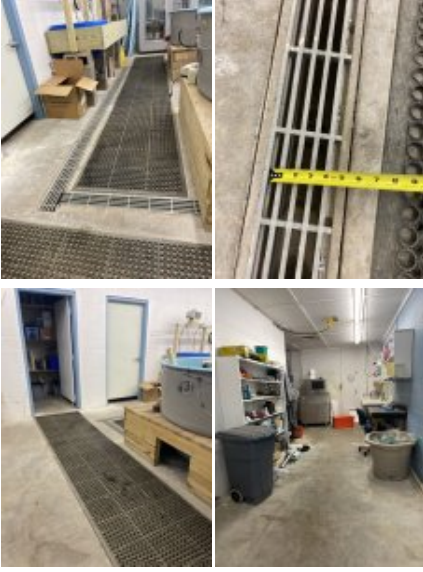
Finding Number	Area Description	Finding	As Built	Recommendation	Citation	Photos	Figure
58	Structures on Property (Public) - Tour/Public Components : Wet Lab (Interior) - TOUR	The path of contains multiple issues and is not accessible. The path of travel exceeds the maximum allowable cross and running slope requirements. It also contains changes in level and/or gaps that exceed the allowable maximum requirements. The path of travel does not meet the minimum width requirements for clearances, turning spaces, and/or passing spaces. The floor or ground surface is not firm, stable, and slip resistant.	Floor mats and floor grating are not compliant but necessary for building infrastructure.	Route around wet lab tanks does not need to be accessible but tour program does need to meet Title II requirements for accessible programs/services. Finding route which bypasses grating and floor mats, while clearing pathway clutter is an example of program modification.	2012 TAS Section: 403.1  2010 ADAS Section: 403.1  2015 ABAAS Section: 403.1

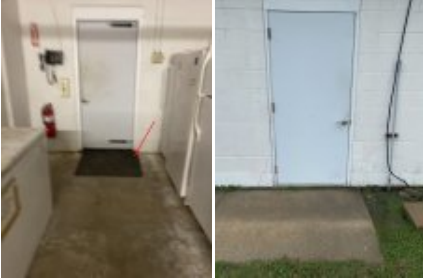
59	Structures on Property (Public) - Tour/Public Components : Wet Lab (Interior) - TOUR - Entrance Doors	The floor mat at the door is not secured in place. If carpet or carpet tile is used on a ground or floor surface, then it shall be securely attached; have a firm cushion, pad or backing or no cushion or pad; and have a level loop, textured loop, level-cut pile or level-cut/uncut pile texture. The maximum pile height shall be 1/2 inch. Exposed edges of carpet shall be fastened to floor surfaces and have trim along the entire length of the exposed edge. Recessed doormats shall be adequately anchored to prevent interference with wheelchair traffic.	Door mat is not of compliant size or style and does not meet compliance.	<a href="https://www.access-board.gov/ada/#ada-302_2">https://www.access-board.gov/ada/#ada-302_2</a>	2012 TAS Section: 302.2  2010 ADAS Section: 302.2  2015 ABAAS Section: 302.2

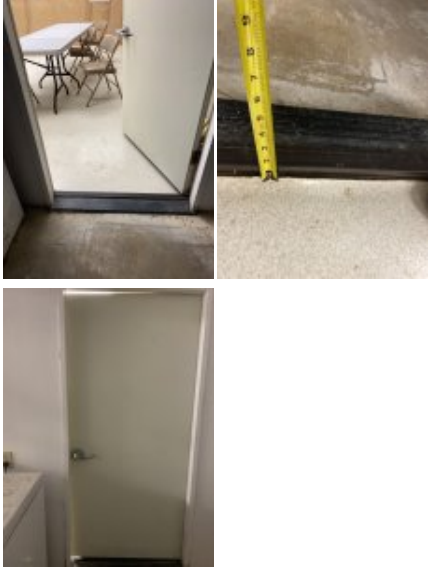
Finding Number	Area Description	Finding	As Built	Recommendation	Citation	Photos	Figure
61	Structures on Property (Public) - Tour/Public Componets : Wet Lab (Interior) - TOUR - Conference Room - TOUR	The threshold is greater than 1/2 inch high. The threshold at a doorway shall be no higher than 1/2 inch. Changes in level between 1/4 inch and 1/2 inch must be beveled at 1:2 or less. 1/4 inch is the maximum vertical rise.	Conference room entrance door threshold exceeds 1/2" tolerance.	<a href="https://www.access-board.gov/ada/#ada-404_2_5">https://www.access-board.gov/ada/#ada-404_2_5</a>	2012 TAS Section: 404.2.5  2010 ADAS Section: 404.2.5  2015 ABAAS Section: 404.2.5

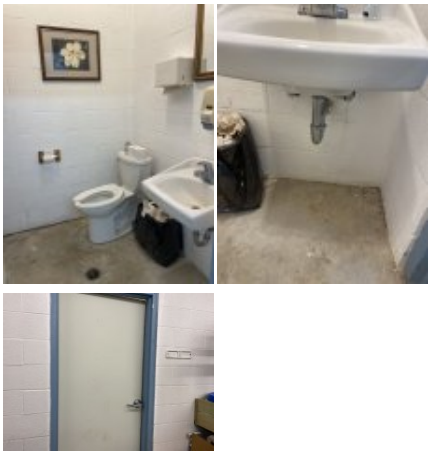
Finding Number	Area Description	Finding	As Built	Recommendation	Citation	Photos	Figure
63	Structures on Property (Public) - Tour/Public Componets : Wet Lab (Interior) - TOUR - Restroom (Unisex) Public/Staff	The restroom is not nearly compliant. The restroom does not have the required minimum clear floor space or maneuvering clearances for the toilet. The restroom does not have the required minimum clear floor space or maneuvering clearances for the lavatory. The entry door does not contain the required minimum maneuvering spaces on the pull/push sides. The entry door encroach into the required clear floor space for fixtures. Grab bars are missing and/or incorrectly installed. Accessories, such as toilet seat covers, paper towel holders, garbage cans, hand dryers, and mirrors are either too high or without clear floor space or both. The restroom contain floor level changes greater than a 1/2 inch of the floor drains and is slope (XX) - (XX), the shower is too small and missing numerous accessible elements.	This restroom requires a number of componets to gain compliance.	<a href="https://www.access-board.gov/ada/#ada-213_2">https://www.access-board.gov/ada/#ada-213_2</a> Review restrooms componets to make accessible. <a href="https://www.access-board.gov/ada/#ada-603">https://www.access-board.gov/ada/#ada-603</a>	2012 TAS Section: 213.2  2010 ADAS Section: 213.2  2015 ABAAS Section: F213.2

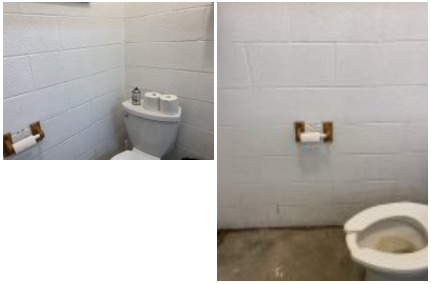
64	Structures on Property (Public) - Tour/Public Componets : Wet Lab (Interior) - TOUR - Restroom (Unisex) Public/Staff	Accessible toilets must have grab bars installed. The side grab bar must extend at least 54 inches minimum beyond the rear wall and start a maximum of 12 inches from the rear wall. The rear grab bar must be a minimum of 36 inches long and extend from the centerline of the toilet 12 inches minimum on one side and 24 inches minimum on the other side. Grab bars shall be installed in a horizontal position, 33 inches minimum and 36 inches maximum above the finish floor measured to the top of the gripping surface.	There are no grab bars installed at this time.	<a href="https://www.access-board.gov/ada/#ada-604_5">https://www.access-board.gov/ada/#ada-604_5</a> Review grab bar componets to make accessible <a href="https://www.access-board.gov/ada/#ada-609">https://www.access-board.gov/ada/#ada-609</a>	2012 TAS Section: 604.5  2010 ADAS Section: 604.5  2015 ABAAS Section: 604.5

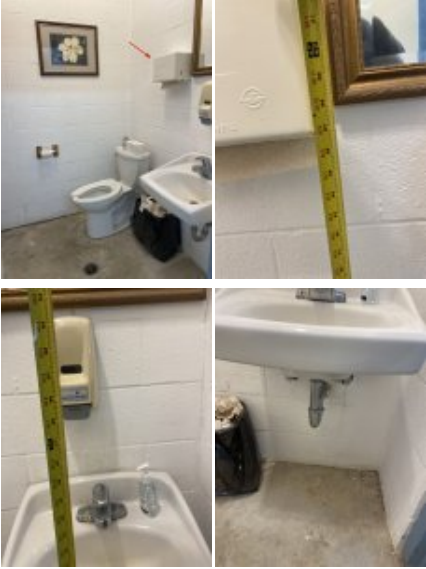
Finding Number	Area Description	Finding	As Built	Recommendation	Citation	Photos	Figure
65	Structures on Property (Public) - Tour/Public Componets : Wet Lab (Interior) - TOUR - Restroom (Unisex) Public/Staff	The lavatory contains several non compliant features, there is inadequate knee and toe space, the pipes are not wrapped or protected properly, the bowl is too low, the rim height exceed 34 inches A.F.F., and the faucet is non-requires tight grasping, pinching, or twisting of the wrist. The knee clearance, measured from the bottom of the apron or the outside bottom edge of the lavatory, must be 27 inches at a point located 8 inches back from the front edge and continuing to 11 inches minimum in depth at 9 inches above the floor. The top of the lavatory rim may be no higher than 34 inches.	A number of lavatory elements do not meet compliance, mirror, paper towel dispenser, and soap dispenser height not compliant, sink pipes are exposed. Space provided to access lavatory meets compliance once trashcan is removed.	<a href="https://www.access-board.gov/ada/#ada-213_3_4">https://www.access-board.gov/ada/#ada-213_3_4</a> Review lavatory componets to make accessible. <a href="https://www.access-board.gov/ada/#ada-606">https://www.access-board.gov/ada/#ada-606</a>	2012 TAS Section: 606.1  2010 ADAS Section: 606.1

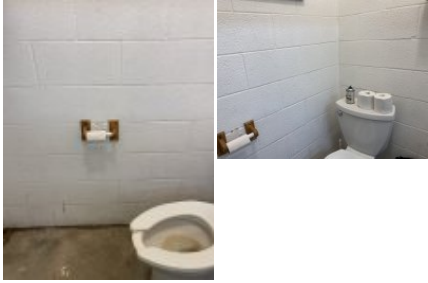
68	Structures on Property (Public) - Tour/Public Componets : Wet Lab (Interior) - TOUR - Restroom (Unisex) Public/Staff	The toilet paper is not installed within the compliant range in front of the toilet. Toilet paper dispensers shall be 7 inches minimum and 9 inches maximum in front of the water closet measured to the centerline of the dispenser. The outlet of the dispenser shall be 15 inches minimum and 48 inches maximum above the finish floor and shall not be located behind grab bars. Dispensers shall not be of a type that controls delivery or that does not allow continuous paper flow. There shall be a clearance of 1 1/2 inches minimum below the grab bar.	TP dispenser location is not compliant. Mounted too close to front of toilet.		<a href="https://www.access-board.gov/ada/#ada-604_7">https://www.access-board.gov/ada/#ada-604_7</a>	2012 TAS Section: 604.7  2010 ADAS Section: 604.7  2015 ABAAS Section: 604.7
