CF- Dickinson TX, Region 1 Office ADA Evaluation

1502 Pine Grove Dr

Accessibility Evaluation

Inspection Date: 04/13/2023

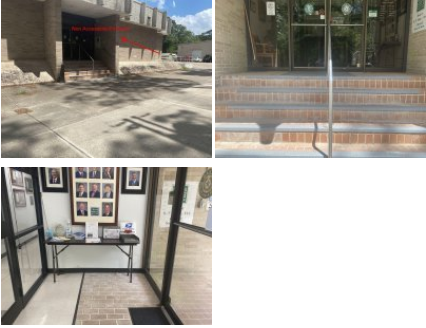
Finding Number	Area Description	Finding	As Built	Recommendation	Citation	Photos	Figure
1	Exterior of Property (Public): HQ Parking Lot (L) Side of Building (0 Spaces)	The entrance is not accessible and is missing signage. An identification sign identifying that this entrance is not accessible and directional signage pointing to the accessible entrance is required. When a directional sign is required, it should be located to minimize backtracking. In some cases, this could mean locating a sign at the beginning of a route, not just at the inaccessible entrances to a building.	Sign missing directing visitors to accessible entrance.	https://www.access-board.gov/ada/#ada-216_6	2010 ADAS Section: 216.6 2015 ABAAS Section: F216.6

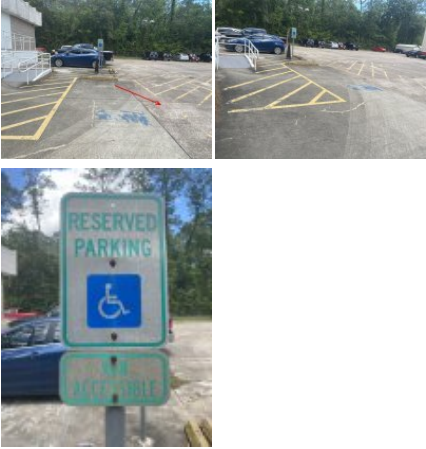
2	Exterior of Property (Public): HQ Parking Lot (R) Side of Building (2 Spaces) 1 Van 1 Car - Van Accessible Stall	The stripe is missing at the right side of the right parking stall which identifies its border. Vehicle spaces shall be marked to define the width, and shall have an adjacent access aisle.	Designated markings on ground beginning to fade on (R) side of stall and ISA insignia symbol is dilapidated. Stall and access aisles are compliant in dimensions	https://www.access-board.gov/aba/#aba-502_1 https://www.access-board.gov/aba/#aba-502_2	2012 TAS Section: 502.2 2010 ADAS Section: 502.2 2015 ABAAS Section: 502.1, 502.2

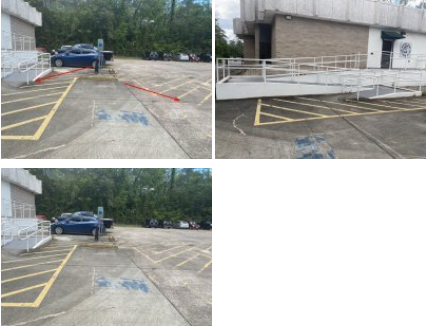
4	Exterior of Property (Public): HQ Parking Lot (R) Side of Building (2 Spaces) 1 Van 1 Car - Access Aisle (Van)	The access aisle is in not nearly compliant. The access aisle is not as long as the parking space it serves. There are no markings to discourage parking. The floor or ground surface is not firm stable or slip resistant. The parking space contains changes in level and/or gaps that exceed the maximum allowable requirements.	Access aisle on (R) side meets compliance in dimensions but markings are faded. Access aisle on (L) side obstructed by ramp, needs verification that if van stall 11' access aisle 5' or van stall 8' access aisle 8' is provided obstruction free for entire space. Striping markings for (L) side access aisle meets compliance.		https://www.access-board.gov/aba/#aba-502_3 2012 TAS Section: 502.3 2010 ADAS Section: 502.3 2015 ABAAS Section: 502.3

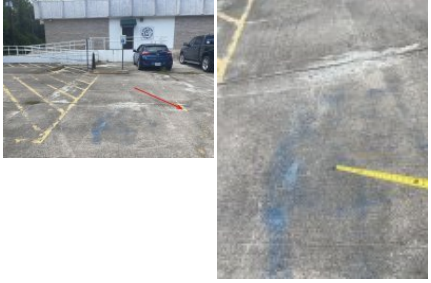
Finding Number	Area Description	Finding	As Built	Recommendation	Citation	Photos	Figure
5	Exterior of Property (Public): HQ Parking Lot (R) Side of Building (2 Spaces) 1 Van 1 Car - Car Accessible Stall	The stripe is missing at the right side of the right parking stall which identifies its border. Vehicle spaces shall be marked to define the width, and shall have an adjacent access aisle.	Striping for (R) side of accessible stall is missing. ISA insignia is dilapidated. Accessible stall dimensions meet compliance.	https://www.access-board.gov/aba/#aba-502_1 https://www.access-board.gov/aba/#aba-502_2	2012 TAS Section: 502.2 2010 ADAS Section: 502.2 2015 ABAAS Section: 502.1, 502.2

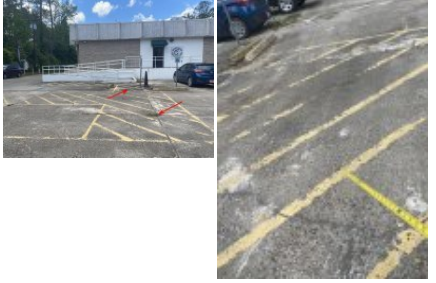
Finding Number	Area Description	Finding	As Built	Recommendation	Citation	Photos	Figure
7	Exterior of Property (Public): HQ Parking Lot (R) Side of Building (2 Spaces) 1 Van 1 Car - Access Aisle (Car)	The access aisle is in not nearly compliant. The access ai the minimum width. The access aisle is not as long as the parking space it serves. There are no markings to discourage parking. The floor or ground surface is not firm stable or slip resistant. The parking space contains changes in level and/or gaps that exceed the maximum allowable requirements.	Access aisle has large cracks and overgrowths preventing access. Access aisle markings are dilapidated and faded. Access aisle dimensions meet compliance.	https://www.access-board.gov/aba/#aba-502_3	2012 TAS Section: 502.3 2010 ADAS Section: 502.3 2015 ABAAS Section: 502.3

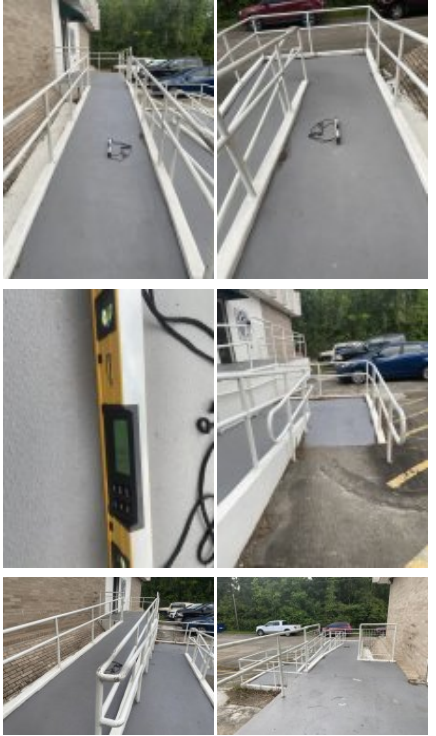
8	Exterior of Property (Public): HQ Parking Lot (R) Side of Building (2 Spaces) 1 Van 1 Car - Pathway to Building (Parking Lot to Accessible Entrance)	The ramps exceeds the maximum running slope (direction of travel) allowable of 8.33%. Ramps should have the least possible slope but in no case more than 8.3% (1:12).	Ramp run exceeds 8.33% allowance, measured at 9.5%. Needs to remain debris free and top of landing walkway requires minor repair due to cracking. Ramp surfacing, railing, and edge protection meet compliance.	https://www.access-board.gov/ada/#ada-405_2	2012 TAS Section: 405.2 2010 ADAS Section: 405.2 2015 ABAAS Section: 405.2

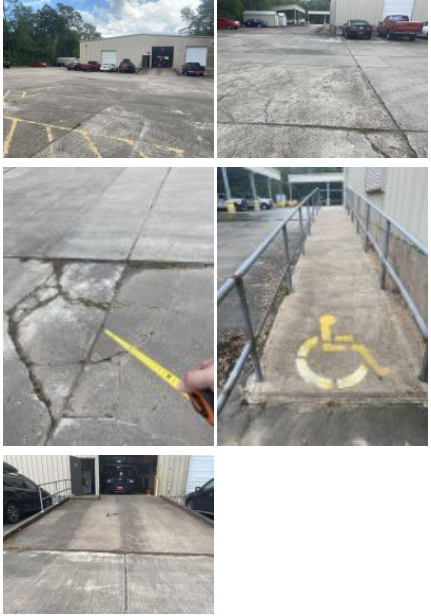
Finding Number	Area Description	Finding	As Built	Recommendation	Citation	Photos	Figure
11	Exterior of Property (Public): Lab & Conference Room Building (Exterior) - TOUR	The building entrance is not located on an accessible route. When a building, or portion of a building, is required to be accessible, an accessible route of travel shall be provided to all portions of the building, to accessible building entrances and between the building and the public way. At least one accessible route within the boundary of the site must be provided from public transportation stops, accessible parking and accessible passenger loading zones and public streets or sidewalks to the accessible building entrance they serve. The accessible route shall, to the maximum extent feasible, coincide with the route for the general public. At least one accessible route shall connect accessible buildings, facilities, elements and spaces that are on the same site. At least one accessible route shall connect accessible building or facility entrances with all accessible spaces and elements.	There is no accessible route via primary or secondary entrance to building. Neither route provided to building meet compliance. Route through parking lot uneven, large cracks, over growth prevent access. Ramps provided to access building do not meet compliance. This building is not accessible]	Review accessible pathway componets to make accessible https://www.access-board.gov/ada/#ada-206_2_1 https://www.access-board.gov/ada/#ada-402 https://www.access-board.gov/ada/#ada-403_1	2012 TAS Section: 206.2.1 2010 ADAS Section: 206.2.1 2015 ABAAS Section: F206.2.1

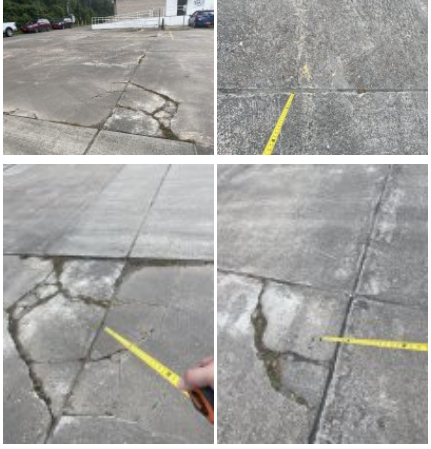
12	Exterior of Property (Public): Lab & Conference Room Building (Exterior) - TOUR	The accessible route contains loose gravel and/or surface materials that do not provide for a stable, firm slip resistant surface. Floor and ground surfaces shall be stable, firm, and slip resistant.	No accessible route from parking to lab building with conference room. Large cracks and gaps prevent access. Parking lot to lab/conference room	https://www.access-board.gov/ada/#ada-302_1	2012 TAS Section: 302.1 2010 ADAS Section: 302.1 2015 ABAAS Section: 302.1

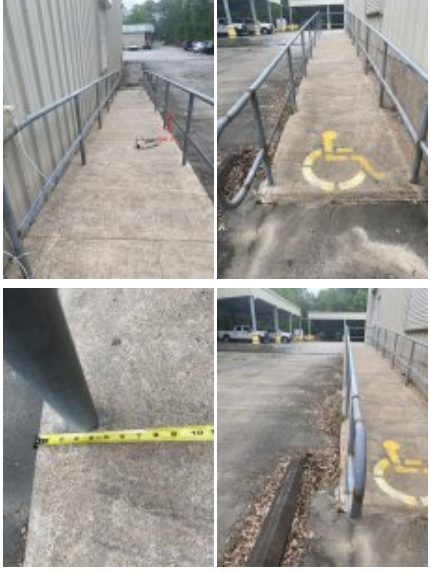
Finding Number	Area Description	Finding	As Built	Recommendation	Citation	Photos	Figure
13	Exterior of Property (Public): Lab & Conference Room Building (Exterior) - TOUR - Path of Travel Ramp (L) Side Entrance	The required edge protection is missing from the ramp run and/or ramp landing. Edge protection shall be provided on each side of ramp runs and at each side of ramp landings. The floor or ground surface of the ramp run or landing shall extend 12 inches minimum beyond the inside face of a handrail or a curb or barrier shall be provided that prevents the passage of a 4 inch diameter sphere, where any portion of the sphere is within 4 inches of the finish floor or ground surface.	No compliant edge protection is provided. Edge protection is either missing or not compliant and placed over 4" min requirement. This is considered the accessible entrance.	Recommend upgrading this entrance to full compliance instead of alternate entrance through garage. Edge protection https://www.access-board.gov/ada/#ada-405_9 Extended ground or floor surface https://www.access-board.gov/ada/#ada-405_9_1 Curb or barrier https://www.access-board.gov/ada/#ada-405_9_2	2012 TAS Section: 405.9.1, 405.9.2, 405.9 2010 ADAS Section: 405.9.2, 405.9.1, 405.9 2015 ABAAS Section: 405.9, 405.9.1, 405.9.2

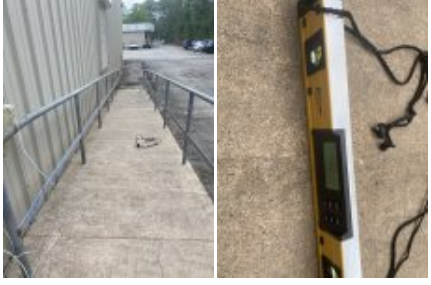
14	Exterior of Property (Public): Lab & Conference Room Building (Exterior) - TOUR - Path of Travel Ramp (L) Side Entrance	The ramps exceeds the maximum running slope (direction of travel) allowable of 8.33%. Ramps should have the least possible slope but in no case more than 8.3% (1:12).	Measures at 10.2%	https://www.access-board.gov/ada/#ada-405_2	2012 TAS Section: 405.2 2010 ADAS Section: 405.2 2015 ABAAS Section: 405.2

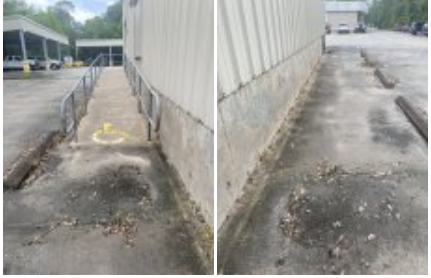
15	Exterior of Property (Public): Lab & Conference Room Building (Exterior) - TOUR - Path of Travel Ramp (L) Side Entrance	The accessible route contains loose gravel and/or surface materials that do not provide for a stable, firm slip resistant surface. Floor and ground surfaces shall be stable, firm, and slip resistant.	Debris and other loose materials preventing access.	https://www.access-board.gov/ada/#ada-302_1	2012 TAS Section: 302.1 2010 ADAS Section: 302.1 2015 ABAAS Section: 302.1

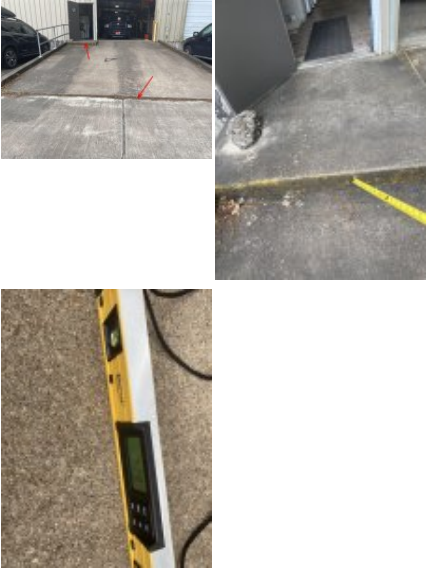
17	Exterior of Property (Public): Lab & Conference Room Building (Exterior) - TOUR - Path of Travel (Main Route)	The path of contains multiple issues and is not accessible. The path of travel exceeds the maximum allowable cross and running slope requirements. It also contains changes in level and/or gaps that exceed the allowable maximum requirements. The path of travel does not meet the minimum width requirements for clearances, turning spaces, and/or passing spaces. The floor or ground surface is not firm, stable, and slip resistant.	Route is not compliant due to ramp slope, and large lip to access entrance. This areas does not operate as main or accessible entrance. This is considered secondary entrance and is mainly used for vehicle work.	Recommend upgrading alternate access route, with ramp, to full compliance instead of this route. https://www.access-board.gov/ada/#ada-403_1	2010 ADAS Section: 403.1 2015 ABAAS Section: 403.1

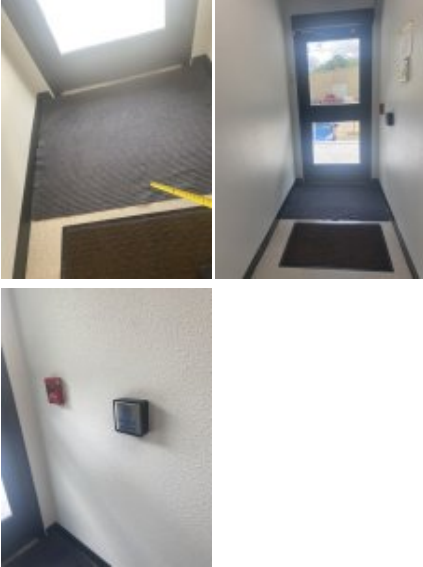
Finding Number	Area Description	Finding	As Built	Recommendation	Citation	Photos	Figure
19	Structures on Property (Public) - Tour/Public Componets : HQ Building (Interior) - Accessible Entrance Doors	The floor mat at the door is not secured in place. If carpet or carpet tile is used on a ground or floor surface, then it shall be securely attached; have a firm cushion, pad or backing or no cushion or pad; and have a level loop, textured loop, level-cut pile or level-cut/uncut pile texture. The maximum pile height shall be 1/2 inch. Exposed edges of carpet shall be fastened to floor surfaces and have trim along the entire length of the exposed edge. Recessed doormats shall be adequately anchored to prevent interference with wheelchair traffic.	Floor Mat is not in good working condition or secured to floor, not compliant Auto door entrance meets compliance for interior mount. This entrance is considered accessible entrance and would need a few elements to meet full compliance.	https://www.access-board.gov/ada/#ada-302_2	2012 TAS Section: 302.2 2010 ADAS Section: 302.2 2015 ABAAS Section: 302.2

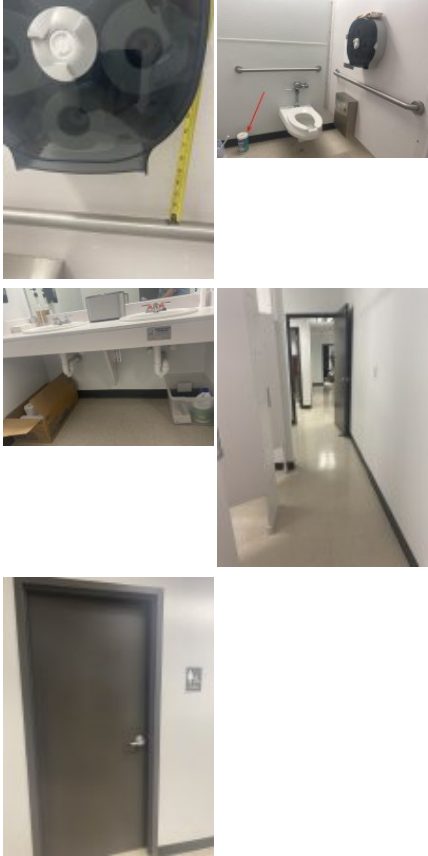
Finding Number	Area Description	Finding	As Built	Recommendation	Citation	Photos	Figure
22	Structures on Property (Public) - Tour/Public Componets : HQ Building (Interior) - Restroom (Women's) Public/Staff	The toilet paper dispenser is mounted too close to the top of the grab bar, minimizing the gripping surface. Adjacent elements shall be positioned to provide unobstructed use of grab bars. The space between the grab bar and projecting objects above shall be 12 inches minimum.	Majority of restroom componets meet compliance. TP dispenser mounted in wrong location, impedes access. Remove obstruction into restroom clear floor space.	https://www.access-board.gov/ada/#ada-609_3	2012 TAS Section: 609.3 2010 ADAS Section: 609.3 2015 ABAAS Section: 609.3

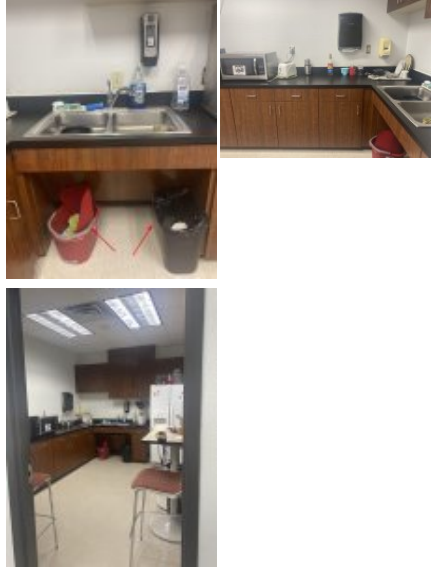
Finding Number	Area Description	Finding	As Built	Recommendation	Citation	Photos	Figure
25	Structures on Property (STAFF): HQ Building (Interior) - Kitchenette	Knee and toe space has not been provided at the sink. Kitchen sinks must be provided with a clear floor space positioned for a forward approach including knee and toe clearance.	Knee and toe space is obstructed to sink due to clutter. Paper towel dispenser placed out of range. Remove clutter and provide compliant paper towel option to meet compliance.	https://www.access-board.gov/ada/#ada-606_2 https://www.access-board.gov/ada/#ada-804_4 https://www.access-board.gov/ada/#ada-308_1	2012 TAS Section: 606.2, 804.4 2010 ADAS Section: 606.2, 804.4 2015 ABAAS Section: 606.2, 804.4

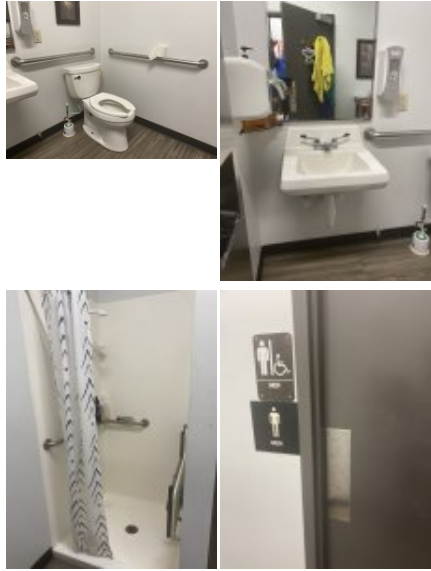
26	Structures on Property (STAFF): Lab/Conference Room Building (Interior) - Restroom/Showers (Men's)	The toilet paper dispenser does not allow a continuous flow. Toilet paper dispensers shall be 7 inches minimum and 9 inches maximum in front of the water closet measured to the centerline of the dispenser. The outlet of the dispenser shall be 15 inches minimum and 48 inches maximum above the finish floor and shall not be located behind grab bars. Dispensers shall not be of a type that controls delivery or that does not allow continuous paper flow. There shall be a clearance of 1 1/2 inches minimum below the grab bar.	Restroom meets most compliance standards. TP dispenser is not provided.	https://www.access-board.gov/ada/#ada-604_7	2012 TAS Section: 604.7 2010 ADAS Section: 604.7 2015 ABAAS Section: 604.7

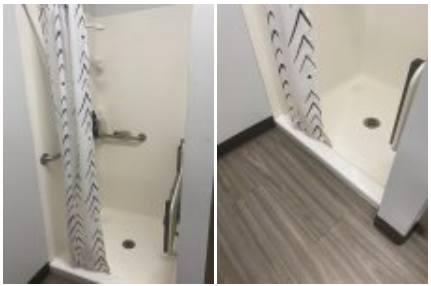
Finding Number	Area Description	Finding	As Built	Recommendation	Citation	Photos	Figure
27	Structures on Property (STAFF): Lab/Conference Room Building (Interior) - Restroom/Shower (Men's)	There are no accessible bathing and shower facilities. Where bathtubs or showers are provided, at least one accessible bathtub or at least one accessible shower shall be provided.	Shower has some accessible componets but is not considered compliant due to threshold entrance, and shower head location/type.	There is no accessible shower at this time https://www.access-board.gov/ada/#ada-213_3_6 Review shower or tub componets to make accessible https://www.access-board.gov/ada/#ada-607 https://www.access-board.gov/ada/#ada-608	2012 TAS Section: 213.3.6 2010 ADAS Section: 213.3.6 2015 ABAAS Section: F213.3.6

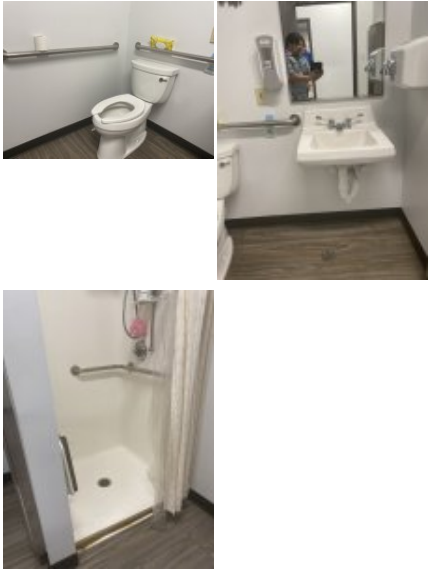
28	Structures on Property (STAFF): Lab/Conference Room Building (Interior) - Restroom/Shower (Women's)	The toilet paper dispenser does not allow a continuous flow. Toilet paper dispensers shall be 7 inches minimum and 9 inches maximum in front of the water closet measured to the centerline of the dispenser. The outlet of the dispenser shall be 15 inches minimum and 48 inches maximum above the finish floor and shall not be located behind grab bars. Dispensers shall not be of a type that controls delivery or that does not allow continuous paper flow. There shall be a clearance of 1 1/2 inches minimum below the grab bar.	Restroom meets most compliance standards. TP dispenser is not provided.	https://www.access-board.gov/ada/#ada-604_7	2012 TAS Section: 604.7 2010 ADAS Section: 604.7 2015 ABAAS Section: 604.7
