CF-Rockport TX, Region 2 Office ADA Evaluation

702 Navigation Cir

Accessibility Evaluation

Inspection Date: 02/16/2023

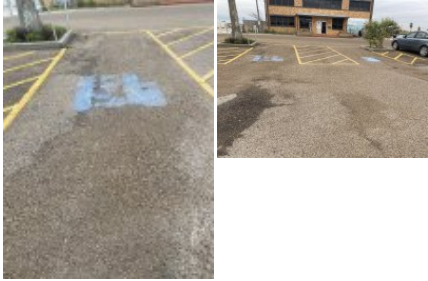
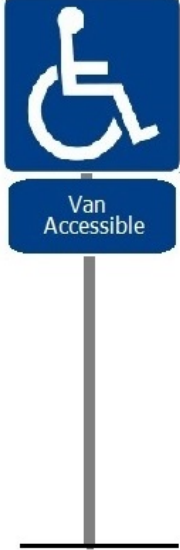
2	Exterior of Property (Public): HQ Parking Lot (2 Spaces) 2 Unlabeled - Unlabeled Stall (L) Side	The van stall is missing a sign identifying it as a van accessible stall. Parking space identification signs shall include the International Symbol of Accessibility. Signs identifying van parking spaces shall contain the designation "van accessible."	Both stalls are missing accessible parking signs, one spot needs to be designated van, both stalls and access aisle meet van dimensions requirements.	https://www.access-board.gov/ada/#ada-502_6	2012 TAS Section: 502.6 2010 ADAS Section: 502.6 2015 ABAAS Section: 502.6

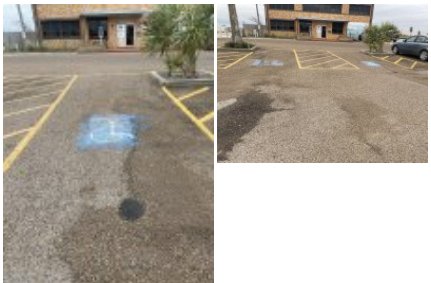
Finding Number	Area Description	Finding	As Built	Recommendation	Citation	Photos	Figure	
4	Exterior of Property (Public): HQ Parking Lot (2 Spaces) 2 Unlabeled - Unlabeled Stall (R) Side	The van stall is missing a sign identifying it as a van accessible stall. Parking space identification signs shall include the International Symbol of Accessibility. Signs identifying van parking spaces shall contain the designation "van accessible."	Both stalls are missing accessible parking signs, one spot needs to be designated van, both stalls and access aisle meet van dimensions requirements.		https://www.access-board.gov/ada/#ada-502_6	2012 TAS Section: 502.6 2010 ADAS Section: 502.6 2015 ABAAS Section: 502.6

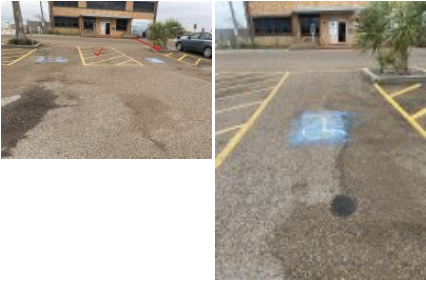
8	Exterior of Property (Public): HQ Parking Lot (2 Spaces) 2 Unlabeled - Access Aisle (R) Side Unlabeled Stall	The access aisle is not as long as the parking space/s they serve and is obstructed by a curb or other obstruction which reduces its required length. Access aisles shall extend the full length of the parking spaces they serve.	Access aisle impeded by planter obstruction, access aisle needs to run entire length of parking space. Technically not necessary since shared access aisle satisfies compliance.	Recommend removing access aisle or reconfiguring parking lot to allow for space required. https://www.access-board.gov/ada/#ada-502_3_2	2012 TAS Section: 502.3.2 2010 ADAS Section: 502.3.2 2015 ABAAS Section: 502.3.2

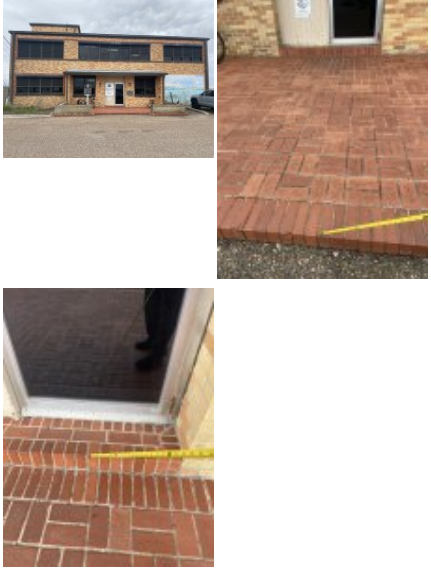
Finding Number	Area Description	Finding	As Built	Recommendation	Citation	Photos	Figure	
10	Exterior of Property (Public): HQ Parking Lot (2 Spaces) 2 Unlabeled - Pathway to Building (Parking Lot to HQ Entrance)	The building entrance is not located on an accessible route. When a building, or portion of a building, is required to be accessible, an accessible route of travel shall be provided to all portions of the building, to accessible building entrances and between the building and the public way. At least one accessible route within the boundary of the site must be provided from public transportation stops, accessible parking and accessible passenger loading zones and public streets or sidewalks to the accessible building entrance they serve. The accessible route shall, to the maximum extent feasible, coincide with the route for the general public. At least one accessible route shall connect accessible buildings, facilities, elements and spaces that are on the same site. At least one accessible route shall connect accessible building or facility entrances with all accessible spaces and elements.	Due to lip and thresholds there is no accessible route into building. This building is not accessible.		https://www.access-board.gov/ada/#ada-206_2_1	2012 TAS Section: 206.2.1 2010 ADAS Section: 206.2.1 2015 ABAAS Section: F206.2.1

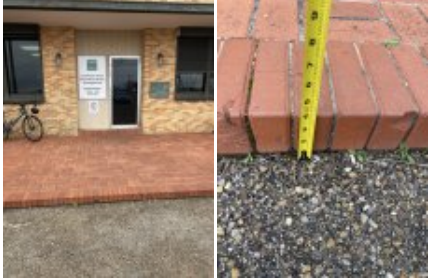
11	Exterior of Property (Public): HQ Parking Lot (2 Spaces) 2 Unlabeled - Pathway to Building (Parking Lot to HQ Entrance)	The walkway contains changes in level greater than a 1/2 inch high that should be ramped. Changes in level greater than 1/2 inch high shall be constructed as a ramp or curb ramp.	Lip prevent access into building. Measures at 4"		https://www.access-board.gov/ada/#ada-303_4	2012 TAS Section: 303.4 2010 ADAS Section: 303.4 2015 ABAAS Section: 303.4

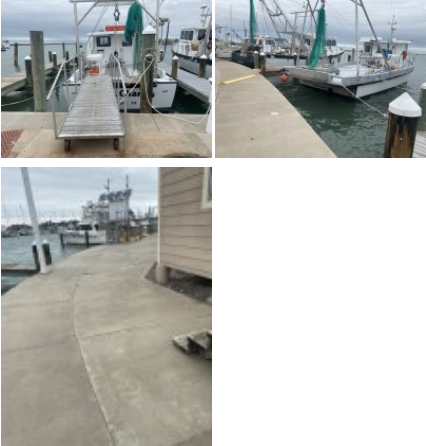
Finding Number	Area Description	Finding	As Built	Recommendation	Citation	Photos	Figure
12	Exterior of Property (Public): Research and Skiv Vessels	State and local governments have an obligation to make their programs and services accessible to persons with disabilities. This may or may not require the alteration, addition or construction of existing facilities which predate The Americans with Disabilities Act (ADA) of 1990. Under the Code of Federal Regulations Section 35.151(b)(2) State and Local Government Title II entities may provide programmatic access where alterations to existing facilities would result in undue financial and administrative burdens. For Example, A public entity has six courtrooms in two existing buildings and determines that only three of those courtrooms and the public use and common use areas serving those courtrooms in one building are needed to be made accessible in order to satisfy its program access obligations. The entity must comply with 2010 Standards unless compliance would result in undue financial and administrative burdens and must take other actions that would not result in an undue financial burden to ensure access to persons with disabilities. This may include the scheduling of the various types of cases, hearings etc. in accessible courtrooms and relocating them where necessary to accommodate persons with disabilities. Having a defined program and effective communication process in place to ensure the public and employees can request accommodations is necessary to ensure equal access to the county's court system. Program access is not part of this evaluation and this information is being provided as an advisory only.	Site does allow volunteers to accompany research outings on water. These boats and trips are not accessible. Exterior route leading to boats meets compliance.	Volunteer forms should address physical requirements to participate in program, if forms do not address this already. Provide an equitable experience for volunteers who do not meet physical requirements to participate in program. It's recommended volunteers have a few mobility issues and majority of physical abilities to accompany trips due to safety concerns and type of work needed to accomplish.	2010 ADAS Section: Advisory

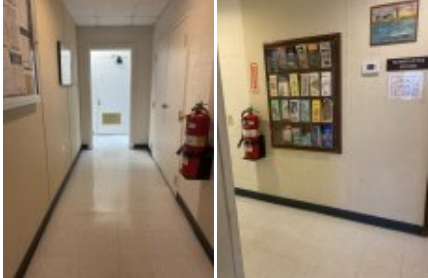
Finding Number	Area Description	Finding	As Built	Recommendation	Citation	Photos	Figure
13	Structures on Property (Public) - Tour/Public Componets : HQ Building (Interior) Lobby Area 1st Floor	The element projects more than 4 inches into the circulation path. Wall-mounted objects that have leading edges between 27 inches and 80 inches from the floor must not project more than 4 inches into the circulation path. Protruding objects that extend to the floor or within 27 inches of the floor are cane detectable and are therefore not hazardous. Where it is necessary or desirable to have objects protrude from the wall, a manner of cane detection must be provided.	Fire extinguisher is protruding object, There are no official ADA fire extinguisher height or fire alarm ADA requirements. However, there are rules that govern the placement of all protruding objects, no matter their function, to accommodate blind and other visually impaired people	https://www.access-board.gov/ada/#ada-307_2	2012 TAS Section: 307.2 2010 ADAS Section: 307.2 2015 ABAAS Section: 307.2

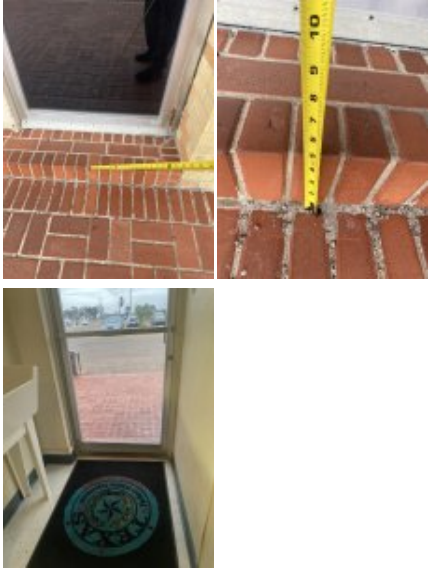
14	Structures on Property (Public) - Tour/Public Componets : HQ Building (Interior) Lobby Area 1st Floor - Entrance/Exit Doors	The door maneuvering clearance contains changes in level. Floor or ground surface within required maneuvering clearances shall comply with Floor or Ground Surfaces. Changes in level are not permitted. The entire maneuvering clearance must be free of obstructions and must be flat (2% max. slope is considered flat in any direction).	Large lip over 4" prevent access to door entrance.	https://www.access-board.gov/ada/#ada-404_2_4_4	2012 TAS Section: 404.2.4.4 2010 ADAS Section: 404.2.4.4 2015 ABAAS Section: 404.2.4.4

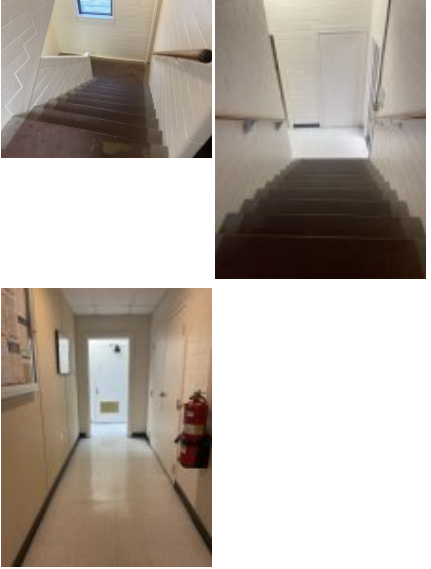
Finding Number	Area Description	Finding	As Built	Recommendation	Citation	Photos	Figure
15	Structures on Property (Staff) : HQ Building (Interior) Staff Areas 2nd Floor	At least one accessible route (i.e. elevator, ramp or platform lift) shall connect each story and mezzanine in multi-story buildings and facilities. The following buildings and facilities do not require vertical access: In private buildings or facilities that are less than three stories or that have less than 3000 square feet per story, an accessible route shall not be required to connect stories provided that the building or facility is not a shopping center, a shopping mall, the professional office of a health care provider, a terminal, depot or other station used for specified public transportation, an airport passenger terminal, or another type of facility as determined by the Attorney General. The building or facility is not currently being used as a shopping center, a shopping mall, the professional office of a health care provider, a terminal, depot or other station used for specified public transportation or an airport passenger terminal. If this changes in the future, the building or facility may not be eligible for this exception. The elevator exemption does not obviate or limit, in any way the obligation to comply with the other accessibility requirements established in the 2010 ADAS for the second floor as they are readily achievable to do so.	There is no accessible route to 2nd floor. All 2nd floor elements are for staff only.	Access to 2nd floor is not required at this time.	2012 TAS Section: 206.2.3 2010 ADAS Section: 206.2.3 2015 ABAAS Section: F206.2.3

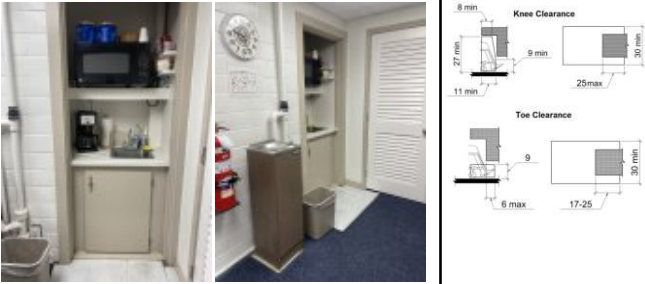
16	Structures on Property (Staff) : HQ Building (Interior) Staff Areas 2nd Floor - Kitchenette	The required number of accessible sinks is not provided. Where sinks are provided, at least 5 percent, but no fewer than one, of each type provided in each accessible room or space shall be accessible. The toe clearance is the space under the sink between the finish floor or ground and 9 inches above the finish floor 30 inches wide minimum. The toe clearance shall extend a minimum of 17 inches and a maximum of 25 inches underneath the sink.	Best practice to make sinks accessible via front approach in any areas where food prep is done. Sinks are not accessible via frontal or parallel approach due to rim height. Sinks do not require knee and toe space since there is no stove top oven in vicinity. This sink would qualify for parallel approach.	https://www.access-board.gov/ada/#ada-212_3	2012 TAS Section: 212.3 2010 ADAS Section: 212.3 2015 ABAAS Section: F212.3

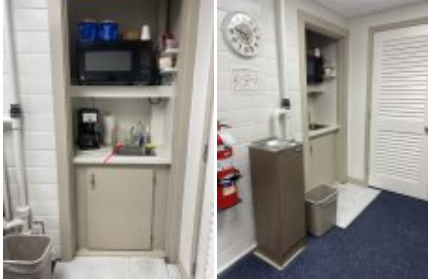
18	Structures on Property (Staff) : HQ Building (Interior) Staff Areas 2nd Floor - Kitchenette	Knee and toe space has not been provided at the sink. Kitchen sinks must be provided with a clear floor space positioned for a forward approach including knee and toe clearance.	Sink does not provide parallel or forward approach. Sink can be made to approach via parallel since they do not have a kitchenette or food prep area in traditional sense Not enough clear floor space provided for parallel approach.	https://www.access-board.gov/ada/#ada-606_2 https://www.access-board.gov/ada/#ada-804_4	2012 TAS Section: 606.2, 804.4 2010 ADAS Section: 606.2, 804.4 2015 ABAAS Section: 606.2, 804.4

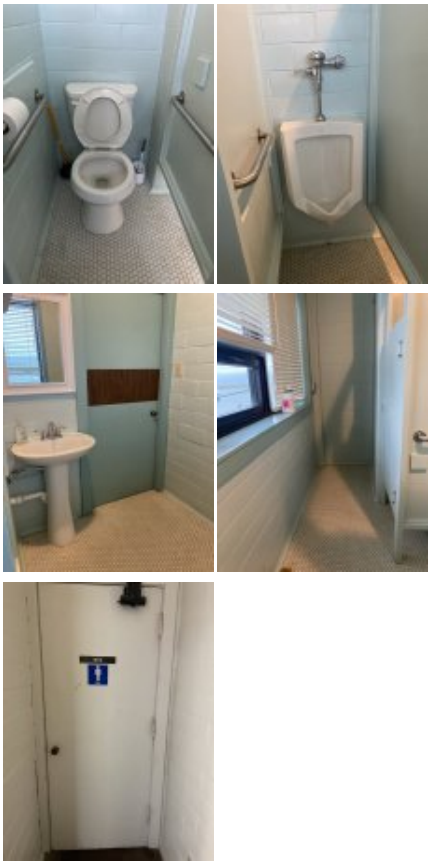
Finding Number	Area Description	Finding	As Built	Recommendation	Citation	Photos	Figure
19	Structures on Property (Staff) : HQ Building (Interior) Staff Areas 2nd Floor - Restroom (Men's)	The restrooms is not nearly compliant. - The restroom does not have the required minimum clear floor space or maneuvering clearances for the toilet. - The restroom does not have the required minimum clear floor space or maneuvering clearances for the lavatory. - The entry door does not contain the required minimum 60 inches maneuvering space on the pull side - The entry door encroach into the required clear floor space for fixtures. - Door opening pressure was measured at greater than 5 pounds. - Grab bars are incorrectly installed. - Accessories, such as toilet seat covers, paper towel holders, garbage cans, hand dryers and mirrors are either too high or without clear floor space or both. - The restroom contain floor level changes greater than a 1/2 inch at the floor drains.	This restroom requires a number of componets to gain compliance.	https://www.access-board.gov/ada/#ada-213_2 Review restrooms componets to make accessible. https://www.access-board.gov/ada/#ada-603	2012 TAS Section: 213.2 2010 ADAS Section: 213.2 2015 ABAAS Section: F213.2

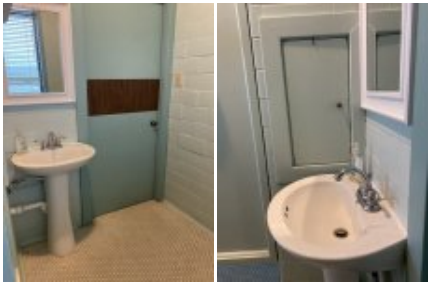
20	Structures on Property (Staff) : HQ Building (Interior) Staff Areas 2nd Floor - Restroom (Men's)	There are not enough accessible lavatories. Where lavatories are provided, at least one shall be accessible and shall not be located in a toilet compartment.	Restroom sinks are required to have front approach with knee and toe space provided. Mirror height and soap dispenser not compliant.	https://www.access-board.gov/ada/#ada-213_3_4 Review lavatory componets to make accessible. https://www.access-board.gov/ada/#ada-606	2012 TAS Section: 213.3.4 2010 ADAS Section: 213.3.4 2015 ABAAS Section: F213.3.4

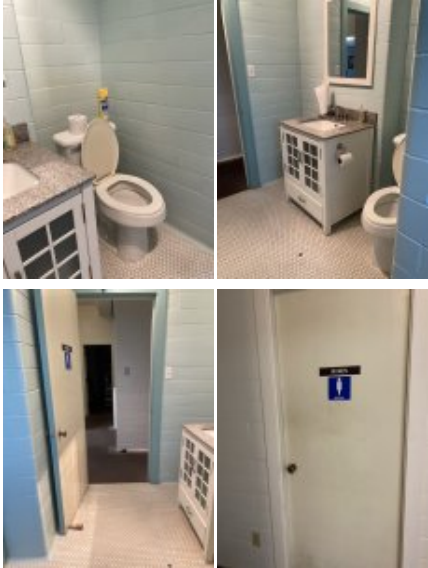
22	Structures on Property (Staff) : HQ Building (Interior) Staff Areas 2nd Floor - Restroom (Women's)	The restroom is not nearly compliant. The restroom does not have the required minimum clear floor space or maneuvering clearances for the toilet. The restroom does not have the required minimum clear floor space or maneuvering clearances for the lavatory. The entry door does not contain the required minimum maneuvering spaces on the pull/push sides. The entry door encroach into the required clear floor space for fixtures. Grab bars are missing and/or incorrectly installed. Accessories, such as toilet seat covers, paper towel holders, garbage cans, hand dryers, and mirrors are either too high or without clear floor space or both. The restroom contain floor level changes greater than a 1/2 inch of the floor drains and is slope (XX) - (XX), the shower is too small and missing numerous accessible elements.	This restroom requires a number of componets to gain compliance.	https://www.access-board.gov/ada/#ada-213_2 https://www.access-board.gov/ada/#ada-603	2012 TAS Section: 213.2 2010 ADAS Section: 213.2 2015 ABAAS Section: F213.2
