# Sea Center CF- ADA Evaluation

**CF-Lake Jackson TX, Sea Center ADA Evaluation**

**Accessibility Evaluation**

**Inspection Date: 07/28/2021**

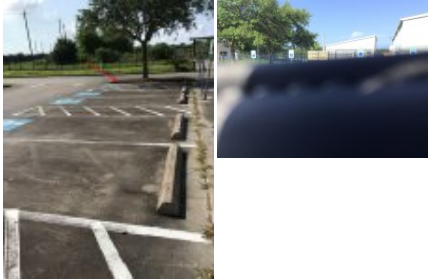
Finding Number	Area Description	Finding	As Built	Recommendation	Citation	Photos	Figure																										
1	Exterior of Property (Public): Visitors Center Parking Lot (6 Spaces) 1 Van 5 Car	The parking lot has been found to be in substantial compliance with accessibility codes, standards, and regulations. Needs Photo representation.	Parking lot meets majority compliance standards, Parking lot considered compliant. There are 6 accessible spots in front of building (1 Van 5 Car) and ? access aisles. Needs photo representation	N/A	2012 TAS Section: Advisory 2010 ADAS Section: Advisory 2015 ABAAS Section: Advisory																												
2	Exterior of Property (Public): Visitors Center Parking Lot (6 Spaces) 1 Van 5 Car	The required number of van accessible stalls is not provided. There are (XX) accessible parking stalls including (XX) designated for a van. There should be a minimum of (XX) accessible parking stalls including a minimum of (XX) van accessible stalls.	Due to parking lot size an additional van stall needs to be added. There are 6 accessible spots in front of building. Far (L) accessible stall meets van stall dimensions and markings requirements. Pending photo representation,	Recommend adding additional van stall identified on far (L) side of parking lot. <a href="https://www.access-board.gov/ada/#ada-208_2">https://www.access-board.gov/ada/#ada-208_2</a> <a href="https://www.access-board.gov/ada/#ada-208_2_4">https://www.access-board.gov/ada/#ada-208_2_4</a>	2012 TAS Section: 208.2, 208.2.4  2010 ADAS Section: 208.2, 208.2.4  2015 ABAAS Section: F208.2, F208.2.4

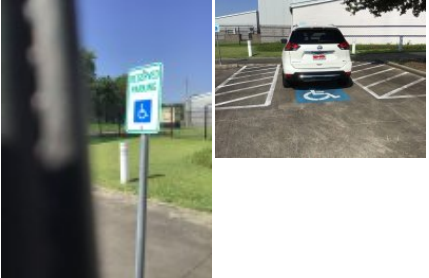
Finding Number	Area Description	Finding	As Built	Recommendation	Citation	Photos	Figure
4	Exterior of Property (Public): Visitors Center Parking Lot (6 Spaces) 1 Van 5 Car - Van Accessible Stall	The van stall is missing a sign identifying it as a van accessible stall. Parking space identification signs shall include the International Symbol of Accessibility. Signs identifying van parking spaces shall contain the designation "van accessible."	Accessible van stall missing designated van parking sign. Pending better photo representation	<a href="https://www.access-board.gov/ada/#ada-502_6">https://www.access-board.gov/ada/#ada-502_6</a>	2012 TAS Section: 502.6 2010 ADAS Section: 502.6 2015 ABAAS Section: 502.6

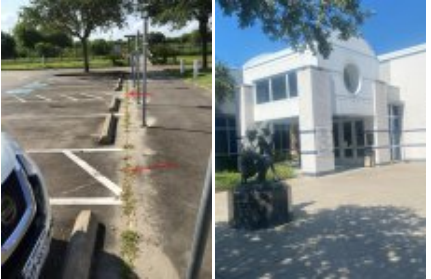
Finding Number	Area Description	Finding	As Built	Recommendation	Citation	Photos	Figure
7	Exterior of Property (Public): Visitors Center Parking Lot (6 Spaces) 1 Van 5 Car - Access Aisles (? Total)	The access aisles has been found to be in substantial compliance with accessibility codes, standards, and regulations.	The access aisles (? total) meet compliance in dimensions, markings, and sloping requirements. Needs photo representation.	N/A	2012 TAS Section: Advisory 2010 ADAS Section: Advisory 2015 ABAAS Section: Advisory		
8	Exterior of Property (Public): Visitors Center Parking Lot (6 Spaces) 1 Van 5 Car - Pathway to Building (Parking Lot to Visitors Center)	The accessible route contains loose gravel and/or surface materials that do not provide for a stable, firm slip resistant surface. Floor and ground surfaces shall be stable, firm, and slip resistant.	Pathway has overgrowth preventing access. Exterior route leading to building entrance meets compliance. Needs photo representation.	<a href="https://www.access-board.gov/ada/#ada-302_1">https://www.access-board.gov/ada/#ada-302_1</a>	2012 TAS Section: 302.1 2010 ADAS Section: 302.1 2015 ABAAS Section: 302.1

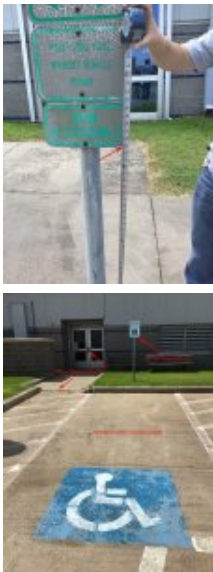
Finding Number	Area Description	Finding	As Built	Recommendation	Citation	Photos	Figure
10	Exterior of Property (Public): Hatchery Building Parking Lot (3 Spaces) 1 Van 2 Car - Van Accessible Stall	The parking sign is mounted too low. Parking space identification signs shall include the International Symbol of Accessibility. Signs identifying van parking spaces shall contain the designation "van accessible." Signs shall be 60 inches minimum above the finish floor or ground surface measured to the bottom of the sign.	The sign height is 39" and needs to be replaced soon due to poor condition.	<a href="https://www.access-board.gov/ada/#ada-502_6">https://www.access-board.gov/ada/#ada-502_6</a>	2012 TAS Section: 502.6 2010 ADAS Section: 502.6 2015 ABAAS Section: 502.6

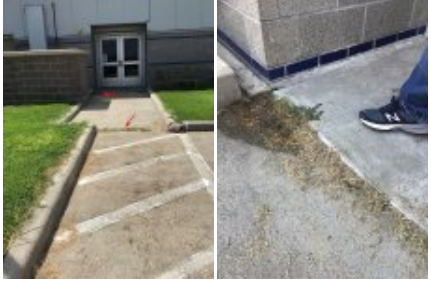
Finding Number	Area Description	Finding	As Built	Recommendation	Citation	Photos	Figure
17	Exterior of Property (Public): Hatchery Building Parking Lot (3 Spaces) 1 Van 2 Car - Pathway to Building (Parking Lot to Volunteer Side Entrance)	The accessible route contains loose gravel and/or surface materials that do not provide for a stable, firm slip resistant surface. Floor and ground surfaces shall be stable, firm, and slip resistant.	From car accessible space to volunteer side entrance. Overgrowth prevent access, large gaps in walkway.	<a href="https://www.access-board.gov/ada/#ada-302_1">https://www.access-board.gov/ada/#ada-302_1</a>	2012 TAS Section: 302.1  2010 ADAS Section: 302.1  2015 ABAAS Section: 302.1

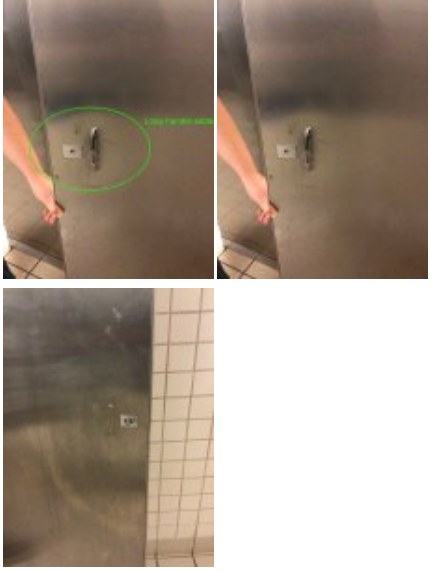
Finding Number	Area Description	Finding	As Built	Recommendation	Citation	Photos	Figure
22	Structures on Property (Public) - Tour/Public Componets : Visitors Center (Interior) - Restroom (Men's)	The water closet compartment is missing a loop handle on the one side of the door. Water closet compartments must be equipped with a door that has a loop or U-shaped handle on both sides of the door near the latch. The latch must be flip-over style, sliding or other hardware not requiring the user to grasp or twist.	Loop handle installed. Pending photo of update/correction	Install a loop handle on pull side of door within compliant range. <a href="https://www.access-board.gov/ada/#ada-604_8_1_2">https://www.access-board.gov/ada/#ada-604_8_1_2</a>	2012 TAS Section: 604.8.1.2  2010 ADAS Section: 604.8.1.2  2015 ABAAS Section: 604.8.1.2

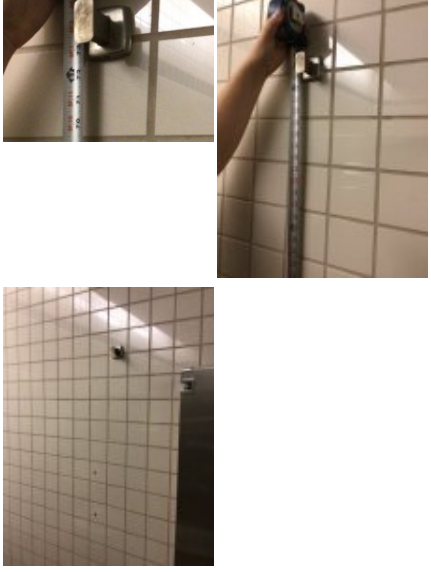
23	Structures on Property (Public) - Tour/Public Componets : Visitors Center (Interior) - Restroom (Men's)	The coat hook is installed greater than 48 inches above the finished floor. Where a forward reach is unobstructed, the high forward reach shall be 48 inches maximum above the finished floor.	Coat hook installed out of range over 72" Pending photo of update/correction	Move coat hook into compliant range of front approach or side approach. <a href="https://www.access-board.gov/ada/#ada-308_2_1">https://www.access-board.gov/ada/#ada-308_2_1</a>	2012 TAS Section: 308.2.1  2010 ADAS Section: 308.2.1  2015 ABAAS Section: 308.2.1

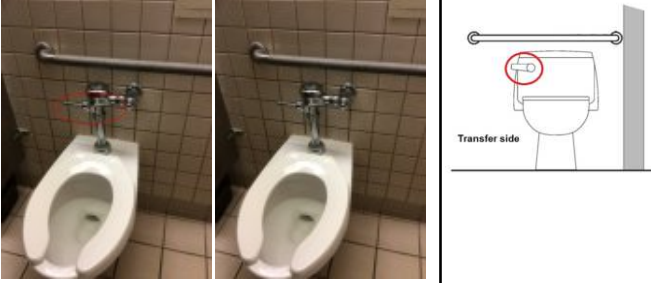
Finding Number	Area Description	Finding	As Built	Recommendation	Citation	Photos	Figure
24	Structures on Property (Public) - Tour/Public Componets : Visitors Center (Interior) - Restroom (Men's)	The flush handle is located on the wrong side of the toilet. Controls shall be operable with one hand and shall not require tight grasping, pinching or twisting. Controls for the flush valves shall be mounted on the wide side of toilet areas, no more than 48 inches above the floor.	Flusher located on wrong side.		<a href="https://www.access-board.gov/ada/#ada-604_6">https://www.access-board.gov/ada/#ada-604_6</a>	2012 TAS Section: 604.6  2010 ADAS Section: 604.6  2015 ABAAS Section: 604.6

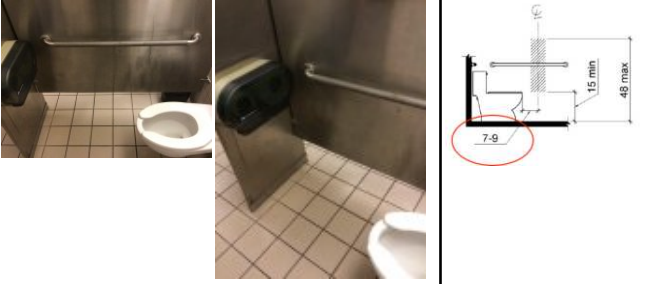
25	Structures on Property (Public) - Tour/Public Componets : Visitors Center (Interior) - Restroom (Men's)	The toilet paper is not installed within the compliant range in front of the toilet. Toilet paper dispensers shall be 7 inches minimum and 9 inches maximum in front of the water closet measured to the centerline of the dispenser. The outlet of the dispenser shall be 15 inches minimum and 48 inches maximum above the finish floor and shall not be located behind grab bars. Dispensers shall not be of a type that controls delivery or that does not allow continuous paper flow. There shall be a clearance of 1 1/2 inches minimum below the grab bar.	TP dispenser mounted in wrong location. Pending photo of update/correction		<a href="https://www.access-board.gov/ada/#ada-604_7">https://www.access-board.gov/ada/#ada-604_7</a>	2012 TAS Section: 604.7  2010 ADAS Section: 604.7  2015 ABAAS Section: 604.7

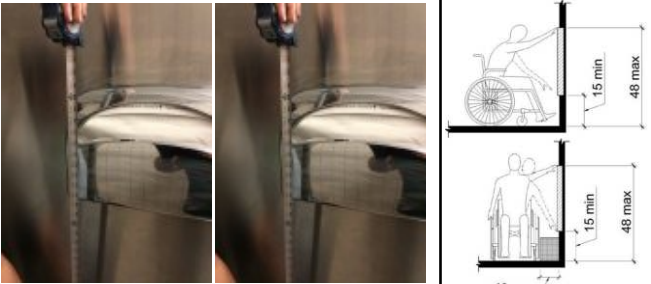
26	Structures on Property (Public) - Tour/Public Componets : Visitors Center (Interior) - Restroom (Men's)	The disposable toilet seat covers is positioned too high for either a side or front approach. Where a clear floor or ground space allows a parallel approach to an element and the side reach is unobstructed, the high side reach shall be 48 inches maximum and the low side reach shall be 15 inches minimum above the finish floor or ground. Where a forward reach is unobstructed, the high forward reach shall be 48 inches maximum and the low forward reach shall be 15 inches minimum above the finish floor or ground.	Measured at 57" Pending photo of update/correction		<a href="https://www.access-board.gov/ada/#ada-308_1">https://www.access-board.gov/ada/#ada-308_1</a>	2012 TAS Section: 308.1  2010 ADAS Section: 308.1  2015 ABAAS Section: 308.1

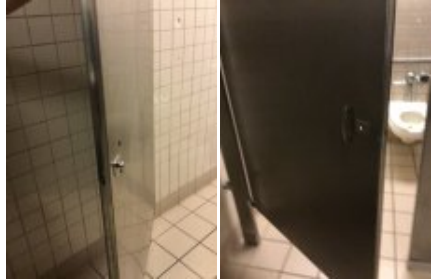
Finding Number	Area Description	Finding	As Built	Recommendation	Citation	Photos	Figure
27	Structures on Property (Public) - Tour/Public Componets : Visitors Center (Interior) - Restroom (Women's)	The Women's restroom has been found to be in substantial compliance with accessibility codes, standards, and regulations.	The restroom meets compliance and is current with ADA standards. Need photo representation of restroom and its elements,	N/A	2012 TAS Section: Advisory  2010 ADAS Section: Advisory  2015 ABAAS Section: Advisory		
28	Structures on Property (Public) - Tour/Public Componets : Visitors Center (Interior) - Restroom (Women's)	The water closet compartment is missing a loop handle on the one side of the door. Water closet compartments must be equipped with a door that has a loop or U-shaped handle on both sides of the door near the latch. The latch must be flip-over style, sliding or other hardware not requiring the user to grasp or twist.	Loop handle installed. Pending photo of update/correction	Install a loop handle on pull side of door within compliant range. <a href="https://www.access-board.gov/ada/#ada-604_8_1_2">https://www.access-board.gov/ada/#ada-604_8_1_2</a>	2012 TAS Section: 604.8.1.2  2010 ADAS Section: 604.8.1.2  2015 ABAAS Section: 604.8.1.2

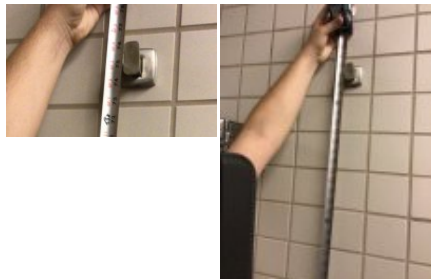
29	Structures on Property (Public) - Tour/Public Componets : Visitors Center (Interior) - Restroom (Women's)	The coat hook is installed greater than 48 inches above the finished floor. Where a forward reach is unobstructed, the high forward reach shall be 48 inches maximum above the finished floor.	Coat hook over 74" Pending photo of update/correction	Move coat hook into compliant range of front approach or side approach. <a href="https://www.access-board.gov/ada/#ada-308_2_1">https://www.access-board.gov/ada/#ada-308_2_1</a>	2012 TAS Section: 308.2.1  2010 ADAS Section: 308.2.1  2015 ABAAS Section: 308.2.1

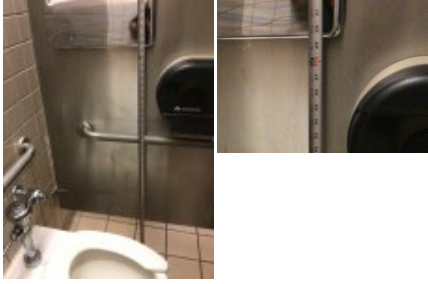
31	Structures on Property (Public) - Tour/Public Componets : Visitors Center (Interior) - Restroom (Women's)	The toilet seat cover is positioned too high for either a side or front approach. Where a clear floor or ground space allows a parallel approach to an element and the side reach is unobstructed, the high side reach shall be 48 inches maximum and the low side reach shall be 15 inches minimum above the finish floor or ground. Where a forward reach is unobstructed, the high forward reach shall be 48 inches maximum and the low forward reach shall be 15 inches minimum above the finish floor or ground.	reach range over 46" Pending photo of update/correction	<a href="https://www.access-board.gov/ada/#ada-308_1">https://www.access-board.gov/ada/#ada-308_1</a>	2012 TAS Section: 308.1  2010 ADAS Section: 308.1  2015 ABAAS Section: 308.1

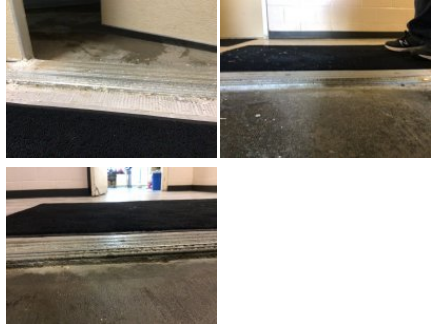
35	Structures on Property (Public) - Tour/Public Componets : Hatchery Building (Interior) - TOUR - Holding Tanks	The threshold has a vertical change greater than 1/4 inch. The threshold at a doorway shall be no higher than 1/2 inch. Changes in level between 1/4 inch and 1/2 inch must be beveled at 1:2 or less. The maximum vertical rise shall be 1/4 inch.	Interior doors All doorway thresholds leading to holding tanks viewing areas are not compliant. Thresholds exceed 1/2" allowance.	<a href="https://www.access-board.gov/ada/#ada-404_2_5">https://www.access-board.gov/ada/#ada-404_2_5</a>	2012 TAS Section: 404.2.5  2010 ADAS Section: 404.2.5  2015 ABAAS Section: 404.2.5

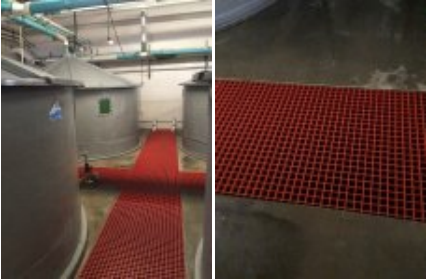
37	Structures on Property (Public) - Tour/Public Componets : Hatchery Building (Interior) - TOUR - Holding Tanks	State and local governments have an obligation to make their programs and services accessible to persons with disabilities. This may or may not require the alteration, addition or construction of existing facilities which predate The Americans with Disabilities Act (ADA) of 1990. Under the Code of Federal Regulations Section 35.151(b)(2) State and Local Government Title II entities may provide programmatic access where alterations to existing facilities would result in undue financial and administrative burdens. For Example, A public entity has six courtrooms in two existing buildings and determines that only three of those courtrooms and the public use and common use areas serving those courtrooms in one building are needed to be made accessible in order to satisfy its program access obligations. The entity must comply with 2010 Standards unless compliance would result in undue financial and administrative burdens and must take other actions that would not result in an undue financial burden to ensure access to persons with disabilities. This may include the scheduling of the various types of cases, hearings etc. in accessible courtrooms and relocating them where necessary to accommodate persons with disabilities. Having a defined program and effective communication process in place to ensure the public and employees can request accommodations is necessary to ensure equal access to the county's court system. Program access is not part of this evaluation and this information is being provided as an advisory only.	Element can be accessed as majority pathways are accessible. Grating in floor is not compliant but can be covered to create accessible route. This element is considered accessible. Viewing window height needs verification	Provide a reasonable modification to allow tour participants an equitable experience during this part of tour. Covering grating on floor are examples of program modification. Route around holding tanks does not need to be accessible but tour program does need to meet Title II requirements for accessible programs/services.	2010 ADAS Section: Advisory

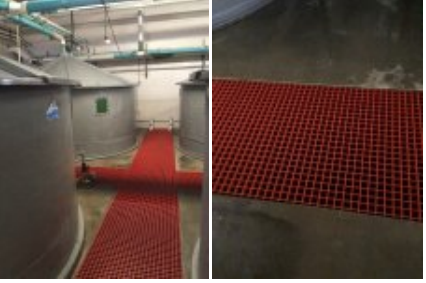
Finding Number	Area Description	Finding	As Built	Recommendation	Citation	Photos	Figure
38	Structures on Property (Public) - Tour/Public Componets : Hatchery Building (Interior) - TOUR - Holding Tanks	Gratings are spaced greater than 1/2 inch in the direction of travel. Openings in floor or ground surfaces shall not allow passage of a sphere more than 1/2 inch diameter. Elongated openings shall be placed so that the long dimension is perpendicular to the dominant direction of travel.	Floor grating and tight areas around holding tanks are not compliant but necessary for building infrastructure.	Route around holding tanks does not need to be accessible but tour program does need to meet Title II requirments for accessible programs/services. Covering grating on floor are examples of program modification.	2012 TAS Section: 302.3  2010 ADAS Section: 302.3  2015 ABAAS Section: 302.3

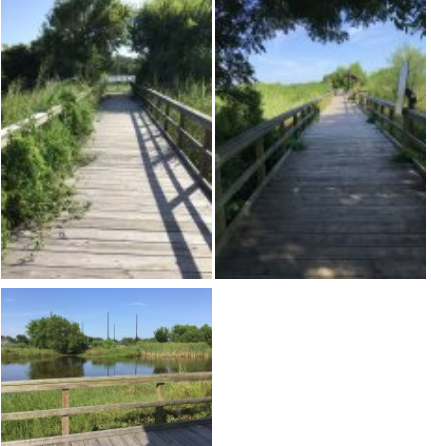
Finding Number	Area Description	Finding	As Built	Recommendation	Citation	Photos	Figure
42	Outdoor Features (Public) : Wetlands Trail	Boardwalk elements include, Guardrail height , Edge protection, Running and Cross Slope, boardwalk surfacing. Guardrails should remain clear of overgrowth and useable.	Boardwalk path of travel and guard railing components need to be evaluated. Pending evaluation	N/A - Refer to Finding	2012 TAS Section: Recommended 2010 ADAS Section: Recommended 2015 ABAAS Section: Recommended

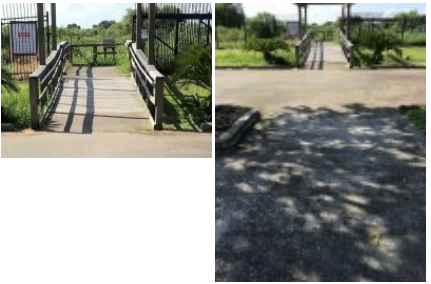
43	Outdoor Features (Public) : Wetlands Trail - Wetland Trail Ramp	Ramp elements include, Guardrail height (verified) , Edge protection, Running and Cross Slope, Ramp surfacing	Ramp components need to be evaluated Pending evaluation	N/A - Refer to Finding	2012 TAS Section: Recommended 2010 ADAS Section: Recommended 2015 ABAAS Section: Recommended

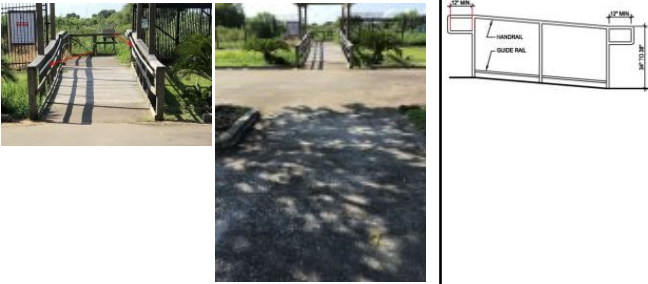
44	Outdoor Features (Public) : Wetlands Trail - Wetland Trail Ramp	The ramp does not have compliant handrails. Handrails are required on both sides of all surfaces that are sloped greater than 5 percent (1:20). Handrails must be between 34 inches and 38 inches above the ramp surface, and must extend horizontally 12 inches beyond the top and bottom of the ramp. The diameter of the handrails must be 1 1/4 inches minimum and 2 inches maximum in cross-sectional nominal dimension for circular handrails. Handrail gripping surfaces with a non-circular cross section shall have a perimeter dimension of 4 inches minimum and 6 1/4 inches maximum, and a cross-section dimension of 2 1/4 inches maximum. The space between handrails and walls must be 1-1/2 inches minimum.	Handrails do not meet compliance in style, mounting location, missing extensions.	Handrails type, style, and installation are not compliant. Review handrail components to make accessible <a href="https://www.access-board.gov/aba/#aba-505_1">https://www.access-board.gov/aba/#aba-505_1</a>	2012 TAS Section: 505.1 2010 ADAS Section: 505.1 2015 ABAAS Section: 505.1

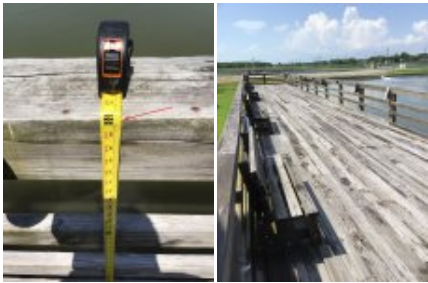
46	Outdoor Features (Public) : Visitors Center Fishing Pier (Wood)	The handrail is higher than 34 inches above the ground/deck surface. At least 25 percent of the railings, guards, or handrails shall be 34 inches maximum above the ground or deck surface.	Handrail height is 36" Fishing pier edge protection, turning space, and surfacing material meet compliance.	Lower handrail height or provide 25% accessible fishing space dispersed evenly for entire fishing pier. <a href="https://www.access-board.gov/ada/#ada-1005_2_1">https://www.access-board.gov/ada/#ada-1005_2_1</a> <a href="https://www.access-board.gov/ada/#ada-1005_2_1_1">https://www.access-board.gov/ada/#ada-1005_2_1_1</a>	2010 ADAS Section: 1005.2.1  2015 ABAAS Section: 1005.2.1

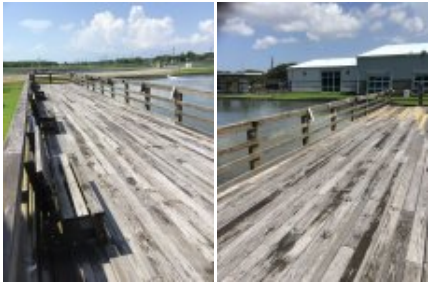
47	Outdoor Features (Public) : Visitors Center Fishing Pier (Wood)	Not enough of the railings, guards, or handrails are at the allowable height. At least 25 percent of the railings, guards, or handrails shall be 34 inches maximum above the ground or deck surface.	Not provided.	Provide evenly dispersed access to 25% of total fishing pier. <a href="https://www.access-board.gov/ada/#ada-1005_2_1">https://www.access-board.gov/ada/#ada-1005_2_1</a> <a href="https://www.access-board.gov/ada/#ada-1005_2_1_1">https://www.access-board.gov/ada/#ada-1005_2_1_1</a>	2010 ADAS Section: 1005.2.1  2015 ABAAS Section: 1005.2.1

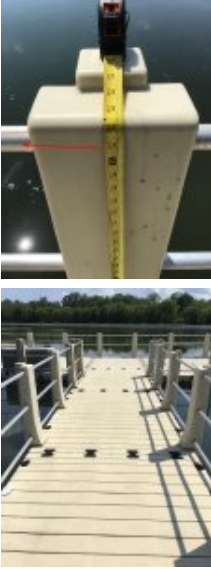
Finding Number	Area Description	Finding	As Built	Recommendation	Citation	Photos	Figure
50	Outdoor Features (Public) : Hatchery Building Fishing Pier (Plastic)	The handrail is higher than 34 inches above the ground/deck surface. At least 25 percent of the railings, guards, or handrails shall be 34 inches maximum above the ground or deck surface.	Handrail height is 36" Fishing pier turning space and surfacing material meet compliance.	Lower handrail height or provide 25% accessible fishing space dispersed evenly for entire fishing pier. <a href="https://www.access-board.gov/ada/#ada-1005_2_1">https://www.access-board.gov/ada/#ada-1005_2_1</a> <a href="https://www.access-board.gov/ada/#ada-1005_2_1_1">https://www.access-board.gov/ada/#ada-1005_2_1_1</a>	2010 ADAS Section: 1005.2.1 2015 ABAAS Section: 1005.2.1

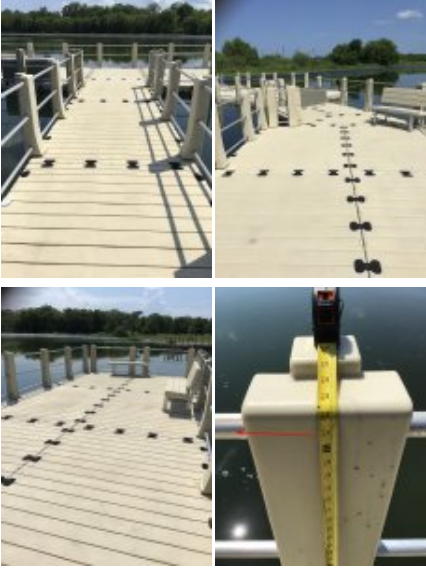
51	Outdoor Features (Public) : Hatchery Building Fishing Pier (Plastic)	Not enough of the railings, guards, or handrails are at the allowable height. At least 25 percent of the railings, guards, or handrails shall be 34 inches maximum above the ground or deck surface.	Guard rail height is 37" and above, not provided.	Provide evenly dispersed access to 25% of total fishing pier. <a href="https://www.access-board.gov/ada/#ada-1005_2_1">https://www.access-board.gov/ada/#ada-1005_2_1</a> <a href="https://www.access-board.gov/ada/#ada-1005_2_1_1">https://www.access-board.gov/ada/#ada-1005_2_1_1</a>	2010 ADAS Section: 1005.2.1 2015 ABAAS Section: 1005.2.1

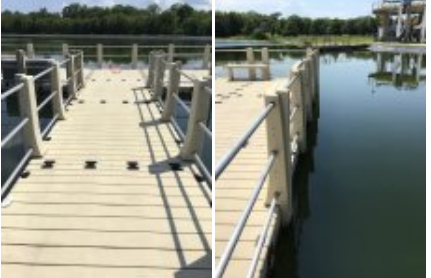
Finding Number	Area Description	Finding	As Built	Recommendation	Citation	Photos	Figure
52	Outdoor Features (Public) : Hatchery Building Fishing Pier (Plastic)	The required edge protection is not provided. Where compliant railings, guards, or handrails are provided, edge protection shall also be provided. Curbs or barriers shall extend 2 inches minimum above the surface of the fishing pier or platform or The ground or deck surface shall extend 12 inches minimum beyond the inside face of the railing. Toe clearance shall be provided and shall be 30 inches wide minimum and 9 inches minimum above the ground or deck surface beyond the railing.	This looks to be out of compliance, over 2" min requirement. Needs to be verified. Fishing pier edge compliance can be satisfied 1 of 2 ways. 1- install curb barrier at 2" minimum vertical to end of deck surface. 2- extend deck surface 12" minimum beyond inside facing guard rail.	Fishing pier edge protection <a href="https://www.access-board.gov/ada/#ada-1005_3">https://www.access-board.gov/ada/#ada-1005_3</a> Curb or barrier <a href="https://www.access-board.gov/ada/#ada-1005_3_1">https://www.access-board.gov/ada/#ada-1005_3_1</a> Extended ground or floor surface <a href="https://www.access-board.gov/ada/#ada-1005_3_2">https://www.access-board.gov/ada/#ada-1005_3_2</a>	2010 ADAS Section: 1005.3.1, 1005.3.2  2015 ABAAS Section: 1005.3.1, 1005.3.2

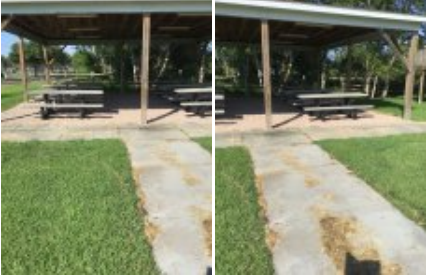
54	Outdoor Features (Public) : Hatchery Building Fishing Pier (Plastic) - Picnic Pavilion (Hatchery Fishing Pier)	There is no outdoor recreation access route that connects accessible elements, spaces, and facilities within the picnic unit. At least one outdoor recreation access route shall connect accessible elements, spaces, and facilities provided within picnic units with mobility features.	Ground/surface material not compliant around picnic tables. Exterior pathway leading to tables is compliant but needs to be debris free. Picnic tables look to be of accessible type and within compliance.	N/A - Refer to Finding	2015 ABAAS Section: F245.4.1

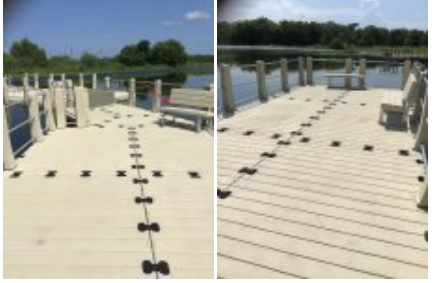
Finding Number	Area Description	Finding	As Built	Recommendation	Citation	Photos	Figure
55	Outdoor Features (Public) : Hatchery Building Fishing Pier (Plastic) - Hatchery Building Fishing Pier Seating Area	Seating area and benches need to be evaluated,	This area needs to be evaluated. Pending evaluation	N/A - Refer to Finding	2012 TAS Section: Recommended  2010 ADAS Section: Recommended  2015 ABAAS Section: Recommended
