TPWD Headquarters EO- ADA Evaluation

TPWD- Austin TX, HQ & Parking ADA Evaluation

Accessibility Evaluation

Inspection Date: 07/01/2020

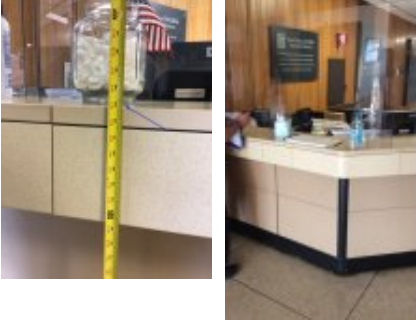
Finding Number	Area Description	Finding	As Built	Recommendation	Citation	Photos	Figure
1	First Floor, Building B100 (Public) : Building Entrance and Lobby (B100) - Service Counter Copy	The counter is too high. A portion of the counter surface that is 36 inches long minimum and 36 inches high maximum above the finish floor shall be provided. Knee and toe space must be provided for a forward approach. A 30 inch by 48 inch clear floor space on an accessible route must be provided for either a forward or parallel approach.	Measures at 43"	Service desks approach requirements https://www.access-board.gov/ada/#ada-904_4 Parallel approach https://www.access-board.gov/ada/#ada-904_4_1 Forward approach https://www.access-board.gov/ada/#ada-904_4_2	2012 TAS Section: 904.4.1 2010 ADAS Section: 904.4.1 2015 ABAAS Section: 904.4.1

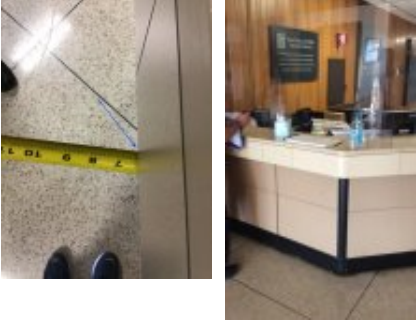
2	First Floor, Building B100 (Public) : Building Entrance and Lobby (B100) - Service Counter Copy	The knee clearance does not extend a minimum 8 inches under the element at 27 inches above the finished floor and/or 11 inches minimum at 9 inches above the floor. ** Measures at 6" Space under an element between 9 inches and 27 inches above the finish floor or ground shall be considered knee clearance. Knee clearance shall extend 25 inches maximum under an element at 9 inches above the finish floor or ground. Knee clearance shall be 11 inches deep minimum at 9 inches above the finish floor or ground, and 8 inches deep minimum at 27 inches above the finish floor or ground. Knee clearance shall be 30 inches wide minimum.	N/A	https://www.access-board.gov/ada/#ada-306_1 https://www.access-board.gov/ada/#ada-306_3_1	2012 TAS Section: 306.1 2010 ADAS Section: 306.1 2015 ABAAS Section: 306.1, 306.3.1

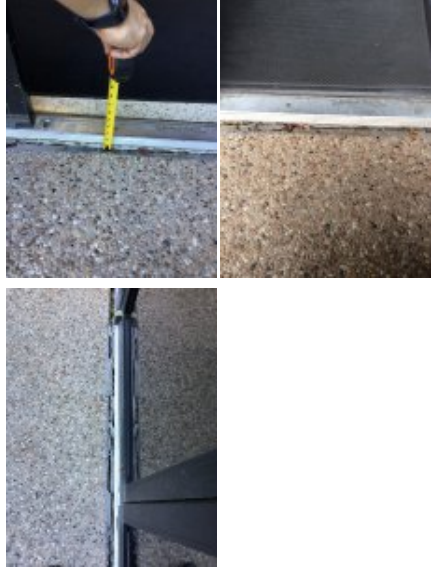
5	First Floor, Building B100 (Public) : Building Entrance and Lobby (B100) - Front Entrance (Facing Parking Lot B100)	The route contains openings greater than 1/2 inch. Gap depth causing threshold infraction by proxy. Openings in floor or ground surfaces shall not allow passage of a sphere more than 1/2 inch diameter. Elongated openings shall be placed so that the long dimension is perpendicular to the dominant direction of travel.	N/A	https://www.access-board.gov/ada/#ada-302_3	2012 TAS Section: 302.3 2010 ADAS Section: 302.3 2015 ABAAS Section: 302.3

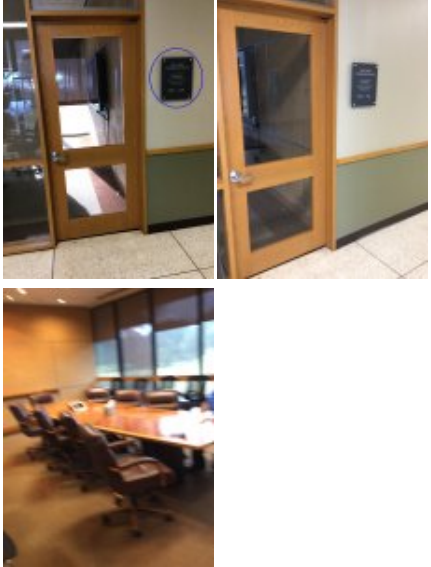
Finding Number	Area Description	Finding	As Built	Recommendation	Citation	Photos	Figure
12	First Floor, Building B100 (Public) : Interior spaces (B100) - Bass Conference Room	The room identification sign is noncompliant. Multiple violations regarding sign contrast, height mount, and braille lettering. Wall signs identifying permanent rooms and spaces of a building shall be in a horizontal format and the characters raised 1/32 inch minimum and shall be sans serif uppercase characters a minimum of 5/8 inch and a maximum of 2 inches high. Characters and their background shall have a non-glare finish. Characters shall contrast with their background with either light characters on a dark background or dark characters on a light background. Signs with raised characters or Braille shall be located 48 inches minimum above the finish floor or ground surface, measured from the baseline of the lowest tactile character and 60 inches maximum above the finish floor or ground surface, measured from the baseline of the highest tactile character.	Signs that identify a room, space or area are required to have raised characters and Braille. This requirement includes both public access areas as well as all employee areas.	Wall sign designation https://www.access-board.gov/ada/#ada-216_2 Wall signs general https://www.access-board.gov/ada/#ada-703_1 .	2012 TAS Section: 216.2, 703.1 2010 ADAS Section: 216.2, 703.1 2015 ABAAS Section: F216.2, 703.1

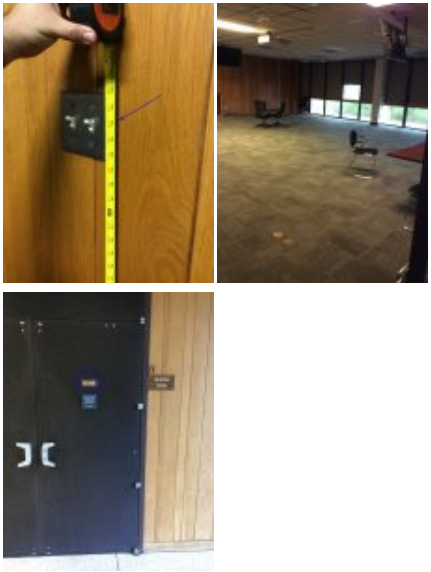
13	First Floor, Building B100 (Public) : Interior spaces (B100) - CHR Conference Room	The light switch is positioned too high for either a side or front approach. Where a clear floor or ground space allows a parallel approach to an element and the side reach is unobstructed, the high side reach shall be 48 inches maximum and the low side reach shall be 15 inches minimum above the finish floor or ground. Where a forward reach is unobstructed, the high forward reach shall be 48 inches maximum and the low forward reach shall be 15 inches minimum above the finish floor or ground.	N/A	https://www.access-board.gov/ada/#ada-308_1	2012 TAS Section: 308.1 2010 ADAS Section: 308.1 2015 ABAAS Section: 308.1

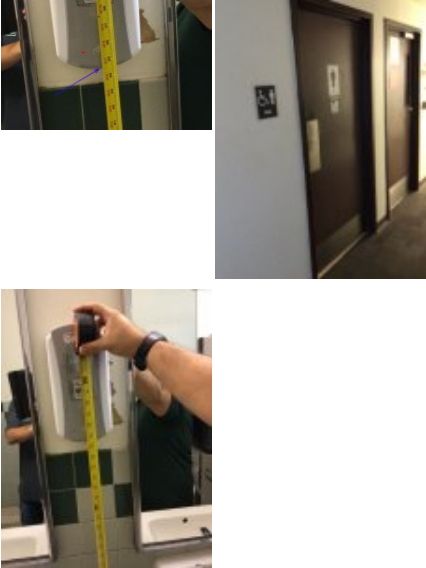
22	First Floor, Building D100 (Public) : Restrooms and water fountains (D100) - Men's restroom (boat)	The soap dispenser's operation mechanism is too high off the floor. Dispensers must have all operable parts a maximum of 48 inches above the floor.	N/A		https://www.access-board.gov/ada/#ada-308_2_1	2012 TAS Section: 308.2.1 2010 ADAS Section: 308.2.1 2015 ABAAS Section: 308.2.1

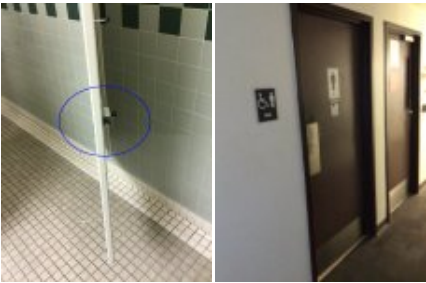
23	First Floor, Building D100 (Public) : Restrooms and water fountains (D100) - Men's restroom (boat)	The water closet compartment is missing a loop handle on one side or both sides of the door. Water closet compartments must be equipped with a door that has a loop or U-shaped handle on both sides of the door immediately below the latch. The latch must be flip-over style, sliding or other hardware not requiring the user to grasp or twist.	N/A		https://www.access-board.gov/ada/#ada-604_8_1_2	2012 TAS Section: 604.8.1.2 2010 ADAS Section: 604.8.1.2 2015 ABAAS Section: 604.8.1.2

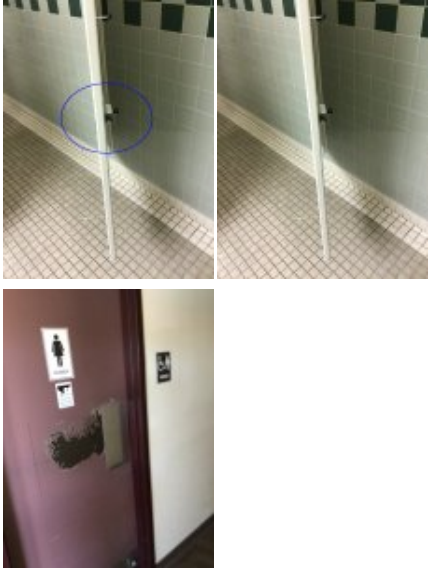
25	First Floor, Building D100 (Public) : Restrooms and water fountains (D100) - Women's restroom (boat)	The water closet compartment is missing a loop handle on one side or both sides of the door. Water closet compartments must be equipped with a door that has a loop or U-shaped handle on both sides of the door immediately below the latch. The latch must be flip-over style, sliding or other hardware not requiring the user to grasp or twist.	N/A		https://www.access-board.gov/ada/#ada-604_8_1_2	2012 TAS Section: 604.8.1.2 2010 ADAS Section: 604.8.1.2 2015 ABAAS Section: 604.8.1.2

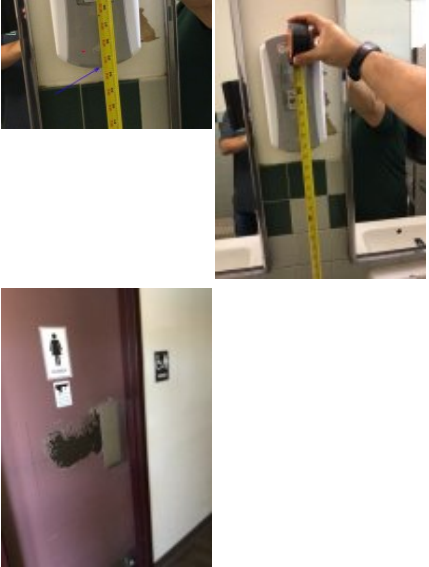
Finding Number	Area Description	Finding	As Built	Recommendation	Citation	Photos	Figure
26	First Floor, Building D100 (Public) : Restrooms and water fountains (D100) - Women's restroom (boat)	The soap dispenser's operation mechanism is too high off the floor. Dispensers must have all operable parts a maximum of 48 inches above the floor.	N/A	https://www.access-board.gov/ada/#ada-308_2_1	2012 TAS Section: 308.2.1 2010 ADAS Section: 308.2.1 2015 ABAAS Section: 308.2.1

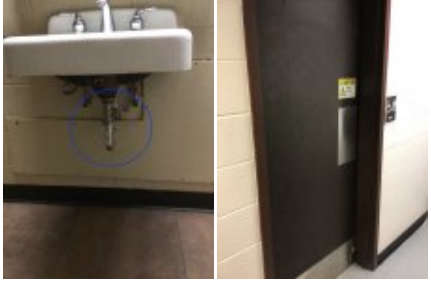
Finding Number	Area Description	Finding	As Built	Recommendation	Citation	Photos	Figure
30	First Floor, Building D100 (STAFF): Interior spaces (D100) - Men's restroom (fleet)	The water and drain pipes under the lavatory are not adequately insulated. Water supply and drain pipes under lavatories and sinks shall be insulated or otherwise configured to protect against contact. There shall be no sharp or abrasive surfaces under lavatories and sinks.	Pipes are not covered		https://www.access-board.gov/ada/#ada-606_5	2012 TAS Section: 606.5 2010 ADAS Section: 606.5 2015 ABAAS Section: 606.5

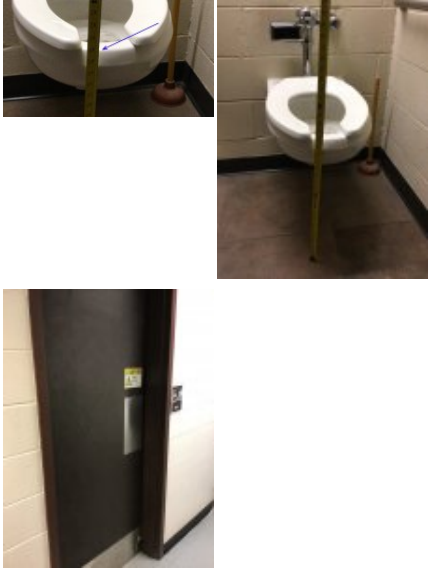
31	First Floor, Building D100 (STAFF): Interior spaces (D100) - Men's restroom (fleet)	The toilet seat is not located within the range allowed off the floor. The height of accessible water closets shall be a minimum of 17 inches and a maximum of 19 inches measured to the top of the toilet seat. The seat itself shall be a maximum of 2 inch high.	Exceed 19" max		https://www.access-board.gov/ada/#ada-604_4	2012 TAS Section: 604.4 2010 ADAS Section: 604.4 2015 ABAAS Section: 604.4

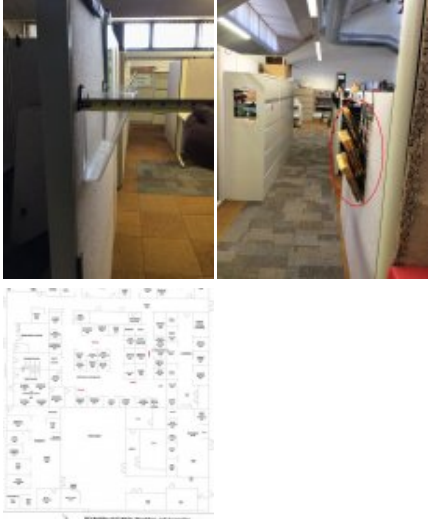
Finding Number	Area Description	Finding	As Built	Recommendation	Citation	Photos	Figure
49	First Floor, Building D100 (STAFF): Interior spaces (D100) - Walkways	There were a small amount of these infractions noted. All infractions are located in license sales/boats cubicles. **Details/locations are marked with red (l) in attached resource map. Wall-mounted objects that have leading edges between 27 inches and 80 inches from the floor must not project more than 4 inches into the circulation path. Protruding objects that extend to the floor or within 27 inches of the floor are cane detectable and are therefore not hazardous. Where it is necessary or desirable to have objects protrude from the wall, a manner of cane detection must be provided.	N/A	https://www.access-board.gov/ada/#ada-307_2	2012 TAS Section: 307.2 2010 ADAS Section: 307.2 2015 ABAAS Section: 307.2

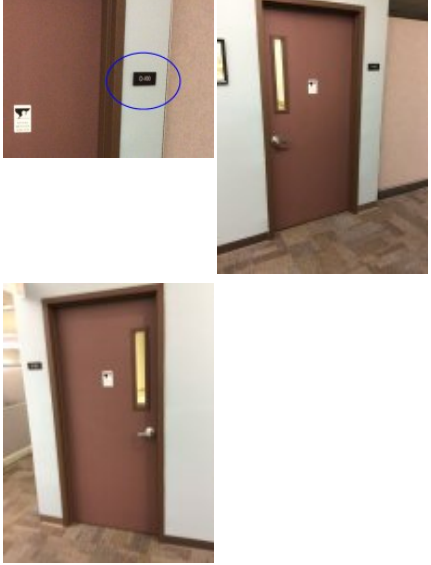
50	First Floor, Building D100 (STAFF): Interior spaces (D100) - Conference Room D100	The room identification sign is noncompliant. Wall signs identifying permanent rooms and spaces of a building shall be in a horizontal format and the characters raised 1/32 inch minimum and shall be sans serif uppercase characters a minimum of 5/8 inch and a maximum of 2 inches high. Characters and their background shall have a non-glare finish. Characters shall contrast with their background with either light characters on a dark background or dark characters on a light background. Signs with raised characters or Braille shall be located 48 inches minimum above the finish floor or ground surface, measured from the baseline of the lowest tactile character and 60 inches maximum above the finish floor or ground surface, measured from the baseline of the highest tactile character.	Signs that identify a room, space or area are required to have raised characters and Braille. This requirement includes both public access areas as well as all employee areas. Sign not compliant	Wall sign designation https://www.access-board.gov/ada/#ada-216_2 Wall signs general https://www.access-board.gov/ada/#ada-703_1	2012 TAS Section: 216.2, 703.1 2010 ADAS Section: 216.2, 703.1 2015 ABAAS Section: F216.2, 703.1

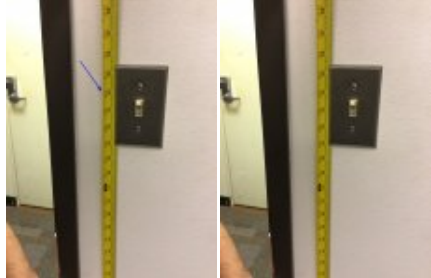
Finding Number	Area Description	Finding	As Built	Recommendation	Citation	Photos	Figure
51	First Floor, Building D100 (STAFF): Interior spaces (D100) - Conference Room D140 (fleet)	The light switch is positioned too high for either a side or front approach. Where a clear floor or ground space allows a parallel approach to an element and the side reach is unobstructed, the high side reach shall be 48 inches maximum and the low side reach shall be 15 inches minimum above the finish floor or ground. Where a forward reach is unobstructed, the high forward reach shall be 48 inches maximum and the low forward reach shall be 15 inches minimum above the finish floor or ground.	over 48"		https://www.access-board.gov/ada/#ada-308_1 2012 TAS Section: 308.1 2010 ADAS Section: 308.1 2015 ABAAS Section: 308.1

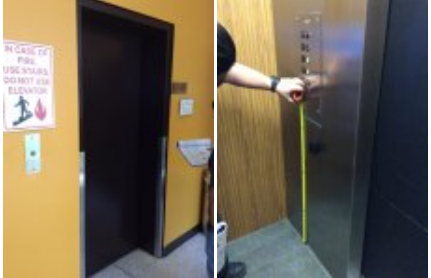
Finding Number	Area Description	Finding	As Built	Recommendation	Citation	Photos	Figure
53	First Floor, Building A100 (STAFF): Building Entrance and Lobby (A100) - Elevators	Specifically the elevator dimensions, door operation, and no audible sound for all elevators on HQ property are non compliant. The existing passenger elevators contain several non compliant features in accordance with ASME A17.1, (Safety Code for Elevators and Escalators). The elevator car size (XX) (length & width) (XX) is are too small, door operation, door size, door protective and reopening devices are noncompliant, hall & car calls are incorrect and/or missing, the hall lantern and door jamb markings are missing and/or incorrect. An audible signal shall sound once for the "up" direction and twice for the "down" direction or shall have verbal annunciators that say "up" or "down." Contact the elevator contractor and/or vendor to ensure compliance with ASME A17.1.	Not compliant	Currently there is not a way a person with physical disability can independently access and utilize elevator. Accommodations would need to be made by TPWD staff to assist with elevator use. https://www.access-board.gov/ada/#ada-407_1	2012 TAS Section: 407.1 2010 ADAS Section: 407.1 2015 ABAAS Section: 407.1

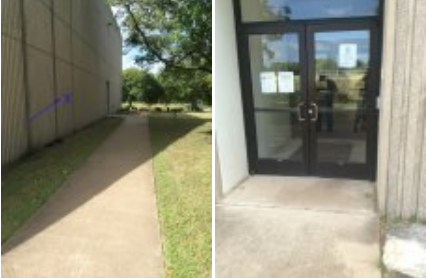
Finding Number	Area Description	Finding	As Built	Recommendation	Citation	Photos	Figure
55	First Floor, Building A100 (STAFF): Building Entrance and Lobby (A100) - Side Entrance (A100)	Due to large gap in sidewalk the entrance is not accessible and is missing signage. An identification sign identifying that this entrance is not accessible and directional signage pointing to the accessible entrance is required. When a directional sign is required, it should be located to minimize backtracking. In some cases, this could mean locating a sign at the beginning of a route, not just at the inaccessible entrances to a building.	no sign provided	Signs that provide direction to or information about interior spaces and facilities must meet visual requirements but are not required to be tactile https://www.access-board.gov/ada/#ada-216_6	2010 ADAS Section: 216.6 2015 ABAAS Section: F216.6

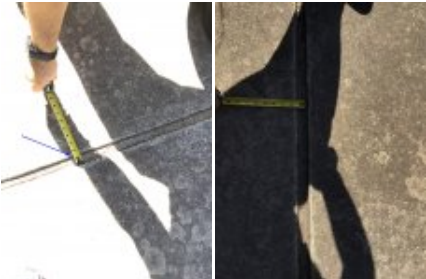
56	First Floor, Building A100 (STAFF): Building Entrance and Lobby (A100) - Side Entrance (A100)	The route contains openings greater than 1/2 inch. ** Side entrance for building A100 is not accessible due to sidewalk gap. Openings in floor or ground surfaces shall not allow passage of a sphere more than 1/2 inch diameter. Elongated openings shall be placed so that the long dimension is perpendicular to the dominant direction of travel.	exceeds 1/2" tolerance	https://www.access-board.gov/ada/#ada-302_3	2012 TAS Section: 302.3 2010 ADAS Section: 302.3 2015 ABAAS Section: 302.3

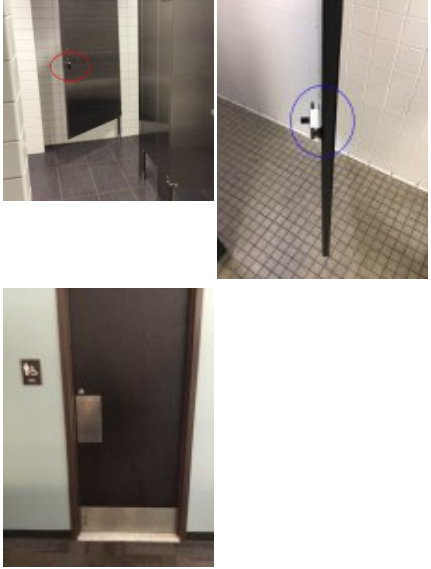
Finding Number	Area Description	Finding	As Built	Recommendation	Citation	Photos	Figure
57	First Floor, Building A100 (STAFF): Restrooms and water fountains (A100) - Men's restroom	The water closet compartment is missing a loop handle on one side or both sides of the door. Water closet compartments must be equipped with a door that has a loop or U-shaped handle on both sides of the door near the latch. The latch must be flip-over style, sliding or other hardware not requiring the user to grasp or twist.	N/A	https://www.access-board.gov/ada/#ada-604_8_1_2	2012 TAS Section: 604.8.1.2 2010 ADAS Section: 604.8.1.2 2015 ABAAS Section: 604.8.1.2

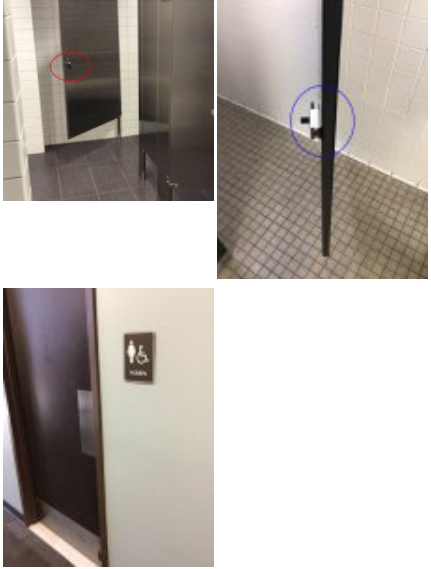
Finding Number	Area Description	Finding	As Built	Recommendation	Citation	Photos	Figure
59	First Floor, Building A100 (STAFF): Restrooms and water fountains (A100) - Women's restroom	The water closet compartment is missing a loop handle on one side or both sides of the door. Water closet compartments must be equipped with a door that has a loop or U-shaped handle on both sides of the door near the latch. The latch must be flip-over style, sliding or other hardware not requiring the user to grasp or twist.	missing one side	https://www.access-board.gov/ada/#ada-604_8_1_2	2012 TAS Section: 604.8.1.2 2010 ADAS Section: 604.8.1.2 2015 ABAAS Section: 604.8.1.2

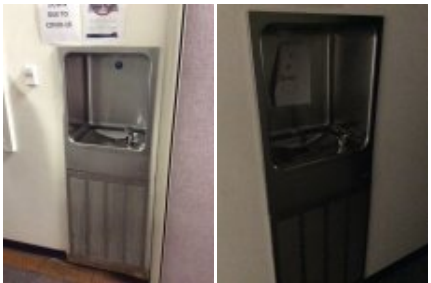
Finding Number	Area Description	Finding	As Built	Recommendation	Citation	Photos	Figure
61	First Floor, Building A100 (STAFF): Restrooms and water fountains (A100) - Water Fountain	The drinking fountain is not accessible. The water fountains spread throughout A100 are not accessible due to a number of factors. **A100 water refill stations are compliant. Drinking fountains must be on an accessible route. An accessible route of travel is 36 inches wide minimum and provides a 30 inch by 48 inch clear floor space centered on the unit that allows a forward approach to the drinking fountain. At "hi-low" type fountains, the centerline of the 30 inch by 48 inch clear floor space must be centered on the "low" fountain. Spout outlets of drinking fountains for standing persons shall be 38 inches minimum and 43 inches maximum above the finish floor or ground. All drinking fountains shall be located completely within alcoves, positioned completely between wing walls, or otherwise positioned so as not to encroach into pedestrian ways. An alcove must not be less than 32 inches in width and 18 inches in depth. Wing walls must project out from the supporting wall at least as far as the drinking fountain.	These fountains have been removed and compliant water refill stations are provided.	Staff or public can use the water refill station located in building A100. Staff can use public water fountains located in building B100 as those are ADA compliant. These water fountains would need to be updated in order to be compliant.	2012 TAS Section: 403.5.1, 602.1 2010 ADAS Section: 403.5.1, 602.1 2015 ABAAS Section: 403.5.1, 602.1

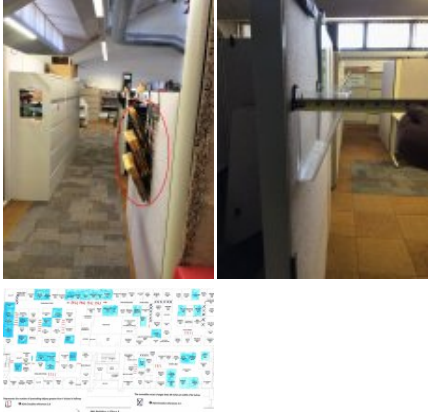
Finding Number	Area Description	Finding	As Built	Recommendation	Citation	Photos	Figure
63	First Floor, Building A100 (STAFF): Interior spaces (A100) - Walkways	The element projects more than 4 inches into the circulation path. There were a number of these infractions spread throughout the floor. The majority are located in infrastructure hallway that runs the length of the building. **Details/locations are marked with red (I) in attached resource map. Wall-mounted objects that have leading edges between 27 inches and 80 inches from the floor must not project more than 4 inches into the circulation path. Protruding objects that extend to the floor or within 27 inches of the floor are cane detectable and are therefore not hazardous. Where it is necessary or desirable to have objects protrude from the wall, a manner of cane detection must be provided.	folders exceed 4" max	https://www.access-board.gov/ada/#ada-307_2	2012 TAS Section: 307.2 2010 ADAS Section: 307.2 2015 ABAAS Section: 307.2

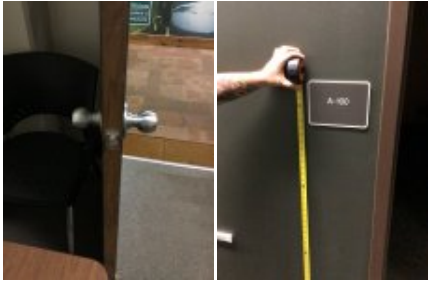
<p>32 min. 90° Hinged Door</p>
65	First Floor, Building A100 (STAFF): Interior spaces (A100) - Conference Room A100	The door exceeds the maximum allowable opening force. Interior doors shall have a maximum opening force of 5 pounds. These forces do not apply to the force required to retract latch bolts or disengage other devices that hold the door or gate in a closed position.	N/A	https://www.access-board.gov/ada/#ada-404_2_9	2012 TAS Section: 404.2.9 2010 ADAS Section: 404.2.9 2015 ABAAS Section: 404.2.9

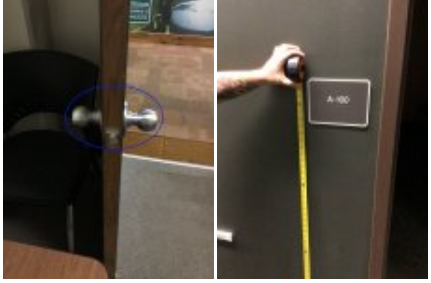
Finding Number	Area Description	Finding	As Built	Recommendation	Citation	Photos	Figure
66	First Floor, Building A100 (STAFF): Interior spaces (A100) - Conference Room A100	The door/gate operating hardware is not accessible. ** Both entry doors for A100 Hand-activated door/gate opening hardware, handles, pulls, latches, locks, and other operating devices on accessible doors shall have a shape that is easy to grasp with one hand and does not require tight grasping, pinching or twisting of the wrist to operate. Hardware shall be 34 inches minimum and 48 inches maximum above the finish floor or ground.	N/A		https://www.access-board.gov/ada/#ada-404_2_7 2012 TAS Section: 404.2.7 2010 ADAS Section: 404.2.7 2015 ABAAS Section: 404.2.7

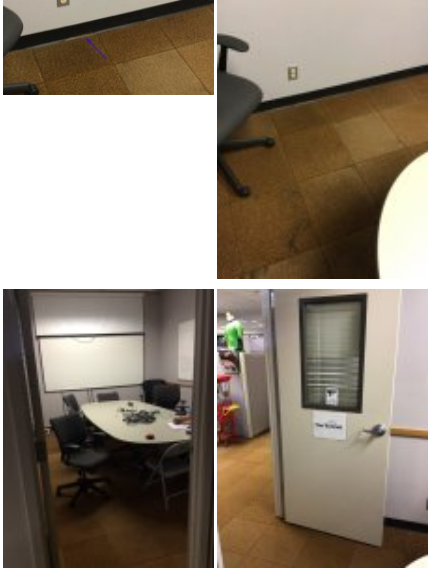
67	First Floor, Building A100 (STAFF): Interior spaces (A100) - Summit Conference Room	Carpet is not securely attached Actual citation is 302.2 Carpet. Carpet or carpet tile shall be securely attached and shall have a firm cushion, pad, or backing or no cushion or pad. Carpet or carpet tile shall have a level loop, textured loop, level cut pile, or level cut/uncut pile texture. Pile height shall be ½ inch (13 mm) maximum. Exposed edges of carpet shall be fastened to floor surfaces and shall have trim on the entire length of the exposed edge. Carpet edge trim shall comply with 303.	N/A	Rubber inserts can be installed to bring carpet flush to wall to eliminate tripping hazard. https://www.access-board.gov/ada/#ada-302_1	2012 TAS Section: 302.1 2010 ADAS Section: 302.1, 302 2015 ABAAS Section: 302.1

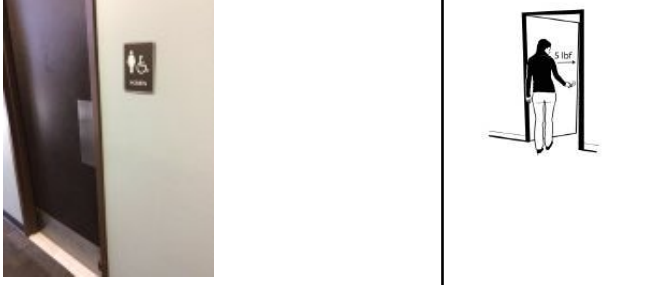
73	Second Floor, Building A200 (STAFF): Restrooms and water fountains (A200) - Women's restroom	The door exceeds the maximum allowable opening force. Interior doors shall have a maximum opening force of 5 pounds. These forces do not apply to the force required to retract latch bolts or disengage other devices that hold the door or gate in a closed position.	N/A		https://www.access-board.gov/ada/#ada-404_2_9	2012 TAS Section: 404.2.9 2010 ADAS Section: 404.2.9 2015 ABAAS Section: 404.2.9

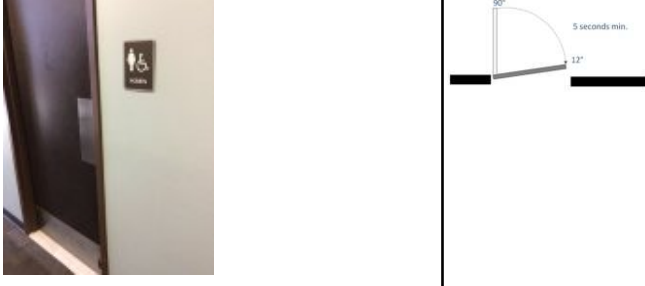
74	Second Floor, Building A200 (STAFF): Restrooms and water fountains (A200) - Women's restroom	The door is equipped with a door closer and returns to a closed position too quickly. Door closers and gate closers shall be adjusted so that from an open position of 90 degrees, the time required to move the door to a position of 12 degrees from the latch is 5 seconds minimum.	N/A		https://www.access-board.gov/ada/#ada-404_2_8_1	2012 TAS Section: 404.2.8.1 2010 ADAS Section: 404.2.8.1 2015 ABAAS Section: 404.2.8.1

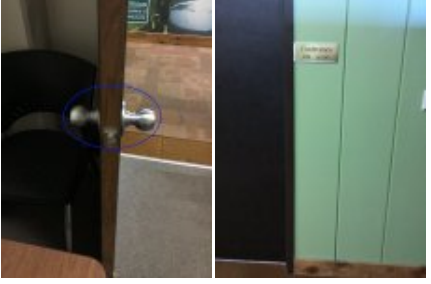
80	Second Floor, Building A200 (STAFF): Interior spaces (A200) - Conference Room A200	The door/gate operating hardware is not accessible. The door is equipped with a door knob, non compliant. Hand-activated door/gate opening hardware, handles, pulls, latches, locks, and other operating devices on accessible doors shall have a shape that is easy to grasp with one hand and does not require tight grasping, pinching or twisting of the wrist to operate. Hardware shall be 34 inches minimum and 48 inches maximum above the finish floor or ground.	door hardware non compliant	https://www.access-board.gov/ada/#ada-404_2_7	2012 TAS Section: 404.2.7 2010 ADAS Section: 404.2.7 2015 ABAAS Section: 404.2.7

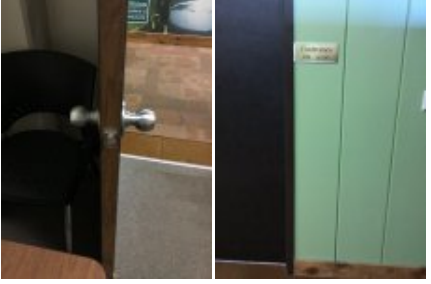
81	Second Floor, Building A200 (STAFF): Interior spaces (A200) - Conference Room A200	The door exceeds the maximum allowable opening force. Interior doors shall have a maximum opening force of 5 pounds. These forces do not apply to the force required to retract latch bolts or disengage other devices that hold the door or gate in a closed position.	exceeds 5lbs of force	https://www.access-board.gov/ada/#ada-404_2_9	2012 TAS Section: 404.2.9 2010 ADAS Section: 404.2.9 2015 ABAAS Section: 404.2.9

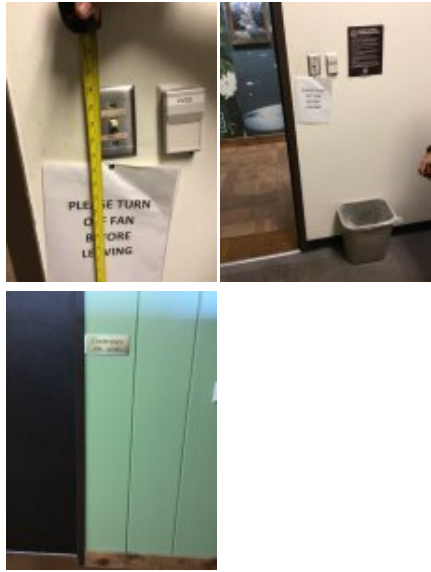
Finding Number	Area Description	Finding	As Built	Recommendation	Citation	Photos	Figure
82	Second Floor, Building A200 (STAFF): Interior spaces (A200) - Conference Room A200	The light switch is positioned too high for either a side or front approach. Where a clear floor or ground space allows a parallel approach to an element and the side reach is unobstructed, the high side reach shall be 48 inches maximum and the low side reach shall be 15 inches minimum above the finish floor or ground. Where a forward reach is unobstructed, the high forward reach shall be 48 inches maximum and the low forward reach shall be 15 inches minimum above the finish floor or ground.	exceeds 48" reach		https://www.access-board.gov/ada/#ada-308_1 2012 TAS Section: 308.1 2010 ADAS Section: 308.1 2015 ABAAS Section: 308.1

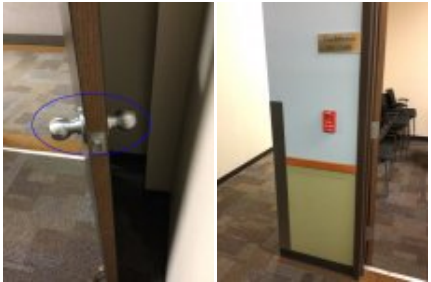
105	First Floor, Building C100 (STAFF): Interior spaces (C100) - Conference Room C100	The door/gate operating hardware is not accessible. The door is equipped with a door knob, non compliant. ** Both sets of doors for Conference room C100 Hand-activated door/gate opening hardware, handles, pulls, latches, locks, and other operating devices on accessible doors shall have a shape that is easy to grasp with one hand and does not require tight grasping, pinching or twisting of the wrist to operate. Hardware shall be 34 inches minimum and 48 inches maximum above the finish floor or ground.	Door hardware not accessible		https://www.access-board.gov/ada/#ada-404_2_7	2012 TAS Section: 404.2.7 2010 ADAS Section: 404.2.7 2015 ABAAS Section: 404.2.7

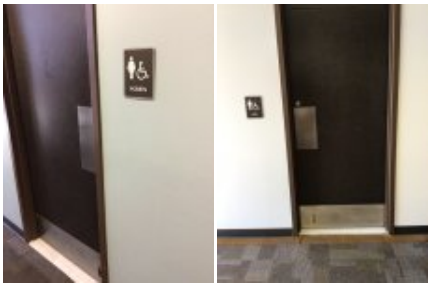
115	Second Floor, Building C200 (STAFF) : Restrooms and water fountains (C200) - Women's restroom (near elevator)	The door exceeds the maximum allowable opening force. Interior doors shall have a maximum opening force of 5 pounds. These forces do not apply to the force required to retract latch bolts or disengage other devices that hold the door or gate in a closed position.	exceeds 5lbs force		https://www.access-board.gov/ada/#ada-404_2_9	2012 TAS Section: 404.2.9 2010 ADAS Section: 404.2.9 2015 ABAAS Section: 404.2.9

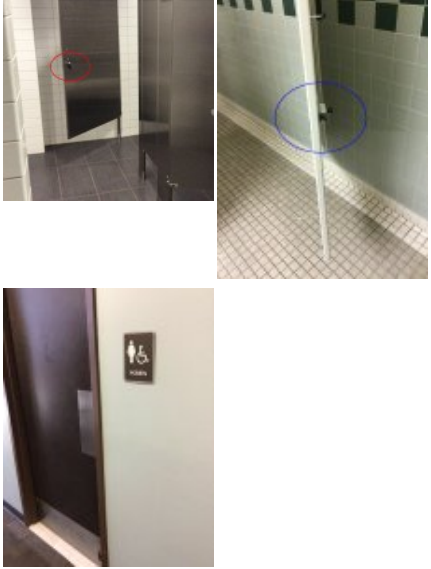
Finding Number	Area Description	Finding	As Built	Recommendation	Citation	Photos	Figure
116	Second Floor, Building C200 (STAFF) : Restrooms and water fountains (C200) - Women's restroom (near elevator)	The water closet compartment is missing a loop handle on both sides of the door. Water closet compartments must be equipped with a door that has a loop or U-shaped handle on both sides of the door immediately below the latch. The latch must be flip-over style, sliding or other hardware not requiring the user to grasp or twist.	N/A	https://www.access-board.gov/ada/#ada-604_8_1_2	2012 TAS Section: 604.8.1.2 2010 ADAS Section: 604.8.1.2 2015 ABAAS Section: 604.8.1.2

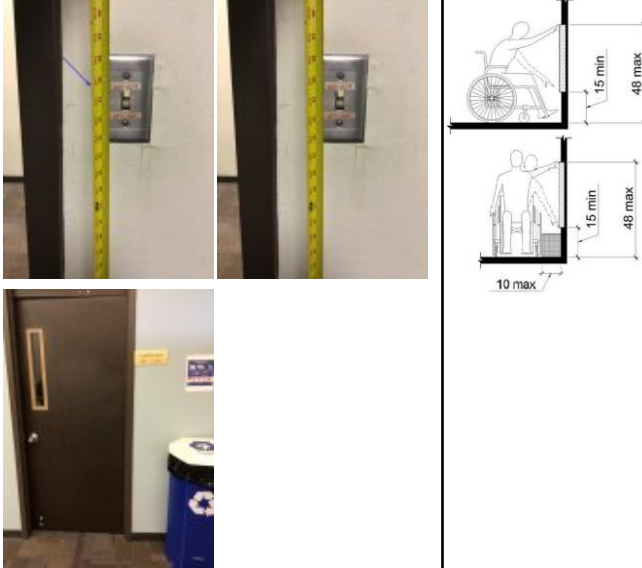
127	Second Floor, Building C200 (STAFF) : Interior spaces (C200) - Conference Room C200	The light switch is positioned too high for either a side or front approach. Where a clear floor or ground space allows a parallel approach to an element and the side reach is unobstructed, the high side reach shall be 48 inches maximum and the low side reach shall be 15 inches minimum above the finish floor or ground. Where a forward reach is unobstructed, the high forward reach shall be 48 inches maximum and the low forward reach shall be 15 inches minimum above the finish floor or ground.	exceeds 48" height		https://www.access-board.gov/ada/#ada-308_1	2012 TAS Section: 308.1 2010 ADAS Section: 308.1 2015 ABAAS Section: 308.1

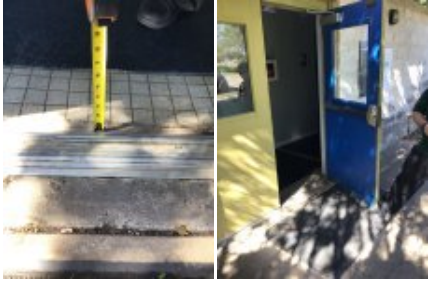
133	First Floor, Gym (STAFF) : Building Entrance - Gym entry doors (from parking lot)	The threshold has a vertical change greater than 1/4 inch. The threshold at a doorway shall be no higher than 1/2 inch. Changes in level between 1/4 inch and 1/2 inch must be beveled at 1:2 or less. The maximum vertical rise shall be 1/4 inch.	threshold not compliant	https://www.access-board.gov/ada/#ada-404_2_5	2012 TAS Section: 404.2.5 2010 ADAS Section: 404.2.5 2015 ABAAS Section: 404.2.5

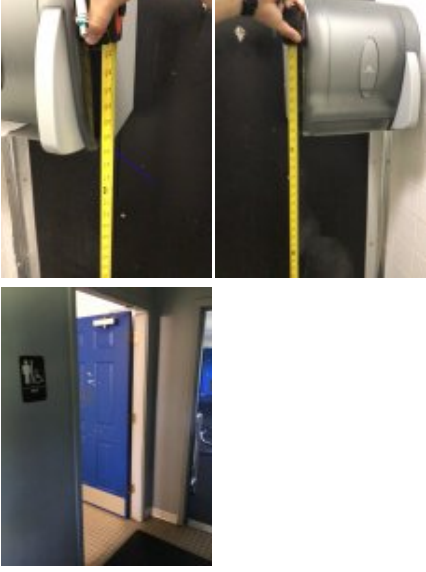
138	First Floor, Gym (STAFF) : Dressing Rooms and Water Fountains - Men's Dressing Room	The paper towel dispenser's operation mechanism is too high off the floor. The towel dispenser in back stall of Men's restroom. ** Applies to paper towel dispenser in ADA compliant stall. Dispensers must have all operable parts a maximum of 48 inches above the floor.	over 48"	https://www.access-board.gov/ada/#ada-308_2_1 https://www.access-board.gov/ada/#ada-308_2_2	2012 TAS Section: 308.2.1 2010 ADAS Section: 308.2.1 2015 ABAAS Section: 308.2.1

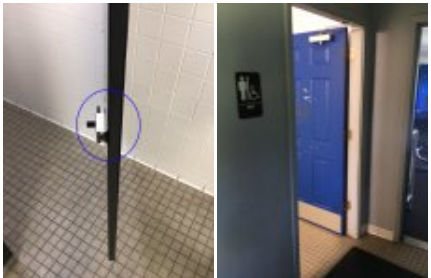
140	First Floor, Gym (STAFF) : Dressing Rooms and Water Fountains - Men's Dressing Room	The water closet compartment is missing a loop handle on one side or both sides of the door. Water closet compartments must be equipped with a door that has a loop or U-shaped handle on both sides of the door immediately below the latch. The latch must be flip-over style, sliding or other hardware not requiring the user to grasp or twist.	N/A	https://www.access-board.gov/ada/#ada-604_8_1_2	2012 TAS Section: 604.8.1.2 2010 ADAS Section: 604.8.1.2 2015 ABAAS Section: 604.8.1.2
