Access Audit Site Report

Lake Corpus Christi State Park

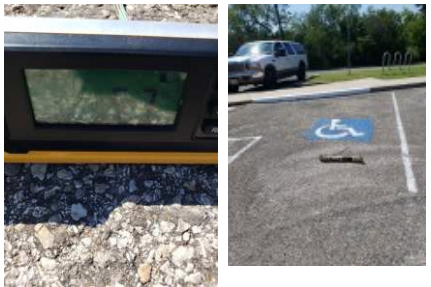
Finding Number	Area Description	Lat/Long	Finding	As Built	Recommendation	Citation	Photos	Figure

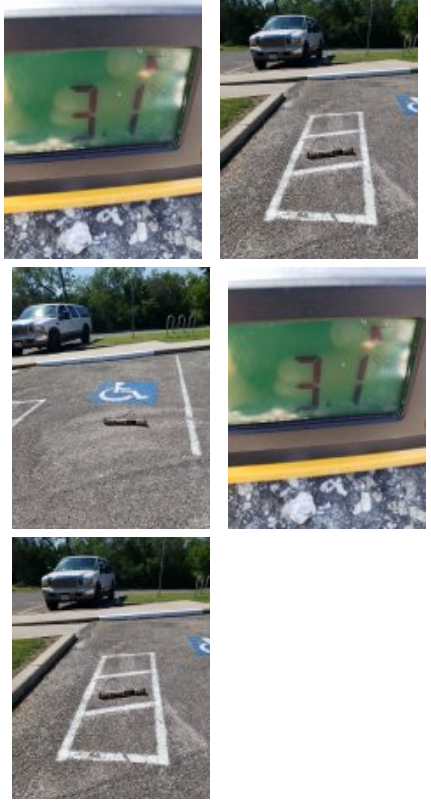
4	Headquarters Area: HQ Parking	[28.0631507, -97.8723375]	The parking stall contains abrupt edges and surface irregularities over a 1/4 inch vertical. Parking spaces and access aisles serving them shall be stable, firm, and slip resistant. Access aisles shall be at the same level as the parking spaces they serve. Changes in level are not permitted and shall not be sloped steeper than 2% in any direction.	Multiple gaps and changes in level (CIL) due to deterioration of paint and/or the parking surface being rough concrete with loose rock, weeds, grass, dirt/sand on top	Resurface accessible stalls and access aisles with a firm, stable, and slip resistant material	2015 ABAAS Section: 502.4 2012 TAS Section: 502.4 2010 ADAS Section: 502.4

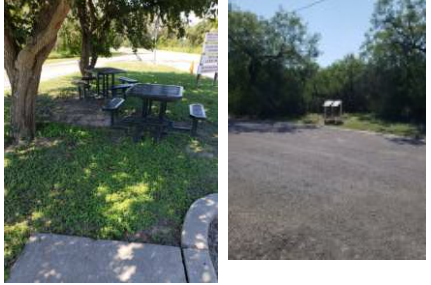
Finding Number	Area Description	Lat/Long	Finding	As Built	Recommendation	Citation	Photos	Figure
8	Headquarters Area: HQ Exterior Accessible Route	[28.0631152 , -97.872373 7]	There is a gap spaced greater than a 1/2 inch. Openings in floor or ground surfaces shall not allow passage of a sphere more than 1/2 inch diameter. Elongated openings shall be placed so that the long dimension is perpendicular to the dominant direction of travel.	Gaps of .5" and .75" along walkway	Correct or fill gaps to be max .5"	2015 ABAAS Section: 302.3 2012 TAS Section: 302.3 2010 ADAS Section: 302.3

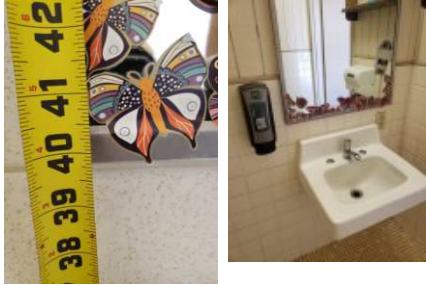
13	Headquarters Area: HQ Left Restroom	[28.0630986 , -97.8721712]	Knee clearance at 27 inches off the floor is not 8 inches minimum deep. The knee clearance, measured from the bottom of the apron or the outside bottom edge of the lavatory, must be 27 inches at a point located 8 inches back from the front edge and continuing to 11 inches minimum in depth at 9 inches above the floor. The top of the lavatory rim may be no higher than 34 inches.	Sink lacks 8" deep knee clearance (0")	Replace sink with one providing 27" knee clearance that is a min 8" deep	2015 ABAAS Section: 306.3.1, 306.3.2, 306.3.3, 306.3.4 , 306.3.5 2012 TAS Section: 306.3.2, 306.3.3, 306.3.4, 306.3.5, 306.3.1 2010 ADAS Section: 306.3.3, 306.3.2, 306.3.4, 306.3.5, 306.3.1

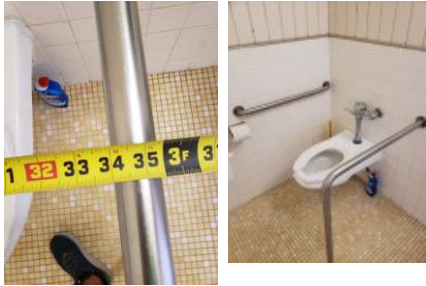
17	Headquarters Area: HQ Left Restroom	[28.0630927 , -97.8721953]	The side grab bar is not long enough. The side grab bar must extend at least 54 inches minimum beyond the rear wall and start a maximum of 12 inches from the rear wall. A 42 inch grab bar installed the maximum distance from the rear wall (12 inches) will leave the leading end 54 inches from the rear wall. Grab bars shall be installed in a horizontal position, 33 inches minimum and 36 inches maximum above the finish floor measured to the top of the gripping surface.	Side grab bar is 30" long and ends 31.5" from rear wall	Replace side grab bar with a 42" long grab bar, mounted max 12" from the rear wall at the close end and min 54" on the far end and 33" to 36" aff	2015 ABAAS Section: 604.5.1 2012 TAS Section: 604.5.1 2010 ADAS Section: 604.5.1

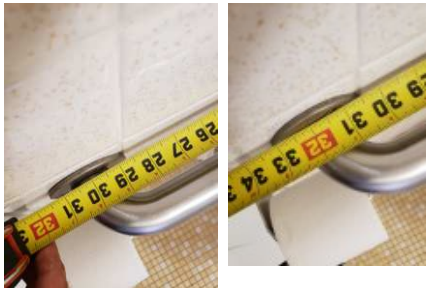
18	Headquarters Area: HQ Left Restroom	[28.0630797 , -97.872198]	The rear grab bar is not 36" long or is not mounted in the correct location. The rear grab bar must be a minimum of 36" long and extend from the toilet centerline a minimum 12" towards the wall side and a minimum 24" towards the open side of the toilet. Grab bars shall be installed in a horizontal position, 33 inches minimum and 36 inches maximum above the finish floor measured to the top of the gripping surface and the space between the grab bar and the top of the tank shall be 1-1/2 inches minimum.	Lacks rear grab bar	Acquire a rear grab bar that is 36" long, mounted behind the toilet, 12" to one side of center and 24" to the other and 33" to 36" aff	2015 ABAAS Section: 604.5.2 2012 TAS Section: 604.5.2 2010 ADAS Section: 604.5.2

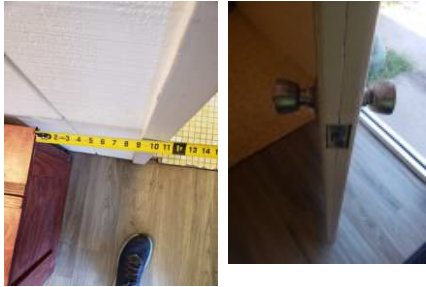
Finding Number	Area Description	Lat/Long	Finding	As Built	Recommendation	Citation	Photos	Figure
24	Headquarters Area: HQ Right Restroom	[28.0631034 , -97.872235 5]	The restroom sign does not comply with one or more applicable requirements for the location, height, and properties of the sign.	Restroom signage lacks proper mounting location and Braille lettering	Replace sign with one of contrasting colors that includes Braille, raised characters, and the symbol of accessibility and mount on the wall, latch side of the door, 48" to the baseline of the lowest character and 60" to the baseline of the highest character.	2015 ABAAS Section: F216.2, 703.1, 703.2, 703.5, 703.6 2012 TAS Section: 216.2, 703.1, 703.2, 703.5, 703.6 2010 ADAS Section: 216.2, 703.1, 703.2, 703.5, 703.6

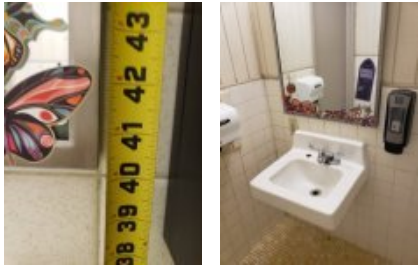
Finding Number	Area Description	Lat/Long	Finding	As Built	Recommendation	Citation	Photos	Figure
26	Headquarters Area: HQ Right Restroom	[28.0630821 , -97.872223 5]	Knee clearance at 27 inches off the floor is not 8 inches minimum deep. The knee clearance, measured from the bottom of the apron or the outside bottom edge of the lavatory, must be 27 inches at a point located 8 inches back from the front edge and continuing to 11 inches minimum in depth at 9 inches above the floor. The top of the lavatory rim may be no higher than 34 inches.	Sink lacks knee clearance - 26.5" clearance	Replace sink with one providing 27" knee clearance that is a min 8" deep.	2015 ABAAS Section: 306.3.1, 306.3.2, 306.3.3, 306.3.4 , 306.3.5 2012 TAS Section: 306.3.2, 306.3.3, 306.3.4, 306.3.5, 306.3.1 2010 ADAS Section: 306.3.3, 306.3.2, 306.3.4, 306.3.5, 306.3.1

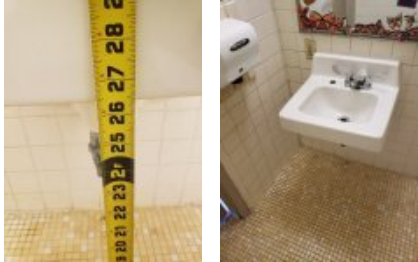
27	Headquarters Area: HQ Right Restroom	[28.0630892 , -97.872195 3]	The water and drain pipes under the lavatory are not adequately insulated. Water supply and drain pipes under lavatories and sinks shall be insulated or otherwise configured to protect against contact. There shall be no sharp or abrasive surfaces under lavatories and sinks.	Sink lacks insulated pipes	Insulate exposed pipes under sink	2015 ABAAS Section: 606.5 2012 TAS Section: 606.5 2010 ADAS Section: 606.5

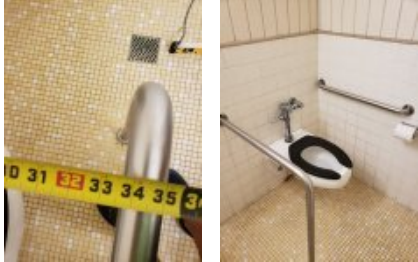
28	Headquarters Area: HQ Right Restroom	[28.0630821 , -97.872194]	The required 56 inches by 60 inches clear floor space for the water closet has been obstructed. The clear floor space around the water closet shall be 60 inches minimum measured perpendicular from the side wall and 56 inches minimum measured perpendicular from the rear wall.	Lacks 60" clear floor space around toilet - 33.5" due to stand alone grab bar location	Remove stand alone grab bar to provide required 60" clearance around toilet.	2015 ABAAS Section: 604.3. 2012 TAS Section: 604.3.1 2010 ADAS Section: 604.3.1

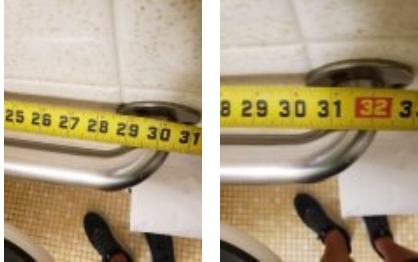
30	Headquarters Area: HQ Right Restroom	[28.0630939 , -97.8721832]	The rear grab bar is not 36" long or is not mounted in the correct location. The rear grab bar must be a minimum of 36" long and extend from the toilet centerline a minimum 12" towards the wall side and a minimum 24" towards the open side of the toilet. Grab bars shall be installed in a horizontal position, 33 inches minimum and 36 inches maximum above the finish floor measured to the top of the gripping surface and the space between the grab bar and the top of the tank shall be 1-1/2 inches minimum.	Lacks rear grab bar	Acquire a rear grab bar that is 36" long, mounted behind the toilet, 12" to one side of center and 24" to the other and 33" to 36" aff	2015 ABAAS Section: 604.5.2 2012 TAS Section: 604.5.2 2010 ADAS Section: 604.5.2

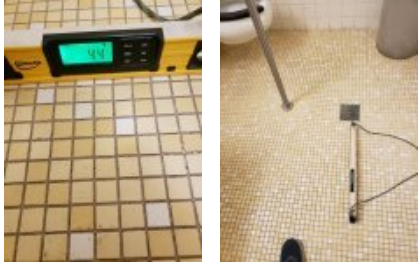
32	Headquarters Area: HQ Right Restroom	[28.0631081 , -97.8721926]	An object or objects project more than 4 inches into the circulation path. Wall-mounted objects that have leading edges between 27 inches and 80 inches from the floor must not project more than 4 inches into the circulation path. Protruding objects that extend to the floor or within 27 inches of the floor are cane detectable and are therefore not hazardous. Where it is necessary or desirable to have objects protrude from the wall, a manner of cane detection must be provided.	Hand dryer protrudes 5.5"	Relocate protruding objects or place cane detectable warning or bollard at foot of item.	2015 ABAAS Section: 307.2 2012 TAS Section: 307.2 2010 ADAS Section: 307.2

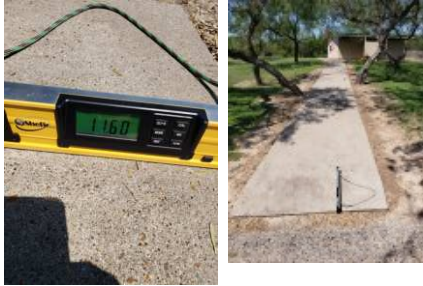
36	Catfish Cove Camping Area: Restroom Parking and Exterior Accessible Route	[28.0584051, -97.8775611]	The running slope of walking surfaces shall not be steeper than 1:20.	Running slope of 11.6% run slope where walkway meets parking	Correct running slope along the AR to max 5%	2015 ABAAS Section: 403.3 2012 TAS Section: 403.3 2010 ADAS Section: 403.3

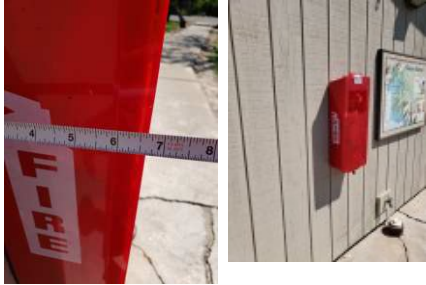
40	Catfish Cove Camping Area: Catfish Cove Men's Restroom	[28.0586299, -97.8776348]	The restroom sign does not comply with one or more applicable requirements for the location, height, and properties of the sign.	Lacks compliant signage	Acquire and mount signage, including Braille and access symbol mounted on wall, latch side of door, 48" to baseline of lowest character and 60" to baseline of highest character	2015 ABAAS Section: F216.2, 703.1, 703.2, 703.5, 703.6 2012 TAS Section: 216.2, 703.1, 703.2, 703.5, 703.6 2010 ADAS Section: 216.2, 703.1, 703.2, 703.5, 703.6

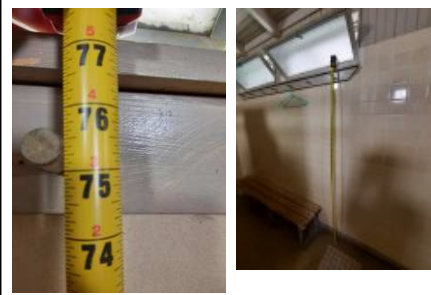
42	Catfish Cove Camping Area: Catfish Cove Men's Restroom	[28.0586571, -97.877630 8]	Coat hooks provided within the room shall be located within one of the reach ranges specified in 308. Shelves shall be 40 inches (1015 mm) minimum and 48 inches (1220 mm) maximum above the finish floor or ground. Where coat hooks or shelves are provided in dressing, fitting or locker rooms without individual compartments, at least one of each type shall comply with 803.5. Where coat hooks or shelves are provided in individual compartments at least one of each type complying with 803.5 shall be provided in individual compartments in dressing, fitting, or locker rooms required to comply with 222.1.	Coat hooks at 75.75" aff	Remount at least one hook to max 48" aff.	2015 ABAAS Section: 308.2.1, 308.1, F222.2, 803.5 2012 TAS Section: 308.2.1, 308.1, 222.2, 803.5 2010 ADAS Section: 308.2.1, 308.1, 222.2, 803.5

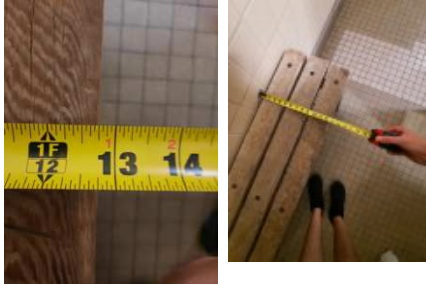
44	Catfish Cove Camping Area: Catfish Cove Men's Restroom	[28.058637, -97.8776348]	There are no accessible bathing or shower facilities. Where facilities for bathing are provided for the public, clients or employees, including showers or bathtubs, at least one shower or bathtub and support facilities such as lockers, and not less than 1 percent of all facilities, shall be accessible.	Lacks accessible bathing or shower facilities	Create an accessible shower in locker/bathing room.	2015 ABAAS Section: F213.3.6 2012 TAS Section: 213.3.6 2010 ADAS Section: 213.3.6

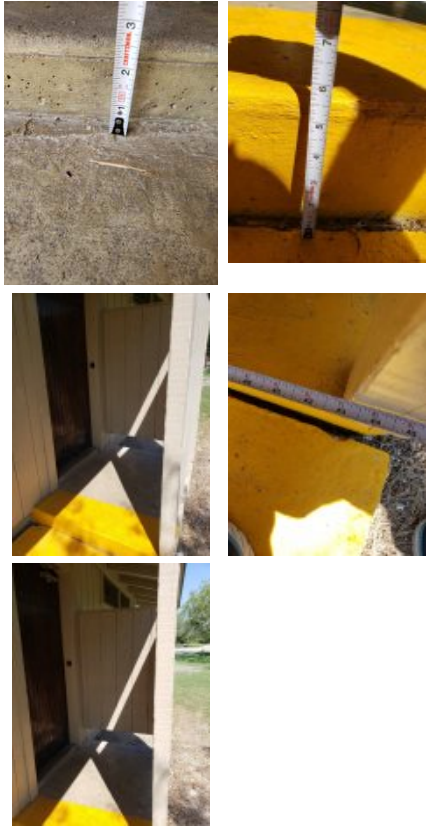
Finding Number	Area Description	Lat/Long	Finding	As Built	Recommendation	Citation	Photos	Figure
46	Catfish Cove Camping Area: Catfish Cove Women's Restroom	[28.0586358 , -97.8776281]	The restroom sign does not comply with one or more applicable requirements for the location, height, and properties of the sign.	Lacks compliant signage	Replace sign with one of contrasting colors that includes Braille, raised characters, and the symbol of accessibility and mount on the wall, latch side of the door, 48" to the baseline of the lowest character and 60" to the baseline of the highest character	2015 ABAAS Section: F216.2, 703.1, 703.2, 703.5, 703.6 2012 TAS Section: 216.2, 703.1, 703.2, 703.5, 703.6 2010 ADAS Section: 216.2, 703.1, 703.2, 703.5, 703.6

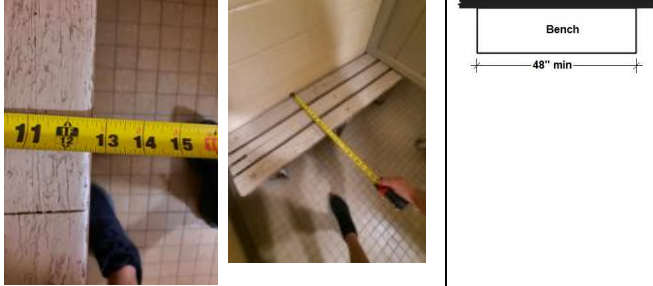
Finding Number	Area Description	Lat/Long	Finding	As Built	Recommendation	Citation	Photos	Figure
50	Catfish Cove Camping Area: Catfish Cove Women's Restroom	[28.0586299 , -97.8776295]	There are no accessible bathing or shower facilities. Where facilities for bathing are provided for the public, clients or employees, including showers or bathtubs, at least one shower or bathtub and support facilities such as lockers, and not less than 1 percent of all facilities, shall be accessible.	Lacks accessible bathing or shower facilities	Create an accessible shower in locker/bathing room.	2015 ABAAS Section: F213.3.6 2012 TAS Section: 213.3.6 2010 ADAS Section: 213.3.6

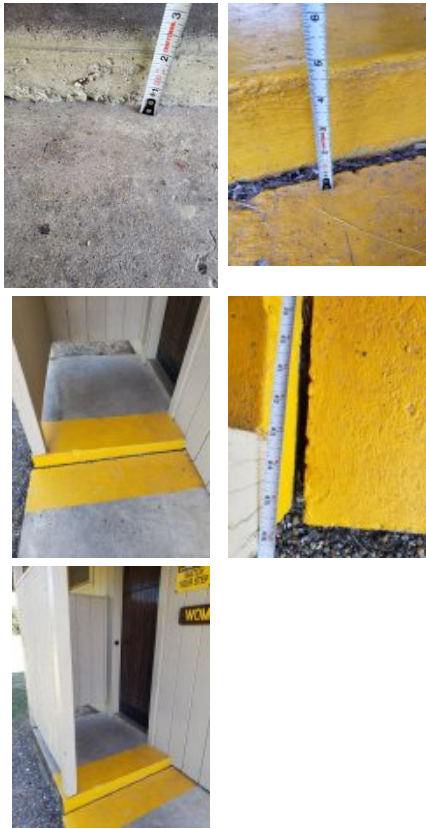
Finding Number	Area Description	Lat/Long	Finding	As Built	Recommendation	Citation	Photos	Figure
52	Catfish Cove Camping Area: Catfish Cove Fishing	[28.0575293 , -97.8797779]	Not enough of the railings, guards, or handrails are at the allowable height. At least 25 percent of the railings, guards, or handrails shall be 34 inches maximum above the ground or deck surface.	Lacks 25% of railings at 34" above deck surface - all railings are 40.5" above deck surface	Lower 25% of the railing; dispersed through pier, to max 34".	2015 ABAAS Section: 1005.2.1 2010 ADAS Section: 1005.2.1

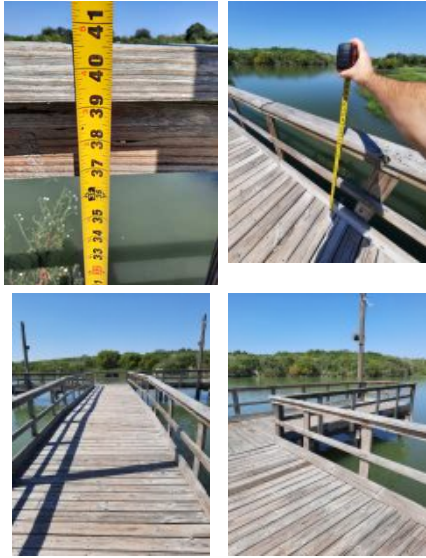
53	Catfish Cove Camping Area: Catfish Cove Fishing	[28.0574488 , -97.8796161]	Accessible routes serving fishing piers and platforms, including gangways and floating piers, shall comply with Chapter 4. EXCEPTIONS: 1. Accessible routes serving floating fishing piers and platforms shall be permitted to use Exceptions 1, 2, 5, 6, 7 and 8 in 1003.2.1. 2. Where the total length of the gangway or series of gangways serving as part of a required accessible route is 30 feet (9145 mm) minimum, gangways shall not be required to comply with 405.2.	Lacks accessible route to fishing pier and fish cleaning station	Create an outdoor accessible route to the fishing pier and fish cleaning station or make corrections for a compliant route.	2015 ABAAS Section: 1005.1, 1005.1 EXCEPTIONS: 1, 1005.1 EXCEPTIONS: 2 2010 ADAS Section: 1005.1, 1005.1 Exception 1, 1005.1 Exception 2

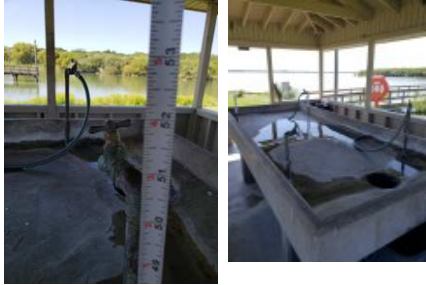
55	Catfish Cove Camping Area: Catfish Cove Fishing	[28.0574843, -97.879558]	The water spout handle is not accessible because it requires tight grasping, pinching or twisting of the wrist.	Water spout handle requires tight grasping, pinching, or twisting of the wrist	Replace water spout handle with an operable part usable without a tight pinch or grasp.	2015 ABAAS Section: 309.4 2012 TAS Section: 309.4 2010 ADAS Section: 309.4

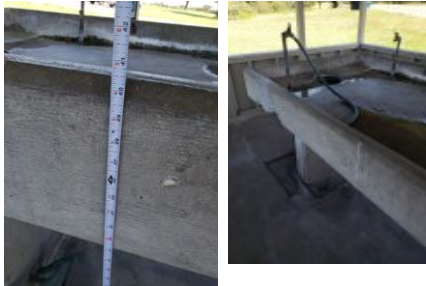
56	Catfish Cove Camping Area: Catfish Cove Fishing	[28.057486, -97.8795489]	The top of the work surface is not within a compliant height range. The tops of tables and counters shall be 28 inches to 34 inches from the floor or ground.	Fish cleaning station work surface at 41.5" aff	Provide tables and work surfaces at 28" to 34" aff with required knee and toe clearances	2015 ABAAS Section: 902.3 2012 TAS Section: 902.3 2010 ADAS Section: 902.3

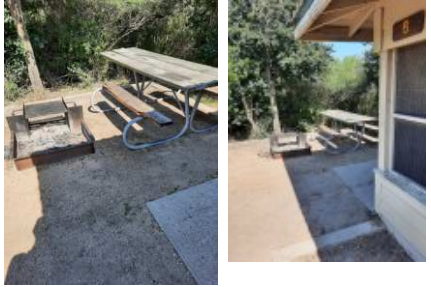
Lake Corpus Christi State Park - 23194 Park Rd 25 Mathis, TX 78368

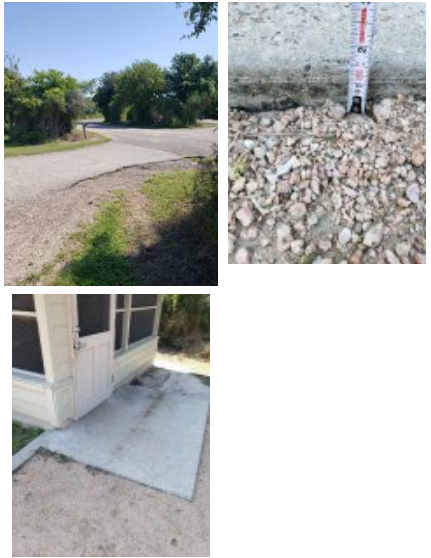
Finding Number	Area Description	Lat/Long	Finding	As Built	Recommendation	Citation	Photos	Figure
68	Bird's Nest Shelter Area: Bird's Nest Shelter 7	[28.0609282 , -97.881548 2]	Picnic tables are required to have clear ground space 36 inches (915 mm) on all usable sides of the table measured from the back edge of the benches.	Lacks 36" clear ground space on all usable sides of the picnic table	Provide required 36" clear ground space around all usable portions of the table as a smart practice.	2015 ABAAS Section: 1011.2.1

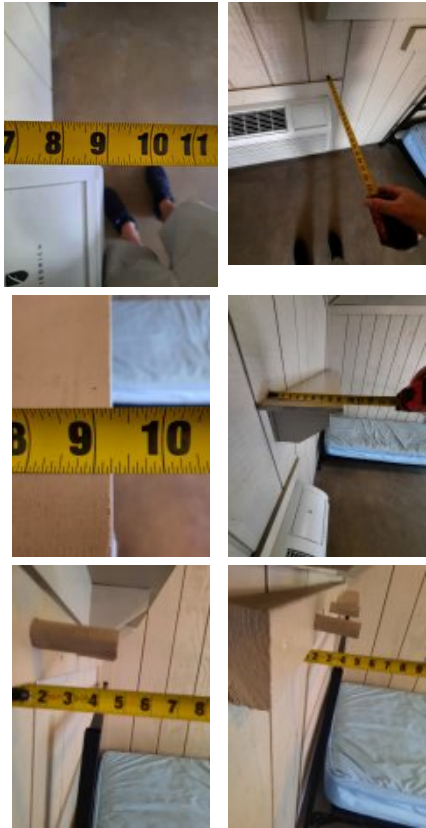
Finding Number	Area Description	Lat/Long	Finding	As Built	Recommendation	Citation	Photos	Figure
76	Bird's Nest Shelter Area: Bird's Nest Shelter 13	[28.0603483 , -97.881701 1]	The two shelves are positioned too high for either a side or front approach. Where a clear floor or ground space allows a parallel approach to an element and the side reach is unobstructed, the high side reach shall be 48 inches maximum and the low side reach shall be 15 inches minimum above the finish floor or ground. Where a forward reach is unobstructed, the high forward reach shall be 48 inches maximum and the low forward reach shall be 15 inches minimum above the finish floor or ground.	Shelves are 55" and 54" above finished floor	Remount shelves to be in reach range of 15" min to 48" max.	2015 ABAAS Section: 308.1 2012 TAS Section: 308.1 2010 ADAS Section: 308.1

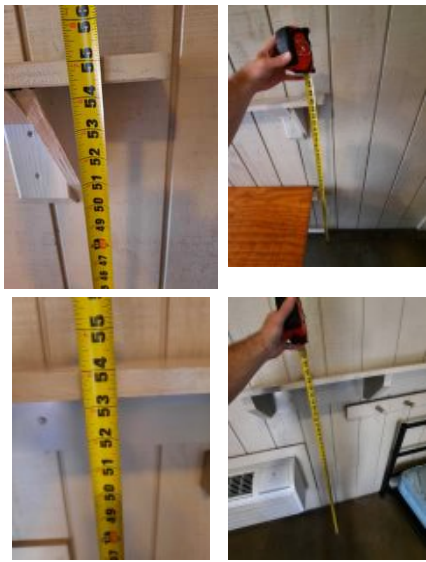
77	Bird's Nest Shelter Area: Bird's Nest Shelter 13	[28.0603392 , -97.881702 3]	Element meets all standards and requirements	More than 30" x 48" of clear floor space to access beds	None	2010 ADAS Section: N/A

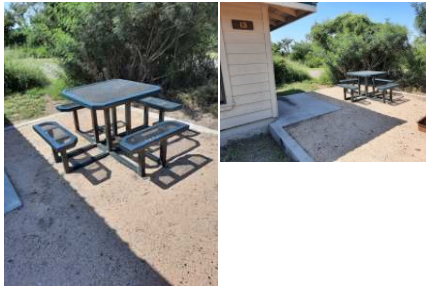
Finding Number	Area Description	Lat/Long	Finding	As Built	Recommendation	Citation	Photos	Figure
80	Bird's Nest Shelter Area: Bird's Nest Shelter 13	[28.0604028 , -97.881714 5]	Clear ground space 48 inches (1220 mm) by 48 inches (1220 mm) should be provided on all usable sides of the fire ring, grill, fireplace, and woodstove. Center the space on each usable side of the grill, fireplace, and woodstove.	Grill lacks 48" by 48" clear ground space due to location of picnic table and water spout concrete slab and protruding bush	Provide required 48" clear ground space centered along usable side of fire ring, grill, fireplace, or woodstove as a smart practice.	2015 ABAAS Section: 1011.2

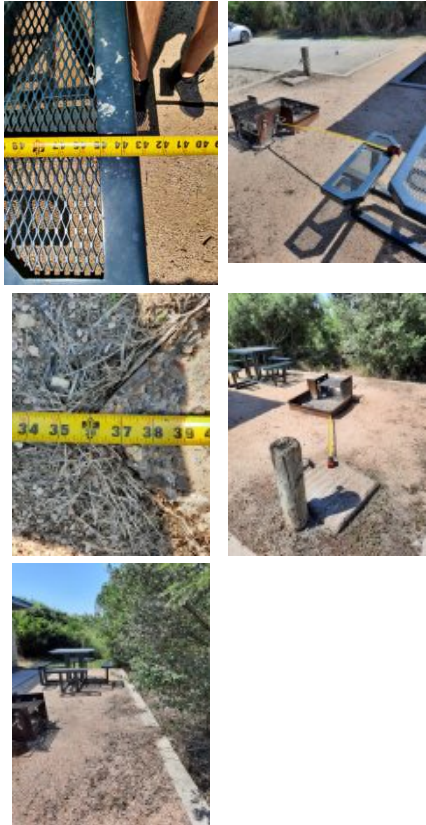
Finding Number	Area Description	Lat/Long	Finding	As Built	Recommendation	Citation	Photos	Figure
81	Bird's Nest Shelter Area: Bird's Nest Shelter 13	[28.060398, -97.881719 8]	Fire building surfaces shall be 9 inches (230 mm) minimum above the ground.	Fire building surface is less than 9" high and is at the same grade as surrounding ground level	Correct fire building surface to be 9" min above the ground as a smart practice. In the alternative, replace fire ring with a compliant accessible fire ring.	2015 ABAAS Section: 1011.5.1

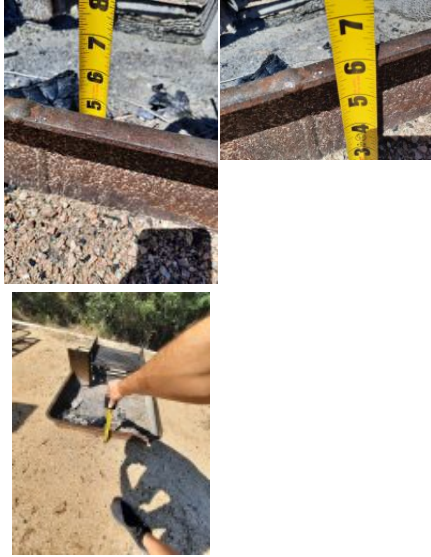
82	Bird's Nest Shelter Area: Bird's Nest Shelter 13	[28.0603838, -97.881725 2]	Water spouts at water hydrants and water utility hook-ups shall be 28 inches (710 mm) minimum and 36 inches (915 mm) maximum above the ground	Operable part of water spout is 17.25" above ground level	Remount water spouts to 28" min or 36" max above the ground as a smart practice	2015 ABAAS Section: 1011.6

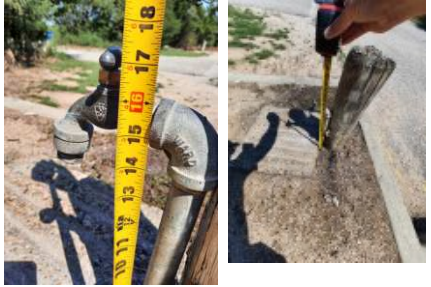
83	Bird's Nest Shelter Area: Bird's Nest Shelter 13	[28.0603294, -97.881693]	Element meets all standards and requirements	Bird's Nest Shelter 13 door complies	None	2010 ADAS Section: N/A

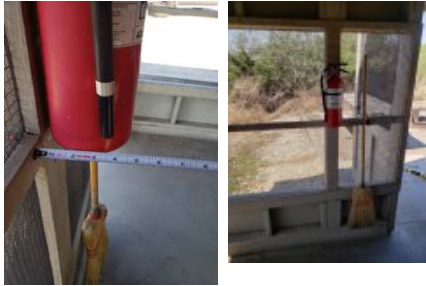
85	Bird's Nest Shelter Area: Bird's Nest Shelter 18	[28.0586559 , -97.880459 2]	The shelf is positioned too high for either a side or front approach. Where a clear floor or ground space allows a parallel approach to an element and the side reach is unobstructed, the high side reach shall be 48 inches maximum and the low side reach shall be 15 inches minimum above the finish floor or ground. Where a forward reach is unobstructed, the high forward reach shall be 48 inches maximum and the low forward reach shall be 15 inches minimum above the finish floor or ground.	Shelf at 54" aff	Remount shelf to be in reach range of 15" min to 48" max, in the alternative, leave as is citing safe harbor.	2015 ABAAS Section: 308.1 2012 TAS Section: 308.1 2010 ADAS Section: 308.1

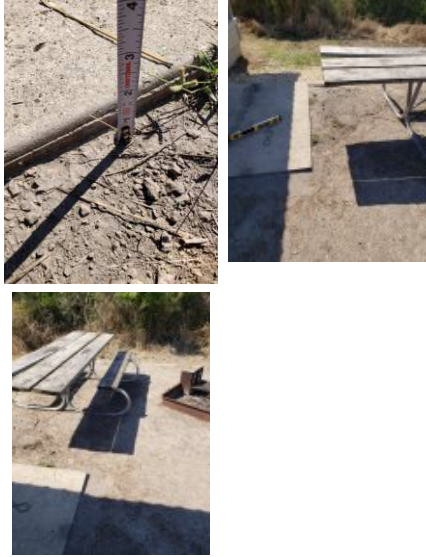
88	Bird's Nest Shelter Area: Bird's Nest Shelter 18	[28.0586678 , -97.880523 6]	Fire building surfaces shall be 9 inches (230 mm) minimum above the ground.	Fire building surface is at the same grade as surrounding ground level	Correct fire building surface to be 9" min above the ground as a smart practice. In the alternative, replace fire ring with a compliant accessible fire ring.	2015 ABAAS Section: 1011.5.1

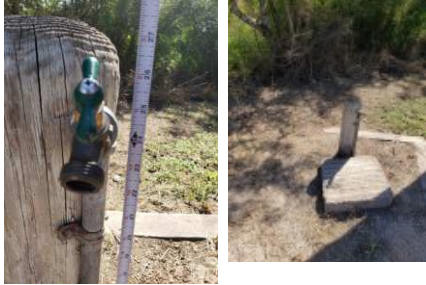
91	Bird's Nest Shelter Area: Bird's Nest Shelter 18	[28.0586559 , -97.8804672]	Element meets all standards and requirements	Shelter 18 door meets all standards and requirements	None	2010 ADAS Section: N/A

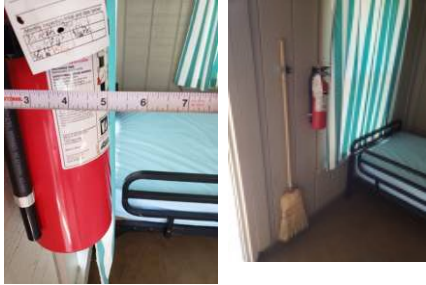
98	Bird's Nest Shelter Area: Bird's Nest Shelter 25	[28.0593802 , -97.880292 9]	The operable part is not accessible because there is not adequate clear floor space for either a forward or side approach. The clear floor or ground space shall be 30 inches minimum by 48 inches minimum.	Lacks clear floor space for coat hooks	Remove, or relocate storage in CFS at fixtures and operable parts along the route.	2015 ABAAS Section: 305.3 2012 TAS Section: 305.3 2010 ADAS Section: 305.3

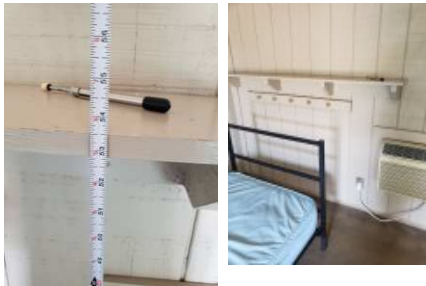
Finding Number	Area Description	Lat/Long	Finding	As Built	Recommendation	Citation	Photos	Figure
100	Bird's Nest Shelter Area: Bird's Nest Shelter 25	[28.0593826 , -97.8802929]	Element meets all standards and requirements	Shelter 25 door meets all standards and requirements	None	2010 ADAS Section: N/A

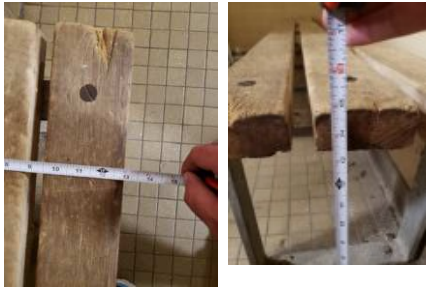
Finding Number	Area Description	Lat/Long	Finding	As Built	Recommendation	Citation	Photos	Figure
108	Bird's Nest Shelter Area: Bird's Nest Men's Restroom	[28.0602489 , -97.8804538]	There are no accessible bathing or shower facilities. Where facilities for bathing are provided for the public, clients or employees, including showers or bathtubs, at least one shower or bathtub and support facilities such as lockers, and not less than 1 percent of all facilities, shall be accessible.	Lacks accessible bathing or shower facilities	Create an accessible shower in locker/bathing room	2015 ABAAS Section: F213.3.6 2012 TAS Section: 213.3.6 2010 ADAS Section: 213.3.6

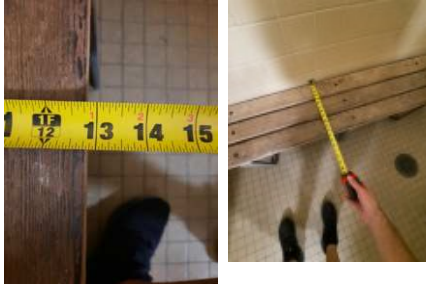
115	Bird's Nest Shelter Area: Bird's Nest Women's Restroom	[28.060256, -97.880445 8]	There are no accessible bathing or shower facilities. Where facilities for bathing are provided for the public, clients or employees, including showers or bathtubs, at least one shower or bathtub and support facilities such as lockers, and not less than 1 percent of all facilities, shall be accessible.	Lacks accessible bathing or shower facilities	Create an accessible shower in locker/bathing room.	2015 ABAAS Section: F213.3.6 2012 TAS Section: 213.3.6 2010 ADAS Section: 213.3.6

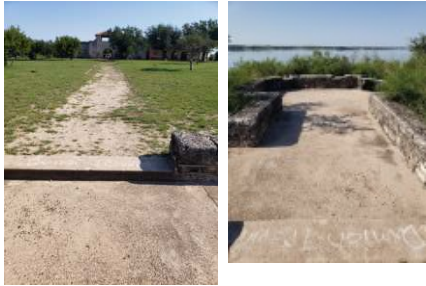
Finding Number	Area Description	Lat/Long	Finding	As Built	Recommendation	Citation	Photos	Figure
124	Bird's Nest Shelter Area: Historic CCC Castle	[28.0582772 , -97.882446 7]	There is no accessible route to the observation area. At least one accessible route shall connect accessible buildings, accessible facilities, accessible elements, and accessible spaces that are on the same site.	Lacks accessible route to observation area - sand and gravel walkway with one step	Create an accessible route with crushed stone or other outdoor material from parking or walkway to observation area and remove barrier at step.	2015 ABAAS Section: F206.2.2 2012 TAS Section: 206.2.2 2010 ADAS Section: 206.2.2

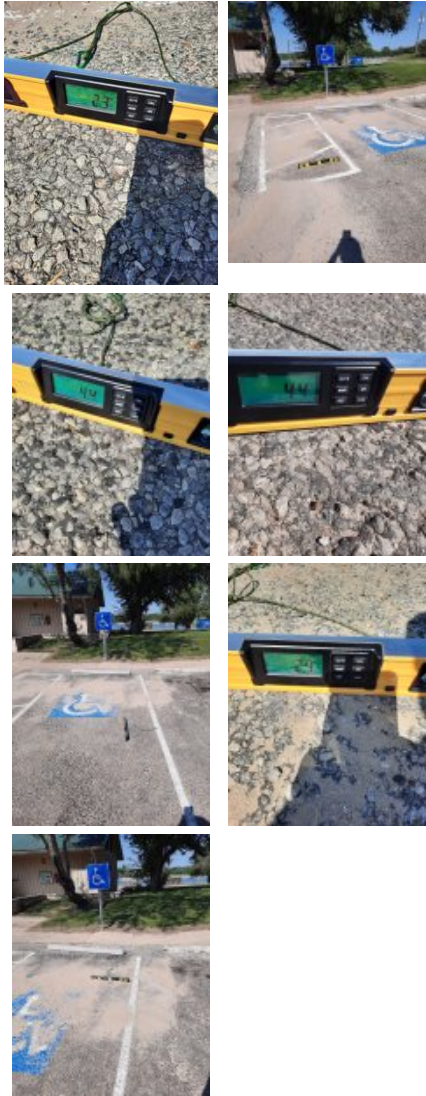
Finding Number	Area Description	Lat/Long	Finding	As Built	Recommendation	Citation	Photos	Figure
130	Cave Swallow Cove Day Use Area: Cave Swallow Restroom Parking	[28.063004, -97.879633 1]	The parking stall contains abrupt edges and surface irregularities over a 1/4 inch vertical. Parking spaces and access aisles serving them shall be stable, firm, and slip resistant. Access aisles shall be at the same level as the parking spaces they serve. Changes in level are not permitted and shall not be sloped steeper than 2% in any direction.	2" gap and 1" CIL at outer edge of access aisle	Repair, bevel and ramp CIL in stalls and access aisles.	2015 ABAAS Section: 502.4 2012 TAS Section: 502.4 2010 ADAS Section: 502.4

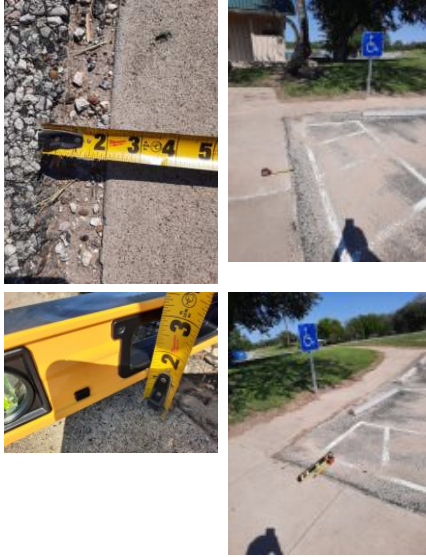
131	Cave Swallow Cove Day Use Area: Cave Swallow Restroom Parking	[28.0630122, -97.879629]	The accessible parking stall signage is incorrect and/or missing from each accessible parking space. Parking space identification signs shall include the International Symbol of Accessibility. Signs identifying van parking spaces shall contain the designation "van accessible." Signs shall be 60 inches minimum above the finish floor or ground surface measured to the bottom of the sign.	Lacks R7-8 sign	Acquire and mount at appropriate heights and locations R7-8 signs as a smart practice.	2015 ABAAS Section: 502.6 2012 TAS Section: 502.6

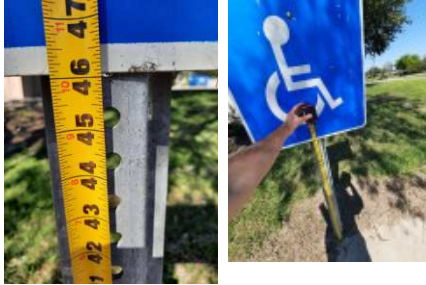
133	Cave Swallow Cove Day Use Area: Cave Swallow Restroom Parking	[28.0630111 , -97.879641 1]	The van stall is missing a sign identifying it as a van accessible stall. Parking space identification signs shall include the International Symbol of Accessibility. Signs identifying van parking spaces shall contain the designation "van accessible."	Lacks van sized stall and accessible sign	Add one van parking sign to one accessible stall and repaint stall and access aisle to 11' and 5' or 8' and 8'. Cost included in previous findings.	2015 ABAAS Section: 502.6 2012 TAS Section: 502.6 2010 ADAS Section: 502.6

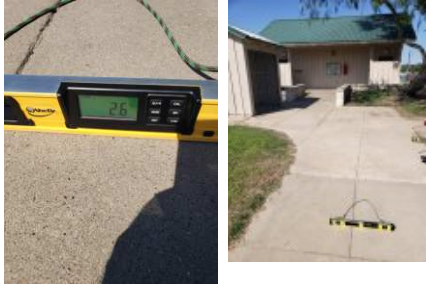
Finding Number	Area Description	Lat/Long	Finding	As Built	Recommendation	Citation	Photos	Figure
136	Cave Swallow Cove Day Use Area: Cave Swallow Restroom Parking	[28.0630892 , -97.879653 2]	The walkway contains abrupt vertical edges and/or variations over a 1/4 inch. 1/4 inch is the maximum vertical rise. Changes in level between 1/4 inch and 1/2 inch must be beveled at 1:2 or less. Changes in level greater than 1/2 inch must be by way of a ramp.	CIL of .5" near restrooms	Repair, bevel or ramp change in level along accessible route.	2012 TAS Section: 303.2, 303.3 2010 ADAS Section: 303.2, 303.3

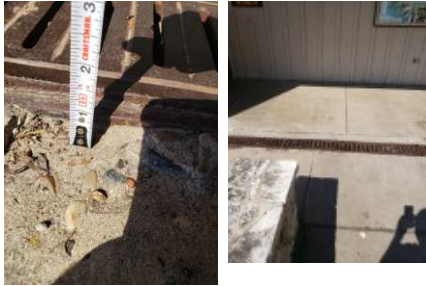
137	Cave Swallow Cove Day Use Area: Cave Swallow Men's Restroom	[28.0631531 , -97.879665 3]	The restroom sign does not comply with one or more applicable requirements for the location, height, and properties of the sign.	Lacks Braille and symbol of access on restroom signage	Acquire and mount signage, including Braille, raised lettering and access symbol mounted on wall, latch side of door, 48" to baseline of lowest character and 60" to baseline of highest character Remount signage to the proper location based on the type of door provided	2015 ABAAS Section: F216.2, 703.1, 703.2, 703.5, 703.6 2012 TAS Section: 216.2, 703.1, 703.2, 703.5, 703.6 2010 ADAS Section: 216.2, 703.1, 703.2, 703.5, 703.6

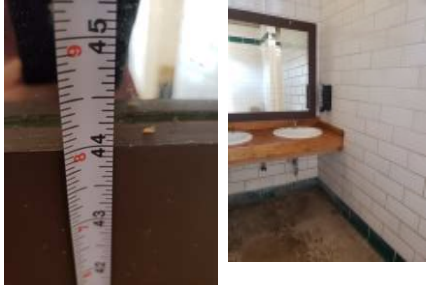
Finding Number	Area Description	Lat/Long	Finding	As Built	Recommendation	Citation	Photos	Figure
139	Cave Swallow Cove Day Use Area: Cave Swallow Men's Restroom	[28.0631531, -97.8796787]	The top rim of the sink is too high. All lavatories/sinks that are designated to be accessible shall be a minimum 17 inches in horizontal depth and mounted with the rim or counter edge no higher than 34 inches above the finished floor.	The top rim of the sink is 35" aff	Lower sinks to max 34" aff to front of rim.	2015 ABAAS Section: 606.3 2012 TAS Section: 606.3 2010 ADAS Section: 606.3

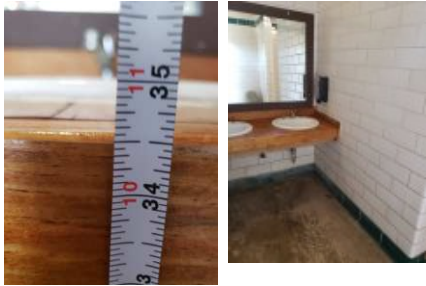
140	Cave Swallow Cove Day Use Area: Cave Swallow Men's Restroom	[28.0631436, -97.8796787]	The water and drain pipes under the lavatory are not adequately insulated. Water supply and drain pipes under lavatories and sinks shall be insulated or otherwise configured to protect against contact. There shall be no sharp or abrasive surfaces under lavatories and sinks.	Sink lacks insulated pipes	Insulate exposed pipes under one sink	2015 ABAAS Section: 606.5 2012 TAS Section: 606.5 2010 ADAS Section: 606.5

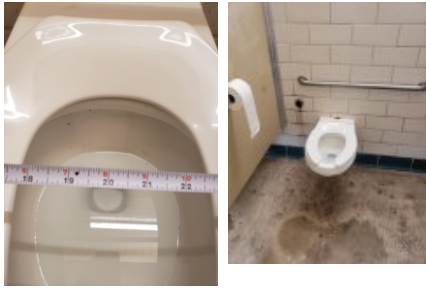
142	Cave Swallow Cove Day Use Area: Cave Swallow Men's Restroom	[28.063146, -97.8796679]	The toilet seat is not located within the range allowed off the floor. The height of accessible water closets shall be a minimum of 17 inches and a maximum of 19 inches measured to the top of a maximum 2-inch high toilet seat.	Toilet seat 21" aff	Replace toilet seat, or re-set or replace toilet to 17" to 19" aff.	2015 ABAAS Section: 604.4 2012 TAS Section: 604.4 2010 ADAS Section: 604.4

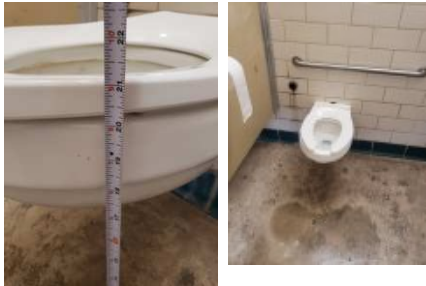
Finding Number	Area Description	Lat/Long	Finding	As Built	Recommendation	Citation	Photos	Figure
143	Cave Swallow Cove Day Use Area: Cave Swallow Men's Restroom	[28.063146, -97.879678 7]	The side grab bar is missing. Grab bars shall be installed in a horizontal position, 33 inches minimum and 36 inches maximum above the finish floor measured to the top of the gripping surface and the space between the grab bar and the top of any obstruction shall be 1-1/2 inches minimum.	Lacks side grab bar	Acquire 42" long side grab bar, mounted max 12" from the rear wall at the close end and min 54" on the far end and 33" to 36" aff.	2015 ABAAS Section: 604.5 2012 TAS Section: 604.5 2010 ADAS Section: 604.5

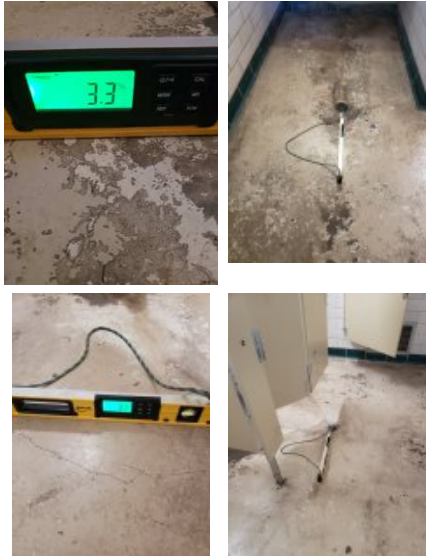
149	Cave Swallow Cove Day Use Area: Cave Swallow Men's Restroom	[28.0631602 , -97.879665 3]	Element meets all standards and requirements	Cave Swallow Men's Restroom door complies	None	2010 ADAS Section: N/A

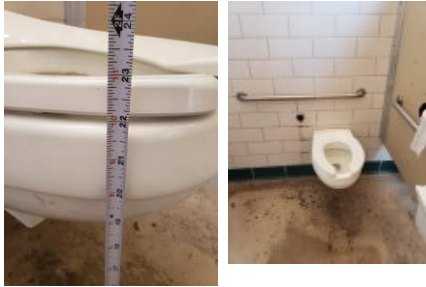
155	Cave Swallow Cove Day Use Area: Cave Swallow Women's Restroom	[28.0631424 , -97.879681 3]	The side grab bars are not in the correct location. Grab bars on the side wall must be installed so that the end closest to the rear wall is maximum 12" from the rear wall. The end furthest from the rear wall must be mounted minimum 54" from the rear wall.	Side grab bar ends 50" from rear wall	Remount side grab bar to max 12" from the rear wall at the close end and min 54" on the far end, and 33" to 36" AFF.	2015 ABAAS Section: 604.5.1 2012 TAS Section: 604.5.1 2010 ADAS Section: 604.5.1

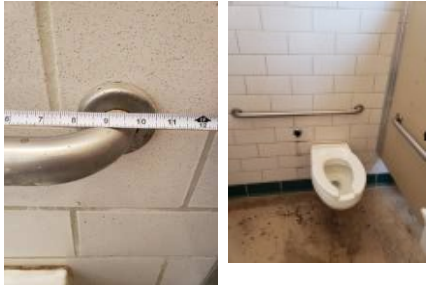
157	Cave Swallow Cove Day Use Area: Cave Swallow Women's Restroom	[28.0631507 , -97.879670 6]	The grab bar height and/or spacing fails. Grab bars must be mounted between 33" and 36" to the top of the gripping surface. There must be 1.5" of clearance between the grab bar and the wall. There must be a minimum of 1.5" of clearance below and minimum 12" above the grab bar to any dispenser or other obstruction.	TP mounted 2" above side grab bar	Remount toilet paper dispenser max 7" to 9" from front of toilet, 15" to 48" aff and min 12" above or 1.5" below grab bar.	2015 ABAAS Section: 609.3, 609.4 2012 TAS Section: 609.4, 609.3 2010 ADAS Section: 609.3, 609.4

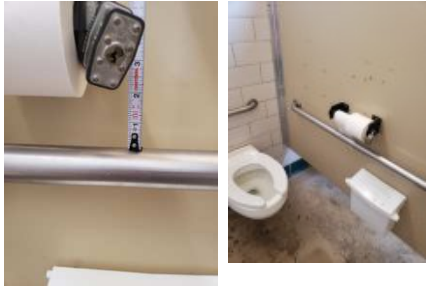
158	Cave Swallow Cove Day Use Area: Cave Swallow Women's Restroom	[28.0631412 , -97.879659 9]	The stall door fails to comply with all of the door requirements. The stall door must be a minimum of 32" wide and have compliant hardware on both sides. The stall door must be self-closing.	Lacks self-closing door	Adjust stall door to be self-closing.	2015 ABAAS Section: 404.2.3, 404.2.7, 604.8.2.2 2012 TAS Section: 404.2.3, 404.2.7, 604.8.2.2 2010 ADAS Section: 404.2.3, 404.2.7, 604.8.2.2

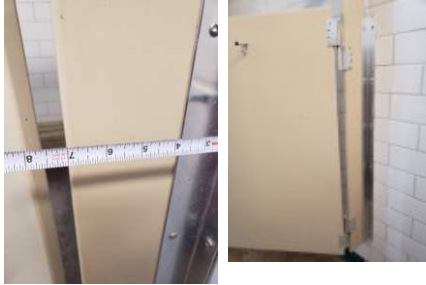
160	Cave Swallow Cove Day Use Area: Cave Swallow Women's Restroom	[28.0631412 , -97.879670 6]	The hand dryer projects more than 4 inches into the circulation path. Wall-mounted objects that have leading edges between 27 inches and 80 inches from the floor must not project more than 4 inches into the circulation path. Protruding objects that extend to the floor or within 27 inches of the floor are cane detectable and are therefore not hazardous. Where it is necessary or desirable to have objects protrude from the wall, a manner of cane detection must be provided.	Hand dryer protrudes 5"	Relocate protruding objects or place cane detectable warning or bollard at foot of item.	2015 ABAAS Section: 307.2 2012 TAS Section: 307.2 2010 ADAS Section: 307.2

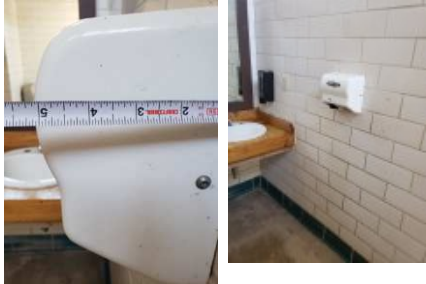
161	Cave Swallow Cove Day Use Area: Cave Swallow Women's Restroom	[28.0631507 , -97.879676]	The accessible route contains running slopes greater than 5 percent and cross slopes greater than 2 percent across the width of the walk and has not been constructed as a ramp (i.e. handrails, wheel guides, etc.). When the slope in the direction of travel of any walk exceeds 1 unit vertical in 20 units horizontal (5-percent slope), it must be constructed as ramp. Surface cross slopes must not exceed one unit vertical in 48 units. Horizontal (2-percent slope).	Slopes of 9% and 5% near floor drain	Correct or repair slope to max 2.08%.	2015 ABAAS Section: 403.3 2012 TAS Section: 403.3 2010 ADAS Section: 403.3

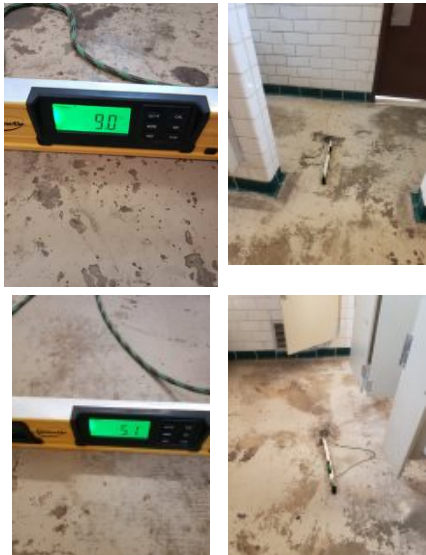
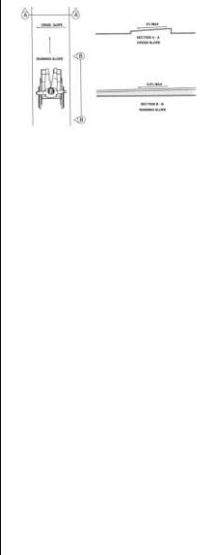
Finding Number	Area Description	Lat/Long	Finding	As Built	Recommendation	Citation	Photos	Figure																						
162	Cave Swallow Cove Day Use Area: Cave Swallow Women's Restroom	[28.063146, -97.879673 3]	Element meets all standards and requirements	Cave Swallow Women's Restroom door complies	None	2010 ADAS Section: N/A

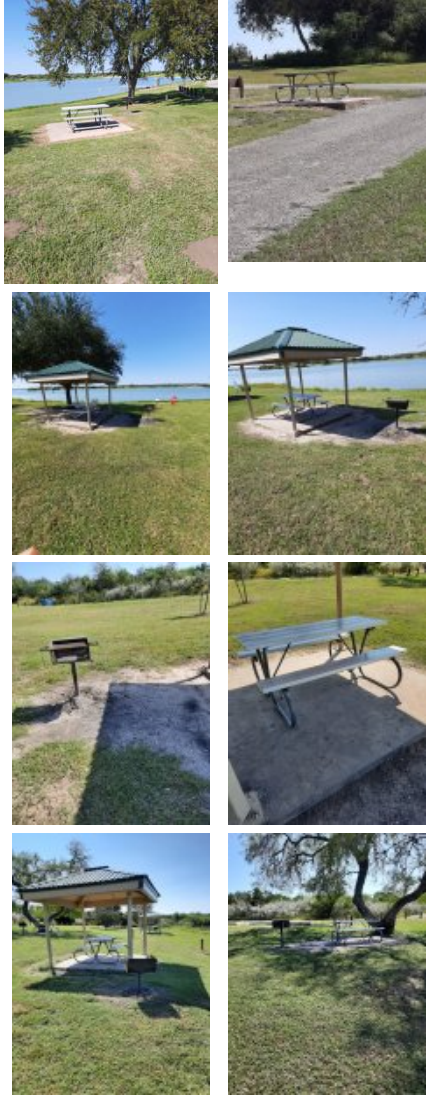
Finding Number	Area Description	Lat/Long	Finding	As Built	Recommendation	Citation	Photos	Figure

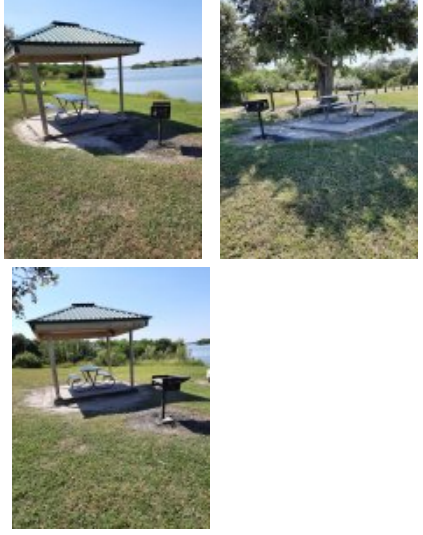
165	Cave Swallow Cove Day Use Area: Cave Swallow Picnic Area	[28.062472, -97.880484 3]	There is no accessible route to multiple picnic area elements such as water spouts, signs, and life rings. At least one accessible route shall connect accessible buildings, accessible facilities, accessible elements, and accessible spaces that are on the same site.	Lacks accessible route to multiple picnic area elements such as water spouts, signs, and life rings	Create an accessible route with crushed stone or other outdoor material from parking or walkway to multiple picnic area elements such as water spouts, signs, and life rings.	2015 ABAAS Section: F206.2.2 2012 TAS Section: 206.2.2 2010 ADAS Section: 206.2.2

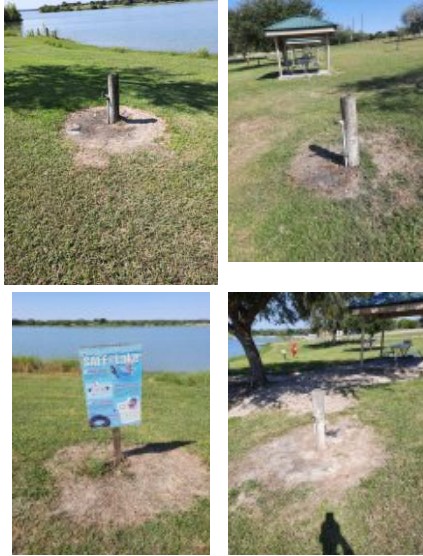
Finding Number	Area Description	Lat/Long	Finding	As Built	Recommendation	Citation	Photos	Figure

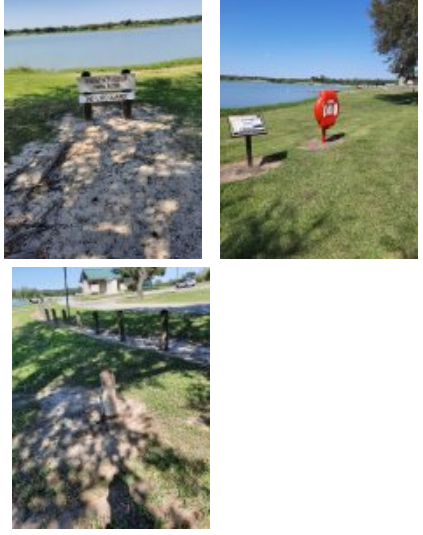
166	Cave Swallow Cove Day Use Area: Cave Swallow Picnic Area	[28.0634311 , -97.8796057]	There is no accessible route to the firewood station, paddle sport rental station, and nearest parking (restroom parking). At least one accessible route shall connect accessible buildings, accessible facilities, accessible elements, and accessible spaces that are on the same site.	Lacks accessible route to firewood station, paddle sport rental station, and nearest parking (restroom parking)	Create an accessible route with crushed stone or other outdoor material from parking or walkway to the firewood station, paddle sport rental station, and nearest parking (restroom parking)	2015 ABAAS Section: F206.2.2 2012 TAS Section: 206.2.2 2010 ADAS Section: 206.2.2

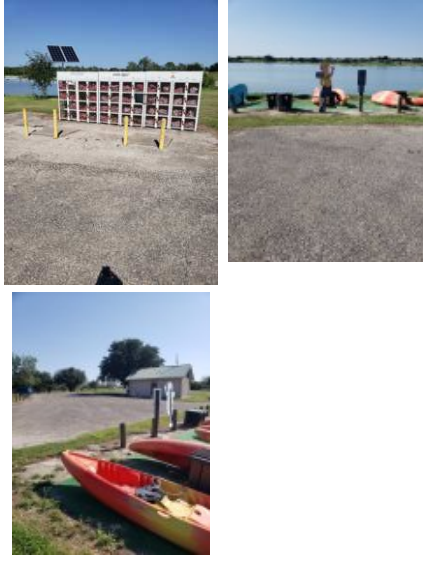
<p>ACCESSIBLE ENTRANCES</p> <p>NOTE: DISTANCE SHOULD meet the minimum distance from the building to the nearest accessible route.</p>

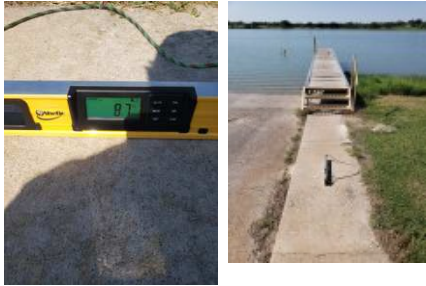
170	Cave Swallow Cove Day Use Area: Cave Swallow Fishing	[28.0632383, -97.880145 4]	The boat slip/pier is not wide enough. Boat slips and boarding piers shall provide clear pier space 60 inches wide minimum and at least as long as the boat slips/boarding pier. Each 10 feet maximum of linear pier edge serving boat slips and boarding piers shall contain at least one continuous clear opening 60 inches wide minimum. The clear width shall be permitted to be reduced to 36 inches minimum for a length of 24 inches maximum provided that reduced width segments are separated by segments that are 60 inches long minimum and 60 inches wide minimum.	Boarding pier lacks 60" clear pier space	Replace pier with one providing 60" wide clearance.	2015 ABAAS Section: 1003.3.1 2012 TAS Section: 1003.3.1 2010 ADAS Section: 1003.3.1

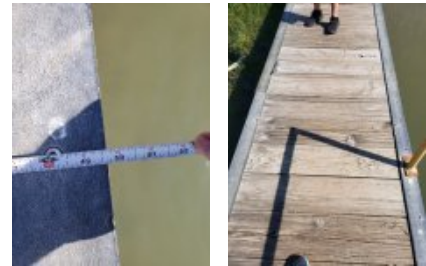
171	Cave Swallow Cove Day Use Area: Cave Swallow Fishing	[28.0632276, -97.880129 3]	The walkway contains abrupt vertical edges and/or variations over a 1/4 inch. 1/4 inch is the maximum vertical rise. Changes in level between 1/4 inch and 1/2 inch must be beveled at 1:2 or less. Changes in level greater than 1/2 inch must be by way of a ramp.	Boarding pier boards are uneven creating multiple gaps and CILS	See previous finding for recommendation on replacement of pier.	2012 TAS Section: 303.2, 303.3 2010 ADAS Section: 303.2, 303.3

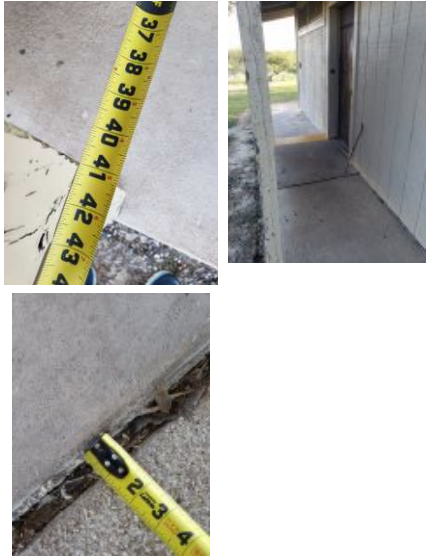
173	Javelina Camping Area: Javelina Men's Restroom	[28.0636856, -97.877178 8]	The restroom sign does not comply with one or more applicable requirements for the location, height, and properties of the sign.	Restroom signage lacks proper mounting location Braille lettering and symbol of access	Acquire and mount signage, including Braille, raised lettering and access symbol mounted on wall, latch side of door, 48" to baseline of lowest character and 60" to baseline of highest character.	2015 ABAAS Section: F216.2, 703.1, 703.2, 703.5, 703.6 2012 TAS Section: 216.2, 703.1, 703.2, 703.5, 703.6 2010 ADAS Section: 216.2, 703.1, 703.2, 703.5, 703.6

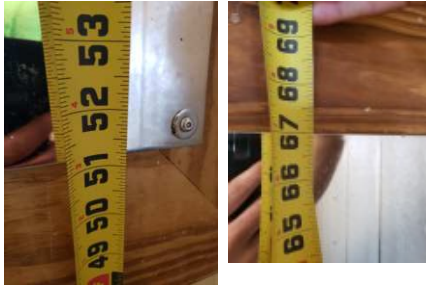
175	Javelina Camping Area: Javelina Men's Restroom	[28.0636975 , -97.8771896]	Knee clearance at 27 inches off the floor is not 8 inches minimum deep. The knee clearance, measured from the bottom of the apron or the outside bottom edge of the lavatory, must be 27 inches at a point located 8 inches back from the front edge and continuing to 11 inches minimum in depth at 9 inches above the floor. The top of the lavatory rim may be no higher than 34 inches.	Sink lacks 8" deep knee clearance, only 2"	Replace sink with one providing 27" knee clearance that is a min 8" deep.	2015 ABAAS Section: 306.3.1, 306.3.2, 306.3.3, 306.3.4 , 306.3.5 2012 TAS Section: 306.3.2, 306.3.3, 306.3.4, 306.3.5, 306.3.1 2010 ADAS Section: 306.3.3, 306.3.2, 306.3.4, 306.3.5, 306.3.1

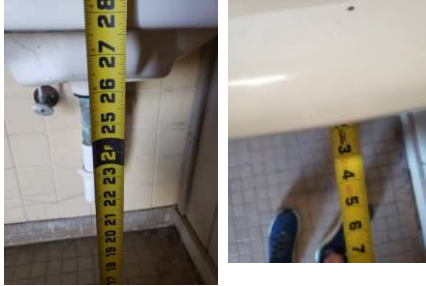
Finding Number	Area Description	Lat/Long	Finding	As Built	Recommendation	Citation	Photos	Figure
176	Javelina Camping Area: Javelina Men's Restroom	[28.0636809 , -97.8771976]	The water and drain pipes under the lavatory are not adequately insulated. Water supply and drain pipes under lavatories and sinks shall be insulated or otherwise configured to protect against contact. There shall be no sharp or abrasive surfaces under lavatories and sinks.	Sink lacks insulated pipes	Insulate exposed pipes under one sink	2015 ABAAS Section: 606.5 2012 TAS Section: 606.5 2010 ADAS Section: 606.5

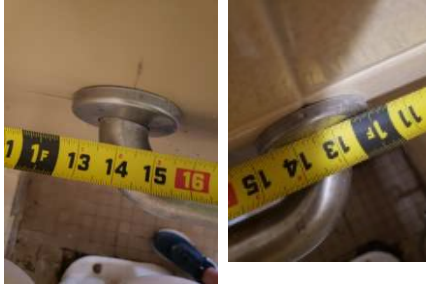
Finding Number	Area Description	Lat/Long	Finding	As Built	Recommendation	Citation	Photos	Figure
179	Javelina Camping Area: Javelina Men's Restroom	[28.0636809 , -97.877194 9]	There is a change in level greater than 1/4 inch. 1/4 inch is the maximum vertical rise. Changes in level between 1/4 inch and 1/2 inch must be beveled at 1:2 or less. Changes in level greater than 1/2 inch must be by way of a ramp.	CILs of .5" (floor drain is below floor grade) and .5" at missing floor tile	Repair, bevel or ramp CIL along AR to max .25".	2015 ABAAS Section: 303.3 2012 TAS Section: 303.3 2010 ADAS Section: 303.3

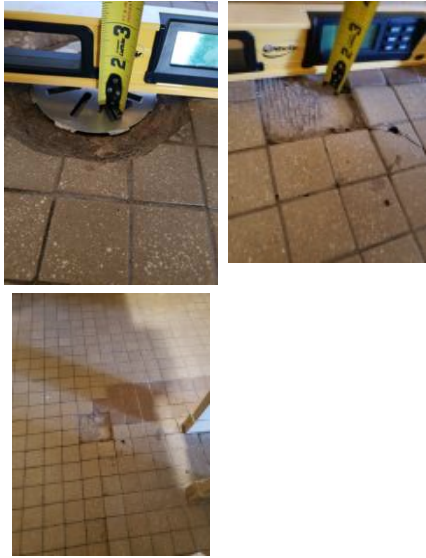
180	Javelina Camping Area: Javelina Men's Restroom	[28.0636856 , -97.877186 9]	Coat hooks provided within the room shall be located within one of the reach ranges specified in 308. Shelves shall be 40 inches (1015 mm) minimum and 48 inches (1220 mm) maximum above the finish floor or ground. Where coat hooks or shelves are provided in dressing, fitting or locker rooms without individual compartments, at least one of each type shall comply with 803.5. Where coat hooks or shelves are provided in individual compartments at least one of each type complying with 803.5 shall be provided in individual compartments in dressing, fitting, or locker rooms required to comply with 222.1.	Coat hooks at 69" aff	Remount at least one hook to max 48" aff.	2015 ABAAS Section: 308.2.1, 308.1, F222.2, 803.5 2012 TAS Section: 308.2.1, 308.1, 222.2, 803.5 2010 ADAS Section: 308.2.1, 308.1, 222.2, 803.5
