Access Audit Site Report

Lake Corpus Christi State Park

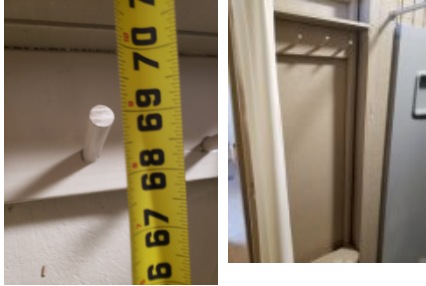
180	Javelina Camping Area: Javelina Men's Restroom	[28.0636856 , -97.877186 9]	Coat hooks provided within the room shall be located within one of the reach ranges specified in 308. Shelves shall be 40 inches (1015 mm) minimum and 48 inches (1220 mm) maximum above the finish floor or ground. Where coat hooks or shelves are provided in dressing, fitting or locker rooms without individual compartments, at least one of each type shall comply with 803.5. Where coat hooks or shelves are provided in individual compartments at least one of each type complying with 803.5 shall be provided in individual compartments in dressing, fitting, or locker rooms required to comply with 222.1.	Coat hooks at 69" aff	Remount at least one hook to max 48" aff.	2015 ABAAS Section: 308.2.1, 308.1, F222.2, 803.5 2012 TAS Section: 308.2.1, 308.1, 222.2, 803.5 2010 ADAS Section: 308.2.1, 308.1, 222.2, 803.5

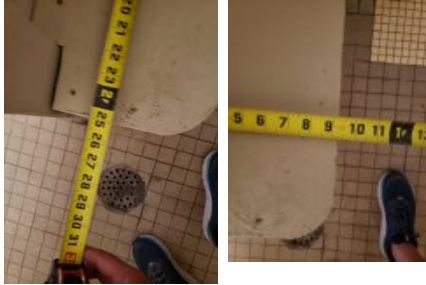
182	Javelina Camping Area: Javelina Men's Restroom	[28.0636856, -97.8771976]	There are no accessible bathing or shower facilities. Where facilities for bathing are provided for the public, clients or employees, including showers or bathtubs, at least one shower or bathtub and support facilities such as lockers, and not less than 1 percent of all facilities, shall be accessible.	Lacks accessible bathing or shower facilities	Create an accessible shower in locker/bathing room.	2015 ABAAS Section: F213.3.6 2012 TAS Section: 213.3.6 2010 ADAS Section: 213.3.6

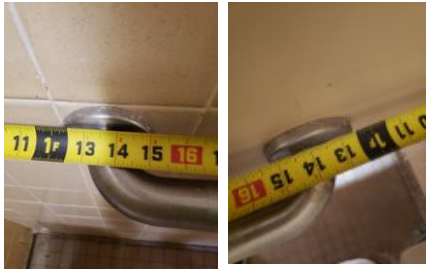
187	Javelina Camping Area: Javelina Women's Restroom	[28.0636762 , -97.8771842]	The side grab bars are not in the correct location. Grab bars on the side wall must be installed so that the end closest to the rear wall is maximum 12" from the rear wall. The end furthest from the rear wall must be mounted minimum 54" from the rear wall.	Side grab bars 13.5" and 14" from rear wall	Remount side grab bar to max 12" from the rear wall at the close end and min 54" on the far end, and 33" to 36" AFF in new wheelchair stall.	2015 ABAAS Section: 604.5.1 2012 TAS Section: 604.5.1 2010 ADAS Section: 604.5.1

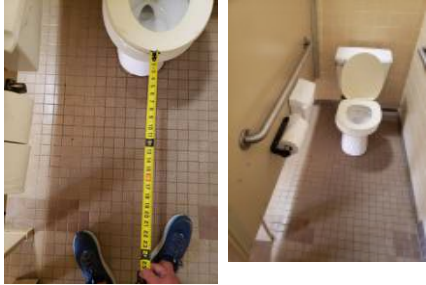
189	Javelina Camping Area: Javelina Women's Restroom	[28.0636844 , -97.877192 3]	The accessible route contains running slopes greater than 5 percent and cross slopes greater than 2 percent across the width of the walk and has not been constructed as a ramp (i.e. handrails, wheel guides, etc.). When the slope in the direction of travel of any walk exceeds 1 unit vertical in 20 units horizontal (5-percent slope), it must be constructed as ramp. Surface cross slopes must not exceed one unit vertical in 48 units. Horizontal (2-percent slope).	Slopes of 2.6% and 2.3% near floor drain	Correct or repair slope to max 2.08%.	2015 ABAAS Section: 403.3 2012 TAS Section: 403.3 2010 ADAS Section: 403.3

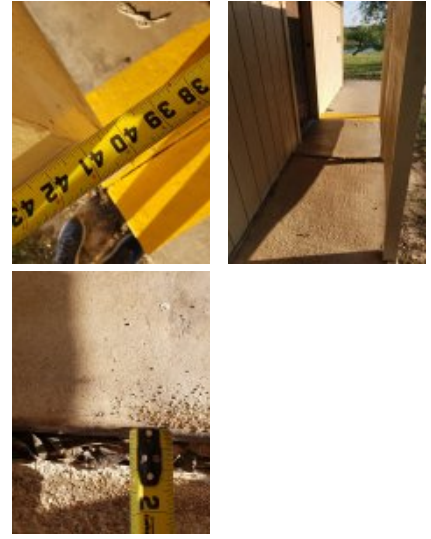
Finding Number	Area Description	Lat/Long	Finding	As Built	Recommendation	Citation	Photos	Figure
194	Javelina Camping Area: Dump Station	[28.0619578 , -97.873941 4]	The surface of the clear ground space shall be firm and stable The slope of the clear ground space surface shall not be steeper than 1:48 in any direction. EXCEPTION: Where the surface is other than asphalt, concrete, or boards, slopes not steeper than 1:20 shall be permitted when necessary for drainage	Dump station area deteriorated asphalt gravel and sand, 18" deep curb blocks access to sewer hookup, water faucet 58" high	Correct surface at dump to firm, stable and having max slope of 2.08% as a smart practice. Lower reach to water spigot to max 28" above the ground.	2015 ABAAS Section: 1011.2.2, 1011.2.3, 1011.2 EXCEPTION

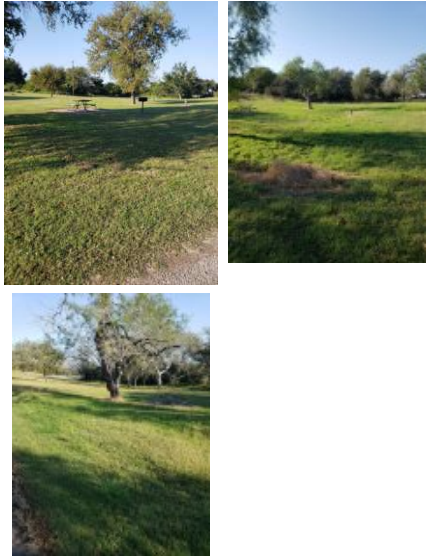
196	Javelina Camping Area: Javelina Restroom Parking	[28.0635436 , -97.877098 4]	The cross slopes (narrow dimension) and/or running slopes (long dimension) of the access aisle exceeds 2%. The running slope and the cross slope in an accessible parking stall and the access aisle must not exceed 2%.	Slopes of 4.5% in stall and 3.9% in access aisle	Repair or correct slope of parking space and access aisle to max 2.08% in any direction	2015 ABAAS Section: 502.4 2012 TAS Section: 502.4 2010 ADAS Section: 502.4

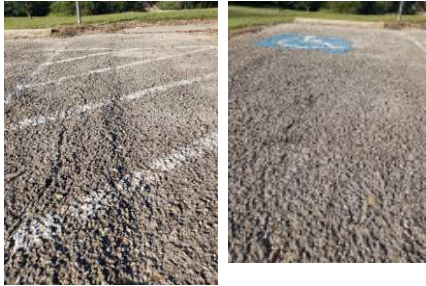
198	Javelina Camping Area: Javelina Restroom Parking	[28.0635294 , -97.877114 5]	The van stall is missing a sign identifying it as a van accessible stall. Parking space identification signs shall include the International Symbol of Accessibility. Signs identifying van parking spaces shall contain the designation "van accessible."	The van stall is missing a sign identifying it as a van accessible stall	Add one van parking sign to van accessible stall and ensure stall and access aisle are 11' and 5' or 8' and 8'	2015 ABAAS Section: 502.6 2012 TAS Section: 502.6 2010 ADAS Section: 502.6

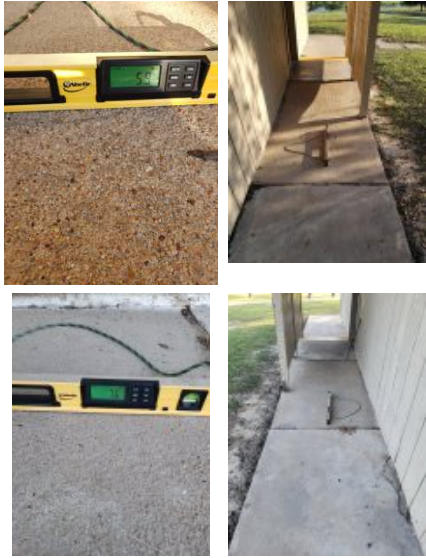
200	Javelina Camping Area: Javelina Restrooms Exterior Accessible Route	[28.0636549 , -97.877178 8]	There is a gap spaced greater than a 1/2 inch. Openings in floor or ground surfaces shall not allow passage of a sphere more than 1/2 inch diameter. Elongated openings shall be placed so that the long dimension is perpendicular to the dominant direction of travel.	CIL of 1" (from parking) and gaps of 1.25", 1", .75", .75" (on accessible route)	Repair, bevel, or ramp CIL along AR Correct or fill gaps to be max .5"	2015 ABAAS Section: 302.3 2012 TAS Section: 302.3 2010 ADAS Section: 302.3

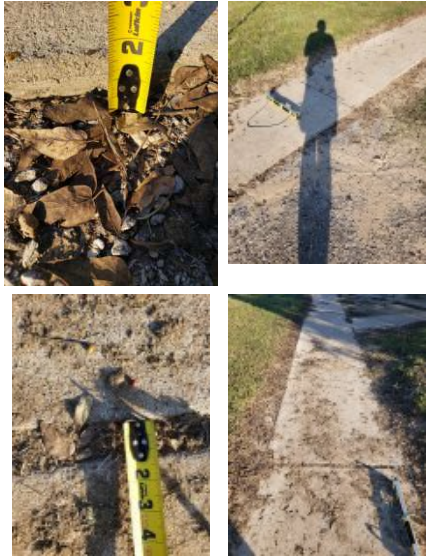
Finding Number	Area Description	Lat/Long	Finding	As Built	Recommendation	Citation	Photos	Figure

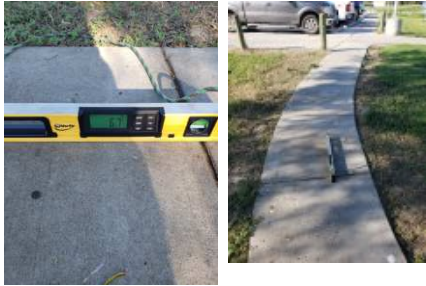
204	Whitetail Run Day Use Area: Whitetail Run Picnic Area	[28.0639602 , -97.8764654]	There are no accessible parking stalls. Each lot where parking is provided for the public as clients, guests or employees, shall provide accessible parking and shall be located on the shortest accessible route of travel from adjacent parking to an accessible entrance. There are a total of 22 parking stalls in the parking lot that could be reasonably associated with this facility. There should be a minimum of 1 accessible stalls with a minimum of 1 being designed as van accessible.	Lacks accessible stalls (22 standard, 0 accessible)	Create one or more 8' accessible parking stalls, with one 5' adjacent access aisle, with proper signage and striping based on the total number of stalls	2015 ABAAS Section: F208.2 2012 TAS Section: 208.2 2010 ADAS Section: 208.2

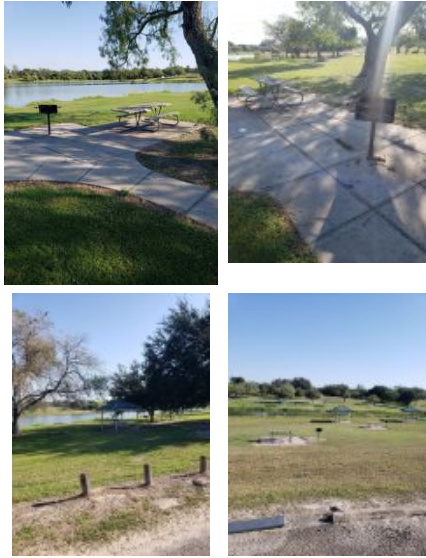
207	Whitetail Run Day Use Area: Whitetail Run Picnic Area Fishing Pier Parking	[28.0639507 , -97.878672 8]	The parking sign is mounted too low. Parking space identification signs shall include the International Symbol of Accessibility complying with. Signs identifying van parking spaces shall contain the designation "van accessible." Signs shall be 60 inches minimum above the finish floor or ground surface measured to the bottom of the sign.	The parking sign is mounted at 58.5" above ground level	Raise existing accessible parking signs so lowest end of bottom sign is min 60" AGL	2015 ABAAS Section: 502.6 2012 TAS Section: 502.6 2010 ADAS Section: 502.6

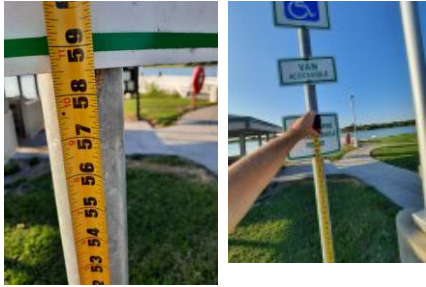
Finding Number	Area Description	Lat/Long	Finding	As Built	Recommendation	Citation	Photos	Figure
208	Whitetail Run Day Use Area: Whitetail Run Picnic Area Fishing Pier Parking	[28.0639696 , -97.8786567]	The cross slopes (narrow dimension) and/or running slopes (long dimension) of the access aisle exceeds 2%. The running slope and the cross slope in an accessible parking stall and the access aisle must not exceed 2%.	Slopes of 2.8% slope at head and 2.6% at foot of stall	Repair or correct slope of parking space and access aisle to max 2.08% in any direction.	2015 ABAAS Section: 502.4 2012 TAS Section: 502.4 2010 ADAS Section: 502.4

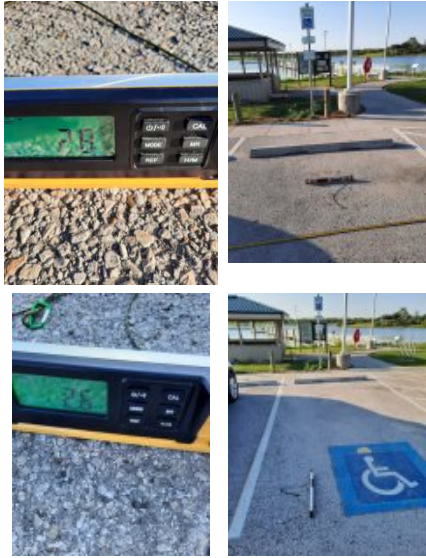
209	Whitetail Run Day Use Area: Whitetail Run Picnic Area Fishing Pier Parking	[28.0639862 , -97.8786326]	There are no van accessible parking stalls. 1 in every 6, minimum of one, required accessible stalls must be a van accessible stall. There are a total of 8 parking stalls in the parking lot that could be reasonably associated with this facility. There should be a minimum of 1 accessible stalls with a minimum of 1 being designed as van accessible.	stall and aisle 126.5" wide, fails dimension for a van accessible parking space	Add van parking sign to 1 accessible stall and repaint stall and access aisle to 11' and 5' or 8' and 8' per the table.	2015 ABAAS Section: F208.2, F208.2.4 2012 TAS Section: 208.2, 208.2.4 2010 ADAS Section: 208.2, 208.2.4

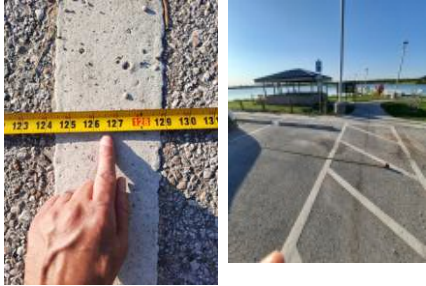
210	Whitetail Run Day Use Area: Whitetail Run Picnic Area Fishing Pier Parking	[28.06343, -97.87105]	Element meets all standards and requirements	Parking lot meets scoping with 8 standard stalls and 1 accessible	None	2010 ADAS Section: N/A

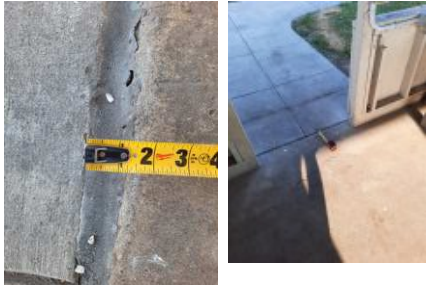
216	Whitetail Run Day Use Area: Whitetail Run Picnic Area Fishing Fish Cleaning Station	[28.0640158 , -97.878752]	The soap dispenser is out of reach range because the depth of the obstruction is greater than 25 inches. Where a high forward reach is over an obstruction, the clear floor space shall extend beneath the element for a distance not less than the reach depth over the obstruction. Where the reach depth exceeds 20 inches, the high forward reach shall be 44 inches maximum and the reach depth shall be 25 inches maximum.	Soap dispenser exceeds reach range due to obstruction of 26" deep work surface	Relocate soap dispenser to provide compliant clear floor space and reach range.	2015 ABAAS Section: 308.2.2 2012 TAS Section: 308.2.2 2010 ADAS Section: 308.2.2

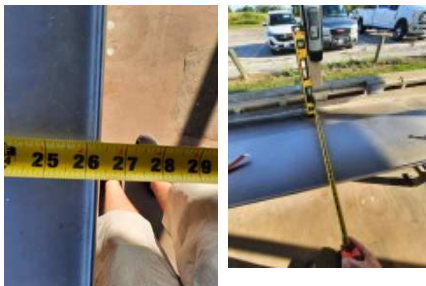
217	Whitetail Run Day Use Area: Whitetail Run Picnic Area Fishing Fish Cleaning Station	[28.0640264 , -97.878761 4]	The water spout handle is not accessible because it requires tight grasping, pinching or twisting of the wrist.	Water spout handle requires tight grasping, pinching, or twisting of the wrist	Replace water spout handle with an operable part usable without a tight pinch or grasp.	2015 ABAAS Section: 309.4 2012 TAS Section: 309.4 2010 ADAS Section: 309.4

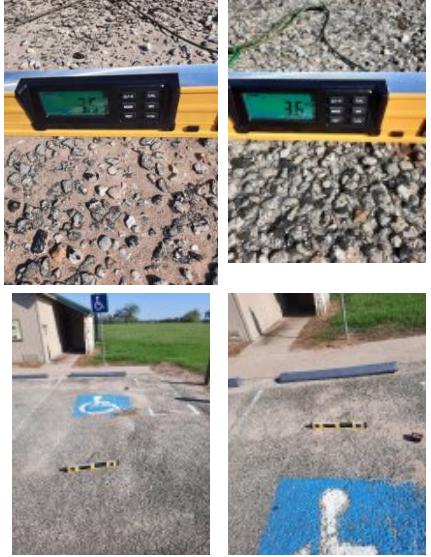
221	Mesquite Camping Area: Mesquite Restroom Parking	[28.067979, -97.8823394]	The cross slopes (narrow dimension) and/or running slopes (long dimension) of the access aisle exceeds 2%. The running slope and the cross slope in an accessible parking stall and the access aisle must not exceed 2%.	Slopes of 3.5% at head and 3.6% at foot of stall	Repair or correct slope of parking space and access aisle to max 2.08% in any direction	2015 ABAAS Section: 502.4 2012 TAS Section: 502.4 2010 ADAS Section: 502.4

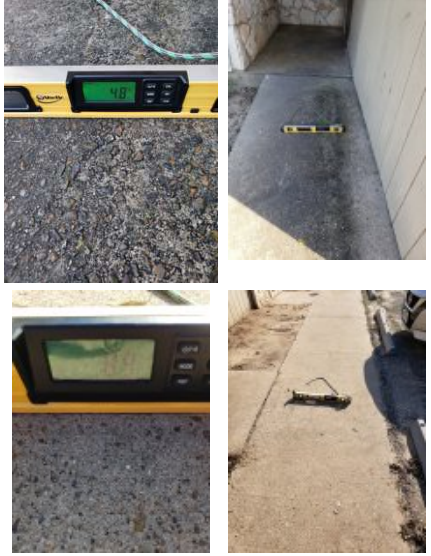
Finding Number	Area Description	Lat/Long	Finding	As Built	Recommendation	Citation	Photos	Figure
226	Mesquite Camping Area: Mesquite Restrooms Exterior Accessible Route	[28.0680169 , -97.882276 4]	There is a gap spaced greater than a 1/2 inch. Openings in floor or ground surfaces shall not allow passage of a sphere more than 1/2 inch diameter. Elongated openings shall be placed so that the long dimension is perpendicular to the dominant direction of travel.	Gaps of .5", .5", and .5"	Correct or fill gaps to be max .5".	2015 ABAAS Section: 302.3 2012 TAS Section: 302.3 2010 ADAS Section: 302.3

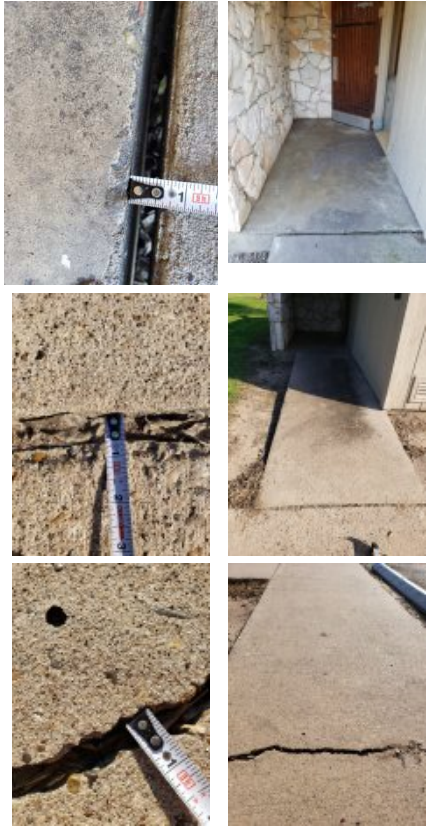
Finding Number	Area Description	Lat/Long	Finding	As Built	Recommendation	Citation	Photos	Figure
227	Mesquite Camping Area: Mesquite Men's Restroom	[28.0679861, -97.8822563]	The mirror is mounted too high. Mirrors must have the bottom edge of the reflecting surface a maximum of 40 inches above the floor if above a sink or counter. Mirrors not located above lavatories or countertops shall be installed with the bottom edge of the reflecting surface 35 inches maximum above the finish floor or ground.	Bottom edge of reflecting surface of mirror is 49.75" aff and top edge of reflecting surface is 67.75" aff	Replace mirror and mount so bottom reflective surface is max 40" AFF and 74" at the top.	2015 ABAAS Section: 603.3 2012 TAS Section: 603.3 2010 ADAS Section: 603.3

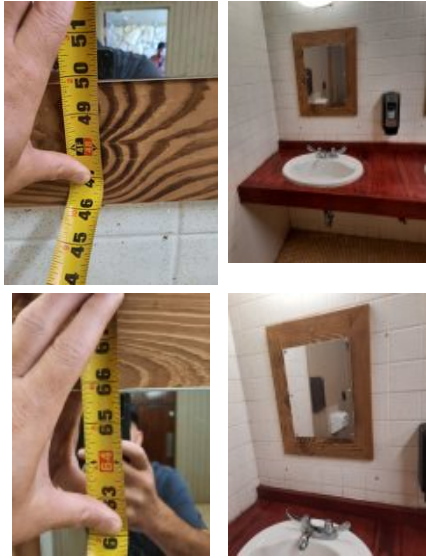
228	Mesquite Camping Area: Mesquite Men's Restroom	[28.0679814, -97.8822509]	The top rim of the sink is too high. All lavatories/sinks that are designated to be accessible shall be a minimum 17 inches in horizontal depth and mounted with the rim or counter edge no higher than 34 inches above the finished floor.	The top rim of the sink is 35.5" aff	Lower sinks to max 34" aff to front of rim.	2015 ABAAS Section: 606.3 2012 TAS Section: 606.3 2010 ADAS Section: 606.3

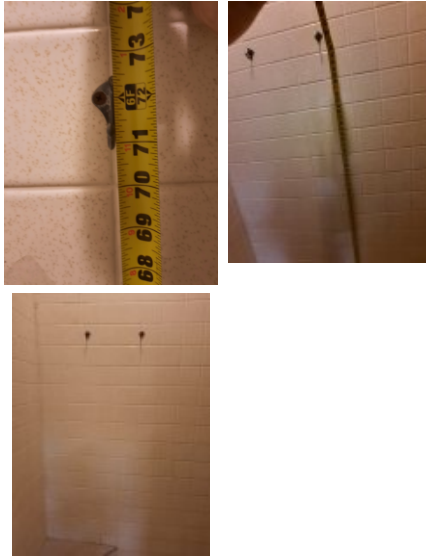
231	Mesquite Camping Area: Mesquite Men's Restroom	[28.0679766, -97.882250 9]	There are not enough accessible toilet compartments. The room contains 0 toilet compartments. A minimum of 1 must be wheelchair accessible .	Lacks wheelchair stall, ambulatory only	Create a wheelchair accessible stall with grab bars and fixtures mounted in correct locations and at correct heights.	2015 ABAAS Section: F213.3.1 2012 TAS Section: 213.3.1 2010 ADAS Section: 213.3.1

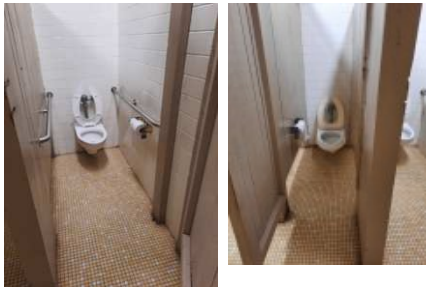
Finding Number	Area Description	Lat/Long	Finding	As Built	Recommendation	Citation	Photos	Figure
232	Mesquite Camping Area: Mesquite Men's Restroom	[28.0679743 , -97.8822375]	The stall door fails to comply with all of the door requirements. The stall door must be a minimum of 32" wide and have compliant hardware on both sides. The stall door must be self-closing.	Stall lacks self-closing door and lacks compliant hardware	Adjust stall door to be self-closing Replace stall hardware with hardware operable without a tight pinch or grasp on both sides of the stall door	2015 ABAAS Section: 404.2.3, 404.2.7, 604.8.2.2 2012 TAS Section: 404.2.3, 404.2.7, 604.8.2.2 2010 ADAS Section: 404.2.3, 404.2.7, 604.8.2.2

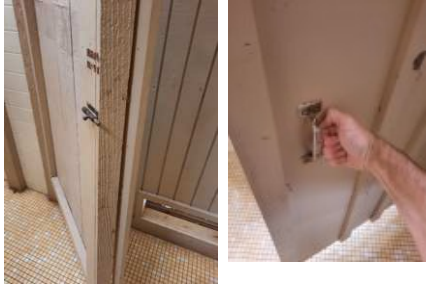
233	Mesquite Camping Area: Mesquite Men's Restroom	[28.067979, -97.8822509]	The side grab bars are not in the correct location. Grab bars on the side wall must be installed so that the end closest to the rear wall is maximum 12" from the rear wall. The end furthest from the rear wall must be mounted minimum 54" from the rear wall.	Side grab bar ends 51.75" from rear wall	Remount one side grab bar to max 12" from the rear wall at the close end and min 54" on the far end, and 33" to 36" AFF in new wheelchair stall.	2015 ABAAS Section: 604.5.1 2012 TAS Section: 604.5.1 2010 ADAS Section: 604.5.1

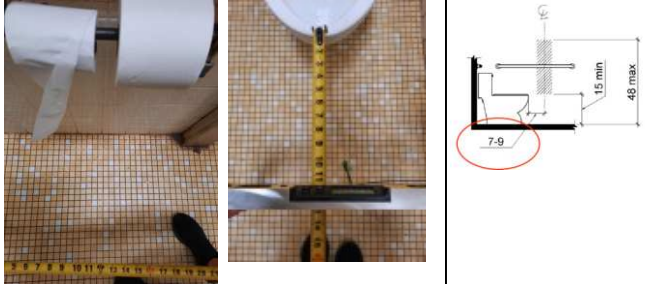
Finding Number	Area Description	Lat/Long	Finding	As Built	Recommendation	Citation	Photos	Figure
235	Mesquite Camping Area: Mesquite Men's Restroom	[28.0679814 , -97.882234 8]	The hand dryer projects more than 4 inches into the circulation path. Wall-mounted objects that have leading edges between 27 inches and 80 inches from the floor must not project more than 4 inches into the circulation path. Protruding objects that extend to the floor or within 27 inches of the floor are cane detectable and are therefore not hazardous. Where it is necessary or desirable to have objects protrude from the wall, a manner of cane detection must be provided.	Hand dryer protrudes 5.5"	Relocate protruding objects or place cane detectable warning or bollard at foot of item.	2015 ABAAS Section: 307.2 2012 TAS Section: 307.2 2010 ADAS Section: 307.2

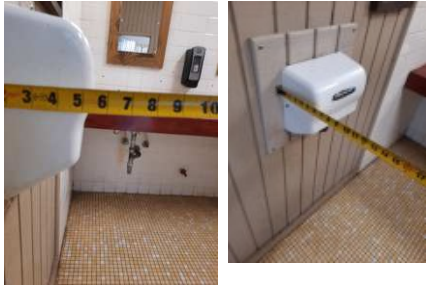
236	Mesquite Camping Area: Mesquite Men's Restroom	[28.0679885 , -97.882250 9]	The accessible route contains running slopes greater than 5 percent and cross slopes greater than 2 percent across the width of the walk and has not been constructed as a ramp (i.e. handrails, wheel guides, etc.). When the slope in the direction of travel of any walk exceeds 1 unit vertical in 20 units horizontal (5-percent slope), it must be constructed as ramp. Surface cross slopes must not exceed one unit vertical in 48 units. Horizontal (2-percent slope).	Slope of 6.2% near floor drain	Correct or repair slope to max 2.08%.	2015 ABAAS Section: 403.3 2012 TAS Section: 403.3 2010 ADAS Section: 403.3

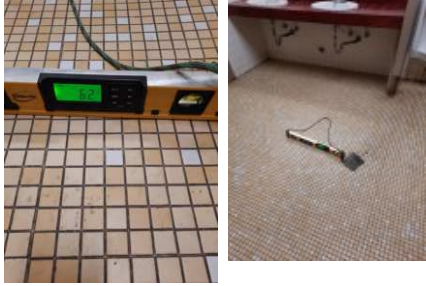
237	Mesquite Camping Area: Mesquite Men's Restroom	[28.0679837 , -97.882250 9]	Exterior doors exceed 8.5 lbs of force to open; fire doors shall have a minimum opening force allowable by the appropriate administrative authority	Exterior door - 12# push	Inspect, adjust, and maintain 8.5 lbf to open exterior doors as a smart practice	2010 ADAS Section: 404.2.9

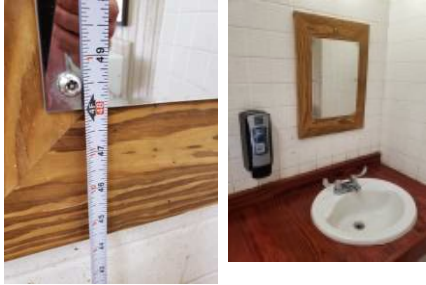
245	Mesquite Camping Area: Mesquite Women's Restroom	[28.0679814 , -97.882242 9]	The top rim of the sink is too high. All lavatories/sinks that are designated to be accessible shall be a minimum 17 inches in horizontal depth and mounted with the rim or counter edge no higher than 34 inches above the finished floor.	The top rim of the sink is 35" aff	Lower sinks to max 34" aff to front of rim.	2015 ABAAS Section: 606.3 2012 TAS Section: 606.3 2010 ADAS Section: 606.3

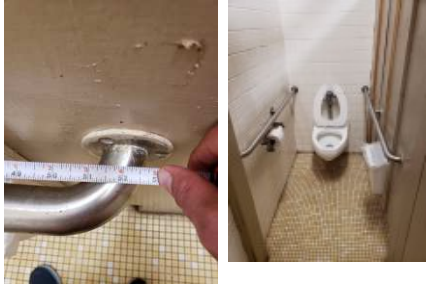
249	Mesquite Camping Area: Mesquite Women's Restroom	[28.0679861 , -97.882248 2]	Coat hooks provided within the room shall be located within one of the reach ranges specified in 308. Shelves shall be 40 inches (1015 mm) minimum and 48 inches (1220 mm) maximum above the finish floor or ground. Where coat hooks or shelves are provided in dressing, fitting or locker rooms without individual compartments, at least one of each type shall comply with 803.5. Where coat hooks or shelves are provided in individual compartments at least one of each type complying with 803.5 shall be provided in individual compartments in dressing, fitting, or locker rooms required to comply with 222.1.	Coat hooks at 72" aff	Remount at least one hook to max 48" aff.	2015 ABAAS Section: 308.2.1, 308.1, F222.2, 803.5 2012 TAS Section: 308.2.1, 308.1, 222.2, 803.5 2010 ADAS Section: 308.2.1, 308.1, 222.2, 803.5

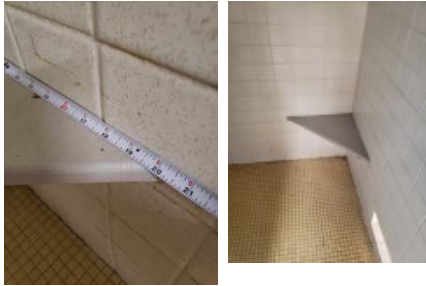
251	Mesquite Camping Area: Mesquite Women's Restroom	[28.0679814 , -97.8822348]	The shower seat height is noncompliant. A seat in a standard roll-in shower compartment shall be a folding type, shall be installed on the side wall adjacent to the controls, and shall extend from the back wall to a point within 3 inches of the compartment entry. A seat in an alternate roll-in type shower compartment shall be a folding type, shall be installed on the front wall opposite the back wall, and shall extend from the adjacent side wall to a point within 3 inches of the compartment entry. The top of the seat shall be 17 inches minimum and 19 inches maximum above the bathroom finish floor.	The shower seat at 21" aff	Remount shower seat to the correct location and height in the shower of 17" to 19" AFF.	2015 ABAAS Section: 610.3 2012 TAS Section: 610.3 2010 ADAS Section: 610.3

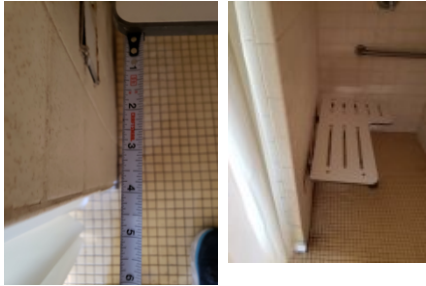
Finding Number	Area Description	Lat/Long	Finding	As Built	Recommendation	Citation	Photos	Figure
253	Mesquite Camping Area: Mesquite Women's Restroom	[28.0679743 , -97.882256 3]	The shower seat does not have a compliant space between it and the wall. The folding seat must be mounted 17-19 inches above the floor, and have a maximum space of 1-1/2 inches between the edge of the seat and the side wall and 2-1/2 inches maximum to the seat wall.	The shower seat mounted 9" from rear wall	Remount shower seat to the correct location and height in the shower. See previous recommendation for cost.	2015 ABAAS Section: 610.3.2 2012 TAS Section: 610.3.2 2010 ADAS Section: 610.3.2

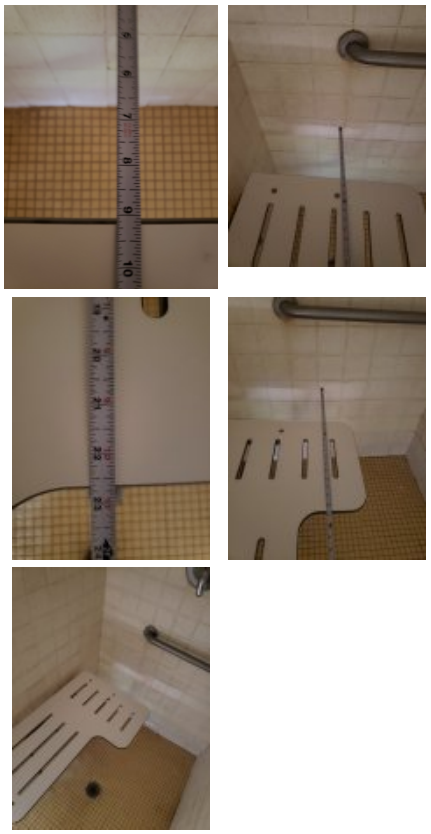
254	Mesquite Camping Area: Mesquite Women's Restroom	[28.0679695 , -97.882245 5]	It is recommended that exterior doors be maintained so that the operating pressure does not exceed 8.5 lb. force to open. The sweep period for doors with closers shall be adjusted so that from an open position of 70 degrees, the door will take at least 3 seconds to move to a point 7 inches from the latch, measured to the leading edge of the door.	Exterior door - 12# push, fast close	For all doors along the public circulation route, inspect, adjust, and maintain 8.5 lbf to open exterior doors as a smart practice For all doors along the public circulation route, inspect, adjust, and maintain closing speed on door closers	2012 TAS Section: 404.2.9, 404.2.9 Advisory, 404.2.8.1 2010 ADAS Section: 404.2.9, 404.2.8.1

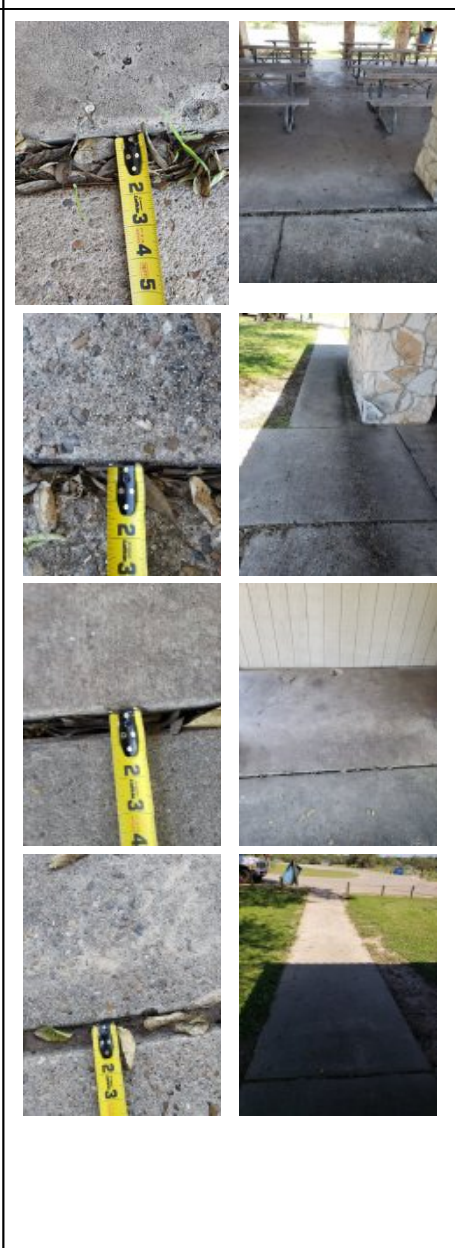
Finding Number	Area Description	Lat/Long	Finding	As Built	Recommendation	Citation	Photos	Figure
259	Mesquite Camping Area: Mesquite Group Pavilion	[28.0661637 , -97.882507 1]	The accessible route of travel contains cross slopes greater than 2%. Cross slopes shall not exceed one unit vertical in 48 units horizontal (2-percent slope).	Cross slope of 3.7% from parking to restroom	Correct or repair cross slope along AR to max 2.08%	2015 ABAAS Section: 403.3 2012 TAS Section: 403.3 2010 ADAS Section: 403.3

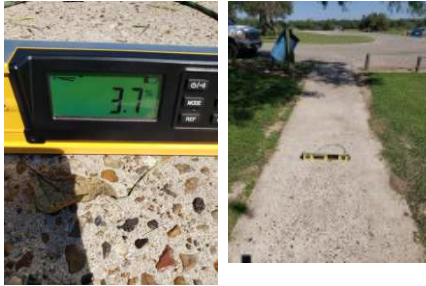
260	Mesquite Camping Area: Mesquite Group Pavilion Mens Restroom	[28.0659933 , -97.882465 5]	It is recommended that exterior doors be maintained so that the operating pressure does not exceed 8.5 lb. force to open. The sweep period for doors with closers shall be adjusted so that from an open position of 70 degrees, the door will take at least 3 seconds to move to a point 7 inches from the latch, measured to the leading edge of the door.	Exterior door - 20# push, fast close	For all doors along the public circulation route, inspect, adjust, and maintain 8.5 lbf to open exterior doors as a smart practice For all doors along the public circulation route, inspect, adjust, and maintain closing speed on door closers	2012 TAS Section: 404.2.9, 404.2.9 Advisory, 404.2.8.1 2010 ADAS Section: 404.2.9, 404.2.8.1

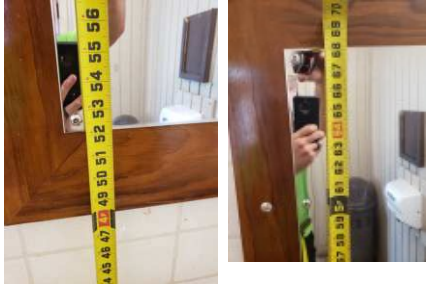
263	Mesquite Camping Area: Mesquite Group Pavilion Mens Restroom	[28.0659696 , -97.882484 3]	The top rim of the sink is too high. All lavatories/sinks that are designated to be accessible shall be a minimum 17 inches in horizontal depth and mounted with the rim or counter edge no higher than 34 inches above the finished floor.	The top rim of the sink is 35.5" aff	Lower sinks to max 34" aff to front of rim	2015 ABAAS Section: 606.3 2012 TAS Section: 606.3 2010 ADAS Section: 606.3

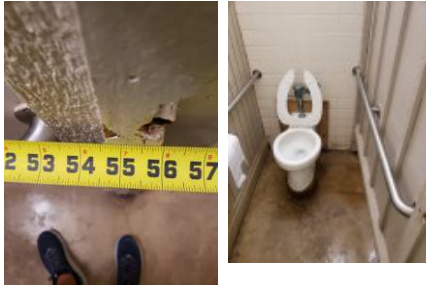
267	Mesquite Camping Area: Mesquite Group Pavilion Mens Restroom	[28.0660063, -97.882482 9]	The side grab bars are not in the correct location. Grab bars on the side wall must be installed so that the end closest to the rear wall is maximum 12" from the rear wall. The end furthest from the rear wall must be mounted minimum 54" from the rear wall.	Side grab bars end 51" from rear wall	Remount one side grab bar to max 12" from the rear wall at the close end and min 54" on the far end, and 33" to 36" AFF in new wheelchair stall.	2015 ABAAS Section: 604.5.1 2012 TAS Section: 604.5.1 2010 ADAS Section: 604.5.1

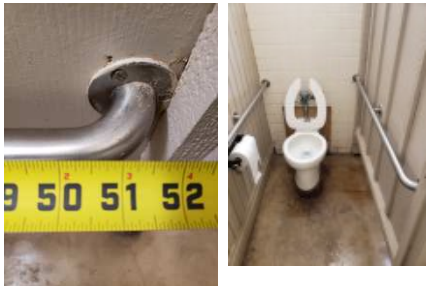
268	Mesquite Camping Area: Mesquite Group Pavilion Mens Restroom	[28.0659578, -97.882486 9]	The hand dryer projects more than 4 inches into the circulation path. Wall-mounted objects that have leading edges between 27 inches and 80 inches from the floor must not project more than 4 inches into the circulation path. Protruding objects that extend to the floor or within 27 inches of the floor are cane detectable and are therefore not hazardous. Where it is necessary or desirable to have objects protrude from the wall, a manner of cane detection must be provided.	Hand dryer protrudes 5.5"	Relocate protruding objects or place cane detectable warning or bollard at foot of item.	2015 ABAAS Section: 307.2 2012 TAS Section: 307.2 2010 ADAS Section: 307.2

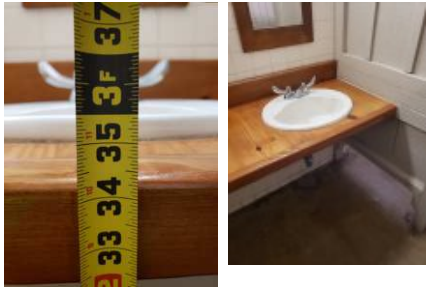
Finding Number	Area Description	Lat/Long	Finding	As Built	Recommendation	Citation	Photos	Figure
272	Mesquite Camping Area: Mesquite Group Pavilion Womens Restroom	[28.0659436 , -97.8824816]	The water and drain pipes under the lavatory are not adequately insulated. Water supply and drain pipes under lavatories and sinks shall be insulated or otherwise configured to protect against contact. There shall be no sharp or abrasive surfaces under lavatories and sinks.	Sink lacks insulated pipes	Insulate exposed pipes under one sink	2015 ABAAS Section: 606.5 2012 TAS Section: 606.5 2010 ADAS Section: 606.5

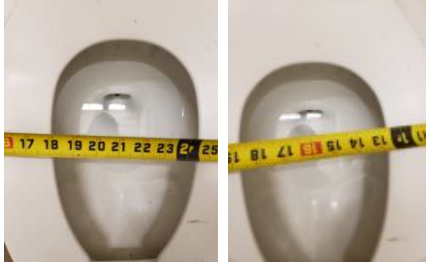
276	Mesquite Camping Area: Mesquite Group Pavilion Womens Restroom	[28.0659625 , -97.882481 6]	The side grab bars are not in the correct location. Grab bars on the side wall must be installed so that the end closest to the rear wall is maximum 12" from the rear wall. The end furthest from the rear wall must be mounted minimum 54" from the rear wall.	Side grab bars end 52" from rear wall	Remount one side grab bar to max 12" from the rear wall at the close end and min 54" on the far end, and 33" to 36" AFF in new wheelchair stall.	2015 ABAAS Section: 604.5.1 2012 TAS Section: 604.5.1 2010 ADAS Section: 604.5.1

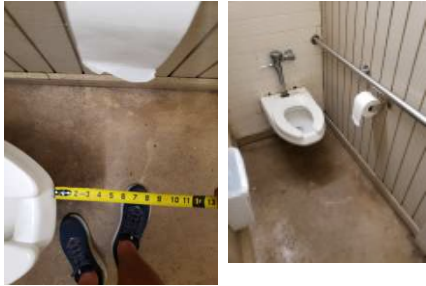
278	Mesquite Camping Area: Mesquite Group Pavilion Womens Restroom	[28.0659897 , -97.882468 2]	The hand dryer projects more than 4 inches into the circulation path. Wall-mounted objects that have leading edges between 27 inches and 80 inches from the floor must not project more than 4 inches into the circulation path. Protruding objects that extend to the floor or within 27 inches of the floor are cane detectable and are therefore not hazardous. Where it is necessary or desirable to have objects protrude from the wall, a manner of cane detection must be provided.	Hand dryer protrudes 5.5"	Relocate protruding objects or place cane detectable warning or bollard at foot of item.	2015 ABAAS Section: 307.2 2012 TAS Section: 307.2 2010 ADAS Section: 307.2

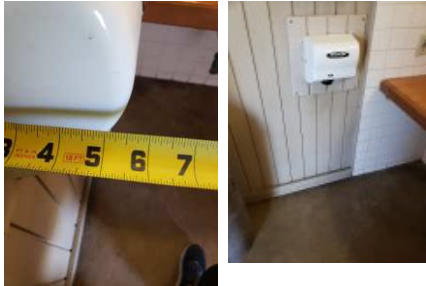
279	Mesquite Camping Area: Mesquite Boat Ramp	[28.0675601 , -97.880374 7]	There are no accessible parking stalls. Each lot where parking is provided for the public as clients, guests or employees, shall provide accessible parking and shall be located on the shortest accessible route of travel from adjacent parking to an accessible entrance. There are a total of approximately 35 parking stalls in the parking lot that could be reasonably associated with this facility. There should be a minimum of 2 accessible stalls with a minimum of 1 being designed as van accessible.	Lacks identified parking area of standard and accessible parking spaces	Create one or more 8' accessible parking stalls, with one 5' adjacent access aisle, with proper signage and striping based on the total number of stalls	2015 ABAAS Section: F208.2 2012 TAS Section: 208.2 2010 ADAS Section: 208.2

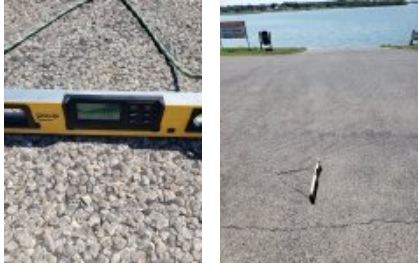
282	Mesquite Camping Area: Mesquite Boat Ramp	[28.067308, -97.8806255]	There is no accessible route to the boat ramp. At least one accessible route shall connect accessible buildings, accessible facilities, accessible elements, and accessible spaces that are on the same site.	Boat ramp 12.7% slope to water, no adjacent accessible route	Create an accessible route with crushed stone or other outdoor material from parking to boat ramp.	2015 ABAAS Section: F206.2.2 2012 TAS Section: 206.2.2 2010 ADAS Section: 206.2.2

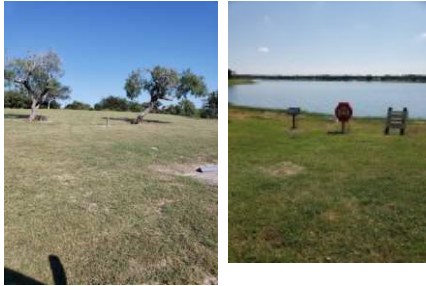
287	Bass Point Day Use Area: Bass Point Picnic Area Parking and Exterior Accessible Route	[28.0645945 , -97.884654 2]	There are no accessible parking stalls. Each lot where parking is provided for the public as clients, guests or employees, shall provide accessible parking and shall be located on the shortest accessible route of travel from adjacent parking to an accessible entrance. There are a total of 60 parking stalls in the parking lot that could be reasonably associated with this facility. There should be a minimum of 3 accessible stalls with a minimum of 1 being designed as van accessible.	Lacks accessible stalls (60 standard, 0 accessible)	Create one or more 8' accessible parking stalls, with one 5' adjacent access aisle, with proper signage and striping based on the total number of stalls	2015 ABAAS Section: F208.2 2012 TAS Section: 208.2 2010 ADAS Section: 208.2

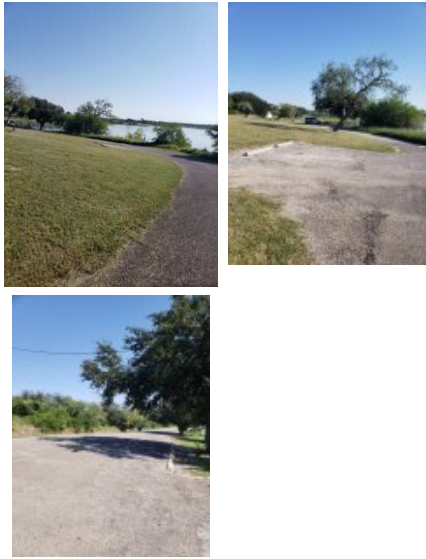
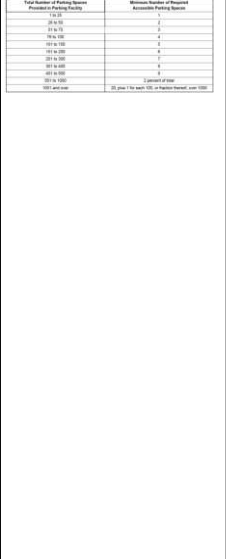
288	Bass Point Day Use Area: Bass Point Picnic Area Parking and Exterior Accessible Route	[28.0650726 , -97.884660 9]	The handrail gripping diameter is noncompliant. Handrail gripping surfaces with a circular cross section shall have an outside diameter of 1 1/4 inches minimum and 2 inches maximum. Handrail gripping surfaces with a non-circular cross section shall have a perimeter dimension of 4 inches minimum and 6 1/4 inches maximum, and a cross-section dimension of 2 1/4 inches maximum.	The handrail gripping diameter is 2.25" diameter	See previous finding for recommendation to replace handrails.	2015 ABAAS Section: 505.7 2012 TAS Section: 505.7 2010 ADAS Section: 505.7

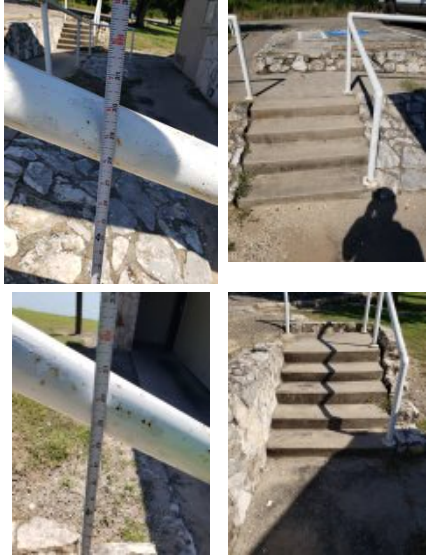
290	Bass Point Day Use Area: Bass Point Picnic Area Parking and Exterior Accessible Route	[28.0650738 , -97.8846448]	The handrail does not have a compliant extension at the bottom of the stair flight. At the bottom of a stair flight, handrails shall extend at the slope of the stair flight for a horizontal distance at least equal to one tread depth beyond the last riser nosing. Extension shall return to a wall, guard, or the landing surface, or shall be continuous to the handrail of an adjacent stair flight.	Lacks handrail extensions at the bottom of the stairway	Replace existing handrail, mounted 34" to 38" aff with top and bottom extensions and having a 1.25" – 2" in diameter, or a non-circular grip that has a perimeter dimension of 4"- 6.25" max with a min gap of 1.5" between handrail and wall	2015 ABAAS Section: 505.10.3 2012 TAS Section: 505.10.3 2010 ADAS Section: 505.10.3

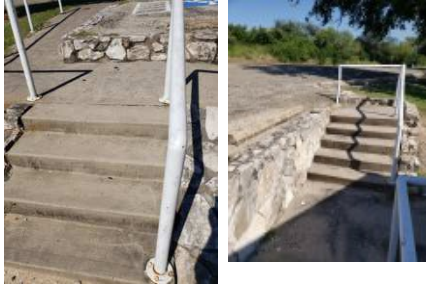
Finding Number	Area Description	Lat/Long	Finding	As Built	Recommendation	Citation	Photos	Figure
292	Bass Point Day Use Area: Bass Point Picnic Area Parking and Exterior Accessible Route	[28.0651128 , -97.884635 4]	The ramp run has not been provided with edge protection. The floor or ground surface of the ramp run or landing shall extend 12 inches minimum beyond the inside face of a handrail or a curb or barrier shall be provided that prevents the passage of a 4 inch diameter sphere, where any portion of the sphere is within 4 inches of the finish floor or ground surface.	Lacks edge protection	Install rail along bottom edge of ramp that prevents a 4" sphere from passing through.	2015 ABAAS Section: 405.9, 405.9.1, 405.9.2 2012 TAS Section: 405.9.1, 405.9.2, 405.9 2010 ADAS Section: 405.9.2, 405.9.1, 405.9

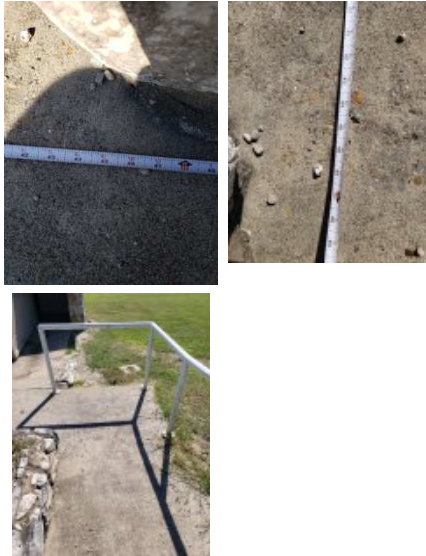
295	Bass Point Day Use Area: Bass Point Picnic Area Parking and Exterior Accessible Route	[28.0651211 , -97.884634]	The landing is not the correct length. Landings shall have a dimension in the direction of ramp run of not less than 60 inches.	Ramp landing is 45" by 48"	Enlarge landing to be 60" deep and as wide as the ramp.	2015 ABAAS Section: 405.7.3 2012 TAS Section: 405.7.3 2010 ADAS Section: 405.7.3

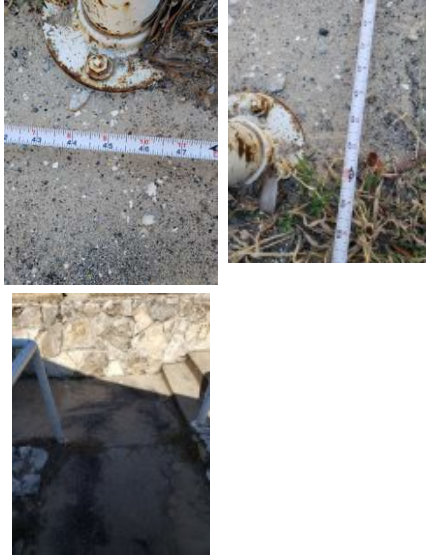
Finding Number	Area Description	Lat/Long	Finding	As Built	Recommendation	Citation	Photos	Figure
296	Bass Point Day Use Area: Bass Point Picnic Area Parking and Exterior Accessible Route	[28.0651247 , -97.884634]	The ramps slope exceeds the maximum running slope (direction of travel) allowable of 8.33%. Ramps should have the least possible slope but in no case more than 8.3% (1:12).	Running slopes of 10.6% and 10.0%	Correct slope of ramp to max 8.33%.	2015 ABAAS Section: 405.2 2012 TAS Section: 405.2 2010 ADAS Section: 405.2

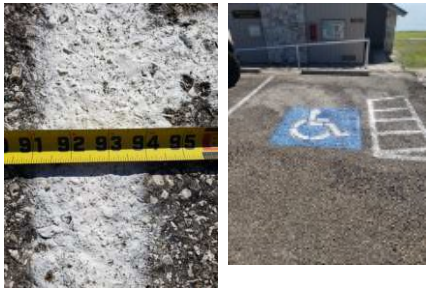
Finding Number	Area Description	Lat/Long	Finding	As Built	Recommendation	Citation	Photos	Figure																												
299	Bass Point Day Use Area: Bass Point Picnic Area Parking and Exterior Accessible Route	[28.0650797 , -97.884678 3]	The access aisle is not a minimum 5 feet wide. A car accessible parking stall's access aisle must be a minimum of 5 feet wide measured from centerline to centerline. Where the access aisle is not adjacent to another parking space or access aisle, measurements shall be permitted to include the full width of the line defining the access aisle.	The access aisle is 28" wide	Repaint access aisles to be 5' each.	2015 ABAAS Section: 502.3.1 2012 TAS Section: 502.3.1 2010 ADAS Section: 502.3.1

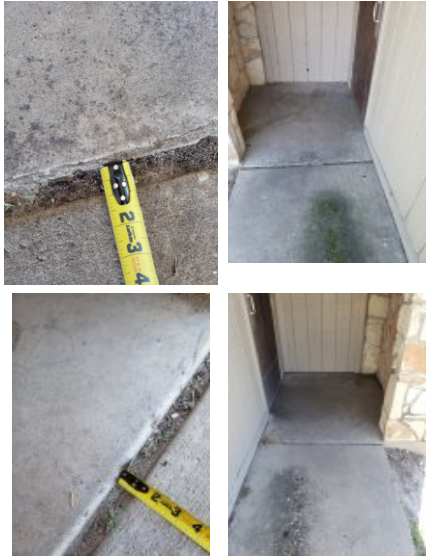
305	Bass Point Day Use Area: Bass Point Men's Restroom	[28.0650963 , -97.884605 9]	The restroom sign does not comply with one or more applicable requirements for the location, height, and properties of the sign.	Lacks braille lettering on restroom signage	Acquire and mount signage, including Braille, raised lettering and access symbol mounted on wall, latch side of door, 48" to baseline of lowest character and 60" to baseline of highest character	2015 ABAAS Section: F216.2, 703.1, 703.2, 703.5, 703.6 2012 TAS Section: 216.2, 703.1, 703.2, 703.5, 703.6 2010 ADAS Section: 216.2, 703.1, 703.2, 703.5, 703.6

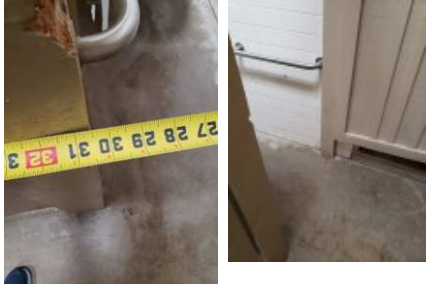
311	Bass Point Day Use Area: Bass Point Men's Restroom	[28.0650915 , -97.8846086]	The side grab bars are not in the correct location. Grab bars on the side wall must be installed so that the end closest to the rear wall is maximum 12" from the rear wall. The end furthest from the rear wall must be mounted minimum 54" from the rear wall.	Side grab bars end 52" from rear wall	Remount one side grab bar to max 12" from the rear wall at the close end and min 54" on the far end, and 33" to 36" AFF in new wheelchair stall.	2015 ABAAS Section: 604.5.1 2012 TAS Section: 604.5.1 2010 ADAS Section: 604.5.1

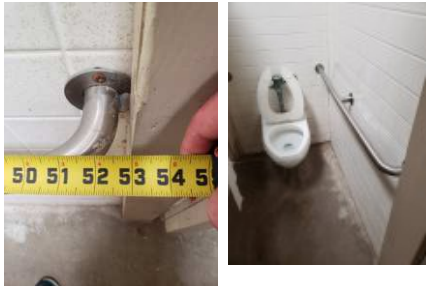
312	Bass Point Day Use Area: Bass Point Men's Restroom	[28.0650868 , -97.8846112]	It is recommended that exterior doors be maintained so that the operating pressure does not exceed 8.5 lb. force to open. The sweep period for doors with closers shall be adjusted so that from an open position of 70 degrees, the door will take at least 3 seconds to move to a point 7 inches from the latch, measured to the leading edge of the door.	Exterior door- 15# push, fast close	For all doors along the public circulation route, inspect, adjust, and maintain 8.5 lbf to open exterior doors as a smart practice For all doors along the public circulation route, inspect, adjust, and maintain closing speed on door closers	2012 TAS Section: 404.2.9, 404.2.9 Advisory, 404.2.8.1 2010 ADAS Section: 404.2.9, 404.2.8.1

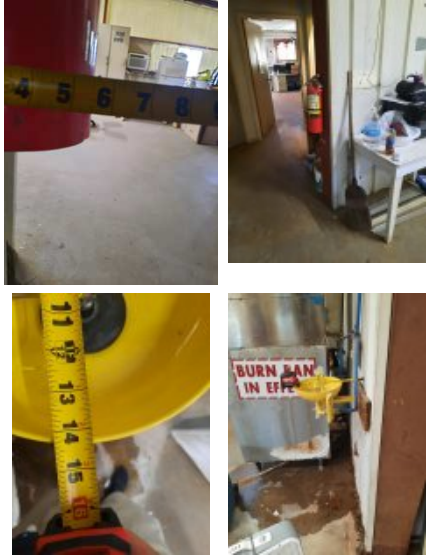
322	Employee Spaces: Maintenance	[28.0642631 , -97.872637 9]	The operable part is not accessible because there is not adequate clear floor space for either a forward or side approach. The clear floor or ground space shall be 30 inches minimum by 48 inches minimum.	Break Room - Lacks clear floor space at eye washing station due to location cooler and box fan	Remove, or relocate storage in CFS at fixtures and operable parts along the route.	2015 ABAAS Section: 305.3 2012 TAS Section: 305.3 2010 ADAS Section: 305.3

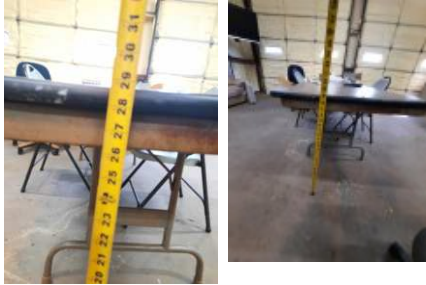
Finding Number	Area Description	Lat/Long	Finding	As Built	Recommendation	Citation	Photos	Figure
323	Employee Spaces: Maintenance	[28.0642726 , -97.8726325]	The top of the work surface is not within a compliant height range. The tops of tables and counters shall be 28 inches to 34 inches from the floor or ground.	Break Room - Table knee clearance at 26"	Provide tables and work surfaces at 28" to 34" aff with required knee and toe clearances.	2015 ABAAS Section: 902.3 2012 TAS Section: 902.3 2010 ADAS Section: 902.3

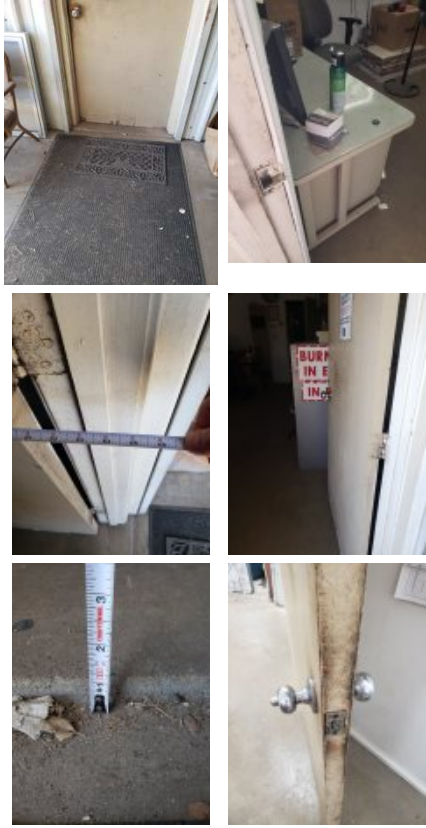
Finding Number	Area Description	Lat/Long	Finding	As Built	Recommendation	Citation	Photos	Figure

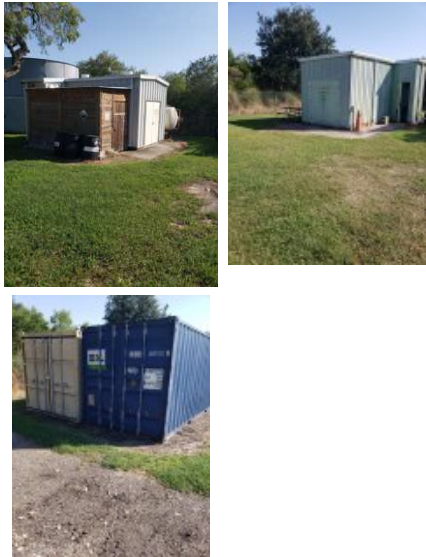
327	Employee Spaces: Maintenance	[28.0640596 , -97.872476 9]	There is no accessible route to the storage sheds and containers. At least one accessible route shall connect accessible buildings, accessible facilities, accessible elements, and accessible spaces that are on the same site.	Lacks accessible route to storage sheds and containers	Create an accessible route with crushed stone or other outdoor material from parking or walkway to the storage sheds and containers.	2015 ABAAS Section: F206.2.2 2012 TAS Section: 206.2.2 2010 ADAS Section: 206.2.2

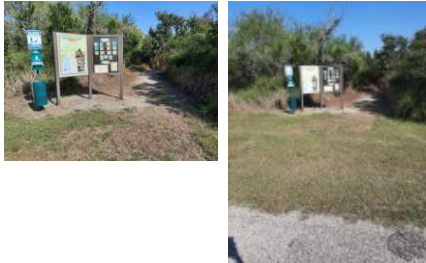
332	Trailheads: Trails	[28.058528, -97.876557 6]	There is no accessible route to the informational sign, pet waste station, bike rack, and trailhead for the Catfish Point Trail. At least one accessible route shall connect accessible buildings, accessible facilities, accessible elements, and accessible spaces that are on the same site.	Lacks accessible route to the informational sign, pet waste station, bike rack, and trailhead for the Catfish Point Trail	Create an accessible route with crushed stone or other outdoor material from parking or walkway to the informational sign, pet waste station, bike rack, and trailhead for the Catfish Point Trail	2015 ABAAS Section: F206.2.2 2012 TAS Section: 206.2.2 2010 ADAS Section: 206.2.2

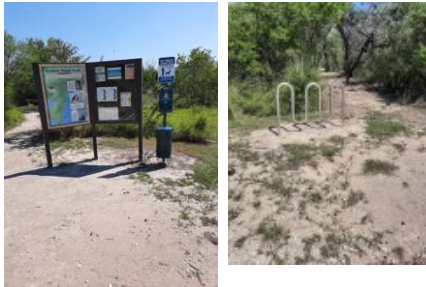
333	Trailheads: Trails	[28.0582891 , -97.876307 1]	The surface of trails, passing spaces, and resting intervals shall be firm and stable.	Lacks firm and stable surface for Catfish Point Trail	Replace surface of Catfish Point trail to be firm and stable as a smart practice.	2015 ABAAS Section: 1017.2

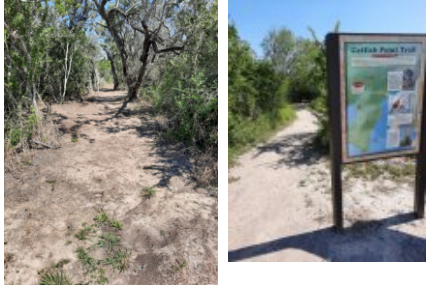
334	Trailheads: Trails	[28.0589708 , -97.881701 1]	There is no accessible route to the informational sign and trailhead for the Kiskadee Trail. At least one accessible route shall connect accessible buildings, accessible facilities, accessible elements, and accessible spaces that are on the same site.	Lacks accessible route to the informational sign and trailhead for the Kiskadee Trail	Create an accessible route with crushed stone or other outdoor material from parking or walkway to the informational sign and trailhead for the Kiskadee Trail	2015 ABAAS Section: F206.2.2 2012 TAS Section: 206.2.2 2010 ADAS Section: 206.2.2

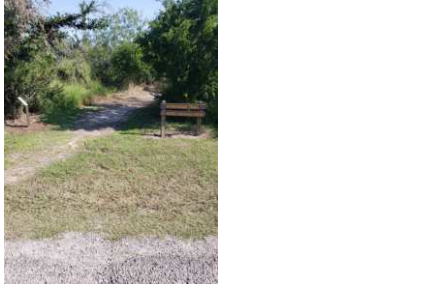
Finding Number	Area Description	Lat/Long	Finding	As Built	Recommendation	Citation	Photos	Figure
335	Trailheads: Trails	[28.0589802 , -97.881703 7]	Visual characters shall be 40 inches (1015 mm) minimum above the finish floor or ground. EXCEPTION: Visual characters indicating elevator car controls shall not be required to comply with 703.5.6.	Kiskadee Trail - Informational sign lacks required height above the ground	Remount signage to min 40" aff as a smart practice.	2015 ABAAS Section: 703.5.6, 703.5.6 EXCEPTION 2012 TAS Section: 703.5.6, 703.5.6 Exception 2010 ADAS Section: 703.5.6, 703.5.6 Exception
