Site Accessibility Evaluation

Monahans Sandhills State Park

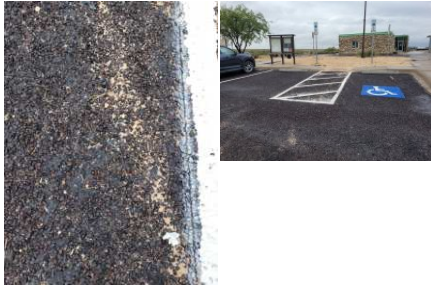
Monahans Sandhills State Park - 2500 I-20 Monahans, TX 79756

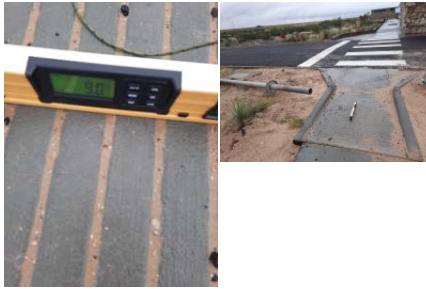
Monahans Sandhills State Park - 2500 I-20 Monahans, TX 79756

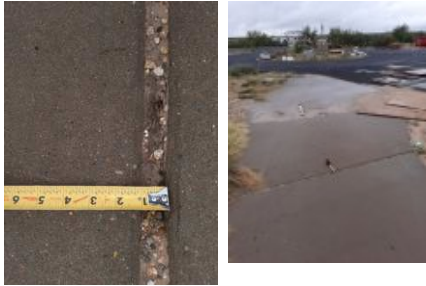
9	Headquarters Area/Dunagan Visitor's Center: HQ - Exterior Accessible Route	[31.6189575, -102.8117243]	There is a gap spaced greater than a 1/2 inch. Openings in floor or ground surfaces shall not allow passage of a sphere more than 1/2 inch diameter. Elongated openings shall be placed so that the long dimension is perpendicular to the dominant direction of travel.	Gap of 1.5" on route from upper parking lot to Visitors Center	Correct or fill gaps to be max .5".	2015 ABAAS Section: 302.3 2012 TAS Section: 302.3 2010 ADAS Section: 302.3

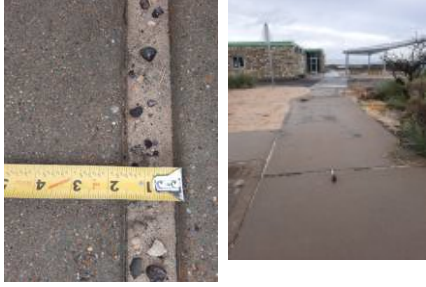
11	Headquarters Area/Dunagan Visitor's Center: HQ - Exterior Accessible Route	[31.619028, -102.8117557]	The accessible route contains loose gravel and/or surfaces that do not provide for a stable, firm slip resistant surface.	Sand and loose rock on curb ramp bottom landing and on left and right ramps	Frequently inspect and maintain routes where wash out is present.	2015 ABAAS Section: 302.1 2012 TAS Section: 302.1 2010 ADAS Section: 302.1

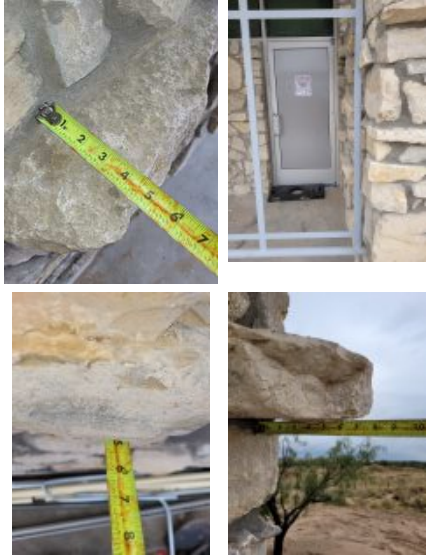
13	Headquarters Area/Dunagan Visitor's Center: HQ - Exterior Accessible Route	[31.6185906, -102.8123973]	There is a gap spaced greater than a 1/2 inch. Openings in floor or ground surfaces shall not allow passage of a sphere more than 1/2 inch diameter. Elongated openings shall be placed so that the long dimension is perpendicular to the dominant direction of travel.	1.5" gap approaching outdoor restrooms	Correct or fill gaps to be max .5".	2015 ABAAS Section: 302.3 2012 TAS Section: 302.3 2010 ADAS Section: 302.3

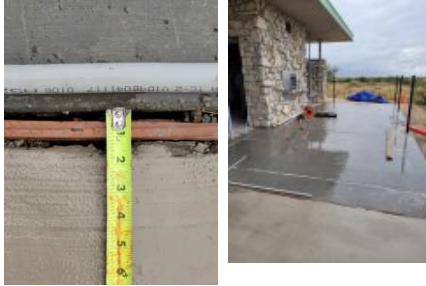
Finding Number	Area Description	Lat/Long	Finding	As Built	Recommendation	Citation	Photos	Figure
14	Headquarters Area/Dunagan Visitor's Center: HQ - Exterior Accessible Route	[31.618745, -102.81213 83]	The running slope of walking surfaces shall not be steeper than 1:20. The cross slope of walking surfaces shall not be steeper than 1:48.	Route from Visitors Center to outdoor restrooms - 2.7% cross slope by stonewall within Visitors Center, 3% at turn to steps	Correct running slopes to max 5% and cross to max 2.08%.	2012 TAS Section: 403.3 2010 ADAS Section: 403.3

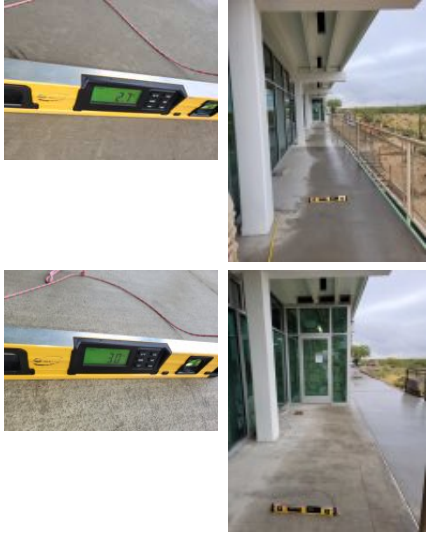
15	Headquarters Area/Dunagan Visitor's Center: HQ - Exterior Accessible Route	[31.6187365, -102.8121 148]	The stair risers are not uniform in height. Stair riser heights shall be 7 inches maximum and 4 inches minimum. On any given flight of stairs, all steps shall have uniform riser height and uniform tread widths.	Stairs from Visitors Center to lower lot - top step is 5", rest are 6"	Correct riser heights on stairs to consistent height between 4" to 7", leave as is if technically infeasible	2015 ABAAS Section: 504.2 2012 TAS Section: 504.2 2010 ADAS Section: 504.2

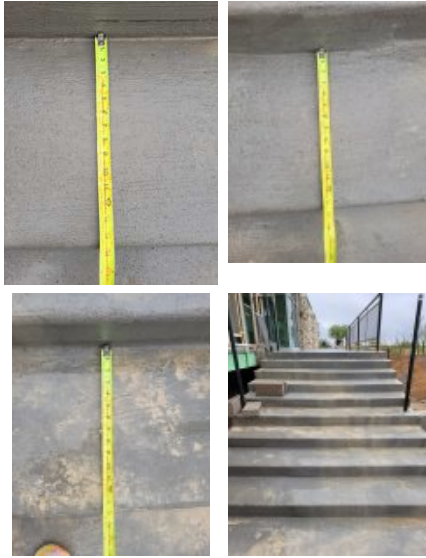
Finding Number	Area Description	Lat/Long	Finding	As Built	Recommendation	Citation	Photos	Figure
16	Headquarters Area/Dunagan Visitor's Center: HQ - Exterior Accessible Route	[31.6187217, -102.8121429]	Treads shall be 11 inches (280 mm) deep minimum and uniform	Stairs from Visitors Center to lower lot - not uniform, all range between 13.5 -14.5	Correct tread depth on stairs to 11" minimum and consistent, leave as is if technically infeasible	2015 ABAAS Section: 504.2 2012 TAS Section: 504.2 2010 ADAS Section: 504.2

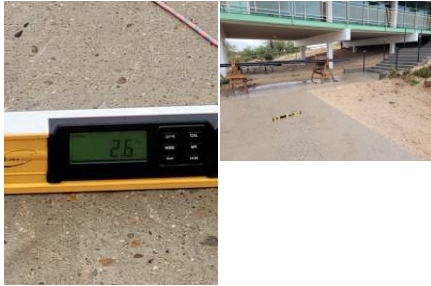
20	Headquarters Area/Dunagan Visitor's Center: HQ - Exterior Accessible Route	[31.6186451 , -102.8122 261]	There is a gap spaced greater than a 1/2 inch. Openings in floor or ground surfaces shall not allow passage of a sphere more than 1/2 inch diameter. Elongated openings shall be placed so that the long dimension is perpendicular to the dominant direction of travel.	2" gap at turn to steps from lower lot	Correct or fill gaps to be max .5".	2015 ABAAS Section: 302.3 2012 TAS Section: 302.3 2010 ADAS Section: 302.3

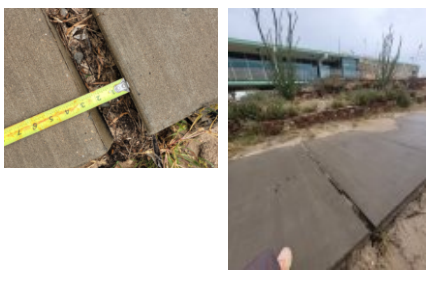
22	Headquarters Area/Dunagan Visitor's Center: HQ - Exterior Accessible Route	[31.6186771 , -102.8119 772]	There is a gap spaced greater than a 1/2 inch. Openings in floor or ground surfaces shall not allow passage of a sphere more than 1/2 inch diameter. Elongated openings shall be placed so that the long dimension is perpendicular to the dominant direction of travel.	2" gap by air conditioning system on path to lower lot	Correct or fill gaps to be max .5".	2015 ABAAS Section: 302.3 2012 TAS Section: 302.3 2010 ADAS Section: 302.3

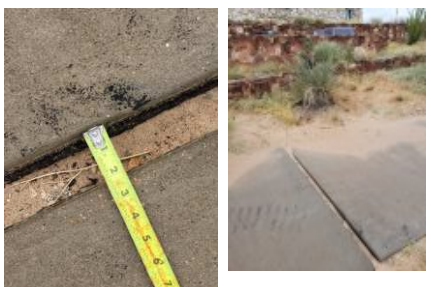
Monahans Sandhills State Park - 2500 I-20 Monahans, TX 79756

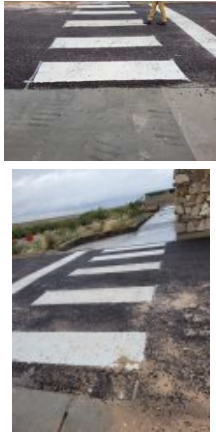
25	Headquarters Area/Dunagan Visitor's Center: HQ - Exterior Accessible Route	[31.61893, -102.8121]	Picnic tables shall provide at least one wheelchair space for each 24 linear feet (7320 mm) of usable table surface perimeter. Wheelchair spaces shall be 30 inches (760 mm) minimum by 48 inches (1220 mm) minimum. Wheelchair spaces shall be positioned for a forward approach to the table and provide knee and toe clearance complying with 306 under the table	1 of 1 picnic table at Visitors Center lacks toe clearance	Replace picnic table with one of an accessible design as a smart practice	2015 ABAAS Section: 1011.4.2

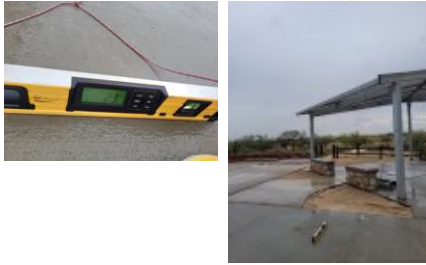
27	Headquarters Area/Dunagan Visitor's Center: HQ - Exterior Accessible Route	[31.6189857 , -102.8119 416]	The accessible route of travel that crosses or adjoins the vehicular way and the walking surface is not separated by curbs, railings, or other elements between the pedestrian areas and vehicular areas. If a walk crosses or adjoins a vehicular way, and the walking surfaces are not separated by curbs, railings or other elements between the pedestrian areas and vehicular areas, the boundary between the areas shall be defined by a continuous detectable warning which is 36 inches wide.	Shade structure side of entry to Visitors Center - lacks detectable warning on Visitors Center side	Install detectable warning where accessible route crosses the vehicular way as a smart practice.	2012 TAS Section: 705.1 2010 ADAS Section: 705

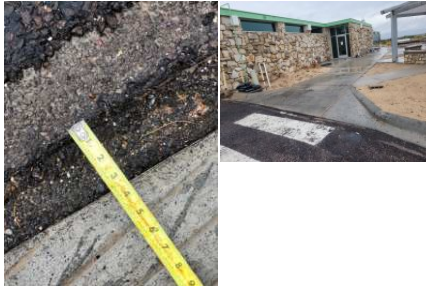
29	Headquarters Area/Dunagan Visitor's Center: HQ - Exterior Accessible Route	[31.6190094 , -102.8118 718]	The walkway contains abrupt vertical edges and/or variations over a 1/4 inch. 1/4 inch is the maximum vertical rise. Changes in level between 1/4 inch and 1/2 inch must be beveled at 1:2 or less. Changes in level greater than 1/2 inch must be by way of a ramp.	.75" change in level (CIL) from upper lot to Visitors Center on shade side	Repair, bevel or ramp CIL along AR.	2012 TAS Section: 303.2, 303.3 2010 ADAS Section: 303.2, 303.3

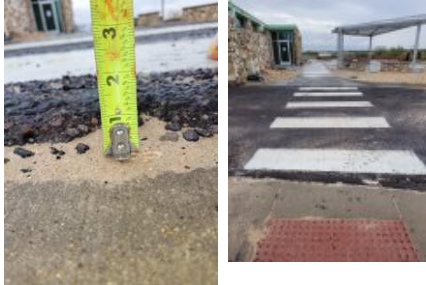
Monahans Sandhills State Park - 2500 I-20 Monahans, TX 79756

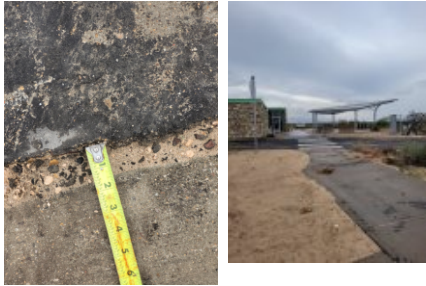
31	Headquarters Area/Dunagan Visitor's Center: HQ - Public Spaces	[31.6189038, -102.8120289]	The threshold has a gap greater than 1/2 inch wide. Exterior doors are recommended to be maintained at 8.5 lbf as a smart practice. Force is to be measured at the operating hardware or 30 inches from the hinges, whichever is greater.	Exterior door to shade structure of Visitor's Center - 15# push, 1.75" gap on pull side	For all doors along the public circulation route, fill gaps at door entries to max .5". For all doors along the public circulation route, inspect, adjust, and maintain 8.5 lbf to open exterior doors as a smart practice.	2010 ADAS Section: 404.2.3, 404.2.7, 404.2.4, 404.2.11, 404.2.11 Exception

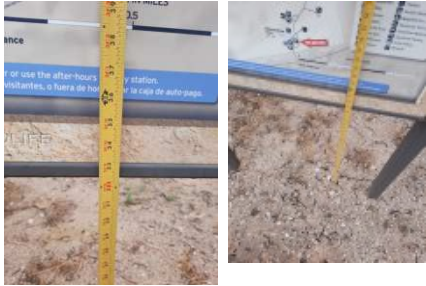
38	Headquarters Area/Dunagan Visitor's Center: HQ - Public Spaces	[31.61895, -102.8117]	Element meets all standards and requirements	1 of 1 garbage can at upper parking complies	None	2010 ADAS Section: N/A

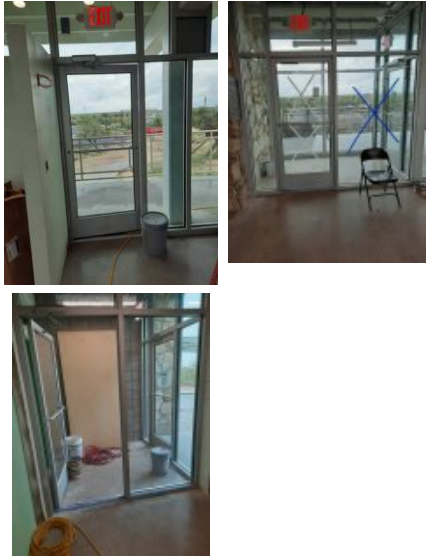
40	Headquarters Area/Dunagan Visitor's Center: HQ - Public Spaces	[31.61886, -102.812]	Element meets all standards and requirements	Empty rooms from stone wall to restroom - compliant as is	None	2010 ADAS Section: N/A

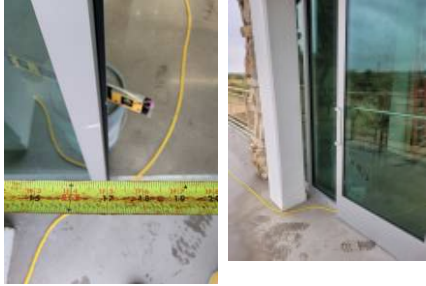
Finding Number	Area Description	Lat/Long	Finding	As Built	Recommendation	Citation	Photos	Figure
42	Headquarters Area/Dunagan Visitor's Center: HQ - Public Spaces	[31.6188472, -102.8120188]	An item or items project more than 4 inches into the circulation path. Wall-mounted objects that have leading edges between 27 inches and 80 inches from the floor must not project more than 4 inches into the circulation path. Protruding objects that extend to the floor or within 27 inches of the floor are cane detectable and are therefore not hazardous. Where it is necessary or desirable to have objects protrude from the wall, a manner of cane detection must be provided.	Stone wall at end - 2 instances where rocks project - 4.5", 5"	Relocate protruding objects or place cane detectable warning or bollard at foot of item.	2015 ABAAS Section: 307.2 2012 TAS Section: 307.2 2010 ADAS Section: 307.2

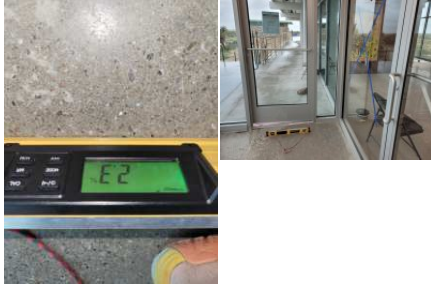
Monahans Sandhills State Park - 2500 I-20 Monahans, TX 79756

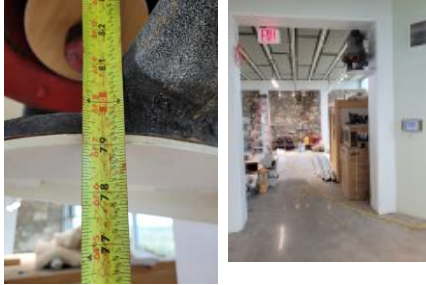
45	Headquarters Area/Dunagan Visitor's Center: HQ - Employee Spaces	[31.618872, -102.811959]	Spaces and elements within employee work areas shall only be required to comply with 206.2.8, 207.1, and 215.3 and shall be designed and constructed so that individuals with disabilities can approach, enter, and exit the employee work area. Employee work areas, or portions of employee work areas, other than raised courtroom stations, that are less than 300 square feet (28 m2) and elevated 7 inches (180 mm) or more above the finish floor or ground where the elevation is essential to the function of the space shall not be required to comply with these requirements or to be on an accessible route.	3 of 3 doors have 10.5 lbf to open/close	Inspect, adjust, and maintain 5 lbf to open interior doors.	2015 ABAAS Section: F203.9 2012 TAS Section: 203.9 2010 ADAS Section: 203.9

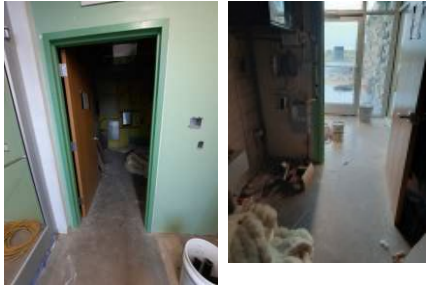
Finding Number	Area Description	Lat/Long	Finding	As Built	Recommendation	Citation	Photos	Figure
47	Headquarters Area/Dunagan Visitor's Center: HQ - Employee Spaces	[31.6185483, -102.8124107]	Element meets all standards and requirements	Plumbers chase and storage room at Restroom building - complies	None	2010 ADAS Section: N/A

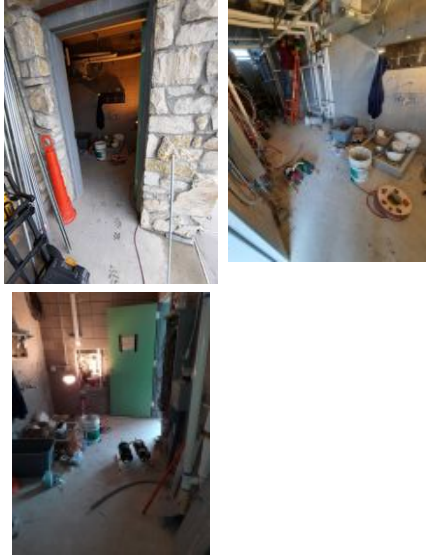
48	Headquarters Area/Dunagan Visitor's Center: HQ - Employee Spaces	[31.61886, -102.812]	Element meets all standards and requirements	Closet by restroom within Visitors Center - complies	None	2010 ADAS Section: N/A		
49	Headquarters Area/Dunagan Visitor's Center: HQ - Restrooms	[31.6188162, -102.8120751]	The restroom sign does not comply with one or more applicable requirements for the location, height, and properties of the sign.	Restrooms within Visitors Center - restroom lacks signage	Acquire and mount signage, including Braille, raised lettering and access symbol mounted on wall, latch side of door, 48" to baseline of lowest character and 60" to baseline of highest character.	2015 ABAAS Section: F216.2, 703.1, 703.2, 703.5, 703.6 2012 TAS Section: 216.2, 703.1, 703.2, 703.5, 703.6 2010 ADAS Section: 216.2, 703.1, 703.2, 703.5, 703.6

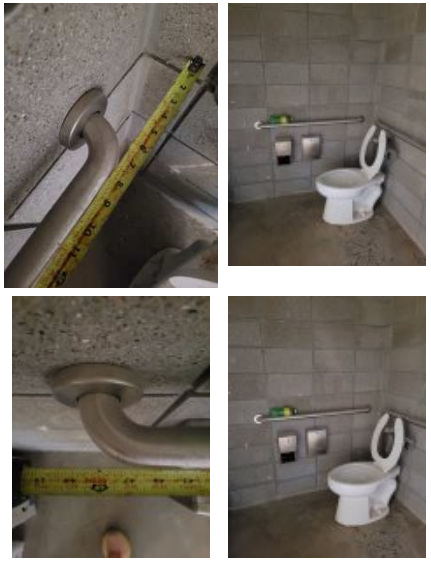
Finding Number	Area Description	Lat/Long	Finding	As Built	Recommendation	Citation	Photos	Figure
52	Headquarters Area/Dunagan Visitor's Center: HQ - Restrooms	[31.6188128, -102.8120845]	The grab bar height and/or spacing fails. Grab bars must be mounted between 33" and 36" to the top of the gripping surface. There must be 1.5" of clearance between the grab bar and the wall. There must be a minimum of 1.5" of clearance below and minimum 12" above the grab bar to any dispenser or other obstruction.	Restroom within Visitors Center - 1.75" between both grab bars	Replace grab bars with ones providing 1.5" clearance between grab bars and wall.	2015 ABAAS Section: 609.3, 609.4 2012 TAS Section: 609.4, 609.3 2010 ADAS Section: 609.3, 609.4

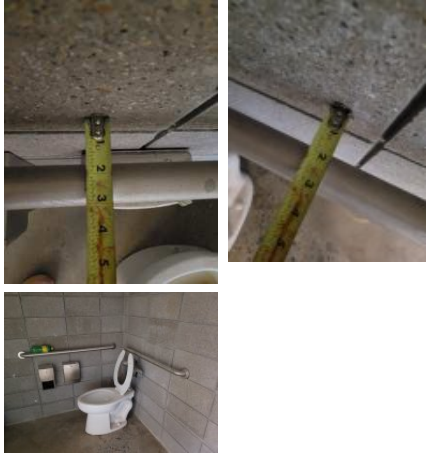
53	Headquarters Area/Dunagan Visitor's Center: HQ - Restrooms	[31.61886, -102.812]	Element meets all standards and requirements	Restroom within Visitors Center - door complies	None	2010 ADAS Section: N/A

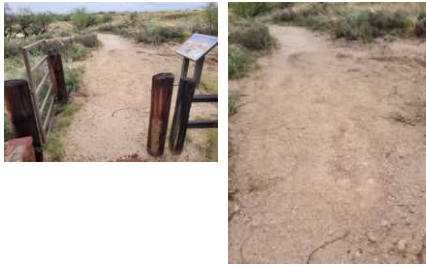
Finding Number	Area Description	Lat/Long	Finding	As Built	Recommendation	Citation	Photos	Figure
55	Headquarters Area/Dunagan Visitor's Center: HQ - Men's Outdoor Building Restroom	[31.6185303, -102.8123912]	The restroom sign does not comply with one or more applicable requirements for the location, height, and properties of the sign.	lacks signage, lacks International Symbol of Accessibility	Acquire and mount signage, including Braille, raised lettering and access symbol mounted on wall, latch side of door, 48" to baseline of lowest character and 60" to baseline of highest character.	<p>2015 ABAAS Section: F216.2, 703.1, 703.2, 703.5, 703.6</p> <p>2012 TAS Section: 216.2, 703.1, 703.2, 703.5, 703.6</p> <p>2010 ADAS Section: 216.2, 703.1, 703.2, 703.5, 703.6</p>

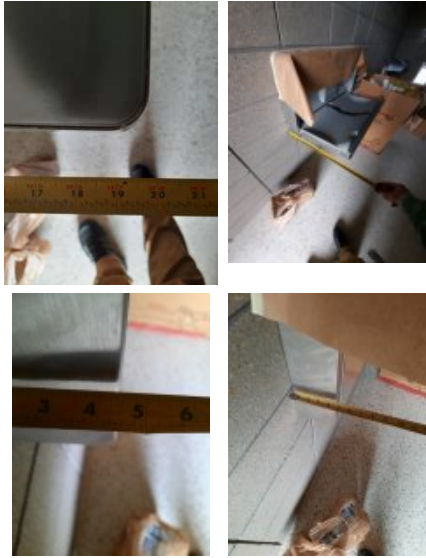
57	Headquarters Area/Dunagan Visitor's Center: HQ - Men's Outdoor Building Restroom	[31.6185349, -102.8123992]	The side grab bars are not in the correct location. Grab bars on the side wall must be installed so that the end closest to the rear wall is maximum 12" from the rear wall. The end furthest from the rear wall must be mounted minimum 54" from the rear wall.	side grab bar extends 50.5" to grab bar end	Remount side grab bar to max 12" from the rear wall at the close end and min 54" on the far end, and 33" to 36" aff.	2015 ABAAS Section: 604.5.1 2012 TAS Section: 604.5.1 2010 ADAS Section: 604.5.1

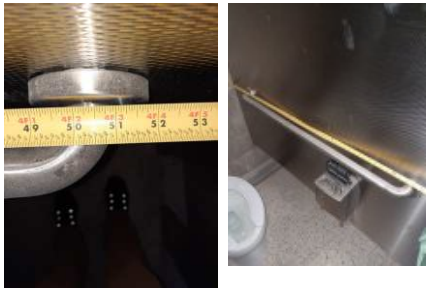
Finding Number	Area Description	Lat/Long	Finding	As Built	Recommendation	Citation	Photos	Figure
58	Headquarters Area/Dunagan Visitor's Center: HQ - Men's Outdoor Building Restroom	[31.6185246, -102.8124127]	The grab bar height and/or spacing fails. Grab bars must be mounted between 33" and 36" to the top of the gripping surface. There must be 1.5" of clearance between the grab bar and the wall. There must be a minimum of 1.5" of clearance below and minimum 12" above the grab bar to any dispenser or other obstruction.	Side grab bar 1.75" from partition	Replace side grab bar with one that provides 1.5" clearance between grab bar and wall. Cost in previous finding.	2015 ABAAS Section: 609.3, 609.4 2012 TAS Section: 609.4, 609.3 2010 ADAS Section: 609.3, 609.4

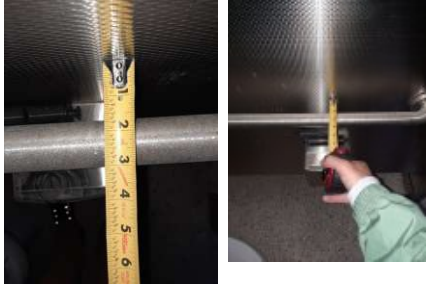
59	Headquarters Area/Dunagan Visitor's Center: HQ - Men's Outdoor Building Restroom	[31.6185326, -102.8124033]	The stall doorway extends down too close to the route of travel. Any obstruction that overhangs a route of travel must be a minimum of 80 inches above the walking surface as measured from the bottom of the obstruction.	79.25" high doorways to stalls	Raise doorway stall to min 80", or pad object to prevent hazard in overhead clearance along AR. In the alternative, leave as is citing construction tolerance.	2015 ABAAS Section: 307.4 2012 TAS Section: 307.4 2010 ADAS Section: 307.4

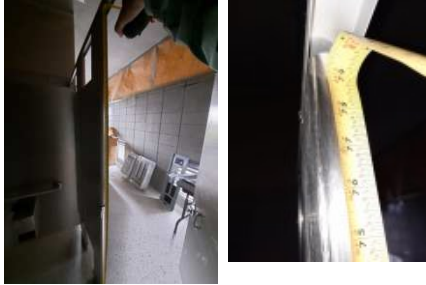
60	Headquarters Area/Dunagan Visitor's Center: HQ - Men's Outdoor Building Restroom	[31.6185285, -102.8124013]	Element meets all standards and requirements	Men's Restroom door at Restroom building complies	None	2010 ADAS Section: N/A

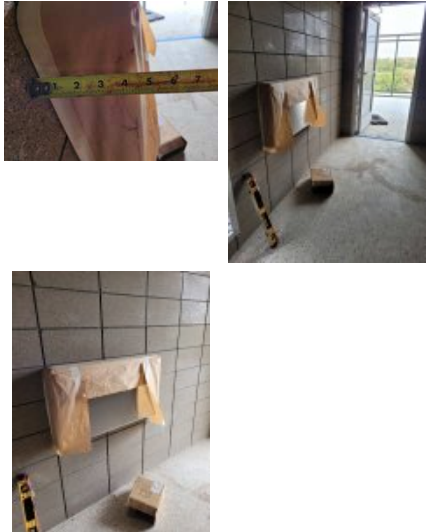
63	Headquarters Area/Dunagan Visitor's Center: HQ - Womens Outdoor Building Restroom	[31.618524, -102.81239]	The dimensions of the toilet stall do not comply. Wheelchair accessible compartments shall be 60 inches wide and 59 inches deep minimum for floor mounted water closets measured perpendicular to the rear wall. Door shall not swing into the minimum clear floor space required for the toilet.	59" width	Widen accessible stalls to min. 60" clear width, 59" depth	2015 ABAAS Section: 604.8.1.1 2012 TAS Section: 604.3.2 2010 ADAS Section: 604.3.2

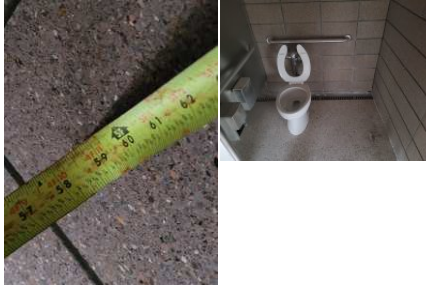
Finding Number	Area Description	Lat/Long	Finding	As Built	Recommendation	Citation	Photos	Figure
64	Headquarters Area/Dunagan Visitor's Center: HQ - Womens Outdoor Building Restroom	[31.6185285, -102.8123954]	The required 56 inches by 60 inches clear floor space for the water closet has been obstructed. The clear floor space around the water closet shall be 60 inches minimum measured perpendicular from the side wall and 56 inches minimum measured perpendicular from the rear wall.	59" width	Provide required 60" clearance around toilet. See previous finding.	2015 ABAAS Section: 604.3. 2012 TAS Section: 604.3.1 2010 ADAS Section: 604.3.1

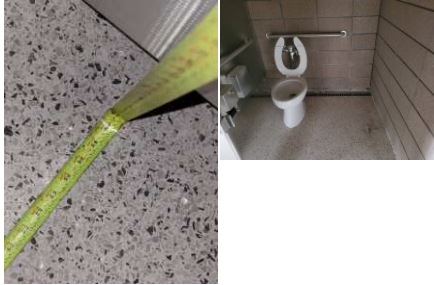
65	Headquarters Area/Dunagan Visitor's Center: HQ - Womens Outdoor Building Restroom	[31.6185285, -102.8123954]	The side grab bars are not in the correct location. Grab bars on the side wall must be installed so that the end closest to the rear wall is maximum 12" from the rear wall. The end furthest from the rear wall must be mounted minimum 54" from the rear wall.	side grab bar extends 50.5" to grab bar end	Remount side grab bar to max 12" from the rear wall at the close end and min 54" on the far end, and 33" to 36" aff.	2015 ABAAS Section: 604.5.1 2012 TAS Section: 604.5.1 2010 ADAS Section: 604.5.1

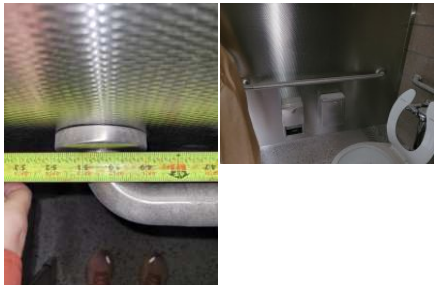
66	Headquarters Area/Dunagan Visitor's Center: HQ - Womens Outdoor Building Restroom	[31.6185228, -102.8124034]	The grab bar height and/or spacing fails. Grab bars must be mounted between 33" and 36" to the top of the gripping surface. There must be 1.5" of clearance between the grab bar and the wall. There must be a minimum of 1.5" of clearance below and minimum 12" above the grab bar to any dispenser or other obstruction.	1.75" clearance between grab bars	Replace grab bars with ones that provide 1.5" clearance between bars and walls.	2015 ABAAS Section: 609.3, 609.4 2012 TAS Section: 609.4, 609.3 2010 ADAS Section: 609.3, 609.4

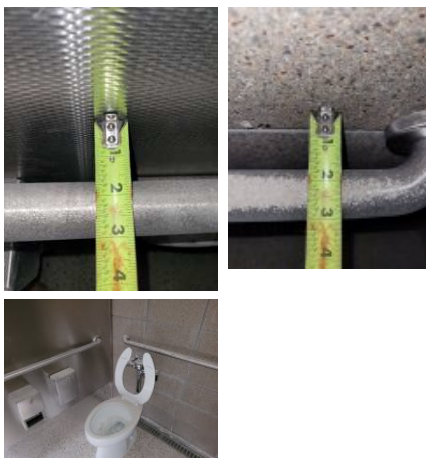
Finding Number	Area Description	Lat/Long	Finding	As Built	Recommendation	Citation	Photos	Figure
67	Headquarters Area/Dunagan Visitor's Center: HQ - Womens Outdoor Building Restroom	[31.618524, -102.81239 81]	There is a change in level greater than 1/4 inch. 1/4 inch is the maximum vertical rise. Changes in level between 1/4 inch and 1/2 inch must be beveled at 1:2 or less. Changes in level greater than 1/2 inch must be by way of a ramp.	.5" change in level at drain system under sink, not beveled	Repair, bevel or ramp CIL along accessible route (AR) to max .25".	2015 ABAAS Section: 303.3 2012 TAS Section: 303.3 2010 ADAS Section: 303.3

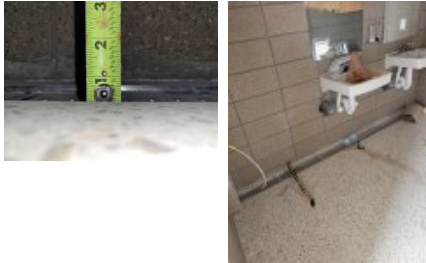
68	Headquarters Area/Dunagan Visitor's Center: HQ - Womens Outdoor Building Restroom	[31.6185368, -102.8123 943]	Exterior doors exceed 8.5 lbs of force to open; fire doors shall have a minimum opening force allowable by the appropriate administrative authority	Women's Outdoor Restroom door - 15lbf	Inspect, adjust, and maintain 8.5 lbf to open exterior doors as a smart practice	2010 ADAS Section: 404.2.9

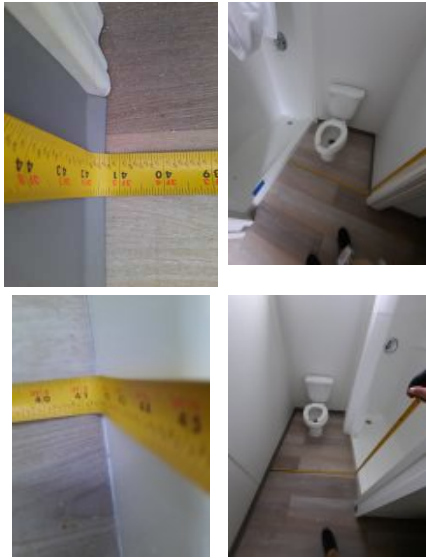
Finding Number	Area Description	Lat/Long	Finding	As Built	Recommendation	Citation	Photos	Figure
77	Employee Areas: Maintenance	[31.62164, -102.8079]	The restroom sign does not comply with one or more applicable requirements for the location, height, and properties of the sign.	larger trailer - lacks any signage	Acquire and mount signage, including Braille and raised lettering, mounted on wall, latch side of door, 48" to baseline of lowest character and 60" to baseline of highest character.	2015 ABAAS Section: F216.2, 703.1, 703.2, 703.5, 703.6 2012 TAS Section: 216.2, 703.1, 703.2, 703.5, 703.6 2010 ADAS Section: 216.2, 703.1, 703.2, 703.5, 703.6

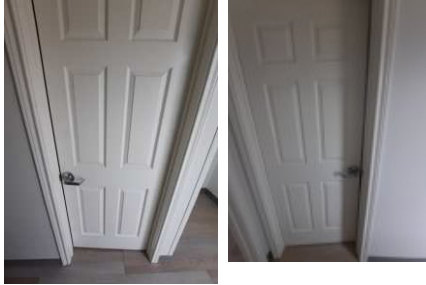
78	Employee Areas: Maintenance	[31.62177, -102.808]	Spaces and elements within employee work areas shall only be required to comply with 206.2.8, 207.1, and 215.3 and shall be designed and constructed so that individuals with disabilities can approach, enter, and exit the employee work area. Employee work areas, or portions of employee work areas, other than raised courtroom stations, that are less than 300 square feet (28 m2) and elevated 7 inches (180 mm) or more above the finish floor or ground where the elevation is essential to the function of the space shall not be required to comply with these requirements or to be on an accessible route.	larger trailer - lacks means of entry (no stairs at time of audit) - 33" to threshold, 1.25" threshold	Provide a ramp for access to the trailer.	2015 ABAAS Section: F203.9 2012 TAS Section: 203.9 2010 ADAS Section: 203.9

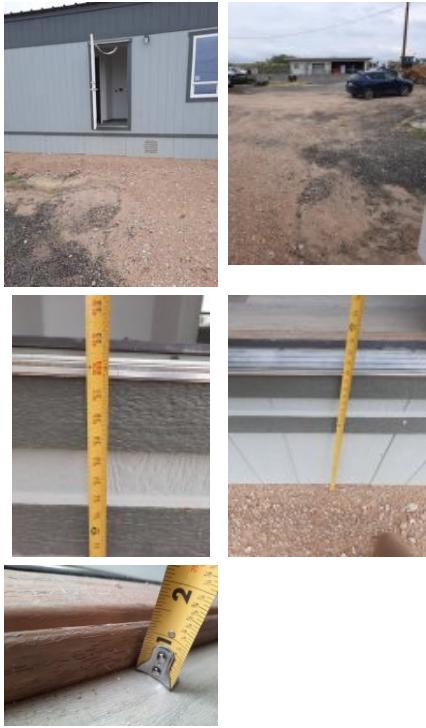
Finding Number	Area Description	Lat/Long	Finding	As Built	Recommendation	Citation	Photos	Figure

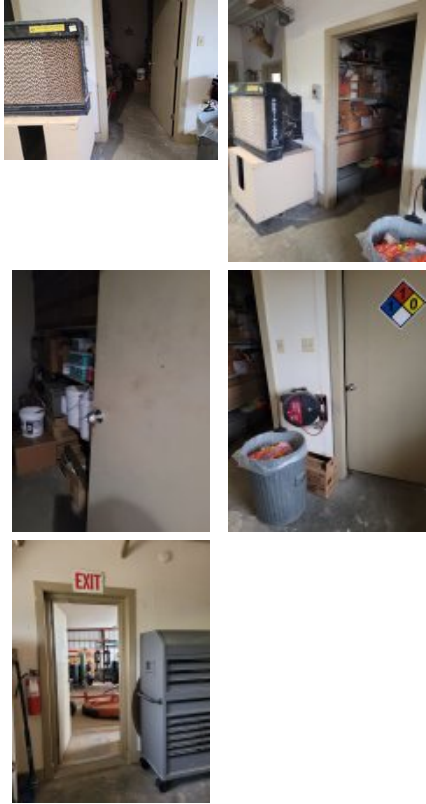
82	Employee Areas: Maintenance	[31.6217036, -102.8079177]	Picnic tables shall provide at least one wheelchair space for each 24 linear feet (7320 mm) of usable table surface perimeter. Wheelchair spaces shall be 30 inches (760 mm) minimum by 48 inches (1220 mm) minimum. Wheelchair spaces shall be positioned for a forward approach to the table and provide knee and toe clearance complying with 306 under the table	0 of 2 picnic tables on route at maintenance, not accessible	Replace one picnic table with one of an accessible design as a smart practice and place along an accessible route.	2015 ABAAS Section: 1011.4.2

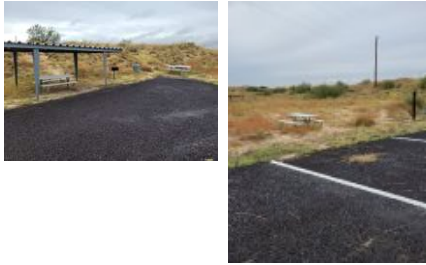
97	Equestrian Area: Equestrian - Campsites	[31.6213092, -102.8118152]	An accessible access route is not provided between elements, spaces and the facilities provided within the accessible camping unit. At least one outdoor recreation access route shall connect accessible elements, spaces and facilities provided within camping units with mobility features.	no route to any amenities (3 of 3 picnic tables, 3 of 3 spigots, 2 of 2 trash, equestrian stalls)	Create AR with crushed and compacted stone or similar outdoor material to one of each type of amenity.	2015 ABAAS Section: F244.5.1

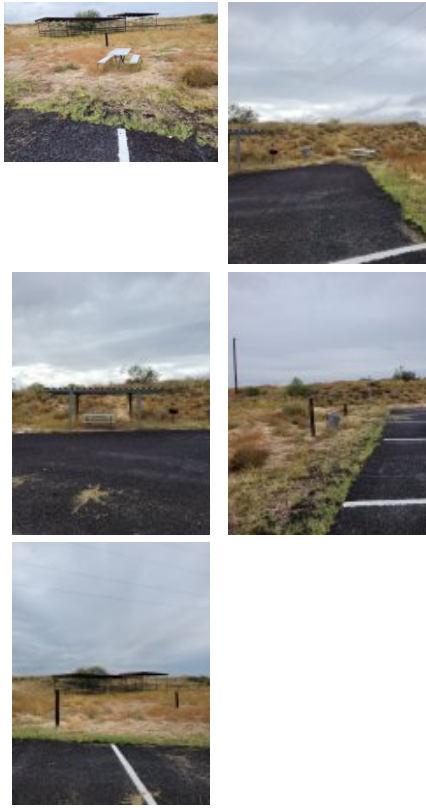
Finding Number	Area Description	Lat/Long	Finding	As Built	Recommendation	Citation	Photos	Figure
98	Equestrian Area: Equestrian - Campsites	[31.6247957 , -102.81251 8]	The shade structure extends down too close to the route of travel. Any obstruction that overhangs a route of travel must be a minimum of 80 inches above the walking surface as measured from the bottom of the obstruction.	equestrian pull off after maintenance - 72.5" AFF at overhang	Raise shade structure to min 80", or pad object to prevent hazard in overhead clearance.	2015 ABAAS Section: 307.3 2012 TAS Section: 307.3 2010 ADAS Section: 307.3

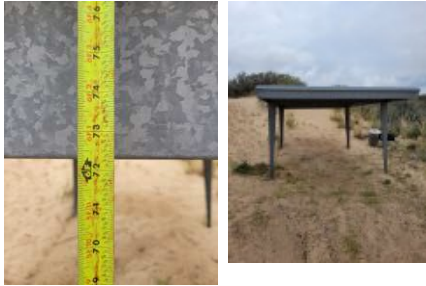
99	Equestrian Area: Equestrian - Campsites	[31.6247846 , -102.8125 177]	There is no accessible route to the picnic amenities. At least one accessible route shall connect accessible buildings, accessible facilities, accessible elements, and accessible spaces that are on the same site.	shade structure after maintenance - no route to grill, shade structure, or trash	Create an accessible route with crushed stone or other outdoor material from parking or walkway to picnic amenities.	2015 ABAAS Section: F206.2.2 2012 TAS Section: 206.2.2 2010 ADAS Section: 206.2.2

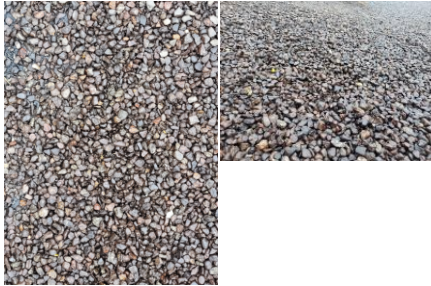
Finding Number	Area Description	Lat/Long	Finding	As Built	Recommendation	Citation	Photos	Figure
103	Sandhills Picnic Pavilion: Pavilion, Section House, Temporary HQ, Picnic Area - Exterior Accessible Route	[31.6349069, -102.8149571]	The landing at the bottom of the ramp has a slope greater than 2%. Bottom landings shall have a dimension in the direction of ramp run of not less than 60 inches and have a slope of less than 2% in any direction.	ramp at HQ entry - bottom of landing is loose gravel	Resurface ramp landing to be firm and stable.	2015 ABAAS Section: 405.7.1, 405.7.1 EXCEPTION 2012 TAS Section: 405.7.1, 405.7.1 Exception 2010 ADAS Section: 405.7.1, 405.7.1 Exception

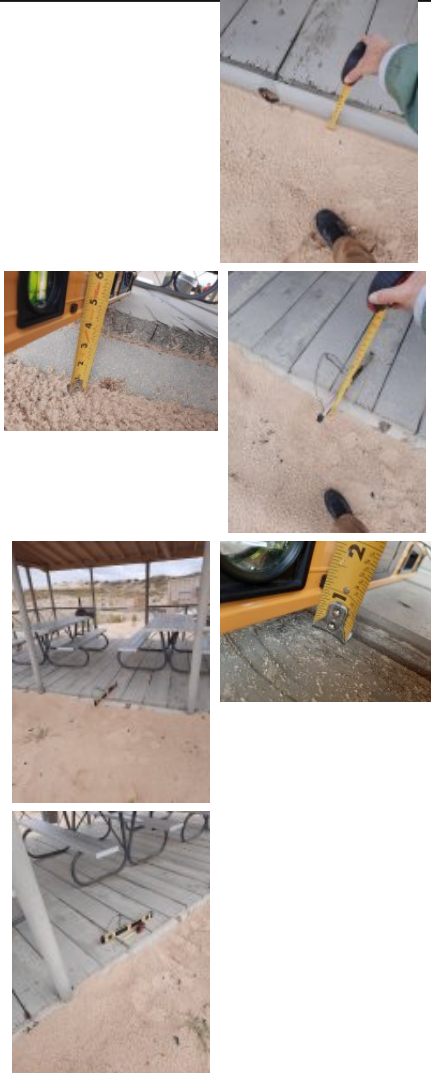
Finding Number	Area Description	Lat/Long	Finding	As Built	Recommendation	Citation	Photos	Figure
116	Sandhills Picnic Pavilion: Pavilion	[31.6349288, -102.8151684]	The ceiling and support beams extend down too close to the route of travel. Any obstruction that overhangs a route of travel must be a minimum of 80 inches above the walking surface as measured from the bottom of the obstruction.	Height of ceiling at entries is 76.5" AGL, cross support beam also less than 80" AGL	Raise ceiling to min 80", or pad object to prevent hazard in overhead clearance.	2015 ABAAS Section: 307.3 2012 TAS Section: 307.3 2010 ADAS Section: 307.3

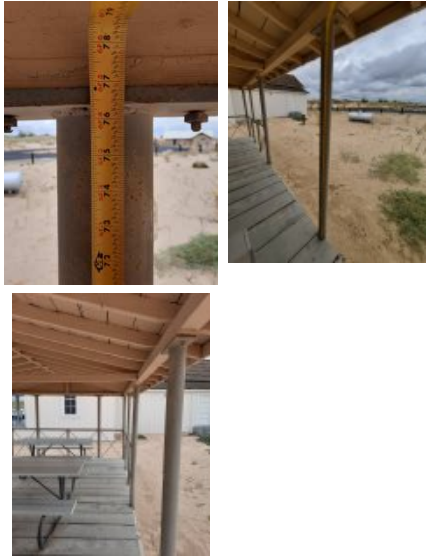
117	Sandhills Picnic Pavilion: Pavilion	[31.6349391, -102.8151724]	Picnic tables shall provide at least one wheelchair space for each 24 linear feet (7320 mm) of usable table surface perimeter. Wheelchair spaces shall be 30 inches (760 mm) minimum by 48 inches (1220 mm) minimum. Wheelchair spaces shall be positioned for a forward approach to the table and provide knee and toe clearance complying with 306 under the table	3 of 3 picnic tables are not of an accessible design	Replace two picnic tables with ones of an accessible design as a smart practice.	2015 ABAAS Section: 1011.4.2

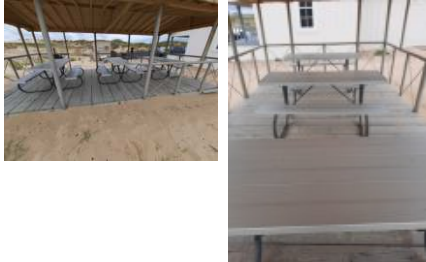
Finding Number	Area Description	Lat/Long	Finding	As Built	Recommendation	Citation	Photos	Figure
118	Sandhills Picnic Pavilion: Pavilion	[31.6349311, -102.8151644]	Where picnic facilities contain two or fewer picnic units, each picnic unit shall provide mobility features complying with F245.2.	Lacks route to garbage can, bench, and grill	Create an ORAR to shelter or picnic area and provide accessible features as a smart practice.	2015 ABAAS Section: F245.2.1

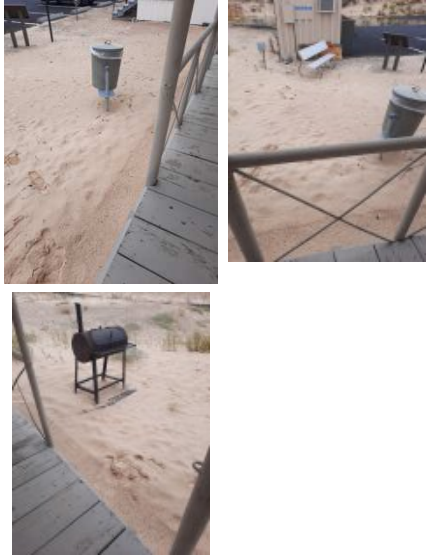
119	Sandhills Picnic Pavilion: Pavilion	[31.6349345, -102.8151697]	Where provided, cooking surfaces shall be 15 inches (380 mm) minimum and 34 inches (865 mm) maximum above the ground.	Cooking surface of grill is approximately 39" AGL	Raise or lower cooking surface to be 15" min to 34" max above the ground; in the alternative, replace with a compliant surface as a smart practice.	2015 ABAAS Section: 1011.5.2

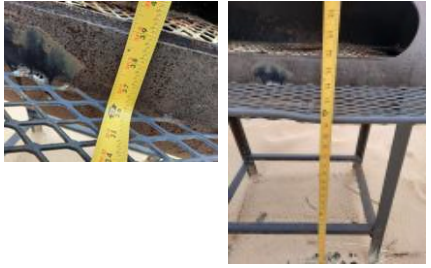
120	Sandhills Picnic Pavilion: Pavilion	[31.6349274, -102.8150671]	Benches shall have a 36" by 48" clear ground space (CGS) positioned near the bench with one side of the space adjoining an outdoor recreation access route (ORAR) or trail, as applicable The CGS shall not overlap with the ORAR or trail or another CGS	2 of 2 benches at temporary headquarters at Sandhill Group Picnic Shelter lacks CGS	Construct firm, stable, and slip resistant pads at least 36" by 48" adjacent to 20% of benches, and locate along an AR as a smart practice.	2015 ABAAS Section: 1011.2.1

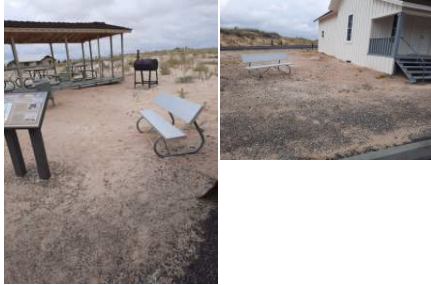
Finding Number	Area Description	Lat/Long	Finding	As Built	Recommendation	Citation	Photos	Figure
121	Sandhills Picnic Pavilion: Pavilion - Picnic Areas	[31.6349771, -102.8148987]	The operable part is positioned too high for either a side or front approach. Where a clear floor or ground space allows a parallel approach to an element and the side reach is unobstructed, the high side reach shall be 48 inches maximum and the low side reach shall be 15 inches minimum above the finish floor or ground. Where a forward reach is unobstructed, the high forward reach shall be 48 inches maximum and the low forward reach shall be 15 inches minimum above the finish floor or ground.	Sled return shelf at 60" AGL	Provide a lowered return shelf at max 48" AGL.	2015 ABAAS Section: 308.1 2012 TAS Section: 308.1 2010 ADAS Section: 308.1

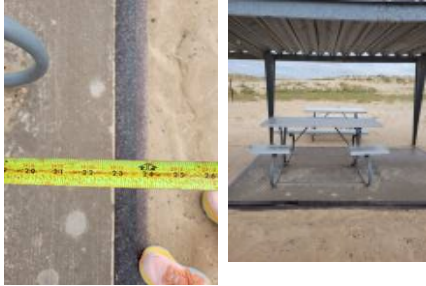
Monahans Sandhills State Park - 2500 I-20 Monahans, TX 79756

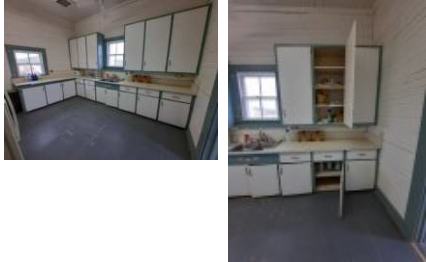
131	Sandhills Picnic Pavilion: Pavilion - Section House	[31.6348198, -102.8151249]	The top rim of the sink is too high. All lavatories/sinks that are designated to be accessible shall be a minimum 17 inches in horizontal depth and mounted with the rim or counter edge no higher than 34 inches above the finished floor.	Sink rim 35.75" AFF	Lower sinks to max 34" above the finished floor (AFF) to front of rim.	2015 ABAAS Section: 606.3 2012 TAS Section: 606.3 2010 ADAS Section: 606.3

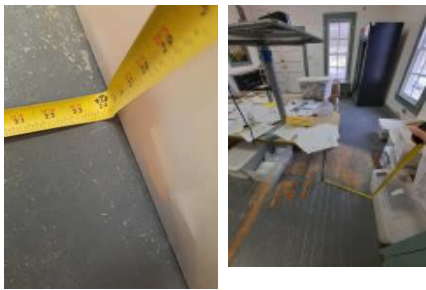
139	Sandhills Picnic Pavilion: Pavilion - Section House	[31.6348311, -102.8151228]	The operable part is positioned too high for either a side or front approach. Where a clear floor or ground space allows a parallel approach to an element and the side reach is unobstructed, the high side reach shall be 48 inches maximum and the low side reach shall be 15 inches minimum above the finish floor or ground. Where a forward reach is unobstructed, the high forward reach shall be 48 inches maximum and the low forward reach shall be 15 inches minimum above the finish floor or ground.	Heating unit controls 77" AFF	Remount operable parts to be in reach range of 15" min to 48" max	2015 ABAAS Section: 308.1 2012 TAS Section: 308.1 2010 ADAS Section: 308.1

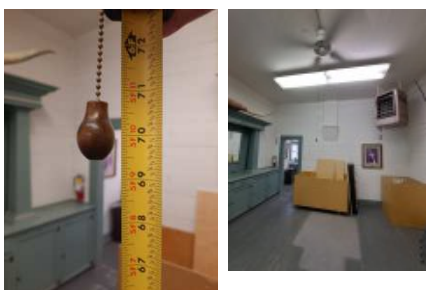
Finding Number	Area Description	Lat/Long	Finding	As Built	Recommendation	Citation	Photos	Figure
141	Sandhills Picnic Pavilion: Pavilion - Section House	[31.6348265, -102.8151161]	The operable part is not accessible because it requires tight grasping, pinching or twisting of the wrist.	Ceiling fan pull requires tight pinch	Replace operable part with one usable without a tight pinch or grasp	2015 ABAAS Section: 309.4 2012 TAS Section: 309.4 2010 ADAS Section: 309.4

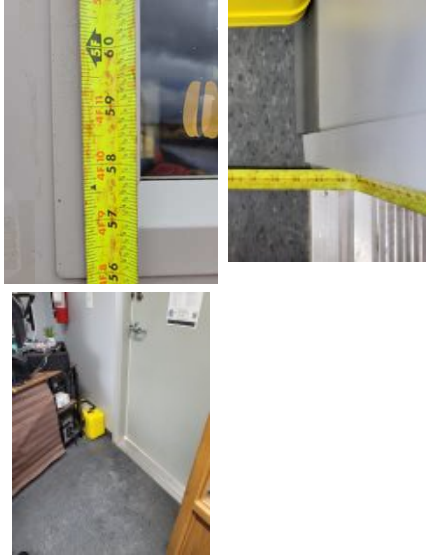
<p>The photos show: 1) A close-up of a door handle with a yellow measuring tape indicating a height of approximately 58.75 inches above the finish floor. 2) A view of a door frame with a yellow measuring tape showing a back clearance of 21.5 inches on the push side. 3) A wider view of a door in a room with a desk, showing the overall maneuvering clearance.</p>

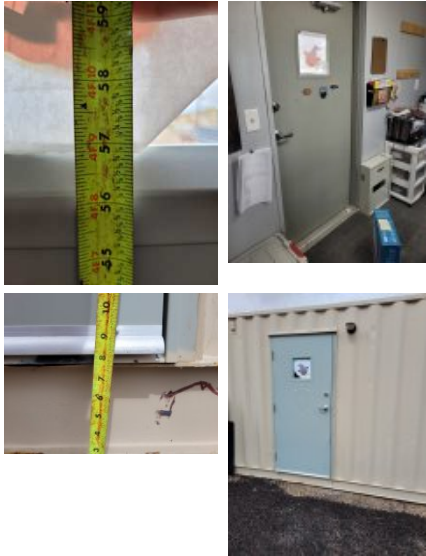
Monahans Sandhills State Park - 2500 I-20 Monahans, TX 79756

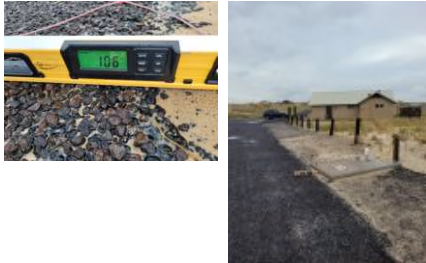
149	Willow Draw Camping Area: Willow Draw - RV Dump Station	[31.61886, -102.812]	Element meets all standards and requirements	reach range for spigot complies at 32" AGL	None	2010 ADAS Section: N/A		
150	Willow Draw Camping Area: Willow Draw - Sample Campsite 25	[31.63566, -102.8168]	An accessible access route is not provided between elements, spaces and the facilities provided within the accessible camping unit. At least one outdoor recreation access route shall connect accessible elements, spaces and facilities provided within camping units with mobility features.	site 25 - no route to 2 of 2 grills, 1 of 1 picnic table	Create AR with crushed and compacted stone or similar outdoor material to camp sites and one of each type of amenity.	2015 ABAAS Section: F244.5.1

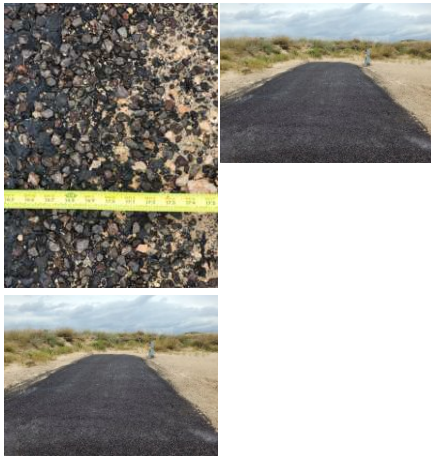
Finding Number	Area Description	Lat/Long	Finding	As Built	Recommendation	Citation	Photos	Figure
154	Willow Draw Camping Area: Willow Draw - Sample Campsite 25	[31.63566, -102.8168]	The surface of parking spaces and pull-up spaces shall be firm and stable. The slope of the surface of parking spaces and pull-up spaces shall not be steeper than 1:48 in any direction. EXCEPTION: Where the surface is other than asphalt, concrete, or boards, slopes not steeper than 1:20 shall be permitted when necessary for drainage.	site 25 - 6.4% slope	Correct surface of parking spaces to be firm and stable with slopes max of 2.08% or 5% for surfaces other than concrete, asphalt or boards as a smart practice.	2015 ABAAS Section: 1012.4, 1012.5, 1012.5 EXCEPTION

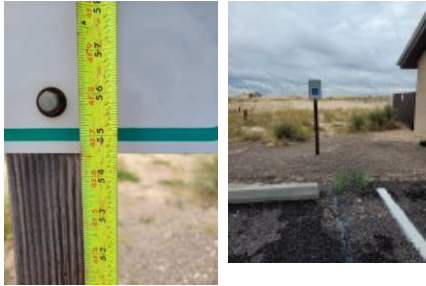
160	Willow Draw Camping Area: Willow Draw - Parking	[31.6351, -102.816]	The van stall is missing a sign identifying it as a van accessible stall. Parking space identification signs shall include the International Symbol of Accessibility. Signs identifying van parking spaces shall contain the designation "van accessible."	at restroom - lacks van sign	Add one van parking sign to one accessible stall and repaint stall and access aisle to 11' and 5' or 8' and 8'.	2015 ABAAS Section: 502.6 2012 TAS Section: 502.6 2010 ADAS Section: 502.6

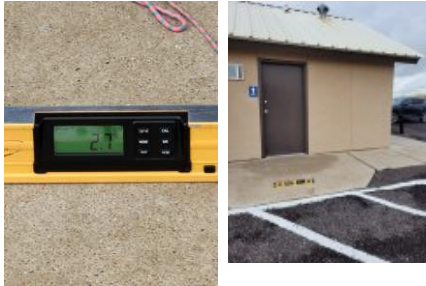
161	Willow Draw Camping Area: Willow Draw - Exterior Accessible Route	[31.63518, -102.8159]	The curb ramp on the accessible route contains cross slopes greater than 2%. Surface cross slopes shall not exceed one unit vertical in 48 units horizontal (2-percent slope).	2.7% cross slope at curb ramp to restroom from accessible parking	Correct curb ramp cross slope to max 2.08%	2015 ABAAS Section: 405.3 2012 TAS Section: 405.3 2010 ADAS Section: 405.3

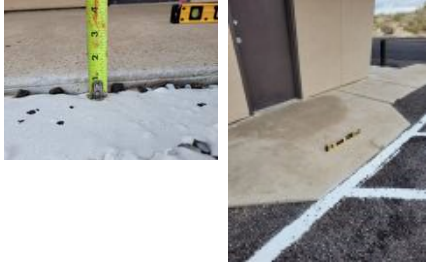
Finding Number	Area Description	Lat/Long	Finding	As Built	Recommendation	Citation	Photos	Figure
164	Willow Draw Camping Area: Willow Draw - Exterior Accessible Route	[31.6351694 , -102.8158992]	There is a gap spaced greater than a 1/2 inch. Openings in floor or ground surfaces shall not allow passage of a sphere more than 1/2 inch diameter. Elongated openings shall be placed so that the long dimension is perpendicular to the dominant direction of travel.	around restroom building - five instances of 2"-2.5" gaps around building	Correct or fill gaps to be max .5".	2015 ABAAS Section: 302.3 2012 TAS Section: 302.3 2010 ADAS Section: 302.3

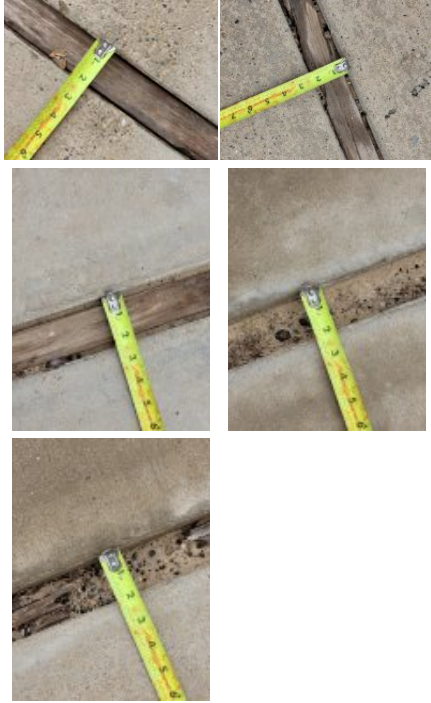
165	Willow Draw Camping Area: Willow Draw - Exterior Accessible Route	[31.6351097 , -102.8159295]	The running slope of walking surfaces shall not be steeper than 1:20. The cross slope of walking surfaces shall not be steeper than 1:48.	5.4% cross slope at turn by men's sign	Correct running slopes to max 5% and cross to max 2.08%.	2012 TAS Section: 403.3 2010 ADAS Section: 403.3

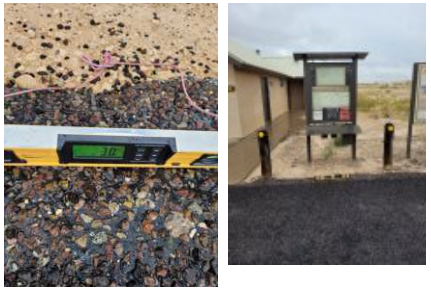
166	Willow Draw Camping Area: Willow Draw - Exterior Accessible Route	[31.6350812 , -102.815845]	The 30 inches minimum by 48 inches minimum clear floor space required at the operable part is not flat (2% or 1:48 maximum slope) in all directions. Changes in level are not permitted at required clear floor or ground space except that slopes not steeper than 1:48 shall be permitted.	3% slope in clear floor space for after hours check in at restroom	Correct or repair slope in CFS to max 2.08%	2015 ABAAS Section: 305.2 2012 TAS Section: 305.2 2010 ADAS Section: 305.2

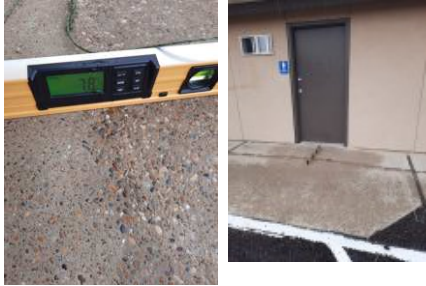
168	Willow Draw Camping Area: Willow Draw - Men's Restroom	[31.6351692 , -102.8158 843]	The rim of the urinal is too high. Wall-hung urinals must be provided with an elongated rim projecting a minimum of 13 1/2 inches from the wall and a maximum of 17 inches above the floor.	Both urinal rim heights 24" AFF, both urinal flush handles at 53.5" AGL	Lower one urinal so that rim height is max 17" AFF and flush handles are max 48" AFF.	2015 ABAAS Section: 605.2 2012 TAS Section: 605.2 2010 ADAS Section: 605.2

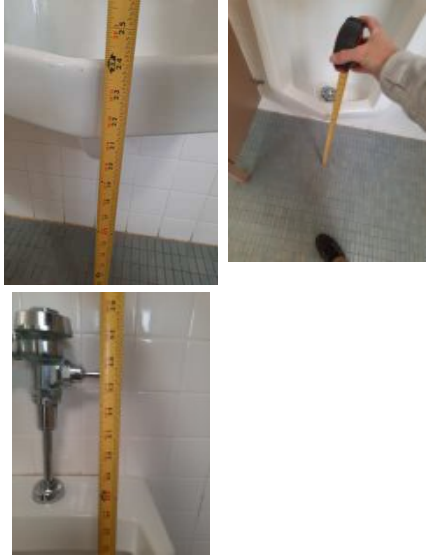
Finding Number	Area Description	Lat/Long	Finding	As Built	Recommendation	Citation	Photos	Figure
169	Willow Draw Camping Area: Willow Draw - Men's Restroom	[31.6351783, -102.8158629]	The bowl of the urinal does not extend out from the wall far enough. Urinals must project a minimum of 13-1/2 inches measured from the outer face of the urinal rim to the back of the fixture and be a maximum of 17 inches above the floor.	Urinal depth is 12.5"	Replace urinal with one having a 13.5" min depth mounted at max 17" to rim with flush controls max 48" aff	2015 ABAAS Section: 605.2 2012 TAS Section: 605.2 2010 ADAS Section: 605.2

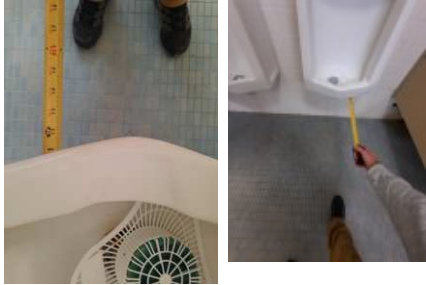
170	Willow Draw Camping Area: Willow Draw - Men's Restroom	[31.635176, -102.8158763]	The toilet is not located within the range allowed from the side wall or partition. The centerline of the toilet must be 16 to 18 inches from the side wall.	toilet centerline 20.25" towards side wall	Remount toilets to 16" to 18" from the side wall to centerline.	2015 ABAAS Section: 604.2 2012 TAS Section: 604.2 2010 ADAS Section: 604.2

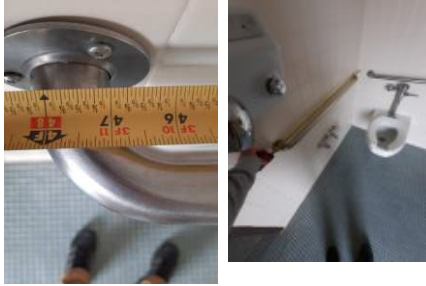
171	Willow Draw Camping Area: Willow Draw - Men's Restroom	[31.6351715, -102.815887]	The side grab bars are not in the correct location. Grab bars on the side wall must be installed so that the end closest to the rear wall is maximum 12" from the rear wall. The end furthest from the rear wall must be mounted minimum 54" from the rear wall.	side grab bar extends 47.5" to grab bar end	Remount side grab bar to max 12" from the rear wall at the close end and min 54" on the far end, and 33" to 36" aff.	2015 ABAAS Section: 604.5.1 2012 TAS Section: 604.5.1 2010 ADAS Section: 604.5.1

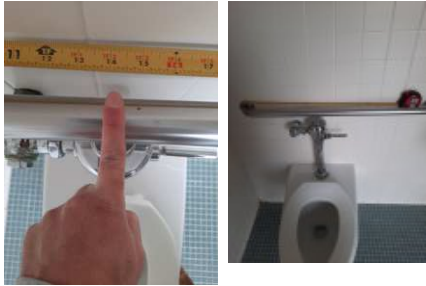
173	Willow Draw Camping Area: Willow Draw - Men's Restroom	[31.6351578, -102.8158816]	The grab bar height and/or spacing fails. Grab bars must be mounted between 33" and 36" to the top of the gripping surface. There must be 1.5" of clearance between the grab bar and the wall. There must be a minimum of 1.5" of clearance below and minimum 12" above the grab bar to any dispenser or other obstruction.	Toilet pipes 1" below rear grab bar, hand dryer 9.5" above side grab bar	Remount hand dryer 15" to 48" above the finished floor (AFF) and min 12" above or 1.5" below grab bar. Adjust pipes if feasible to provide 1.5" clearance below grab bar.	2015 ABAAS Section: 609.3, 609.4 2012 TAS Section: 609.4, 609.3 2010 ADAS Section: 609.3, 609.4

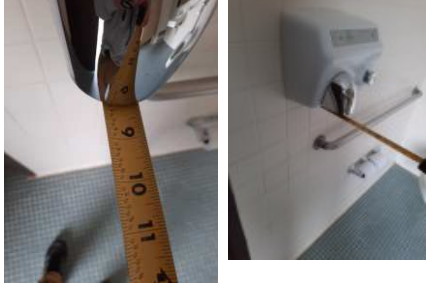
175	Willow Draw Camping Area: Willow Draw - Men's Restroom	[31.6351555, -102.8158789]	An item or items project more than 4 inches into the circulation path. Wall-mounted objects that have leading edges between 27 inches and 80 inches from the floor must not project more than 4 inches into the circulation path. Protruding objects that extend to the floor or within 27 inches of the floor are cane detectable and are therefore not hazardous. Where it is necessary or desirable to have objects protrude from the wall, a manner of cane detection must be provided.	Hand dryer protrudes 8.25"	Relocate protruding objects or place cane detectable warning or bollard at foot of item. Pricing included in previous finding.	2015 ABAAS Section: 307.2 2012 TAS Section: 307.2 2010 ADAS Section: 307.2

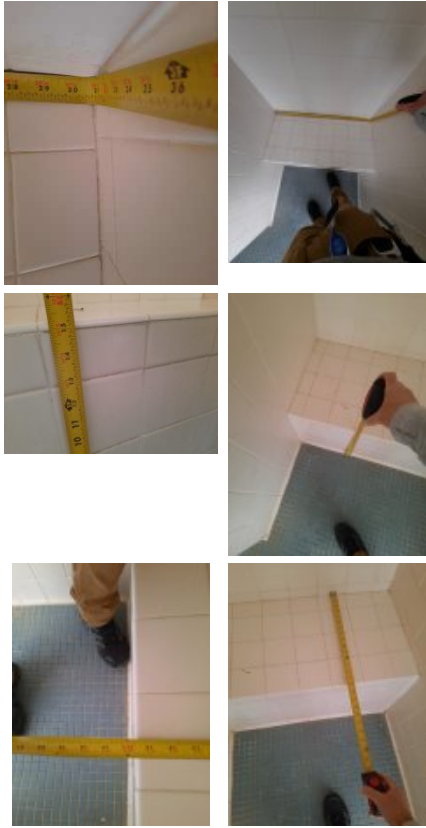
179	Willow Draw Camping Area: Willow Draw - Men's Restroom	[31.635162, -102.8158889]	Transfer type shower compartments shall be 36 inches (915 mm) by 36 inches (915 mm) clear inside dimensions measured at the center points of opposing sides and shall have a 36 inch (915 mm) wide minimum entry on the face of the shower compartment. Clearance of 36 inches (915 mm) wide minimum by 48 inches (1220 mm) long minimum measured from the control wall shall be provided.	38.5" wide shower and entry	Reconfigure transfer shower to compliant 36" by 36" clear inside dimension	2015 ABAAS Section: 608.2.1 2012 TAS Section: 608.2.1 2010 ADAS Section: 608.2.1
