Site Accessibility Evaluation

Monahans Sandhills State Park

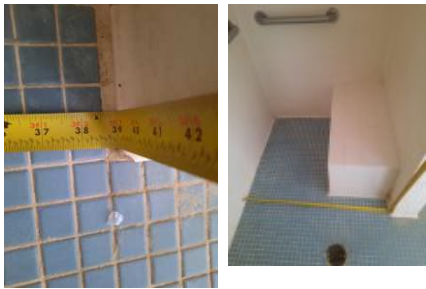
179	Willow Draw Camping Area: Willow Draw - Men's Restroom	[31.635162, -102.8158889]	Transfer type shower compartments shall be 36 inches (915 mm) by 36 inches (915 mm) clear inside dimensions measured at the center points of opposing sides and shall have a 36 inch (915 mm) wide minimum entry on the face of the shower compartment. Clearance of 36 inches (915 mm) wide minimum by 48 inches (1220 mm) long minimum measured from the control wall shall be provided.	38.5" wide shower and entry	Reconfigure transfer shower to compliant 36" by 36" clear inside dimension	2015 ABAAS Section: 608.2.1 2012 TAS Section: 608.2.1 2010 ADAS Section: 608.2.1

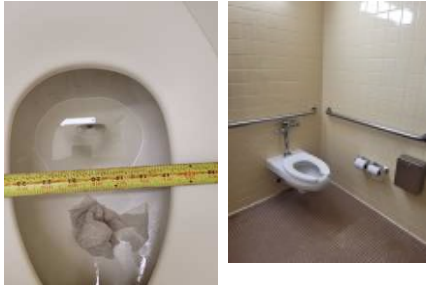
189	Willow Draw Camping Area: Willow Draw - Women's Restroom	[31.6351602, -102.8158858]	The side grab bars are not in the correct location. Grab bars on the side wall must be installed so that the end closest to the rear wall is maximum 12" from the rear wall. The end furthest from the rear wall must be mounted minimum 54" from the rear wall.	side grab bar extends 47" to grab bar end	Remount side grab bar to max 12" from the rear wall at the close end and min 54" on the far end, and 33" to 36" aff.	2015 ABAAS Section: 604.5.1 2012 TAS Section: 604.5.1 2010 ADAS Section: 604.5.1

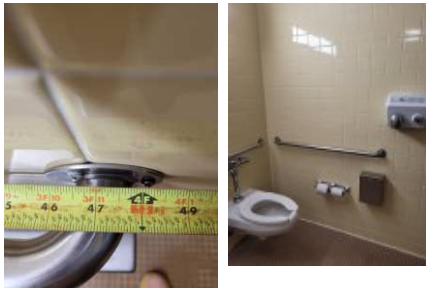
190	Willow Draw Camping Area: Willow Draw - Women's Restroom	[31.6351533, -102.8158805]	The grab bar height and/or spacing fails. Grab bars must be mounted between 33" and 36" to the top of the gripping surface. There must be 1.5" of clearance between the grab bar and the wall. There must be a minimum of 1.5" of clearance below and minimum 12" above the grab bar to any dispenser or other obstruction.	rear has .5" clearance under grab bar due to toilet	Remount grab bars in accessible stall to 33" to 36" above the finished floor (AFF) and provide min 12" above and 1.5" below grab bar.	2015 ABAAS Section: 609.3, 609.4 2012 TAS Section: 609.4, 609.3 2010 ADAS Section: 609.3, 609.4

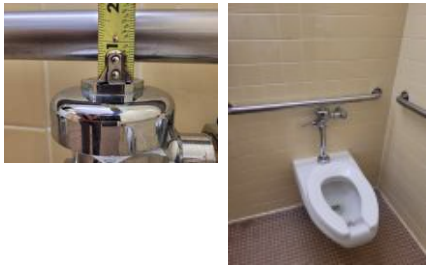
Finding Number	Area Description	Lat/Long	Finding	As Built	Recommendation	Citation	Photos	Figure
191	Willow Draw Camping Area: Willow Draw - Women's Restroom	[31.6351556, -102.8158858]	An item or items project more than 4 inches into the circulation path. Wall-mounted objects that have leading edges between 27 inches and 80 inches from the floor must not project more than 4 inches into the circulation path. Protruding objects that extend to the floor or within 27 inches of the floor are cane detectable and are therefore not hazardous. Where it is necessary or desirable to have objects protrude from the wall, a manner of cane detection must be provided.	dryer projects 8"	Relocate protruding objects or place cane detectable warning or bollard at foot of item.	2015 ABAAS Section: 307.2 2012 TAS Section: 307.2 2010 ADAS Section: 307.2

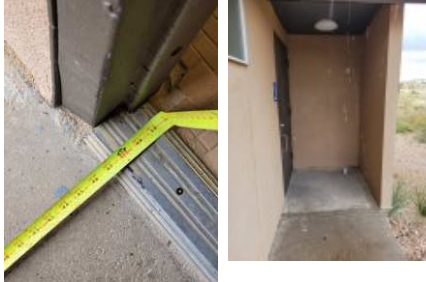
193	Willow Draw Camping Area: Willow Draw - Women's Restroom	[31.635158, -102.8158851]	Coat hooks provided within the room shall be located within one of the reach ranges specified in 308. Shelves shall be 40 inches (1015 mm) minimum and 48 inches (1220 mm) maximum above the finish floor or ground. Where coat hooks or shelves are provided in dressing, fitting or locker rooms without individual compartments, at least one of each type shall comply with 803.5. Where coat hooks or shelves are provided in individual compartments at least one of each type complying with 803.5 shall be provided in individual compartments in dressing, fitting, or locker rooms required to comply with 222.1.	hook 65" AFF	Remount at least one hook to max 48" aff.	2015 ABAAS Section: 308.2.1, 308.1, F222.2, 803.5 2012 TAS Section: 308.2.1, 308.1, 222.2, 803.5 2010 ADAS Section: 308.2.1, 308.1, 222.2, 803.5

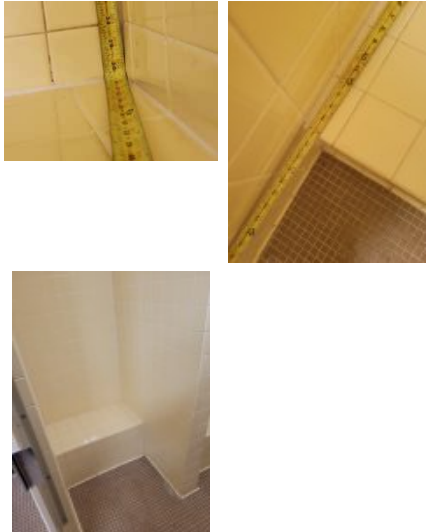
195	Willow Draw Camping Area: Willow Draw - Women's Restroom	[31.6351648, -102.8158904]	Transfer type shower compartments shall be 36 inches (915 mm) by 36 inches (915 mm) clear inside dimensions measured at the center points of opposing sides and shall have a 36 inch (915 mm) wide minimum entry on the face of the shower compartment. Clearance of 36 inches (915 mm) wide minimum by 48 inches (1220 mm) long minimum measured from the control wall shall be provided.	shower opening 40" width	Reconfigure transfer shower to compliant 36" by 36" clear inside dimension.	2015 ABAAS Section: 608.2.1 2012 TAS Section: 608.2.1 2010 ADAS Section: 608.2.1

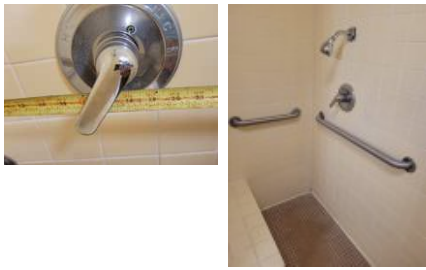
Finding Number	Area Description	Lat/Long	Finding	As Built	Recommendation	Citation	Photos	Figure
197	Willow Draw Camping Area: Willow Draw - Women's Restroom	[31.6351762, -102.8158878]	There is no hand held sprayer unit. The sprayer unit must have a 59 inches hose and be mounted 48 inches maximum to the top of mounting bracket off the floor. The shower spray unit shall have an on/off control with a non-positive shutoff. If an adjustable-height shower head on a vertical bar is used, the bar shall be installed so as not to obstruct the use of grab bars.	shower head lacks hose, fixed shower head 53" AFF	Replace shower control with a compliant lever control with a shower head on a 59" hose and usable as hand held or lower fixed shower head to max 48" AFF.	2015 ABAAS Section: 608.6 2012 TAS Section: 608.6 2010 ADAS Section: 608.6

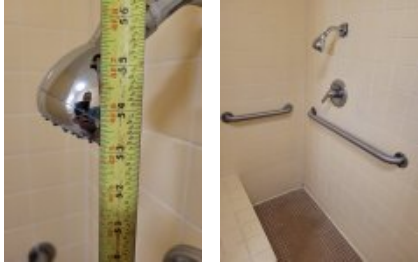
<p>SHOWER SPRAY UNIT</p>

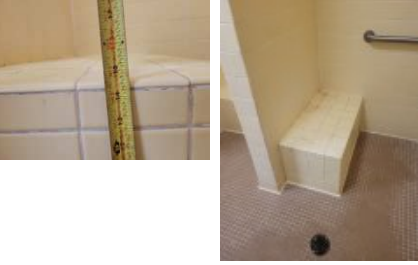
198	Willow Draw Camping Area: Willow Draw - Women's Restroom	[31.6351602, -102.8158931]	The shower seat height is noncompliant. A seat in a standard roll-in shower compartment shall be a folding type, shall be installed on the side wall adjacent to the controls, and shall extend from the back wall to a point within 3 inches of the compartment entry. A seat in an alternate roll-in type shower compartment shall be a folding type, shall be installed on the front wall opposite the back wall, and shall extend from the adjacent side wall to a point within 3 inches of the compartment entry. The top of the seat shall be 17 inches minimum and 19 inches maximum above the bathroom finish floor.	shower seat at 14.5" AFF	Remount shower seat to the correct location and height of 17" to 19" AFF in the shower	2015 ABAAS Section: 610.3 2012 TAS Section: 610.3 2010 ADAS Section: 610.3

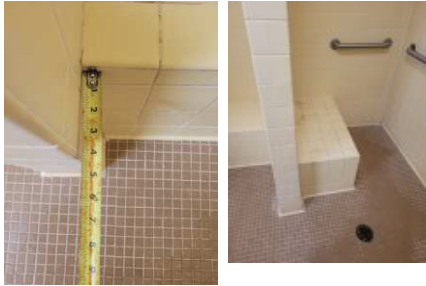
200	Willow Draw Camping Area: Willow Draw - Women's Restroom	[31.6351758 , -102.8158 704]	The 30 inches minimum by 48 inches minimum clear floor space required at the operable part is not flat (2% or 1:48 maximum slope) in all directions. Changes in level are not permitted at required clear floor or ground space except that slopes not steeper than 1:48 shall be permitted.	3.4% slope in clear floor space for shower transfer	Correct or repair slope in CFS to max 2.08%	2015 ABAAS Section: 305.2 2012 TAS Section: 305.2 2010 ADAS Section: 305.2

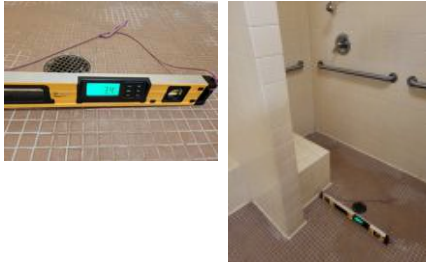
Finding Number	Area Description	Lat/Long	Finding	As Built	Recommendation	Citation	Photos	Figure
201	Willow Draw Camping Area: Willow Draw - Women's Restroom	[31.6351575, -102.8158946]	The stall door fails to comply with all of the door requirements. The stall door must be a minimum of 32" wide and have compliant hardware on both sides. The stall door must be self-closing.	shower stall door - not self closing, lacks hardware on push	Adjust stall door to be self-closing Replace stall hardware with hardware operable without a tight pinch or grasp on both sides of the stall door	2015 ABAAS Section: 404.2.3, 404.2.7, 604.8.2.2 2012 TAS Section: 404.2.3, 404.2.7, 604.8.2.2 2010 ADAS Section: 404.2.3, 404.2.7, 604.8.2.2

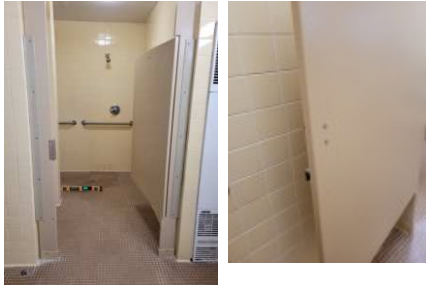
202	Willow Draw Camping Area: Willow Draw - Women's Restroom	[31.6351689, -102.8158758]	Exterior doors exceed 8.5 lbs of force to open; fire doors shall have a minimum opening force allowable by the appropriate administrative authority	Door to accessible stall - 25lbf	Inspect, adjust, and maintain 8.5 lbf to open exterior doors as a smart practice	2010 ADAS Section: 404.2.9

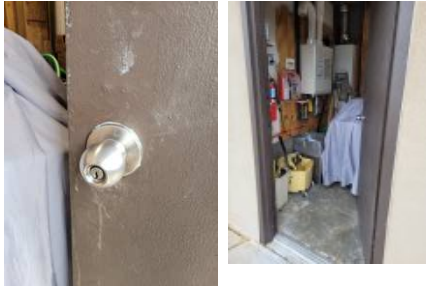
Monahans Sandhills State Park - 2500 I-20 Monahans, TX 79756
