FEDERAL AID PROJECT F-221-M-5

INLAND FISHERIES DIVISION MONITORING AND MANAGEMENT PROGRAM

2014 Fisheries Management Survey Report

Stamford Reservoir

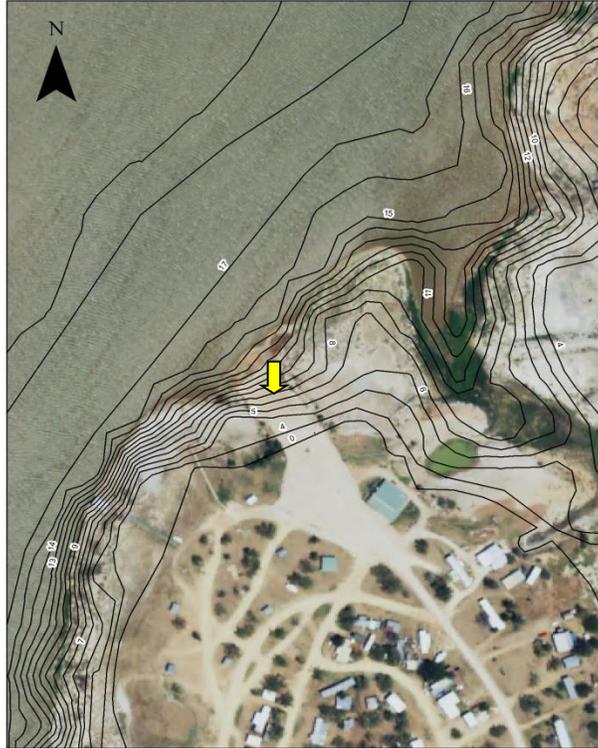
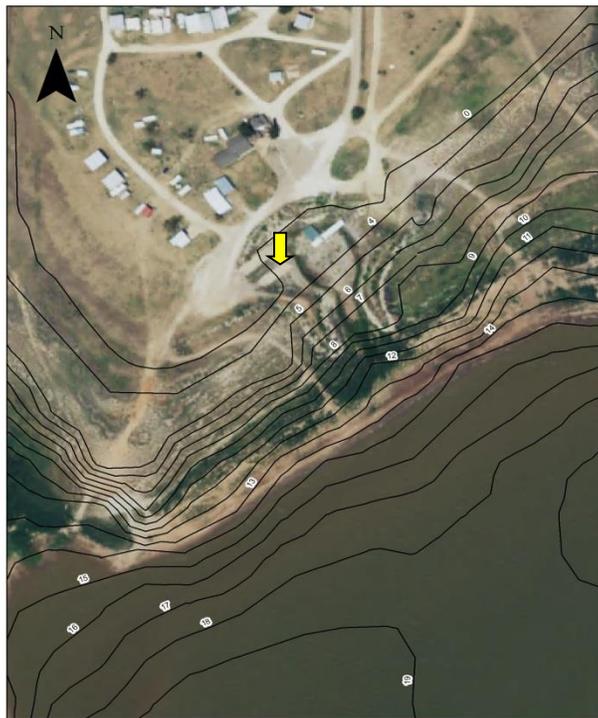
APPENDIX B

Aerial photographs with bathymetric one-foot contours (Scale 1:2000; USDA National Agricultural Imagery Program 2014) at Stamford Marina (top) and Anchor Marina (bottom) boat ramps, Stamford Reservoir, Haskell County, Texas. Yellow arrow indicates location of each ramp.

Stamford Reservoir has two public boat ramps. However, during the survey period (until mid-May 2015), both ramps were out of water because of prolonged drought and low water level. During the periods of low water level, anglers accessed portions of the lake bed and launched small boats off the bank. Anchor Marina Ramp is located on the north side of the reservoir off of Farm-to-Market Rd 3495 and Anchor Lane. The second boat ramp is located at Stamford Marina on the southern side of the reservoir off of FM 2976 and Stamford Marina Drive. Bank and handicapped access were restricted to the areas around the boat ramps and a pay-for-fishing dock that operated sporadically from 2008-present. Additional boat ramp characteristics are located in Table 2. Aerial photographs of the ramps are available in Appendix B.

ISSUE 2: During most of the survey period, boaters were unable to access the reservoir at the two access sites (Anchor and Stamford marinas) because of low water level. As a result, many boaters launched in sloped areas of exposed lake bed near the ramps. During a period of low water level, boat ramp improvements could be made to extend Stamford Marina Ramp for access; Anchor Marina Ramp cannot be feasibly extended (photos of ramps in Appendix B).
