Middle Colorado River Basin Bioassessment

River Studies Report No. 30

Inland Fisheries Division
Texas Parks and Wildlife Department
Austin, Texas

July 2020

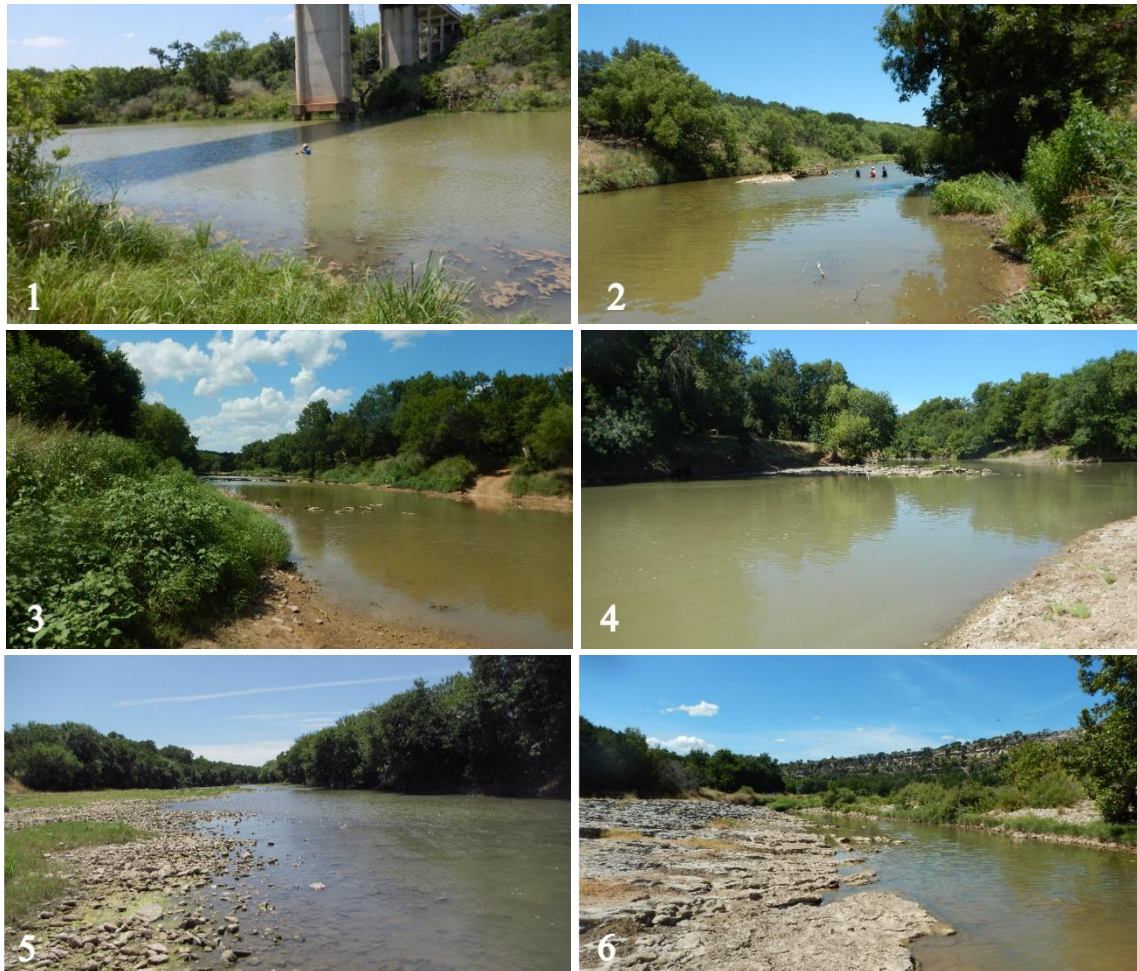
FIGURE 4.—Supplemental sites 1–6 on the Colorado River sampled in summer 2017 in McCulloch and San Saba counties, TX.

Six mainstem supplemental collection sites were sampled throughout the middle Colorado River Basin (Sites 1–6; Figure 1; Table 1). These sites were sampled to update fish occurrence data in the statewide Fishes of Texas Project database (Hendrickson and Cohen 2015). A subset was selected for mussel sampling (Sites 2, 4, and 5). Limited quantitative habitat data was collected from supplemental sites; however, photos of each site are included to provide a reference of conditions at the time of sampling (Figure 4).

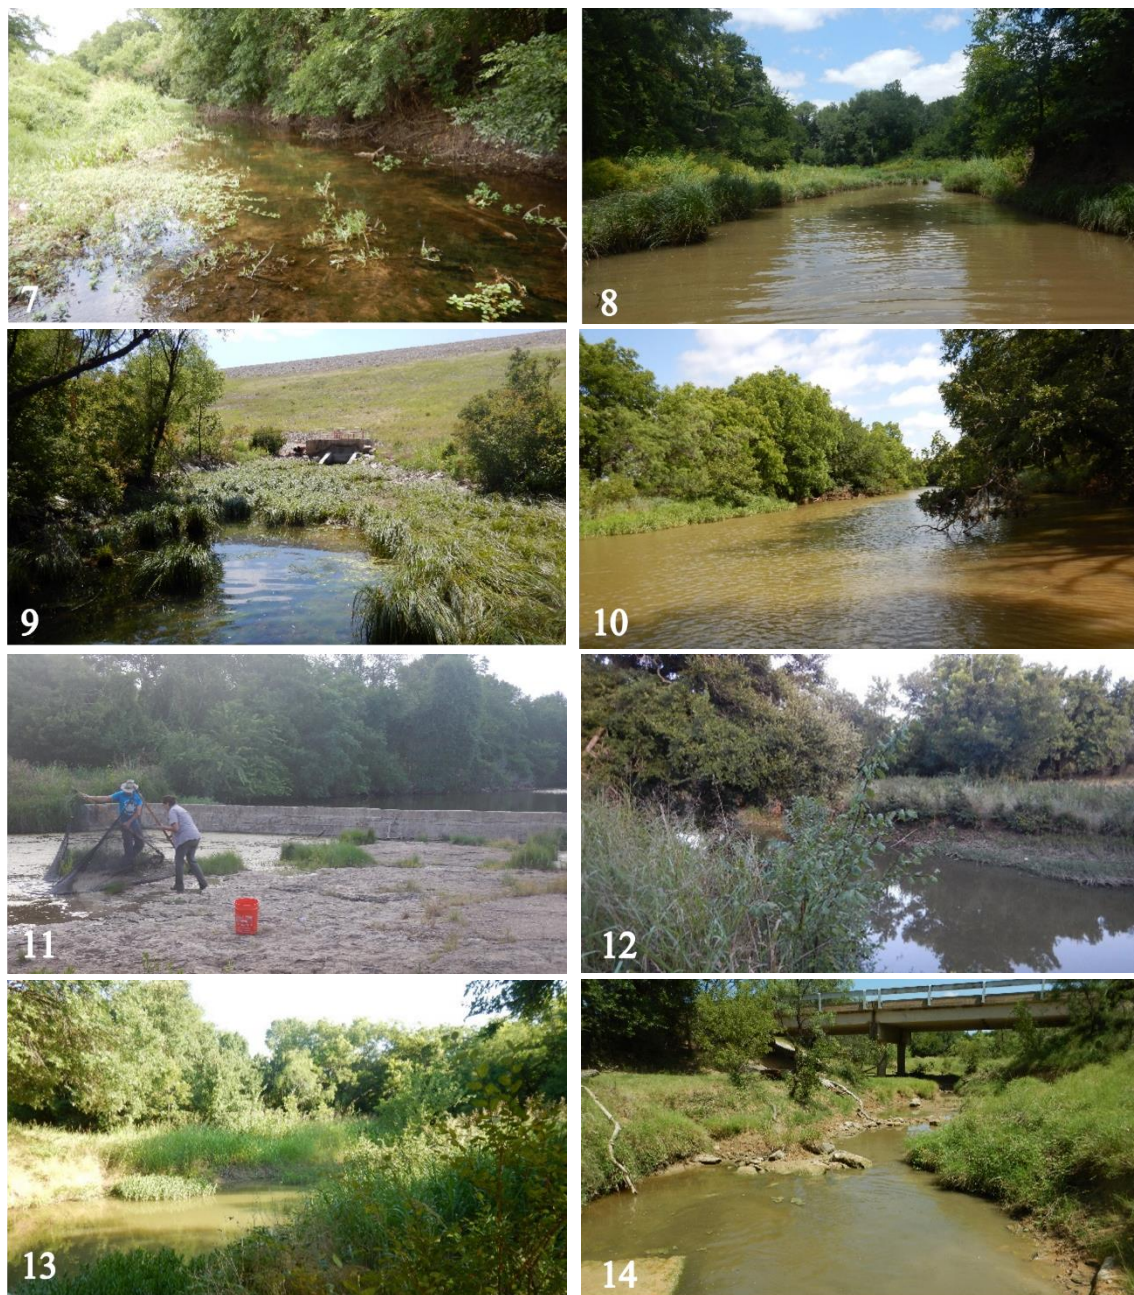
FIGURE 5.—Supplemental tributary sites 7–33 (*29 not pictured) on the Colorado River sampled in spring and summer 2017 in Brown, Coleman, McCulloch, Mills, and San Saba counties, TX.

Twenty-six supplemental tributary sites were sampled throughout the basin (Sites 7–33; Figure 1; Table 1). These sites were sampled to fill temporal or spatial fish data gaps and two were selected for mussel surveys (Sites 18 and 29). Limited quantitative habitat data was collected; however, photos of each site are included to provide a reference of conditions at the time of sampling (Figure 5).

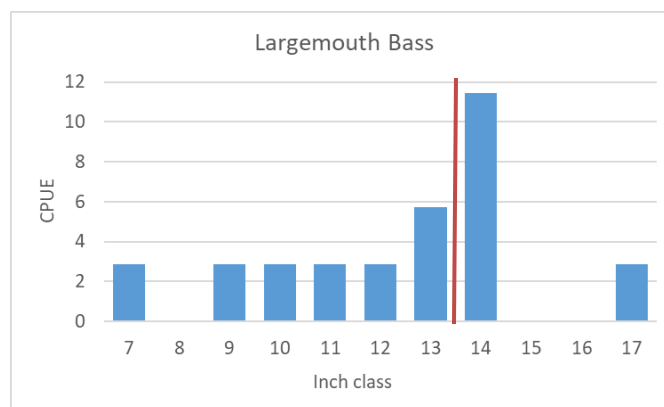
FIGURE 17. —Number of Largemouth Bass collected by inch class caught per hour (CPUE) during boat electrofishing at Site A on the Colorado River at Colorado River Bend State Park on July 27, 2017 with the red line denoting the minimum length limit. Additional juvenile Largemouth Bass were collected seining, but were not measured for total length and are not included here.
